Corrosion of Post-Tensioning Strands in UngROUTED Ducts - Unstressed Condition

A thesis submitted in partial fulfillment
of the requirements for the degree of
Master of Science in Materials Science and Engineering
Department of Chemical and Biomedical Engineering
College of Engineering
University of South Florida

Keywords: Wire Bending, Relative Humidity,
Seven-wire Steel Strand, Shallow Pitting, Marine Exposure

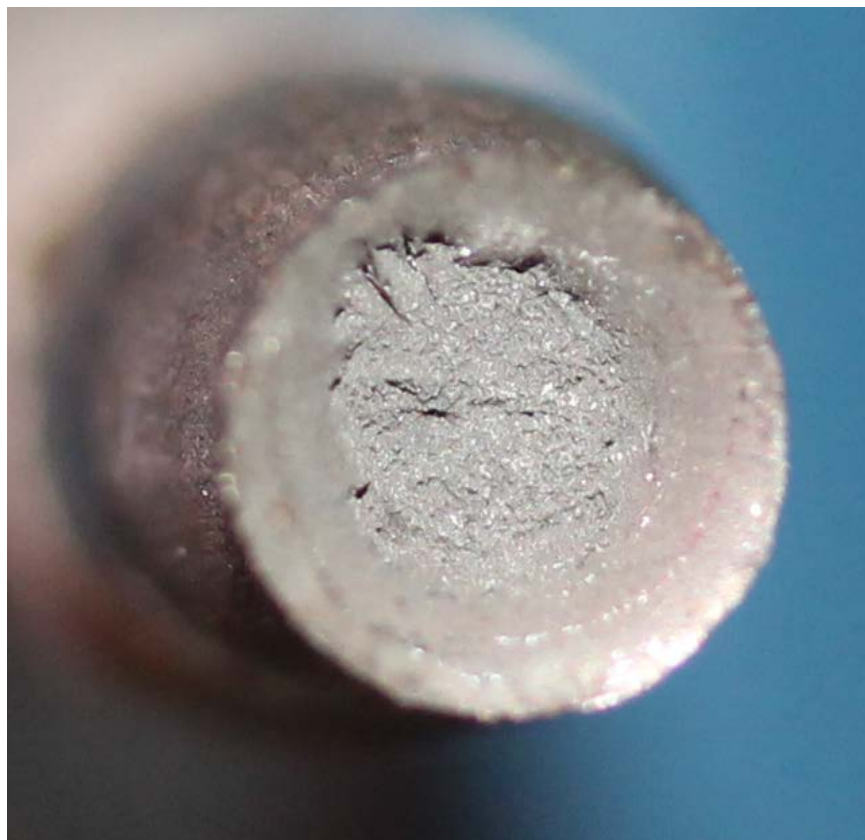
Figure 54 Typical Fracture Surface (3/4)

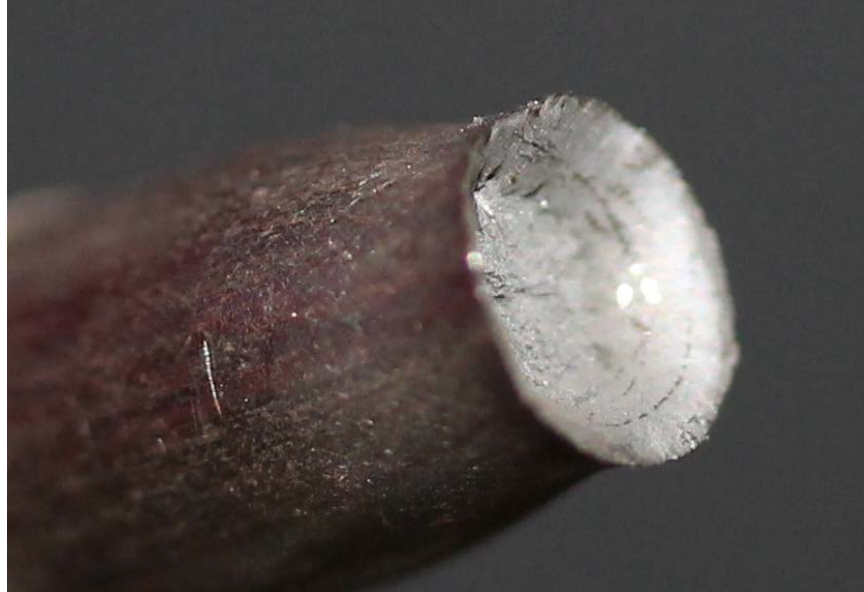
Figure 55 Typical Fracture Surface (4/4)

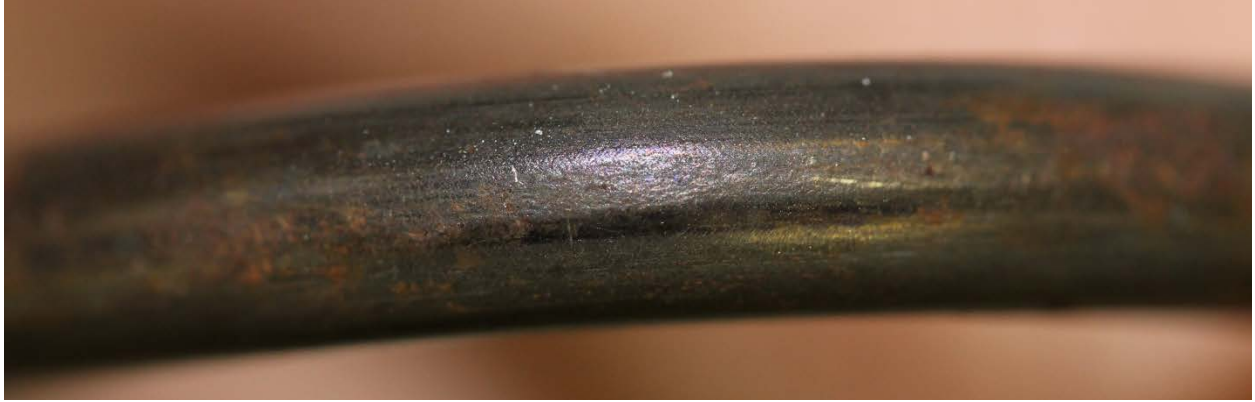
Figure 56 9-Month SSK Wet Exposure Sample - Exterior of Bend Surface

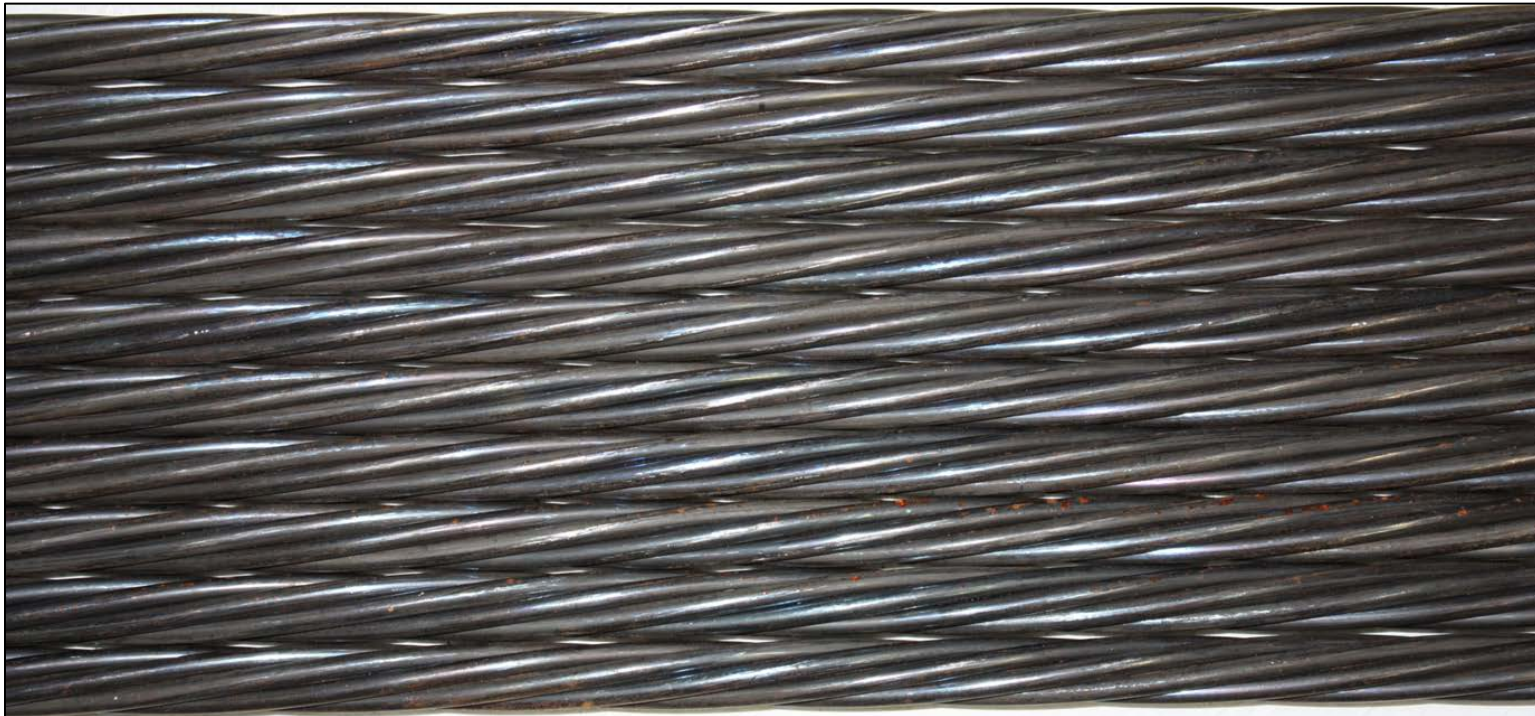
Figure A1.71 Typical As Received Condition of Strands Prior to Exposure
