## Creating A Scaling Relationship Between Peak Discharge And Drainage Area To Identify Tile Drainage Inputs Into An Agricultural Stream

Ryan Plath

CREATING A SCALING RELATIONSHIP BETWEEN PEAK DISCHARGE AND  
DRAINAGE AREA TO IDENTIFY TILE DRAINAGE INPUTS INTO AN  
AGRICULTURAL STREAM

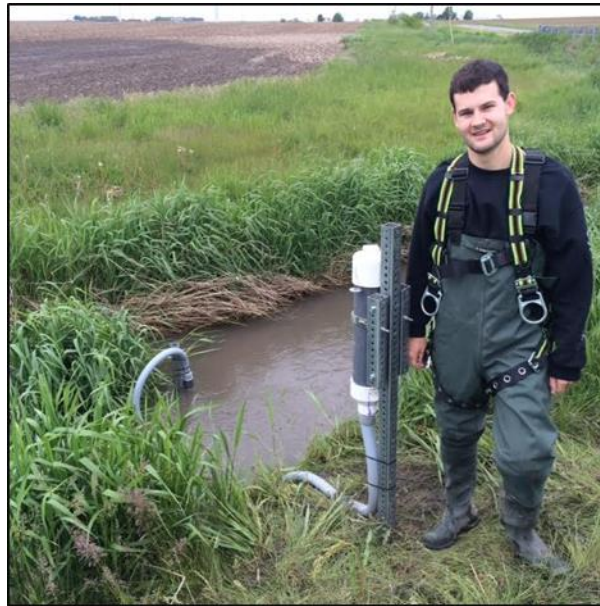
*Figure 5.* The PVC Stilling well (in the stream) connected by conduit to the onshore PVC Unit. I secured both ends to metal posts.

I installed HOBO MX pressure transducers at the eight different sampling locations along Money Creek. At each site, the sensing end of the pressure transducer was secured in a PVC stilling well. The wiring was run through conduit to an onshore PVC unit that housed the logging end of the pressure transducer and protected the electronic components from the elements (Figs. 5 & 6).

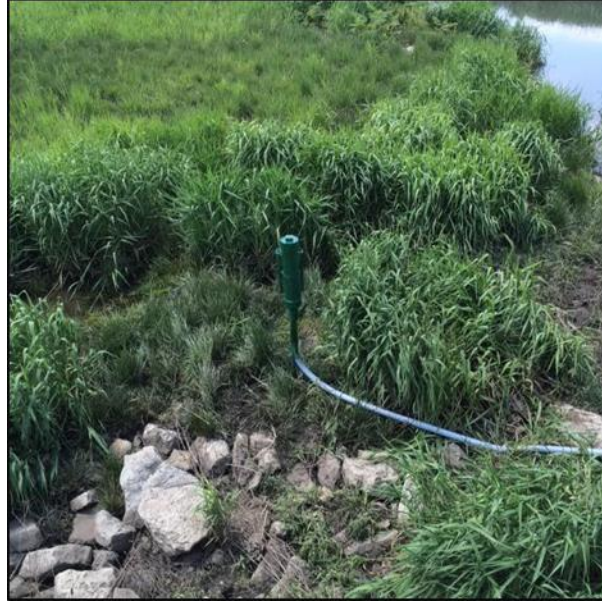
*Figure 6.* The onshore PVC Unit that houses the logging end of the pressure transducer.

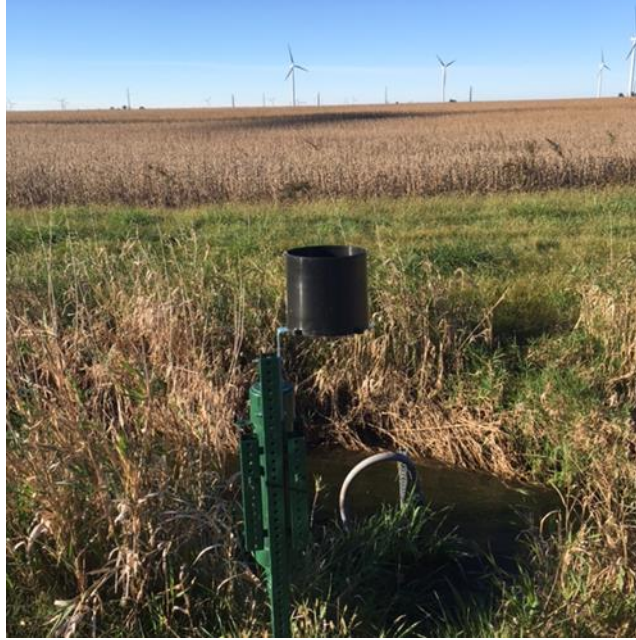
*Figure 9.* Rain gauge setup used at each site. I attached Rain gauge to the post that houses the logging end of the pressure transducer.

I collected precipitation data from September 23, 2016 through January 21, 2017. I deployed Rainwise tipping-bucket rain gauges at each of the eight sites, but discarded the data from Site 3 because it only made measurements during installation and removal. I attached the rain gauges, approximately 1.2 meters above the ground to posts that house the logging end of the pressure transducer (Fig. 9). The rain gauge at site 5 was clogged with sediment on January 21, 2017, so measured precipitation values are likely artificially low in December and January. This study did not use publically available Bloomington airport precipitation data from before September 23, because that data does not provide the necessary spatial or temporal resolution needed for analysis of individual stream sites.

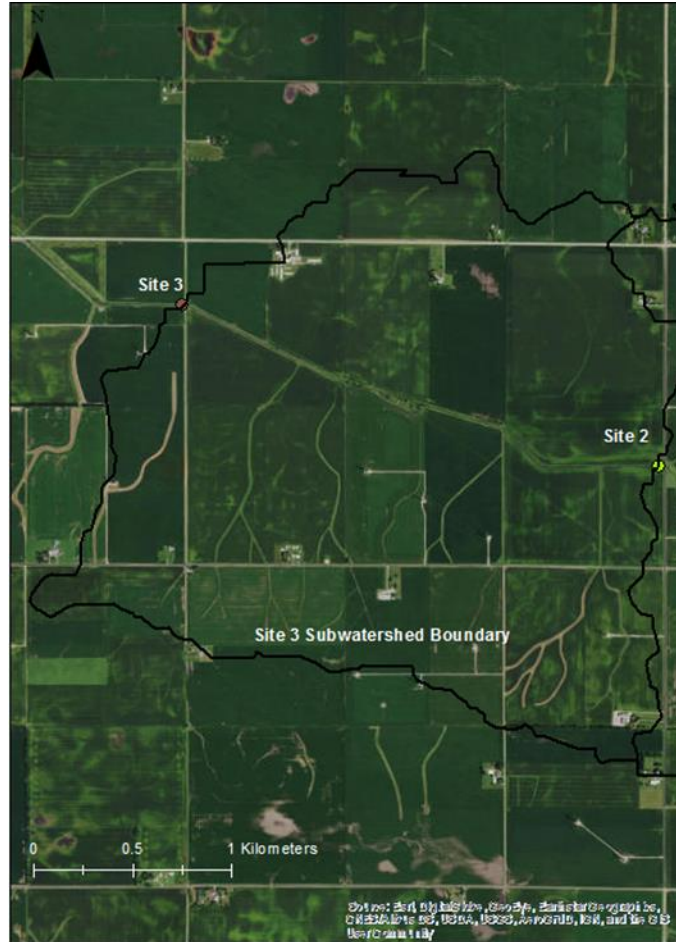
*Figure 61.* An Aerial image showing the site 3 subwatershed and the western border of the Site 2 subwatershed. The creek flows from east to west. Notice that the total area of fields that exist both within and outside of the Site 3 watershed is limited.

Despite there not being any patterns within the outliers suggesting tile drain input, there did appear to be a few separate patterns within the summary tables of data. Site 3 appears to be an upper outlier repeatedly during tileflow conditions; it was an upper outlier three times during

early summer tileflow and twice during fall tileflow conditions (Table 7-9). During the no tileflow period, it was only above the scaling relationship once, during Storm 7. In the other storms during no-tileflow, the site was either not an outlier or an outlier that plotted below the scaling relationship.

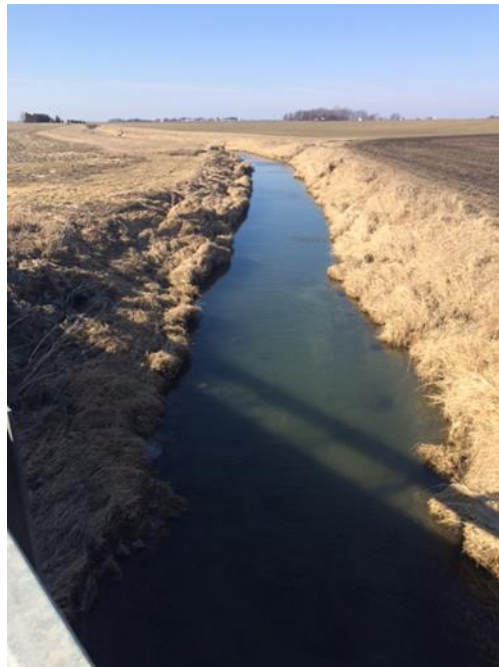
Figure 63. Picture of site 5 before storm 17. Notice the ripple section is not present.

appears to have caused a sudden drop in measured stage (Fig. 62). Signs of beavers have been observed in this watershed. This sudden drop in stage could have been the result of a beaver dam that burst downstream during the storm, thus suddenly lowering stage. Upon visual examination, there appeared to be a change in channel morphology from this drop in stage. The pressure transducer, which originally was at the streambed, was now around six inches above the surface of the streambed due to scouring. Originally, the streambed had a mixture of sediment near the bottom, now the streambed is just bare clay (Fig. 63 & 64). Storm 17 converted the area just downstream of the recording station from a straight stretch of stream into a ripple section with large cobbles and boulders, much of which appears to be from limestone blocks that were used to fill the area beneath the bridge during construction (Figs. 64 & 65).

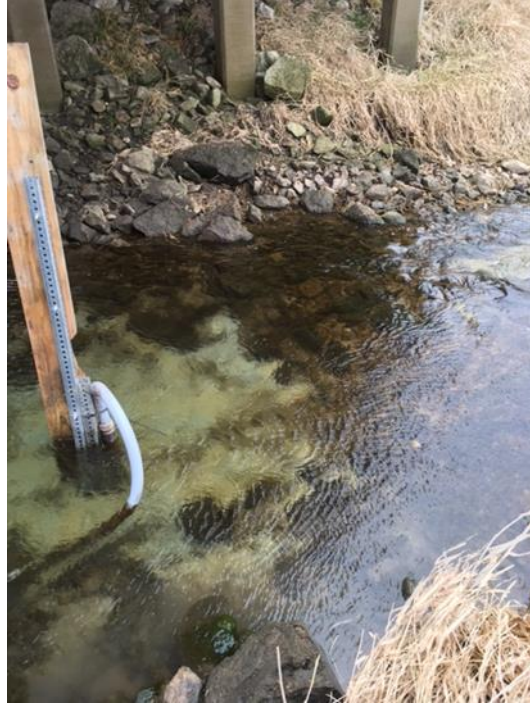
*Figure 64.* Streambed scouring and bare clay beneath the pressure transducer at Site 5 after Storm 17. Note the transition from the scoured pool section of the stream to the run with larger cobbles and boulders.

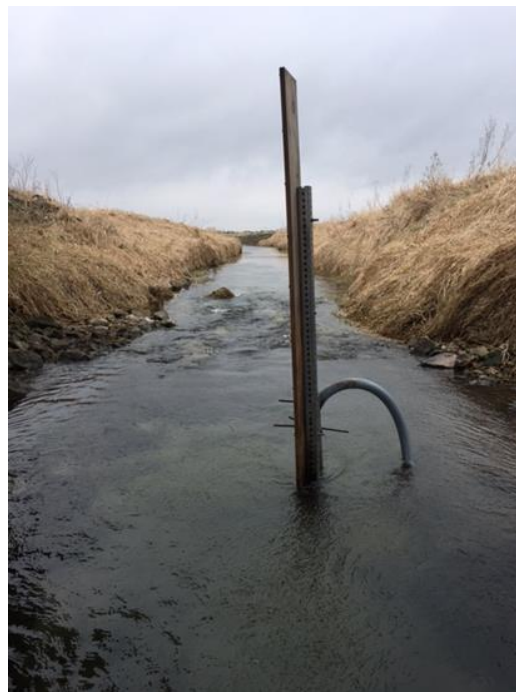
*Figure 65.* The streambed morphology changed after Storm 17. The storm moved cobbles and boulders, from near the pressure transducer and bridge, downstream to the area with ripples. This invalidated the rating curve at Site 5 for any measurement after the morphologic change.

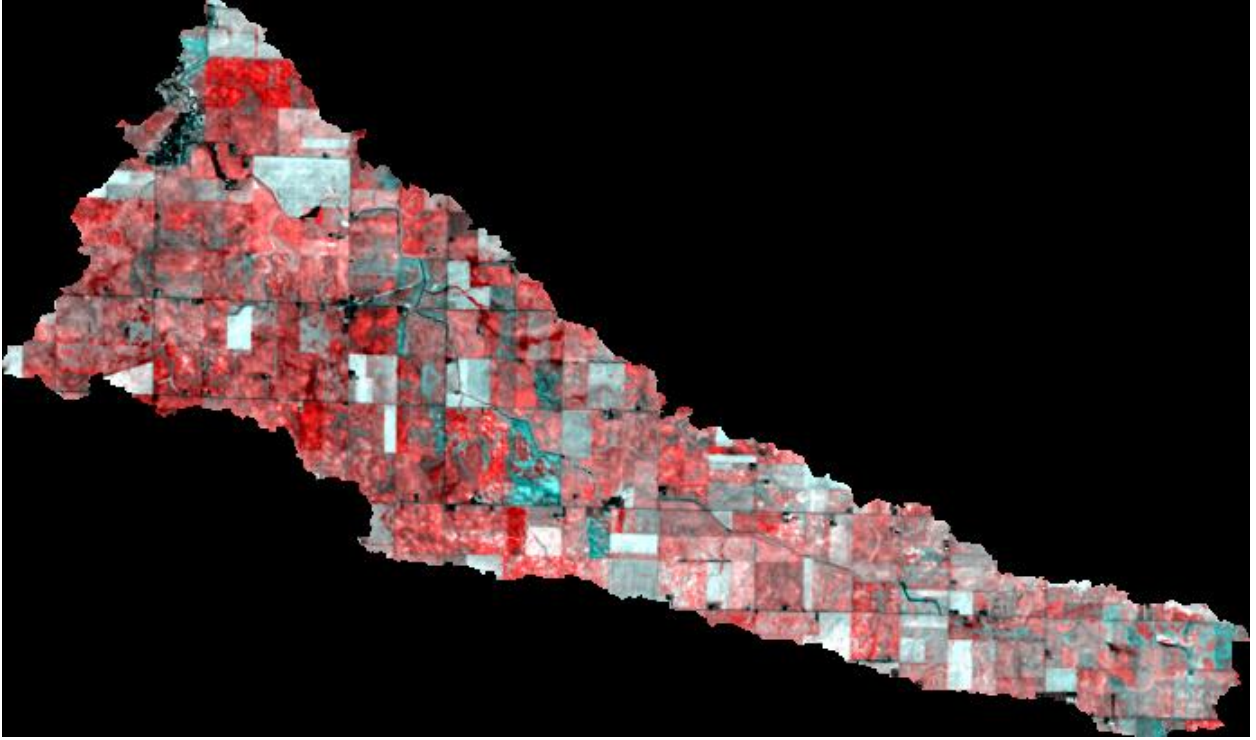
*Figure A – 1.* Map produced through remote sensing project.

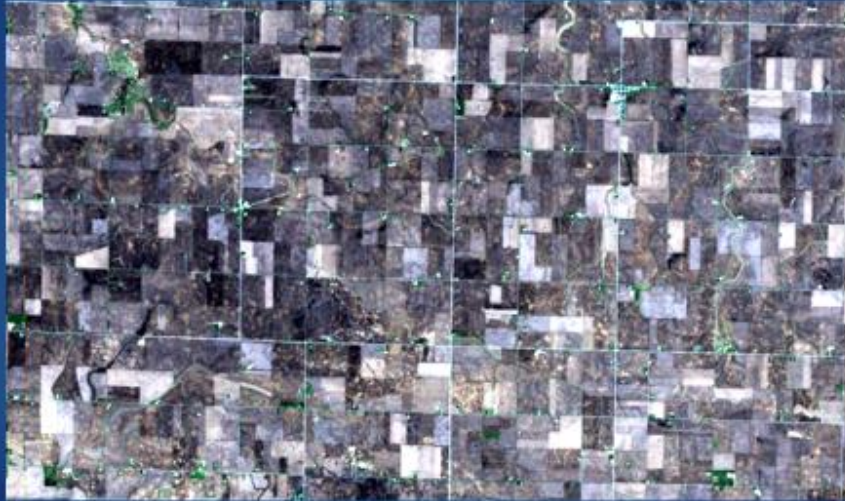
## Step 3

- ▶ Mixed Raster image for **band 5** of the two selected images
  - ▶ Image 1 = red
  - ▶ Image 2 = Green and blue

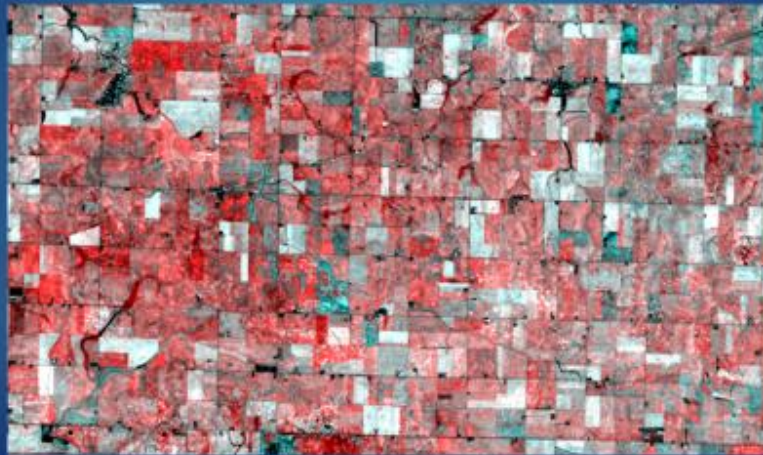
## Step 4

- ▶ Image Differencing

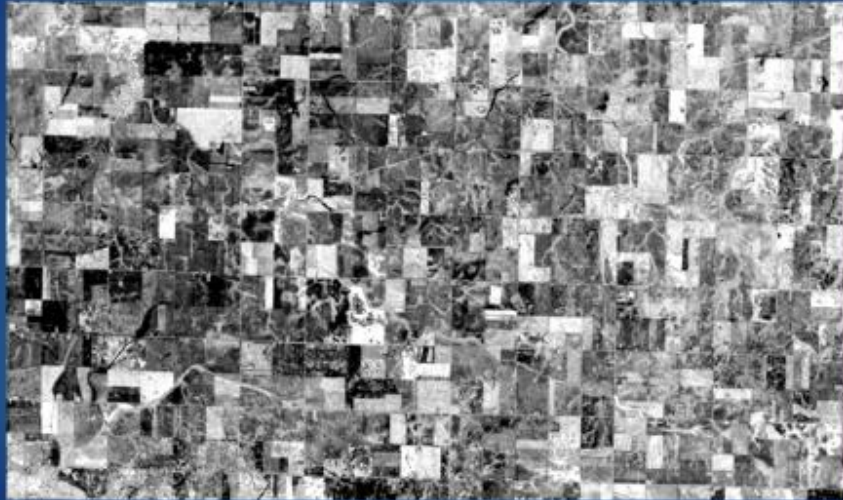
## Step 5

- ▶ Built mask of watershed

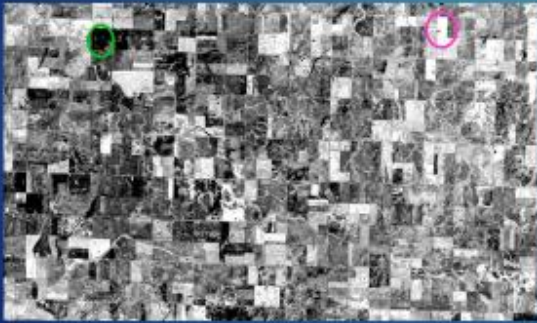
- ▶ Pink Circles represent well drained fields
- ▶ Green Circles represent poorly drained fields
- ▶ Grays/pale colors represent little to no change
