Damage detection through acoustic emission of fracture processes in concrete masonry units

DAMAGE DETECTION THROUGH ACOUSTIC EMISSION OF FRACTURE
PROCESSES IN CONCRETE MASONRY UNITS

A THESIS

MASTER OF SCIENCE IN CIVIL ENGINEERING

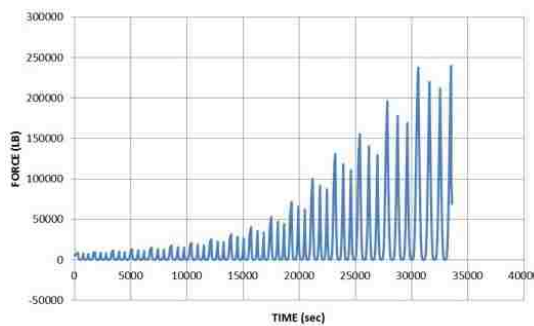
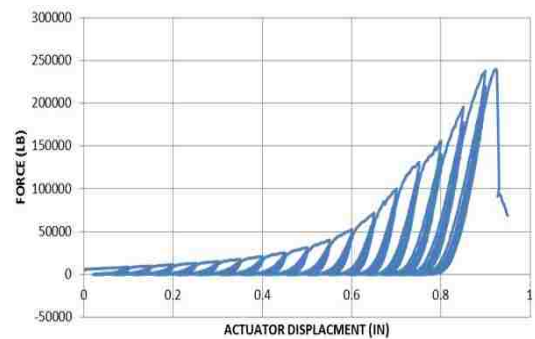
(a) Force-Time Plot 37% Rubber CMU Grouted

(b) Force-Displacement plot 37% rubber CMU grouted

Two major benefits were identified in the rubber which can be seen in the force displacement relationship. The 37% rubber brick was able to endure more cycles of loading thus higher strain. In contrast, the normal grouted specimen (see Figure 3.4) suffered from a lack of stiffness and strength during the last complete cycle. The softening behavior can be seen in the plots of force and displacement in Figures 3.4b and 3.5b as the change in the slope of the force displacement curve. Interestingly, the slope of the last group of curves in Figure 3.4b is more shallow indicating the material softened. The

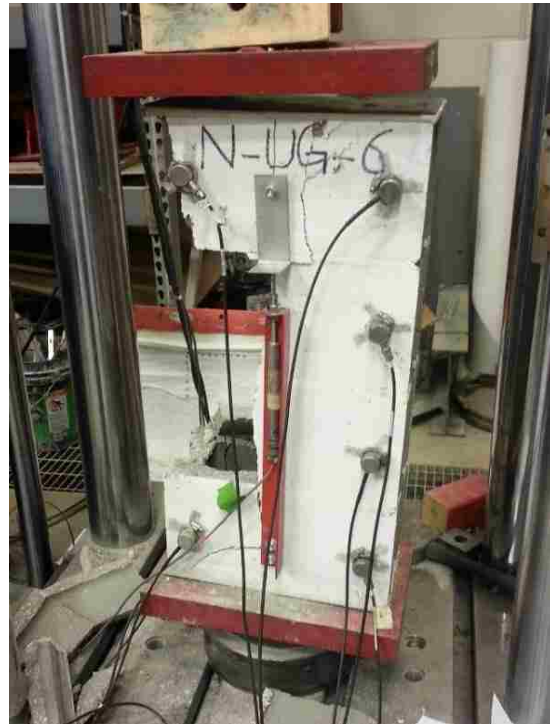
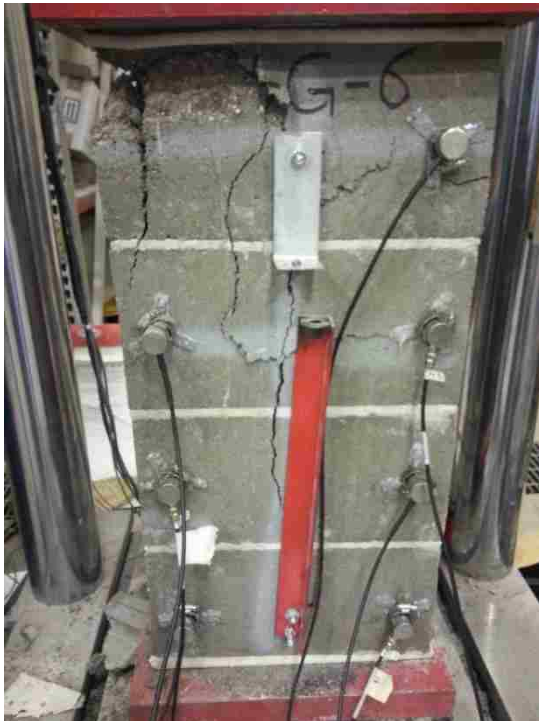
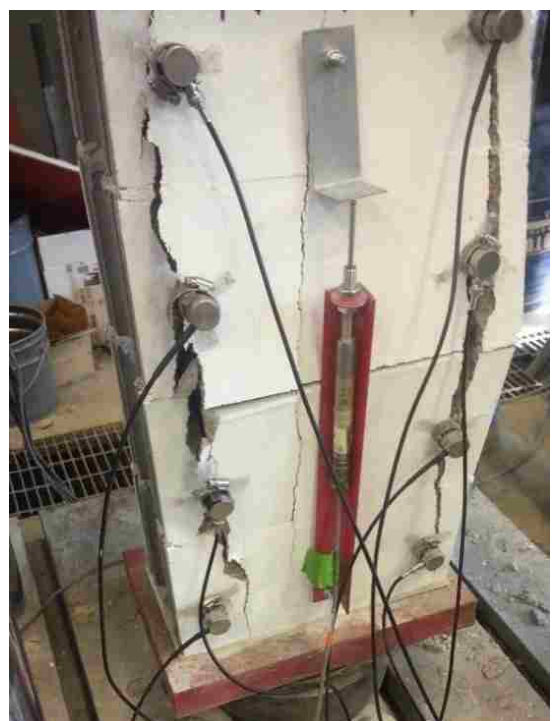
(a) 37% Rubber CMU UngROUTed

(b) Normal CMU UngROUTed

(c) 37% Rubber CMU Grouted

(d) Normal CMU Grouted

Figure 3.6. Damaged specimens with and without grout from the completion of cyclic test with and without Rubber

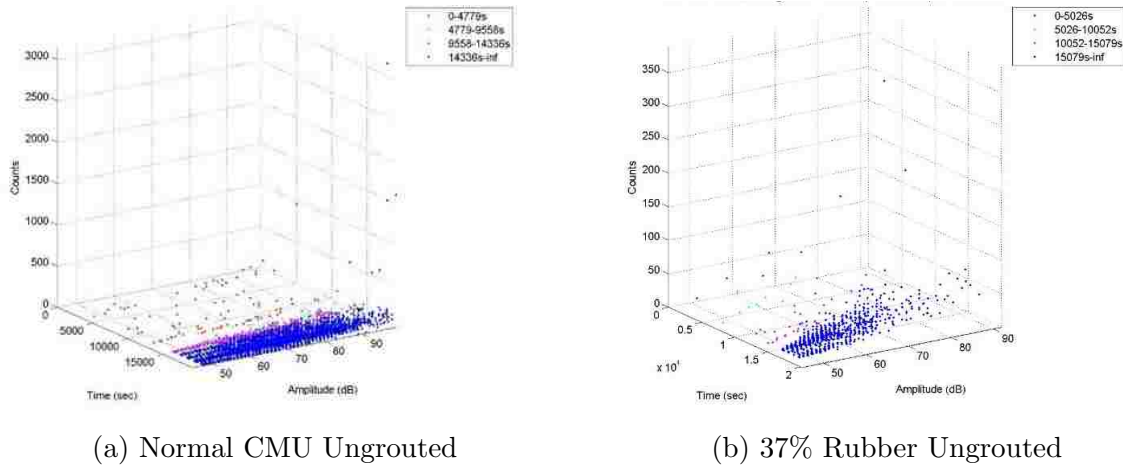
Figure 3.8. R sensors ungrouted specimens amplitude-counts-time

number of times the waveform passed a threshold (counts), there were some interesting trends. Plots of amplitude and counts over time, Figures 3.8 and 3.9 and Appendices A13, A14, A17 and A18 reveal that significant structural damage produces signals with a high amplitude and counts.

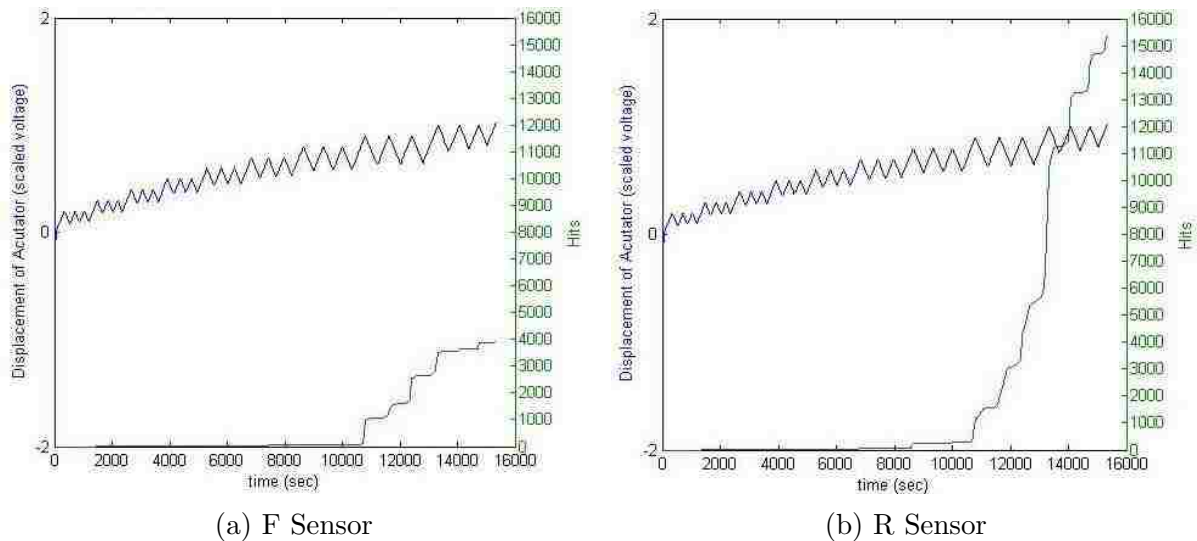
Figure 3.10. Normal CMU Grouted cumulative hits

Two different sensors were used in this study. In general, a large number of AE hits were released at the peak of a new load step which can be seen clearly as a step slope in Figures 3.10b and 3.11b.

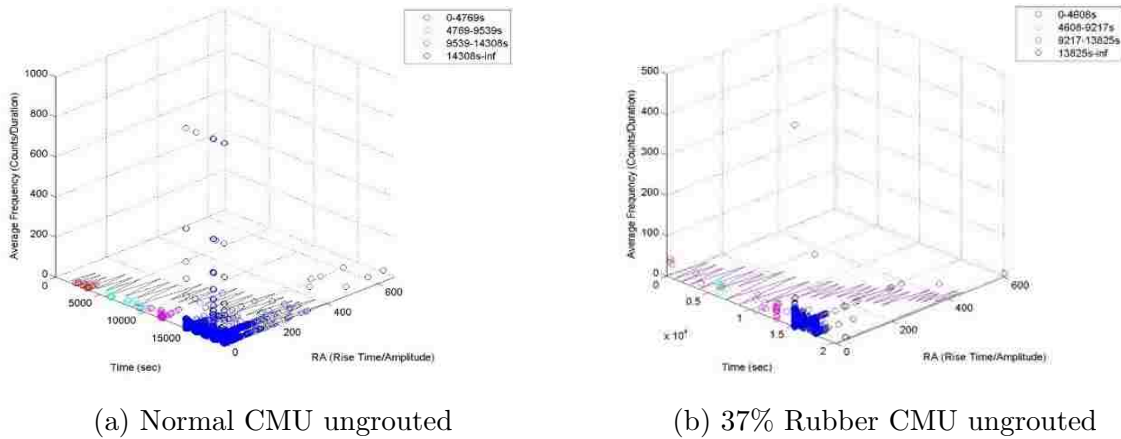
Figure 3.12. RA/AF Plot R Sensor Group ungrouted

An approach taken by Ohtsu and Farhidzadeh is to evaluate RA/AF. Which are the parameters of the risetime divided by the peak amplitude and the average frequency of the individual signal. This method has been accepted by the Japanese Society of Nondestructive Investigation and was used to examine the behavior of cracking. The results are shown in Figures 3.12 and 3.13 and Appendices A15 and A19.

With this approach, signals that lie in the vertical axis correspond to tensile cracks. Signals along the horizontal axis are related as shear dominated. As might be expected, a tensile crack would be caused by a dilation of the compression plane due to the Poisson effect. Grinding between crack surfaces occurred when the existing cracks opened and closed. These new cracks should be registered as shear cracks. The results of these tests showed otherwise. Signals that were at the extremes occurred in

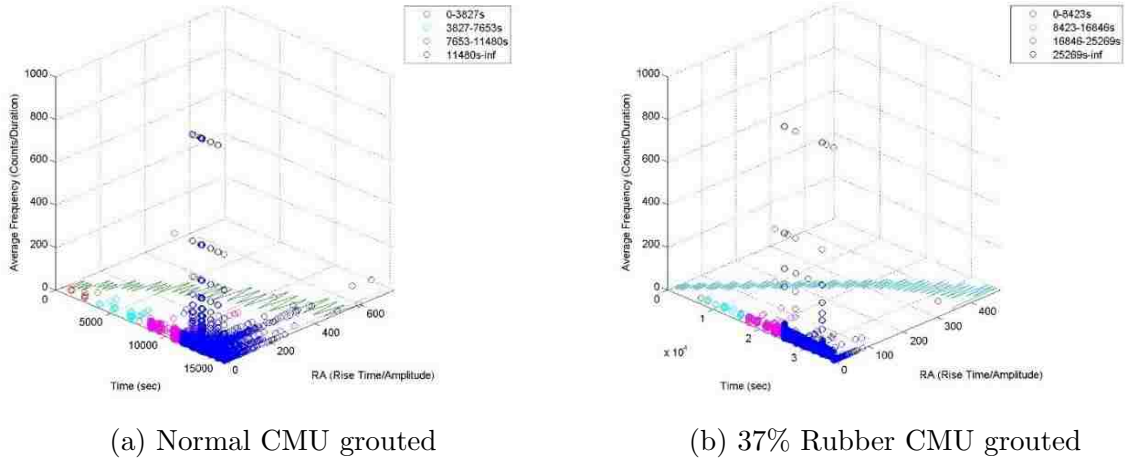
Figure 3.13. RA/AF plot R sensor group grouted

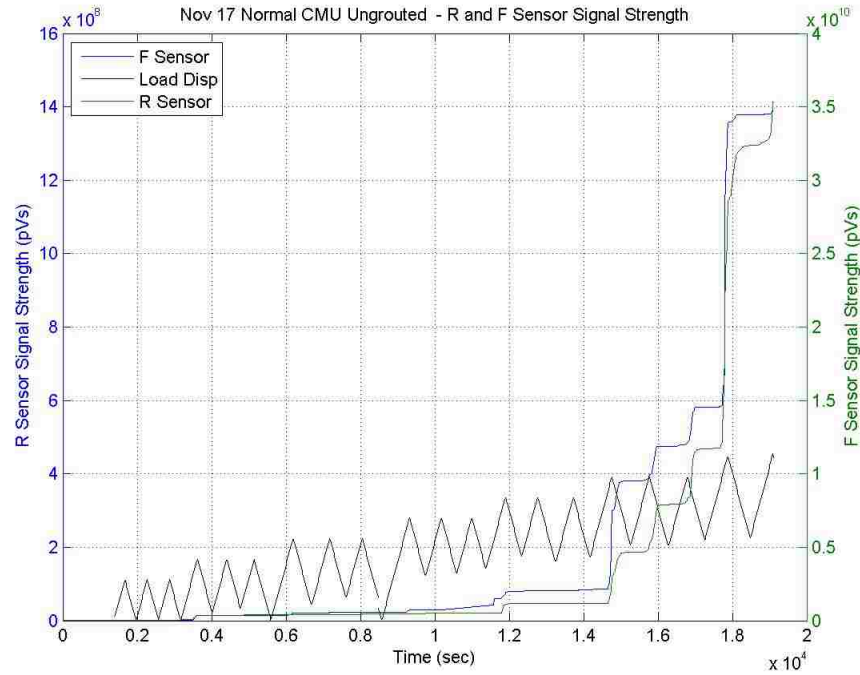
Figure 3.14. Normal CMU ungrouted R and F sensor cumulative signal strength

To keep track of the sound waves which are proportional to released energy, the graphs have been cumulated, this creates a better frame of reference in comparing results from an entire test. Sudden increases in energy correspond to the sudden release of sound waves. New cracking events usually occurred during larger load steps. In looking at Figures 3.15 and in Appendix A24, there are some obviously similarities between the

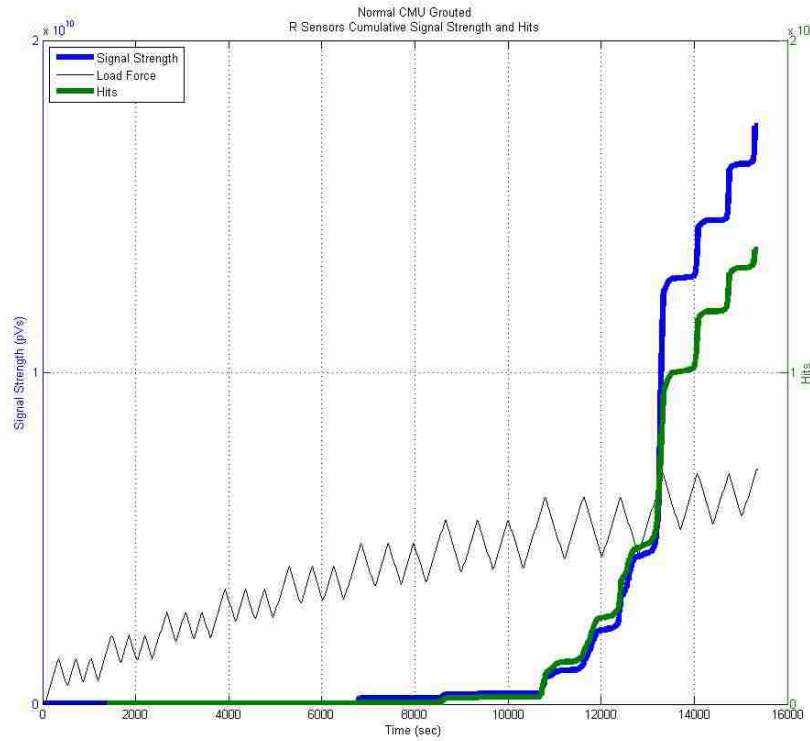
Figure 3.15. Normal grouted cumulative signal strength and hits R sensor group

cumulated hits and signal strength for the R sensors. This agrees with the notion that elastic wave energy released by cracking is proportional to recorded hits. From studying all of the plots it appears that fewer cumulated hits corresponded to a smaller cumulated signal strength. The specimens that had a larger rubber content showed the highest attenuation of frequencies in the upper spectrum. This finding can be seen in plots that compare both the two sensors hits in Figure 3.14 and in Appendix A23. The ungrouted normal CMU had the least attenuation. Both types of sensors collected sounds at the same given moments in time, which is represented by the shape of these curves (see Figure 3.15). The signal strength is a relative term because specimens without grout seemed to produce higher signal strength. Comparing specimens in Appendix A23 this came as a surprise, since it would be expected that a grouted specimen would have cracked more surface area thus accumulated more recorded damage. One possible reason for this behavior was the higher amount of sound reflections from the small element thickness.

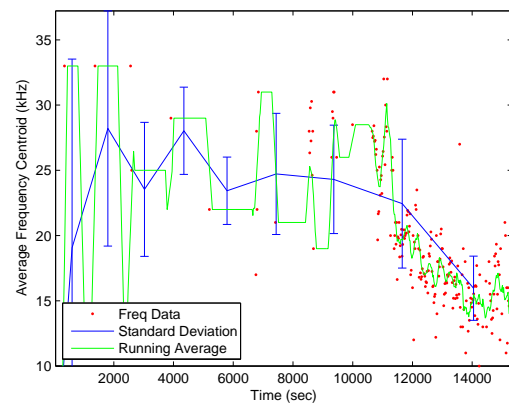
Figure 3.16. Average frequency centroid of individual channels normal CMU prism grouted

any noticeable patterns in the change of the frequency as the cracks were developing. When analyzing the results of the average frequency distribution an interesting behavior existed between the two sensors. The R sensor was in general better at capturing the behavior of decreased signal frequencies at the onset of failure shown in Figures 3.16 through 3.19. Frequencies of the F sensor were not as likely to show this trend as can be seen in Appendices A25 and A26. The results of the R sensors at the end of the test clearly showed a decrease in the frequency centroid from 30 kHz to 18 kHz for channels 6, 22 and 11 with a standard deviation of less than 3kHz.

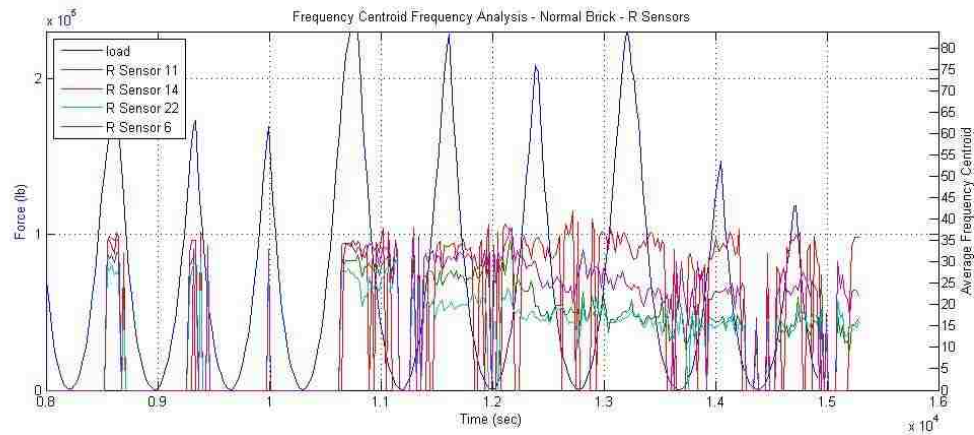
Figure 3.20. Average frequency centroid of R sensors and force (lb) for normal CMU grouted

on the front of each step of damage. In comparing the results of the two specimens, after significant damage, the normal grouted CMU had broken apart into shards. The AE reflects more of a random frequency behavior with this specimen. It can be seen at points of reduced load there still were many signals recorded due to the sounds of large cracks closing. The damage of this specimen can be seen in Figure 3.20 and Figure 3.21. The 37% rubber grouted CMU retained more of its integrity so there is a clear omission of signals at zero force as well as less general randomness of frequency centroids.

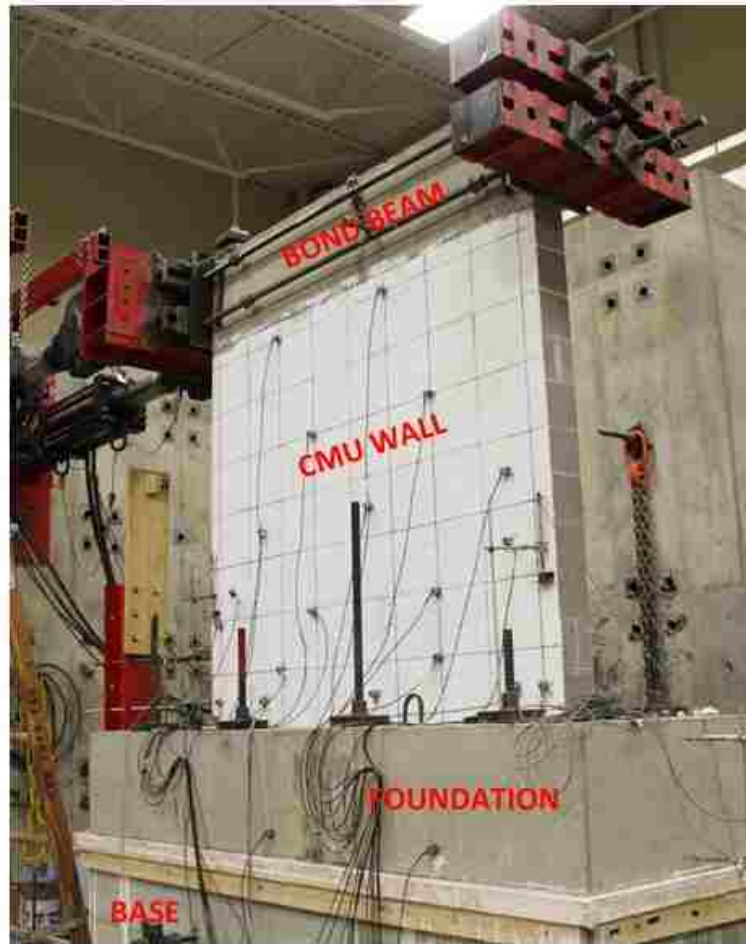
Figure 4.1. Masonry shear wall setup showing components

4.2.1. Wall Specimens. Two walls were tested with two different post-tensioning configurations. A running bond pattern was used to construct the masonry shear walls. Each wall was fully grouted with 8-inch nominal concrete masonry units (CMU). An image of the setup is given in Figure 4.1.

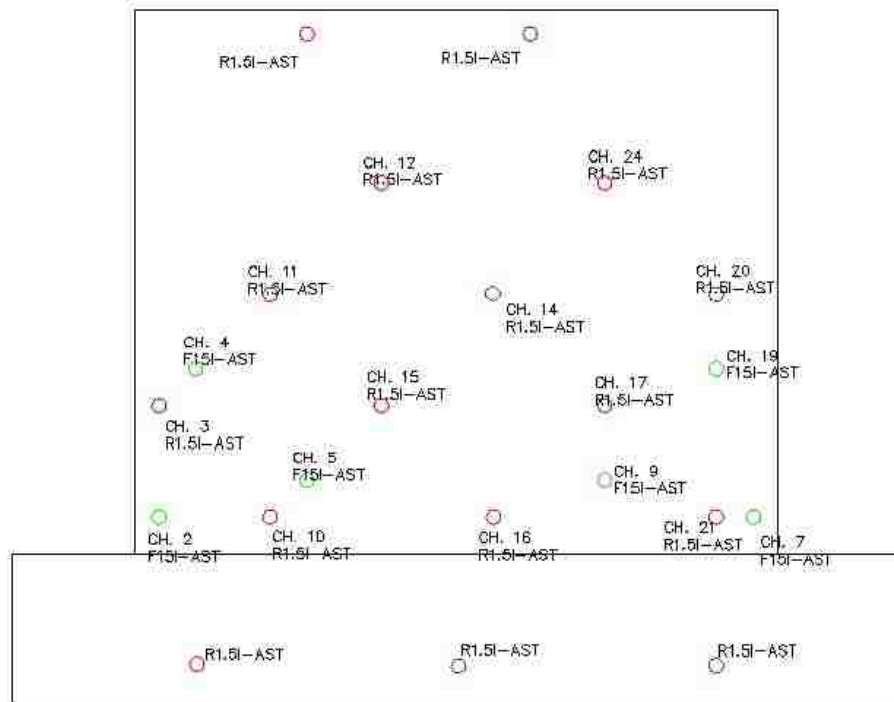
Figure 4.3. Shear Wall Two sensor layout, where red circles are R sensors and green circles are F sensors

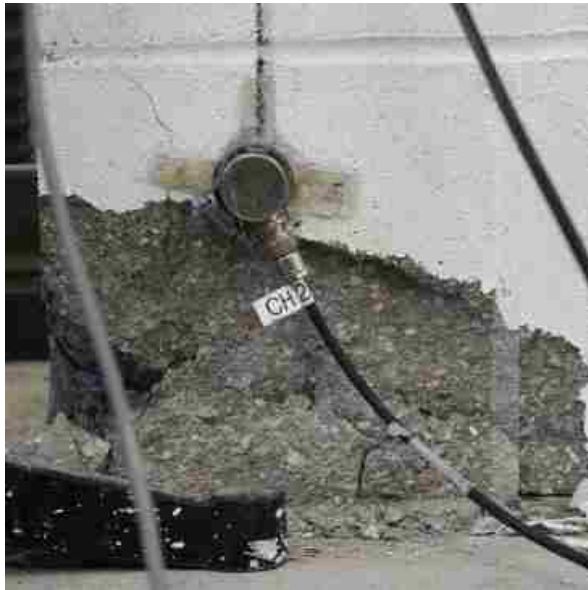
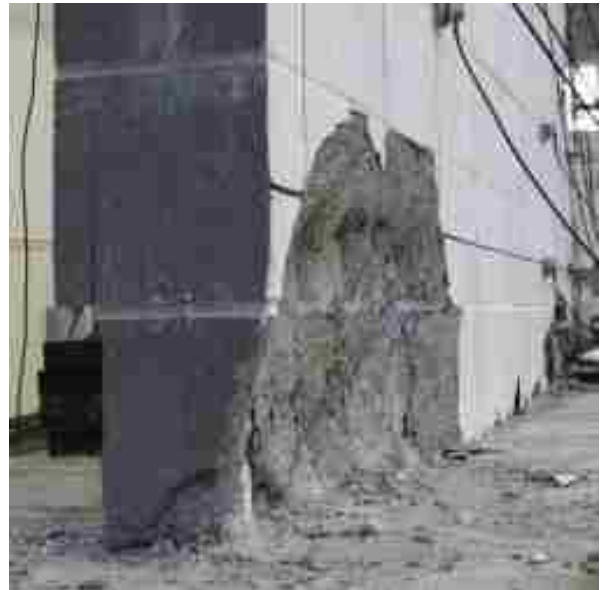
(a) Stage one

(b) Stage two

(c) Stage three

(d) Stage four

The first sign of cracking occurred at the end of the wall and progressed as the strain became more significant (see Figure 4.7a). The material properties were different for each wall because each was a composite of concrete masonry, mortar and grout. The

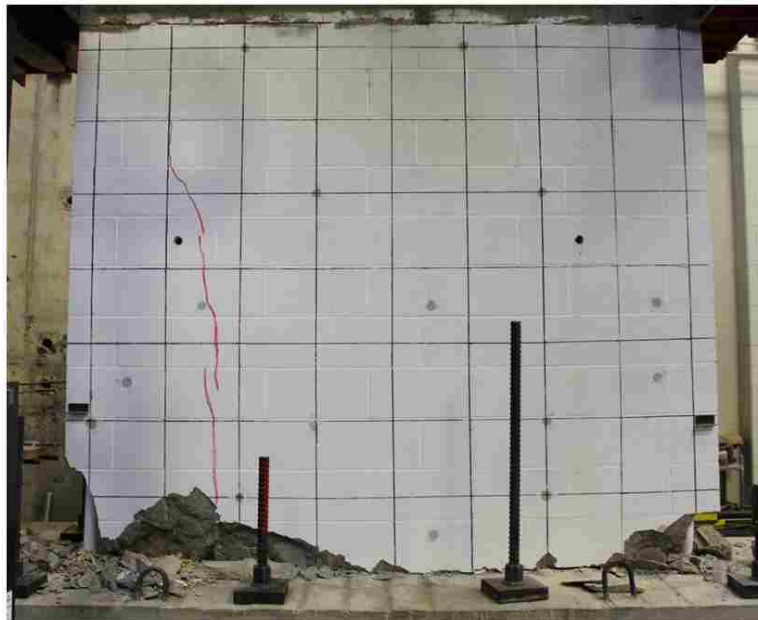
Figure 4.10. Shear Wall Two damage (vertical shear crack shown in red)

The wall's final state at the conclusion of the test is illustrated in Figure 4.10. The wall's peak displacement was increased. The PVC tubes are exposed in Figure 4.10 which reveals the location of the shear walls debonded rods. The damage at the toe of

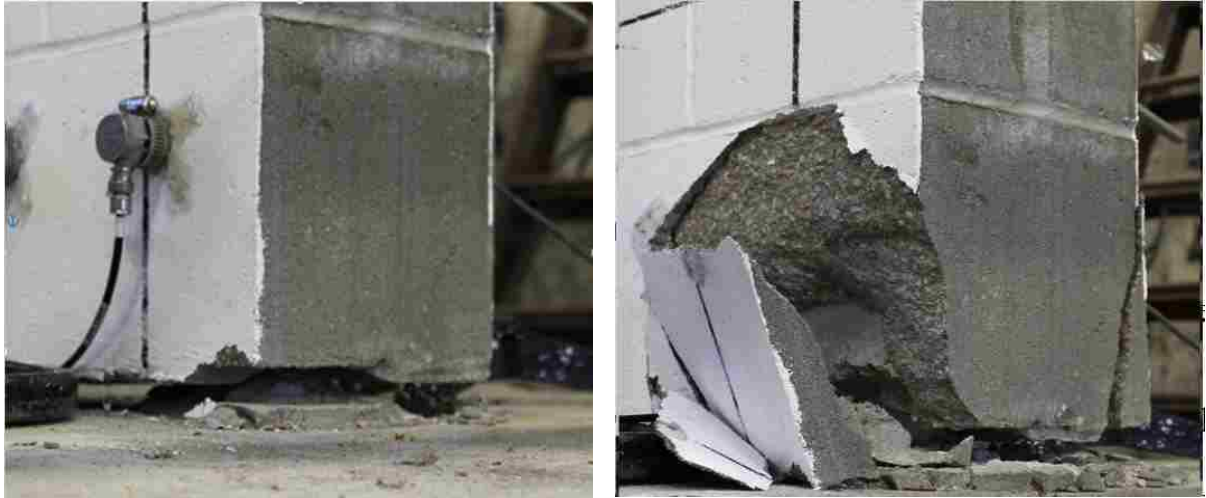
(a) Separation at the Bed Joint

the wall is consistent with the previous test. The wall's rocking can be seen in Figure 4.11a. The toe in tension separated from the base at the bed joint, this separation is shown in Figure 4.11a. In Figure 4.11b the cracking behavior was quite similar between both walls. The cracking at the toes began as vertical cracks and progressed until there were significant brick spalling and grout crushing.

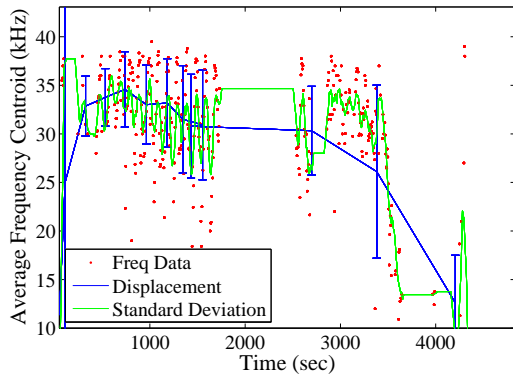
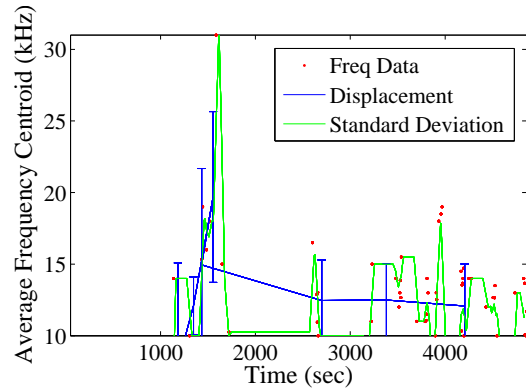
Figure 4.17. Sensor Wall One average frequency centroid R sensor at toe
