Damage detection through acoustic emission of fracture processes in concrete masonry units

DAMAGE DETECTION THROUGH ACOUSTIC EMISSION OF FRACTURE
PROCESSES IN CONCRETE MASONRY UNITS

A THESIS

MASTER OF SCIENCE IN CIVIL ENGINEERING

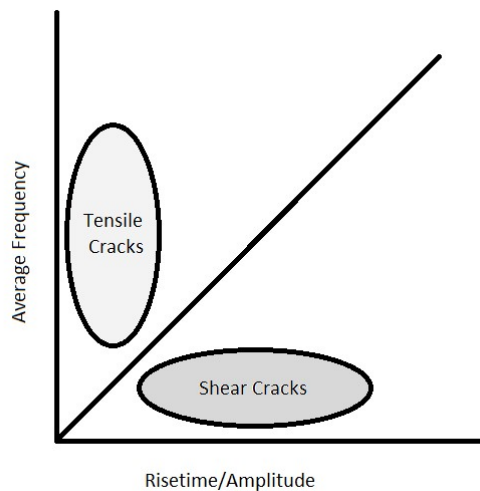
Figure 2.5. RA/AF Diagram For Tensile and Shear Cracking

2.12.1. RA/AF. A method developed for classifying cracks into categories of tensile and shear based on four wave parameters. Risetime divided by peak amplitude and counts divided by duration (average frequency). This theory first outlined by the Japanese Construction and Material Standard is shown in Figure 2.5. As damage progresses, generated sounds will transition from tensile cracking sounds to shear cracking sounds. For most instances, it would be assumed that as cracks transitioned into macro cracks the rubbing due to translation would produce more shear crack noises. This theory could then be used to map crack propagation so it could be used to evaluate damage (Farhidzadeh et al, 2013).

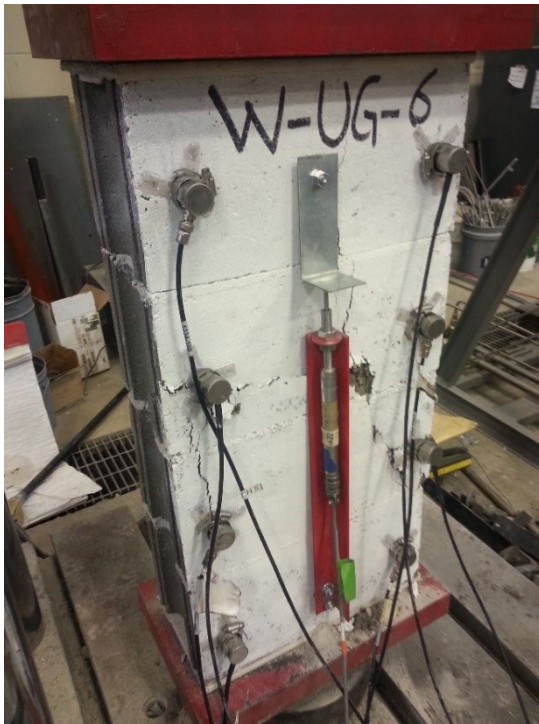
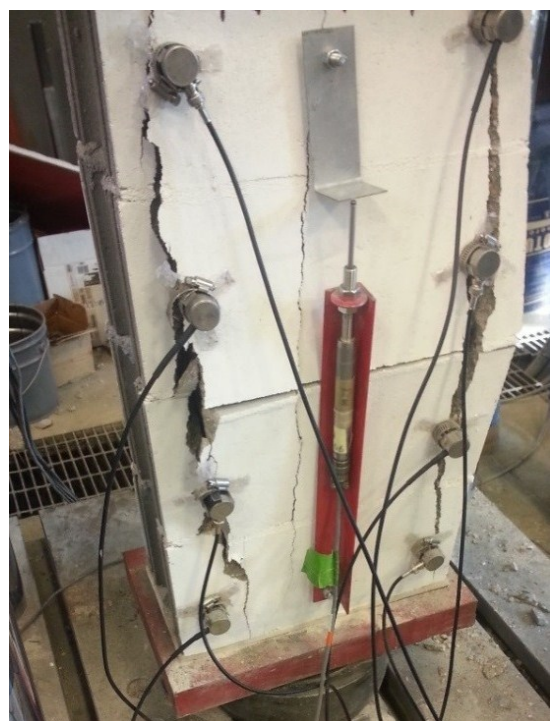
Figure 3.6. Damaged specimens with and without grout from the completion of cyclic test with and without Rubber

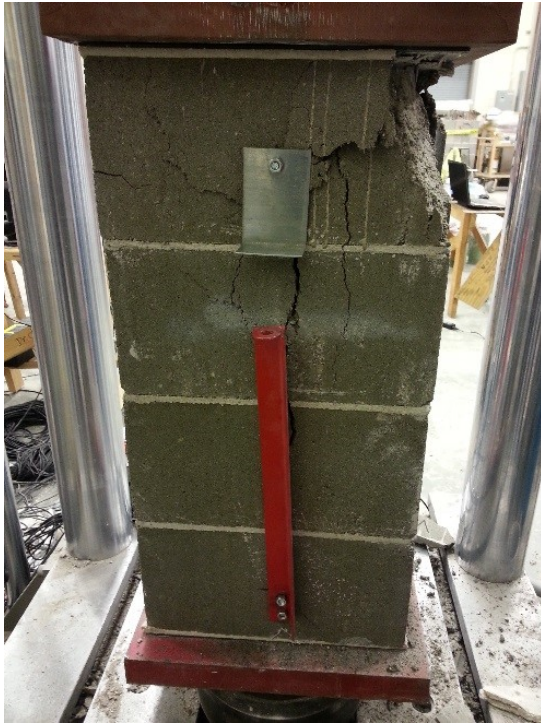
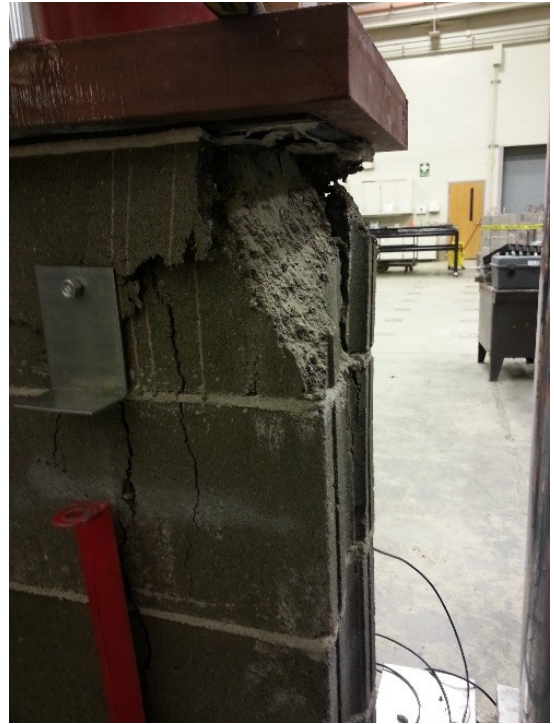
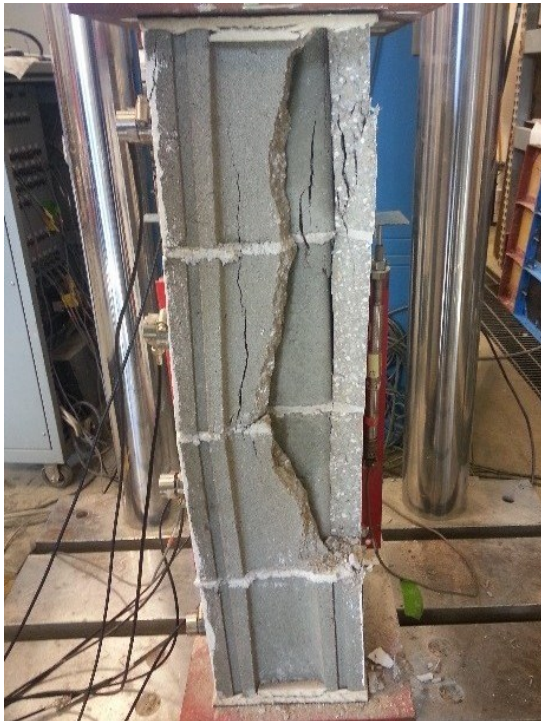
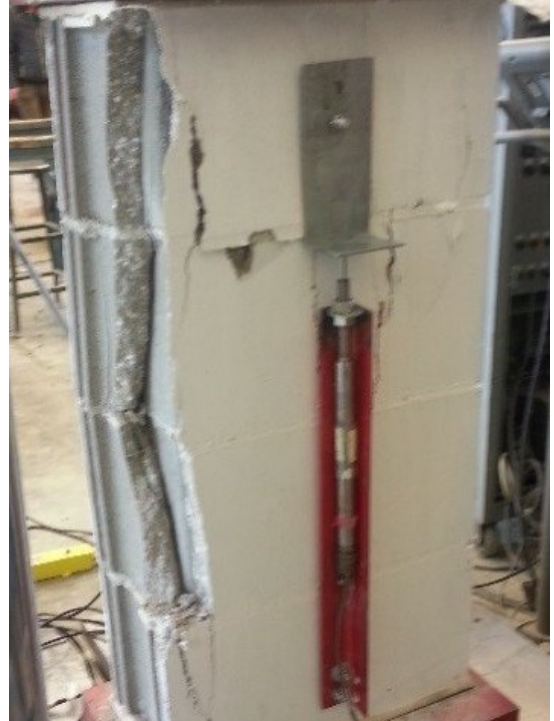
Figure 3.7. Damaged grouted specimens from completion of cyclic test with and without rubber and grout

(a) Backside of 37% Rubber CMU

(b) Edge of 37% Rubber CMU

(c) Edge of Normal CMU

(d) Back Side of Normal CMU

Vertical cracks formed at midsection of the width and depth dimensions, where the compression stress was the highest. Tension stresses developed transverse to the line of compression within the brick due to the Poisson Effect. These cracks propagated into large macrocracks that lead to failure at hairline crack locations. It can be seen that the behavior of the brick differed. In Figures 3.7c and 3.7d the normal CMU cracked throughout every side. Large shards of brick broke away from the grout core. Due to the rapid release of energy, some of the reference CMU simply blew apart (see Figure 3.6b and Appendix A8). The bricks with 37% rubber did not have the same vertical crack formation, instead horizontal shear cracks appeared at the location of high stress at the uppermost brick.

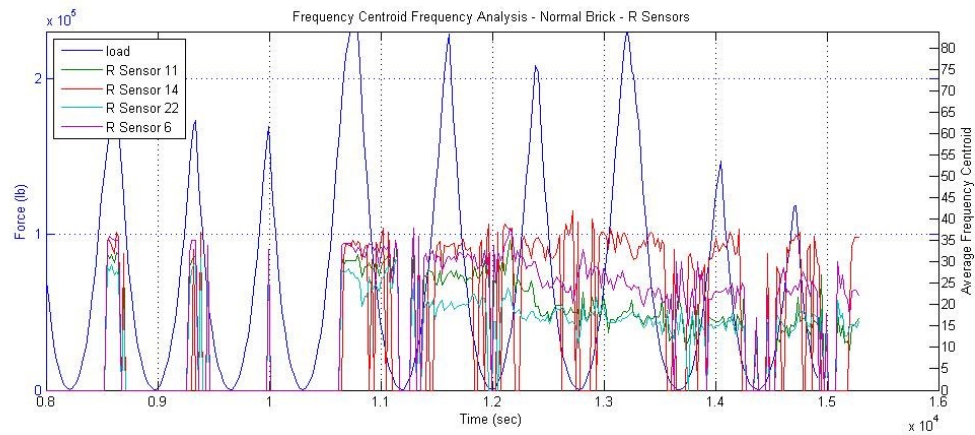
Figure 3.20. Average frequency centroid of R sensors and force (lb) for normal CMU grouted

on the front of each step of damage. In comparing the results of the two specimens, after significant damage, the normal grouted CMU had broken apart into shards. The AE reflects more of a random frequency behavior with this specimen. It can be seen at points of reduced load there still were many signals recorded due to the sounds of large cracks closing. The damage of this specimen can be seen in Figure 3.20 and Figure 3.21. The 37% rubber grouted CMU retained more of its integrity so there is a clear omission of signals at zero force as well as less general randomness of frequency centroids.

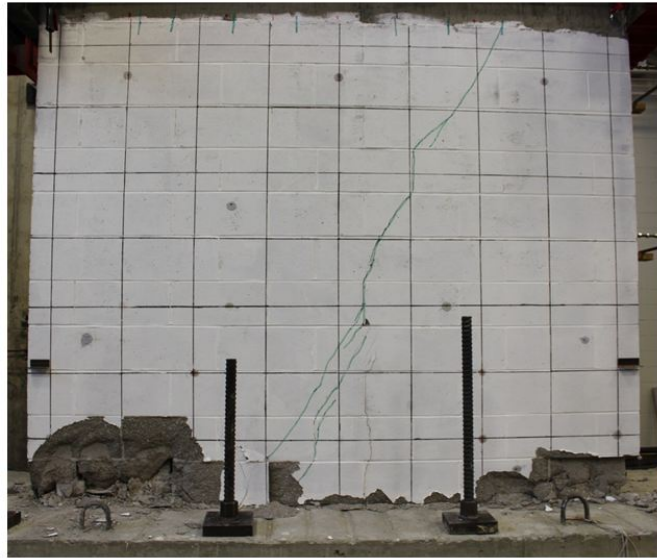
Figure 4.6. Shear Wall One damaged (the shear crack is indicated in green)

A large diagonal shear crack propagated spontaneously as the wall reached a peak displacement of 2.8. This crack can be seen in Figure 4.6. Extensive damage can be seen in both of the walls' toe areas as those areas were subjected to large amounts of compressive force. It should be noted that the wall's damage was primarily related to the wall's compressive force as it was rocked back and forth. From visual inspection, the wall behaved as a rigid body instead of as a flexural member because of the lack of fixity at the base. As the wall was rocked in the north/south direction, compression built up at the toe in that particular direction as the other toe separated at the bed joint. The tensile forces that occurred due to the cantilever action was resisted by post-tensioning. The effect of the additional post-tensioning was additional frictional force between the wall-foundation and higher stiffness seen in the scope of the load hysteresis.

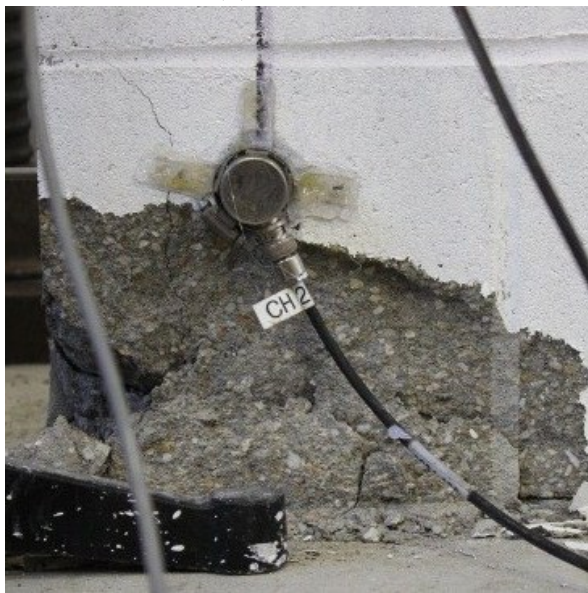
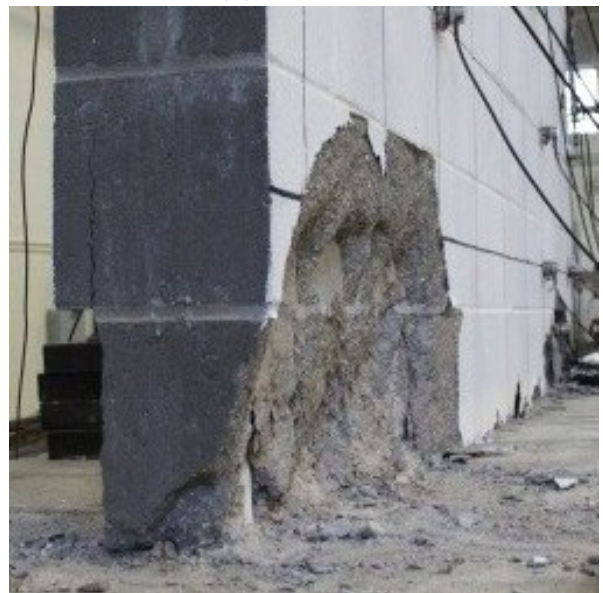
(a) Stage one

(b) Stage two

(c) Stage three

(d) Stage four

The first sign of cracking occurred at the end of the wall and progressed as the strain became more significant (see Figure 4.7a). The material properties were different for each wall because each was a composite of concrete masonry, mortar and grout. The

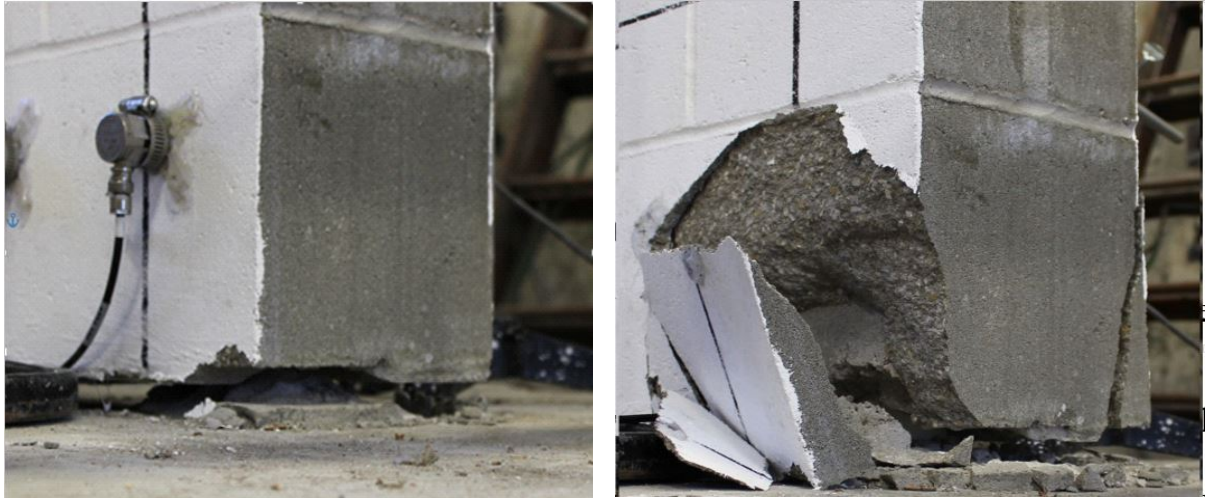
(a) Separation at the Bed Joint

(b) Spalled Brick

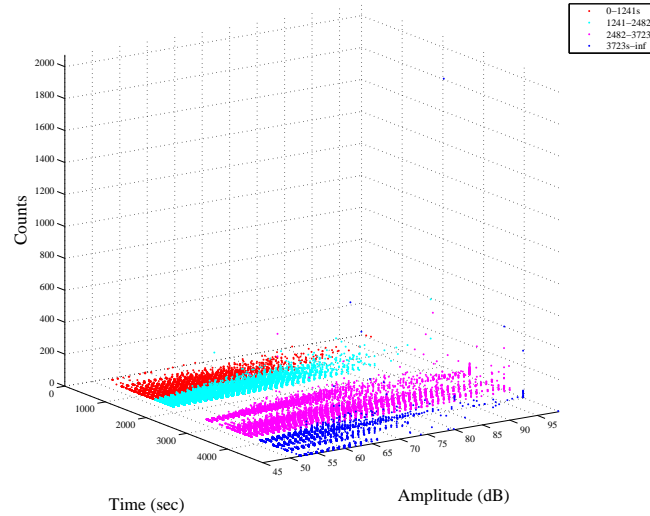
Figure 4.15. Shear Wall One R sensor counts and amplitude of individual hits

The R sensor was capable of detecting significant damage from over 5 feet away. In comparing the F and R sensor within the same zone, it can be seen that the increase in amplitude and counts occurred at the same time during the test. The higher number of counts of the F sensor would be due to the higher frequency. From analyzing these

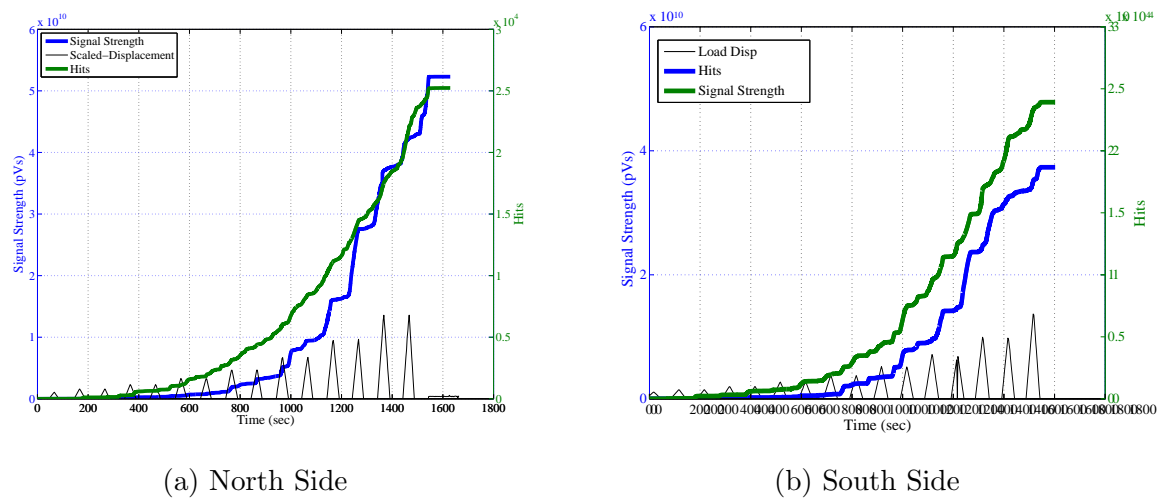
Figure 4.20. Shear Wall Two cumulative signal strength and hits R Sensor

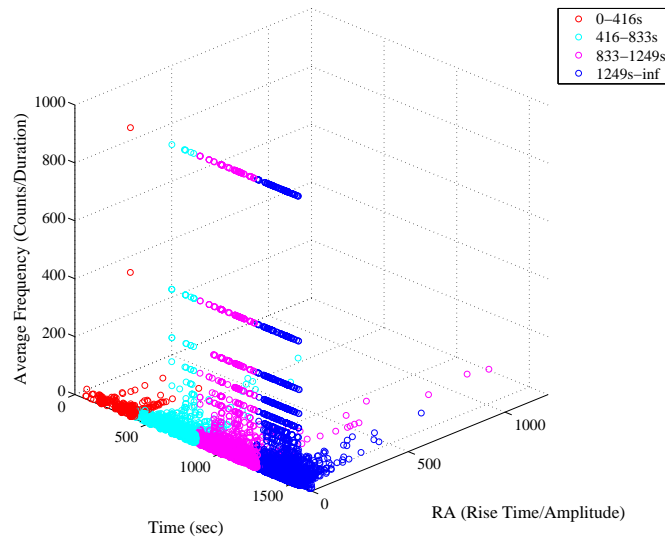
Figure 4.23. Shear Wall Two RA/AF R sensor group north side
