**Deterioration of Wetted
Monumental Granite in Ancient
Egyptian Buildings and Sites
Causes , Symptoms and
Conservation Strategy thoughts
Two case study**

Abdou El-Derby

Journal of Faculty of Archaeology (Qena)

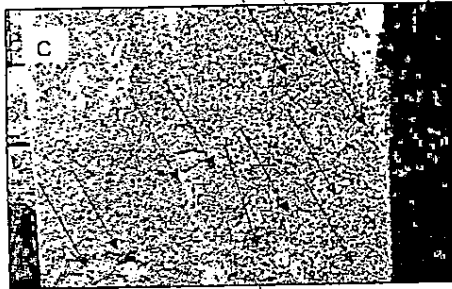
Fig. 4 includes investigations and photos of deterioration symptoms of granite of Osireion: (A), (B) and (C) SEM micrographs X100 and photos showing loss of smooth finished surface, Pulverization, granular disintegration (into grains) and Minute cracks, become the moisture path giving rise to acceleration in chem. and mecha. weathering and produce new micro-cracks or open cracks that are already in existence in granite, (orange borrow), plus a loss of sharpness on corners (blue borrow)

For fracturing see upon the whole (figs. 3 E and 4 A, B, C)

As a general there are more additional external deterioration factors affect the mineralogical and physical characteristics and participate in complexity of deterioration process , which pictures in decomposition , degradation and damage through mineral alteration , flaking , exfoliation – as mentioned before - and granular disintegration into grus in granite of Osireion , run over and revise (figs.4 A, B, C).

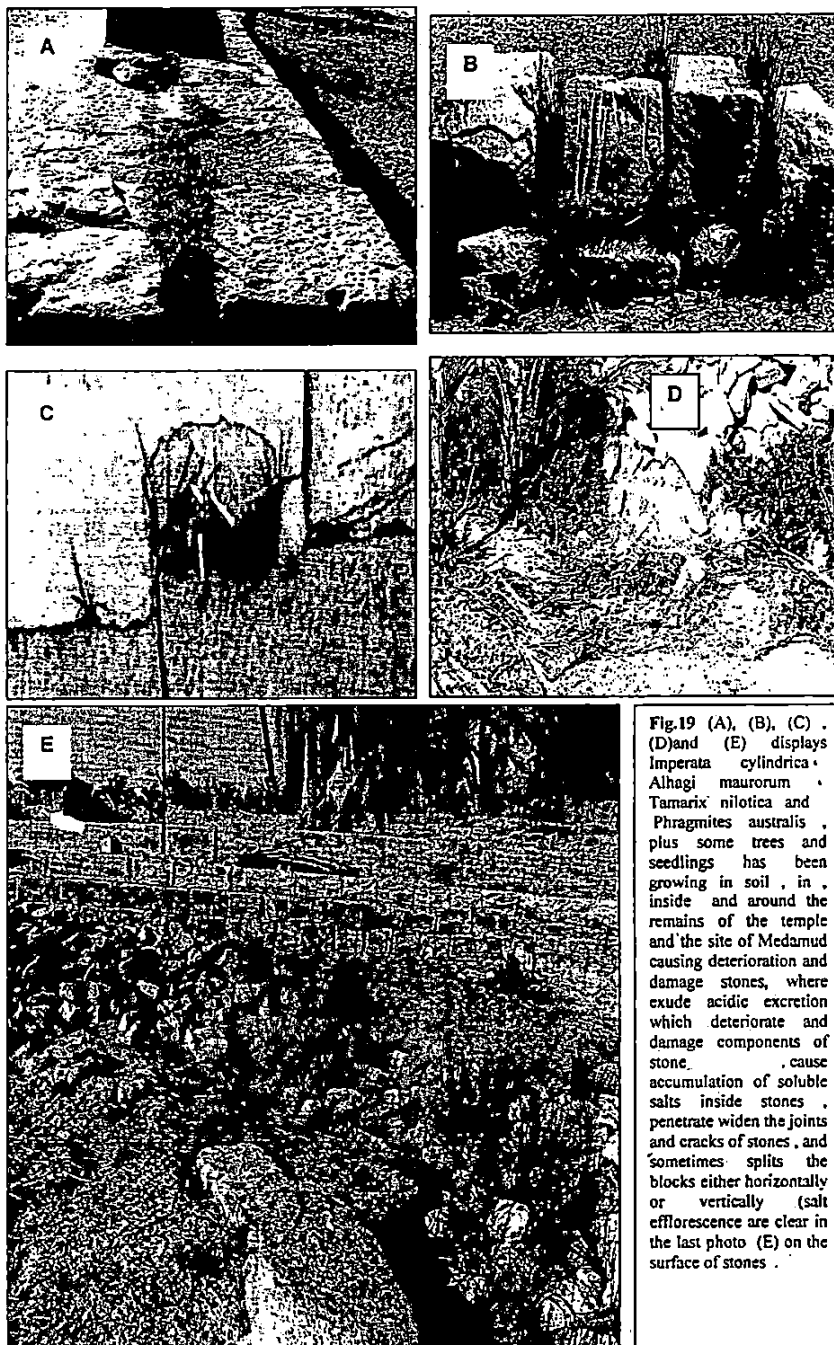
Fig.19 (A), (B), (C) . (D)and (E) displays *Imperata cylindrica* , *Alhagi maurorum* , *Tamarix nilotica* and *Phragmites australis* , plus some trees and seedlings has been growing in soil , in , inside and around the remains of the temple and the site of Medamud causing deterioration and damage stones , where exude acidic excretion which deteriorate and damage components of stone . , cause accumulation of soluble salts inside stones , penetrate widen the joints and cracks of stones , and sometimes splits the blocks either horizontally or vertically (salt efflorescence are clear in the last photo (E) on the surface of stones .

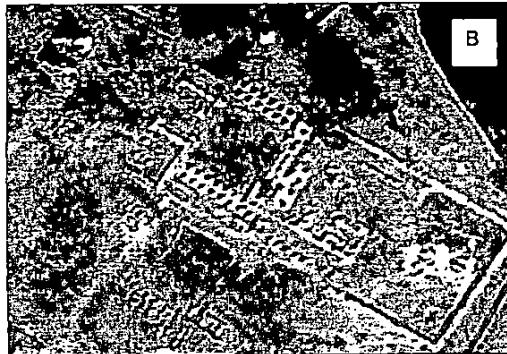
And 20 (B) a part of Medamud temple showing the smashup of temple of Medamud

resulting in incurring to alternative cycles of wetting and drying and a combined reactions of hydration, hydrolysis combined with inadequate sun exposure, plus saline ground water which stamp the sites of two case study: Osireion and Medamud.
