**Development, evaluation and implementation of sensor techniques for bridges
critical to the national transportation system**

A dissertation submitted to the graduate faculty
in partial fulfillment of the requirements for the degree of
DOCTOR OF PHILOSOPHY

Major: Civil Engineering (Structural Engineering)

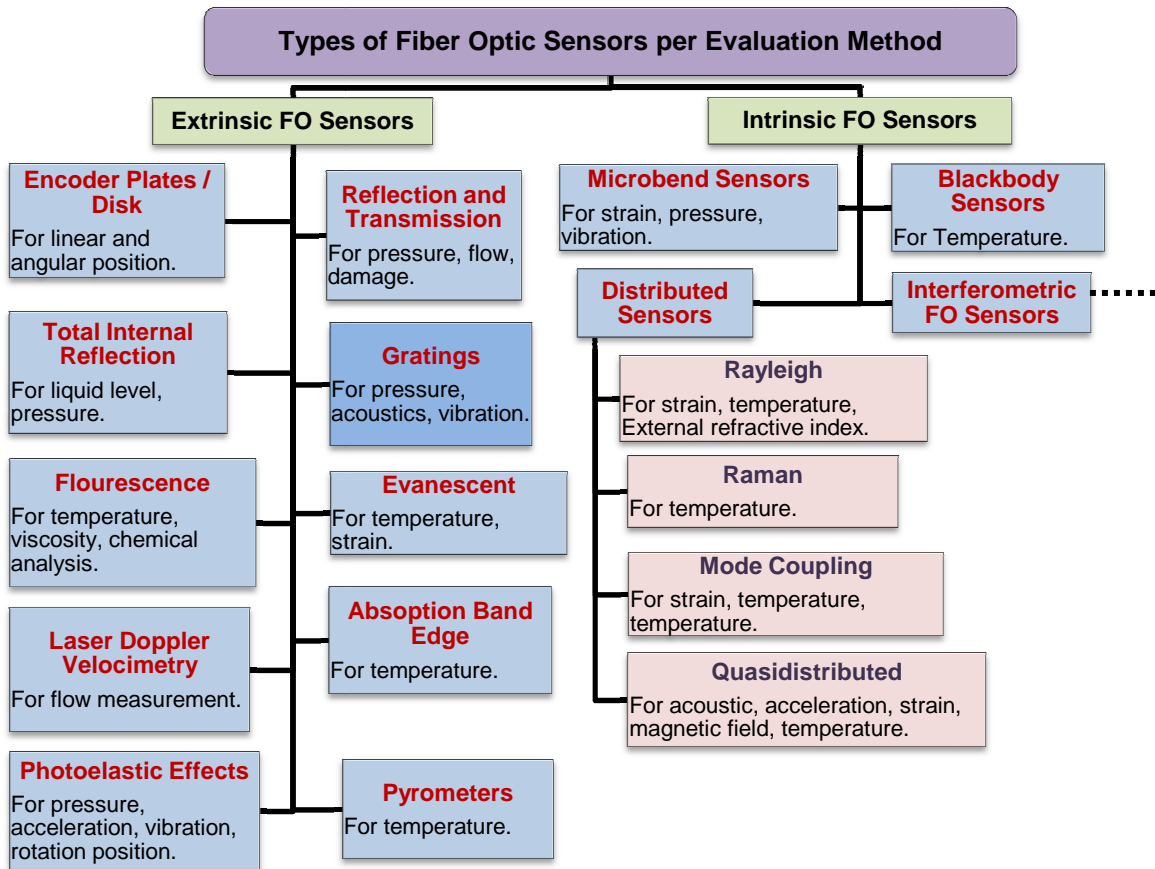
(a) Extrinsic and Intrinsic Fiber Optic Sensors

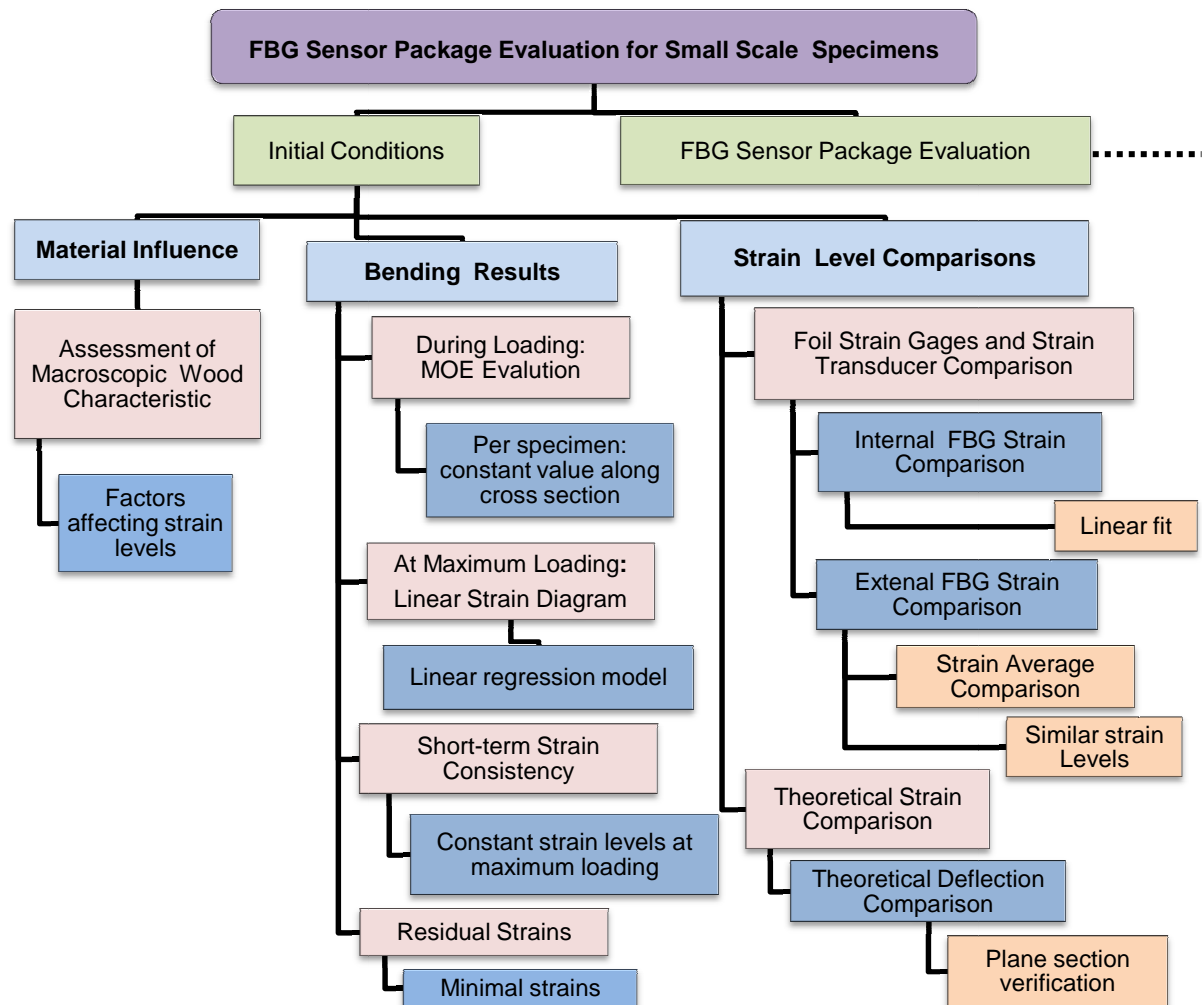
Nine specimens instrumented with structural FBG sensor packages were tested in bending to verify their consistency by evaluating their initial conditions, by comparison to theoretical strains and by comparison to data gathered with foil strain gages and strain transducers. The strain data were collected for variable load duration and temperature conditions (Section 6.2.8.1). The objective of these tests was to evaluate both the elastic and viscous-like behavior of the structural packages. The following flow chart summarized the steps taken in the subsequent sections to evaluate the structural FBG sensor packages (see Figure 6.33 and Figure 6.34).

Figure 6.33. Chart of the Evaluation of the Structural FBG Sensor Package

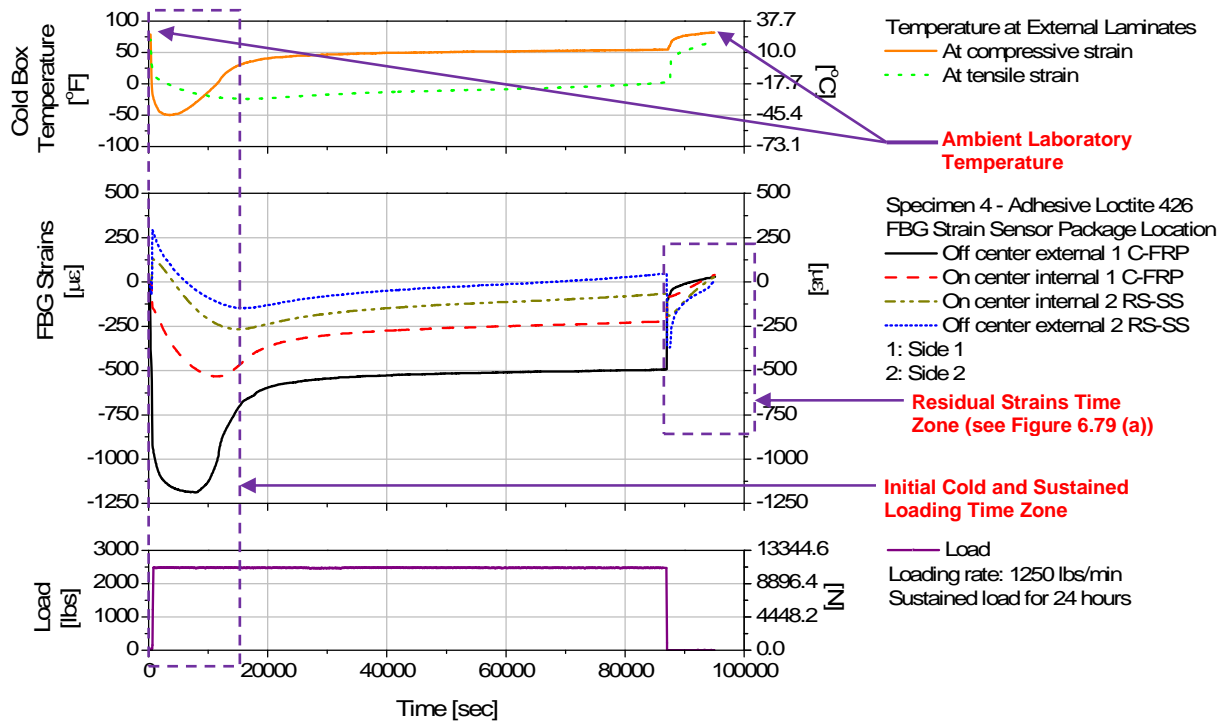
(a) Strains, Load and Temperature vs. Time

(b) Close up of Initial Cold and Sustained Loading Time Zone for Strains and Temperatures
Figure 6.76. Cold and Sustained Loading Test Results for Specimen 4, Side 1 Loading
