## Development of a Management Guide for Concrete Bridge Decks in Utah

A dissertation submitted to the faculty of  
Brigham Young University  
in partial fulfillment of the requirements for the degree of  
Doctor of Philosophy

Department of Civil and Environmental Engineering  
Brigham Young University

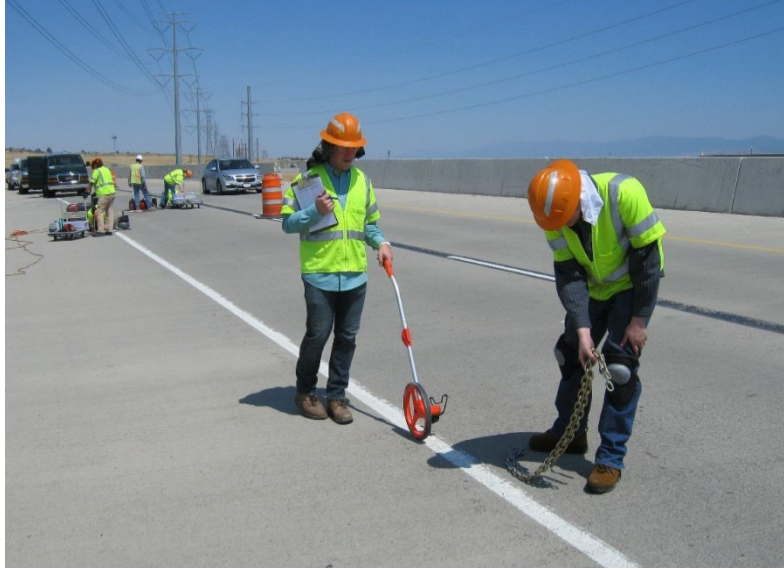
**Figure 2-1 Chain dragging of a concrete bridge deck.**

Chain dragging is the process of dragging a steel chain across a bridge deck surface and listening to changes in the acoustic response (Scott et al. 2003). Delaminations within the deck produce a different frequency than intact concrete, allowing the human ear to identify delaminated portions of the bridge deck (Gucunski et al. 2013). Good-quality concrete will produce a clear ringing sound (Henderson et al. 1999). When delaminations are present, however, the acoustic response is a dull, hollow sound resulting from flexural oscillations within the deck (Gucunski et al. 2013, Henderson et al. 1999, Stratfull 1973a). These flexural

oscillations occur after some form of impact, such as chain dragging or sounding with a hammer or rod, and it typically manifests as a sound from 1 to 3 kHz (Guthrie et al. 2019a).

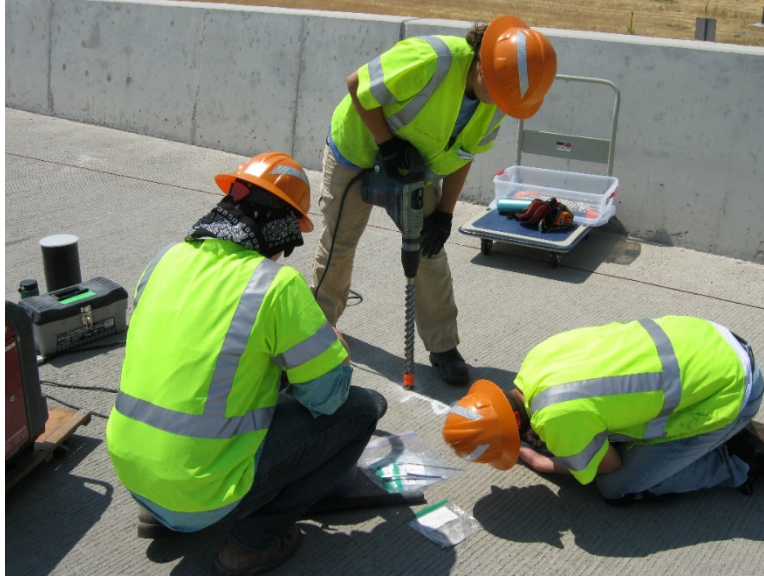
**Figure 2-2 Concrete powder sampling for chloride concentration testing.**

Chloride concentration testing is among the most common techniques for evaluating the condition of a concrete bridge deck (ASTM 1978). This is a destructive test, typically performed on pulverized concrete samples, that is used to determine if chloride concentrations may be high enough to initiate corrosion of the reinforcing steel. Concrete is extracted from the bridge deck either as a core or as powder and then tested for chloride concentration. Figure 2-2 shows collection of concrete powder for chloride concentration testing using a rotary hammer drill.

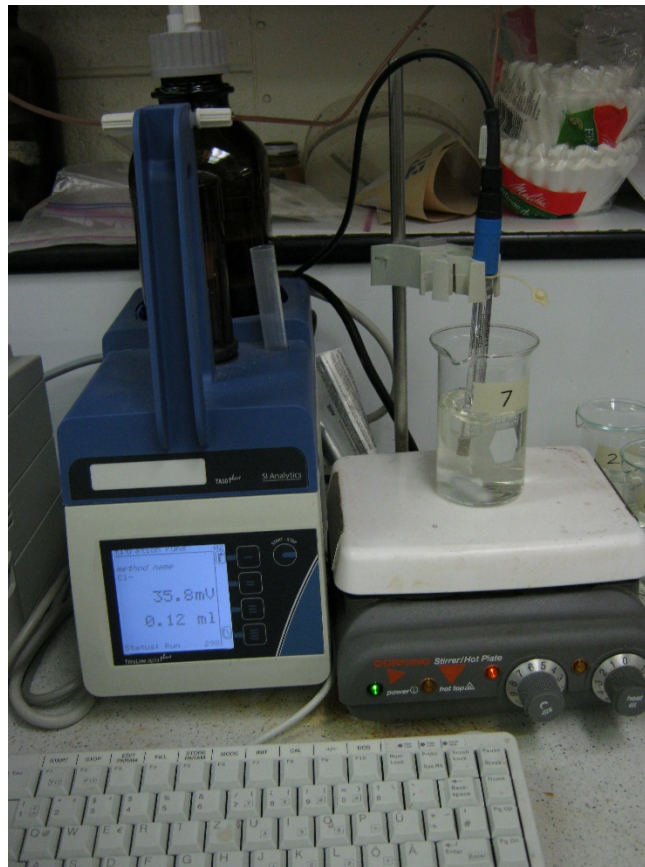
**Figure 2-3 Chloride concentration testing.**

Two laboratory methods of chloride concentration testing, differing in the chloride ion extraction technique, have been standardized. In the acid-soluble chloride testing method, a powdered sample of the concrete is dissolved in dilute nitric acid, as described in the ASTM C1152 (Standard Test Method for Acid-Soluble Chloride in Mortar and Concrete). A silver nitrate solution is then used to conduct a potentiometric titration of the chloride ions. Figure 2-3 shows the titration portion of chloride concentration testing. This method measures both the free and chemically bound chloride ions in concrete. Consequently, the results contain measurements of chloride ions that do not contribute to corrosion of the reinforcement. The second laboratory

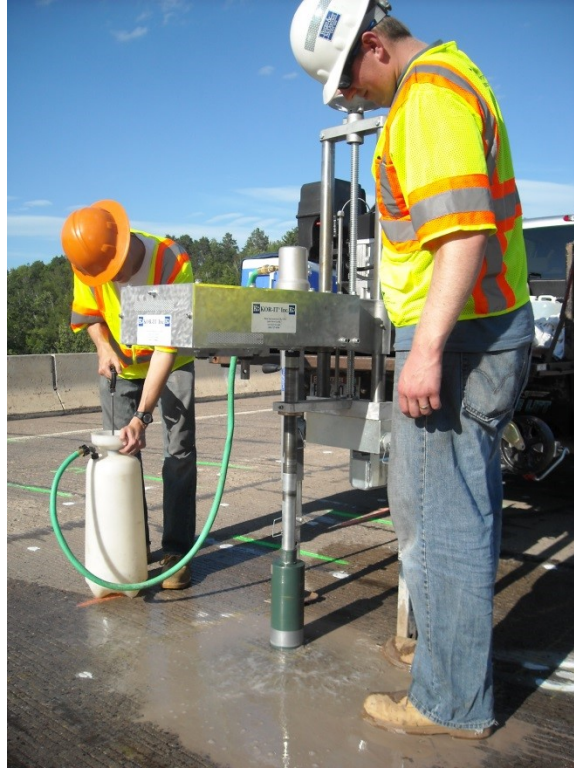
**Figure 2-4 Coring of a concrete bridge deck.**

Coring, as described in ASTM C42 (Standard Test Method for Obtaining and Testing Drilled Cores and Sawed Beams of Concrete), is performed to extract cylindrical samples from concrete elements. Core analysis is a reliable way of determining the condition of in-place concrete down to a certain depth. It allows the concrete beneath the surface to be inspected and analyzed in detail. Figure 2-4 demonstrates the coring procedure.

Concrete specimens are extracted perpendicular to the concrete surface in areas of desired testing, through or between reinforcing bars in the deck. Although typical core diameters are 2.0 to 6.0 in., depending on the purpose of the core, samples having up to an 18-in. diameter can be cored using diamond-impregnated bits attached to a core barrel. In all cases, the depth of coring must be controlled to ensure that the bit does not penetrate the full thickness of the bridge deck, which would allow the core to fall below the deck. If taken for petrographic analyses, cores should be sampled in accordance with ASTM C856 (Standard Practice for Petrographic Examination of Hardened Concrete).

For a trained technician, extracting a concrete core sample can take approximately 20 minutes; however, additional time may be required when a thick asphalt overlay is present or when the concrete comprises silica fume or other admixtures leading to much higher strength. Given that additional time is needed for installation and curing of concrete patches, coring can be a relatively time-consuming method. For personnel safety and quality control, lane closures are required during the coring, patching, and curing processes (Hema et al. 2004).

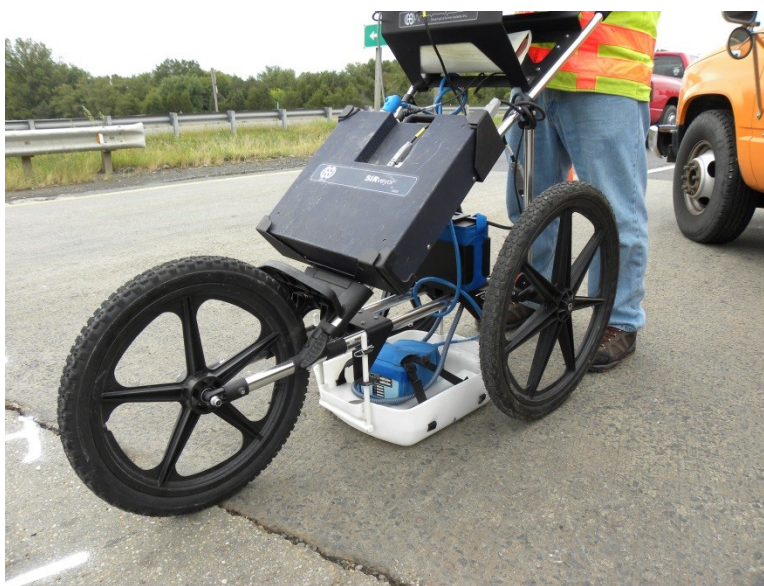
Figure 2-10 GPR testing of a bridge deck.

Most GPR systems designed for scanning reinforced concrete use electromagnetic waves in the frequency band of 1.0 to 2.5 GHz (Saarenketo and Soderqvist 1994) to map subsurface characteristics of bridge decks, including objects buried within the structure (Gucunski et al. 2013). Radar waves are emitted into the bridge deck from a surface antenna that may be in contact with the deck or positioned above the deck (Maser et al. 2001, Shin and Grivas 2003). When radar waves traveling through the bridge deck come in contact with an electrical interface, such as a boundary between two materials having different dielectric values, they are transmitted or reflected to various degrees depending on the dielectric contrast between the two materials

forming the interface (Hugenschmidt and Mastrangelo 2006, Maser et al. 2001). Typically, a small portion of the radar wave is reflected back to the surface antenna, while the remainder of the wave continues through the bridge deck. The travel times and amplitudes of reflected radar waves are recorded and processed, as shown in Figure 2-11 (Hugenschmidt and Mastrangelo 2006, Maser et al. 2001, Shin and Grivas 2003).

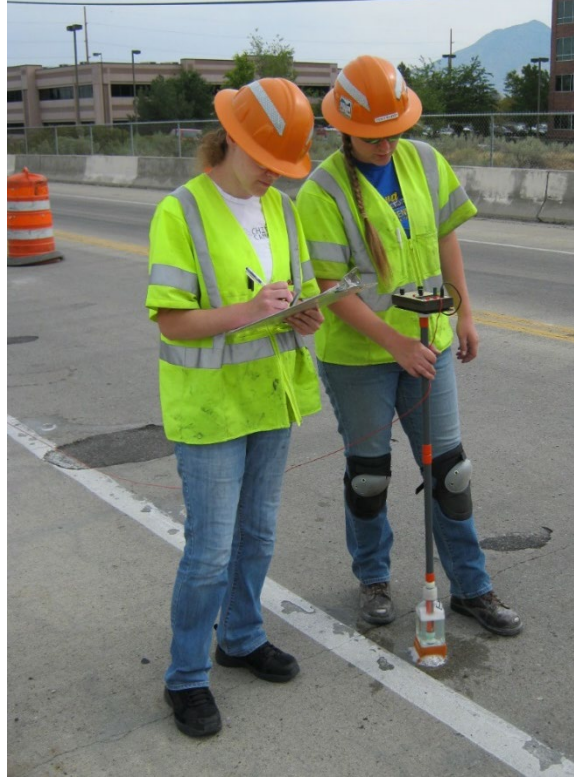
**Figure 2-12 HCP testing.**

The HCP test is a rapid, nondestructive, electrochemical method used to determine the activity of reinforcing steel corrosion in concrete (Finch et al. 1998, Gucunski et al. 2013, Stratfull et al. 1975). HCP measurements provide a classification of the corrosion activity of the steel and indicate locations where the steel is potentially corroding (Stratfull et al. 1975). Figure 2-12 shows HCP testing.

The objective of HCP testing is to measure the voltage, or potential difference, between the reinforcing steel and a half-cell, normally a copper-copper sulfate (Cu-CuSO<sub>4</sub>) reference electrode (CSE) (Pinkerton 2007). The CSE is placed in a bottle of electrolytic solution with a sponge attached to the bottom, which is then placed on the surface of the concrete above the steel reinforcement. Current passes from the CSE to the concrete surface through the sponge soaked with the electrolytic solution (Pinkerton 2007). In the HCP setup, the CSE behaves as the cathode and the reinforcing steel behaves as the anode, as copper is higher in the galvanic series than steel (Broomfield 1997). The CSE is connected to the positive end of a high-input-impedance voltmeter that is connected to a data-logging device. The negative end of the

voltmeter is connected to the reinforcing steel by drilling into the concrete to expose the steel and tapping into the reinforcing steel with a screw so that a good electrical connection is made (Elsener 2001, Stratfull 1973b).

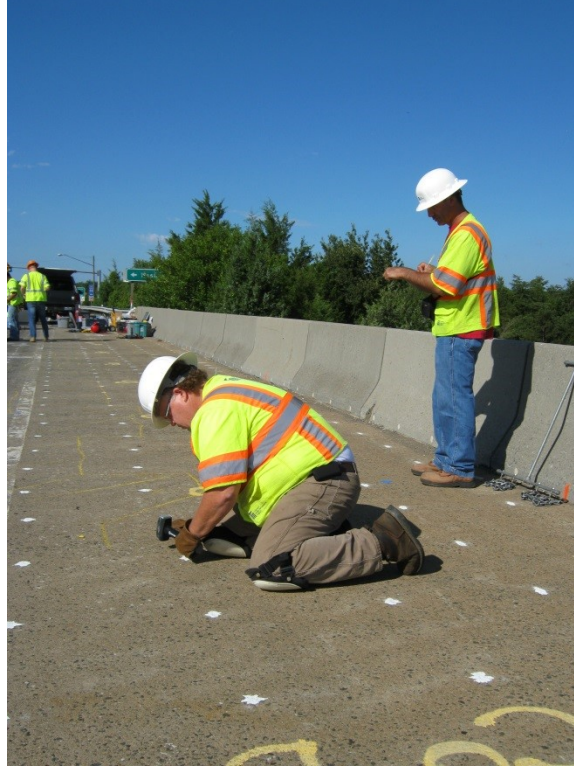
**Figure 2-13 Bridge deck sounding with a hammer.**

Hammer sounding involves using a hammer to strike a bridge deck surface, as shown in Figure 2-13, and listening to changes in the acoustic response (Moore 1975). Delaminations within the deck produce a different frequency of sound than that produced by intact concrete,

allowing the human ear to identify delaminated portions of the bridge deck (Gucunski et al. 2013). Good-quality concrete produces a clear ringing sound (Henderson et al. 1999). When delaminations are present, however, the acoustic response is a dull, hollow sound resulting from flexural oscillations within the deck (Gucunski et al. 2013, Henderson et al. 1999). These flexural oscillations are typically in the range of 1 to 3 kHz (Guthrie et al. 2019a).

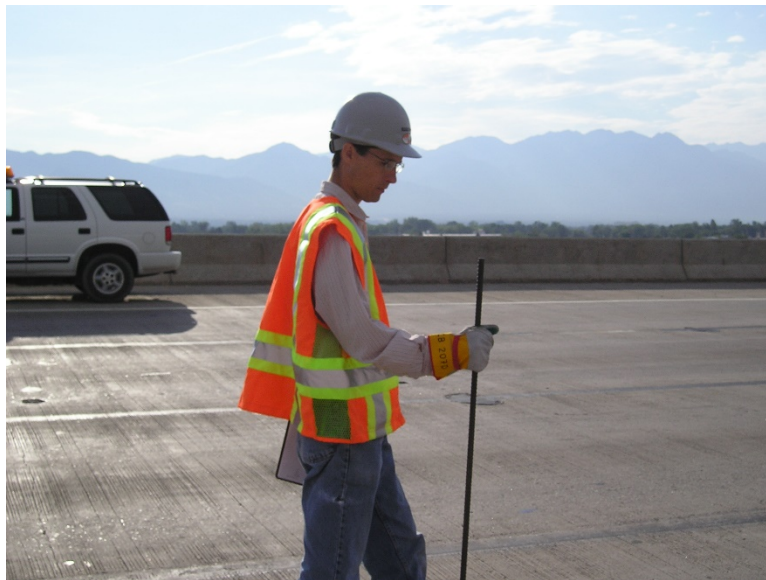
**Figure 2-14 Bridge deck sounding with an iron bar.**

time-consuming, especially for larger bridges. After preparation, the bridge deck is then surveyed by tapping a hammer on the surface and listening for changes in the sound. As an alternative to a standard hammer, an upright iron bar dropped on its end has also been used (Manning 1985), as shown in Figure 2-14. Areas determined to be delaminated are marked on the deck surface and mapped for evaluation. Hammer sounding requires stationary traffic control.

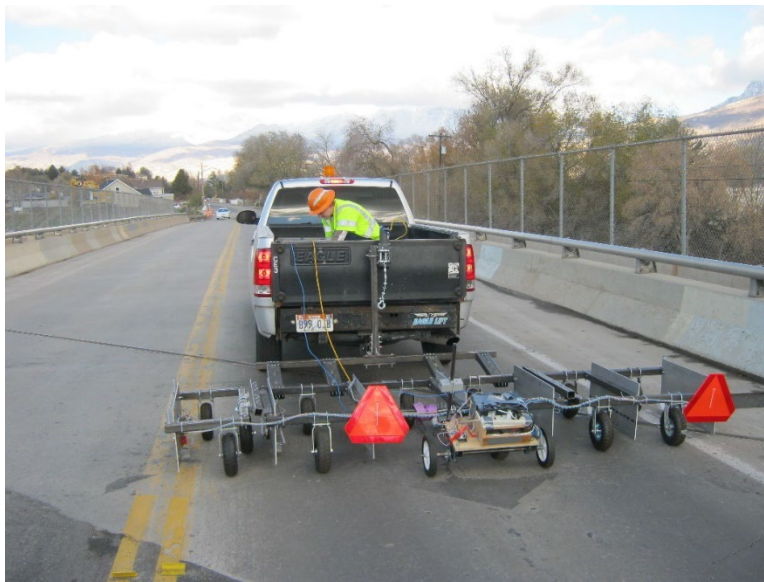
**Figure 2-15 Mallet-based multi-channel impact-echo scanner.**

Historically, impact-echo testing has not been successfully automated; however, researchers have recently developed fully automated prototypes that have been employed on a number of projects (Guthrie et al. 2014, Popovics 2010, Rutgers 2018). Figures 2-15 and 2-16 show two multi-channel devices that can perform impact-echo testing from a continuously moving platform (Guthrie et al. 2019b, Larsen et al. 2020); these devices, which have both been

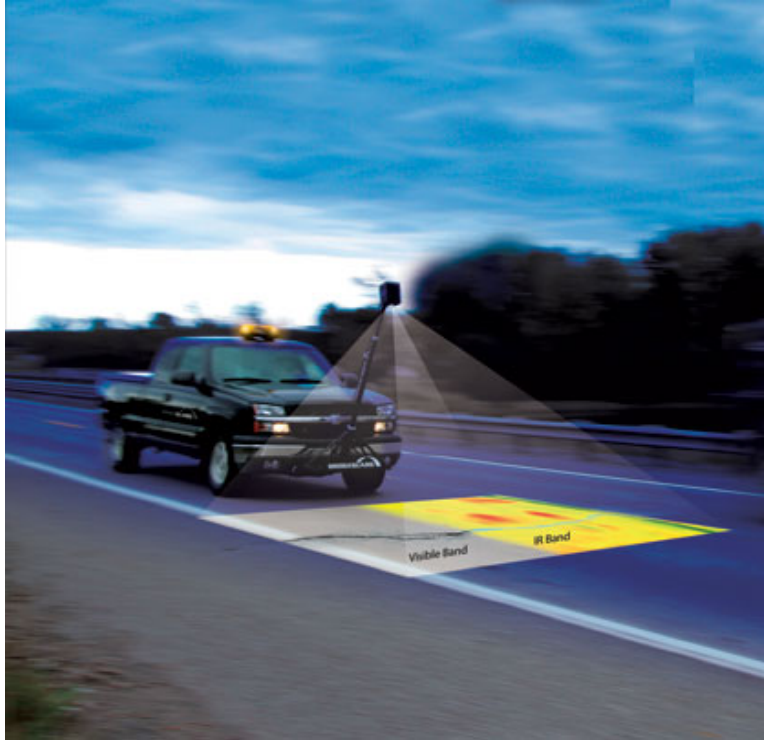
A thermographic scan is performed with sensitive infrared equipment, as shown in Figure 2-18. The components of a thermographic system include an infrared scanner, a control unit, a

**Figure 2-18 Vehicle-mounted infrared thermography scanning (Ruohonen 2013).**

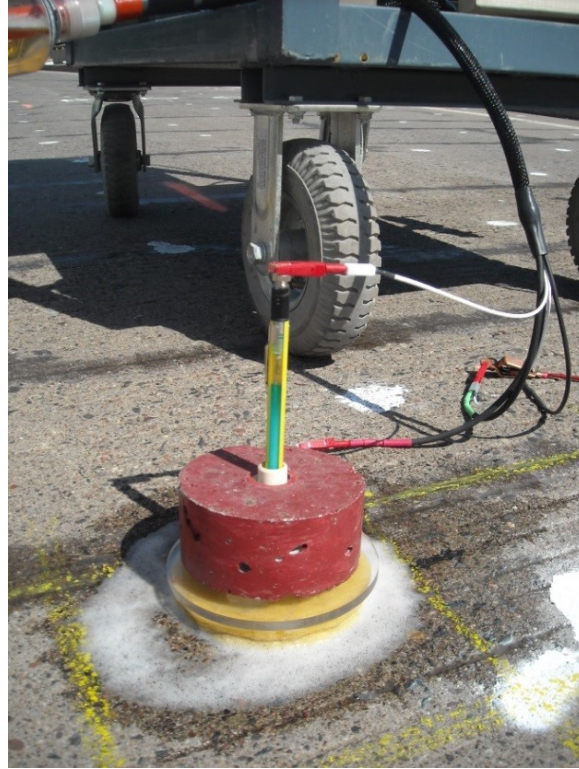
**Figure 2-20 Linear polarization testing.**

Linear polarization testing, also called linear polarization resistance testing, is a nondestructive method of measuring the resistance of the reinforcing steel to polarization (So and Millard 2007). This method is used to estimate the corrosion current density of the reinforcing steel (Andrade and Alonso 2004). Figure 2-20 shows linear polarization testing of a concrete bridge deck.

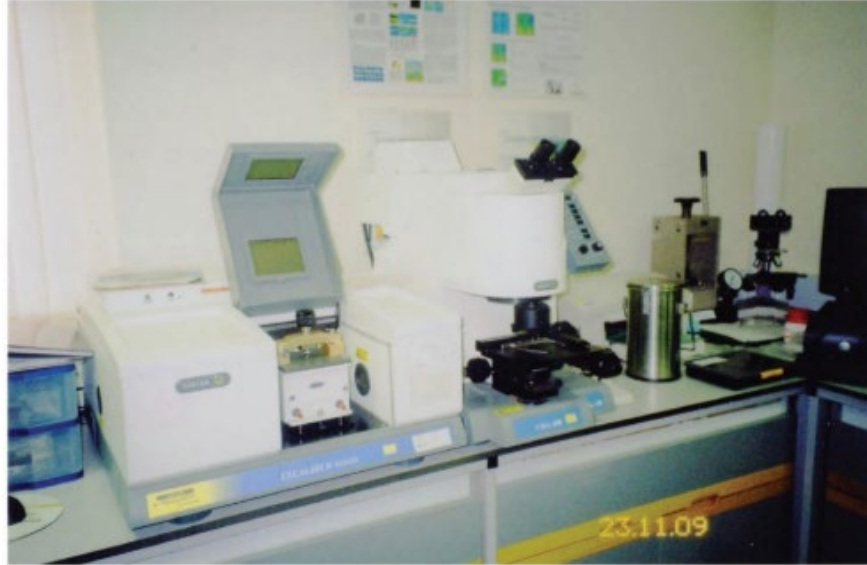
Petrographic image analysis (PIA) requires the use of advanced equipment, such as the petrographic microscope shown in Figure 2-21 (Poole and Sims 2016). The equipment is completely automated and uses digital image acquisition to obtain quantitative information about sizes, shapes, and numbers of pores in a given thin-section. PIA yields a high-resolution scan of thin-sections, cuttings, and core samples in true color. PIA also provides details concerning texture and composition of concrete constituents, including specific textural parameters such as

**Figure 2-21 Petrographic microscope (Poole and Sims 2016).**

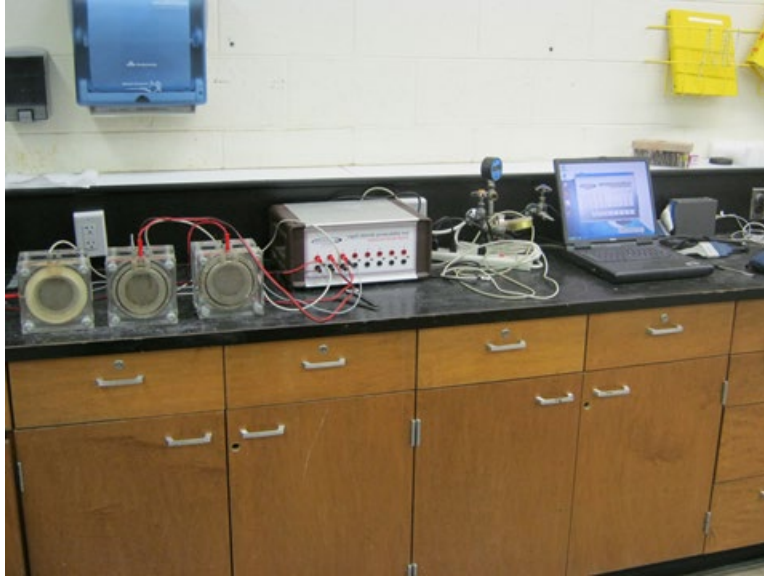
**Figure 2-23 RCP testing.**

Chloride permeability is determined with the RCP test by applying a voltage across a concrete specimen and measuring the electrical charge that passes through the specimen during a 6-hour period, as described in ASTM C1202 (Standard Test Method for Electrical Indication of Concrete's Ability to Resist Chloride Ion Penetration) (Mindess et al. 2003), where a higher value indicates a higher chloride permeability. Measuring the chloride permeability of concrete is one way to determine the risk of deterioration. Low-permeability concrete generally possesses high strength and is resistant to the infiltration of water and chlorides (Elsener and Bohni 1990).

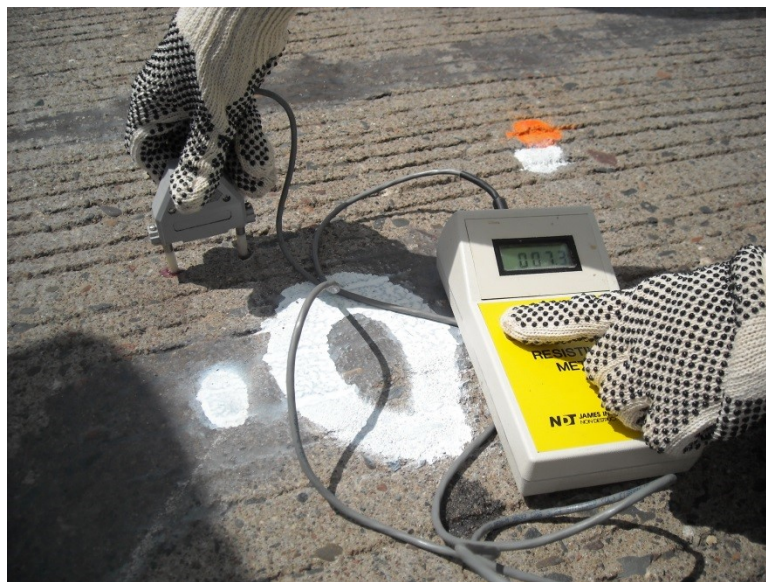
Figure 2-24 Two-prong resistivity testing.

Table 2-5 shows the interpretation of resistivity measurements with respect to the potential risk of corrosion of reinforcing steel in the concrete (Bramshuber and Raupach 2003, James Instruments, Inc. 2004, Song and Saraswathy 2007, Whiting and Naji 2003).

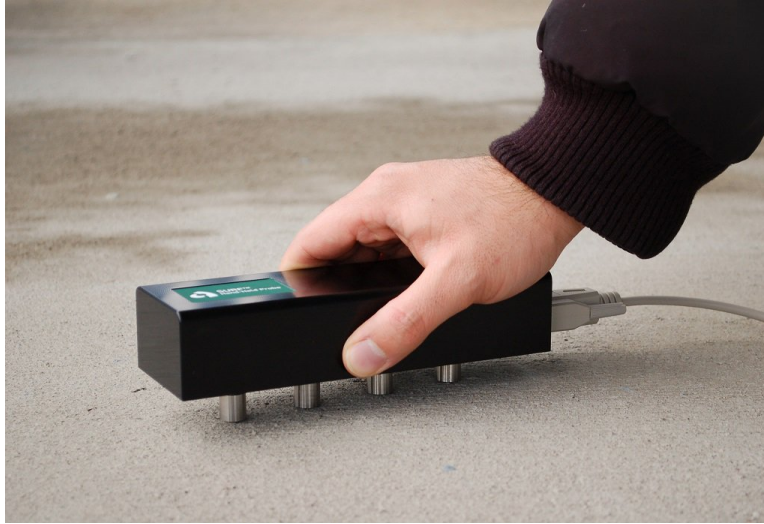
**Figure 2-25 Four-prong resistivity testing (Giatec 2013).**

For use of the four-prong probe, pre-drilled holes are not required. Instead, the probe is positioned directly on the deck surface, as shown in Figure 2-25. The resistivity value should stabilize before being recorded. The probe may then be rotated 180 degrees for a second reading at the same location if an average is needed. Resistivity testing requires stationary traffic control.

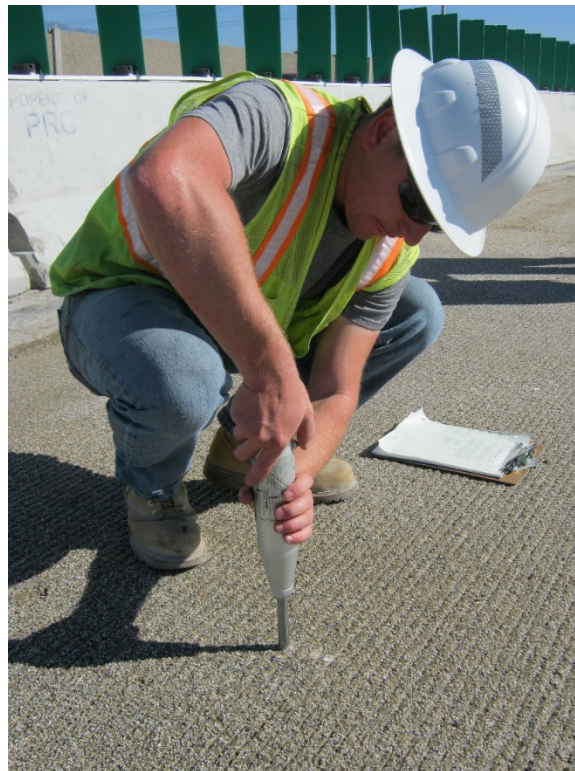
**Figure 2-26 Schmidt rebound hammer testing.**

According to ASTM C805 (Standard Test Method for Rebound Number of Hardened Concrete), the Schmidt hammer must be held perpendicular to the surface being tested to produce accurate results. The hammer is then pushed slowly toward the surface until the hammer impacts, and the impact number is then recorded. Ten readings spaced at least 1.0 in. apart and at least 2.0 in. from the edge of any members should be obtained in each test area, which may take a few minutes per test area. Concrete elements should be at least 4.0 in. thick and fixed within a

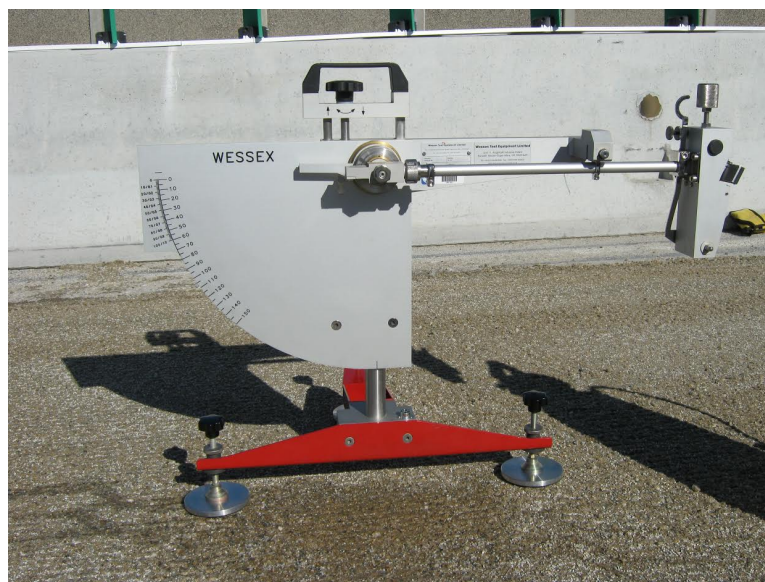
The BPT apparatus, shown in Figure 2-28, is comprised of a pendulum arm that is attached to a vertical support (Mitchell 1987). On the bottom end of the pendulum is a weighted head with a rubber slider. The opposite end of the pendulum is allowed to rotate freely around a spindle. A skid resistance test is conducted by placing the apparatus on the concrete surface to be tested, and, after performing a calibration procedure, raising the pendulum arm to a horizontal position and then releasing it. The pendulum swings freely downward to the bridge deck surface, which is generally soaked with water to achieve a worst-case scenario before the test is

Figure 2-28 Skid resistance testing using the BPT apparatus.

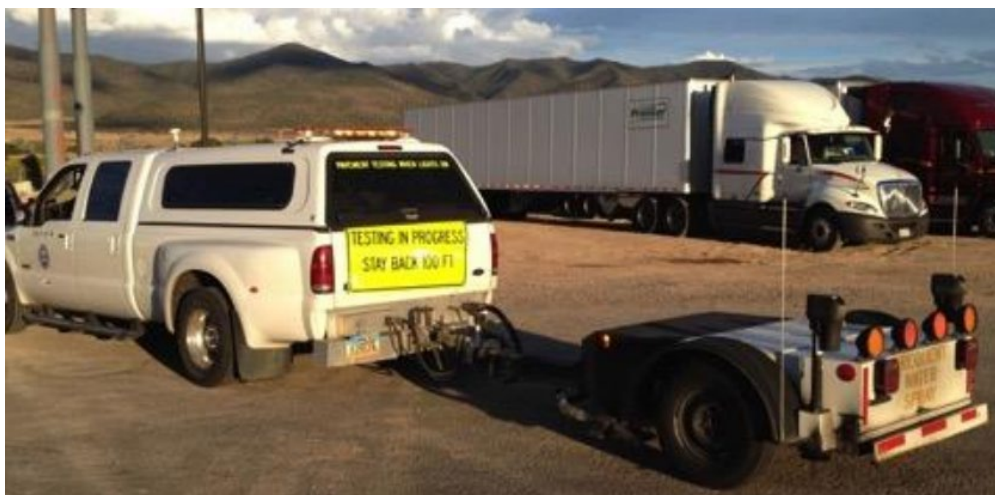
Testing with a locked-wheel skid trailer involves measurement of skid resistance of a deck surface with a specified full-scale automotive tire. The test apparatus, as shown in Figure 2-29, is comprised of a trailer that is towed behind a vehicle. The trailer includes a test wheel, a transducer, instrumentation, a water supply and dispensing system, and actuation controls for braking of the test wheel. The measurement represents the steady-state friction force on a locked test wheel as it is dragged over a wetted deck surface under constant load and at a constant speed. The skid resistance of the paved surface is determined from the resulting force or torque and is reported as a skid number (SN). For more conservative measurements, water is applied in front of the test wheel before locking it, similar to the process of wetting a bridge deck surface before performing a BPT (Smith et al. 2016).

**Figure 2-29 Locked-wheel trailer test apparatus (Smith 2016).**

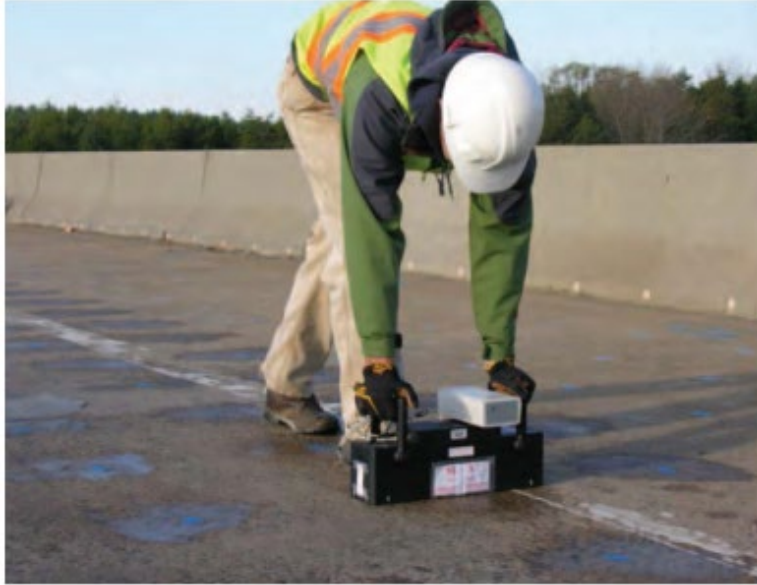
Two different types of transducers are used during an ultrasonic pulse echo test. One is a transmitting transducer, and the other is a receiving transducer (Manning 1985). For testing, the transducers are positioned on the surface of the concrete deck at a specified distance from each other, as shown in Figure 2-30 (Manning 1985). Electronic pulses are generated by the transmitting transducer and recorded by the receiving transducer, and the travel time between the two transducers is measured electronically. As the pulse passes through concrete, its velocity decreases due to the presence of voids associated with porosity and internal cracking. Cracks that are nearly perpendicular to the direction of wave propagation and large enough to disrupt the normal transmission path are most easily detected (Manning 1985). Such cracks are detected

**Figure 2-30 Ultrasonic pulse echo testing (Hema et al. 2004).**

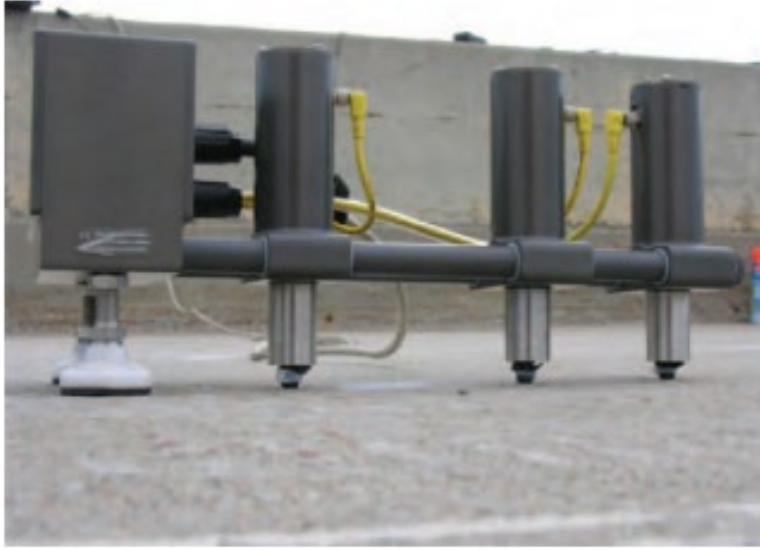
**Figure 2-31 Ultrasonic surface wave equipment (Gucunski et al. 2013).**

Automated projectile sources or solenoid-type impactors are used to generate an impact, which produces elastic waves that propagate through the tested medium (Gucunski et al. 2013). The response of the near-surface material is recorded at two receiver locations (Azari et al. 2014, Gucunski et al. 2013). Figure 2-31 shows a USW apparatus, which includes two adjustable feet (left) to ensure that the apparatus is level, a point of impact (middle), and two receivers (right) (Gucunski et al. 2013). The velocity of the surface waves is determined, and then the modulus of the material is calculated (Azari et al. 2014). Data are typically collected in a grid pattern along

the section to be tested, the data collection process at each point taking about 15 seconds (Nazarian 2005). USW testing requires stationary traffic control.

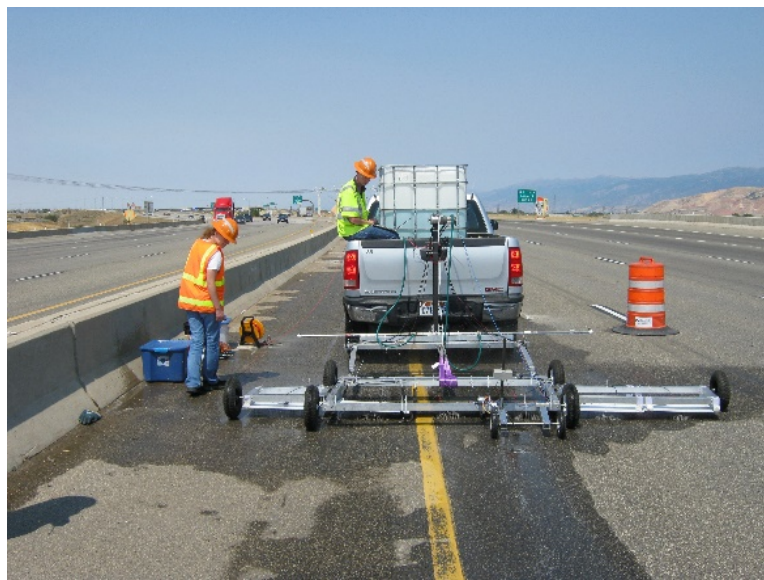
Figure 2-32 VEI testing apparatus (Barton et al. 2019a).

A direct or indirect electrical connection to the reinforcing steel is necessary to perform VEI testing. The VEI apparatus is connected to the top mat of rebar directly with a wire or

indirectly with a large-area electrode that slides along the concrete deck surface with the VEI apparatus (Barton et al. 2019a, Barton et al. 2019b).

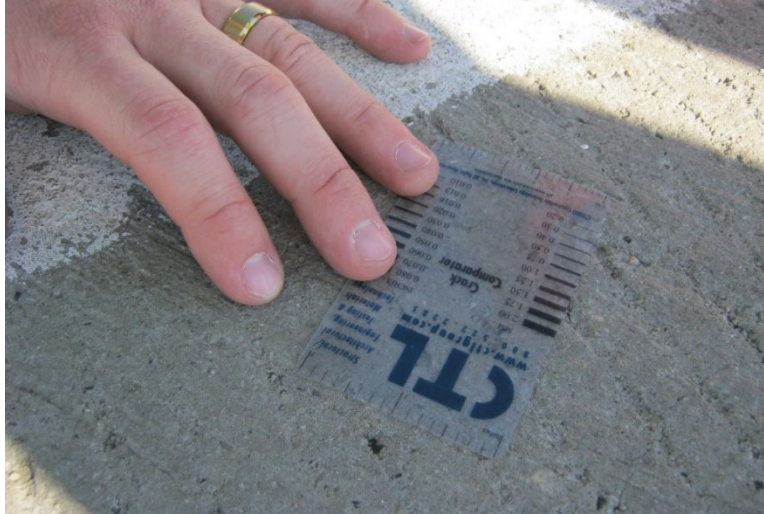
**Figure 2-34 Crack comparator card.**

Scaling is another distress that needs to be considered in visual inspections and should be reported with respect to its location and severity. Four general categories of scaling have been established: light, medium, heavy, and severe (Manning 1985). Light scaling is when the top 0.00 to 0.25 in. of surface concrete has flaked off without exposing any coarse aggregate. Medium scaling is characterized by the flaking off of the top 0.25 to 0.50 in. of surface concrete

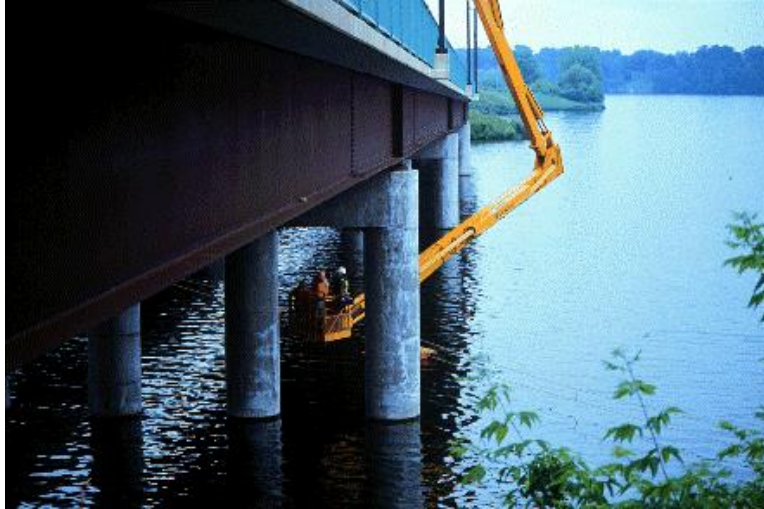
One major disadvantage of the visual inspection method is that it is subjective (Moore et al. 2001) and may not provide an accurate assessment of the bridge deck condition (Manning 1985, Shin and Grivas 2003). Furthermore, the method is slow, qualitative, and potentially

**Figure 2-35 Visual inspection of a reinforced concrete bridge deck (Hema et al. 2004).**

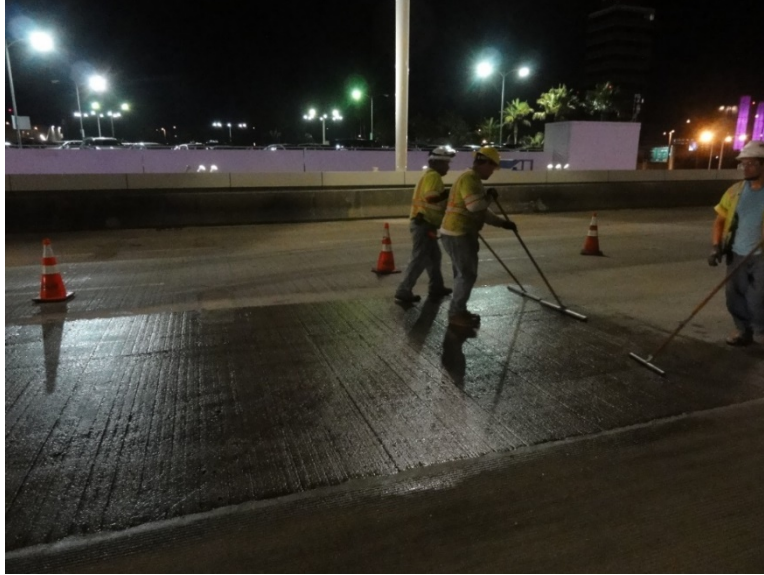
Sealants can be applied using sprayers, rollers, brushes, or squeegees (Weyers et al. 1993). Figure 2-36 shows a methacrylate sealant being applied with a squeegee. Silicon-based sealants can be dissolved in a carrier such as alcohol and sprayed onto the deck to improve

**Figure 2-36 Methacrylate sealant application process.**

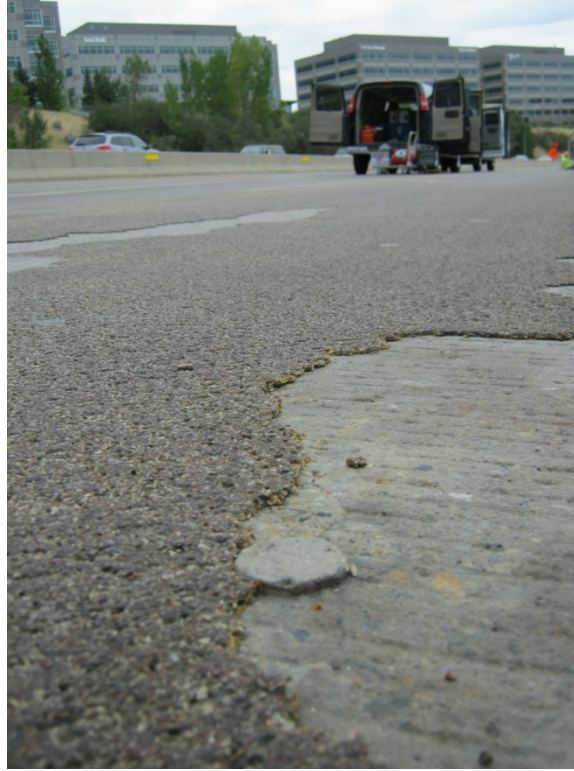
**Figure 2-37 Failing polymer overlay.**

Polymer overlays should be applied before significant distresses have developed in the bridge deck (Guthrie et al. 2005). The success of a polymer overlay can be influenced by the quality of construction, materials selection, mixture design, bond strength, and application techniques (Ramey and Derickson 2003, Stenko and Chawalwala 2001, Tabatabai et al. 2016).

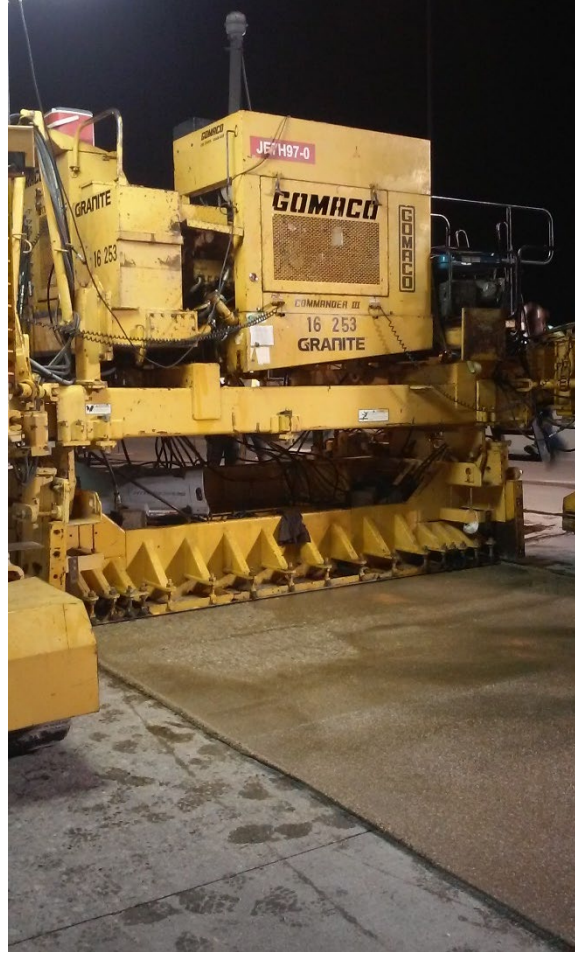
**Figure 2-38 PPC overlay placement.**

For premixed overlays, the binder, initiator, and aggregates are mixed in a mixer, placed on the deck, and finished using a vibrating screed. Premixed overlays are typically 0.50 to 1.0 in. thick (Tabatabai et al. 2016). Figure 2-38 shows placement of a pre-mixed polyester polymer concrete (PPC) overlay.

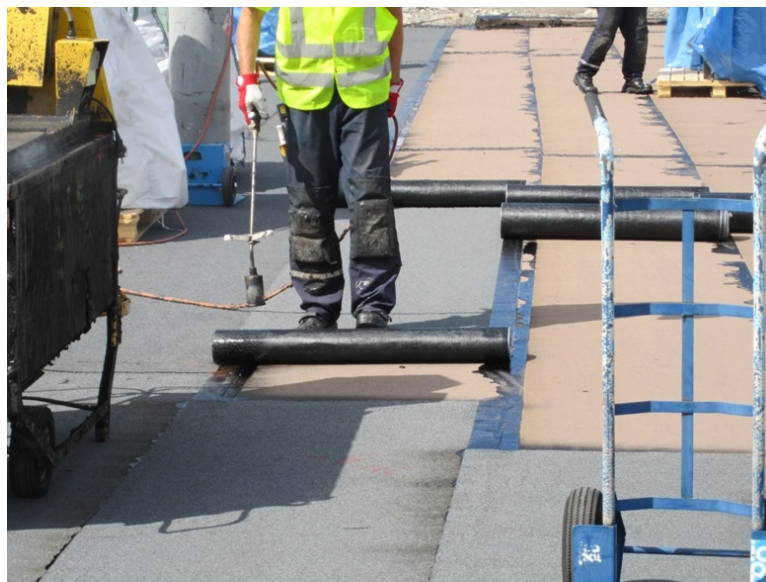
**Figure 2-39 Preformed membrane application process.**

As with other preservation treatments, surface preparation of the bridge deck prior to applying the membrane is the most important part of the process. The deck must be completely repaired to ensure good bonding and the absence of air voids under the membrane (Manning 1995). The deck must be cleaned of all dirt, grease, oil, and other materials that may inhibit proper bonding or damage the membrane, and the bridge deck surface should then be allowed to dry before the membrane is applied (Manning 1995, Sprinkel et al. 1993). Typically, a primer or tack coat is added before membrane application to improve the bond between the membrane and the deck (Kepler et al. 2000). Applications of preformed membranes and spray-applied membranes are shown in Figures 2-39 and Figure 2-40, respectively (Mays 1992).

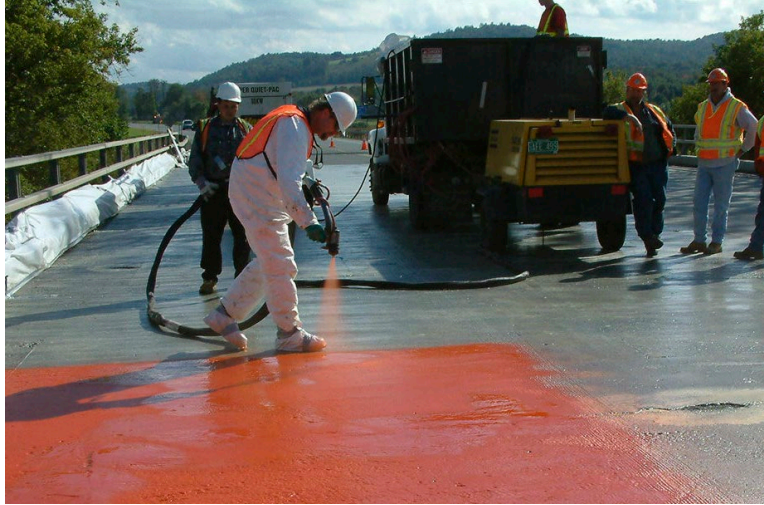
**Figure 2-40 Spray-applied membrane application process (Bridge Preservation 2016).**

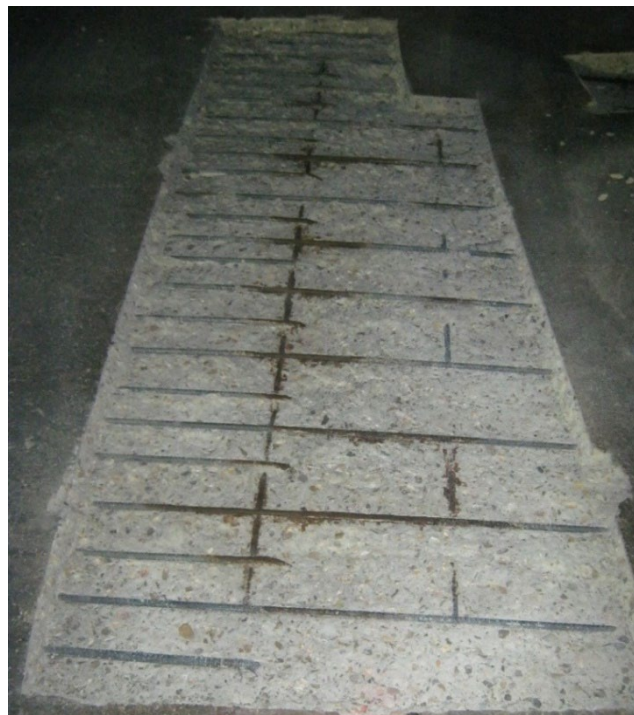
**Figure 2-43 Cover concrete removal.**

The process of repairing delaminations and potholes requires that the damaged areas be located and marked using chain dragging, hammer sounding, impact-echo testing, and/or visual inspection. To ensure that all deteriorated concrete is removed, an extra 6.0 in. of concrete is commonly removed from around the edge of a delamination or pothole. A saw is used to cut around the boundary, typically to the depth of the top mat of reinforcement, and jackhammers are used to remove the damaged concrete, sometimes to a specified depth below the top mat, before the area is cleaned with sandblasting (Hema et al. 2004, Weyers et al. 1993). Figure 2-43 shows a saw-cut and jackhammered area before the repair concrete was placed.

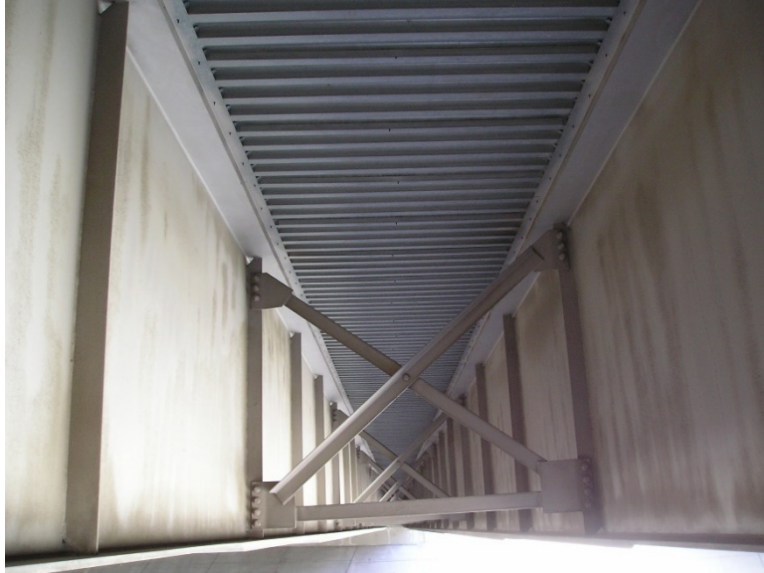
**Figure 2-45 Bottom view of SIPMF (Guthrie et al. 2006).**

SIPMFs are placed between girders and act as formwork for concrete placement. Figure 2-45 shows an SIPMF installed on a bridge deck (Guthrie et al. 2006).

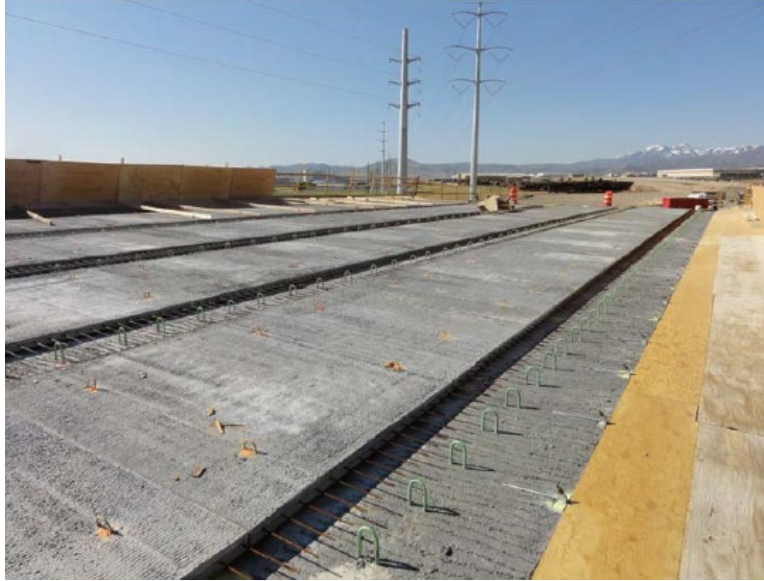
**Figure 2-46 Precast half-deck panels.**

Precast half-deck panels rest on the top flanges of the bridge girders and span between girders, as shown in Figure 2-46. A layer of reinforcement is configured above the panels, and then the upper half of the deck is cast directly on top of the panels and girders (Guthrie and Yaede 2014).

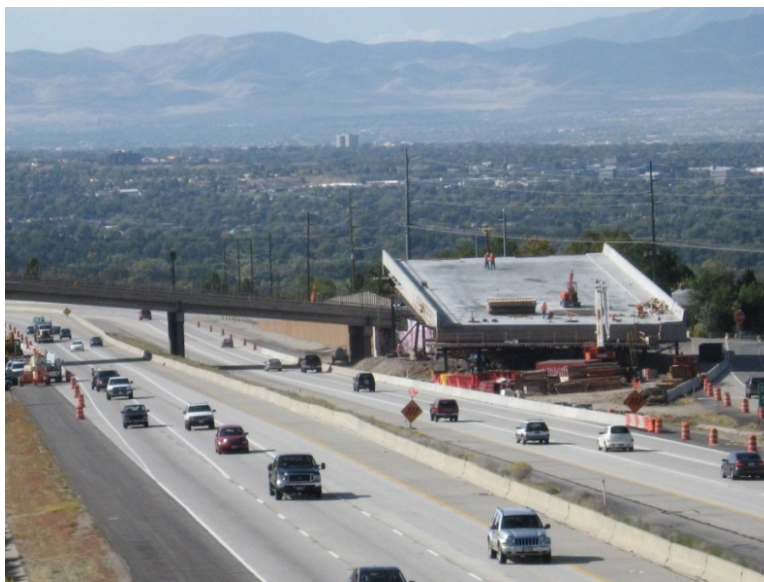
**Figure 2-48 ABC taking place in the gore area.**

The main benefits for ABC include increased safety and decreased traffic congestion. Safety is increased because construction takes place off of the roadway in the gore area,

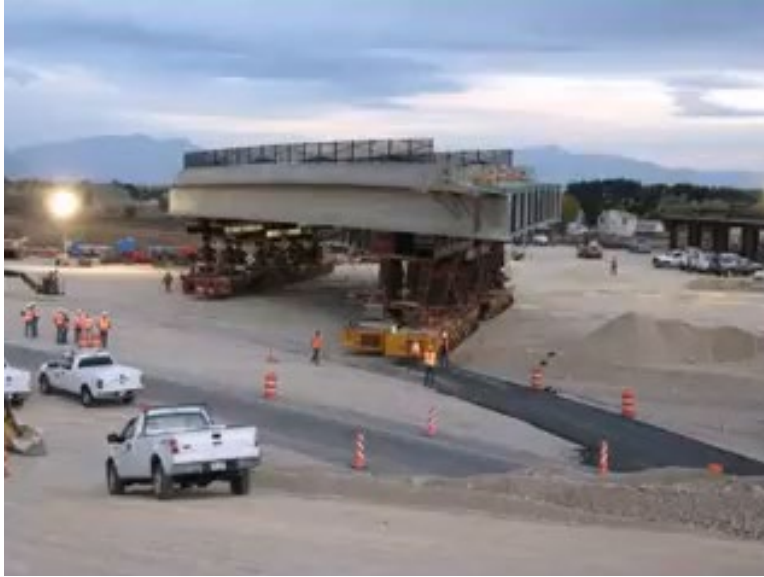
**Figure 2-49 Movement of a bridge using mobile transporters.**

protecting both drivers and construction workers, and traffic congestion is decreased because normal trafficking of the existing bridge and roadway can continue during construction of the new bridge. Once the new bridge is completed, removal of the old bridge and installation of the new bridge can be completed in the course of one or two nights, depending on the project, requiring lane closures only during that time (Culmo 2011, FHWA 2017).

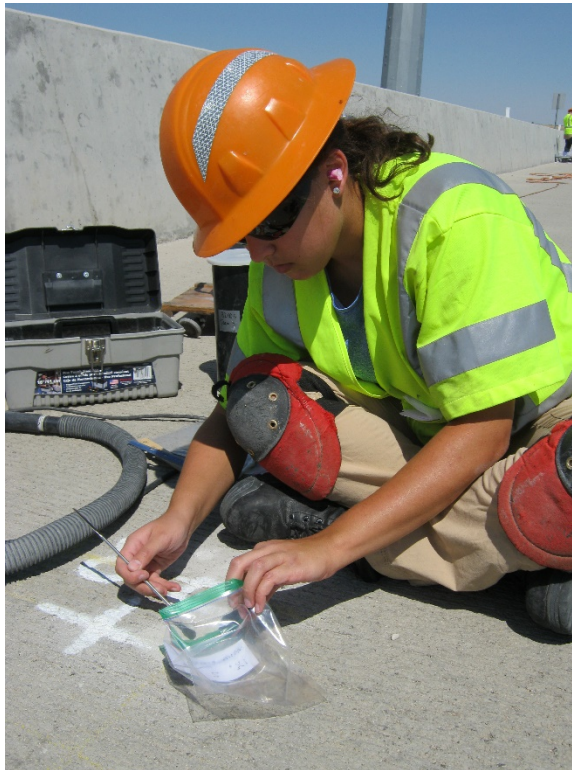
**Figure 3-17 Chloride concentration sampling.**

overlay, a 6-in.-diameter core of the overlay was first removed to expose the concrete bridge deck surface; chloride concentration sampling could then be performed at each test location. Test locations 1 and 2, as well as 7 and 8, were deliberately co-located for the purpose of comparing chloride profiles obtained from the two locations. At test locations 1 and 8, chloride concentration sampling was performed immediately over a reinforcing bar, usually close to an intersection of transverse and longitudinal bars, while at test locations 2 and 7 chloride concentration sampling was performed between bars but within approximately 4 in. of the sampling location immediately over a bar. Samples were collected on 0.5-in. depth intervals to a depth of 4 in. at test locations 2, 4, 5, and 7; 0.5-in. depth intervals until the top mat of reinforcing steel was reached at test locations 1 and 8; and 1-in. depth intervals to a depth of 7 in. at test locations 3 and 6. At locations 3 and 6, the lower mat of reinforcing steel was encountered on some decks, causing a shallower sampling depth at those locations. Because F-562 was scheduled to receive a PPC overlay shortly after testing, samples were collected on 1-in. depth intervals to a slightly greater depth of 8 in. at test locations 3, 4, 5, and 6 to better understand the pre-overlay deck condition in support of a related research effort (Stevens and Guthrie 2020); however, sampling at test locations 1, 2, 7, and 8 was consistent with the procedures used at the other decks. Each sampling hole was patched with rapid-setting, air-entrained grout. On decks with asphalt overlays, a bituminous sealant was applied to seal the bottom of each core hole, and an asphalt repair material was then compacted into the holes. Chloride concentration testing was performed in the BYU Highway Materials Laboratory using the acid-soluble chloride testing method in general accordance with ASTM C1152.

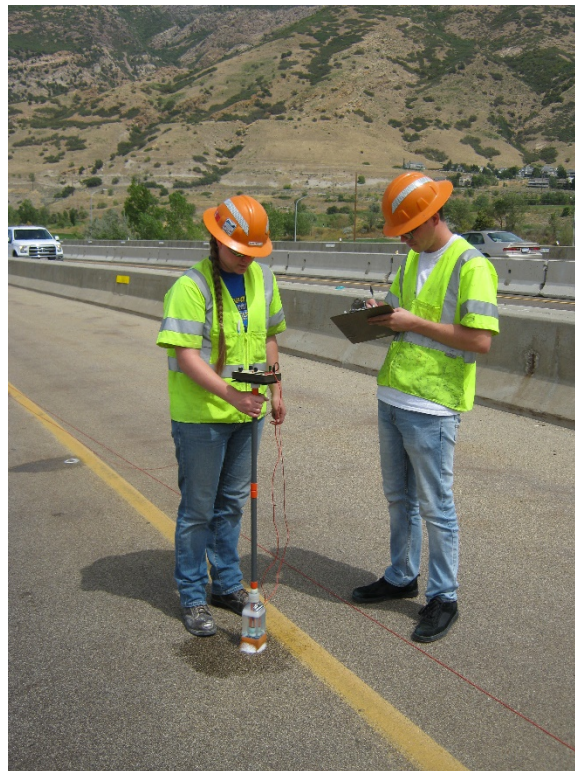
**Figure 3-19 HCP testing.**

HCP testing was performed on bridge decks with uncoated, or black, bar in general accordance with ASTM C876. The reinforcing steel was first tapped at test locations 1 and 8 to measure the electrical resistance of the top mat of reinforcement within the test area; for the two bridge decks with black bar, the transverse distance between test locations 1 and 8 was 4 ft,

requiring electrical current to pass through at least one junction between longitudinal and transverse rebar. After verifying that the top mat of reinforcement was electrically continuous, the HCP apparatus was connected to one of the taps, and a reading was obtained at each test location, as shown in Figure 3-19.
