## Development of a Management Guide for Concrete Bridge Decks in Utah

A dissertation submitted to the faculty of  
Brigham Young University  
in partial fulfillment of the requirements for the degree of  
Doctor of Philosophy

Department of Civil and Environmental Engineering  
Brigham Young University

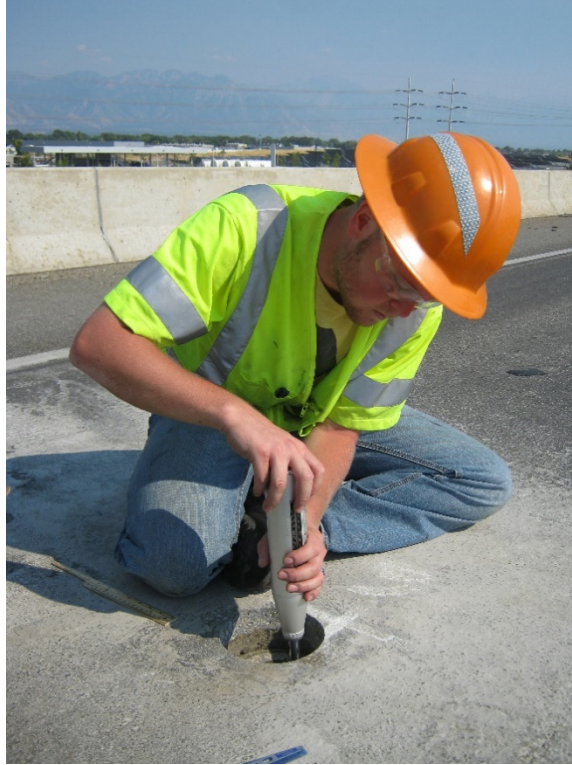
**Figure 3-20 Schmidt rebound hammer testing.**

Schmidt rebound hammer testing was performed in general accordance with ASTM C805, as shown in Figure 3-20. Before testing, the concrete surface was smoothed using a masonry grinding wheel mounted to an angle grinder. When a polymer overlay was present, the grinding wheel was also used to grind through the overlay to expose and smooth the bare concrete bridge deck. When an asphalt overlay was present, testing was performed through a 6-

in.-diameter core hole on the exposed concrete bridge deck surface following removal of any membrane materials and after smoothing the concrete with the grinding wheel. Three readings within an approximately 2-in.-diameter area were recorded and averaged at each test location. The hammer was held perpendicular to the deck surface in each case.

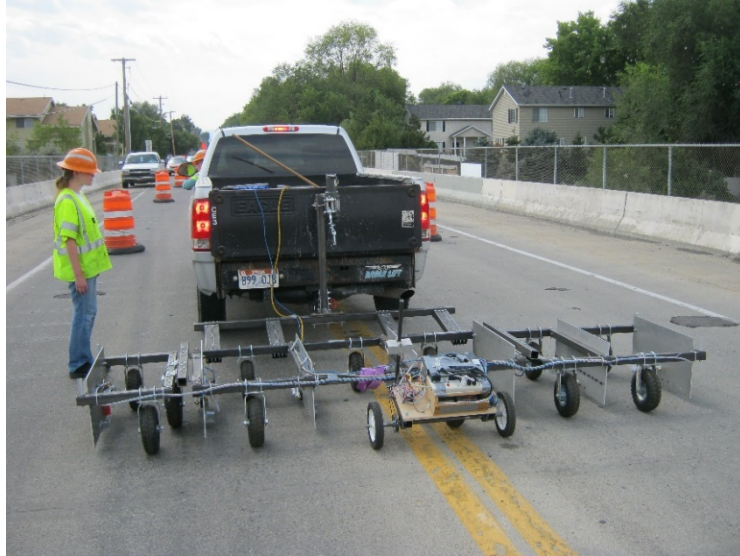
**Figure 3-21 Impact-echo testing.**

Impact-echo testing was performed on the 10 bridge decks that did not have an asphalt overlay. The full width of the testing area was scanned using a multi-channel, mallet-based, impact-echo apparatus, as shown in Figure 3-21. The spatial resolution of data collected using the impact-echo apparatus was 2 ft in the transverse direction and approximately 1 ft in the longitudinal direction (Larsen et al. 2020).

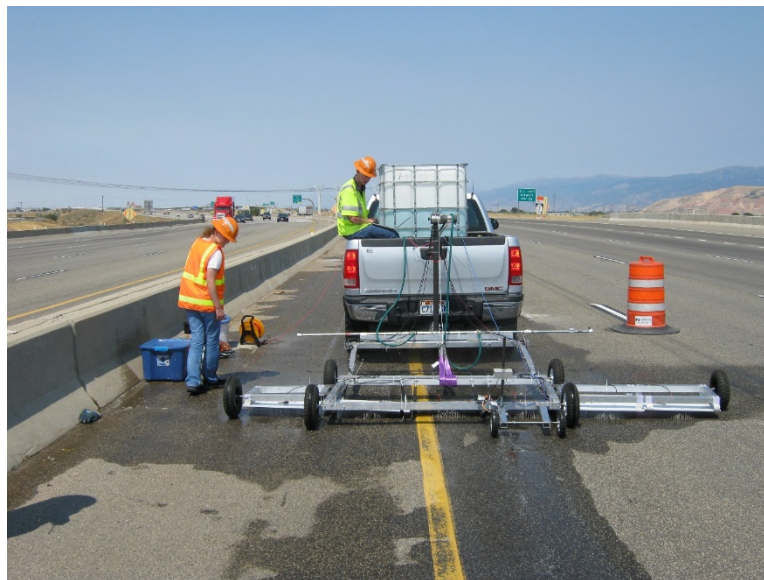
**Figure 3-22 VEI testing.**

VEI testing was performed on all 15 bridge decks. The full width of the testing area was scanned using a multi-channel VEI apparatus, as shown in Figure 3-22. The VEI apparatus required an electrical connection to a rebar tap, which was available at either test location 1 or 8

on each bridge deck. The spatial resolution of data collected using the VEI apparatus was 2 ft in the transverse direction and approximately 1 ft in the longitudinal direction (Baxter et al. 2020).

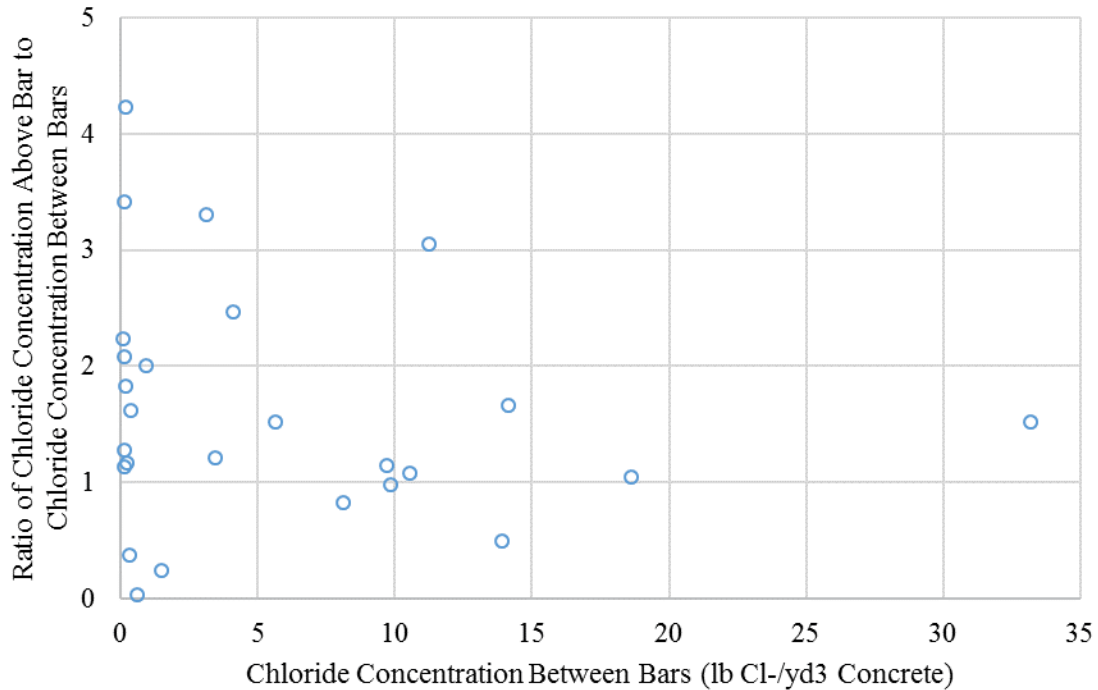
**Figure 3-23 Chloride concentrations directly above and between reinforcing bars at the depth of the top mat of rebar.**

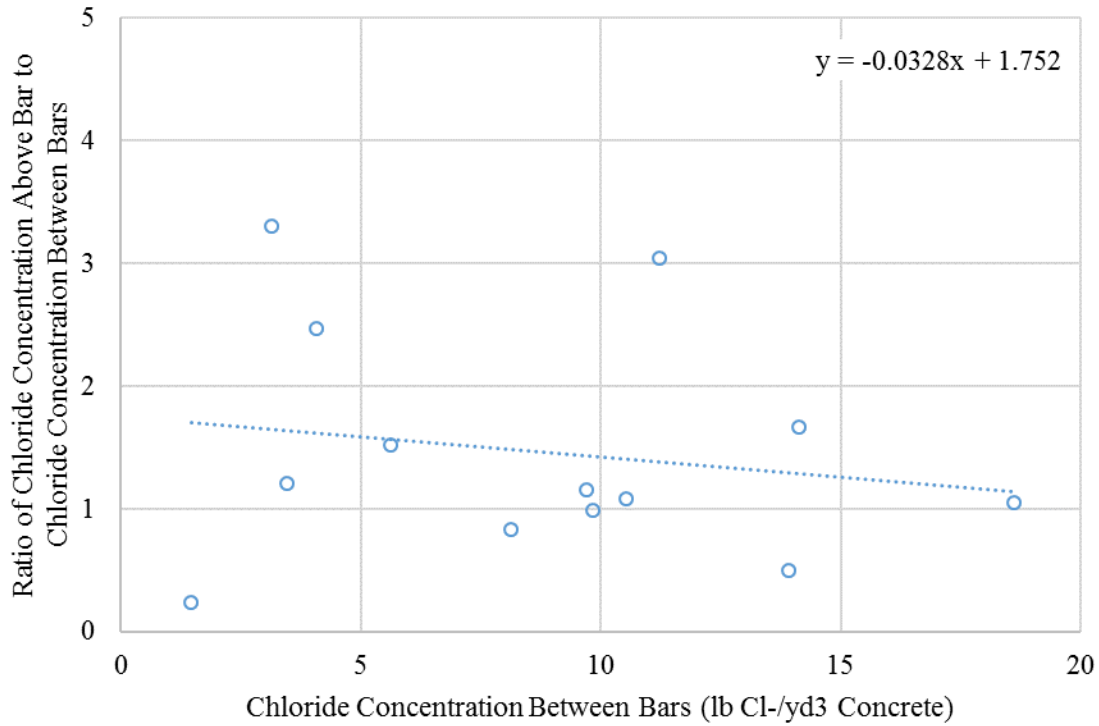
**Figure 3-24 Linear regression for selected chloride concentrations directly above and between reinforcing bars at the depth of the top mat of rebar.**

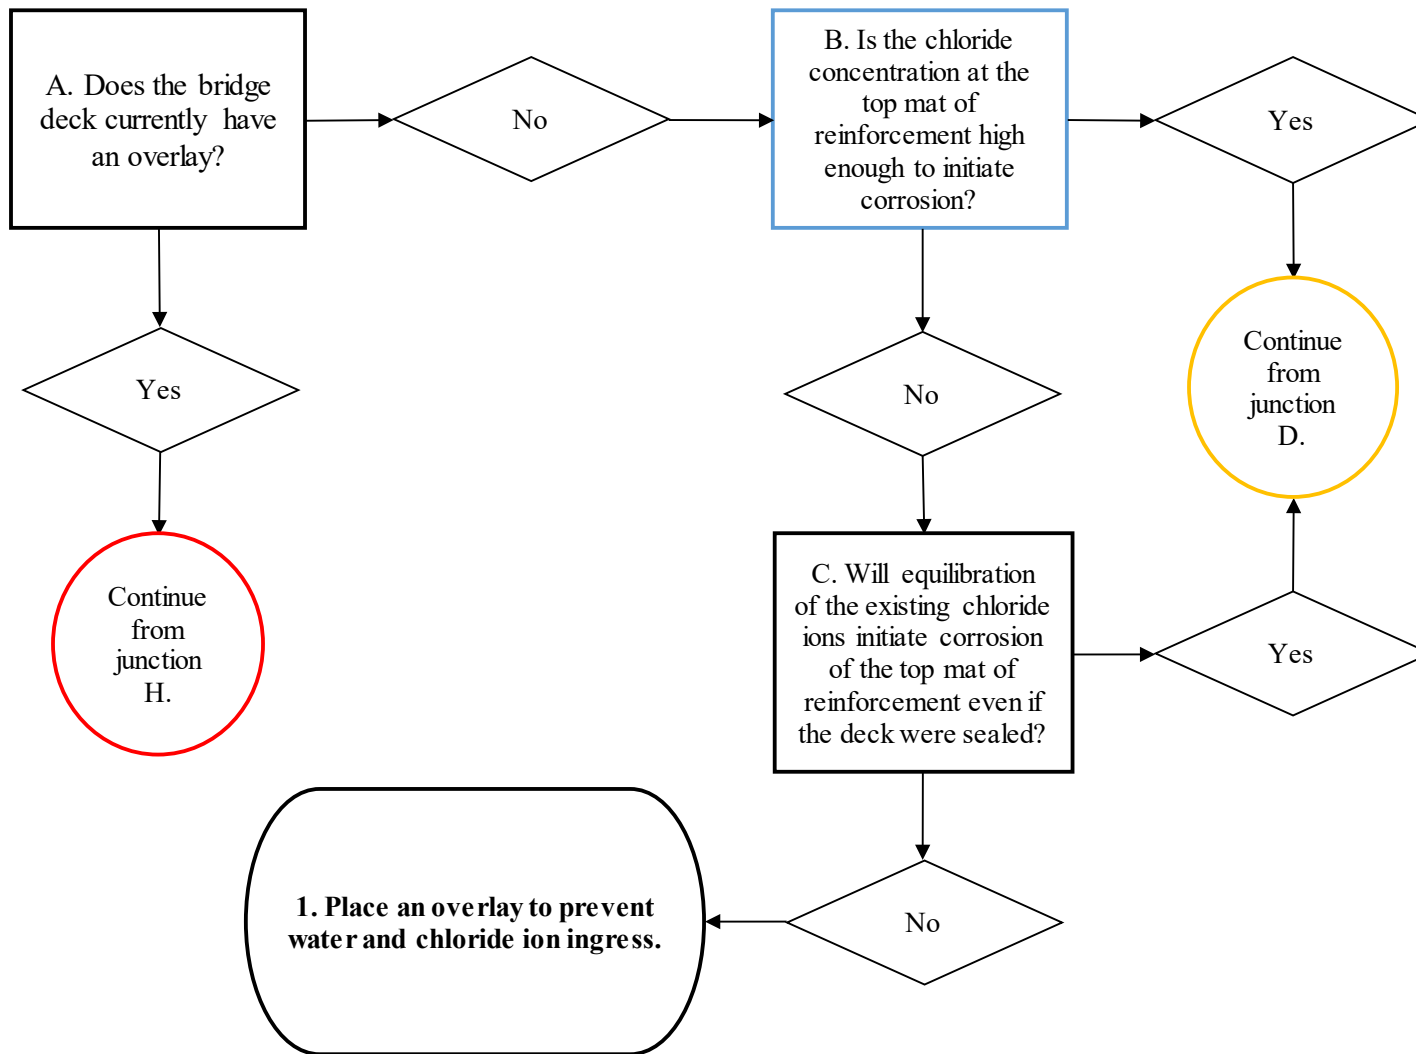
Figure 4-1 Decision tree (junctions A to C).

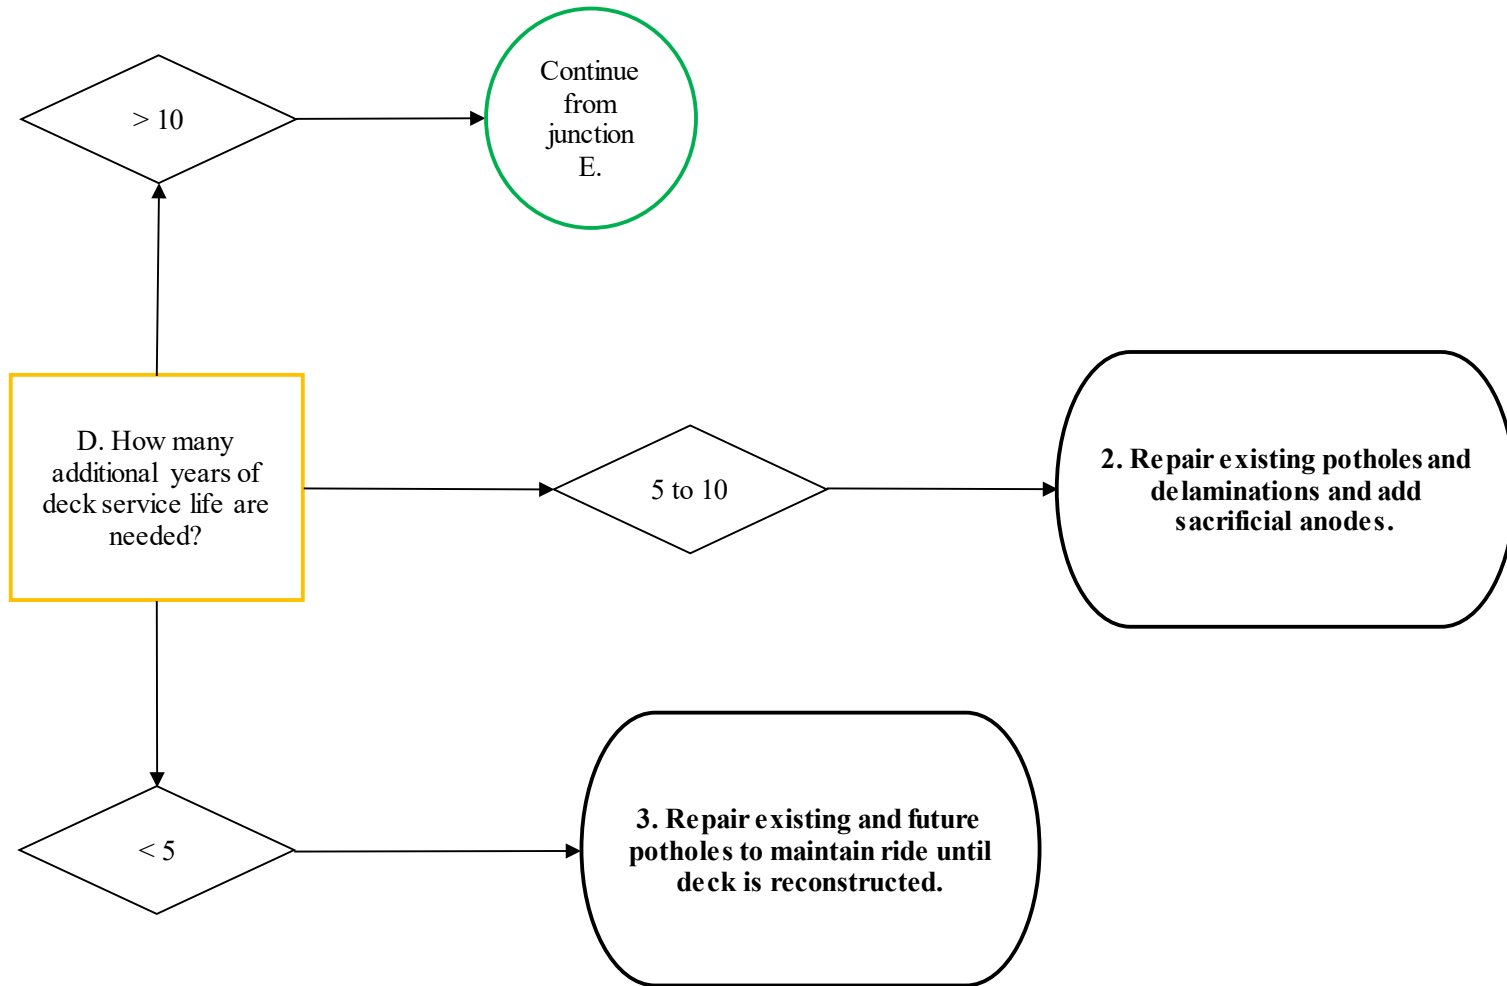
Figure 4-2 Decision tree (junction D).

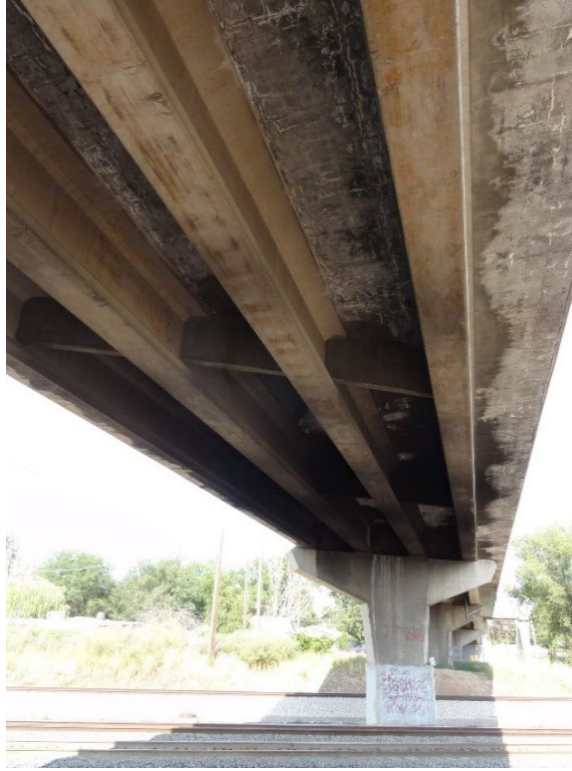
**Figure 4-7 Significant cracking and efflorescence on the underside of a bridge deck.**

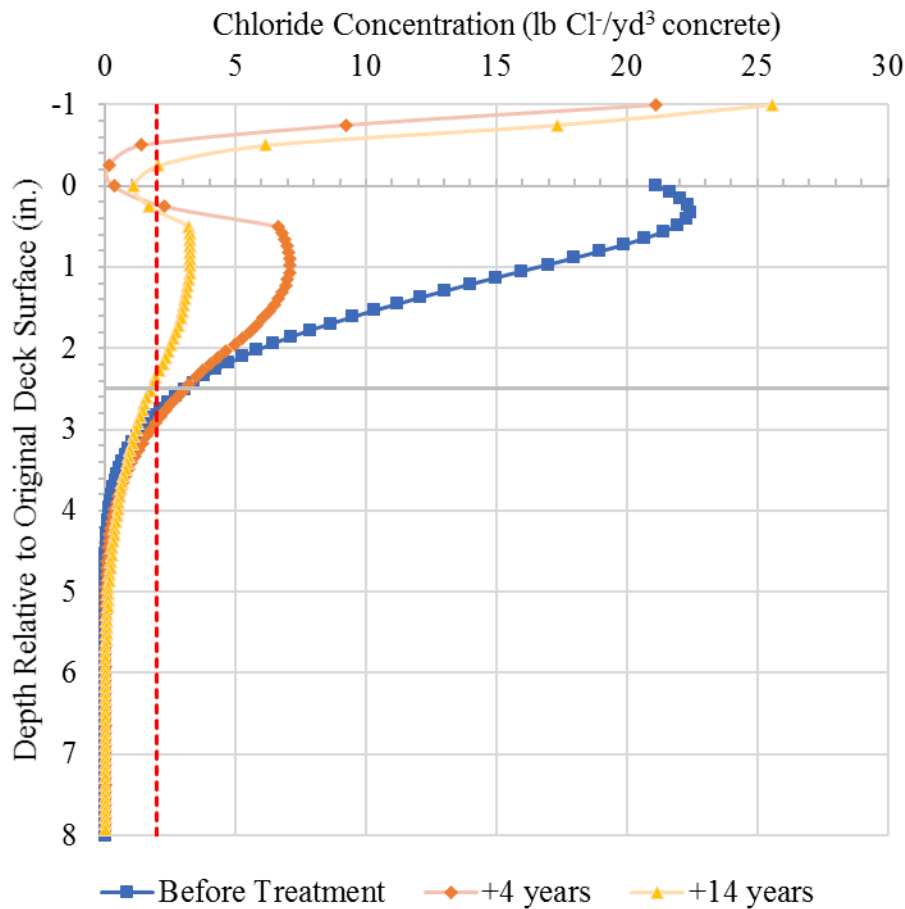
**Figure 4-9 Chloride concentration profile for a scenario in which a 0.5-in. scarification and 1.5-in. overlay is applied.**
