Earthquake effects on artificial groundwater recharge efforts in south Japan

Keywords Kumamoto earthquake · Artificial recharge system · Paddy field infiltration · Resilient groundwater management

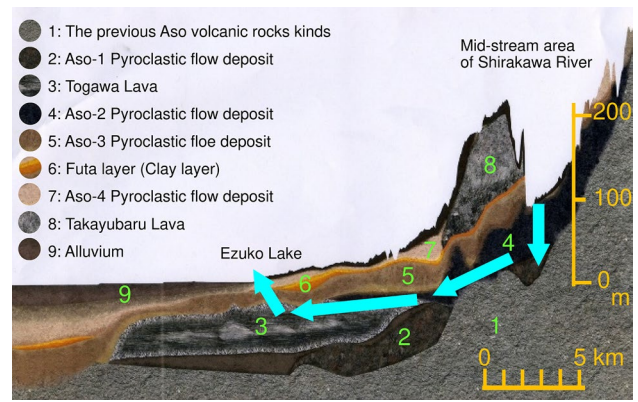
Fig. 2 Example of cross-sectional geological profile and general groundwater flow

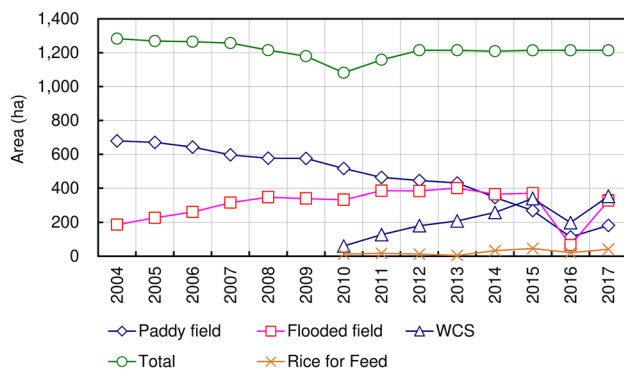
Fig. 5 Area change of paddy fields, flood paddy fields, WCS, and rice for feed (groundwater recharge measures started in 2004 and the Kumamoto earthquake occurred in 2016)

fodder. Fodder rice is matured rice harvested at the end of October. As farmers can receive governmental subsidies by producing WCS as well as by allowing their paddy fields to be flooded during fallow periods, the artificial recharge area has continuously increased from 2004. The planted acreage of WCS was 60.6 ha (5.1% of total 1200 ha paddy field area) in 2010. It increased rapidly to 132.7 ha (11.1%) in 2011, 215.7 ha (18%) in 2013, and 342.2 ha (28.5%) in 2015 (Fig. 5; WCS).

On the other hand, planted rice for feed acreage has not increased substantially. In 2010, it was 12.5 ha (1% of total rice paddy area), 17.1 ha (1.4%) in 2011, 4.7 ha (0.4%) in 2013, and 45.6 ha (3.8%) in 2015 (Fig. 5; rice for feed). Farmers did not increase their profit by growing rice for fodder due to that they then cannot use their fields for flooding. In any case, the cultivation of rice for human consumption in the mid-stream part of the Shirakawa River Basin continues to decrease.

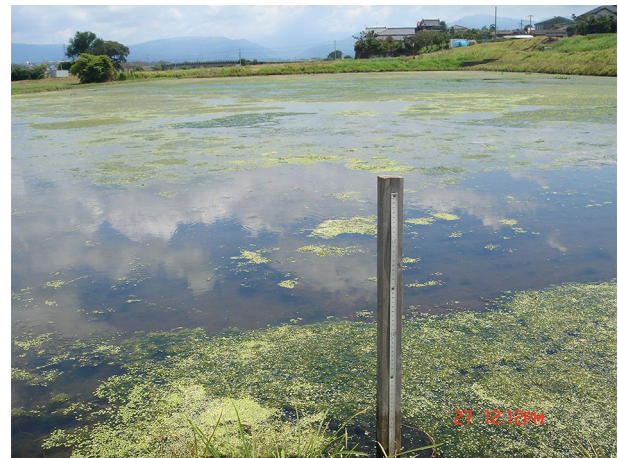
Fig. 6 Example of measures to increase recharge in the mid-stream of the Shirakawa River Basin

Water infiltration surveys were conducted to calculate the amount of water recharging the groundwater in the artificial recharge area. In the water infiltration surveys, the water level was recorded depending on time using stakes with scale after flooding and closing the entrance of water to the fields (Fig. 6). Then, daily water infiltration rate was estimated using the inclination of regression line based on decline of water level with time.

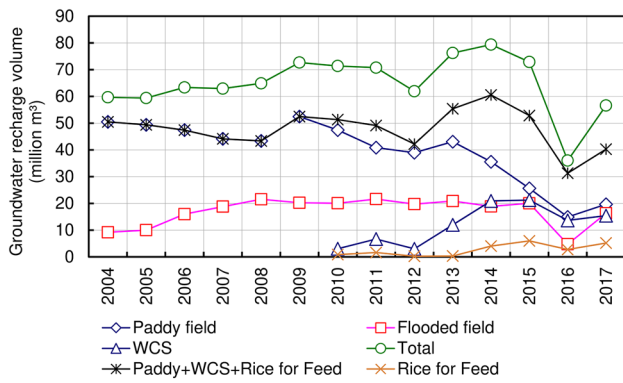
Fig. 7 Annual groundwater recharge volume in paddy, flooded, WCS, and rice for feed (groundwater recharge measures started in 2004 and the Kumamoto earthquake occurred in 2016)

Figure 7 shows the total groundwater recharge volume for the entire artificial recharge system in the mid-stream area of the Shirakawa River during 2004–2017 (Fig. 4). The groundwater recharge volume from the recharge system was about 9.2 million m^3 in 2004 (first year), about 10 million m^3 in 2005, and about 20 million m^3 in 2007 (Fig. 7; flooded fields). The increase in artificial recharge was achieved due to a continuous increase in flooded area as described in “Materials and methods”. The recharge volume was maintained at about 20 million m^3 from 2007 to 2015 due to an almost constant flooded area (Ichikawa 2015a). The total groundwater recharge volume, thus, includes contributions from WCS, rice for feed, paddy fields, and flooded fields. As seen from Fig. 7, there was a temporary decline in recharge volume during 2012. This was due to a flood event of the Shirakawa River that caused damage to farmland areas.

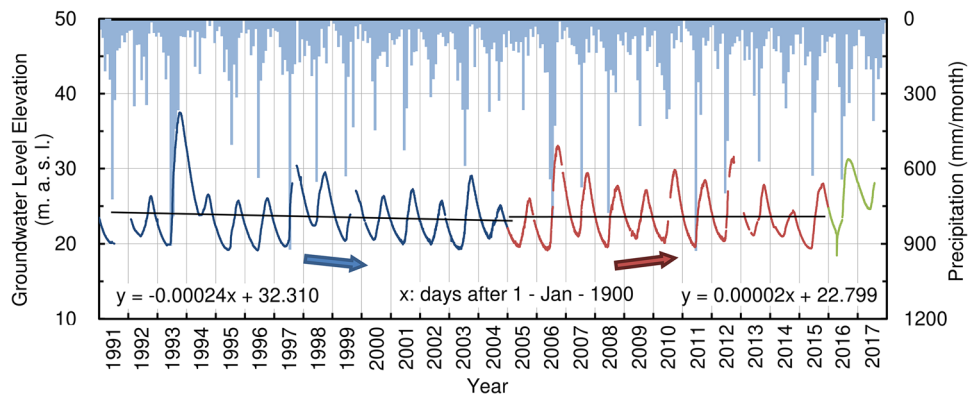
Fig. 8 Groundwater level change in the Kumamoto groundwater basin

to a slightly increasing trend (+0.00002 m/day) (Fig. 8). The downstream (Ezuko Lake) of the artificial groundwater recharge, system as well, displayed a halt in the declining discharge volumes. During 2005, a minimum discharge from the Ezuko Lake was observed. From 2006 a marked increase was found (Fig. 9). However, from 2008 and onwards, the

Precipitation amount is also an important factor for groundwater recharge in the forests and upland fields. Groundwater level showed higher peaks in some years because of higher precipitation amount (Fig. 8). To evaluate the long-term trend in precipitation, Mann–Kendall test was performed using monthly precipitation data from 1992 to 2004 and 2004 to 2017. However, there were no significant upward or downward trends for these periods ($p > 0.05$). Thus, the decline of groundwater level and spring volume to Ezuko Lake was mainly caused by a decline of groundwater recharge due to the Japanese rice production adjustment policy and urbanization. The continuous rise in groundwater level and increase in the amount of spring water to the Ezuko Lake are thus considered to be effects of the established artificial recharge system.

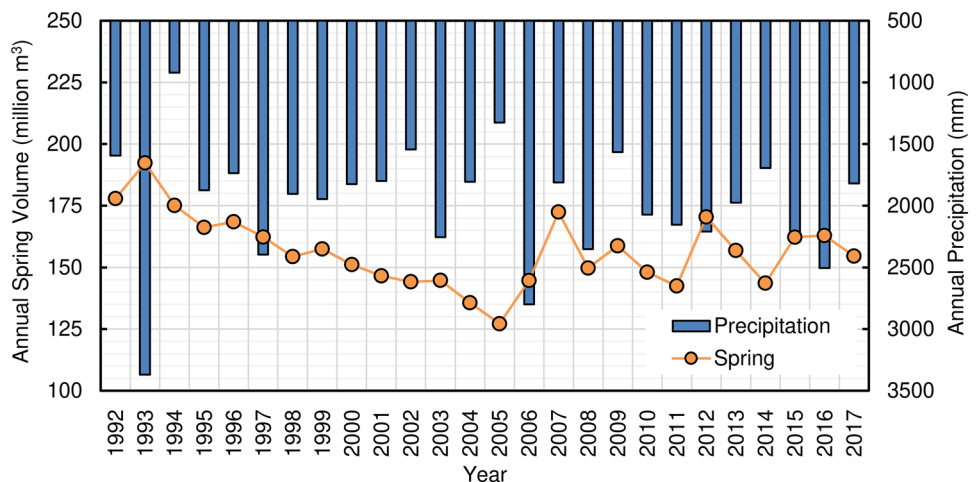
Fig. 9 Annual discharge from the Ezuko Lake and precipitation

average discharge was almost constant (Fig. 9) (Ichikawa 2015b).

However, an immediate effect of the Kumamoto earthquake was a groundwater level rise of more than 2 m (Fig. 11). This rapidly rising groundwater level was probably caused by a sudden release of stored groundwater along the mountain slopes (Wang et al. 2004; Wang and Manga 2015). Moreover, the groundwater level rose during June–September because of extreme amounts of rainfall, 2653 mm in 2016 (annual mean rainfall was 2205 mm during 2003–2010). Even though there was little groundwater recharge in the basin, the spring discharge to the Ezuko Lake increased substantially as shown in Fig. 9. This was caused by the sudden groundwater level rise after the earthquake.

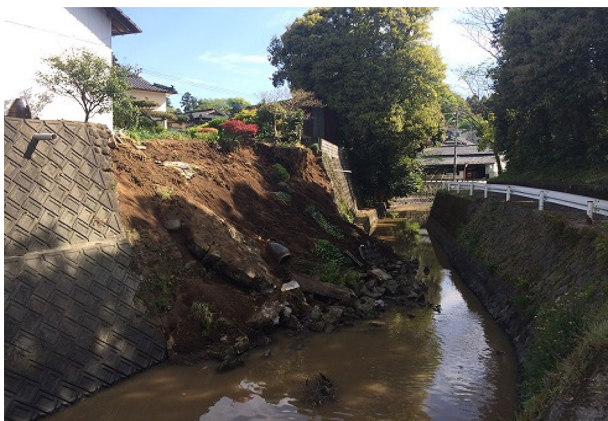
Fig. 10 Example of collapsed irrigation channel in the Shirakawa River Basin

The rainfall on June 19–30 was 593 mm. Most of the irrigation channels supplying water to the flooded fields were destroyed by the earthquake and could not supply water for the artificial groundwater recharge. Figure 10 shows an example of the damage that occurred in the Uwaide irrigation channel. The earthquake, as well, damaged irrigation systems in the mid-section of the Shirakawa River Basin at about 70 locations. As a result, it was impossible to take water from the five weirs except from the Hata and Babakusu weirs. In addition, the heavy rainfall caused landslides that buried the Hata irrigation system. Therefore, almost no water was supplied to the irrigation channels and the recharge system. Thus, the area of the artificial recharge system decreased from 386.6 ha in 2015 to 84.4 ha in 2016 (Ichikawa 2016). The amount of recharge from the flooded fields decreased to only 4.71 million m³ in 2016. This amount was only 23.5% of recharge during the previous year (2015). Because of this situation, the total recharge amount in Shirakawa River Basin decreased to only 49% (36 million m³ in 2016) compared to the previous year (72.9 million m³, 2015). As well, most of the agricultural activity stagnated due to the destruction of the irrigation systems.

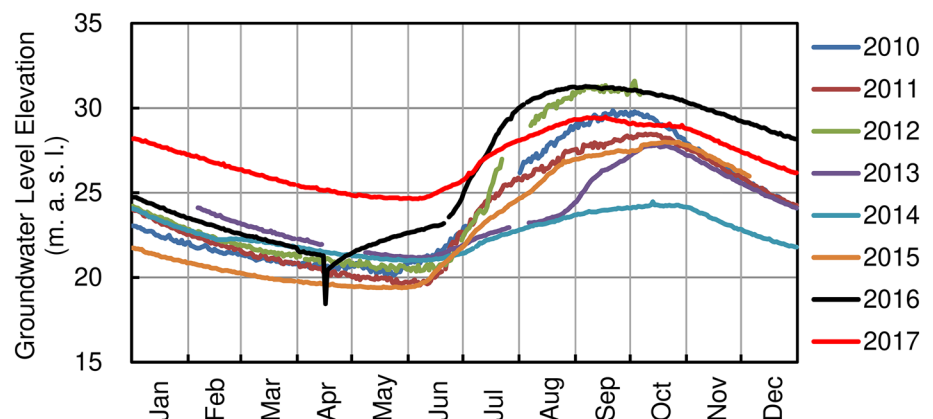
Fig. 11 Examples annual groundwater level changes in the Shirakawa River Basin (Kikuyo observation site)
