Earthquake risk assessment of Mississippi State University

EARTHQUAKE RISK ASSESSMENT OF MISSISSIPPI STATE UNIVERSITY

A Thesis
Submitted to the Faculty of
Mississippi State University
in Partial Fulfillment of the Requirements
for the Degree of Master of Science
in Geosciences
in the Department of Geosciences

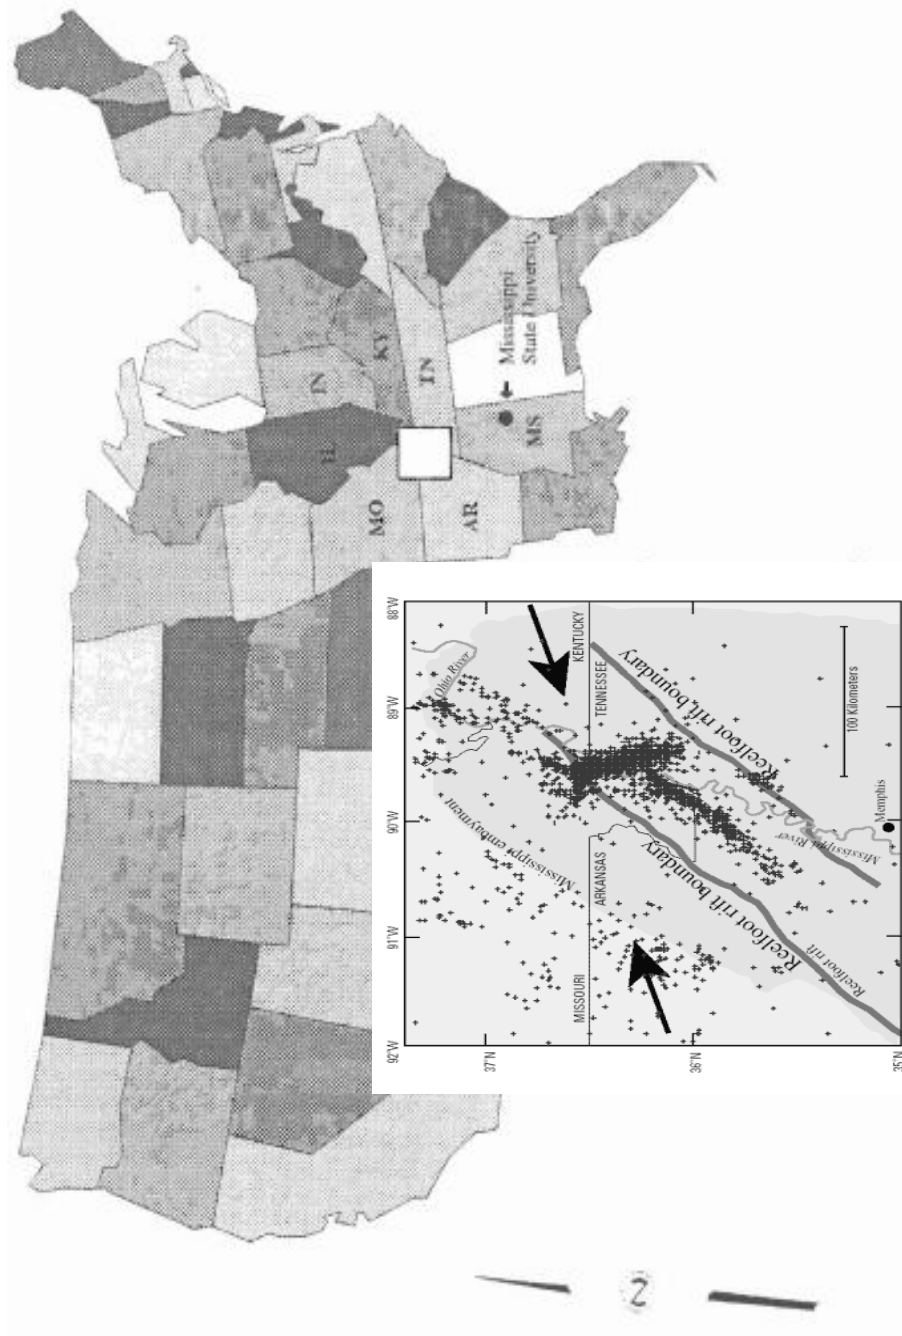
Figure 1 Location of the New Madrid fault zone and the Mississippi State University (After Snodgrass, 1998).

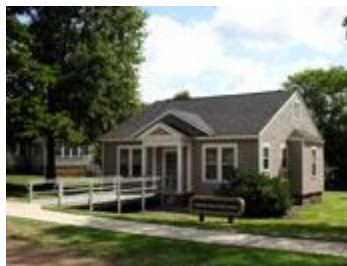
Figure 6 Example for a building constructed using wood - Computer Based Testing Center at MSU

Buildings constructed using wood (Figure 6) usually performs well during an earthquake due to light weight, low rise and structural system used (FEMA 154). Lack of connection between the foundation and superstructures causes the most damage to this type of buildings.

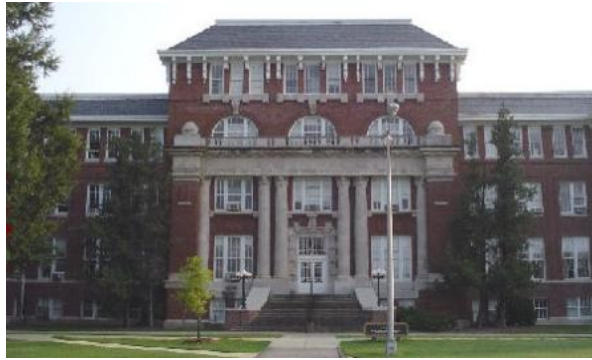
Figure 7 Example for a building constructed using masonry - The Lee Hall at MSU

Masonry buildings (Figure 7) can be reinforced masonry or unreinforced masonry depending on the material used. Reinforced buildings can perform well in moderate earthquakes, but unreinforced buildings perform poorly during an earthquake (FEMA 154).

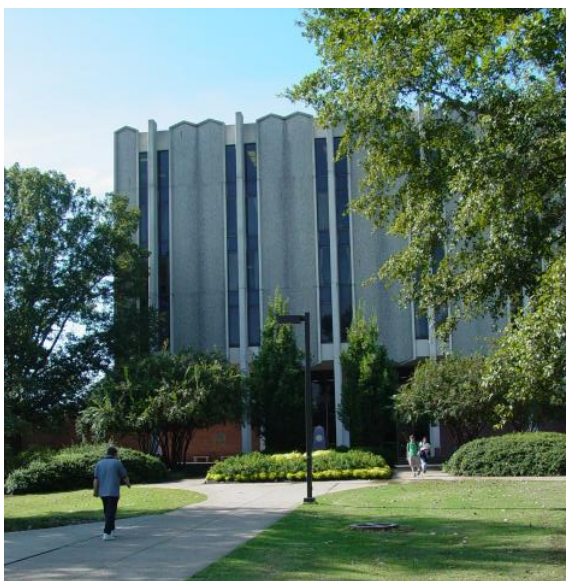
Figure 8 Example for a building constructed using concrete - Allen Hall at MSU

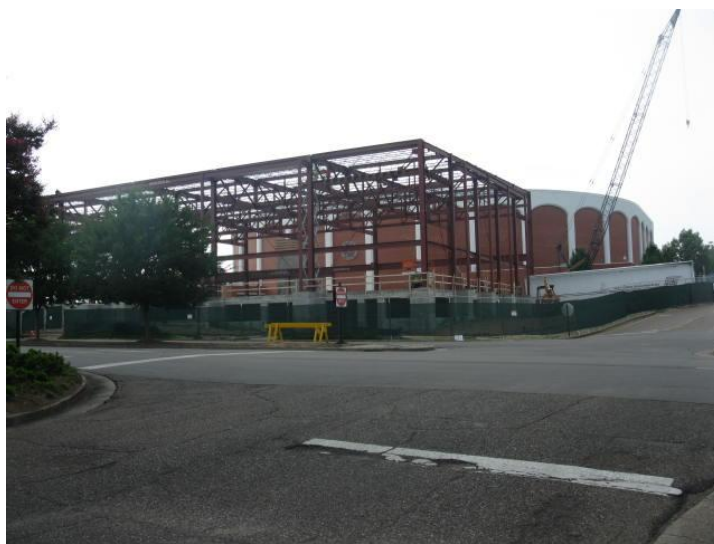
Figure 9 Example for a building constructed using steel – New Construction near Coliseum at MSU

Buildings constructed using steel (Figure 9) can have steel moment resisting frames, braced steel frames, steel frames with cast-in place concrete shear walls, etc.. Damages to this type of buildings include broken connections between the beams and columns, and shear cracking (FEMA 154).

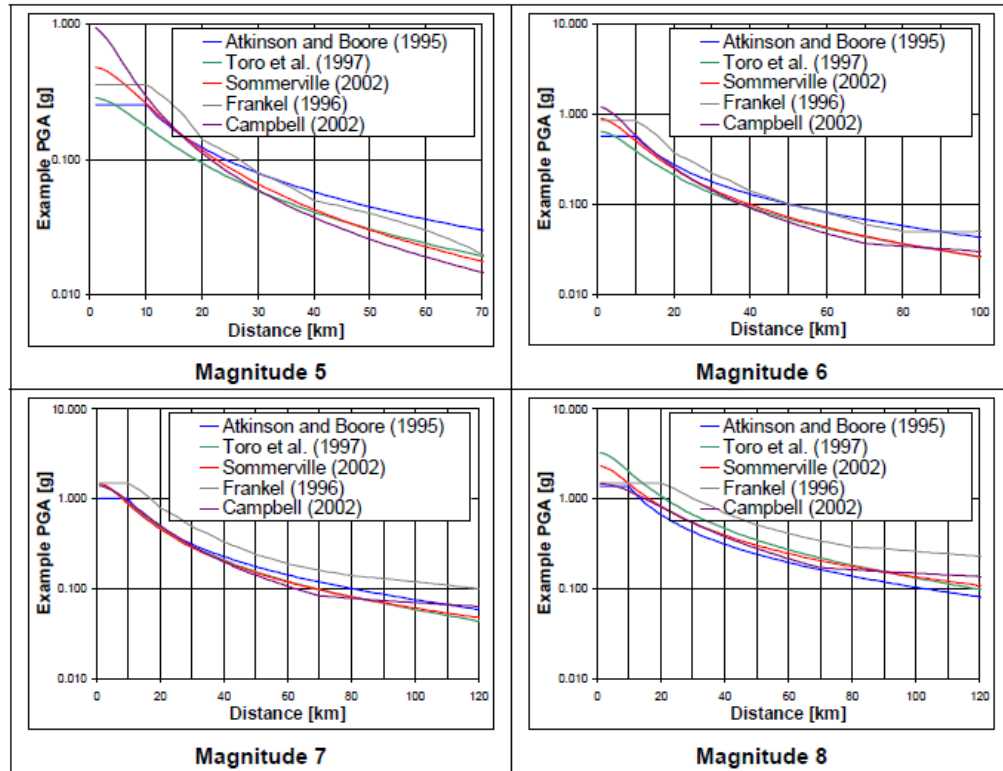
Figure 19 Relationship between Attenuation functions, Moment of magnitude of an earthquake, Distance and Peak Ground Acceleration (HAZUS Technical Manual).

The attenuation of ground shaking with increasing distance from the source is modeled using attenuation functions in HAZUS. Therefore the selection of a suitable attenuation function is crucial for the analysis. Depending on the choice of attenuation functions, the ground shaking can be different for a specific location for the earthquake with same magnitude (Figure 19).
