Effect of slope and paver characteristics on performance of permeable pavement GI.

EFFECT OF SLOPE AND PAVER CHARACTERISTICS ON PERFORMANCE OF
PERMEABLE PAVEMENT GI

A Dissertation

Department of Civil and Environmental Engineering

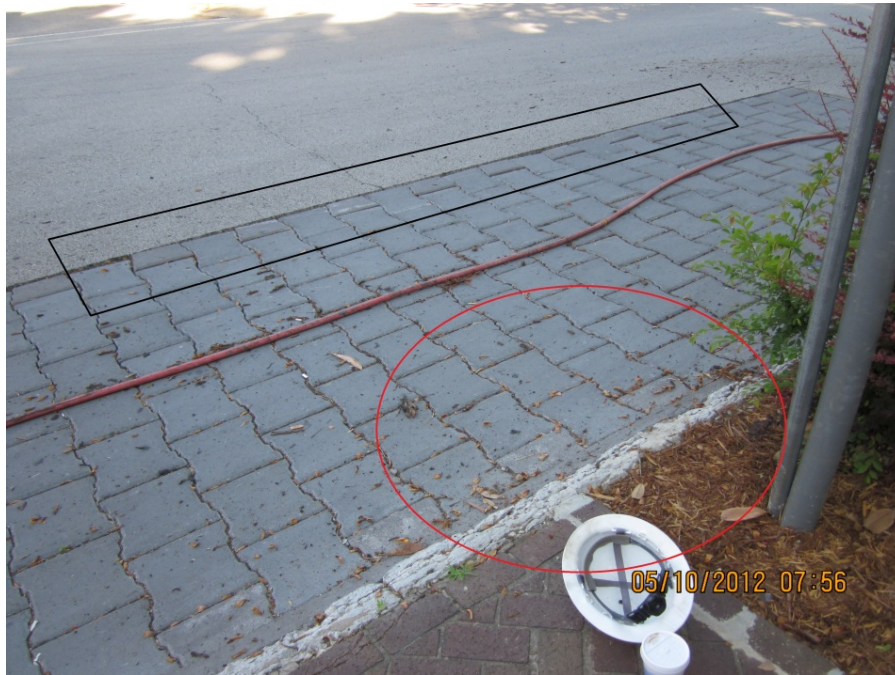
Figure 11: Segment A, 19 G, second maintenance

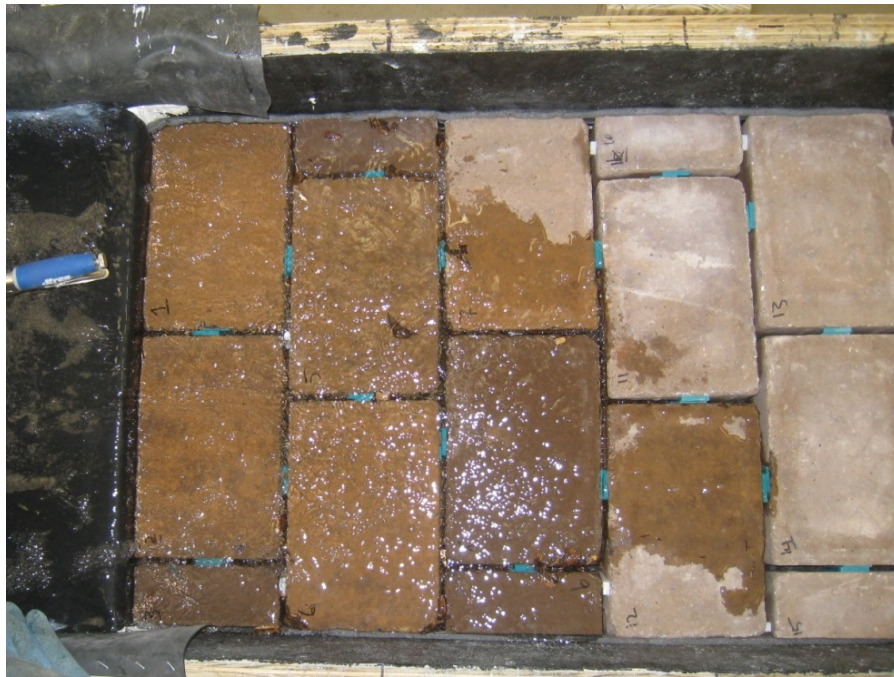
Figure 44: Experiment #1, 1% slope, 6 mm gap size, no aggregate between the pavers

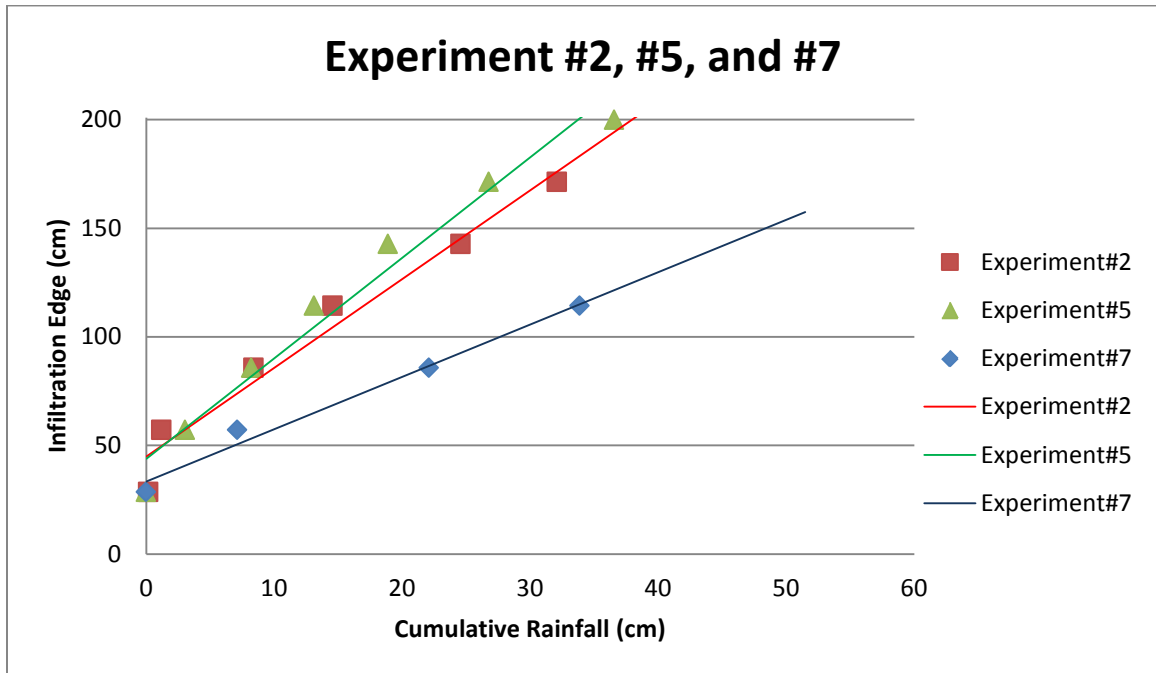
progression in the infiltration edge, but a further increase, from 9 mm to 12 mm, results in the slowest increase in infiltration edge in all three experiments. Figure 71 illustrates the progression of the infiltration edge in these three experiments.

Figure 71: Comparison of progression of infiltration edge in experiments #2, #5, and #7
