Effects of Urbanization on a Small Perennial Stream: Second Creek in Knoxville, Tennessee

Judith Laing Grable
University of Tennessee - Knoxville

Grable, Judith Laing, "Effects of Urbanization on a Small Perennial Stream: Second Creek in Knoxville, Tennessee." PhD diss., University of Tennessee, 2003.
https://trace.tennessee.edu/utk_graddiss/2021

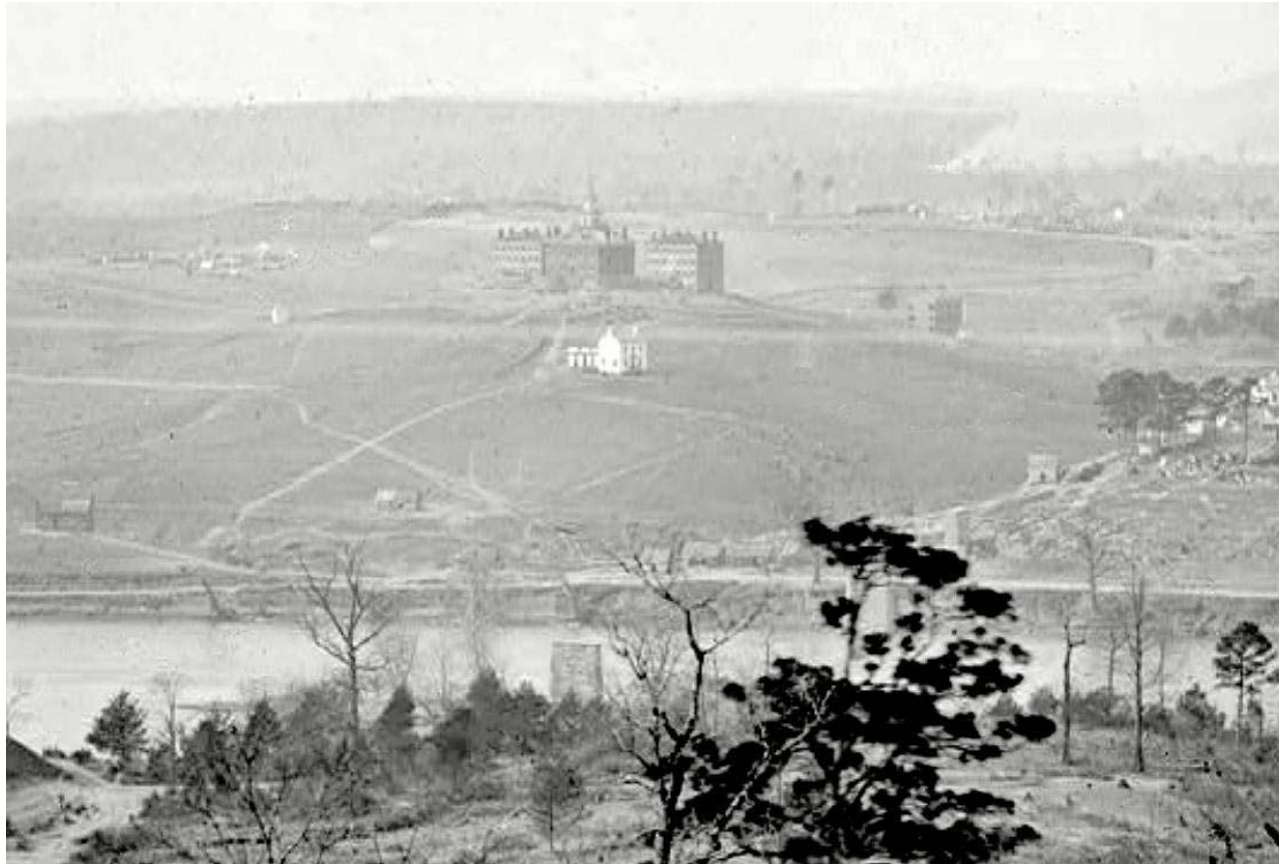
Figure 2.14. Photograph of College Hill. This was the view looking northward across the Tennessee River in 1862. Second Creek is near the right edge of the picture, the large buildings are on top of College Hill. Most of Knoxville lies beyond the right side of the picture. Note the lack of trees in the area. (East Tennessee Historical Society, Knoxville, TN)

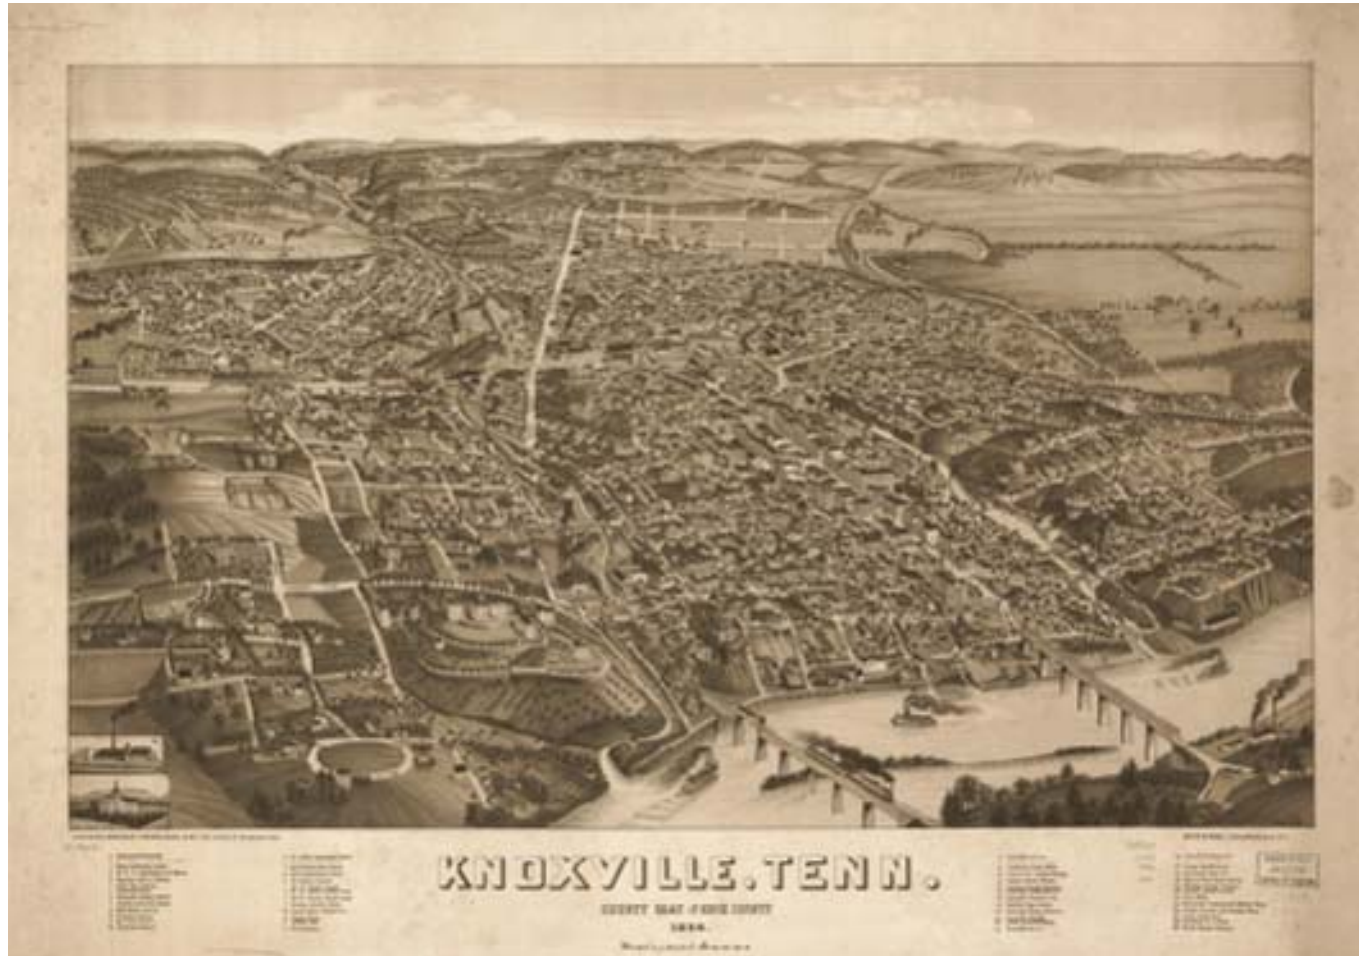
Figure 2.15. Oblique view of Knoxville in 1886. Various industries, including a cotton mill, marble works, iron company, button factory, bucket factory, and an ice company were located adjacent to Second Creek (Map of Knoxville, 1886).

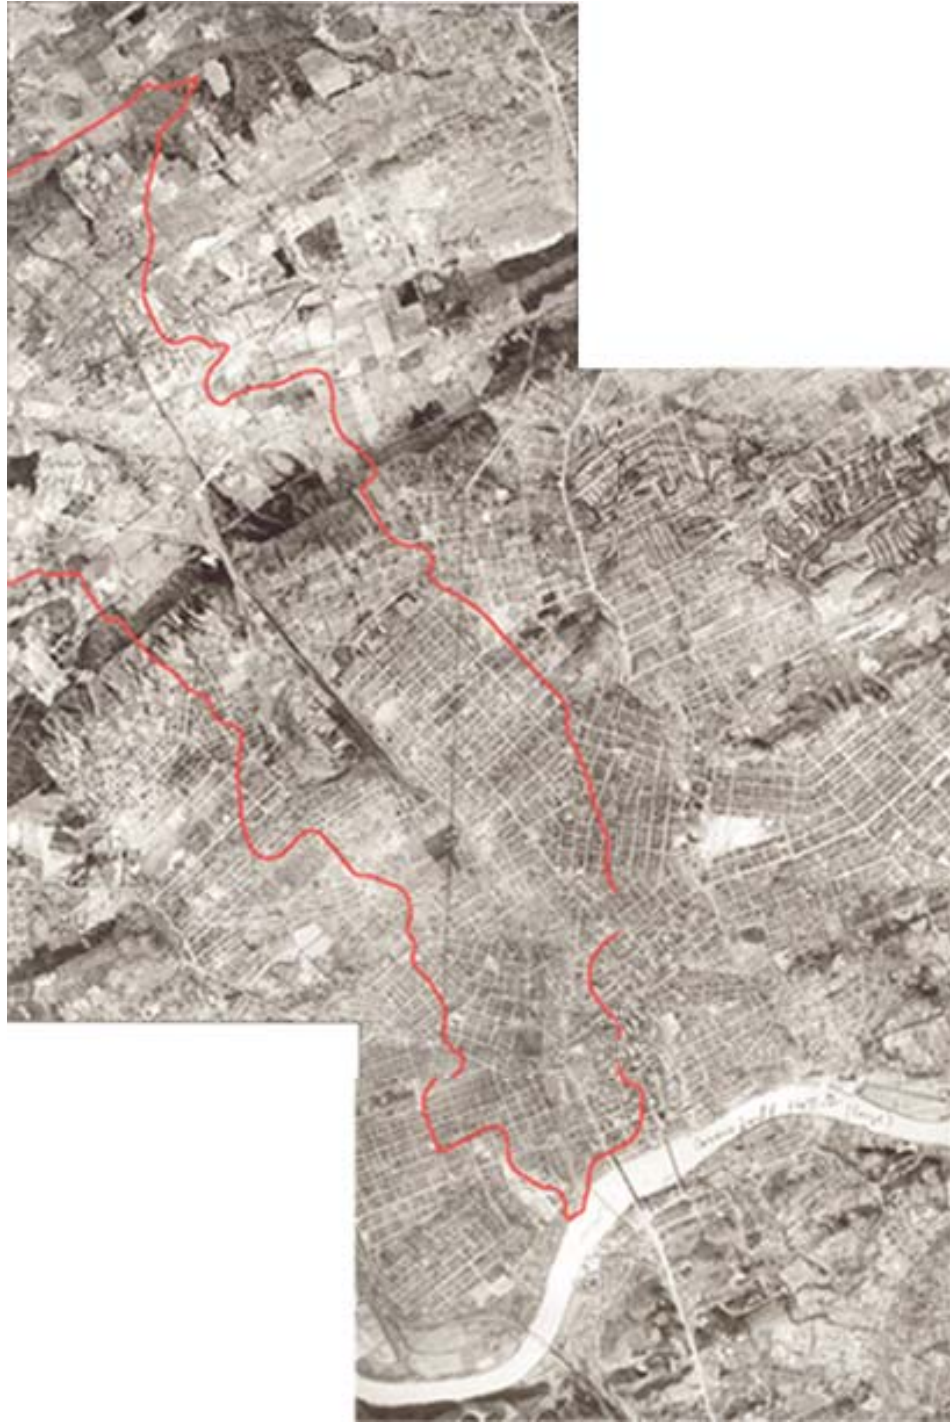
Figure 2.16. Aerial photographs of Knoxville in 1939. Unfortunately, photographs covering the northwestern side of the drainage basin were not available. (SCS 1939)

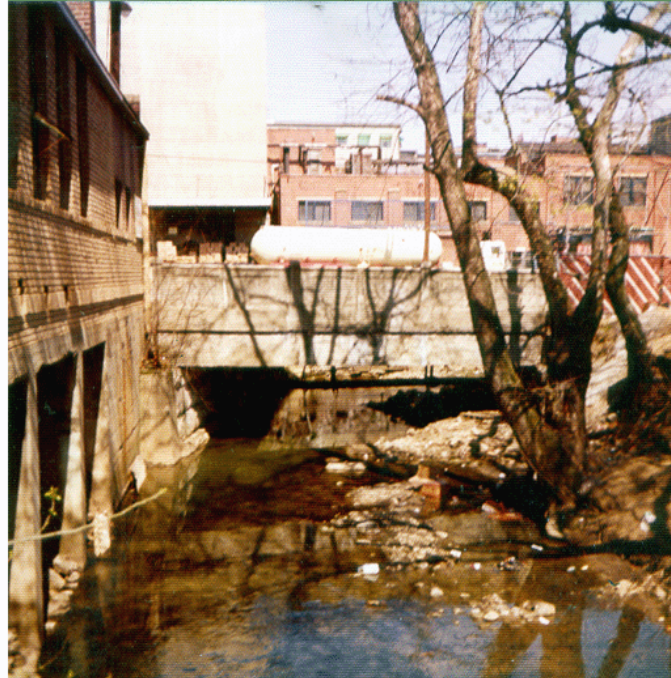
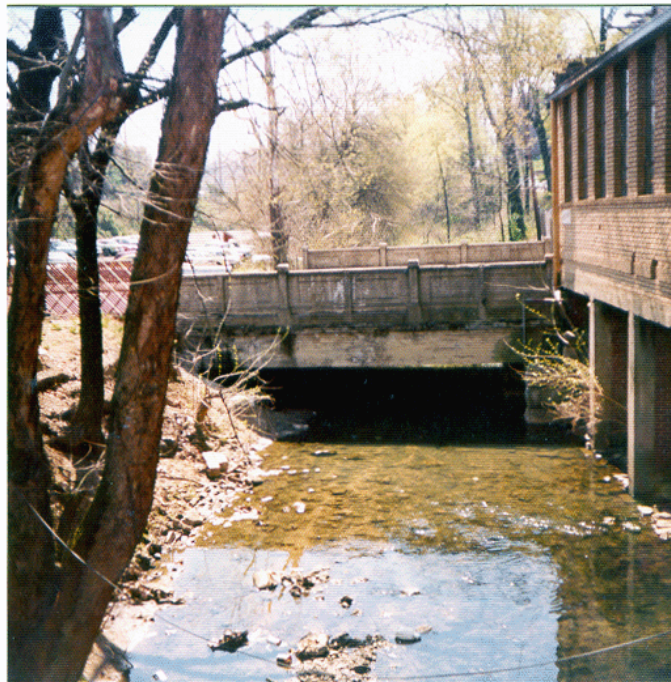
Figure 2.17. Second Creek upstream of Cumberland Avenue in 1979. This part of the creek now flows underground in a large box culvert. *Top*: looking upstream. *Bottom*: looking downstream. (Photographs from TVA Archives, Knoxville, TN.)

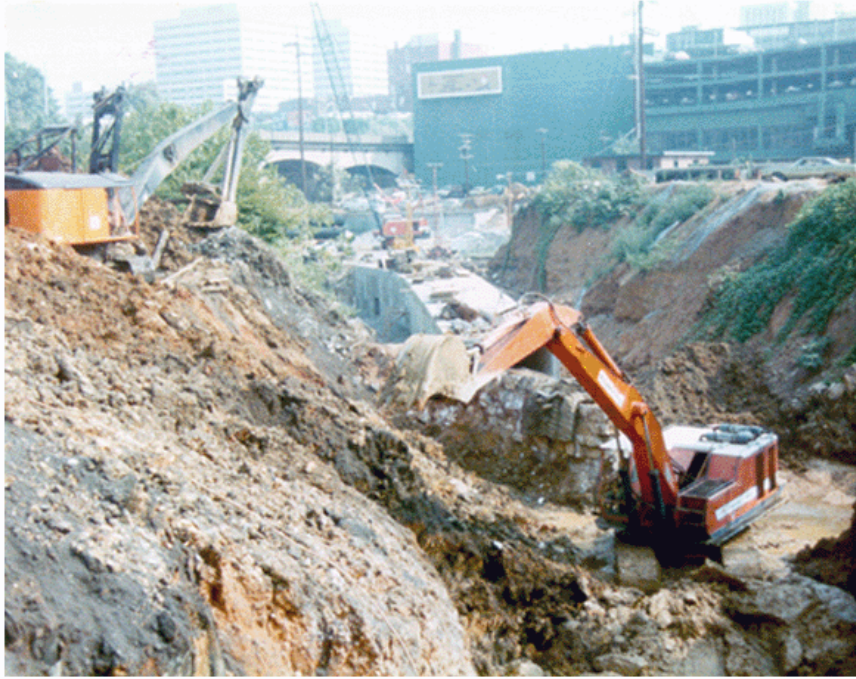
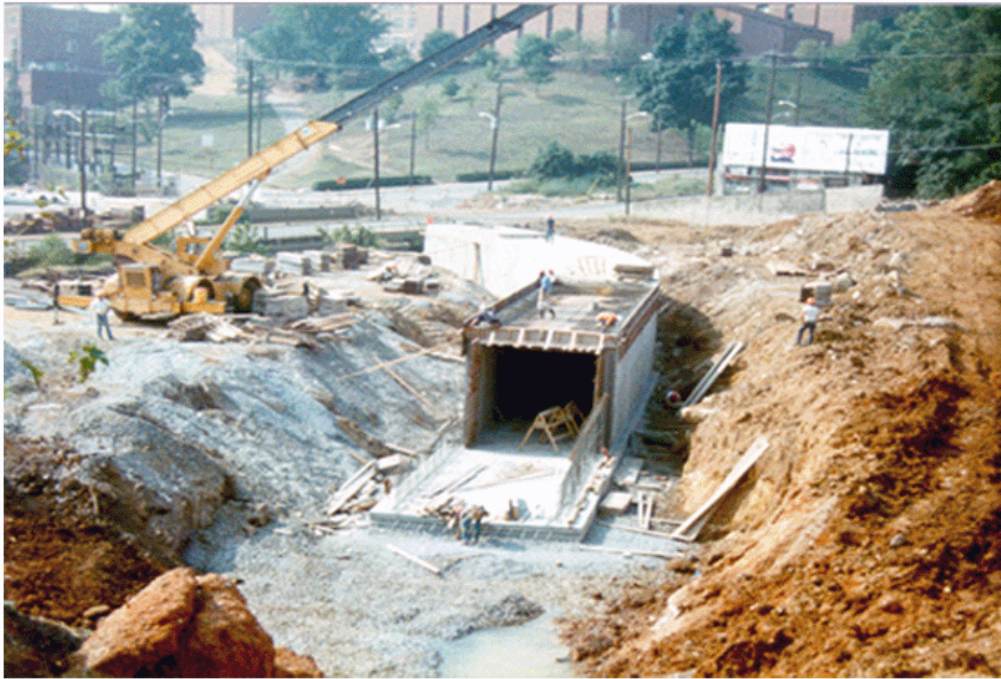
Figure 2.18. Construction in the channel of Second Creek upstream of Cumberland Avenue. These photographs were taken in 1980. (Photographs from TVA Archives, Knoxville, TN.)

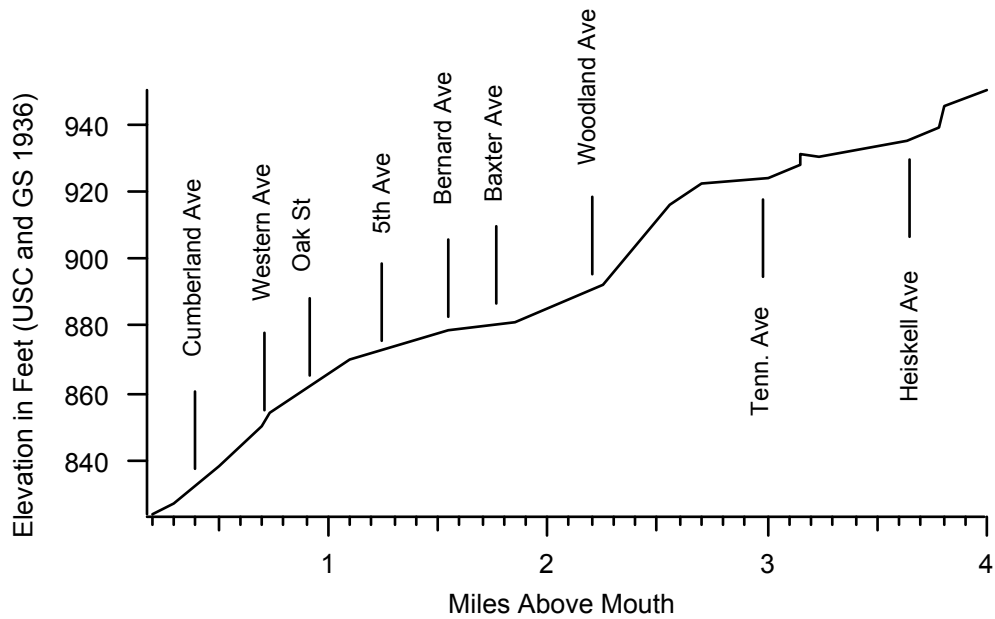
Figure 2.20. 1958 profile of Second Creek downstream from Sharp Ridge. Scales are shown in feet and miles, as they appeared on the original profile (1 meter = 3.28 ft and 1 km = 0.6 mi). (Adapted from TVA, 1958.)

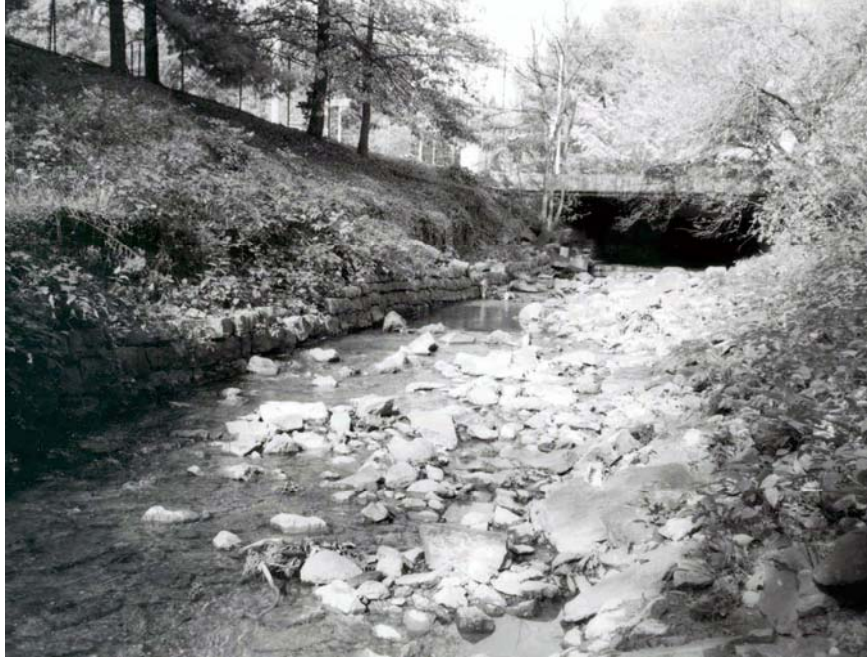
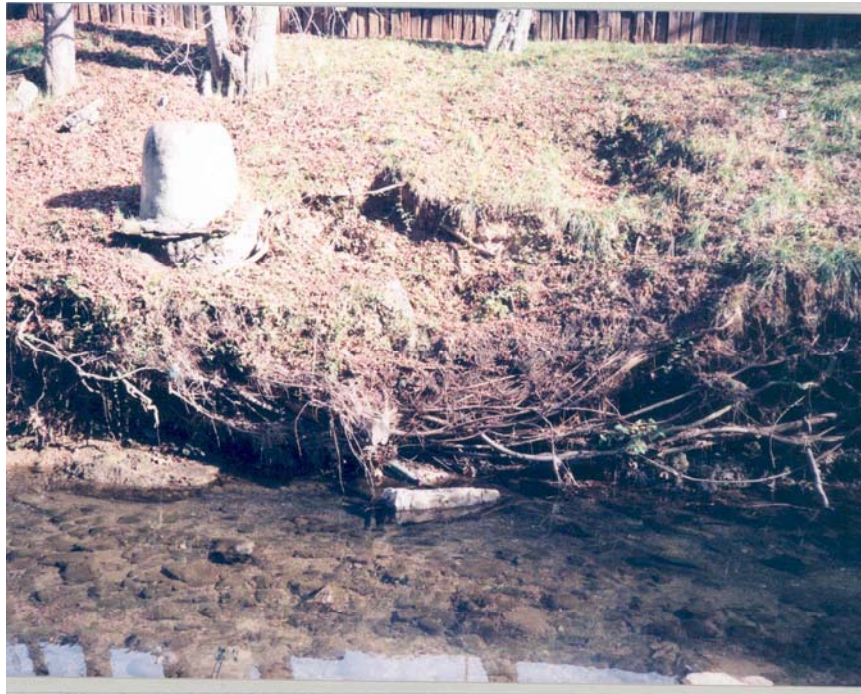
Figure 3.3. Erosion in the upper part of the Cumberland segment. *Top*: Looking upstream towards the Cumberland Avenue box culvert. *Bottom*: The left bank of the stream between two footbridges. A tree was undermined and fell into the stream at this location. (Photographs by the author.)

Most of the banks in the upstream 100 m or so of this segment have been lined with rock walls or large riprap. The right bank is lined with a low shaped-rock wall for about 70 m. The wall has fallen apart at the upstream end (close to the Cumberland Avenue box culvert) and in a 20 m long area located approximately 60 m downstream of the culvert. This wall and rocks in the stream that appear to be from riprap on the opposite bank can be seen in Figure 3.3.

In spite of the measures taken to prevent it, much of the channel in this segment shows signs of recent erosion on both banks. In many places, the lower parts of the streambanks are vertical or nearly so, and tree, shrub, and/or grass roots hang in the air. A tree that was growing on the slope above the left bank became undermined and fell into the stream in 2000. A sewer line access structure high on the left bank between the two footbridges provides evidence of erosion and slumping of the streambank (Figure 3.3). Most of the slumping visible in the photograph occurred between 1996 and 2000. Downstream of the location between the footbridges shown in Figure 3.3, a portion of an old rock wall is now poised to slide to the bottom of the left streambank (Figure 3.4). More places with severe erosion occur along the left bank than the right in this segment of the stream.

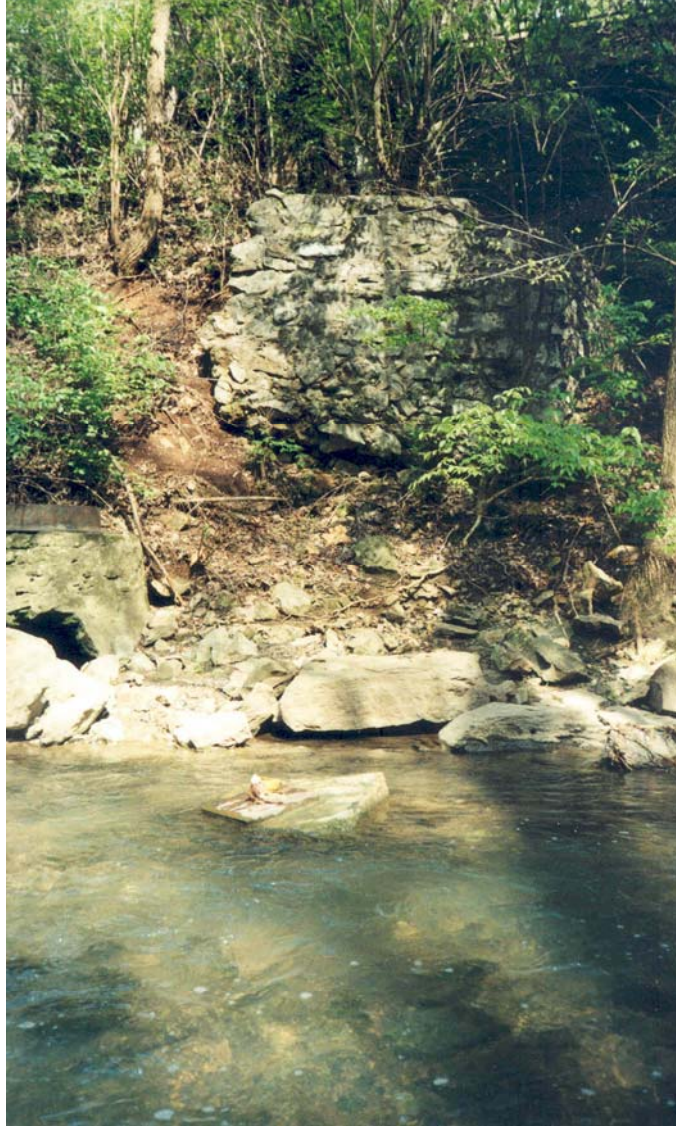
Figure 3.4. Part of an old wall poised to slide into the stream. This location is between sites U and UT on the east side of lower Second Creek. Large rocks at the base of the banks, as seen here, are common in this segment of the stream. The water flows from left to right in the picture. (Photograph by the author.)

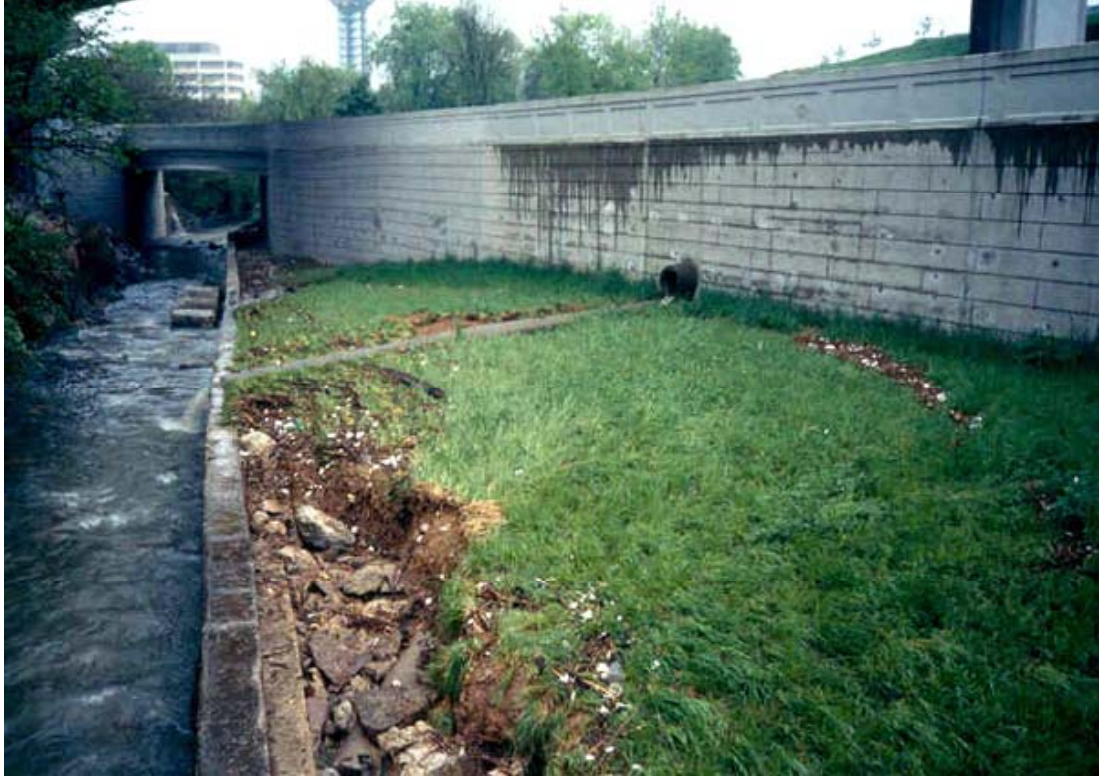
Figure 3.5. The channel near Western Avenue. The channel banks along this part of the stream are lined with concrete, shaped rock, or riprap. This view is looking downstream. World's Fair Park Drive crosses Second Creek in the upper left part of the picture. (Photograph by the author.)

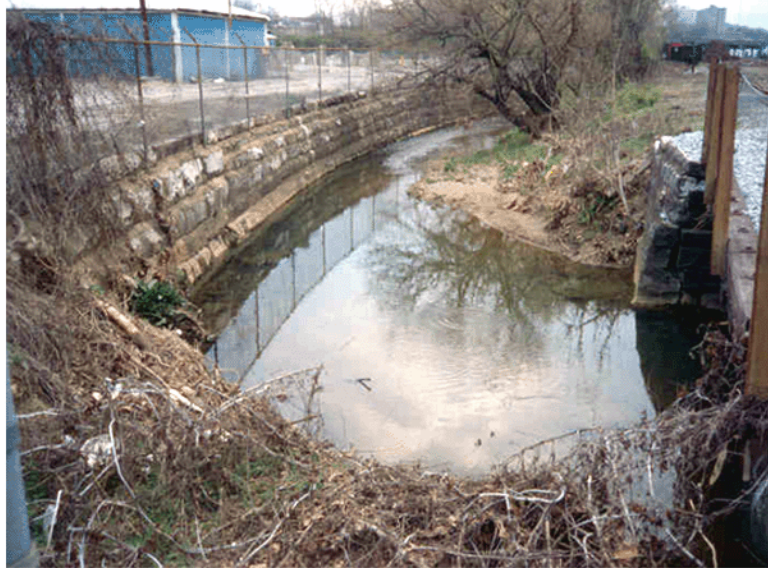
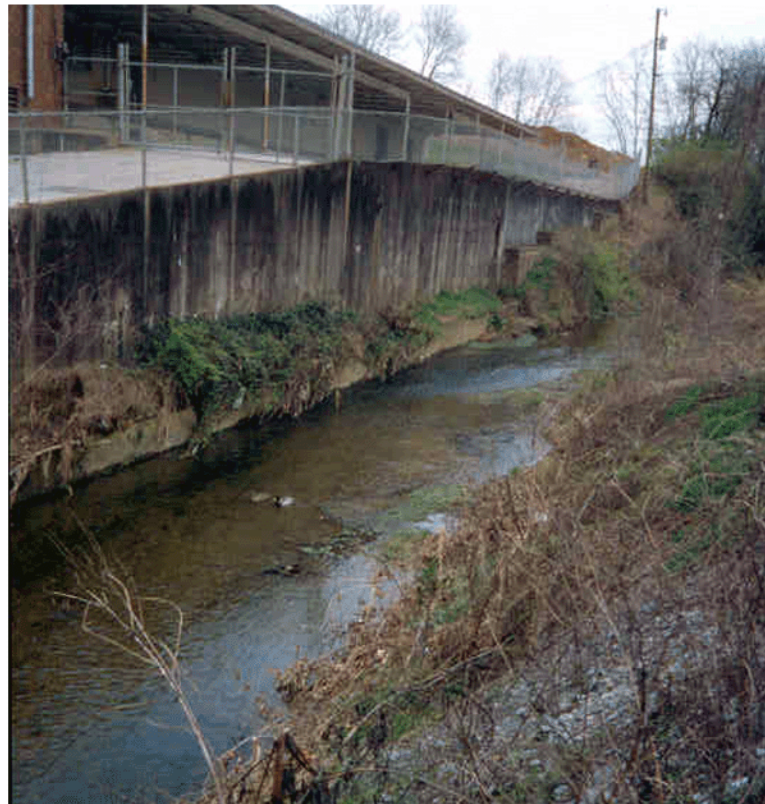
Figure 3.6. Rock and concrete walls downstream and upstream of Bernard Avenue. *Top*: Looking downstream from close to Bernard Avenue. A railroad bridge can be seen at the right side of the picture. *Bottom*: Looking upstream. (Photographs by the author.)

Railroad tracks lie on the top of the left bank of the creek in the 300 m north of Bernard Avenue. Much of this part left bank is surfaced with gravel and riprap, with sparse low vegetation. In 2000, the time of this survey, there were several recently repaired places where erosion had threatened to undermine the tracks. Farther upstream, where the railroad tracks angle away from the creek, mature trees and shrubs line the banks and

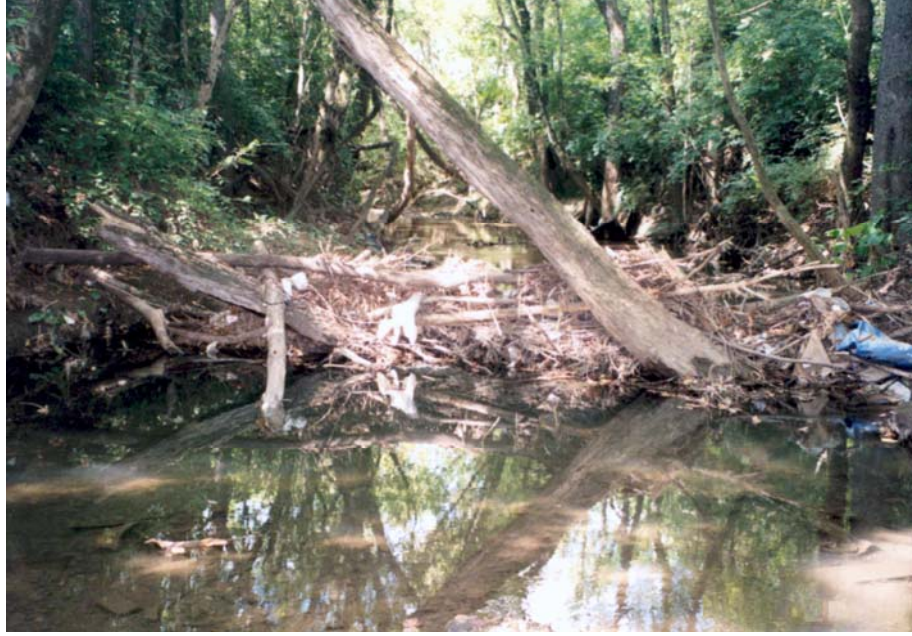
Figure 3.7. A woody debris dam between Bernard and Baxter Avenues. This view is looking upstream. (Photograph by the author.)

A large tree has fallen into the creek from the right bank about 150 m downstream from the center of Baxter Avenue, but some of its roots are still in the bank and it has stayed alive. Woody and other debris have collected against the obstruction it creates (Figure 3.7). A pool has developed on the upstream side of the debris dam and under the tree. Approximately 2 m downstream from the tree, a 10 m long ridge of sediment that is exposed at low water has formed. A bar of alluvium also extends out from the right bank into the debris trapped by the tree trunk.

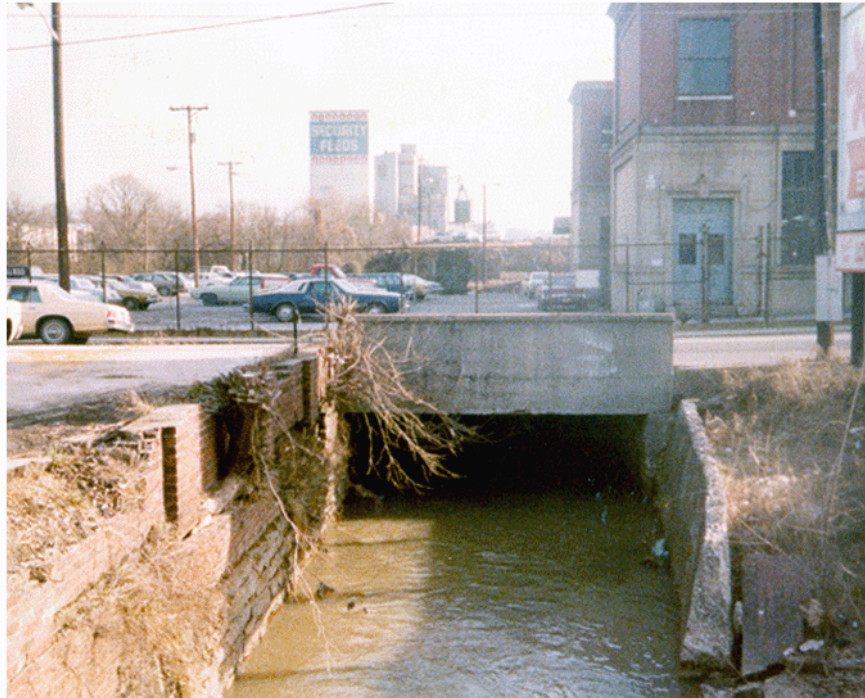
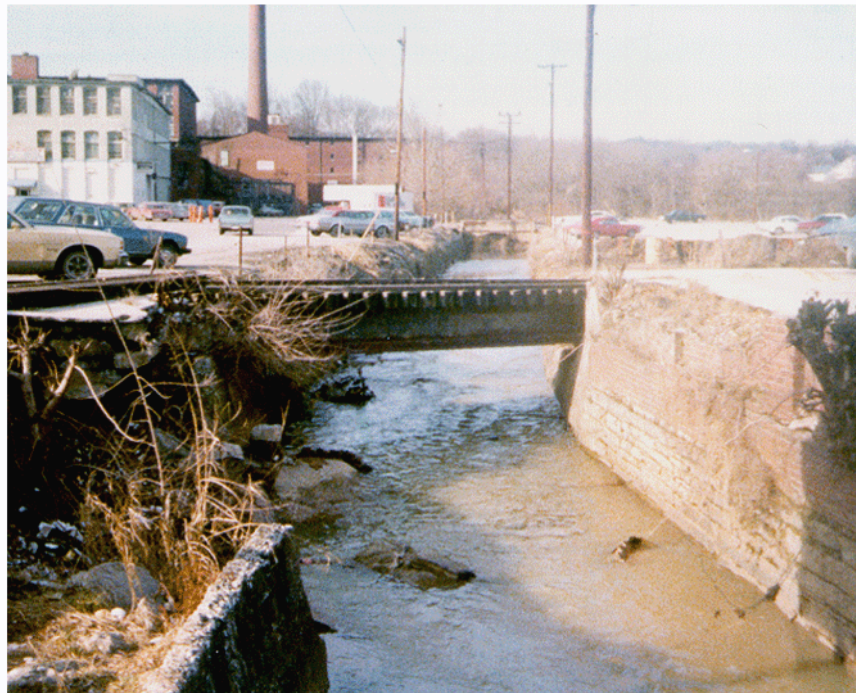
Figure 3.8. Brick and concrete walls upstream from Baxter Avenue. Even in 1979, at the time of these photographs, parts of the walls were falling into the creek. More damage had occurred by 2001. *Top*: Looking downstream at the culvert under Baxter Avenue. *Bottom*: Looking upstream from Baxter Avenue. (Photographs by the author.)

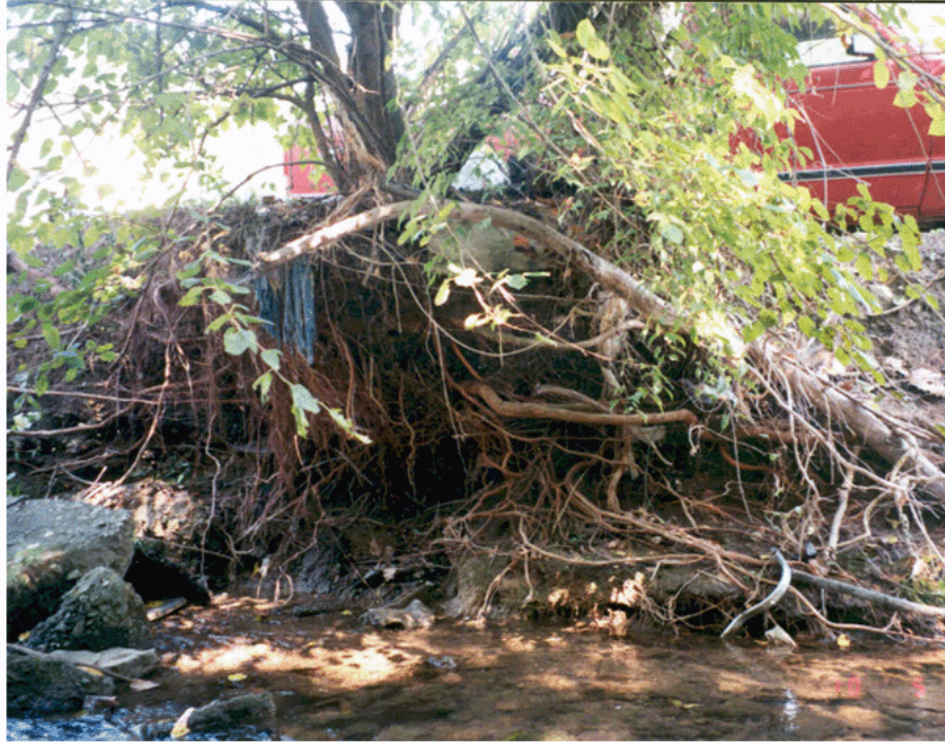
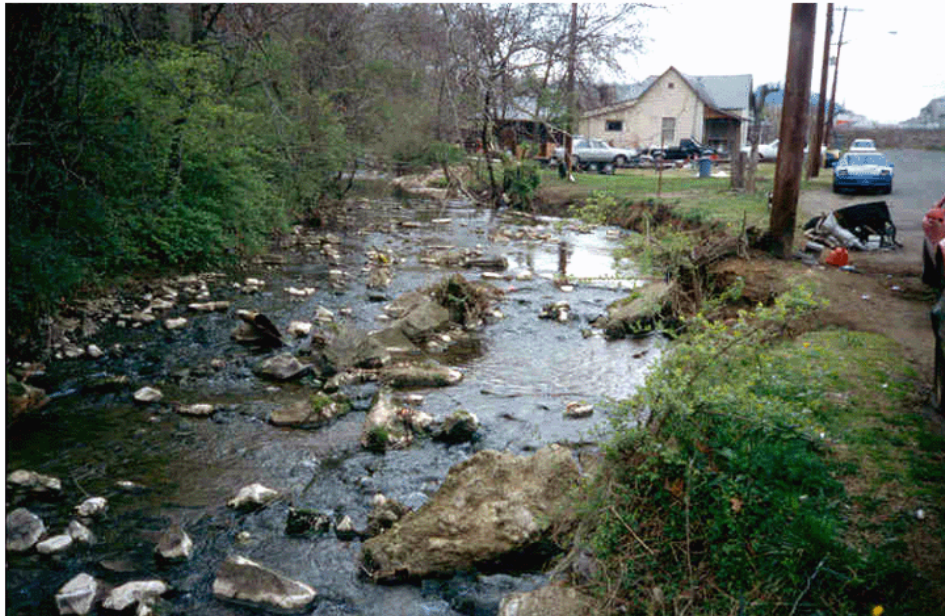
Figure 3.9. Severe erosion upstream of the Oldham Avenue Bridge. The eroding streambank threatens a utility pole and part of Davanna Street. *Top*: Looking toward Davanna Street. *Bottom*: Looking upstream. Devanna Street is visible on the right. (Photographs by the author.)

This segment contains abundant evidence of severe erosion, especially in the portion of the channel upstream from the Oldham Avenue Bridge. The cause of much of the erosion may be the loss of a significant amount of floodplain upstream, in the Coster Yard area. Low-lying land in that area was still accessible to floodwater in 1979, as shown in the photograph in Figure 3.27. In the early 1980s, a long, tall ridge was constructed to support I-275, cutting off the floodplain from Second Creek. If this has been a factor in accelerating erosion downstream of the Coster Yard area, the stream channel has had less than 20 years to become adjusted to the new hydrologic conditions.

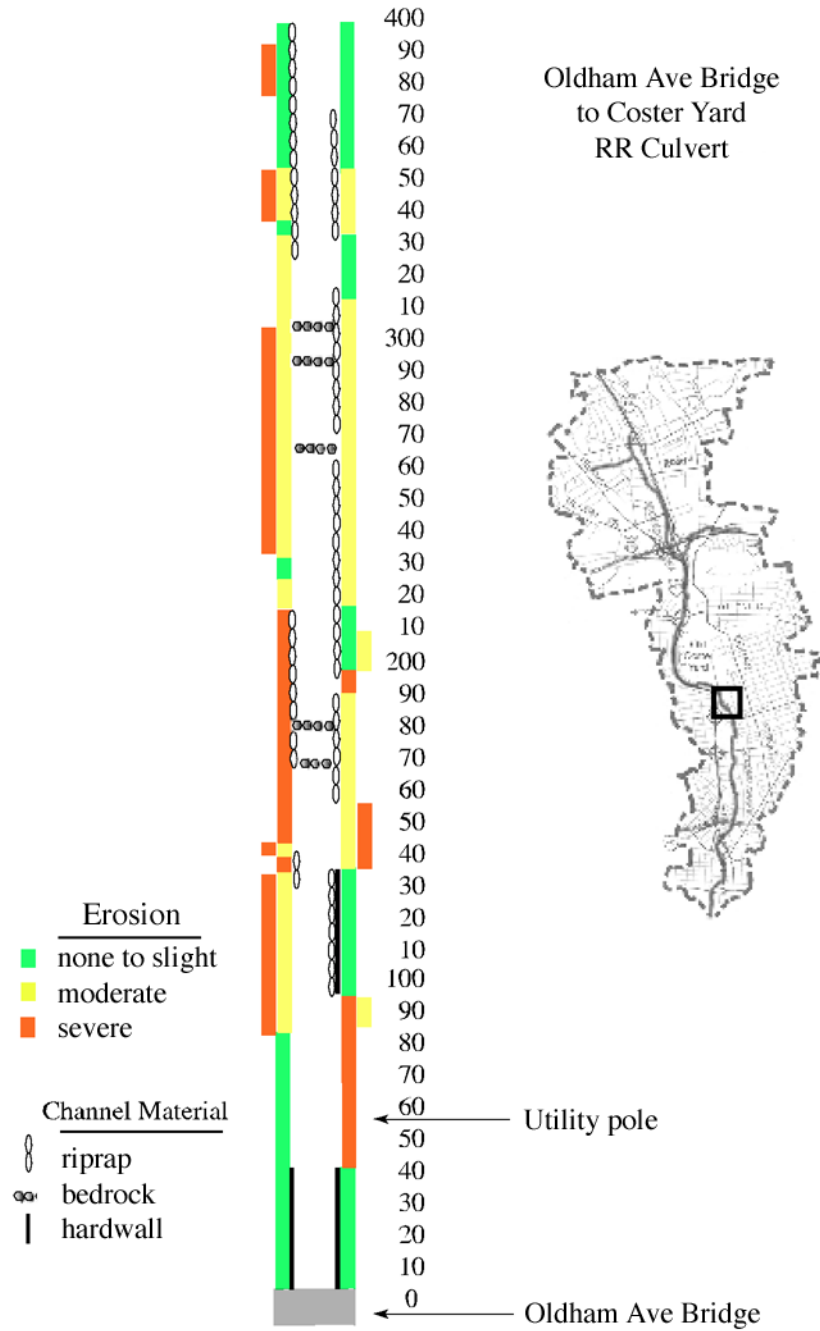
Figure 3.10. Status of the channel north of Oldham Avenue Bridge. Two colors along the edge of the channel indicate both categories of erosion are present. (Base map for locator map by KGIS, Knoxville, TN.)

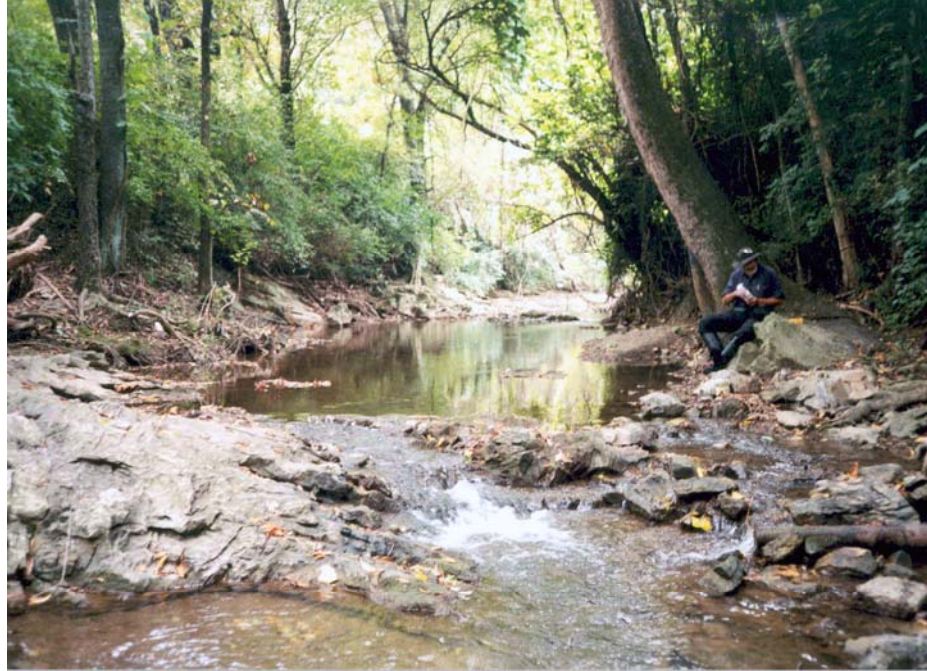
Figure 3.11. Typical scenes in the upstream half of the Davanna segment. *Top*: Bedrock dams form pools in some locations. *Bottom*: Exposed roots and undermined trees are common in this segment. (Photographs by the author.)

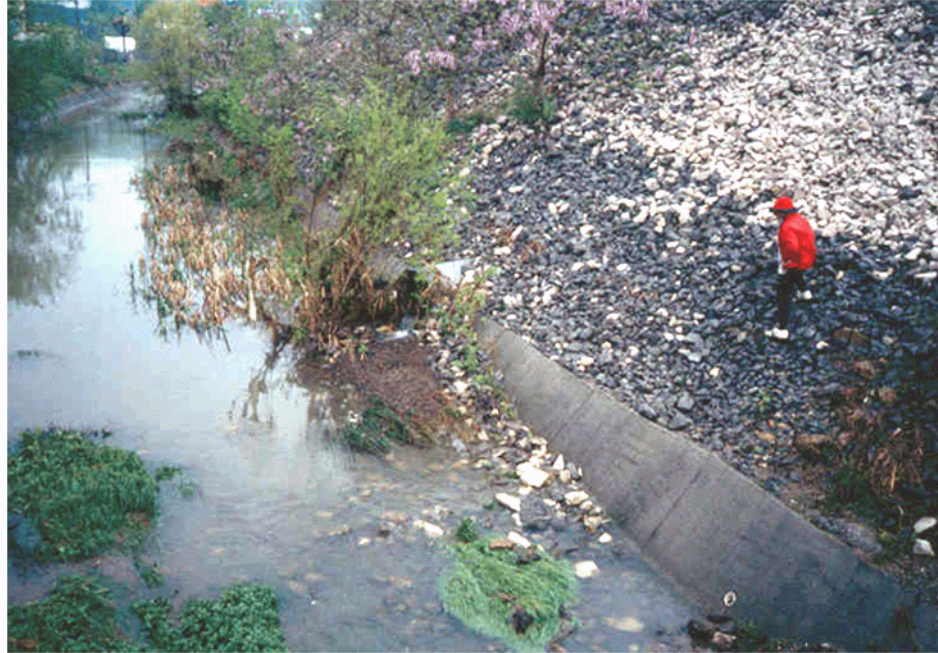
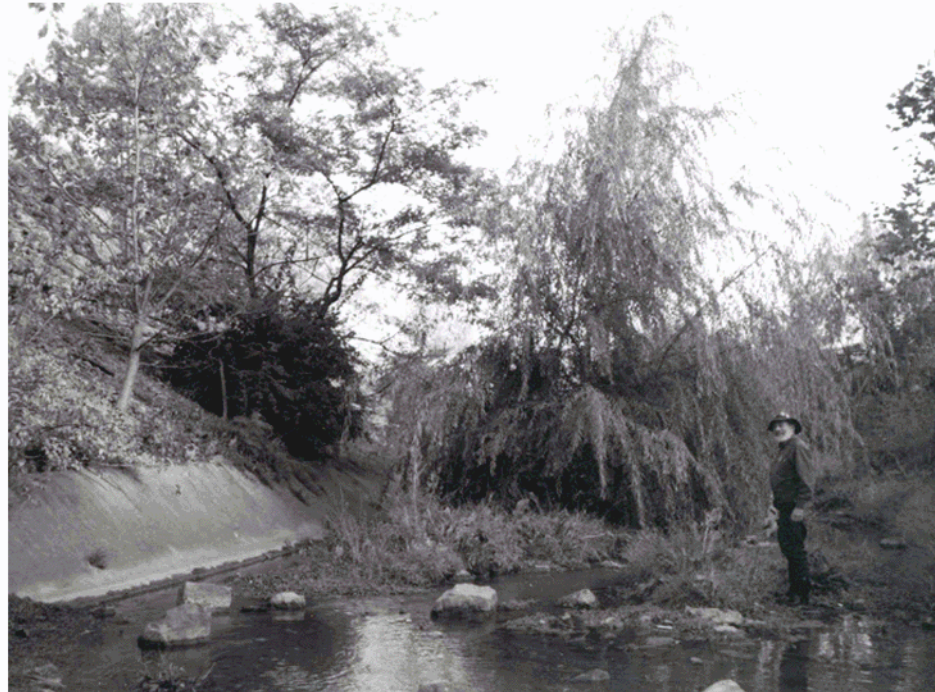
Figure 3.13. Riprap above and vegetation in the channel. *Top*: Looking upstream from the Tennessee Avenue Bridge. I-275 is at the top of the riprap-covered slope. *Bottom*: Looking downstream near the upper end of this channelized segment of the stream. Plants grow on most sediment in the channel. (Photographs by the author.)

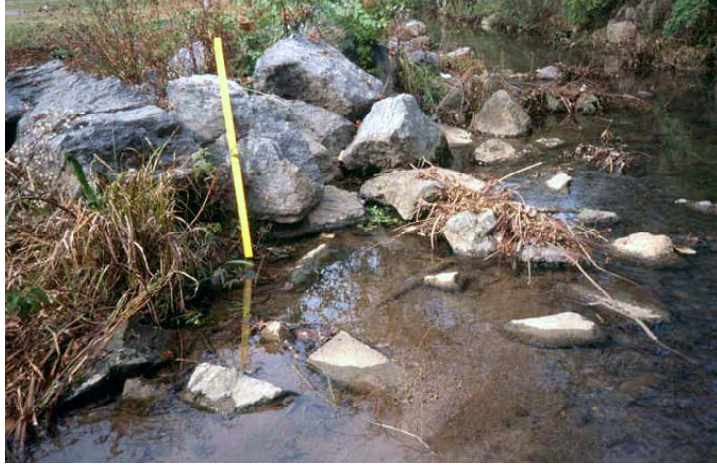
Figure 3.17. Large rocks placed near the Inskip Avenue Bridge. View is looking upstream. The yellow bar is 1.22 m (4 ft) long. (Photograph by the author.)

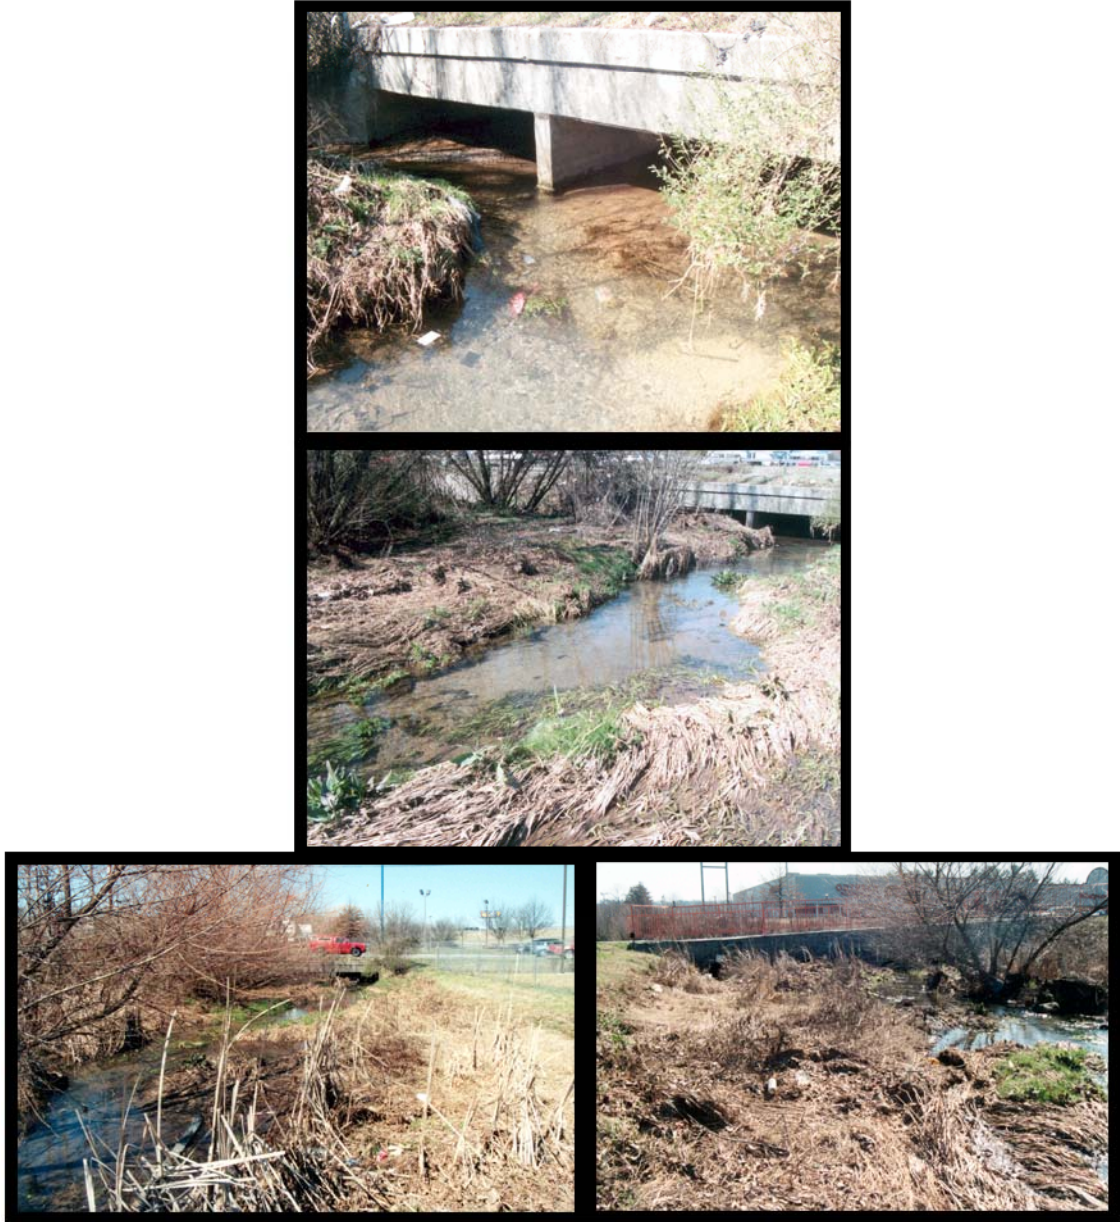
Figure 3.19. The channel close to Merchant Drive. *Top*: The downstream side of the culverts under Merchant Drive. Low flow is diverted toward the viewer by the accumulation of sediment in the center left of the photograph. *Middle*: Looking at the culverts from farther downstream. View is from the left bank. *Bottom left*: Looking upstream towards Merchant Drive. There is a great deal of vegetation on the sediment in the channel. *Bottom right*: Looking downstream along the left bank. One culvert under the Motel Bridge is visible to the right of the tree. These photographs were taken in 2000. The trees were cut down less than a year later. (Photographs by the author.)

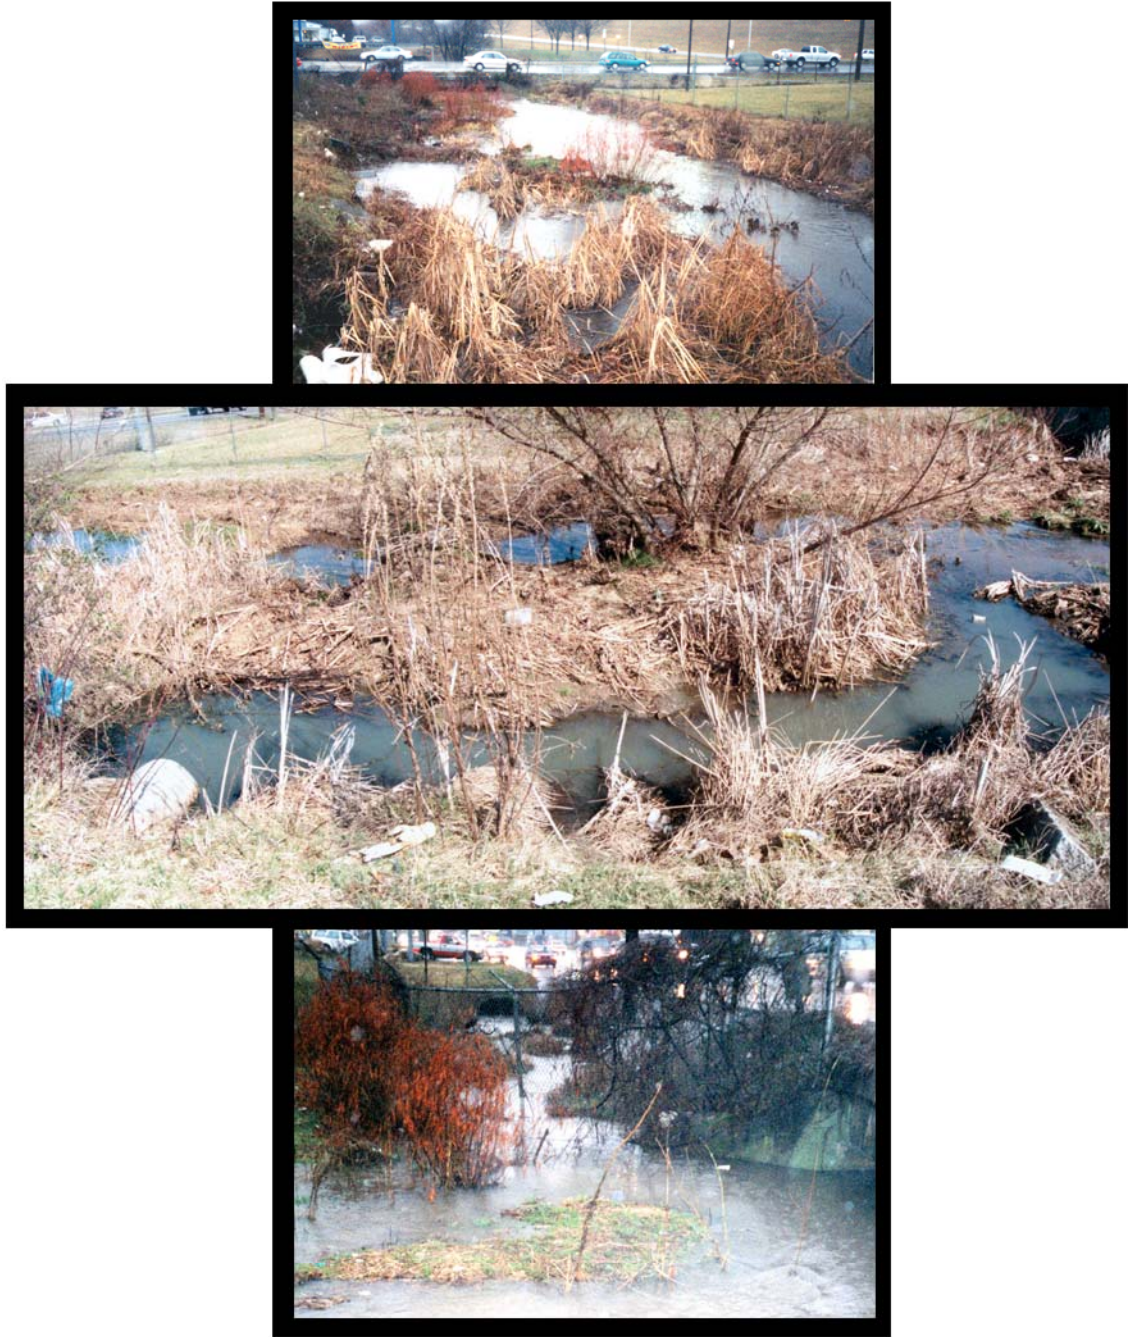
Figure 3.20. The area downstream from Merchant Drive. *Top*: Looking upstream towards Merchant Drive during a modest high water event. *Middle*: A "tributary" entering Second Creek from a 0.91 m diameter concrete pipe. *Bottom*: Looking upstream at storm runoff water running into Second Creek from a ditch along the southwest side of Merchant Drive. (Photographs by the author.)
