Effects of Urbanization on a Small Perennial Stream: Second Creek in Knoxville, Tennessee

Judith Laing Grable
University of Tennessee - Knoxville

Grable, Judith Laing, "Effects of Urbanization on a Small Perennial Stream: Second Creek in Knoxville, Tennessee." PhD diss., University of Tennessee, 2003.
https://trace.tennessee.edu/utk_graddiss/2021

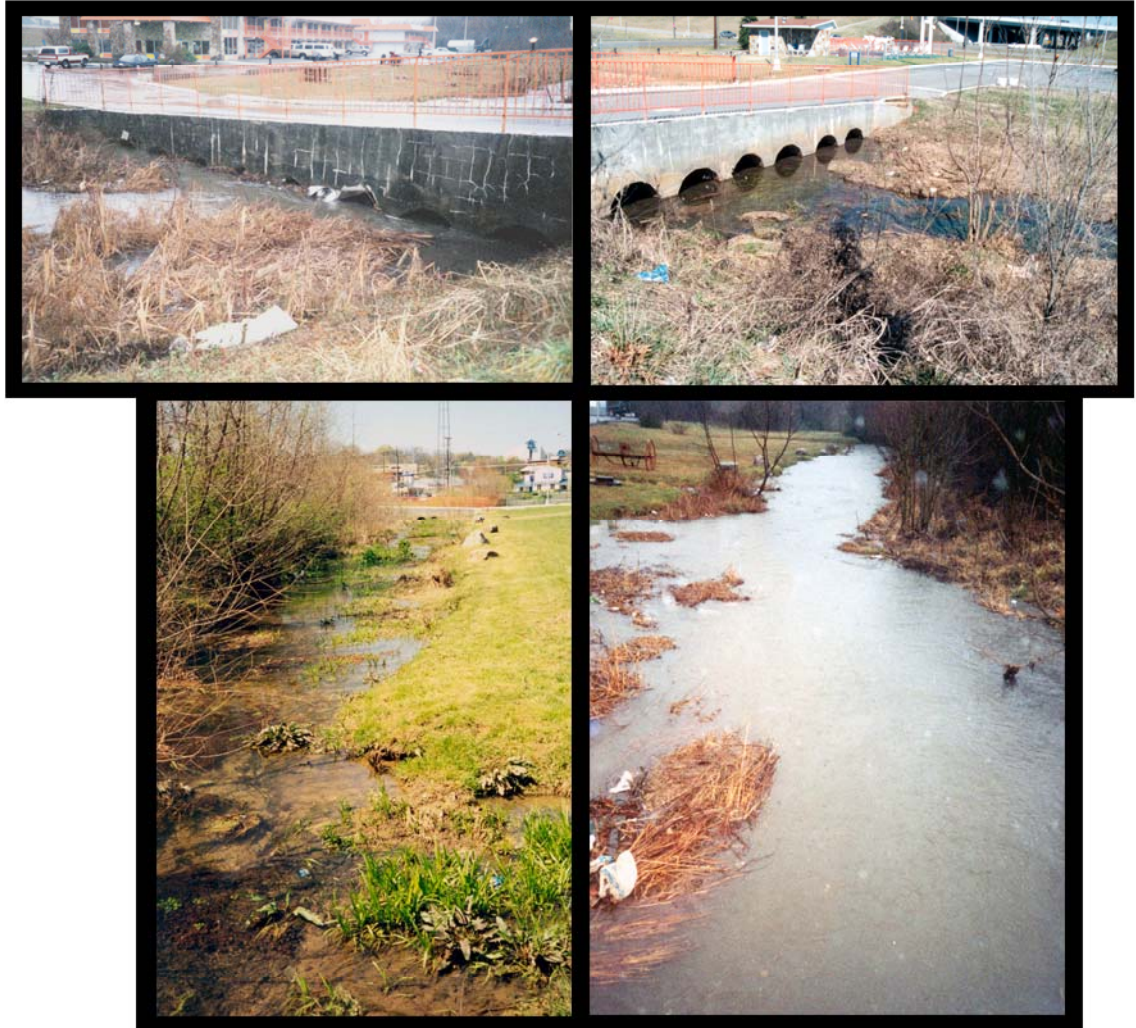
Figure 3.21. Second Creek near the Motel Bridge. *Top left:* The upstream side of the Motel Bridge during a modest high water event. Some debris was collecting at the culvert entrances. A stain above the top of the culverts reveals the level of a recent flow. *Top right:* The downstream side of the Motel Bridge, at a time of low flow. *Bottom left:* Looking upstream towards the Motel Bridge. The left bank is in grass, but the right bank contains thick shrubs and trees. Sediment in the channel at this location is almost knee-deep. *Bottom right:* Looking downstream from the Motel Bridge during the same runoff event as shown in the photograph in the upper left. The channel narrows considerably about 5 m downstream from the bridge. (Photographs by the author.)

Another condition that probably caused sediment to be deposited in the channel is the restriction of flow caused by the Motel Bridge. When I visited the site during a less than bankfull runoff event, I noticed that some of the culverts were partially blocked by debris, and water was pooling upstream of the bridge. A water stain about 0.6 m above the top of the culverts indicates that water rises above the top of the culverts. I would expect even more pooling, with the attendant reduction in water velocity and deposition of sediment, when water levels exceed the height of the culverts in response to greater amounts of storm runoff than I witnessed.

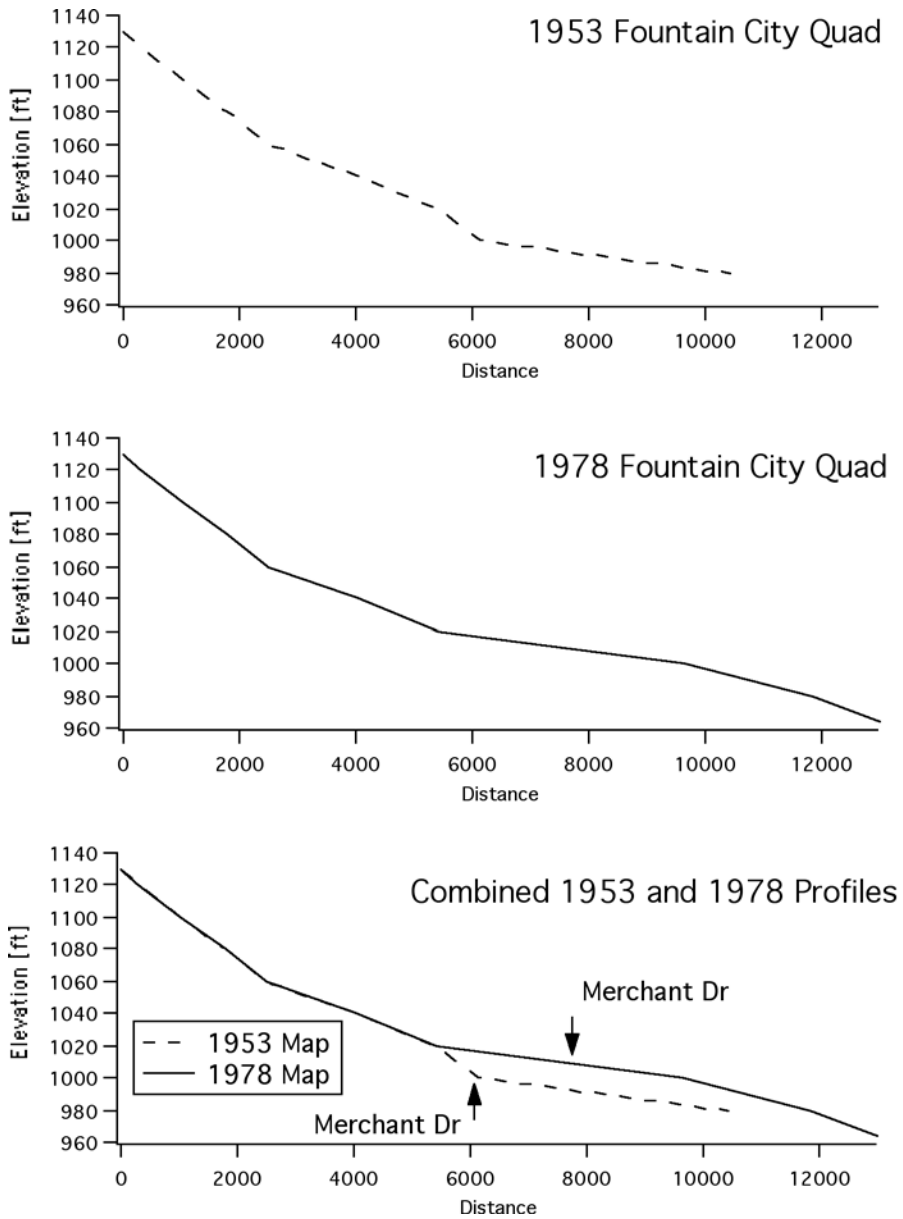
Figure 3.24. Longitudinal stream profiles in the Merchant Drive area. Second Creek was lengthened to flow around the I-75/Merchant Drive interchange, and, as a consequence, the slope of the stream was reduced in that area. Elevation and horizontal distance are presented in miles, as on the original maps (1 m = 3.28 ft; 1 km = 0.624 mi).

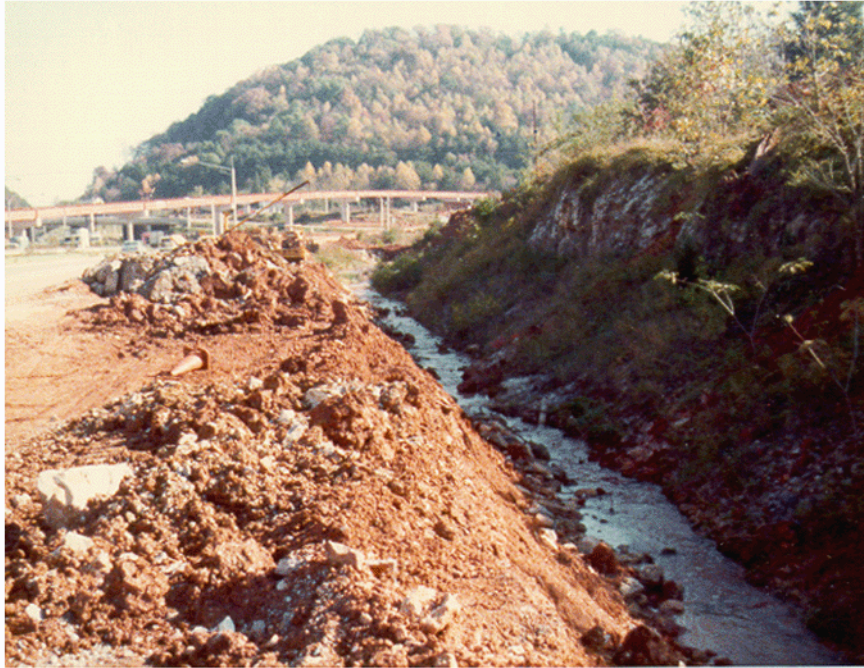
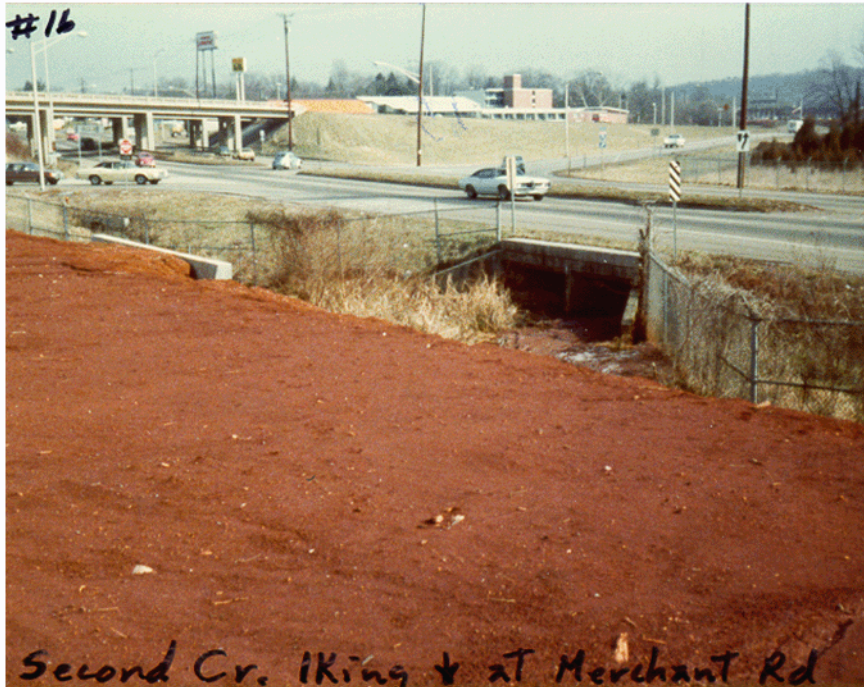
Figure 3.25. Bare soil exposed during construction projects. *Top*: Looking south towards the I-75 – I-640 interchange. *Bottom*: Looking south at Merchant Drive. Both photographs were taken in 1979. (Photographs from TVA archives, Knoxville, TN.)

I watched turbid water flowing down storm drains and ditches that drained to this part of Second Creek in 1999. Unless sediment reduction measures have become more effective since that time, sediment from this part of the basin is contributing to the suspended load of Second Creek. Judging from the material I collected in rising stage samplers at Site I, particle sizes are generally fine, and much of the sediment from this area may be carried through Second Creek as washload. If so, it does not have much effect on channel stability.

There are other possible causes for the sediment deposition in the channel following its relocation. Slopes adjacent to and close to Second Creek upstream of this segment were bare of vegetation during interstate highway construction (as shown earlier in Figure 3.25.) It seems likely that large amounts of sediment continued to be delivered to Second Creek from these slopes for several years, until a thick vegetative cover was established.

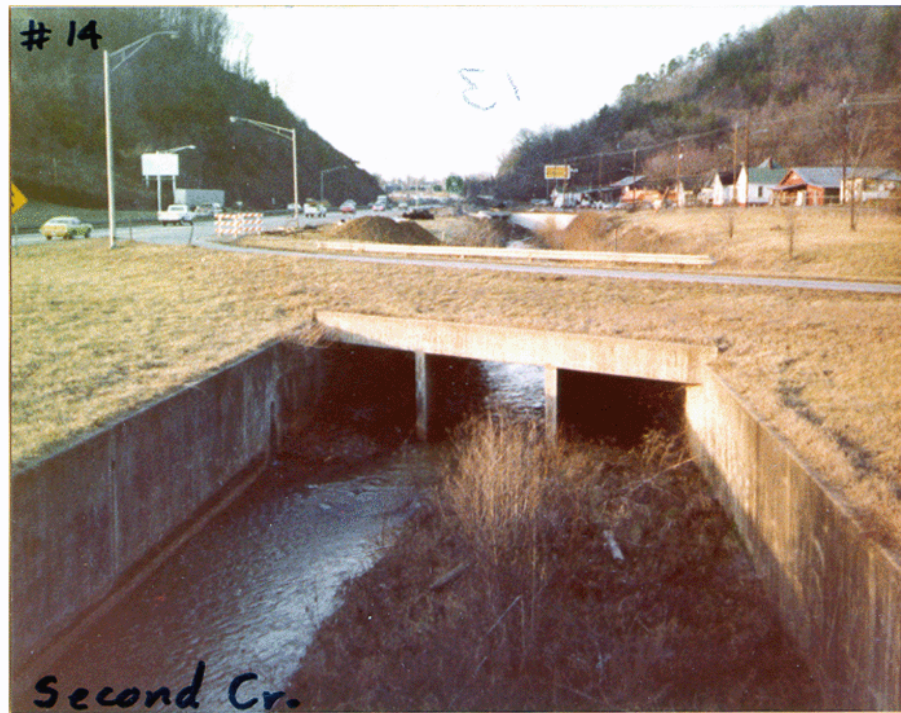
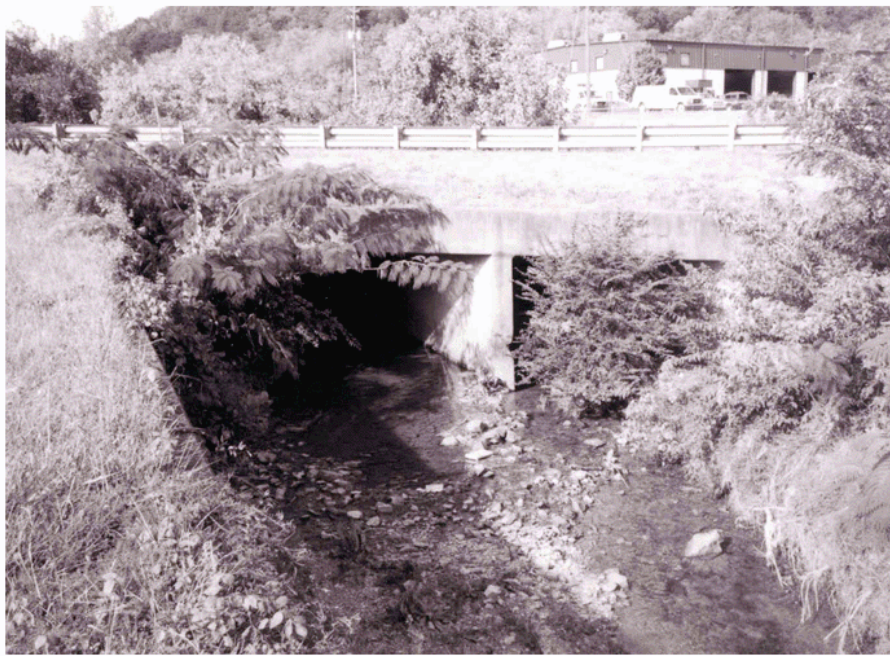
Figure 3.26. Old and modern photographs of the Heiskell culvert area. The triple box culvert shown is located under the on-ramp to I-275 N. Top photograph was taken in 1979, the lower photograph in 2001. (Top photograph from TVA archives, Knoxville, TN. Bottom photograph by the author.)

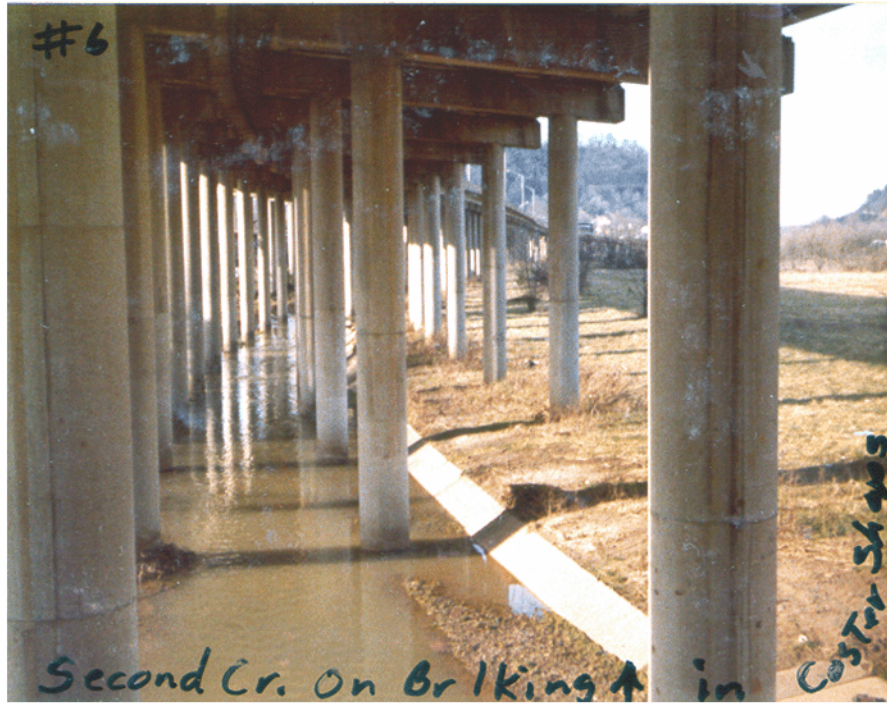
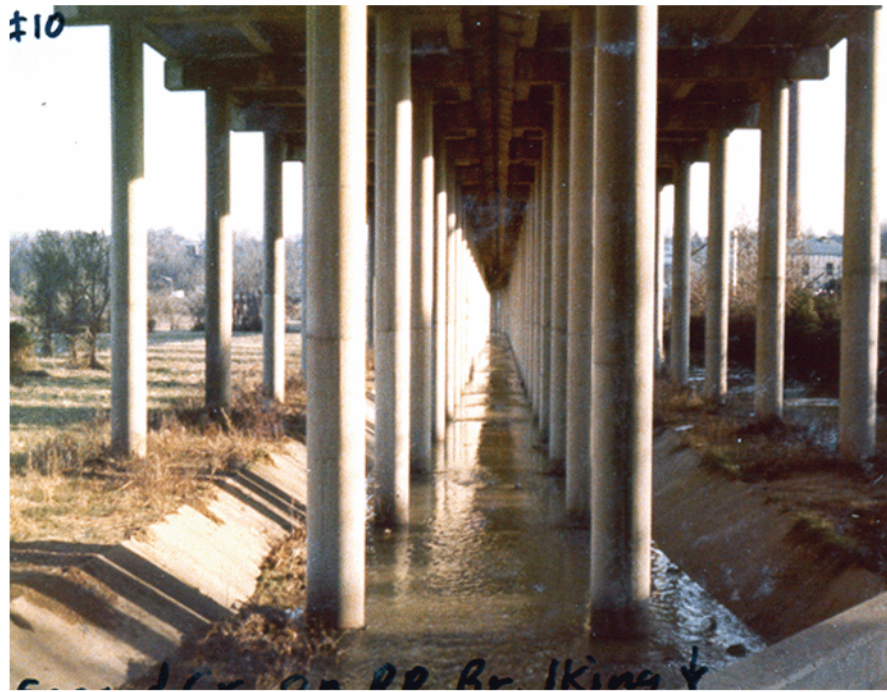
Figure 3.27. Support piers for I-275 in Second Creek in 1979. The view is upstream in the top photograph and downstream in the lower one. (Photographs from TVA archives, Knoxville, TN.)

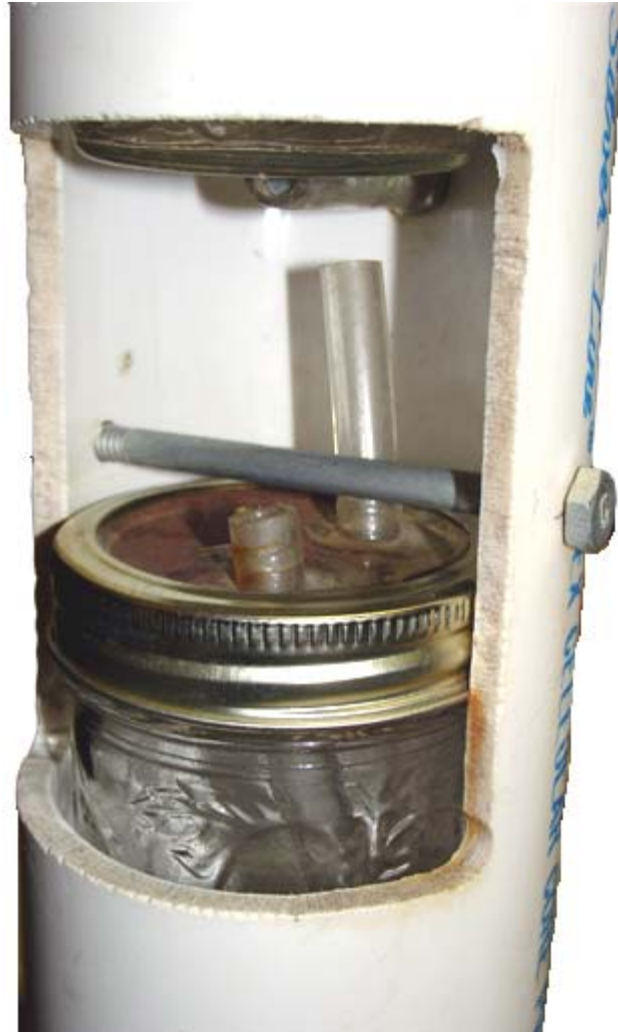
Figure 4.2. Rising stage sampler. (Photograph by the author.)

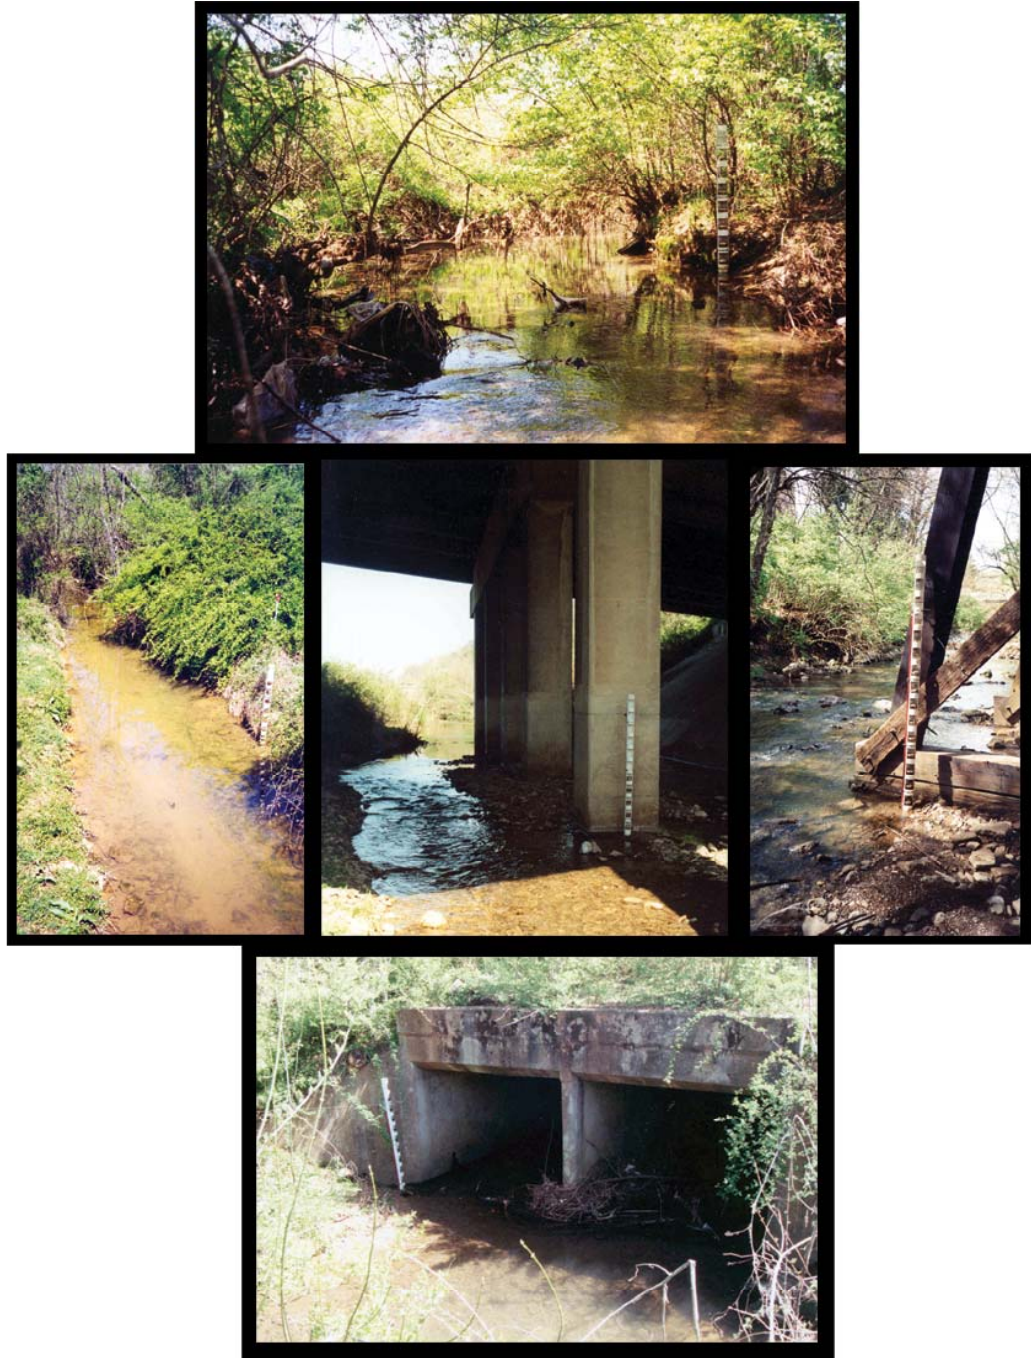
Figure 4.4. Photographs of rising stage sediment samplers in place. *Top*: The Inskip site sampler, looking upstream. *Center left*: The sampler is in the right side of this photograph of the Dutch Valley Tributary, looking upstream. *Middle*: The Heiskell location, looking upstream. The shadow of the farthest downstream support can be seen at the base of the sampler. *Center right*: Sampling site U, looking upstream. *Bottom*: Site C, looking downstream. (Photographs by the author.)

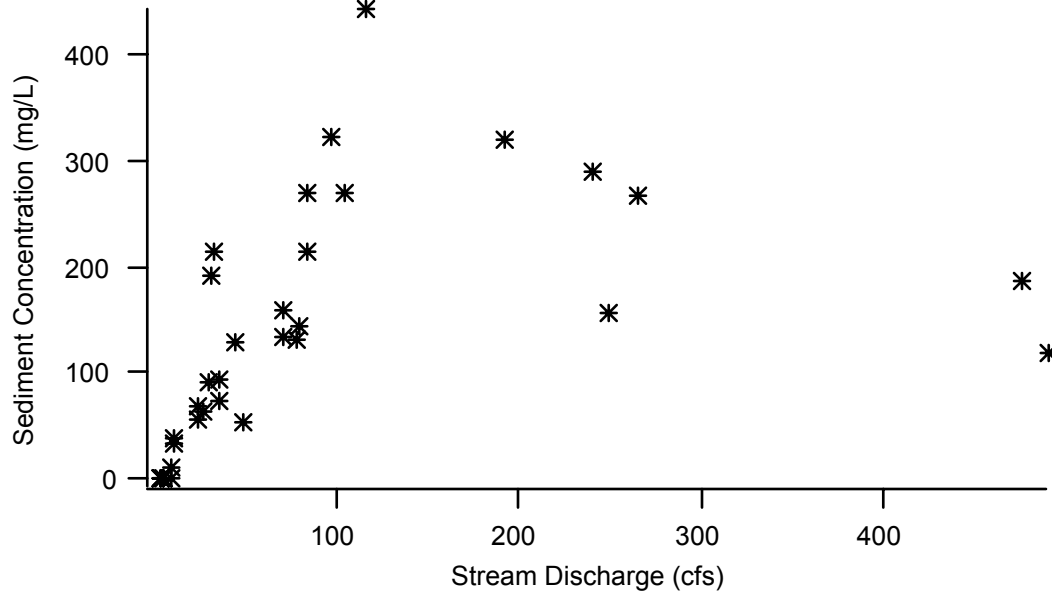
Figure 4.5. Suspended sediment concentrations at Site UT. These samples were collected with depth integrating samplers at several different times.

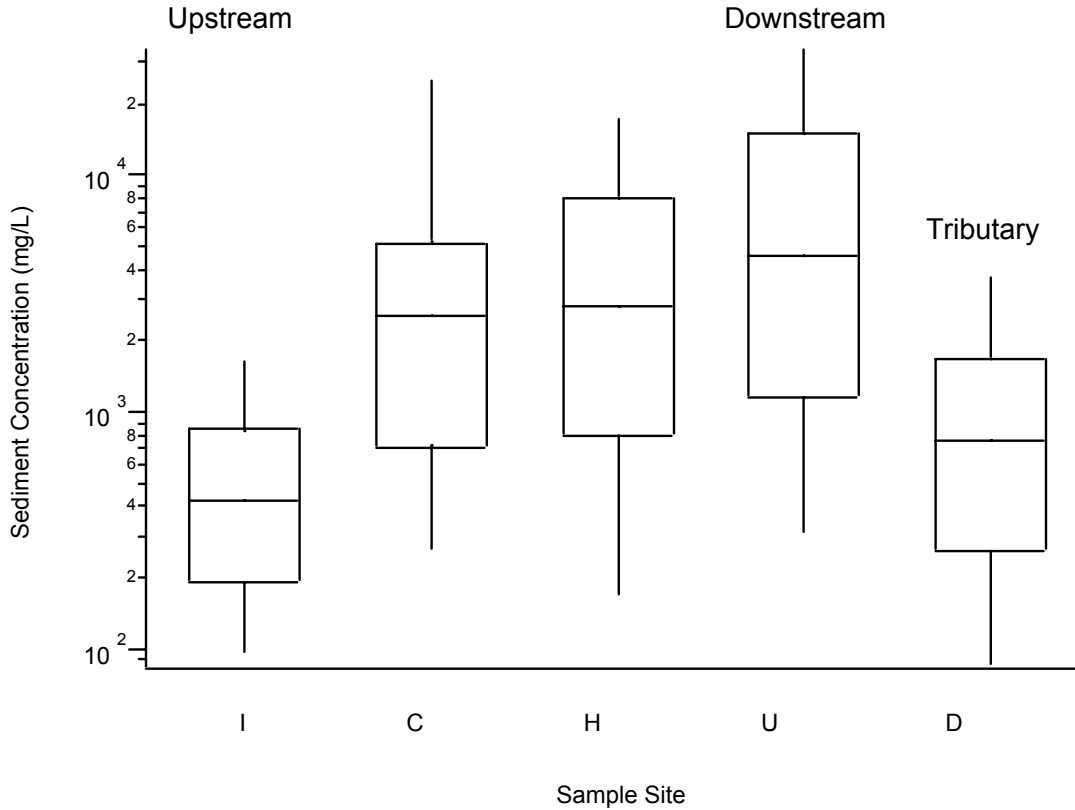
Figure 4.6. Suspended sediment concentrations from all sites. These samples were collected with rising stage samplers.

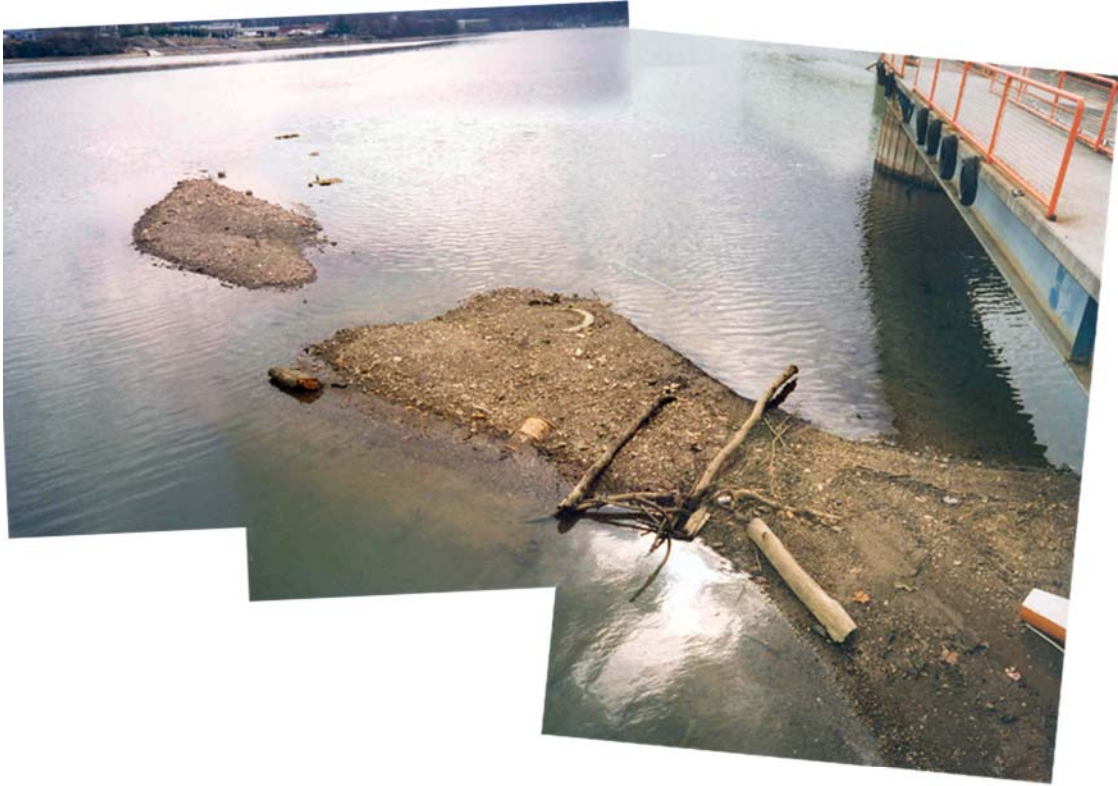
Figure 5.2. Sediment exposed at low water near the outlet of Second Creek. These combined pictures were taken in early 1997. The view is downstream in this upper part of Lake Loudoun reservoir on the Tennessee River. (Photographs by the author.)

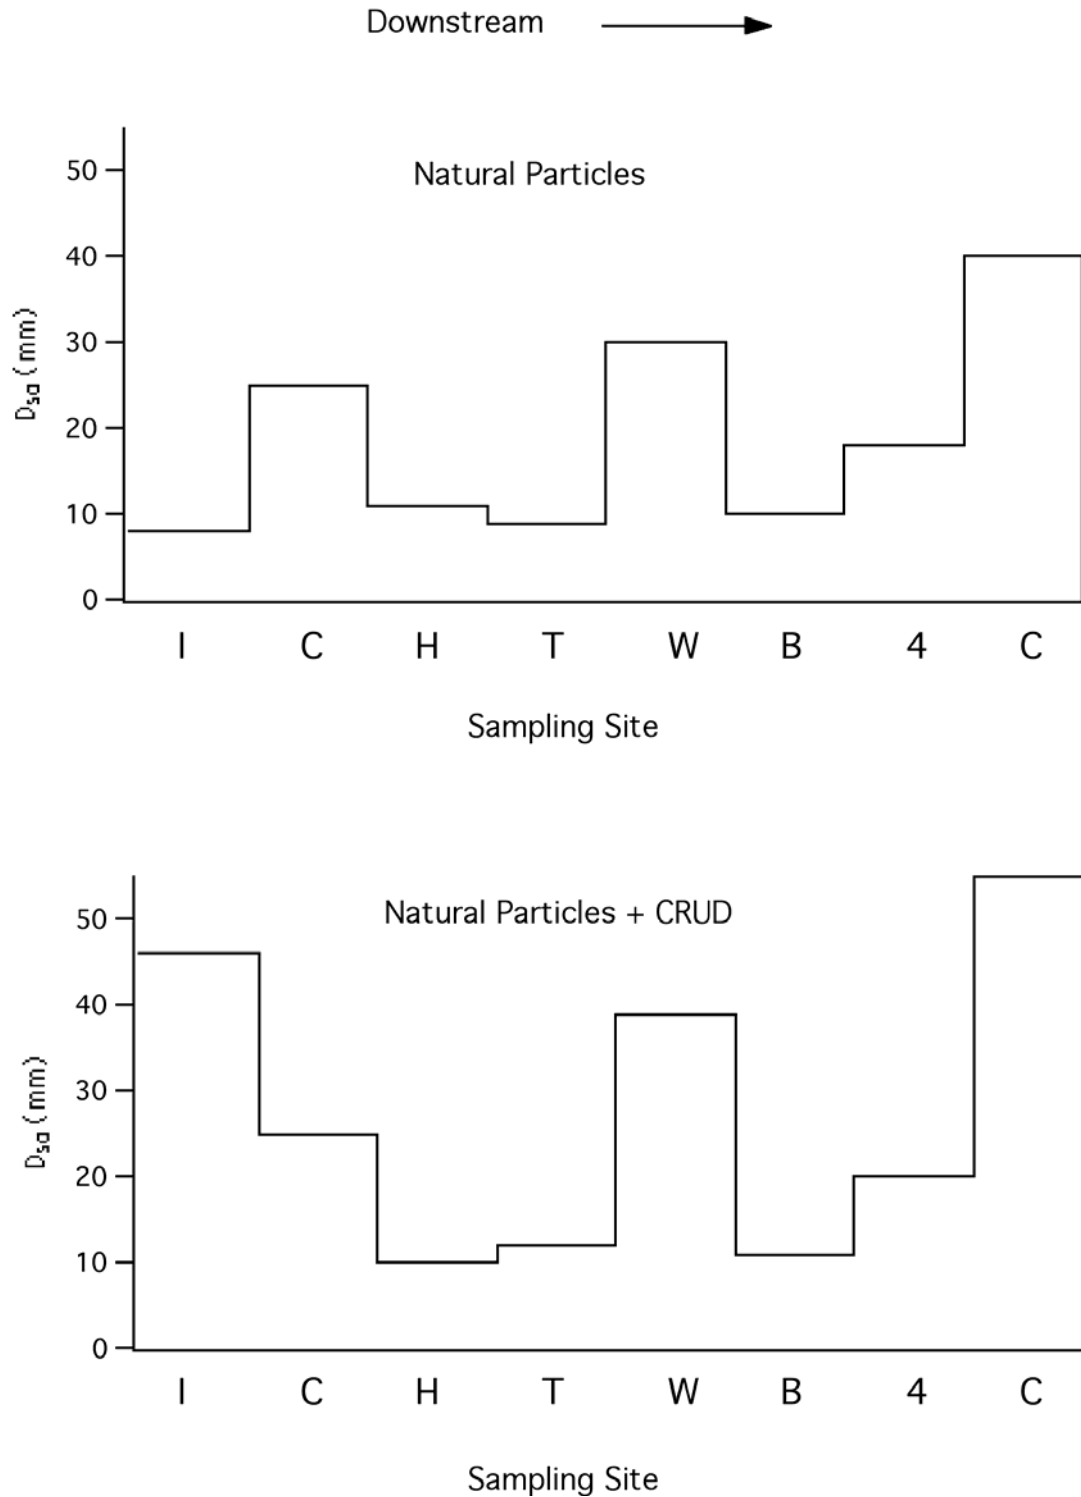
Figure 5.5. Change in median particle diameters due to the addition of anthropogenic particles.

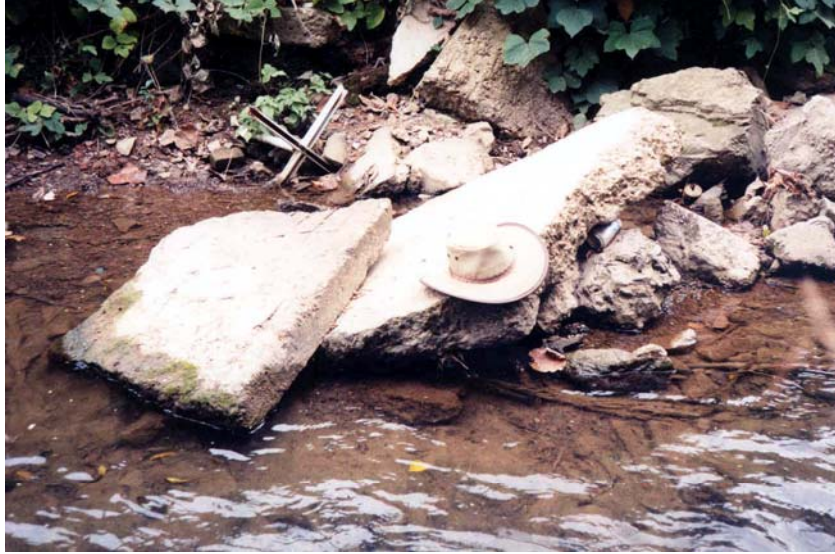
Figure 5.6. Imbricated slabs of concrete in the channel. The positions of these pieces of concrete, located in between Coster Yard and Oldham Avenue, suggest that Second Creek can occasionally move large particles. Flow is from left to right. (Photograph by the author.)

Second Creek, like most urban streams, is flashy, and I have seen evidence that seems to indicate that large particles are sometimes moved by water. The imbricated pieces of concrete shown in Figure 5.6 suggest that large particles have been moved by Second Creek. The location of this phenomenon was about 100 m downstream from the culverts

under multiple railroad tracks south of Coster Yard. There was one other set of large imbricated slabs of concrete in the same vicinity. There was no noticeable change in position of boulders near Site C or near Sites UT or U from 1997 to 1999.

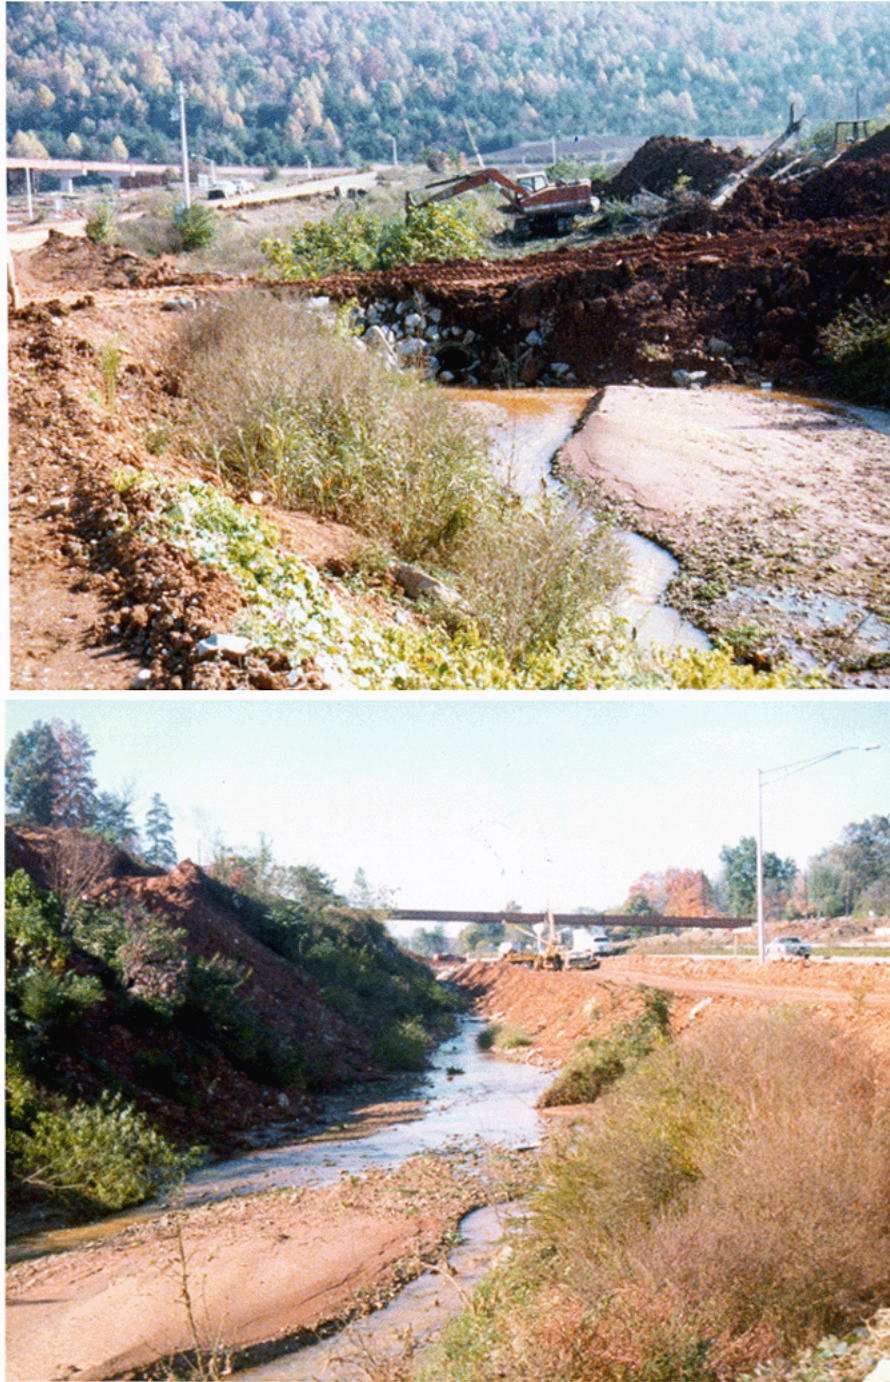
Figure 5.7. Sediment in the channel during construction in 1979. This location is upstream of the I-75/I-640 interchange and Sharp Ridge. The Tillery Road overpass is visible in the background. Photographs courtesy of TVA.

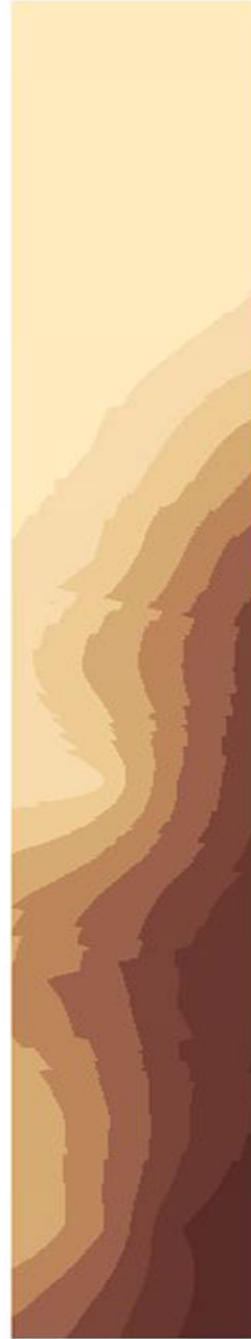
Figure C.1. Continued.

Sediment in east box
of triple-box culvert
under off-ramp

Volume: 37.60 cu m
Surface Area: 60.09 sq m
Culvert Size: 3.25 m x 20 m

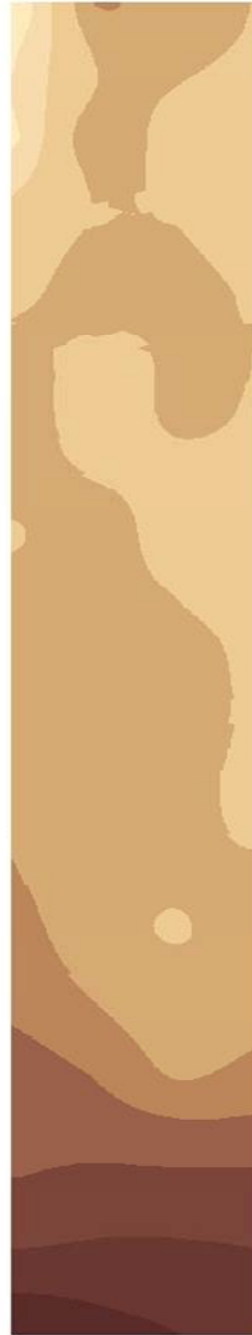
Figure C.1. Continued.

Sediment in central box
of triple-box culvert
under off-ramp

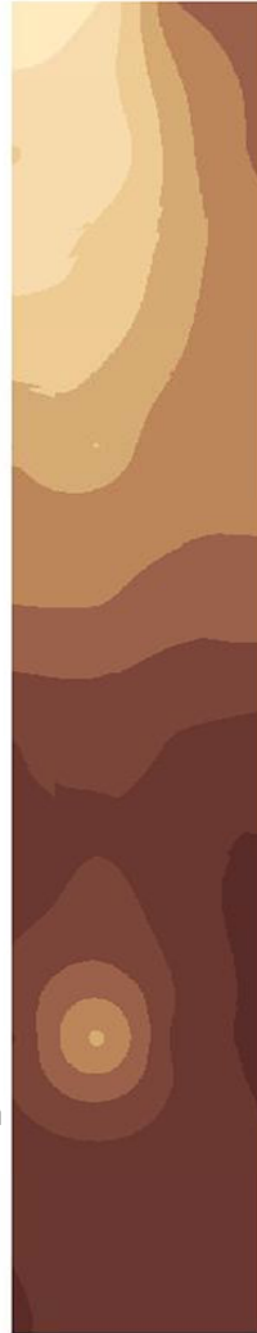
Figure C.1. Continued.

Volume: 21.41 cu m
Surface Area: 54.06 sq m
Culvert Size: 3.25 m x 20 m
