1991

Elevated temperature erosion studies on some materials for high temperature applications

Jianren Zhou
Iowa State University

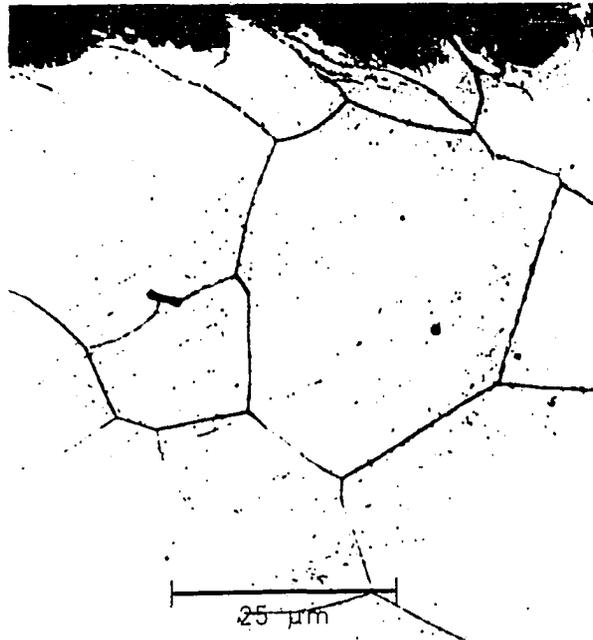
Figure 15: Plastic deformation of grain boundaries of 304 SS due to particle impacts at 800°C

Figure 15 shows how the deformation of grain boundaries occurs close to the surface of 304 SS as a result of the particle impacts at 800°C . The slip bands are not seen here because they were annealed out very quickly at the elevated temperature used in the test.
