Evaluation Of Streambank Stabilization Options On The Tongue River In Cavalier, ND Utilizing Hec-Ras Hydraulic And Sediment Transport Simulations

A Thesis

University of North Dakota

Master of Science

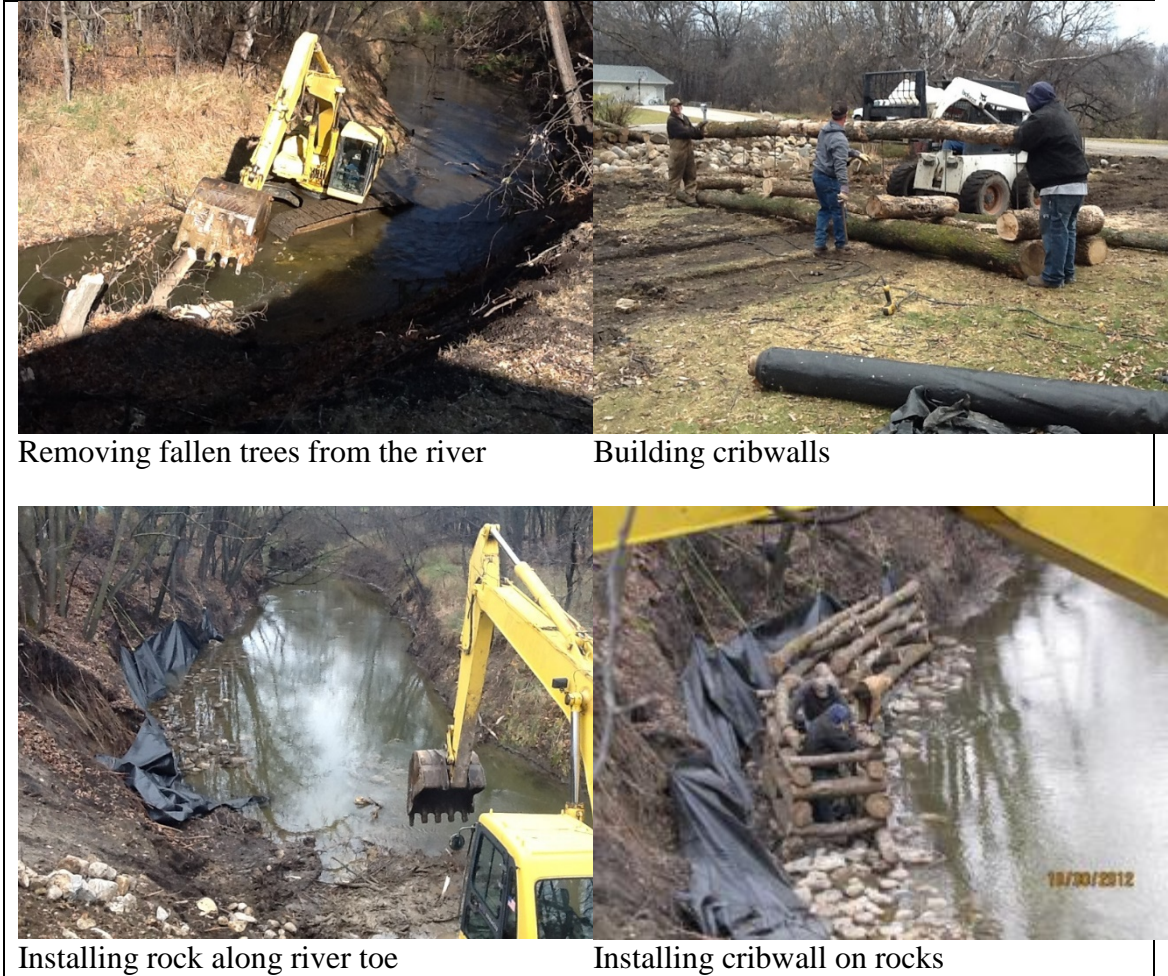
Several landowners applied for assistance in streambank stabilization projects at individual sites. At 201 Woodland Terrace, Site 6 on the map, a cribwall was installed in October of 2012. After removing trees and debris from the channel, a fabric was laid down, then a rock foundation was added along the river toe. Log cribwalls were built on the banks, then a backhoe was used to put them into place on top of the rock. The hollow cells were then filled with soil to keep everything in place. Photos of the process are shown in Figure 7.

Removing fallen trees from the river

Building cribwalls

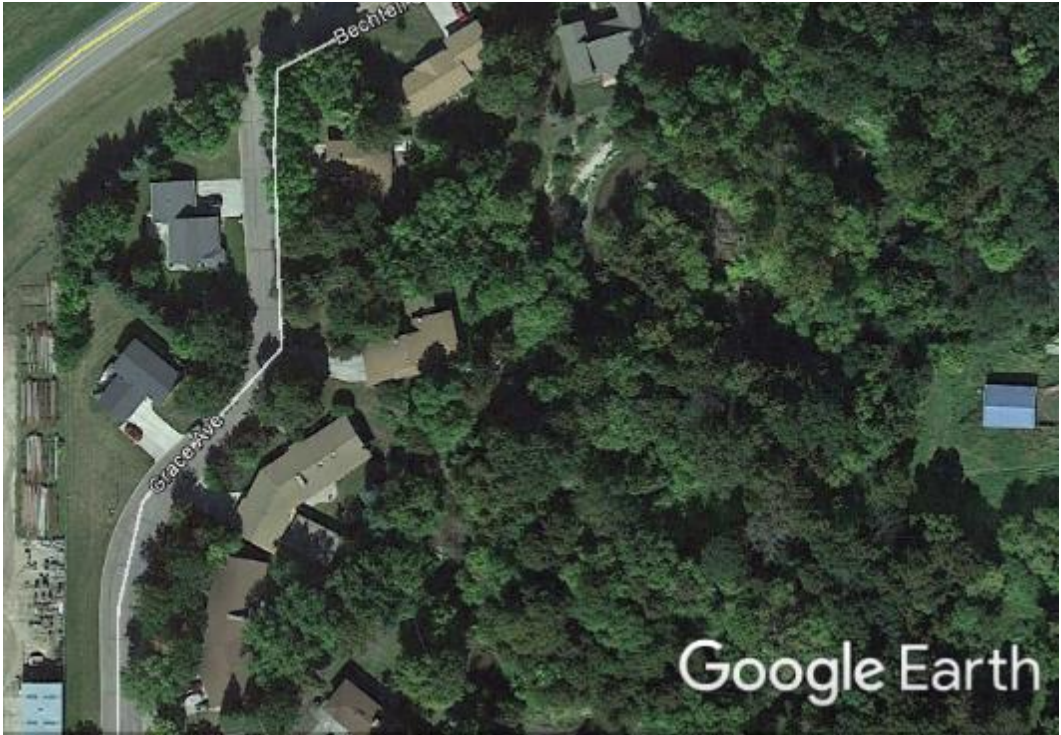
Site 7 on the map in Figure 2 also applied for assistance. The Google Earth imagery in Figure 8 and Figure 9 show that several trees were removed and the bank was stabilized with riprap. This means that the most downstream site identified by the Red River Riparian Project team that has not had a project is Site 8 at Park Street.

Figure 8. Sept 14, 2013 Google Earth aerial imagery at Grace Ave

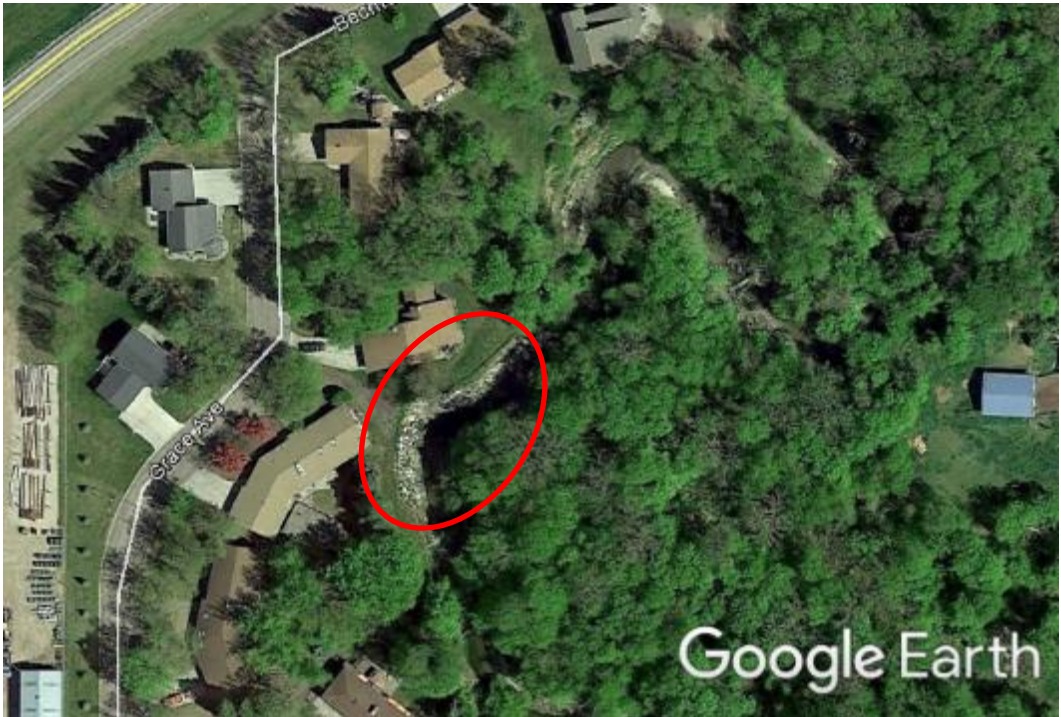
Figure 9. May 16, 2016 Google Earth aerial imagery at Grace Ave

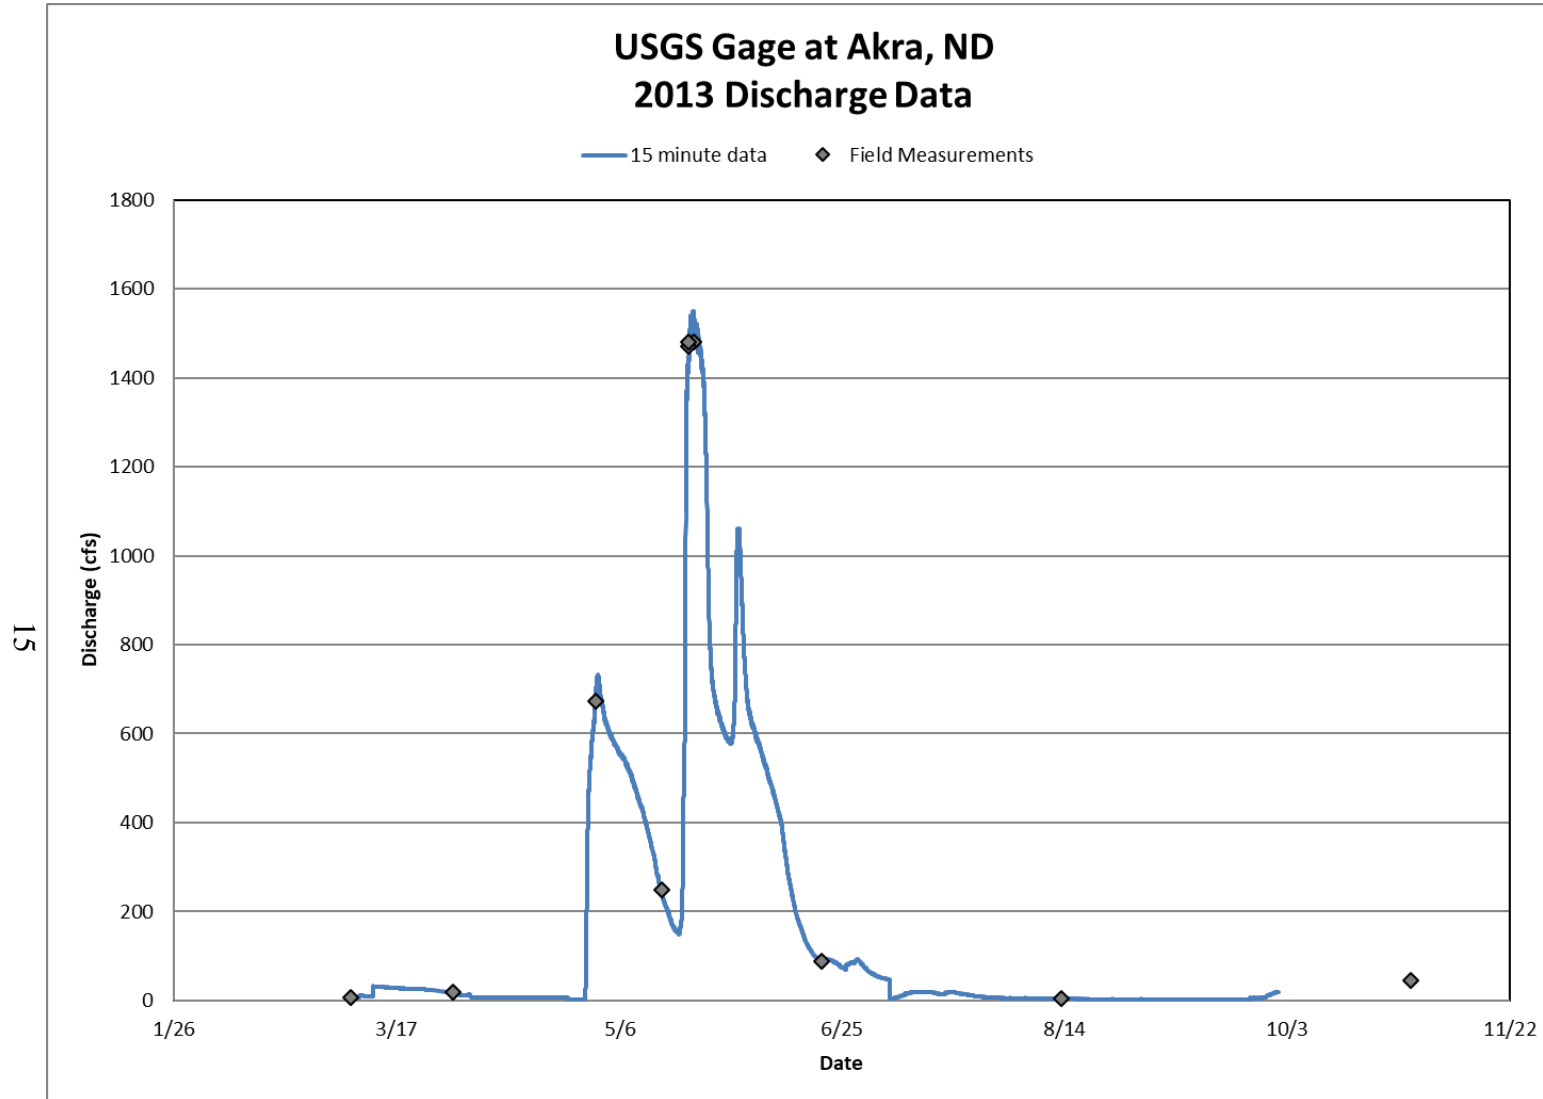
Figure 11. USGS gage at Akra, ND 2013 discharge hydrograph

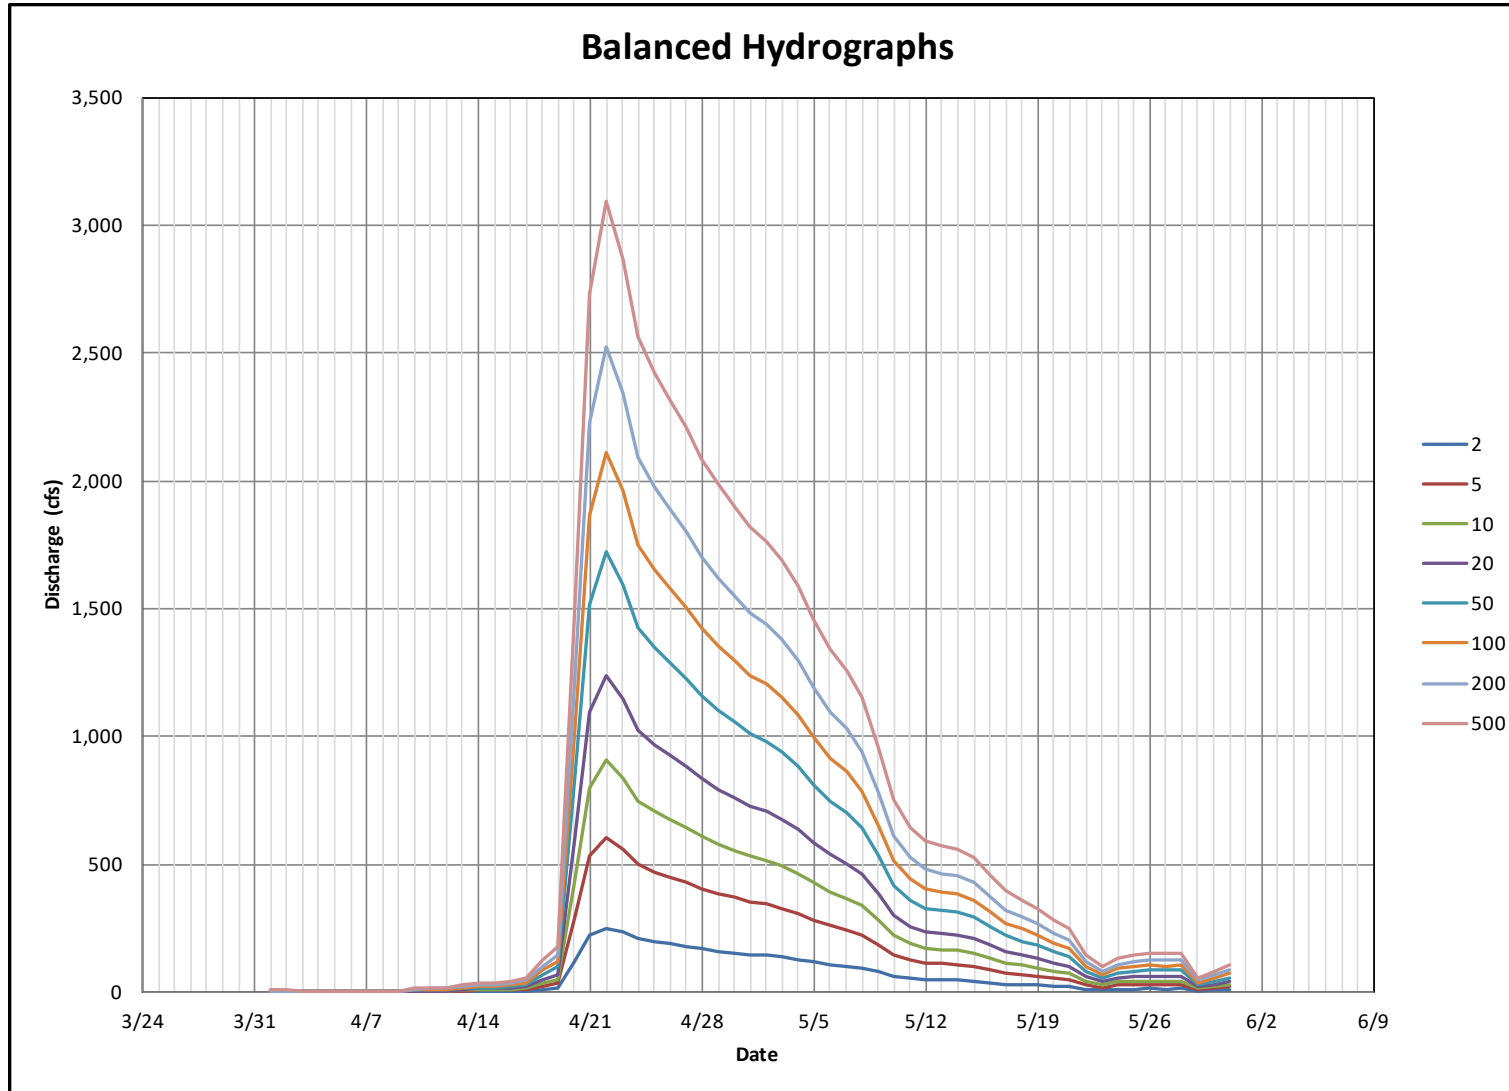
Figure 19. Synthetic balanced hydrographs using 1979 USGS data as pattern hydrograph

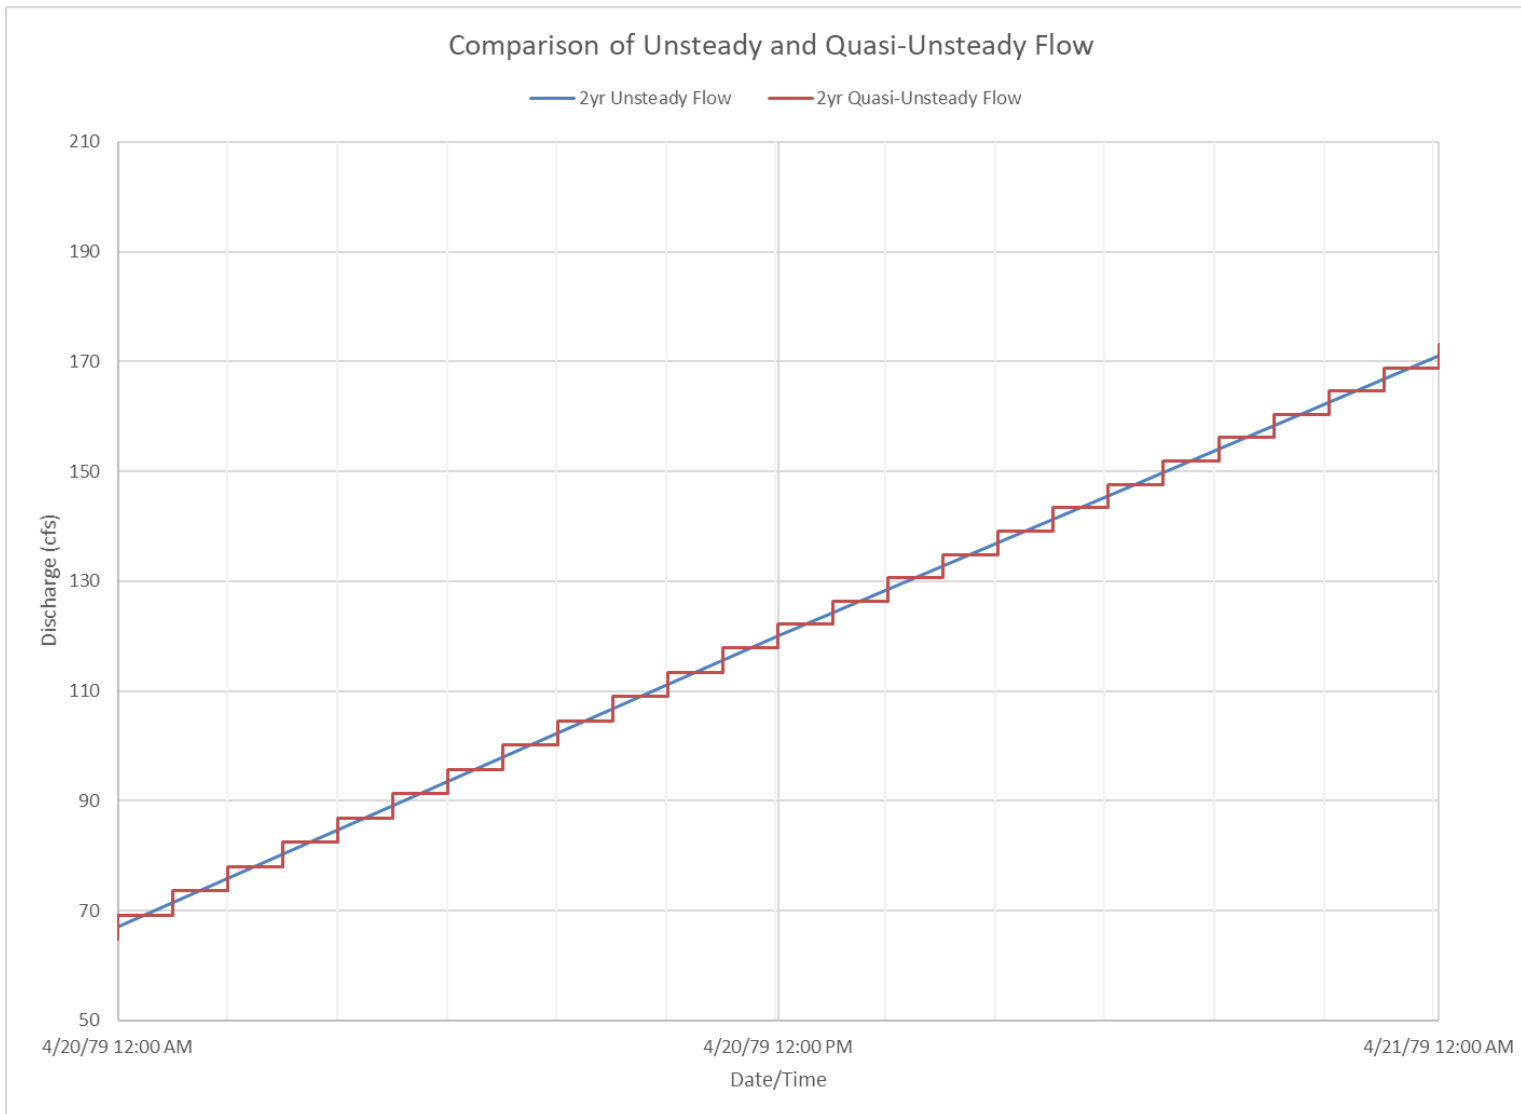
HEC-RAS sediment transport models used to require using quasi-unsteady flow data. The quasi-unsteady flow creates a stepped hydrograph as opposed to the smooth unsteady hydrograph. A smaller time-step of 1 hour can be used to limit the differences in the two hydrographs. A zoomed in view of the 2-year hydrographs is shown in Figure 30 to compare. The latest versions allow use of unsteady flow, which also allows for the use of storage areas and lateral structures so the flow can break out. However, it is noted that the quasi-unsteady model is less likely to have stability issues.

Figure 30. Comparison of unsteady and quasi-unsteady hydrographs

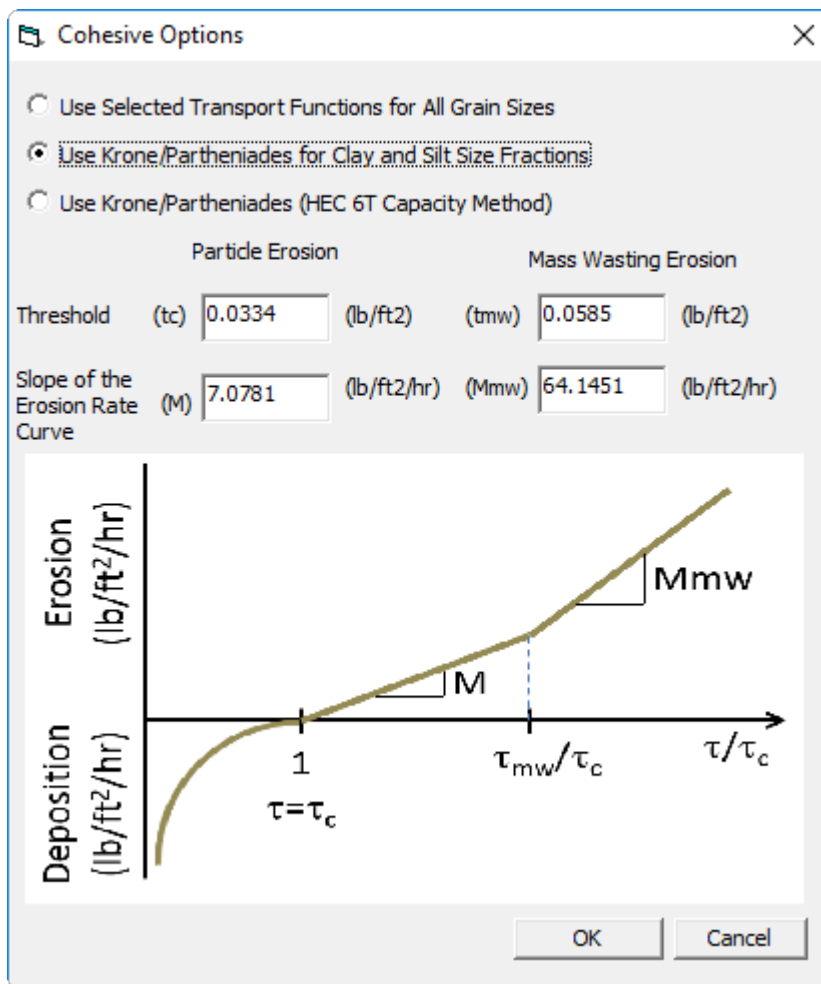
Figure 34. HEC-RAS Cohesive Sediment Options (Brunner, 2016)

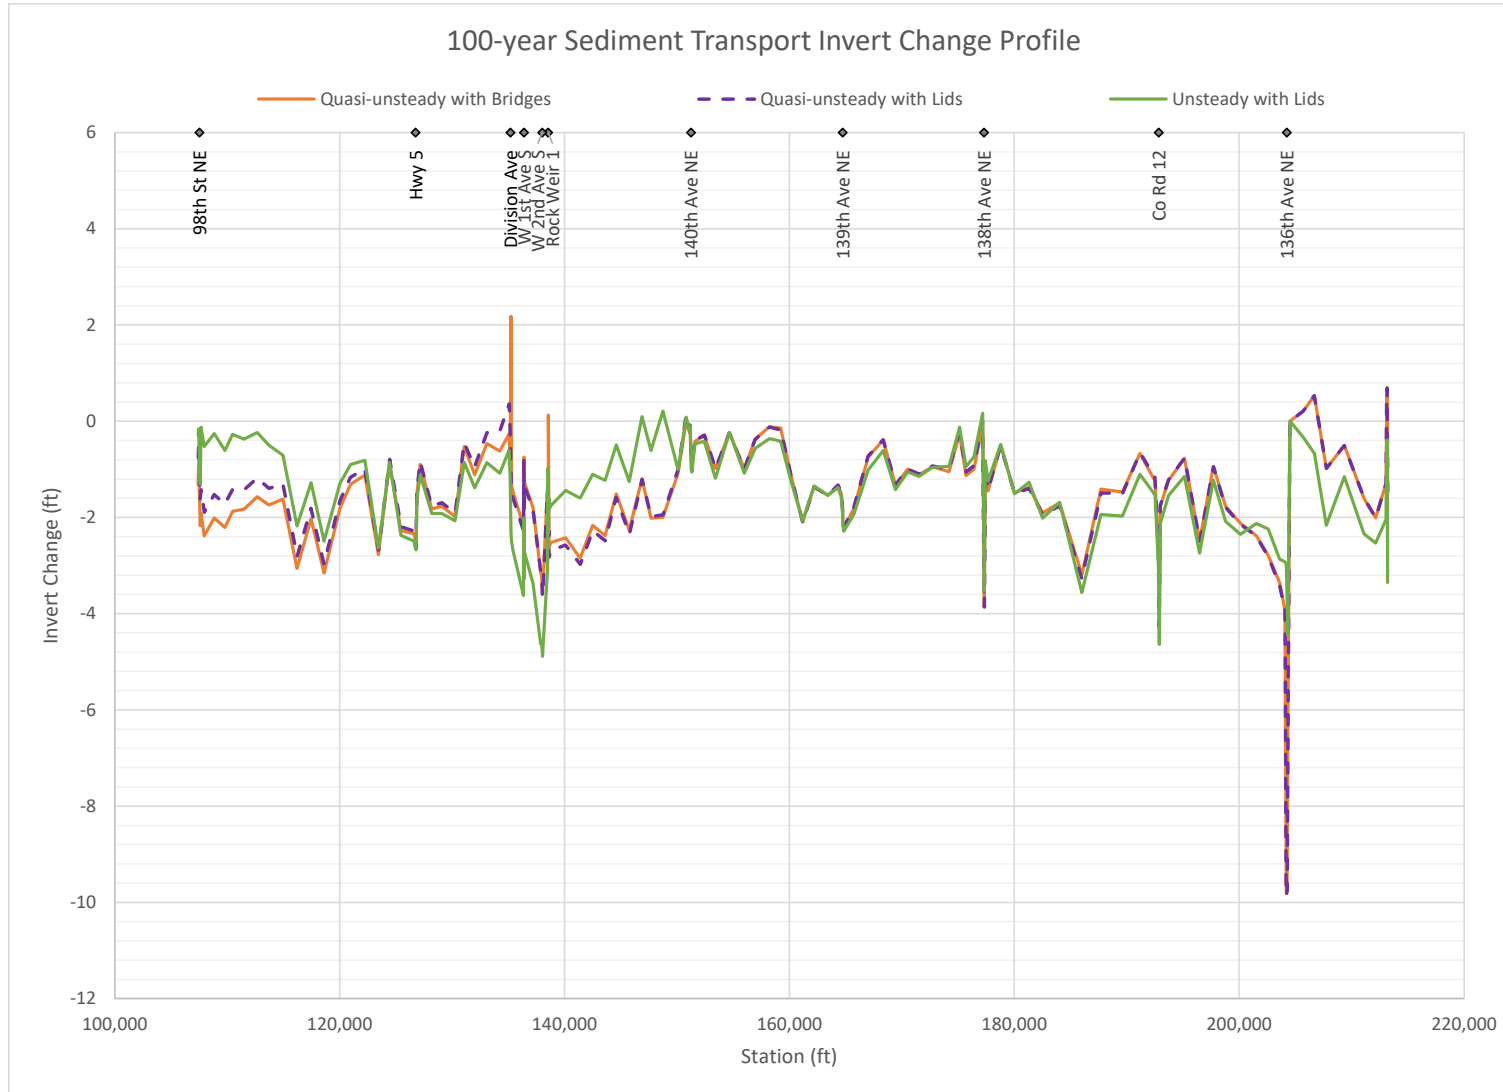
Figure 35. 100-year quasi-unsteady vs unsteady flow invert change results with bridges and lids

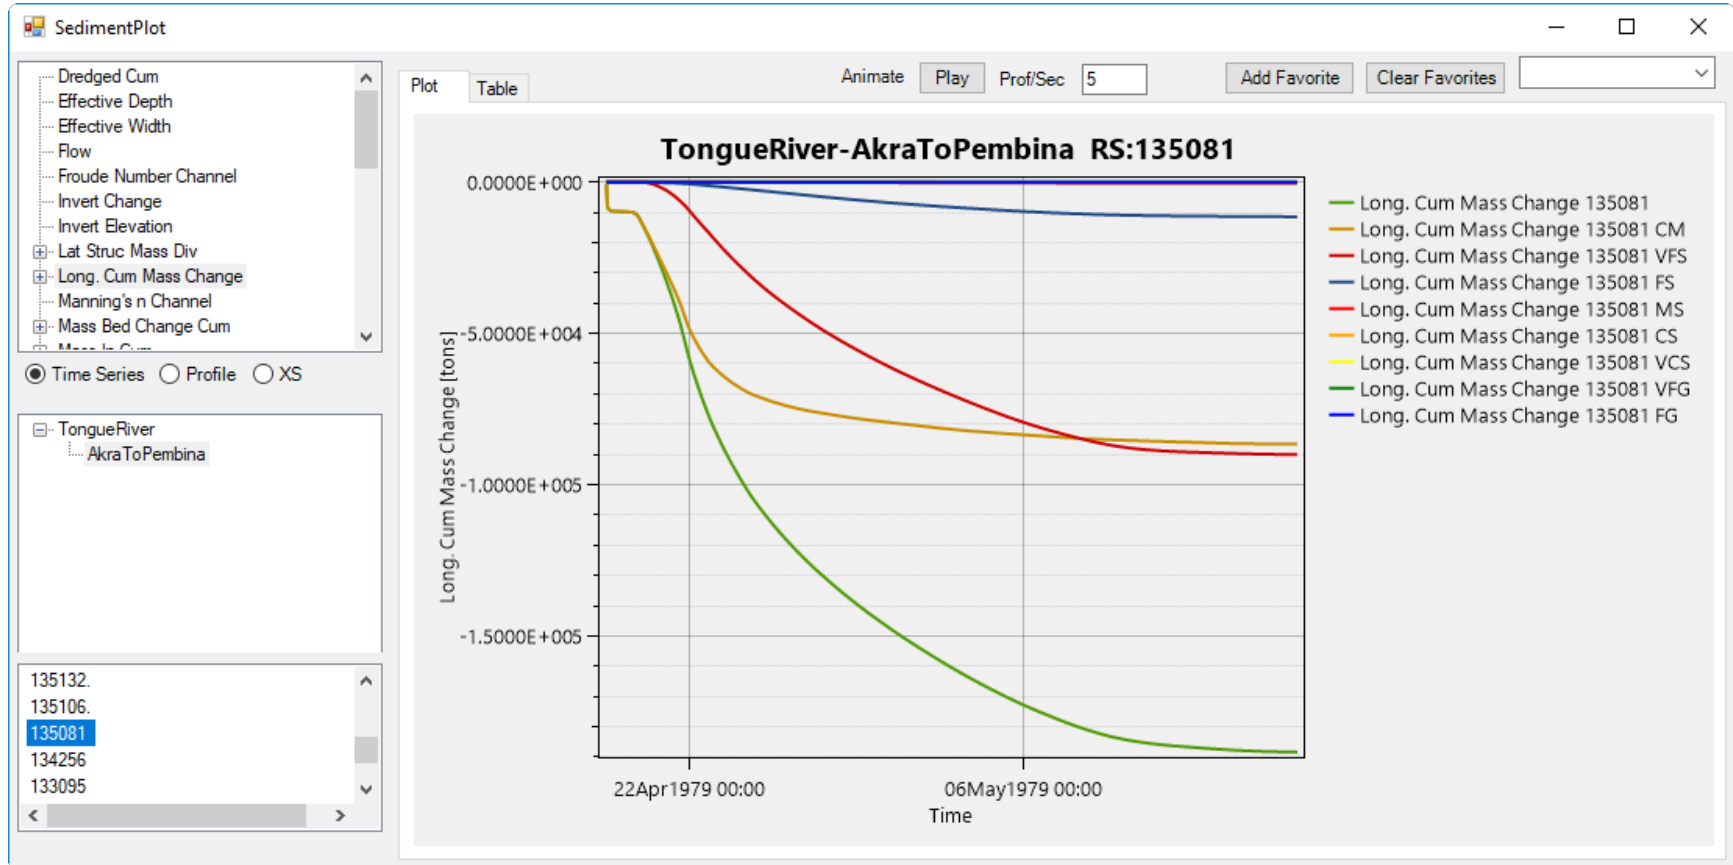
Figure 45 through Figure 50 show the cumulative mass change over time for the 2- and 100-year events at the cross sections with the most erosion for each five foot weir option. The lighter green lines illustrate the total mass change, while the remaining lines are broken down by sediment sizes. All three weirs use the same “Island” gradation in the model. The majority of the mass change in these models is class CM, coarse silt. However, the gradations weren’t tested past the No. 200 sieve, so this volume is all of the silt and clay combined. The dark red line next on the graph is VFS, very fine sand. The graphs also show some FS, fine sand, being moved.

Figure 45. HEC-RAS 2-year sediment cumulative mass change at maximum erosion cross section for Division Ave 5ft weir model

Figure 46. HEC-RAS 100-year sediment cumulative mass change at maximum erosion cross section for Division Ave 5ft weir model

Figure 47. HEC-RAS 2-year sediment cumulative mass change at maximum erosion cross section for Park St 5ft weir model

Figure 48. HEC-RAS 100-year sediment cumulative mass change at maximum erosion cross section for Park St 5ft weir model

Figure 49. HEC-RAS 2-year sediment cumulative mass change at maximum erosion cross section for Woodland Terrace 5ft weir model

Figure 50. HEC-RAS 100-year sediment cumulative mass change at maximum erosion cross section for Woodland Terrace 5ft weir model

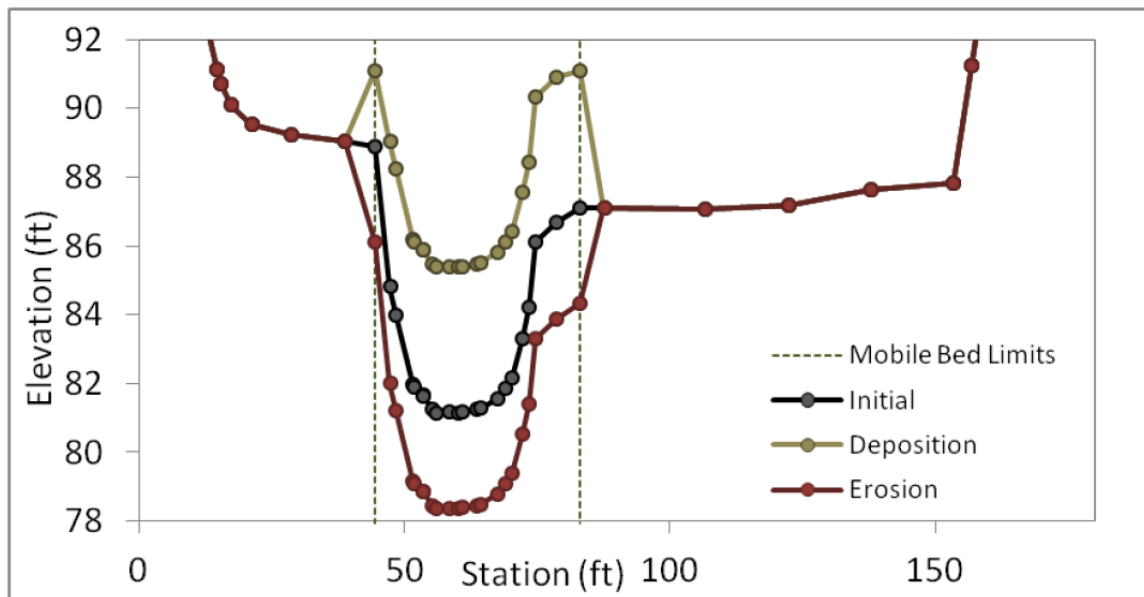
There are several limitations in relation to the capability of the software as well. This is a one-dimensional model, so water does not adjust around the bends to have more erosion on the outside. In addition, HEC-RAS uses the veneer method to change cross section geometry. All of the nodes that are wetted and within the movable bed limits will change the same vertical distance. An example of this is shown in Figure 51.

Figure 51. Example of the veneer method of erosion and deposition in HEC-RAS (Brunner, 2016)
