Evaluation of High-Level Lighting Poles Subjected to Fatigue Loading

Reilly William Thompson
Lehigh University

A Thesis

Civil and Environmental Engineering

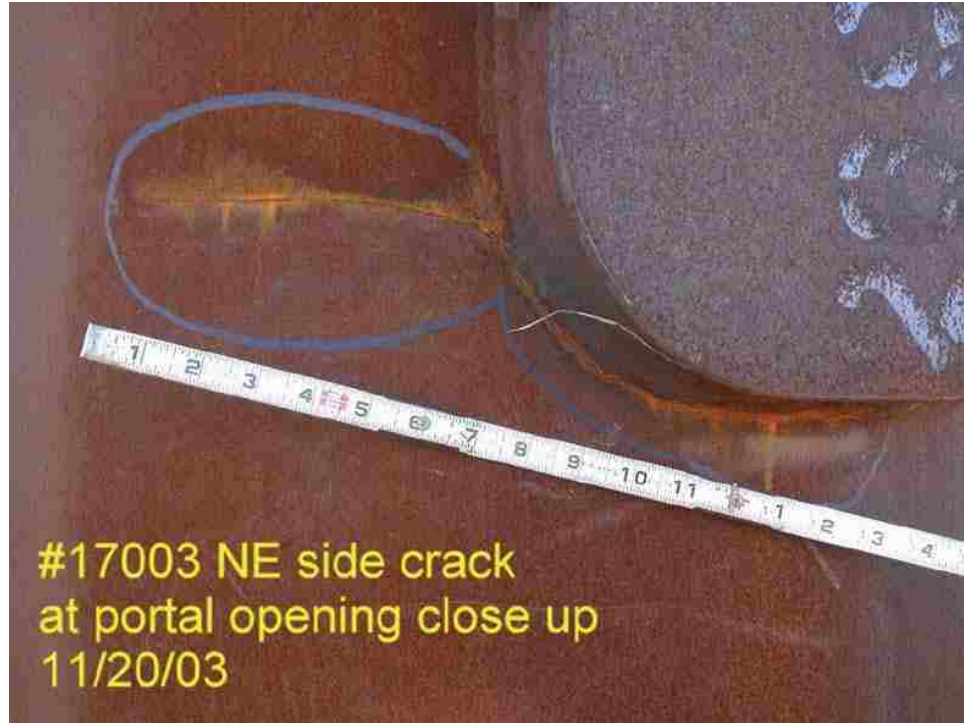
Figure 5. Handhole crack at corner (*reprinted from Koob, 2006*)

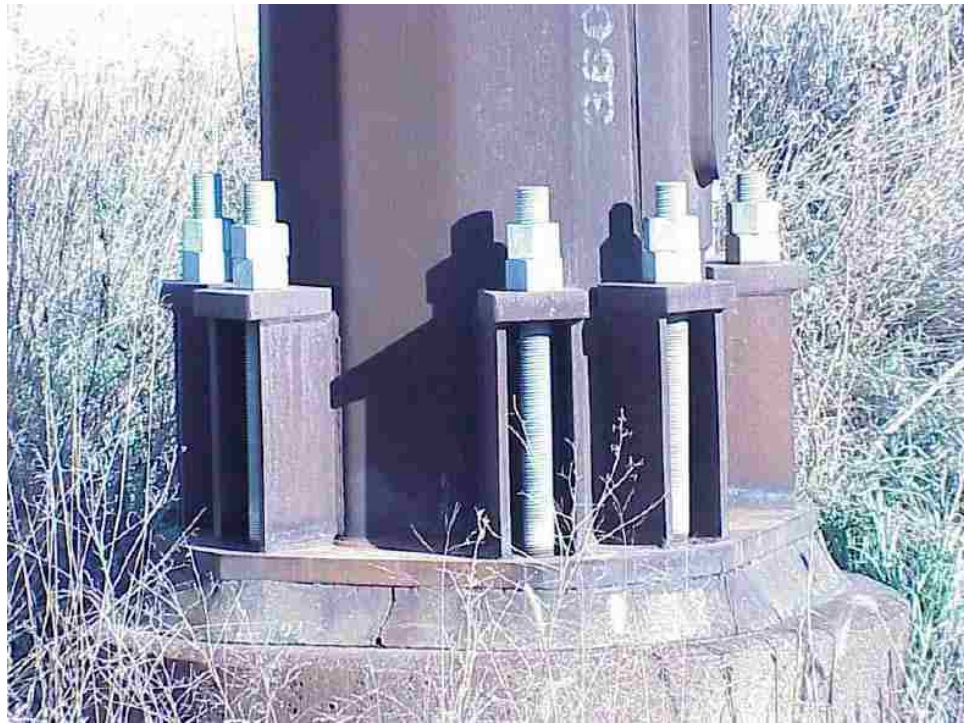
Figure 6. Stool base connection detail (*reprinted from Dexter, 2004*)

A total of 90 structures with a stiffened stool connection at the pole base were installed during the 1970s and 1980s and were constructed of weathering steel as shown in Figure 6. No cracking was observed in these structures, which will be referred to as the stool connection towers. Amongst the stool connection towers, the pole height varied between 100 ft (30 m) and 180 ft (55 m), the diameter at the pole-to-base plate connection varied between 24 in (610 mm) and 33.3 in (846 mm), and the wall thickness varied between 5/16 in (8 mm) and 0.688 in (17 mm).

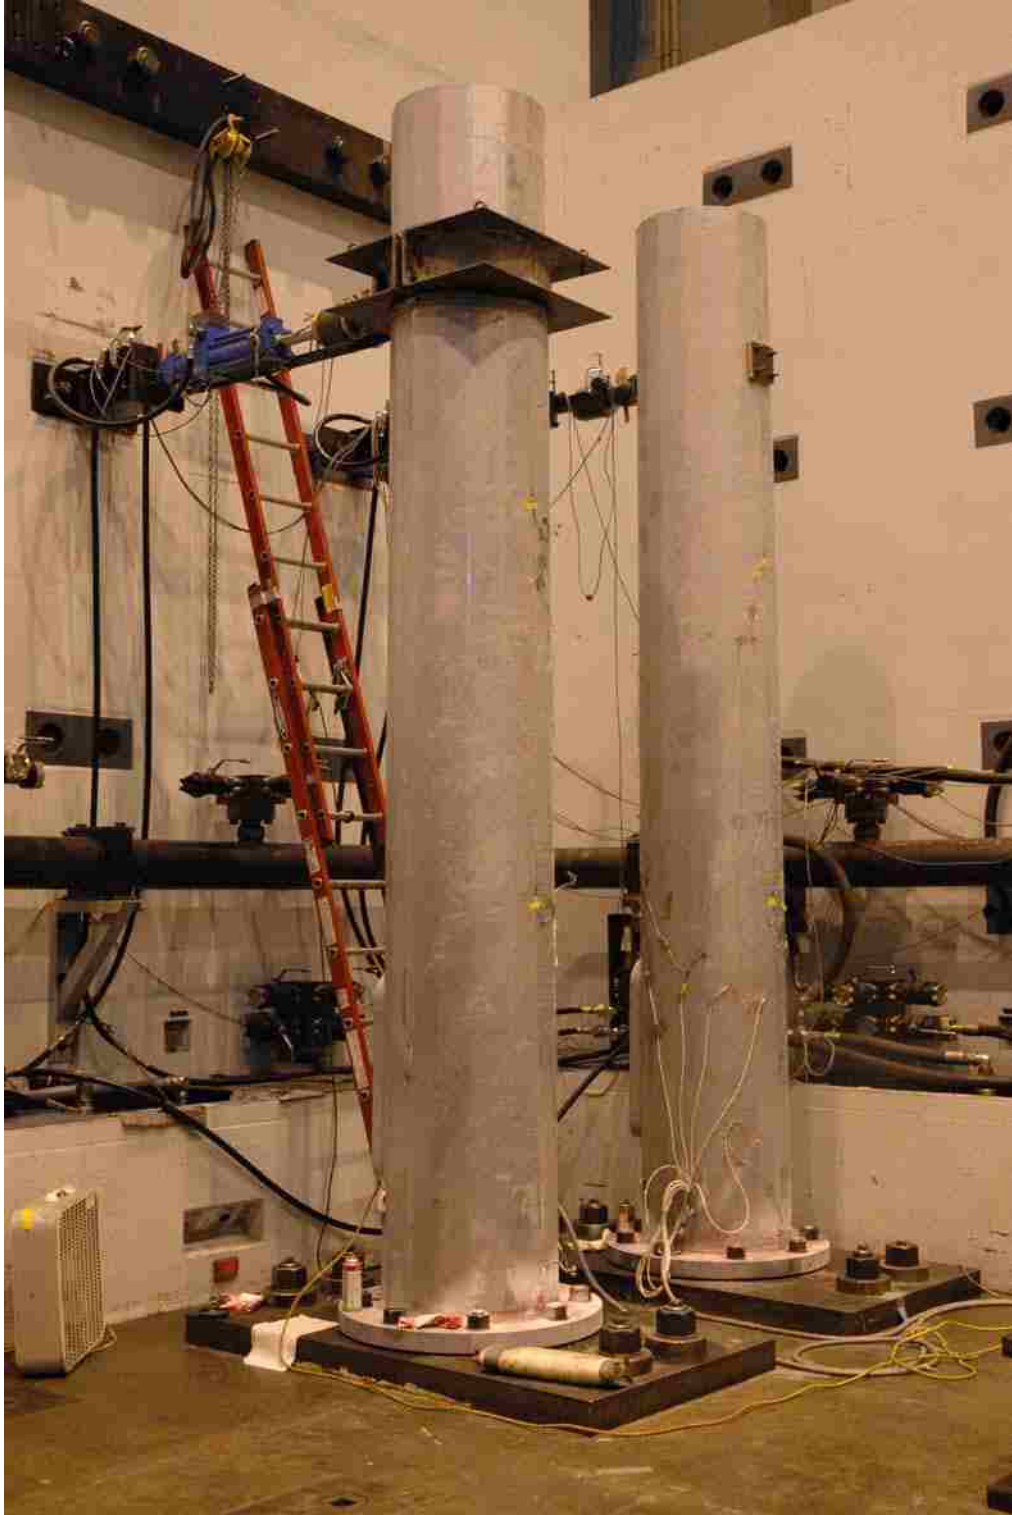
Figure 18. Fatigue testing setup at ATLSS

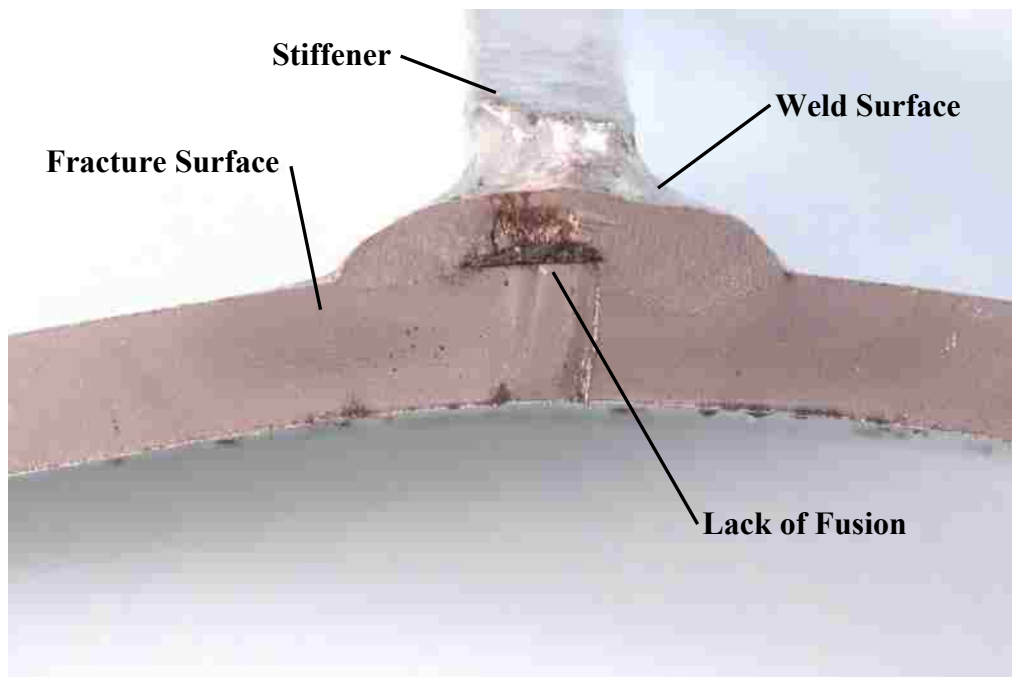
Figure 89. Fatigue cracking from lack of fusion defect in specimen XII-6

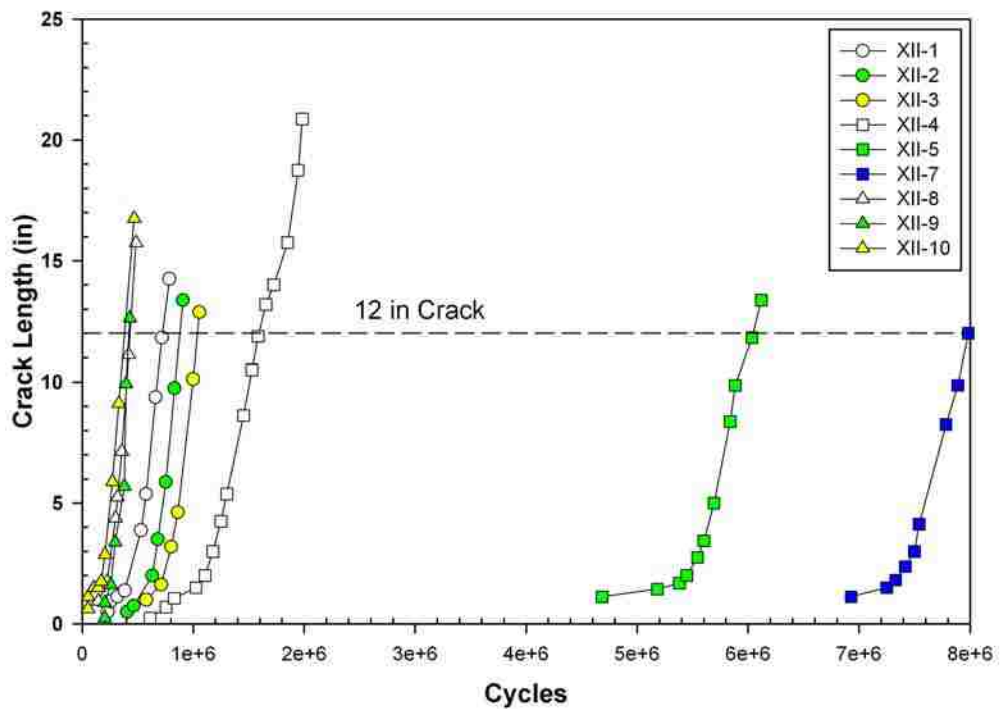
Figure 93. Crack growth versus number of cycles for Type XII specimen

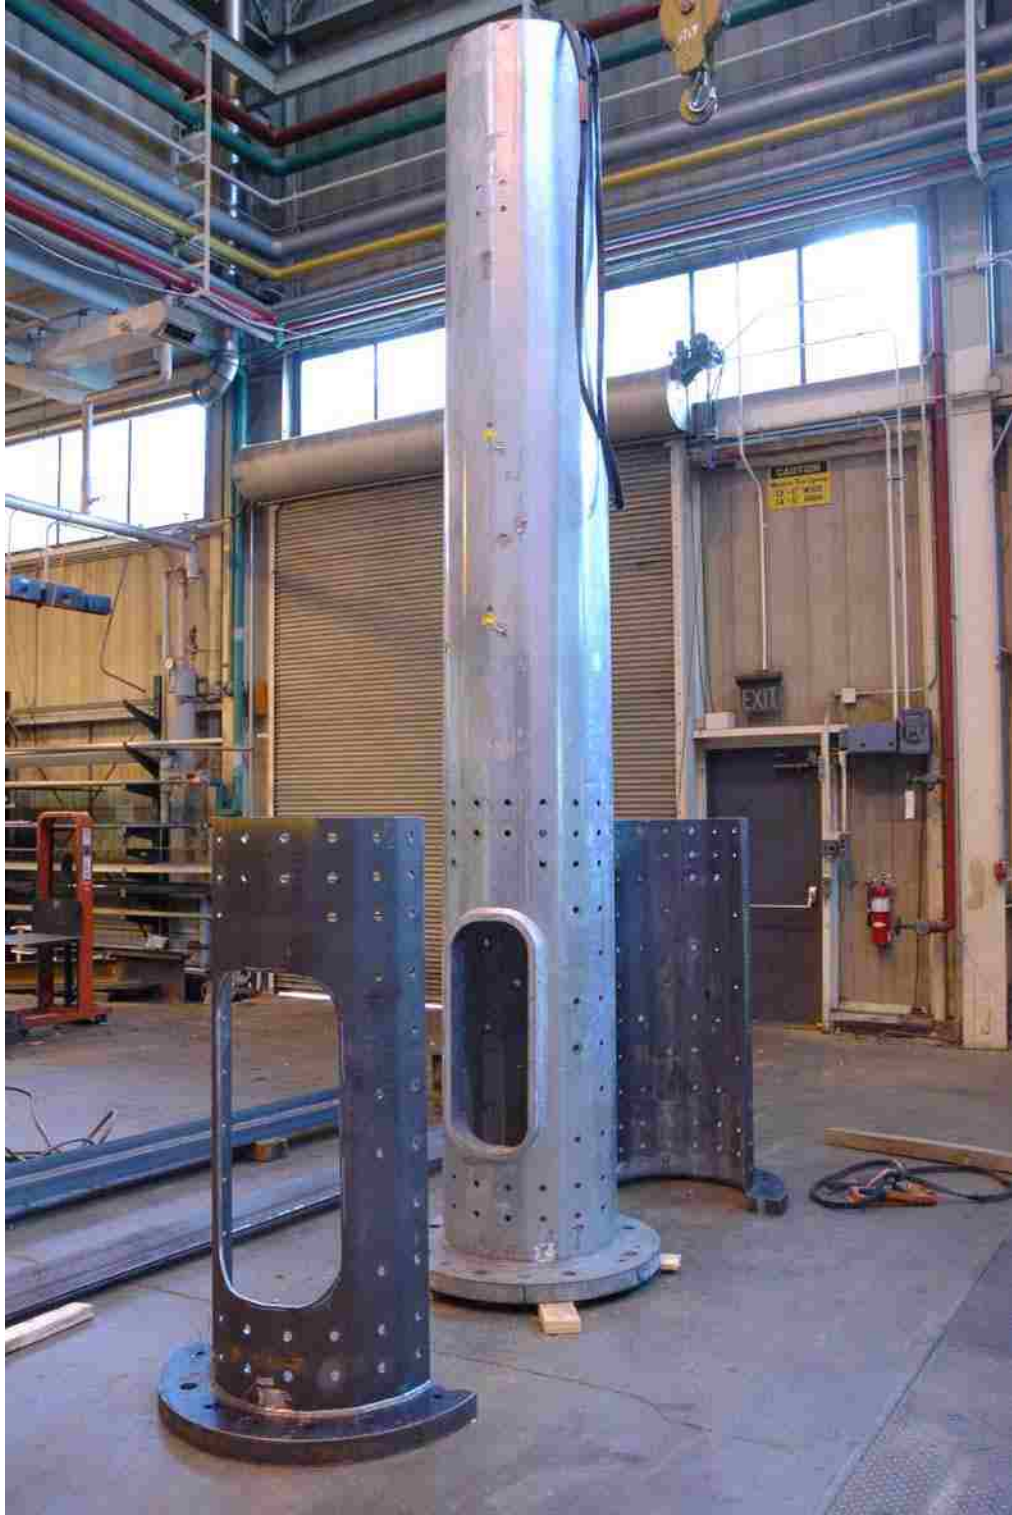
Figure 137. Retrofit jacket ready for connection to Specimen XI-9
