# Evaluation of Iowa asphalt pavement joint cracking

A dissertation submitted to the graduate faculty  
in partial fulfillment of the requirement for the degree of

Major: Civil Engineering (Civil Engineering Materials)

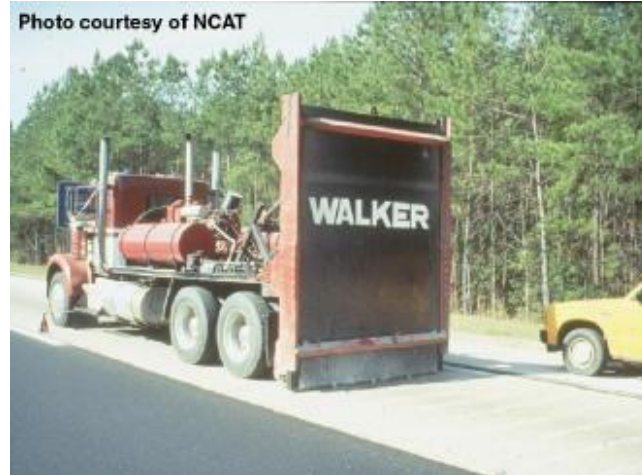
Figure 3 Crack-and-seat

Four major steps are involved in implementing crack-and-seat techniques (see Figure 3): cracking the concrete slab (using a drop hammer or guillotine or modified pile driver or whip hammer), seating the cracked slab, applying special treatments, and placing the HMA overlay. The cracking of the existing pavement reduces the slab movement due to thermal action, thus minimizing or controlling the reflective cracking in the HMA overlay. The resulting pieces should be large enough to retain aggregate interlock between aggregates, and yet small enough to minimize the unreinforced PCC slab joint movement (PCS 1991).

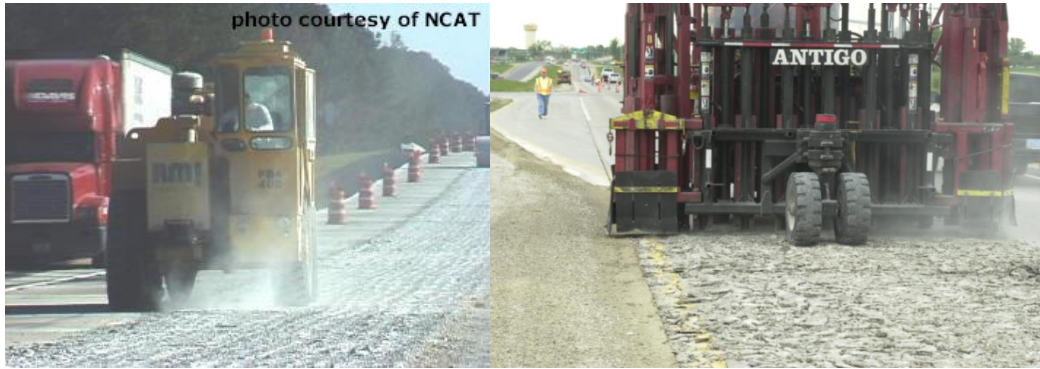
Figure 4 Rubblization: Resonant Pavement Breaker (left) and Multi-Head Breaker (right)

In general, two types of equipment are used in the rubblization process (see Figure 4): Resonant Pavement Breaker (RPB) and Multiple-Head Breaker (MHB). The RPB uses vibrating hammers to break the concrete slab and destroy the bond between the concrete and the steel. The other common rubblizing equipment is the self-contained and self-propelled MHB used by Antigo Construction which is capable of rubblizing the pavement over a minimum width of 13 ft. per pass.

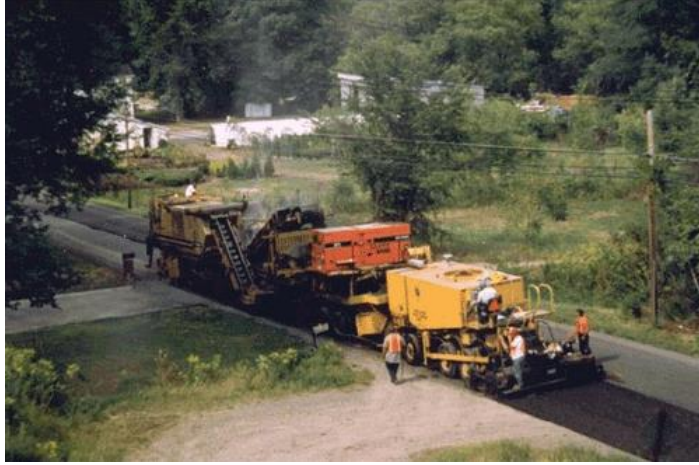
Figure 9 Cold In-Place Recycling (CIR or CIPR) (Source: FHWA)

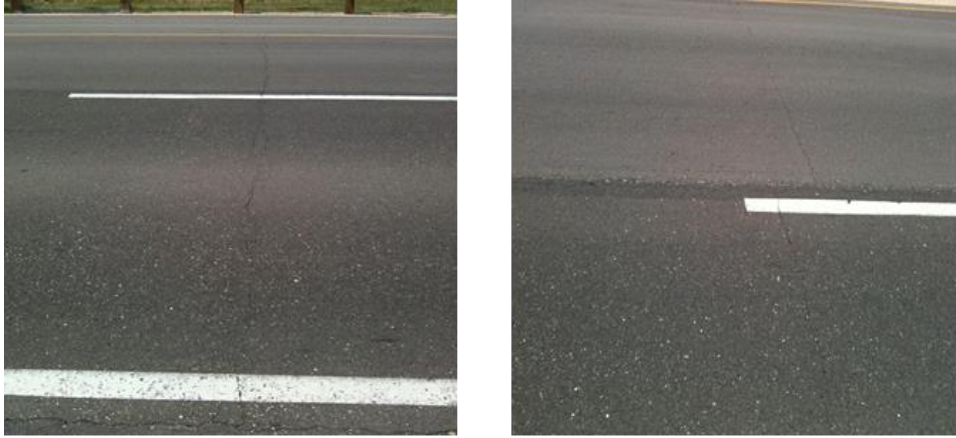
Figure 13 Survey on a project one year after construction (IA-13)

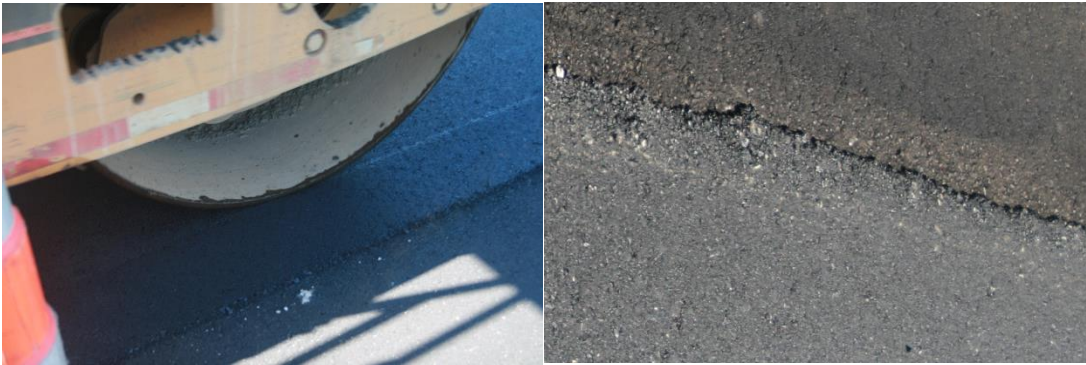
Figure 15 Butt joint construction with hot pinch (pictured on US-61)

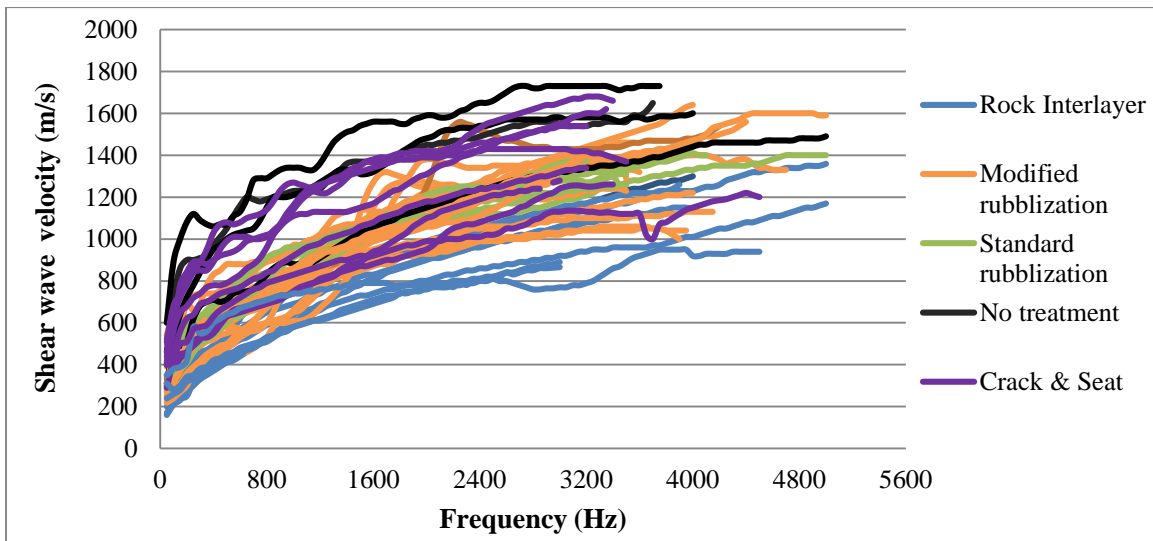
Figure 28 Comparison of dispersion curve for all tested data

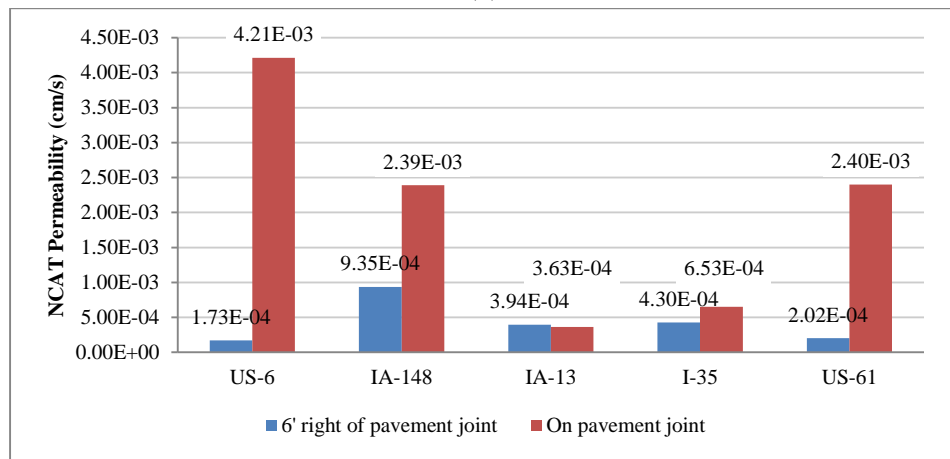
Figure 30 Comparison of mean permeability values using different permeability test methods: (a) K-W Permeameter and (b) NCAT Permeameter

For each test method, the test results were firstly compared to see whether they are capable of detecting the density, permeability and tensile strength differences on longitudinal joint and 6' right of the pavement joint (on pavement mat). Graphical comparisons for all projects are shown in Figure 29 to Figure 31.

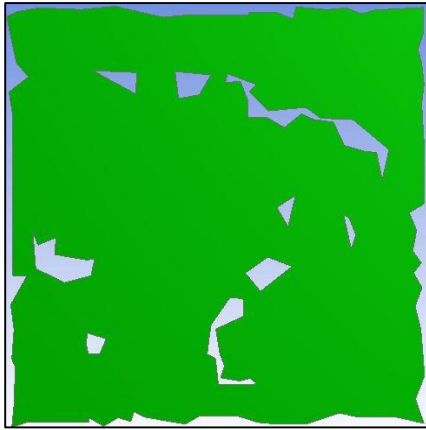
(a) Mix-1 (7.8 % air voids)

(b) Mix-2 (11.3 % air voids)

(c) Mix-3 (16.1% air voids)
