Evaluation of an innovative joint design for the adjacent box beam bridges

DOCTOR OF PHILOSOPHY

Major: Civil Engineering (Structural Engineering)

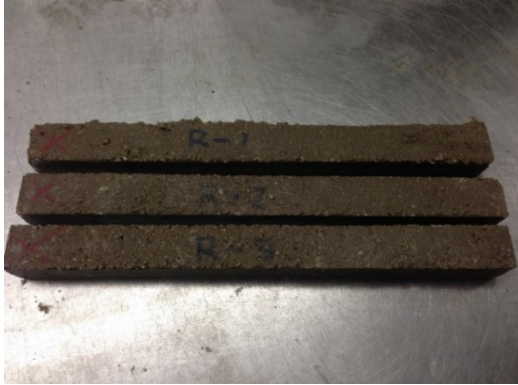
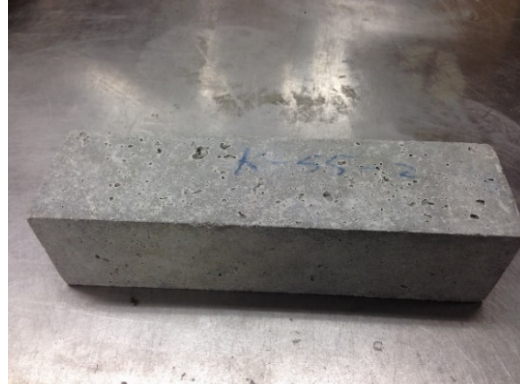
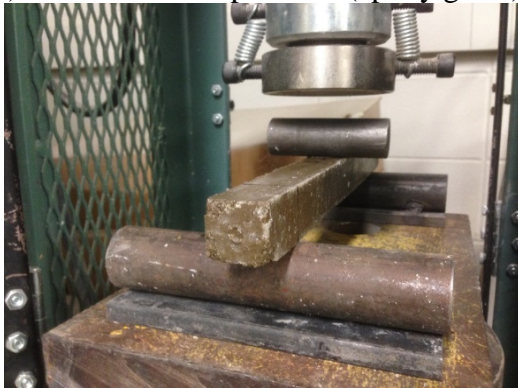
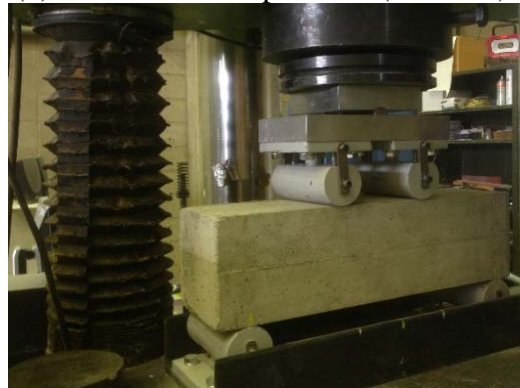
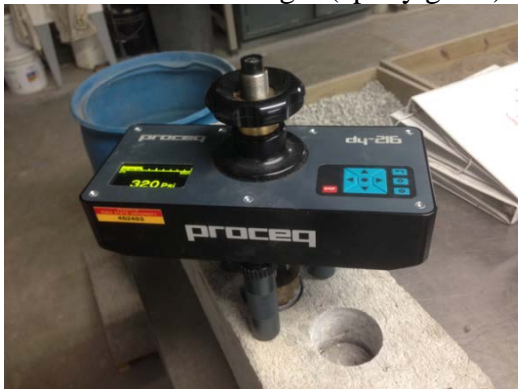
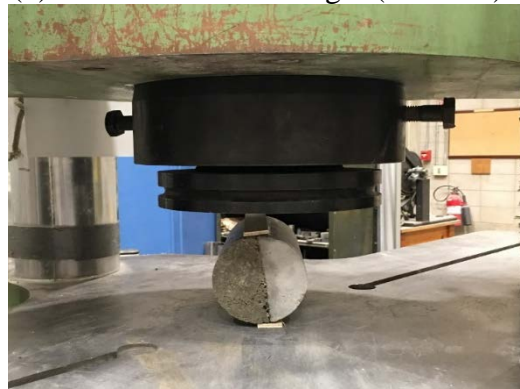
(a) 1"×1"×11.25" specimen (epoxy grout)

(b) 3"×3"×11.25" specimen (concrete)

(c) Flexural tensile strength (epoxy grout)

(d) Flexural tensile strength (concrete)

(e) Pull off test

(f) Split cylinder debonding test

Figure 3-2 Time Dependent Material Properties Test

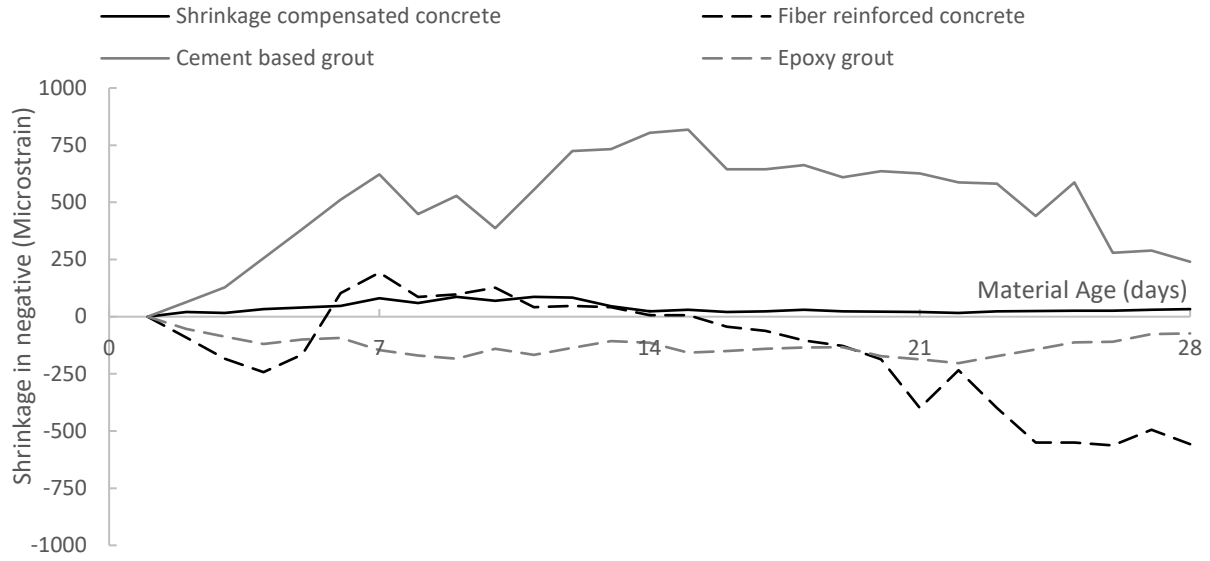
Figure 3-3 Shrinkage Test Results

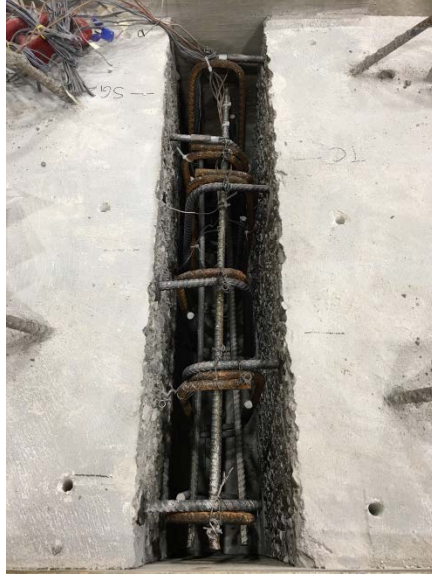
Figure 4-5 Innovative Joint on Specimen-4

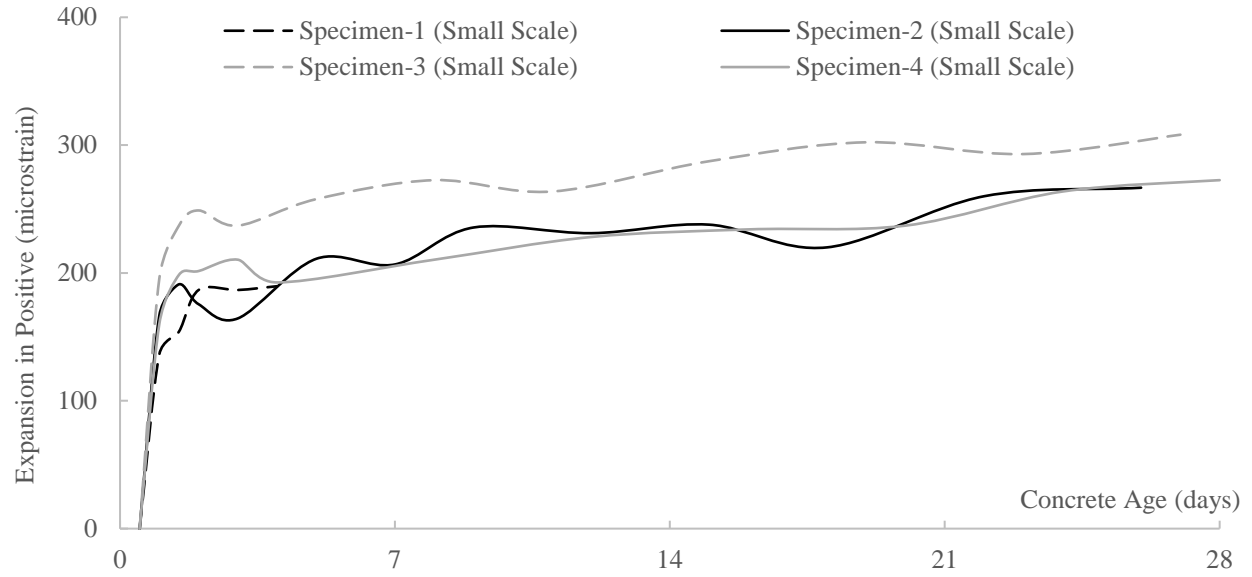
Figure 4-6 Shrinkage Data of Four Joints

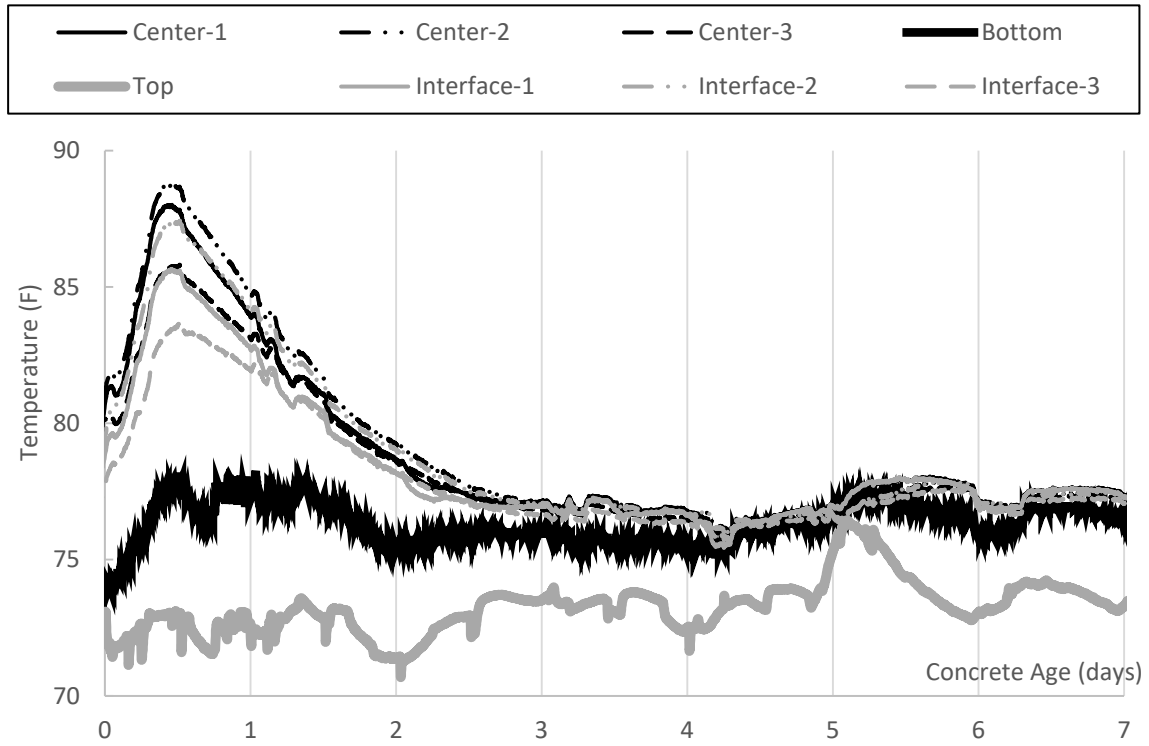
Figure 4-8 Temperature Distribution from Specimen-1

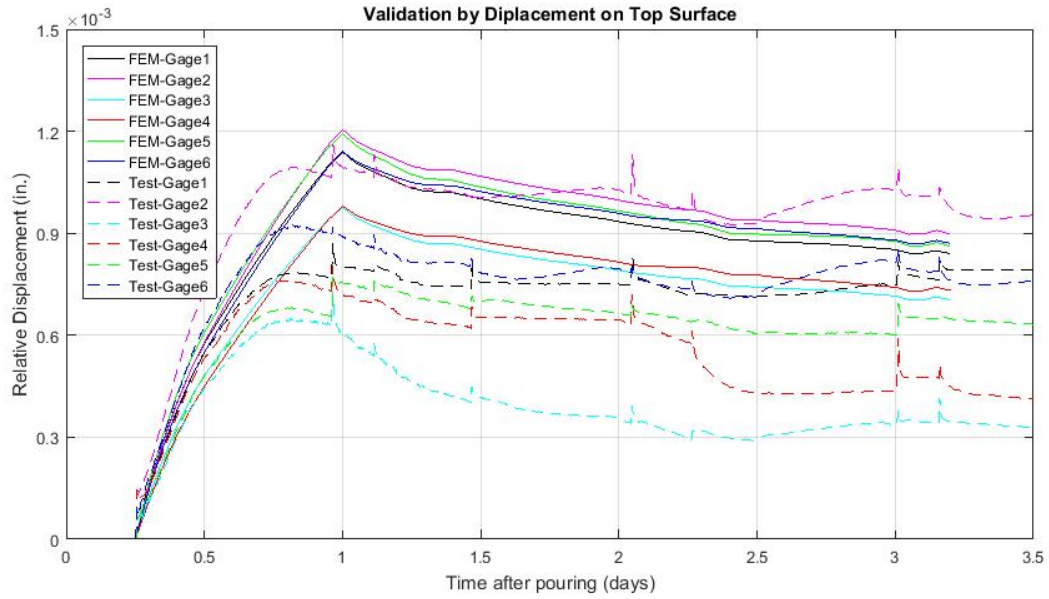
Figure 4-12 Validation by Displacement Data on Top Surface (Joint-2)

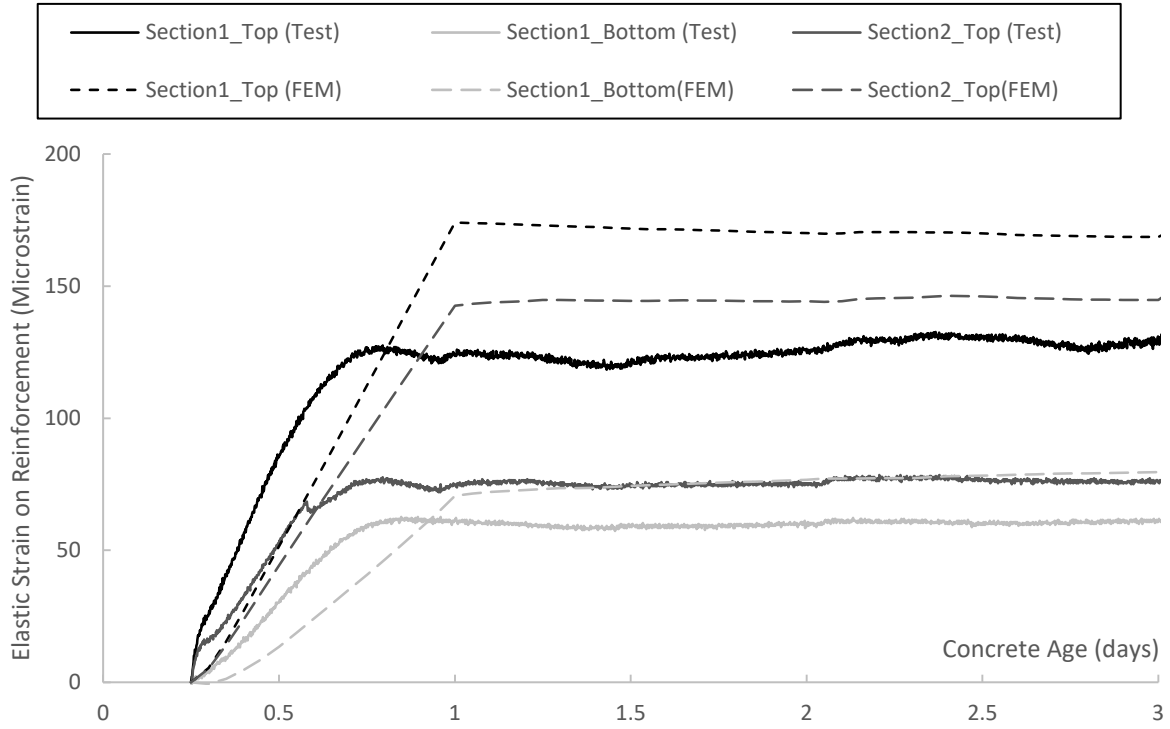
Figure 4-13 Validation by Reinforcement Strain (Joint-2)

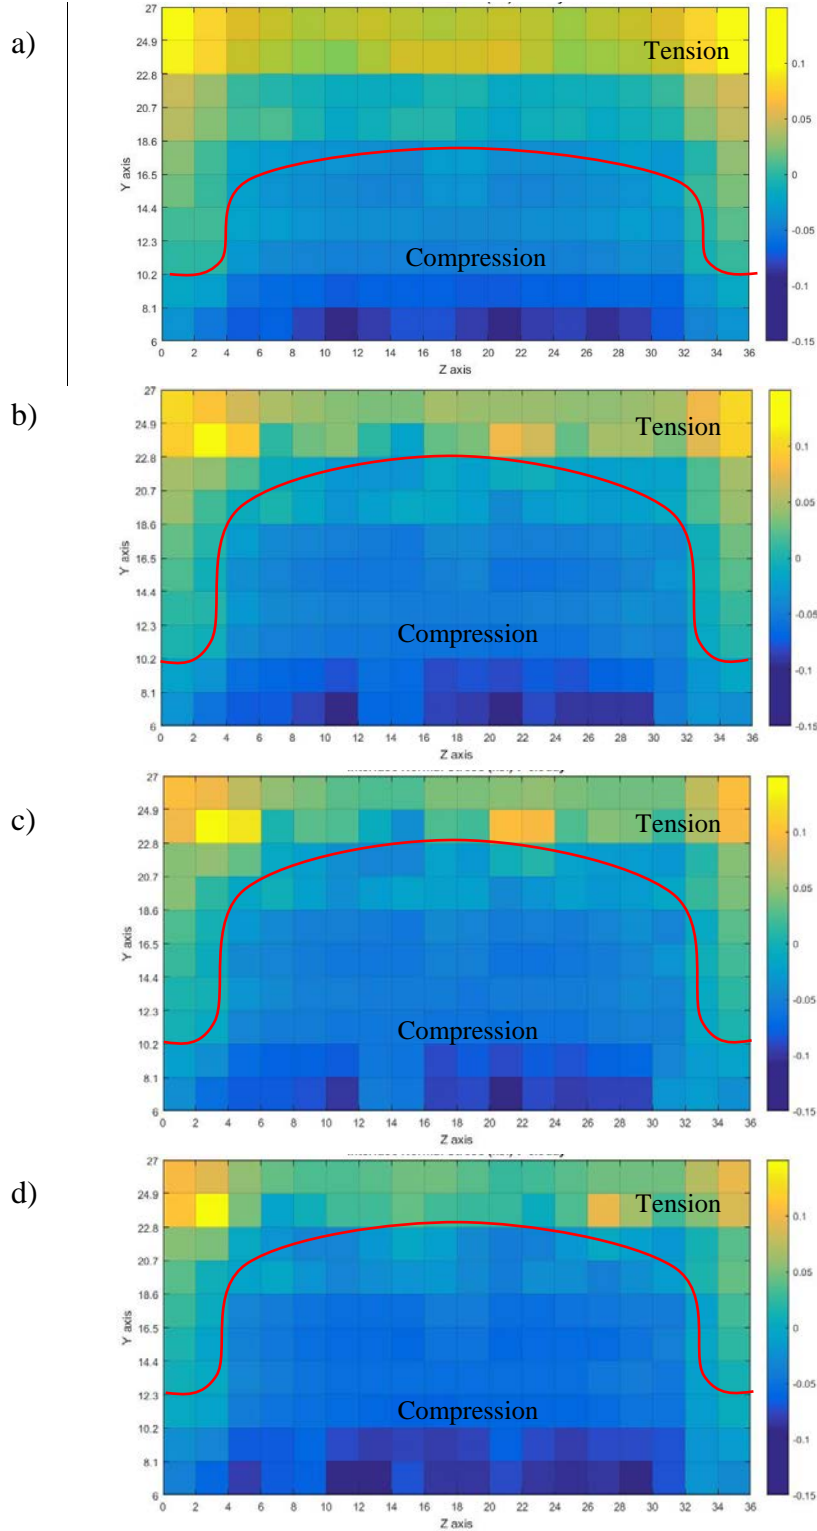
Figure 4-16 Interfacial Normal Stress: a) Specimen 1; b) Specimen 2; c) Specimen 3; d)

Specimen 4

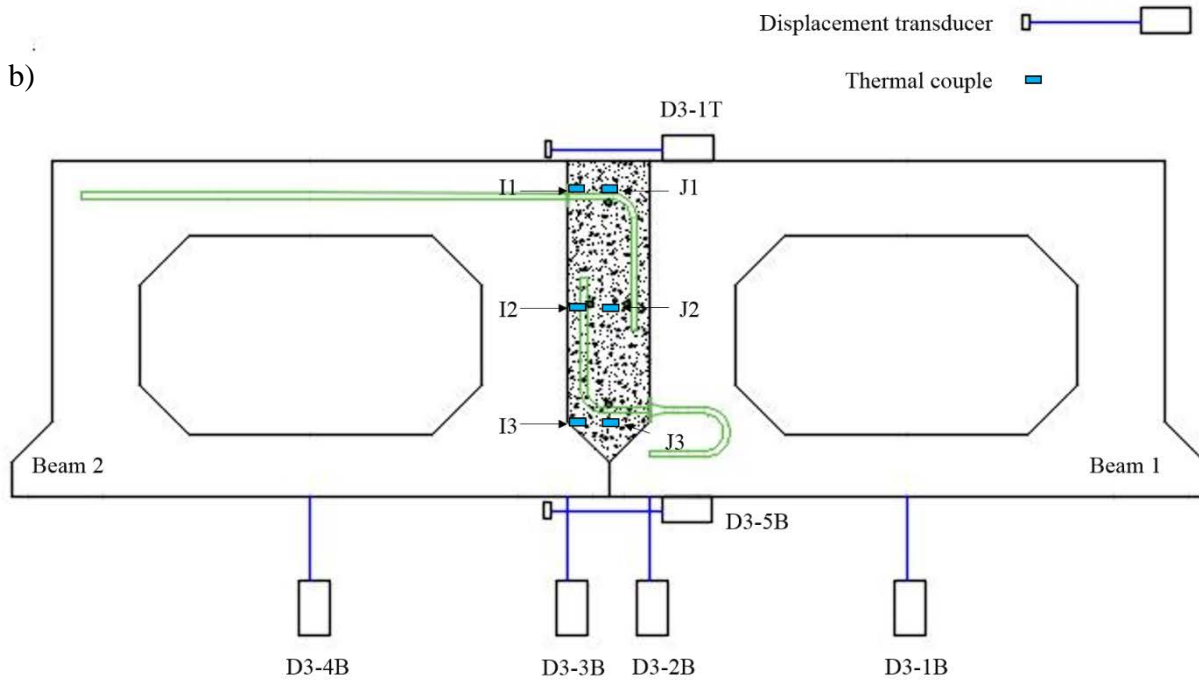
Figure 5-5 Instrumentation: a) Vibrating Wire Strain Gage Map on Top Surface (Similar for bottom surface; b) Instrumentation in Section 3;

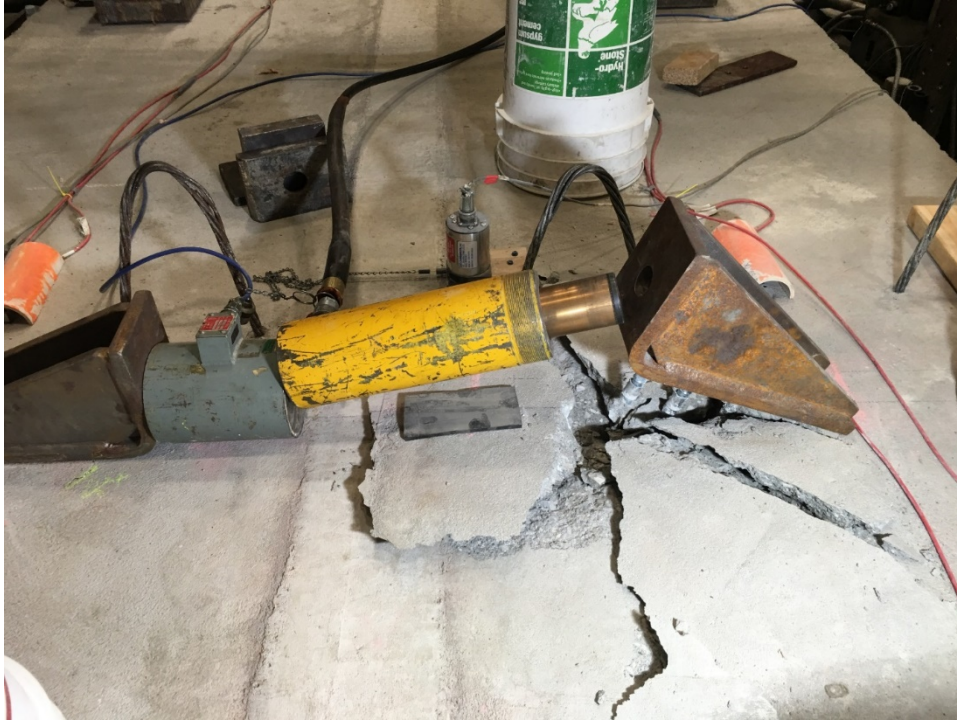
Figure 5-12 Crashed Box Girder due to Horizontal Load
