Evaluation of bridges implementing innovative materials and design

A thesis submitted to the graduate faculty
in partial fulfillment of the requirements for the degree of
MASTER OF SCIENCE

Major: Civil Engineering (Structural Engineering)

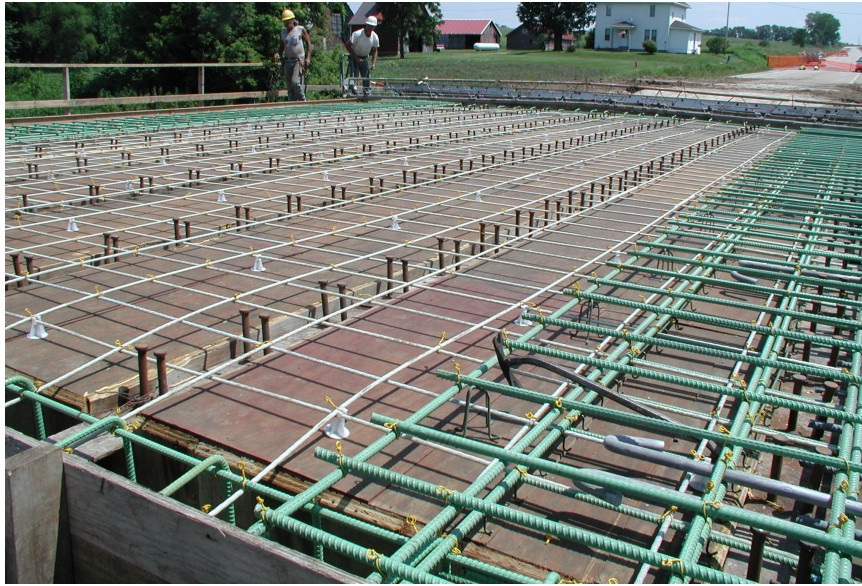
Figure 2.4. Epoxy coated steel and GFRP reinforcement.

The only internal reinforcement between the exterior girders (positive moment region) is a GFRP grid of .375 in. diameter bars in the longitudinal direction spaced at 16 in. on centers and spaced at 10 in. on centers in the transverse direction. The GFRP grid was used to prevent unsightly longitudinal flexural cracks on the underside of the FRC deck and to control temperature and shrinkage effects. Details of the bridge are shown in Figures 2.2 and 2.3, and the GRFP grid and overhang reinforcement during construction is shown in Figure 2.4.

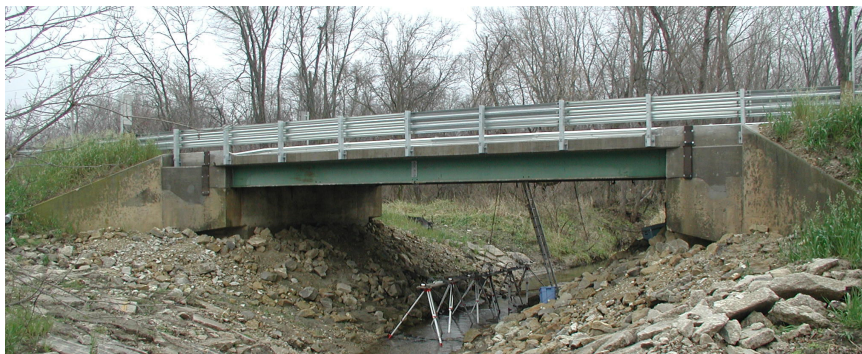
Figure 2.5. Elevation of Tama County SFD bridge.

The deck overhang was designed using conventional reinforced concrete and epoxy coated steel reinforcement bars using the AASHTO code. Table 2.1 summarizes the reinforcement provided in the overhang region and can also be seen in Figure 2.3. An elevation view of the completed Tama County SFD bridge is shown in Figure 2.5.

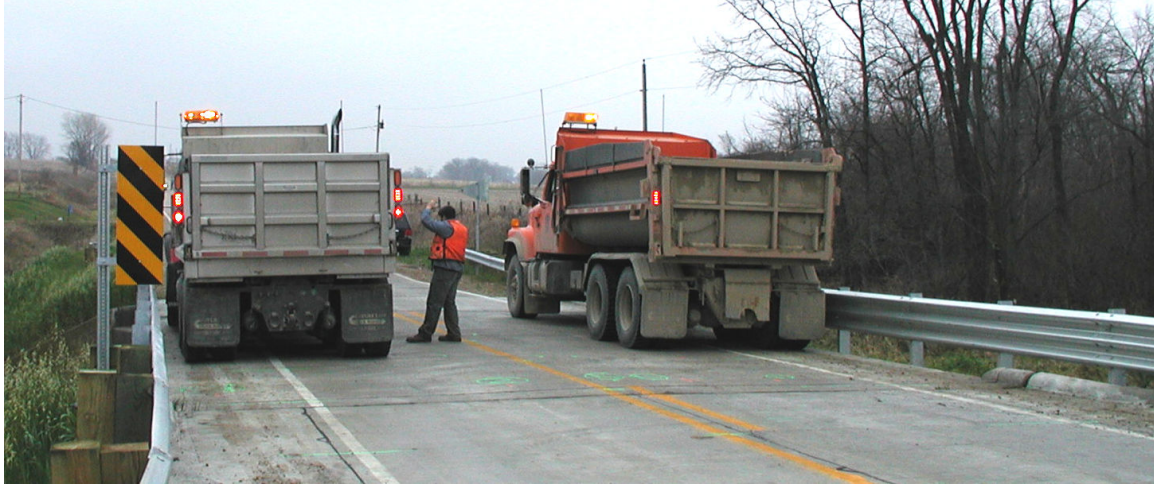
Figure 2.10. Load Case 1 (stationary) during Test 1.

Each load test consisted of seven different load cases. Two stationary load tests (Load Cases 1 and 2) were conducted each once with both trucks on the bridge with the tandem axles at midspan as shown in Figure 2.10. Five load tests (Load Cases 3 through 7) were performed twice with Test Vehicle 2, crossing the bridge at a crawl speed. Data were

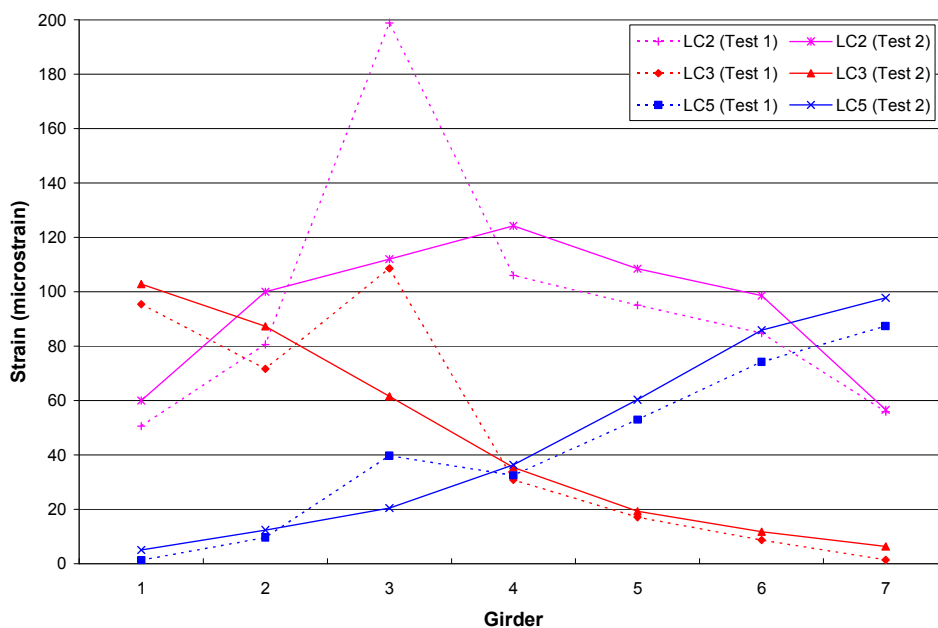
Figure 2.13. Maximum girder strains at midspan from Test 1 and Test 2.

Figure 2.13 displays the maximum bottom flange girder strains at midspan for both Test 1 and Test 2 for various load cases. As was the case for displacements, the strain values for Test 2 are greater than Test 1 with the exception of Girder 3. Also, the shape of the curves for Test 1 and Test 2 are similar to one another. It was assumed that the strain transducer for Girder 3 showed a malfunction in Test 1. The following graph illustrates that the assumption was most likely correct. It is also noted in Figure 2.13, Load Cases 3 and 5 have almost the same value for the center girder because of the symmetry in both the loading and the bridge. Also, the strain plots are very similar to the displacement curves (Figure 2.12) except mirrored about the x-axis.

The maximum midspan flexural strain (107 microstrain) during Test 1 (disregarding Girder 3 due to the malfunction) occurred in the bottom flange of Girder 1 under Load Case

1. The correlating maximum tensile stress in the girder bottom flange (assuming $E_s=29,000$ ksi) was 3.1 ksi, which is approximately 10 percent of the yield stress of the girders (30 ksi). After applying the magnification factor of 1.3, the maximum two lanes loaded stress is 4.03 ksi. The maximum strain of 95 microstrain for Test 1 under a single lane loaded occurred during Load Case 3 at Girder 1. Applying the single lane loaded magnification factor of 1.267, the maximum strain is 121 microstrain and a correlating tensile stress of 3.5 ksi.

The maximum strain values in Test 2 for the bottom flange girders at midspan ranged from just under 100 microstrain in Girder 6 to the highest strain of 124 microstrain in the center girder (Girder 4) in Load Case 2. The maximum tensile stress associated with the maximum strain in Girder 4 (assuming $E_s=29,000$ ksi) was 3.6 ksi, which is 12% of the yield stress of 30 ksi. After applying the magnification factor, the maximum strain is 158 microstrain (maximum stress of 4.6 ksi) in Girder 4.

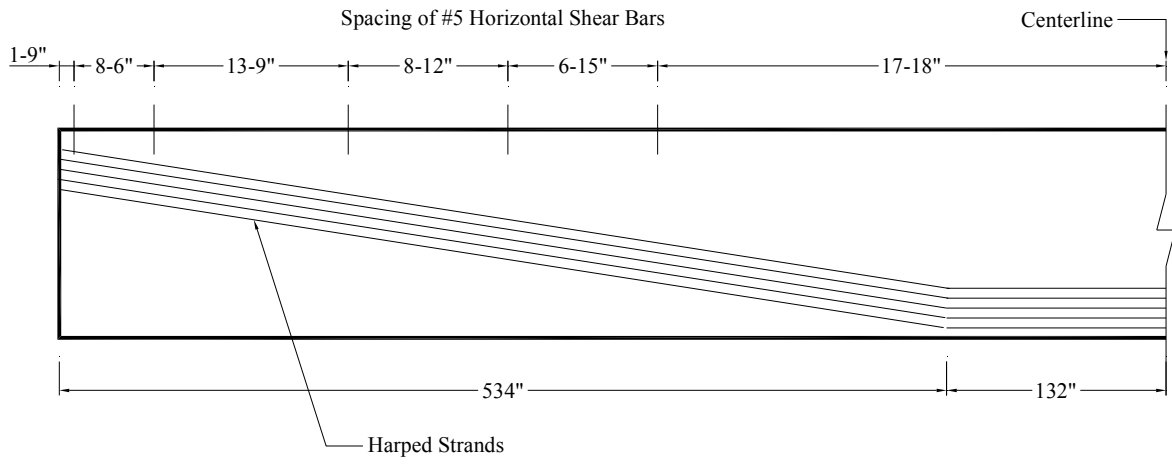
Figure 3.3. Elevation of Wapello County UHPC bridge beams.

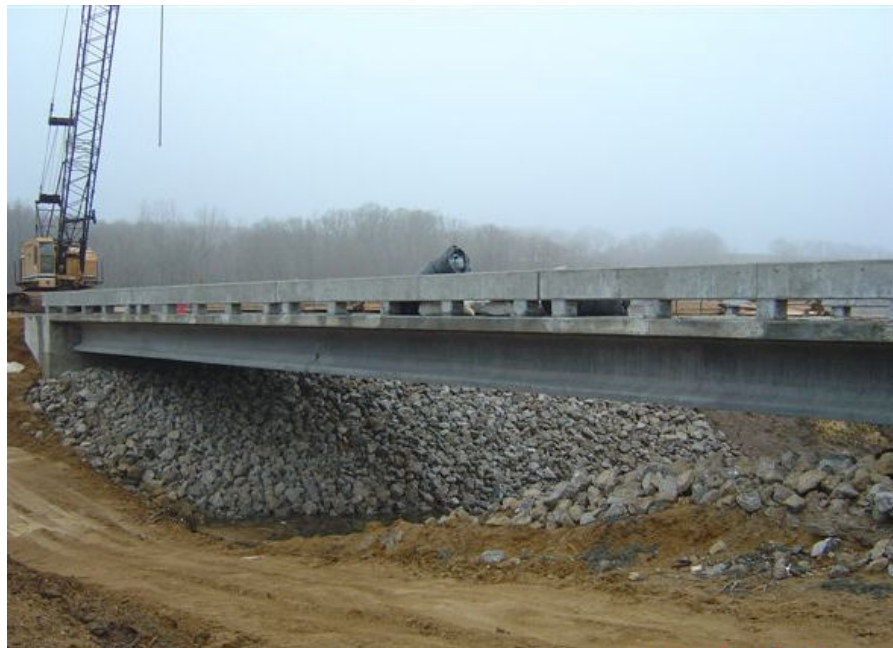
Figure 3.4. Elevation of Wapello County UHPC bridge.

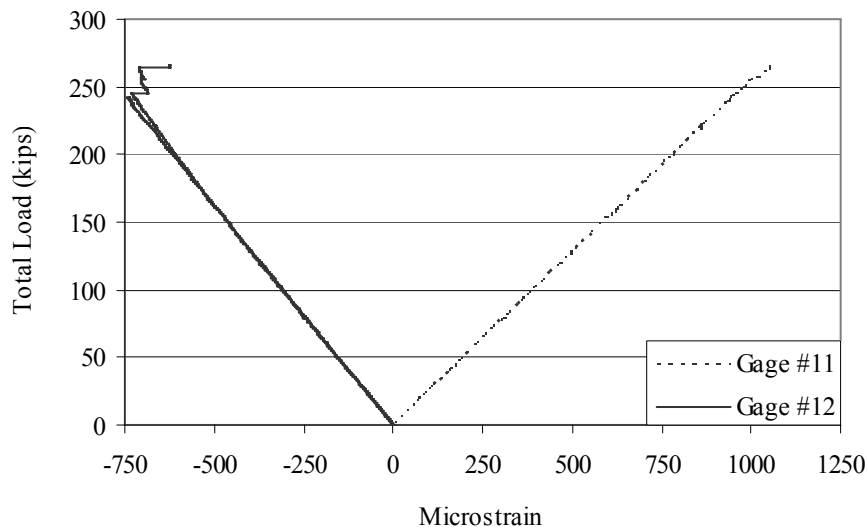
Figure 3.7. Strain at midspan during large-scale flexure test.

The primary purpose of the flexure test was to provide reassurance to the design engineer that the beam had sufficient capacity for implementation in the first United States UHPC bridge in Wapello County, Iowa. This was achieved by reaching a load level above the expected service loads before cracking occurred. The service level is determined by a simple summation of external moments required to be resisted by the bridge beam which included moment from the bridge deck, future overlay, barriers, and the live load as required by code. Using the effective width of the bridge deck according to AASHTO [4], the bridge beams have a larger section than the test beam and therefore can resist even more moment. As can be seen in Figure 3.7, where Gage #11 and Gage #12 are top flange and bottom flange

strains respectively, the total load when non-linearity occurs at cracking was 237.4 kips which corresponds to a moment of 3,730 ft-k, not including the beam self-weight. Using this information and the additional effective width of the slab, a service moment capacity of the bridge beam can be determined which should be larger than the applied service moment as shown in Table 3.2. The same type of process was carried out for the ultimate limit state. However, test data for this beam did not reach this level, and therefore, the quantities shown in Table 3.2 are based off of analysis rather than testing.

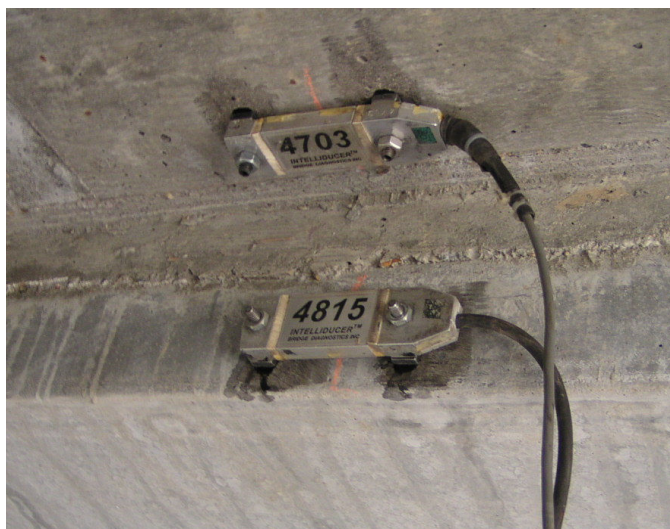
Figure 3.11. BDI strain transducers attached to concrete.

In order to get an overall structural performance profile, Bridge Diagnostics, Inc. (BDI) Intelliducers and Structural Testing System (STS) were used to measure longitudinal live load strains. Figure 3.11 shows two typical BDI strain transducers attached to the top flange and concrete deck of the structure at one particular location.

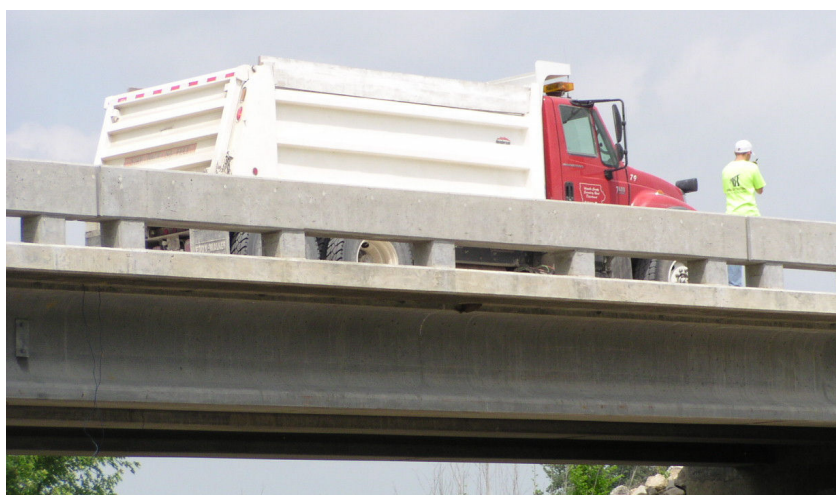
c) Tandem truck used during Test 2

Figure 3.13. Test vehicle configuration.

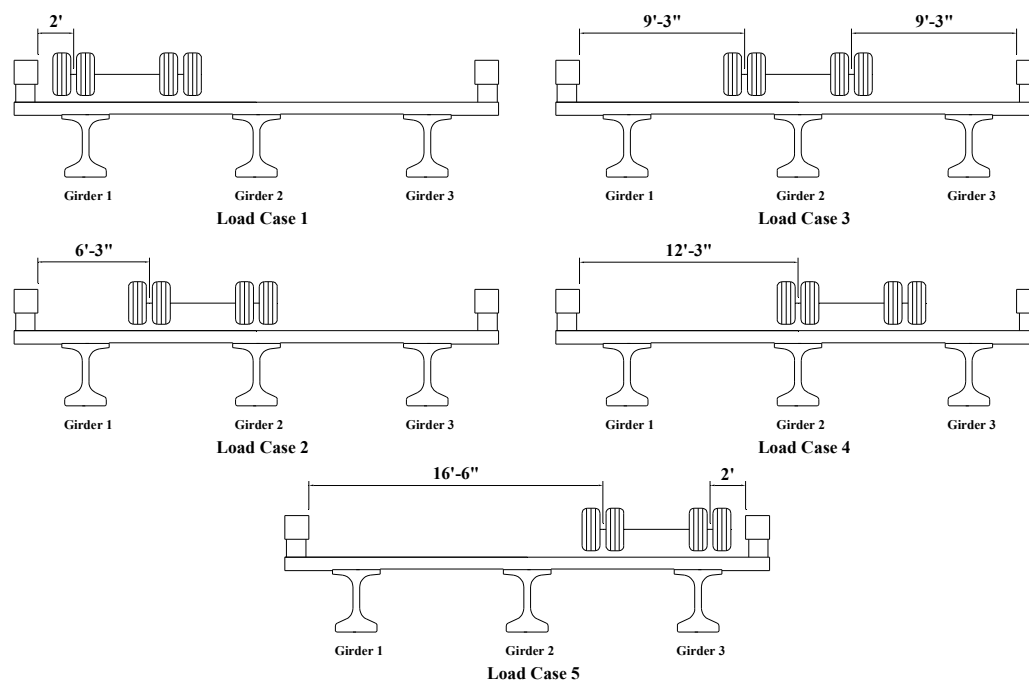
Figure 3.14. Truck positions used in the live load tests.

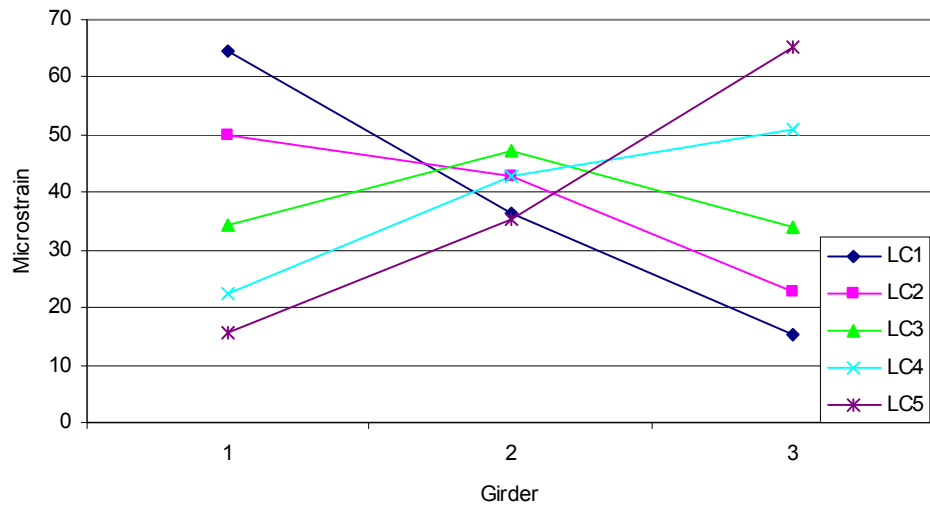
Figure 3.16. Maximum bottom flange girder strains at midspan for Test 2.

Figure 3.16 shows the maximum tensile strain in the girder bottom flange at midspan for the static Load Cases 1 through 5 during Test 2. The maximum midspan flexural strain measured during Test 2 (65.2 microstrain tension) occurred in the bottom flange of girder 3 for Load Case 5. The corresponding maximum tensile stress in the girder bottom flange (assuming $E_c=7820$ ksi) was 510 psi, which is less than 50% percent of the cracking stress of the girders (1.1 ksi). After applying the magnification factor of 1.39, the maximum single lane loaded stress at midspan is 709 psi tension.

By comparing Load Case 1 with Load Case 5 and Load Case 2 with Load Case 3, the transverse symmetry of the bridge and loading can be seen. Also, note that the computed design live load stress from an HS20-44 truck was calculated to be 2.04 ksi and 2.41 ksi tension for the interior and exterior beams, respectively. The above results demonstrate a fairly conservative design for the UHPC bridge.

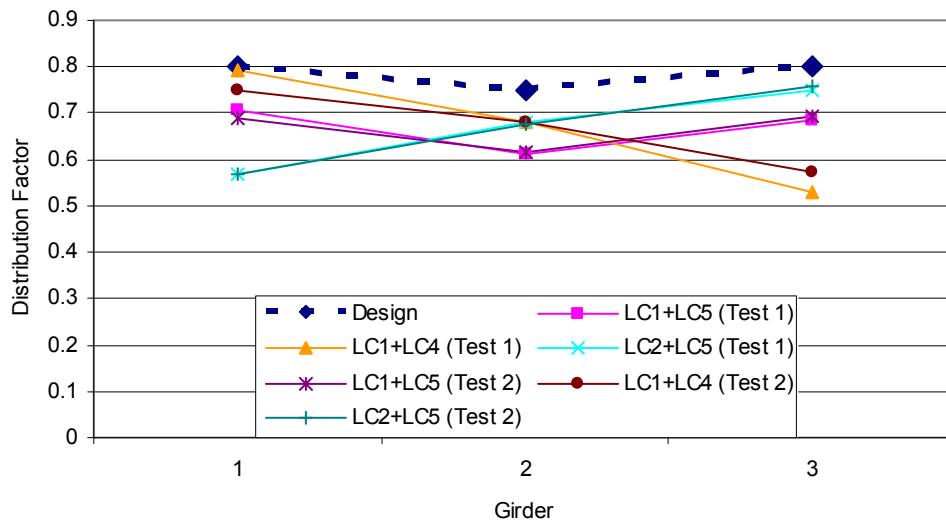
Figure 3.19. Experimental and AASHTO distribution factors from Test 1 and Test 2.

In general, there is a good correlation between Test 1 and Test 2. However, there is a slight variation in the exterior girders which could be attributed to a difference in the transverse location of the truck for each test. In addition, the gravel may not have been evenly distributed in the dump truck which could cause an uneven wheel line load. The higher values for girder 1 and lower values for girder 3 in Test 1 could be a result of the load distributed slightly heavier towards the girder 1 side of the truck.

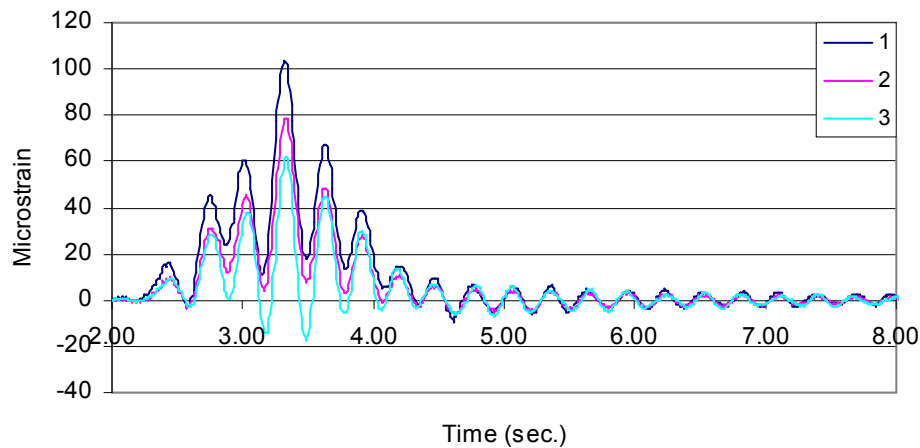
Figure 3.20. Bottom flange midspan girder strain versus time, Load Case 7, Test 1.

Figure 3.20 shows the time history plot for strain of the three girders (labeled 1, 2, 3) at midspan during Load Case 7 in Test 1 which induced the largest strain in a single girder. The maximum strain occurred in girder 1 with a value of 103.5 microstrain tension. After applying the magnification factor, the associated stress is 1076 psi tension, slightly less than the cracking stress of 1.1 ksi but still well below the design stress of 2.41 ksi.

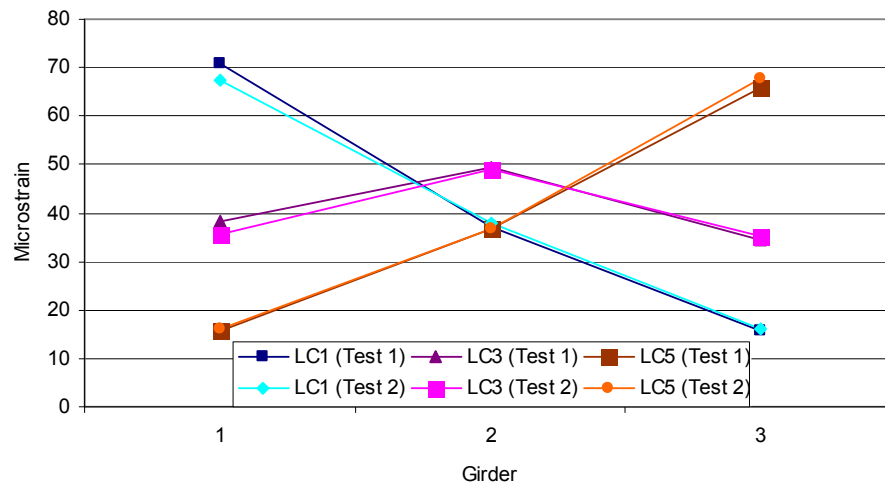
Figure 3.21. Bottom flange girder strains at midspan from Test 1 and Test 2.

The strain values for Test 1 are slightly greater than Test 2 in all cases; however, the shape of the curves for Test 1 and Test 2 are similar to one another. These results were expected since the weight of the truck for Test 1 was 4.1% greater than the weight of the truck for Test 2. Figure 3.21 presents a graph of the maximum bottom flange girder strain at midspan for both Test 1 and Test 2 for the load cases and the values for Test 2 are increased by 4.1%. As can be seen in Figure 3.21, the maximum girder strains from Test 1 are nearly identical to the strains from Test 2 after being adjusted.
