Evaluation of bridges strengthened or newly constructed with innovative materials

A thesis submitted to the graduate faculty
in partial fulfillment of the requirements for the degree of
MASTER OF SCIENCE

Major: Civil Engineering (Structural Engineering)

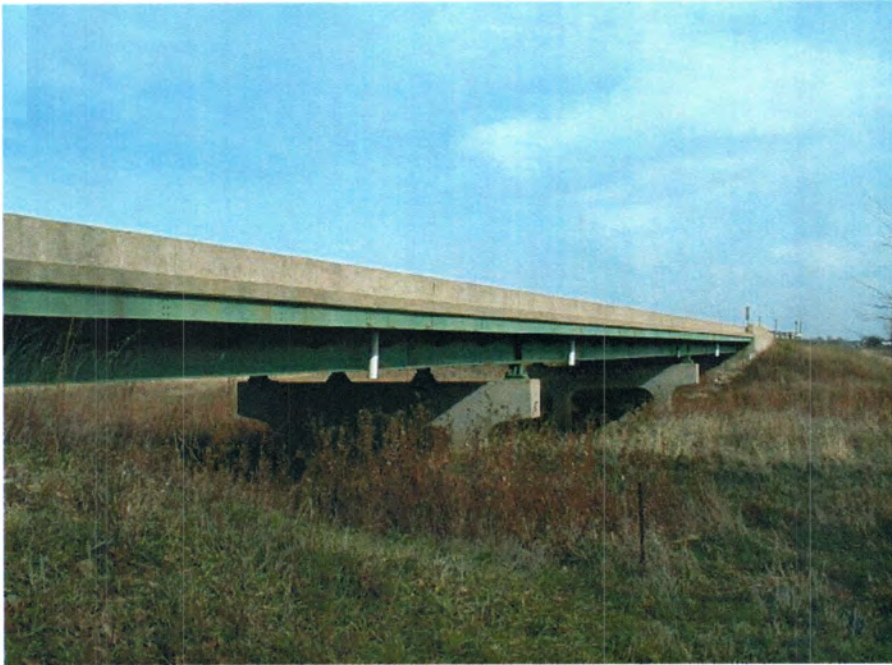
Both abutments show a few hairline cracks. Severe corrosion was found at the abutment bearings and moderate to severe spalls were found near the back wall and the bottom of the concrete deck (see Fig. I-1d). There are signs of moderate to severe corrosion on the exterior beams, and areas with moderate to severe corrosion on the bottom flanges of the abutment diaphragms. Also, a considerable amount of corrosion is present on the deck channels and the top of the web of the curb channels (see Fig. I-1e). The bridge deck has several hairlines and narrow transverse cracks. Both curbs show moderate hairline cracks and small spalls at several locations.

(a) Side view

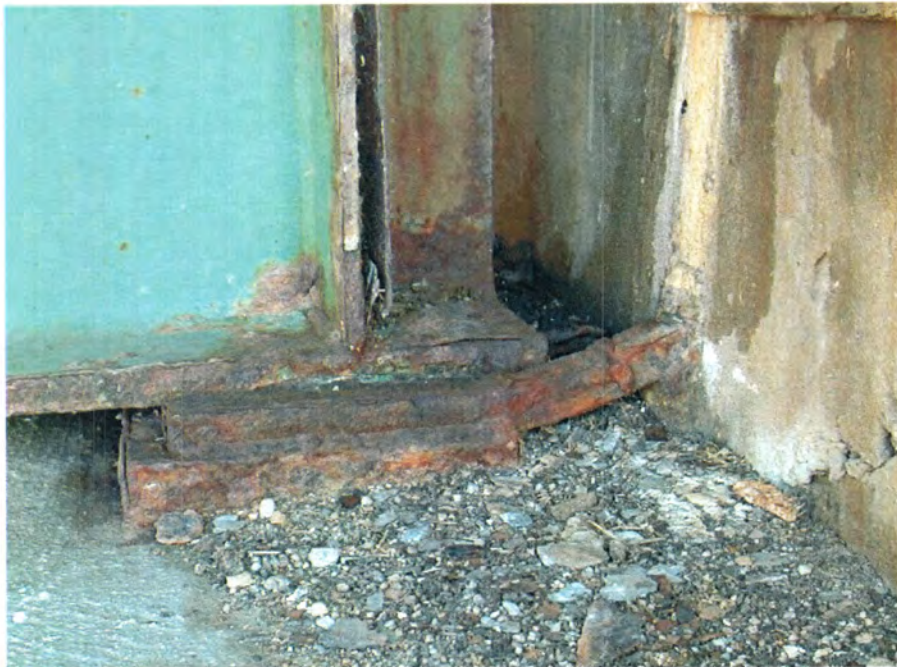
(d) Typical east abutment condition

Figure I-1. Overall bridge photographs - continued.

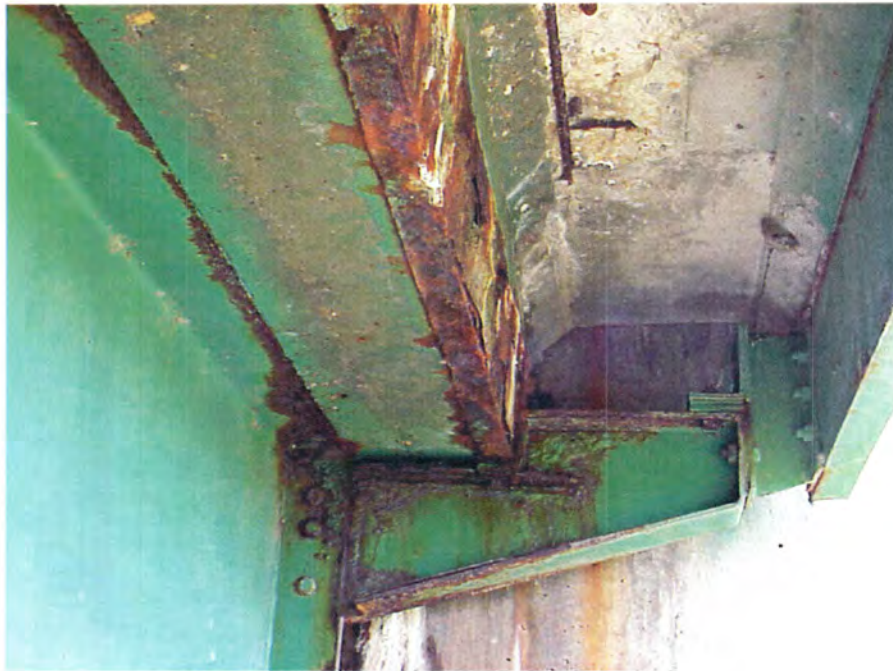
(e) Typical condition of deck soffit and deck channel
 Figure I-1. Overall bridge photographs - continued.

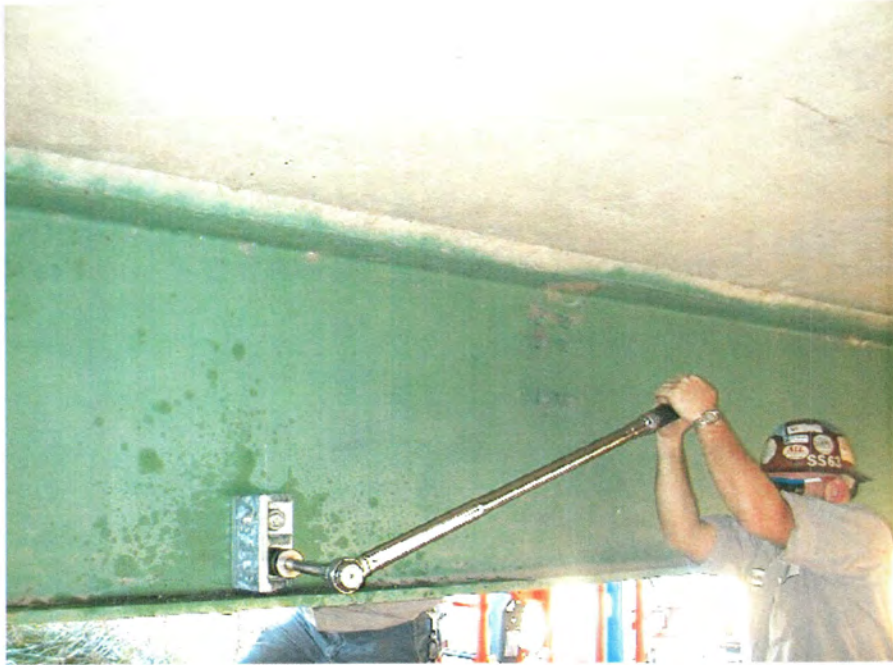
Figure I-5. Installing anchorage assembly.

4. The anchorage assemblies were then bolted to the webs of the beams with 1 in. diameter A325 high-strength bolts torqued in accordance with the manufacturer's recommendation (Fig. I-5).

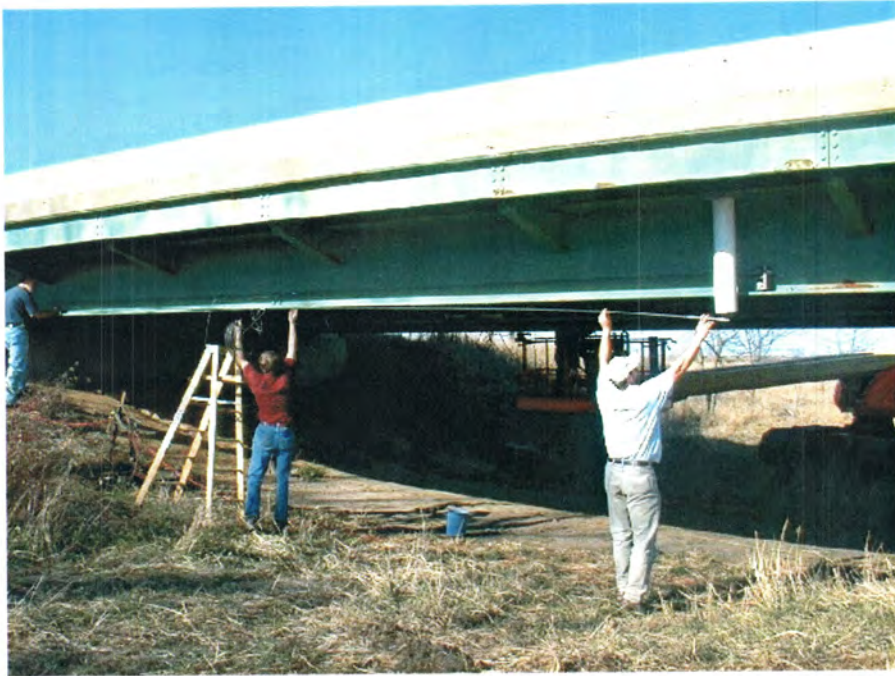
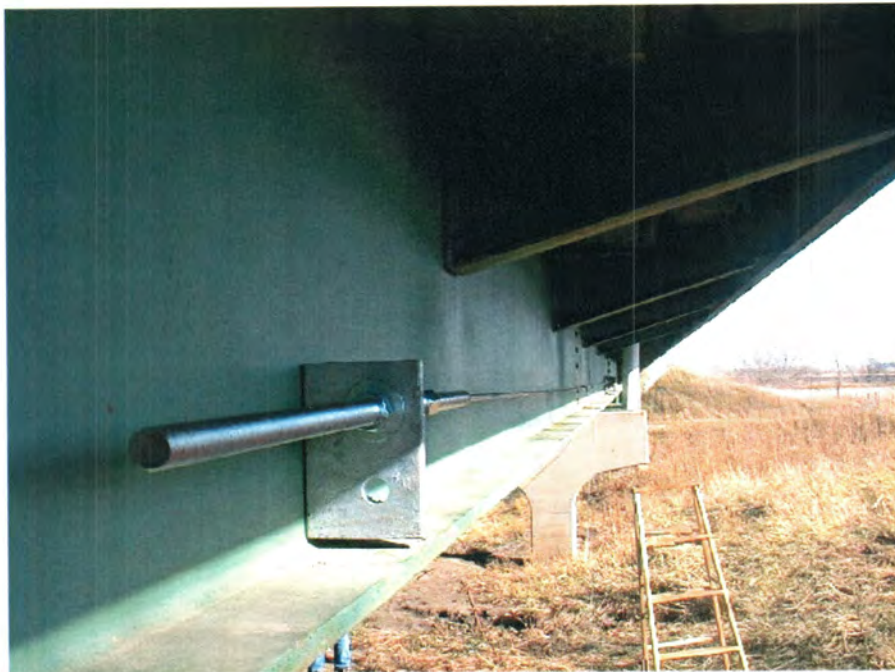
(a) Placement of a CFRP bar

(b) Top CFRP bar in place

Figure I-7. Installation of CFRP bars.

6. The CFRP P-T bars were placed in position between anchorage assemblies on both sides of the web (Fig. I-7). Extra caution was taken during the erection not to damage any of the bars by scratching or excessive sagging.

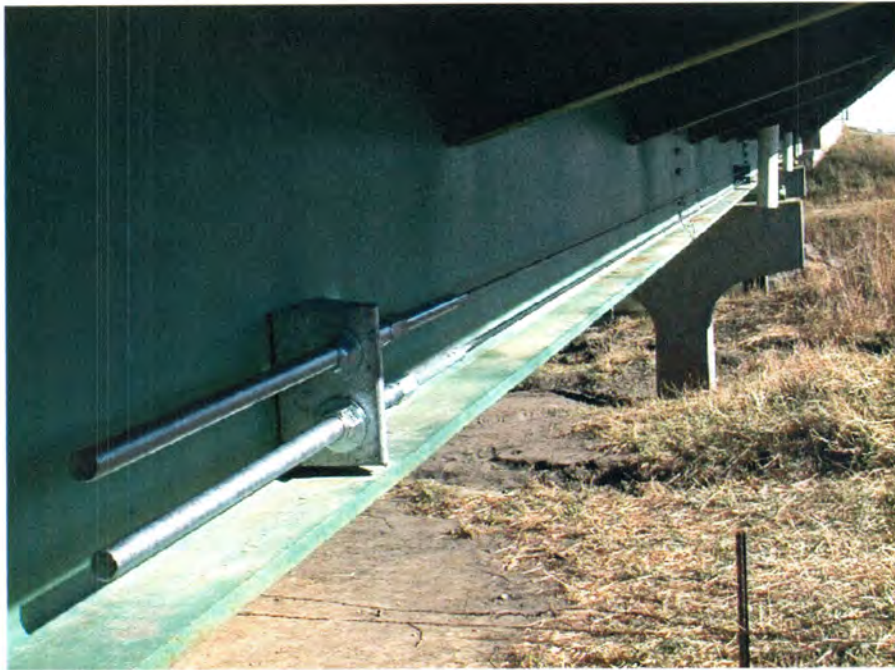
(a) Exterior CFRP bars in west end span

Figure I-11. Photographs of the completed installation.

(b) Interior CFRP bars in west end span

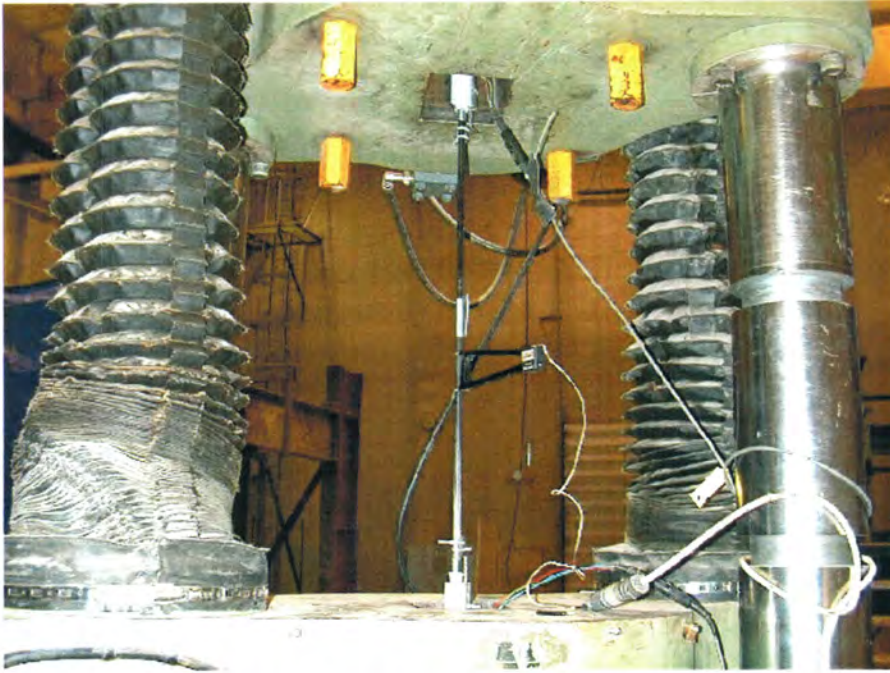
Figure I-15. Test setup for laboratory testing.

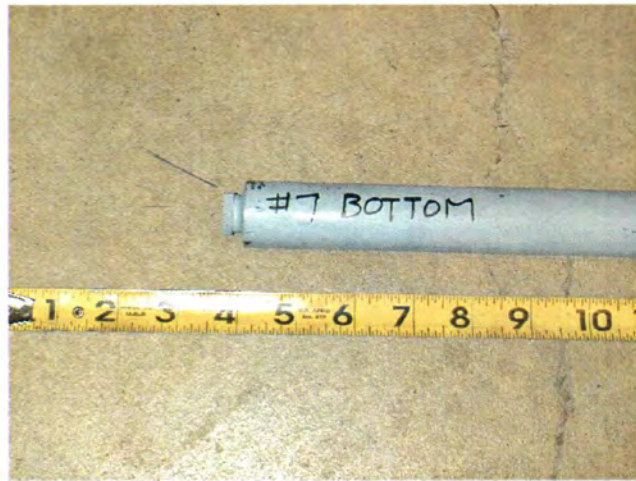
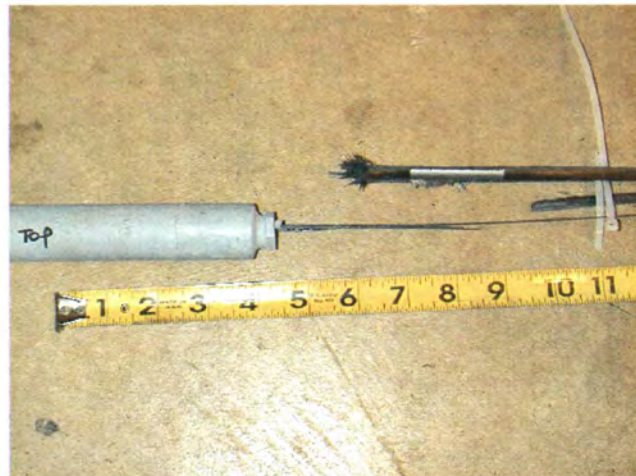
(a) Failure mode 1 (Tensile-rupture)

(b) Failure mode 2 (Pull-out)

(c) Failure mode 3 (Combination)

Figure I-24. Laboratory specimen failure modes.

Although only a very small statistical sample was used in this test, the experimental data shows minimal impact from the different loading rates used in the testing as described in section 3.1. The type of failure mode was also found to be unrelated to the ultimate strength of the CFRP bars. However, the specimens used in the 24-hour, constant load test seemed to exhibit higher stress levels at the first peak than the other specimens.

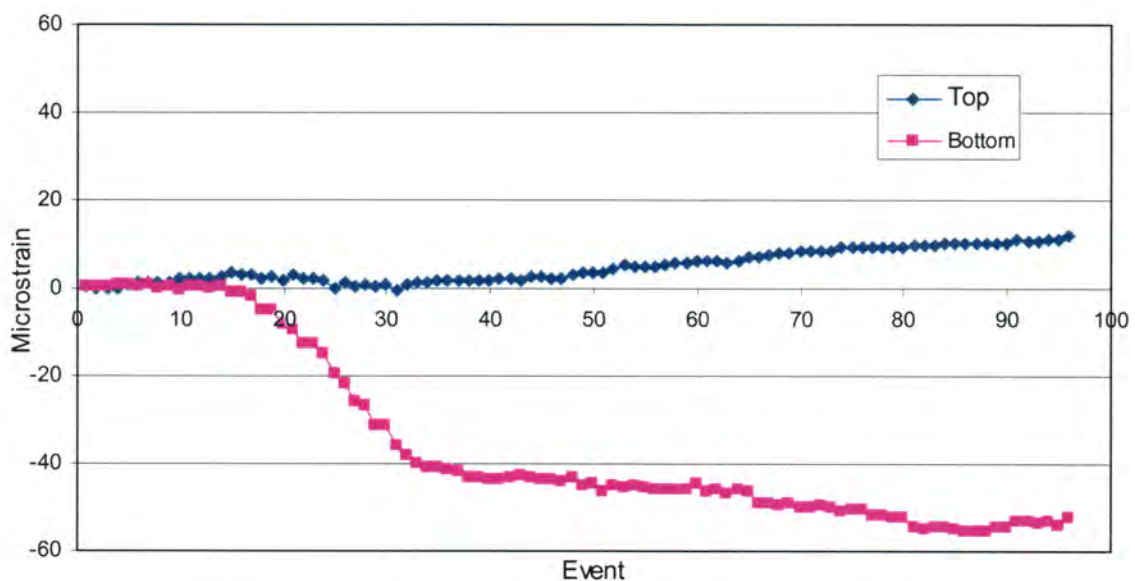
Figure I-31. Strains measured in west end span, Beam 1 during P-T.

Proper P-T in the positive moment region generates strain opposite in sign to those produced by dead and live loads. During the application of the P-T strengthening system, strain was measured to investigate the response of the bridge due to the applied P-T force. As expected, when the force was applied to a specific location, that specific beam would experience the greatest change in strain. For example, when the north exterior beam (Beam 1) in the west end span was post-tensioned (Events 17 through 32 in Fig. I-31), the strain due to the P-T force increased significantly compared to other locations where increases in strain were minimal. Likewise, significant increase in strain can be observed during P-T on Beam 1 in the center span (Events 49 through 64 in Fig. I-32). However, it should be noted that a non-trivial level of strain was measured at other locations as well.

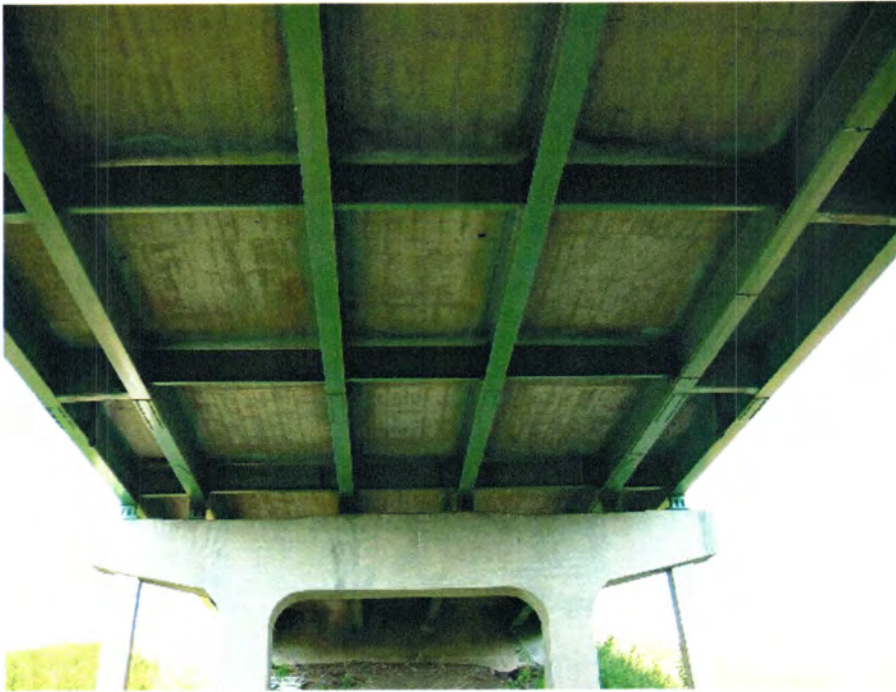
(c) Bottom view

Figure II-1. Overall bridge photographs - continued.

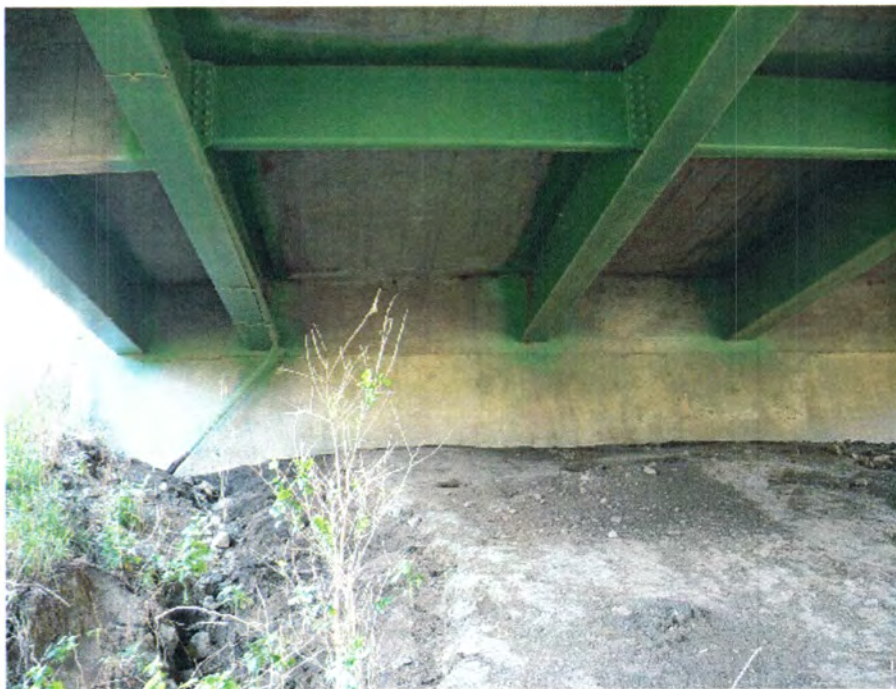
Both abutments have a few random vertical and horizontal hairline cracks and the far abutment footing has a delaminated area at the top of a construction joint. The top and bottom of the deck exhibit several hairline and narrow transverse cracks, and a few small delaminated areas. Both curbs show moderate hairline cracks. The top of the deck has Portland Cement (PC) patches at several locations, and a few small spalls and delaminated areas along the construction joints.

(d) Typical abutment

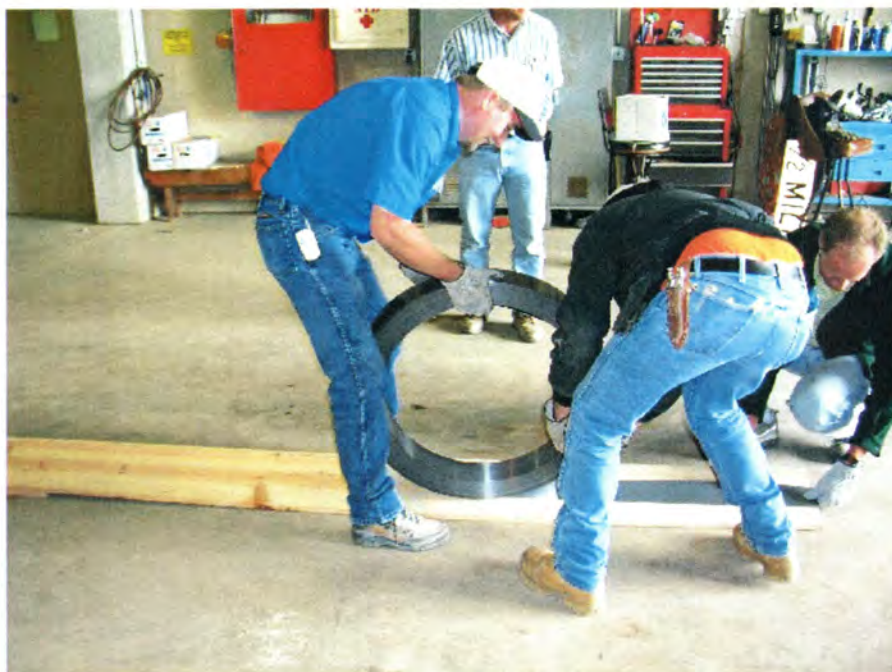
Figure II-3. CFRP plates being unrolled.

The specific CFRP material selected for this application is a pultruded carbon fiber reinforced polymer consisting of continuous unidirectional carbon fiber in an epoxy matrix. The anisotropic CFRP plates were fabricated utilizing a proprietary pultruding process in which the carbon fibers are pretensioned and aligned during impregnation and curing. The plates have a tensile strength of 300 ksi (ASTM D3039) and modulus of elasticity of 20,000 ksi (ASTM D3039). All plate bonding surfaces were supplied in a "sanded" condition to promote adhesion between the bonding surface of the steel beams and plates. Each plate is 4 in. wide and 0.04 in. thick (see Fig. II-3). The CFRP plates have a tensile linear elastic behavior up to failure; their mechanical properties are summarized in Table II-1.

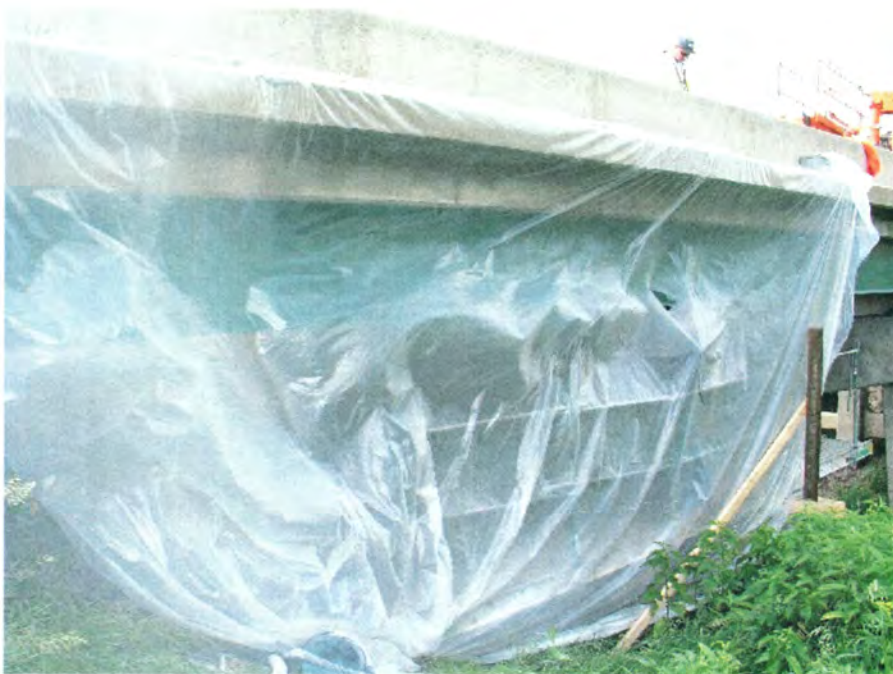
Figure II-10. Work area covered with a layer of vinyl during sandblasting.

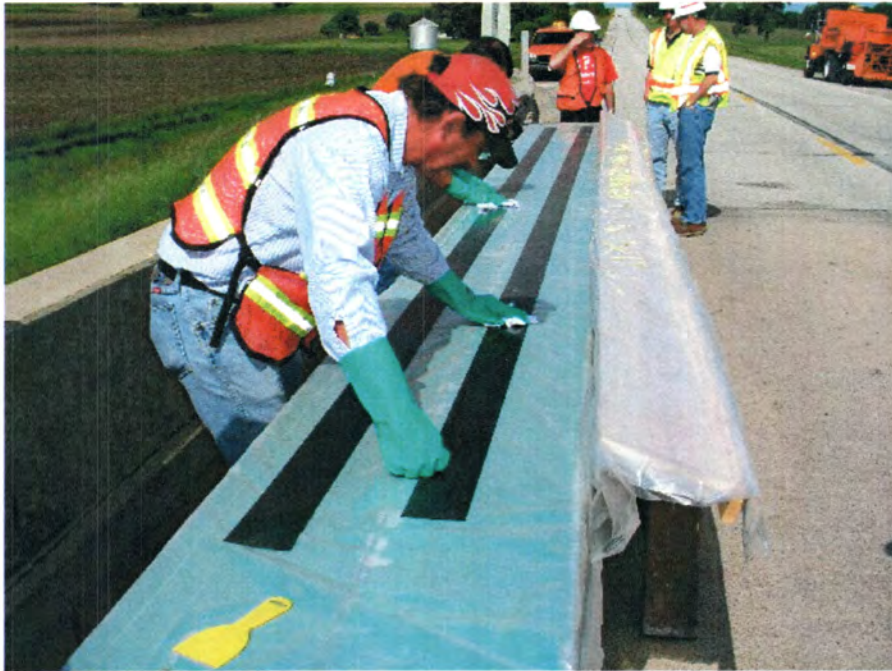
Figure II-13. Cleaning the CFRP plate bonding surface.

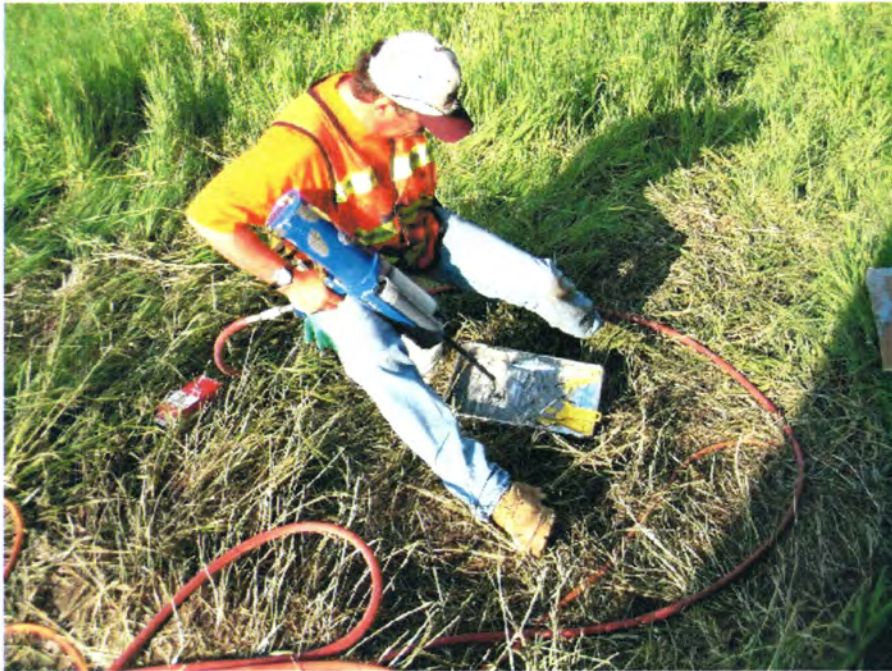
Figure II-15. Preparation of ECS 104 structural epoxy (mixing with a compressed air gun).

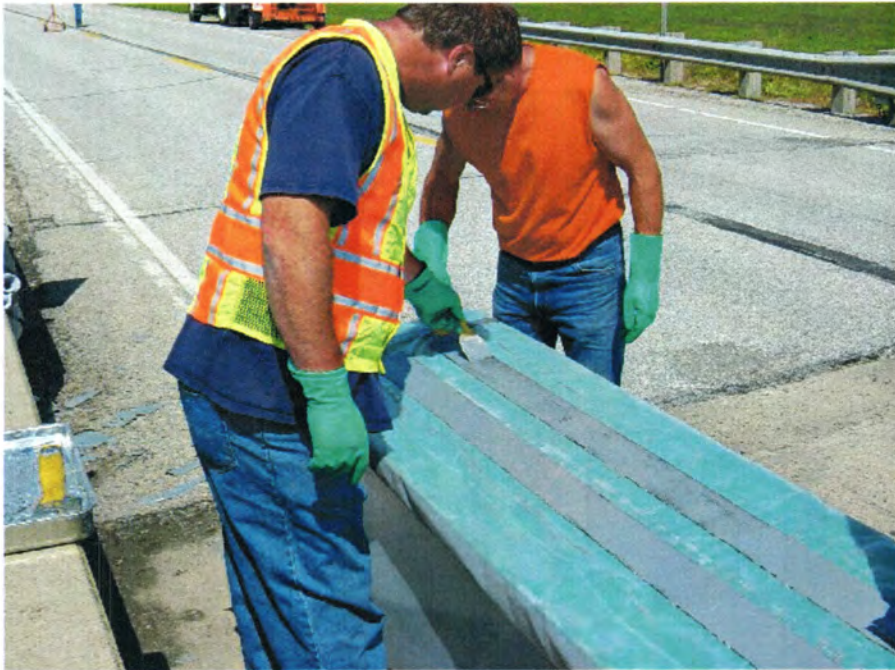
(a) Application of structural epoxy to CFRP plate.

Figure II-17. Epoxy application.

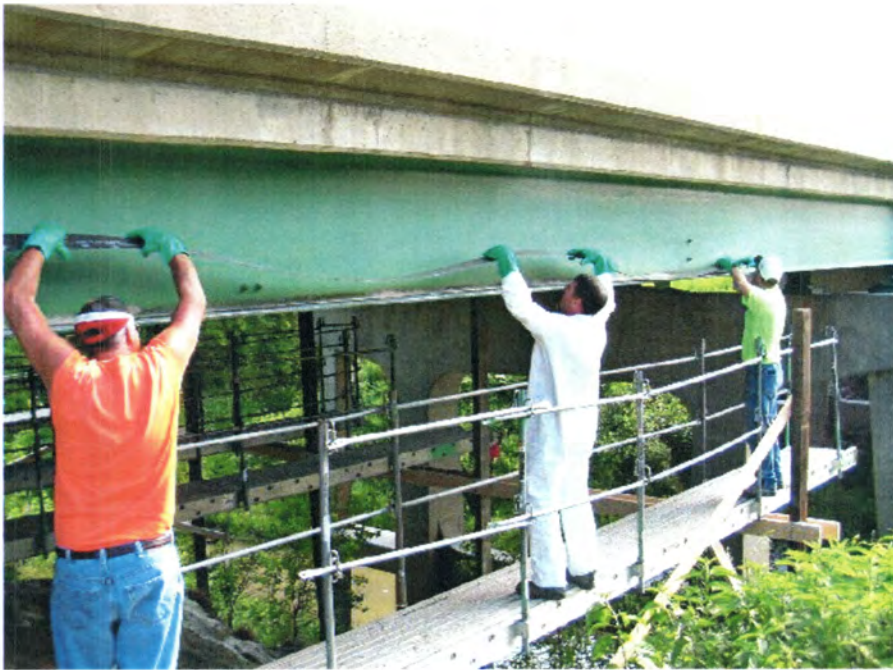
Figure II-18. Placement of CFRP plate on top of Beam 6 bottom flange.

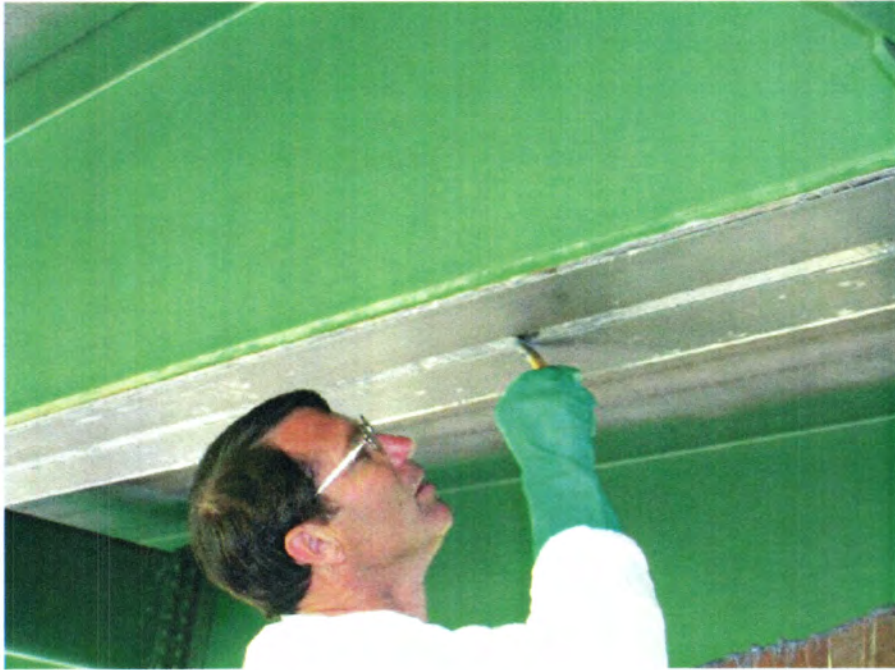
Figure II-20. Removal of excess epoxy.

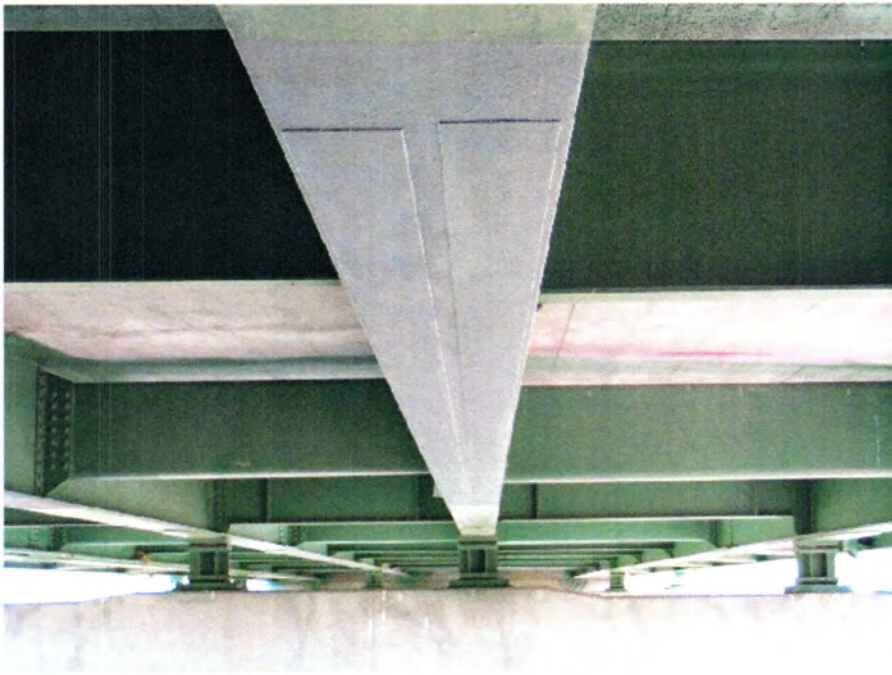
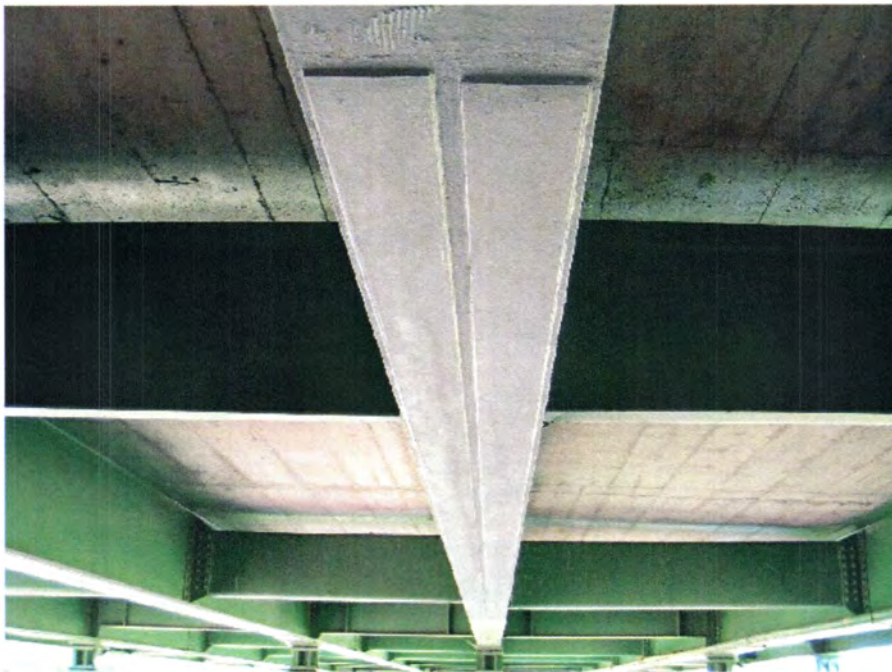
(b) Beam 3 in the west end span

(c) Beam 4 in the east end span

Figure II-21. Photographs of the completed installation - continued.

(d) Top of bottom flange of Beam 6 in the west end span

(e) Bottom of bottom flange of Beam 6 in the east end span

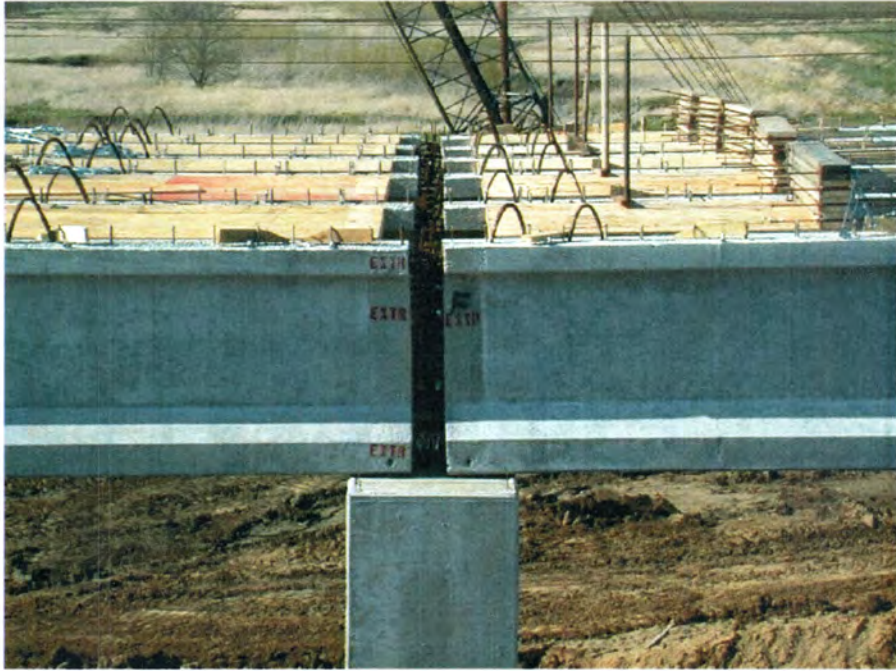
(c) Typical beam connection at pier

Figure III-3. Photographs of typical prestressed I-beams - continued.

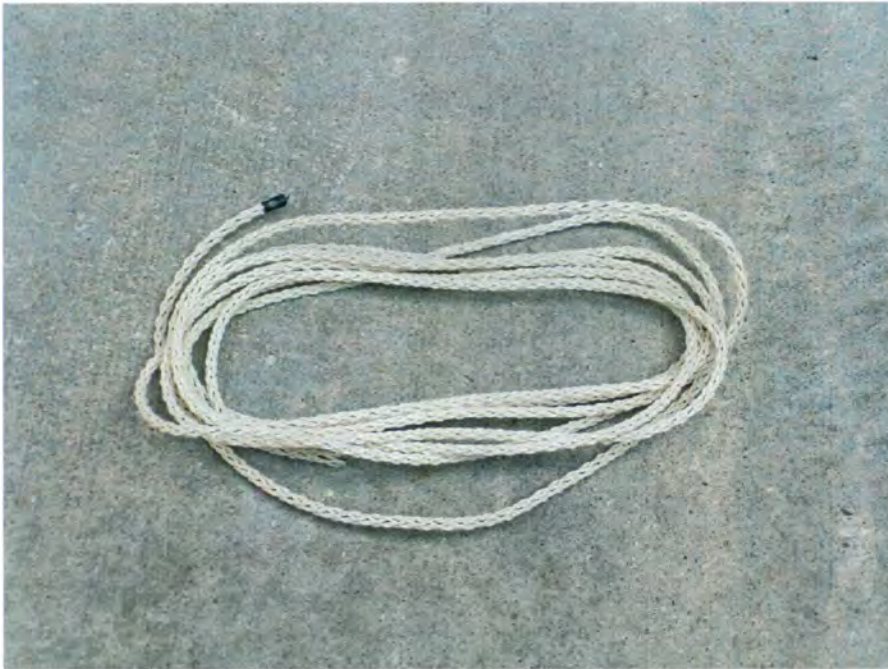
Figure III-8. CMS V2000 silver/silver electrode.

The use of this embeddable sensor offers an ability to monitor an interior state of a structure by measuring parameters that can be used as reliable indicators of the likelihood of corrosion in the surrounding area. Although the sensor does not address the specific electrochemical mechanisms, it provides a reliable and cost-effective monitoring system to measure the basic electrochemical processes.

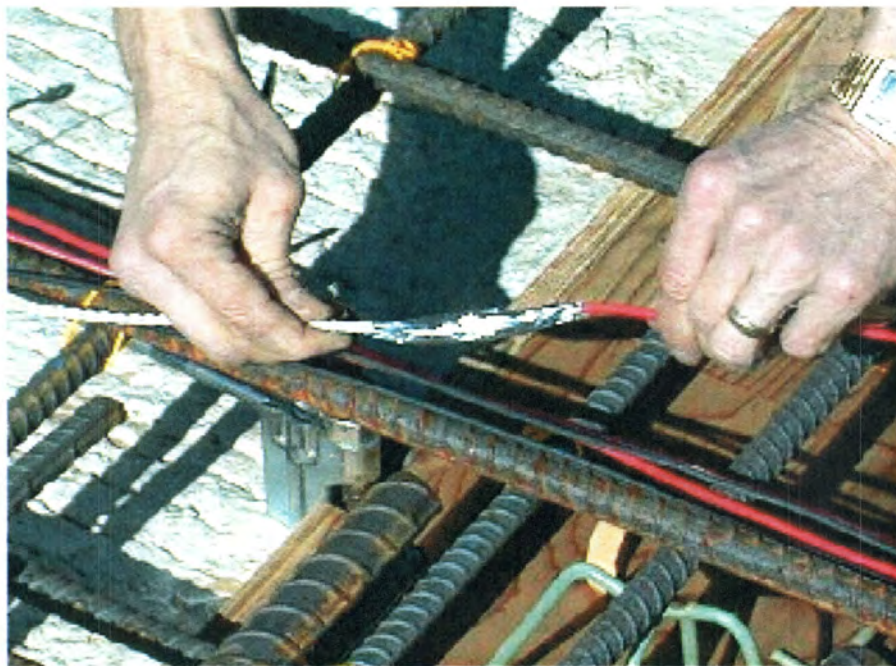
(a) Butt splice of electrode corrosion sensor and lead wire

(b) Butt splice protected with butyl rubber underneath aluminum foil tape

Figure III-11. Connecting V2000 sensor with lead wire.

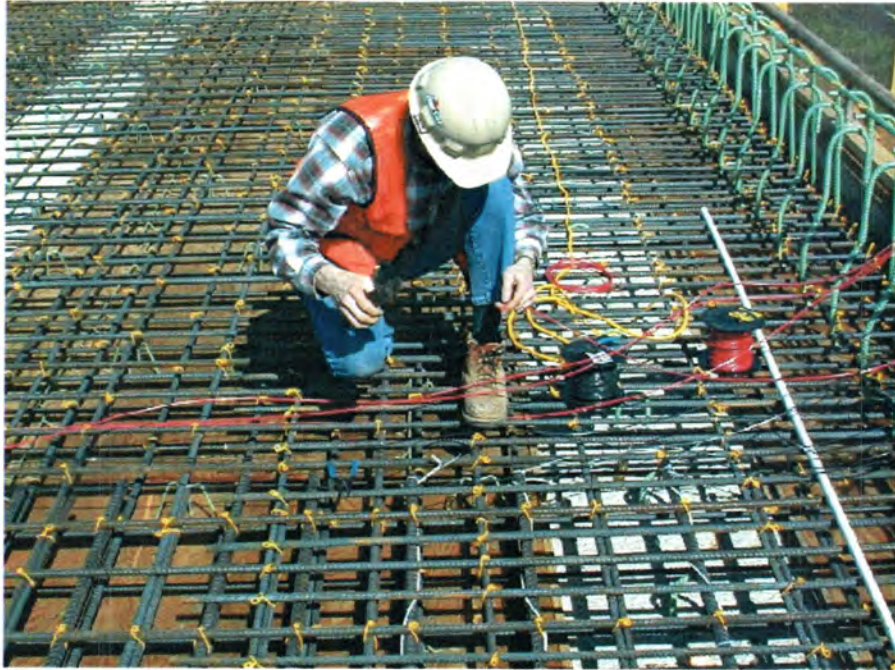
Figure III-12. Extending lead wires for data measurement.

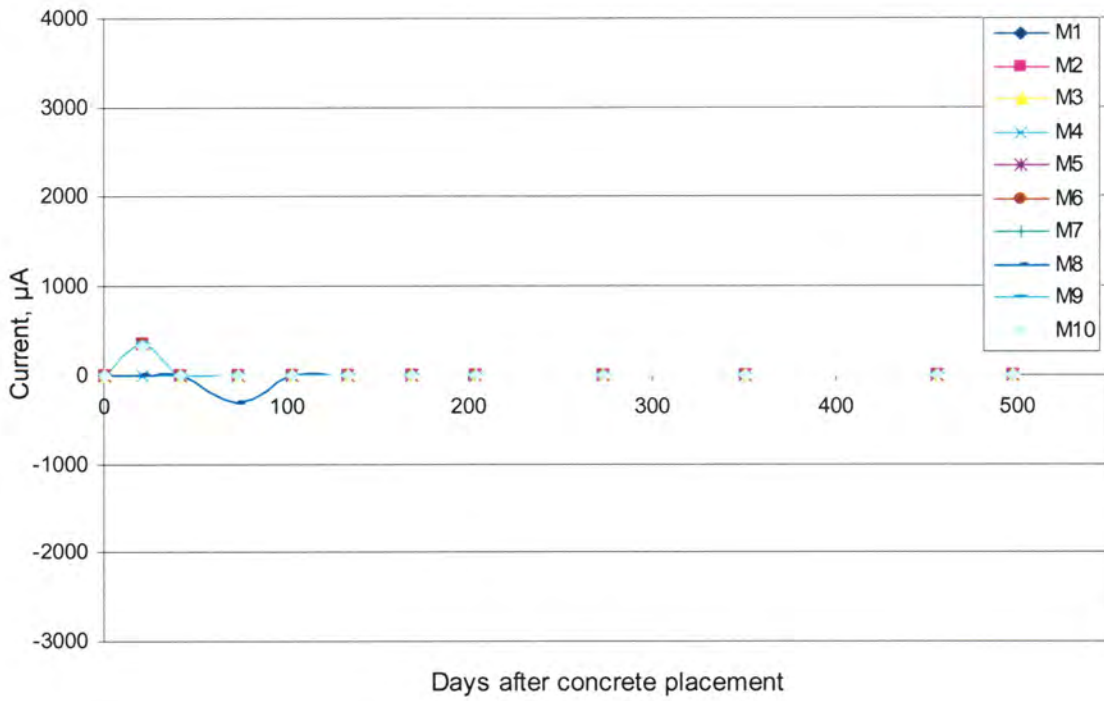
(a) MMFX bridge

(b) Epoxy bridge

is observed in either bridge decks at this point; electrical current readings are currently close to zero as shown in Fig III-17. Although not completed, through monitoring and evaluation with more data collected, this on-going investigation of corrosion monitoring system will allow engineers to better understand the performance of these reinforcing steels under service.
