Evaluation of coatings used for prolonging the durability of cross-laminated timber against weathering and wood decay fungi

A Dissertation
Submitted to the Faculty of
Mississippi State University
in Partial Fulfillment of the Requirements
for the Degree of Doctor of Philosophy
in Sustainable Bioproducts
in the College of Forest Resources

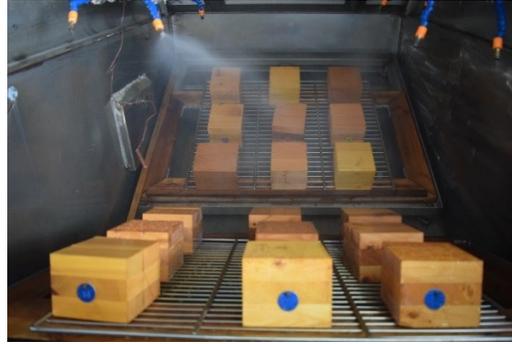
The artificial weathering test was conducted in a weathering apparatus which simulated exterior conditions by alternating cycles of irradiation and water spray. The unit was equipped with UV-A lamps ($W \cdot m^{-2}$ at 340 nm) maintaining constant temperature of 26°C. The samples were exposed to weathering cycles of set 12 hours of UV-light irradiation and 12 hours of water spray (0.36 Lpm) for 15 days (360h) and 75 days (1800h). The weathering tester is shown in Figure 3.3.

Figure 3.3 Weathering apparatus containing blocks fixed at 45° angles to holding racks.

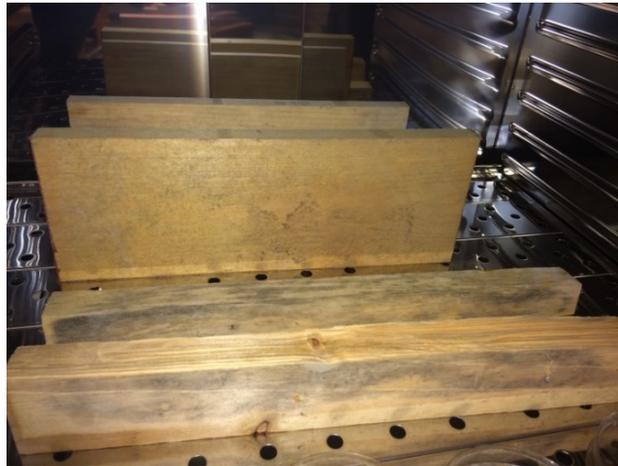
The test was conducted in a climate chamber (Mettler HCP 246, Mettler GmbH, Germany) under non-sterile conditions. Temperature and RH in the chamber were monitored throughout the experimental period. Samples of sapwood of pine naturally infected by *Aspergillus* sp., *Rhizopus* sp., and *Penicillium* sp. were used as inocula sources. During 14 days the chamber was kept under 27°C and 95% RH to be infested with spores (Figure 3.7).

Figure 3.7 Naturally infected samples placed at bottom of the chamber

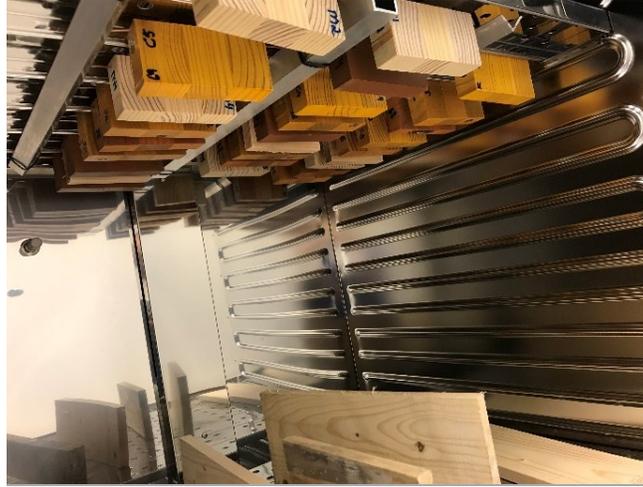
The tested samples were hanged edgewise from the top through aluminum bars spaced with a minimum 10 mm gap between two samples (Figure 3.8).

Figure 3.8 Placement of test samples on the top of chamber.

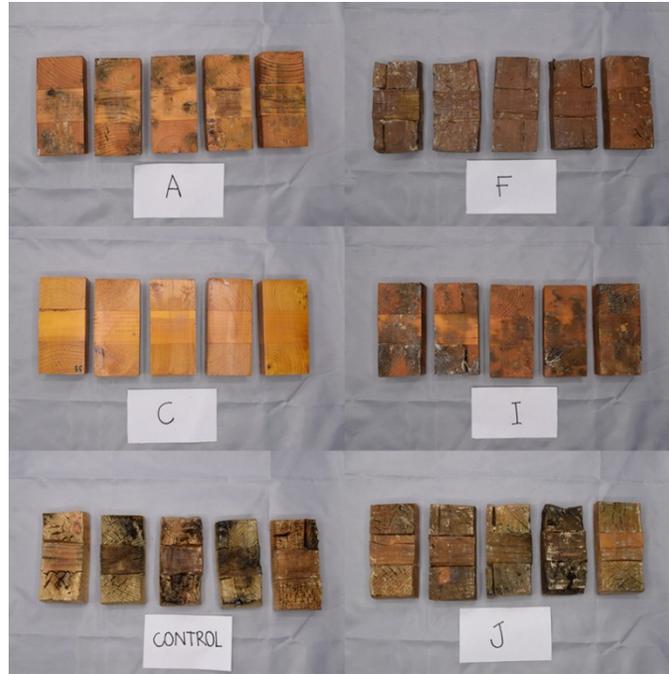
The ability that coating C showed in preventing decay in CLT exposed to a harsh condition (direct soil contact, high humidity, aggressive decay fungi) is of high importance, as CLT rapidly absorbs water (specifically from end-grain) and may be exposed to rain, high humidity and changes in temperature during transport, storage and construction. Currently, industrial CLT panels (heavy equipment mats) available in the market are intended to be used in similar harsh conditions. Hydrophobic coatings such as those tested successfully here may be a temporary solution for short-term exposure of this type CLT panels (Figure 4.11).

Figure 4.11 Appearance of CLT samples after 18 weeks of exposure to *G. trabeum* in soil block test.
