# Experimental Evaluation of Full Scale I-Section Reinforced Concrete Beams with CFRP-Shear Reinforcement

A THESIS

Submitted to the Faculty  
of the University of Miami  
in partial fulfillment of the requirements for  
the degree of Master of Science

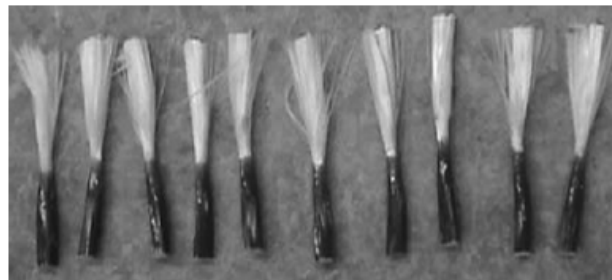
**Figure 2.6 – GFRP Spikes (Eshwar et al. 2008)**

plates have been used to anchor the FRP laminates (Sato et al. 1997, Swamy et al. 1995 & Taljsten 1997). Steel anchors have been shown to be usually impractical for field applications due to the possibility of corrosion and stress concentrations. Therefore, the author investigated the validity of using an anchor system made of FRP material. The first anchor system was made by making a groove onto the specimen. Then, a GFRP bar is inserted with the wet layup laminate into the groove and filled with epoxy forming the anchor. The anchor was also tested using different groove sizes. The other anchor system used is a glass FRP (GFRP) spike. This spike was 4 inches (101.6 mm) long which had 2 inches (50.8 mm) that was pre-impregnated in resin. This spike is then inserted into a hole that is drilled through the laminate and concrete. The unsaturated end is then spread out onto the laminate and impregnated with resin (see Chapter 5 for detailed procedure). Figure 2.5 illustrates the first anchor system and Figure 2.6 shows a picture of the GFRP spike.

In the case of spike anchors, an increase of 25% in ultimate capacity was recorded for one spike placed at the center of the laminate. It was observed that the presence of the spike delayed the potential of a debonding failure. It was also noted that different embedment depths of the spike did not significantly increase capacity. This was not true for the specimens tested with two spikes. In this case, the embedment depth of 3 inches (75 mm) alone had an influence of 10% to the ultimate capacity when compared to a depth of 2 inches (50 mm). Overall the embedment depth had a negligible effect on the ultimate capacity. Failure of these specimens was due to debonding of the CFRP laminate with a thick layer of concrete attached. Specimens with multiple spike anchors had an increase in ultimate shear capacity of 200% when compared to single spikes.

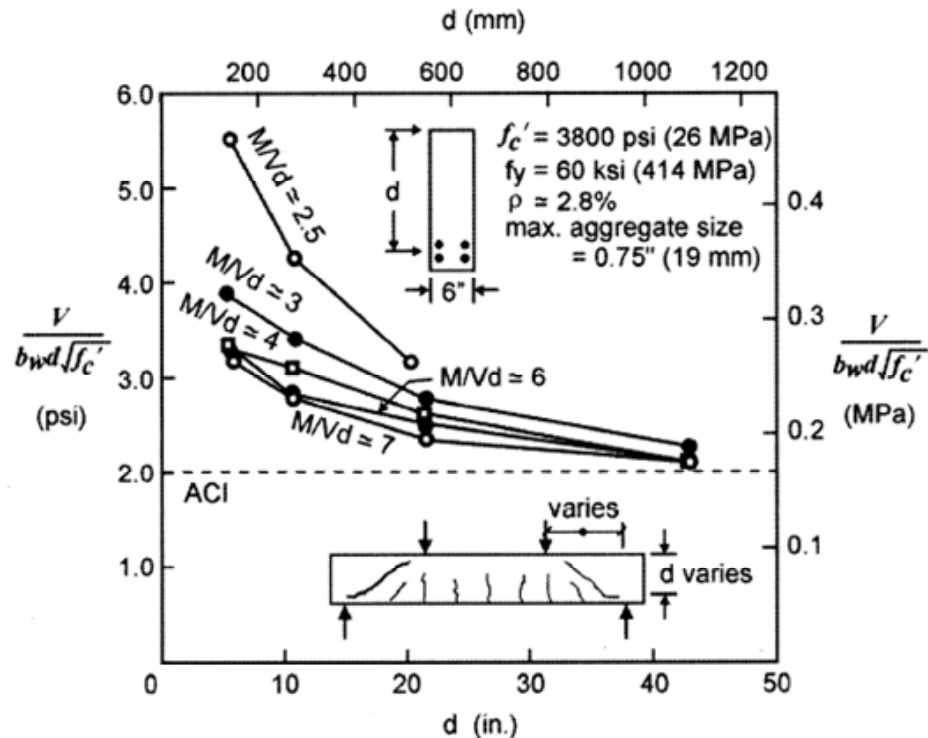
Figure 4.1 – Kani's Test on Size Effect in Shear (Collins et al. 1999)

05. This graph is shown in Figure 4.1, which was adapted from Kani (1966) and illustrated by Collins and Kutchma (1999).

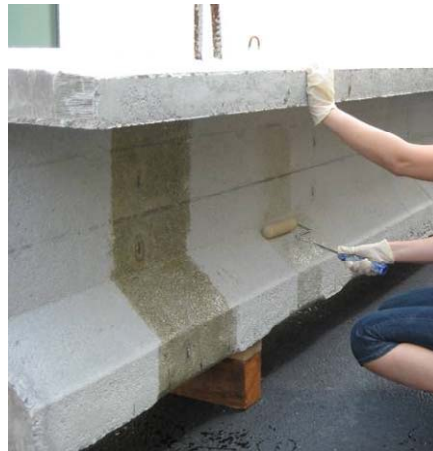
primer used is a two part MBrace Primer. The mixing ratio for the primer is 3:1 (Part A to Part B) by volume. The two parts are mixed in a bucket for three minutes. After mixing, the primer was placed within the marked substrate of the beam by using paint rollers. The primer was allowed to cure for half an hour. Next, the MBrace Putty was mixed. The ratio for the putty is also 3:1 (Part A to Part B) by volume. After three minutes of mixing time, the putty was spread onto the substrate, where the primer was previously placed, covering any voids and offsets with a plastic spatula. The putty was allowed to cure for one hour. The beam is now ready for impregnation of the CFRP sheets. Figures 5.1 and 5.2 show the application of the primer and putty.

**Figure 5.1 – Application of Primer** **Figure 5.2 – Application of Putty**

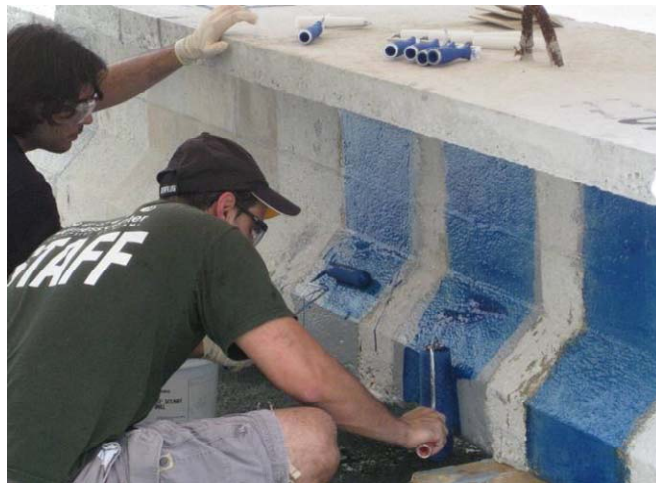
**Figure 5.3 – Application of Saturant**

3. **Impregnating CFRP Sheets.** Once the primer and putty has set, the MBrace Saturant can be applied. The mixing ratio is also 3:1 (Part A to Part B) by

volume. After mixing the saturant for three minutes in a bucket, a thick enough layer that does not run is rolled onto the substrate, where the primer and putty was placed, with a painting roller. The pre-cut CFRP sheet is then placed starting from one side of the beam and stretching it all the way around. Then, a roller with grooves is used to remove any air voids. Then, another layer of saturant is rolled over the sheet. Again, the roller with the grooves is used to remove any air voids. Figures 5.3 through 5.5 show the application process of the CFRP sheets and Figure 5.6 shows the reinforcement schematic for beams B-2a and B-2b.

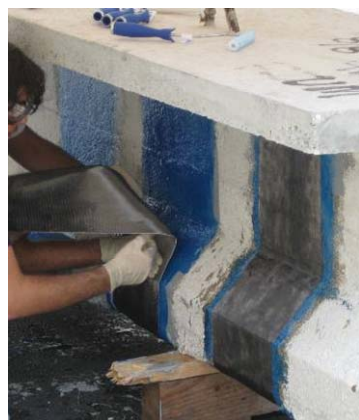
Figure 5.4 – Application of Sheet      Figure 5.5 – Removal of Air Voids

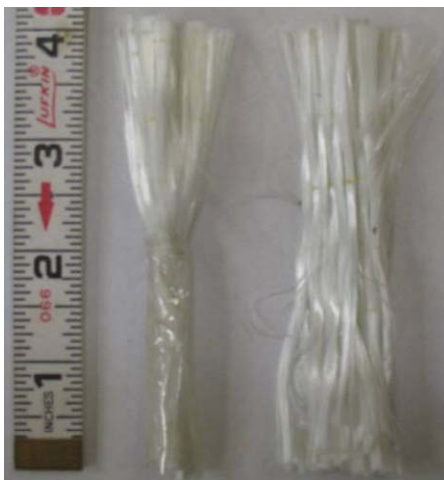
**Figure 5.8 – Prepping of Glass Fibers**

The second anchorage configuration consisted of inserting GFRP spikes through the CFRP laminates used for shear reinforcement. This time, the laminates were bonded to the sides of the beam rather than all the way around forming a U-wrap. The spikes were made with a total length of 4 inches (101.6 mm) and a diameter of  $\frac{1}{2}$  inch (12.7 mm) (75% of final diameter) before being saturated with resin and a final saturated diameter of  $\frac{11}{16}$  inch (17.46 mm). Of the 4 inches (101.6 mm), only 2 inches (50.8 mm) was saturated and cured before installation. To achieve the desired diameter and length, the bundle of fibers was first passed through a wooden block with a  $\frac{1}{2}$  inch (12.7 mm) diameter hole. Then, 2 inches (50.8 mm) were covered with tape so that only half the length of the fibers would be saturated as shown in Figure 5.8.

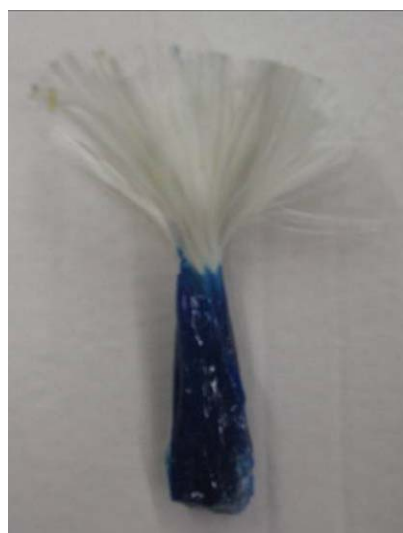
**Figure 5.9 – Finished GFRP Spike**

The loose end of the fibers was then saturated using MBrace Saturant and passed through a wooden block with an 11/16 inch (17.46 mm) diameter hole in order to achieve a uniform diameter. The spikes were then hung instead of being placed on a table in order to avoid the saturated end from flattening out. After curing for 24 hours, the tape was removed and any deformities such as loose fibers or excess resin that had dripped and cured were removed with a blade. Figure 5.9 shows an example of a finished GFRP spike.

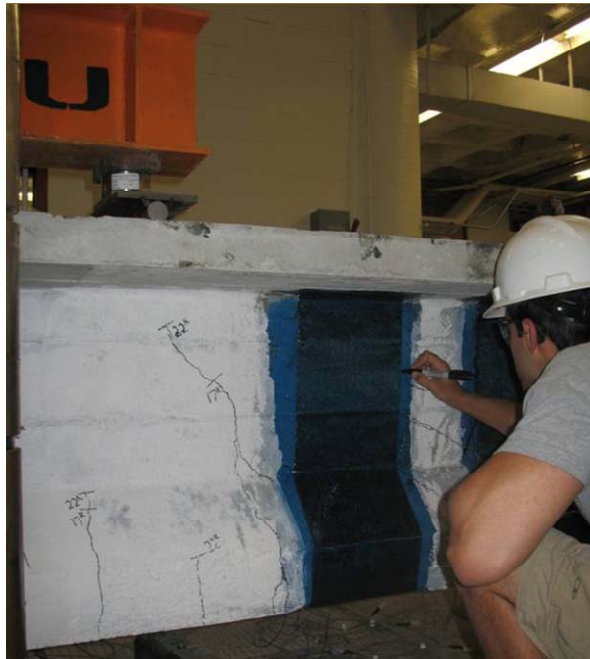
**Figure 6.5 – Beam B-2b Test**

The next specimen to be tested in the group was beam B-2b, which has identical external reinforcement as B-2a. The only difference between beams B-2a and B-2b is the amount of loading cycles. The number of cycles used to load beam B-2b was the same as B-1a. The same loading rate and criteria were also used in stopping, unloading, and marking of the cracks in each cycle. Figure 6.5 shows marking of cracks during a loading cycle.

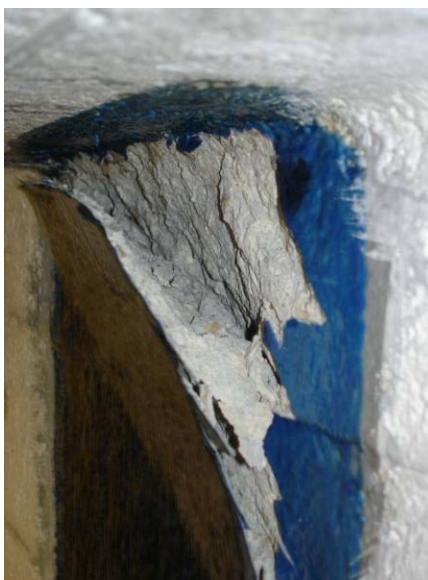
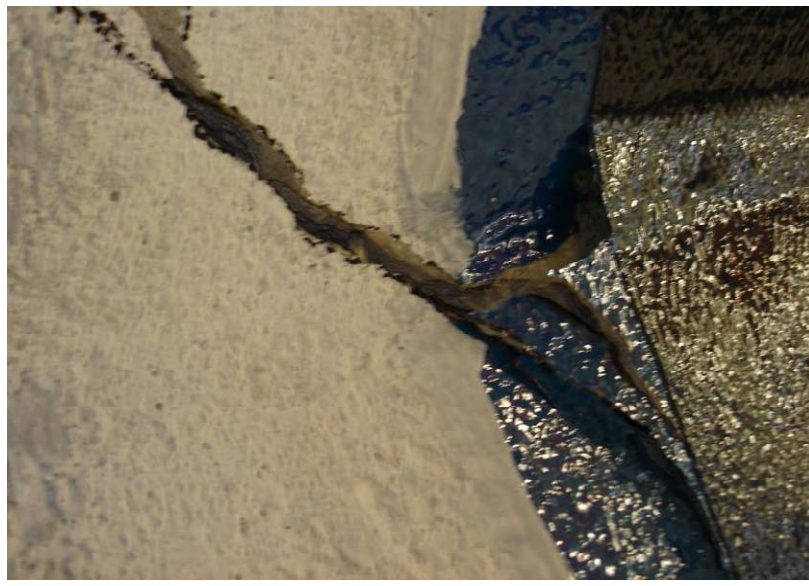
**Figure 7.8 – B-2a Failed Section**

**Figure 7.9 – B-2a Peeling of Laminate**

**Figure 7.10 – B-2a Straightening of Laminate**

The reduction in deflection is due to the high stiffness characteristic of the CFRP. Also, the laminates acted as a form of confinement which in a sense “hold” the beam and keep it from severely deflecting. Failure of the laminate occurred due to straightening of the center laminate followed simultaneously by peeling of the laminate closest to the loading point. As described in Chapter 1, this straightening was caused by a peeling force which acts perpendicular to the laminate. In the area where the laminate peeled, a layer of about ½ inch (12.7 mm) of concrete was observed to have been peeled off along with the laminate. This failure illustrates that the reinforcement is bond critical and that failure occurs in the concrete substrate and not in the CFRP laminate. These failure modes are illustrated in Figures 7.8, 7.9 and 7.10.

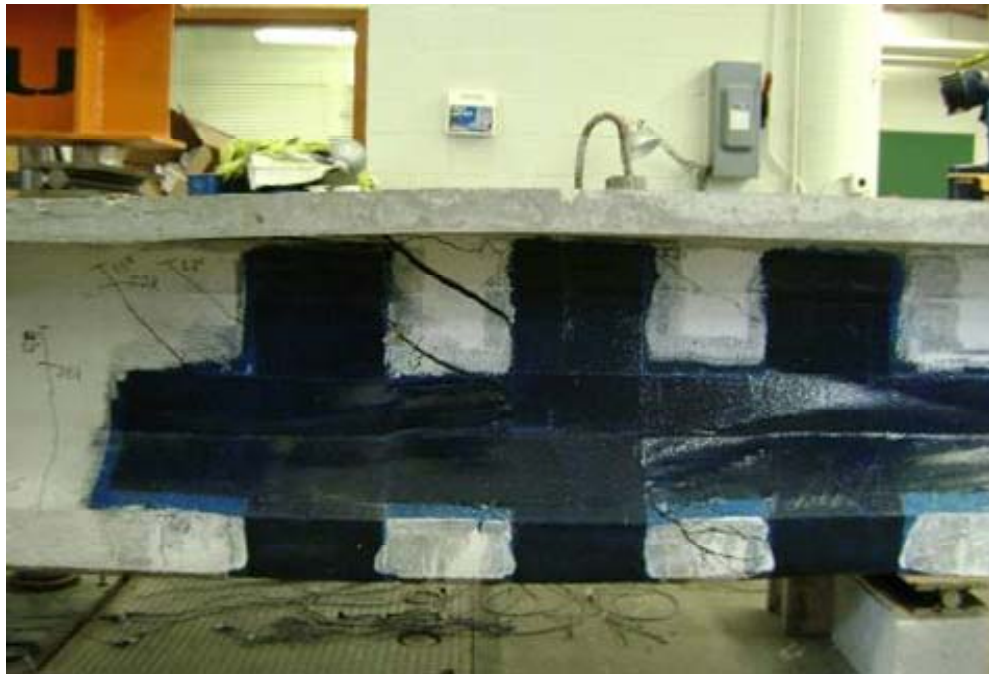
**Figure 7.25 – B-3a Failed Section 1**

Figure 7.26 – B-3a Failed Section 2

Figure 7.27 – Close-up of Horizontal Anchorage

As the shear cracks continued to grow and debonding began in the horizontal laminate, the strength could be observed to decrease somewhat and then increase a small amount until complete debonding and failure occurred. This can be seen in Figure 7.23 within the deflection range of 0.5 and 0.7 inches (12.7 and 17.8 mm). Splitting of the horizontal laminate was also observed. This was due to the fact that the fibers in the horizontal laminate were unidirectional which does not allow it to resist shear forces that are perpendicular to the fiber orientation. Figures 7.25 through 7.27 show the beam after failure.

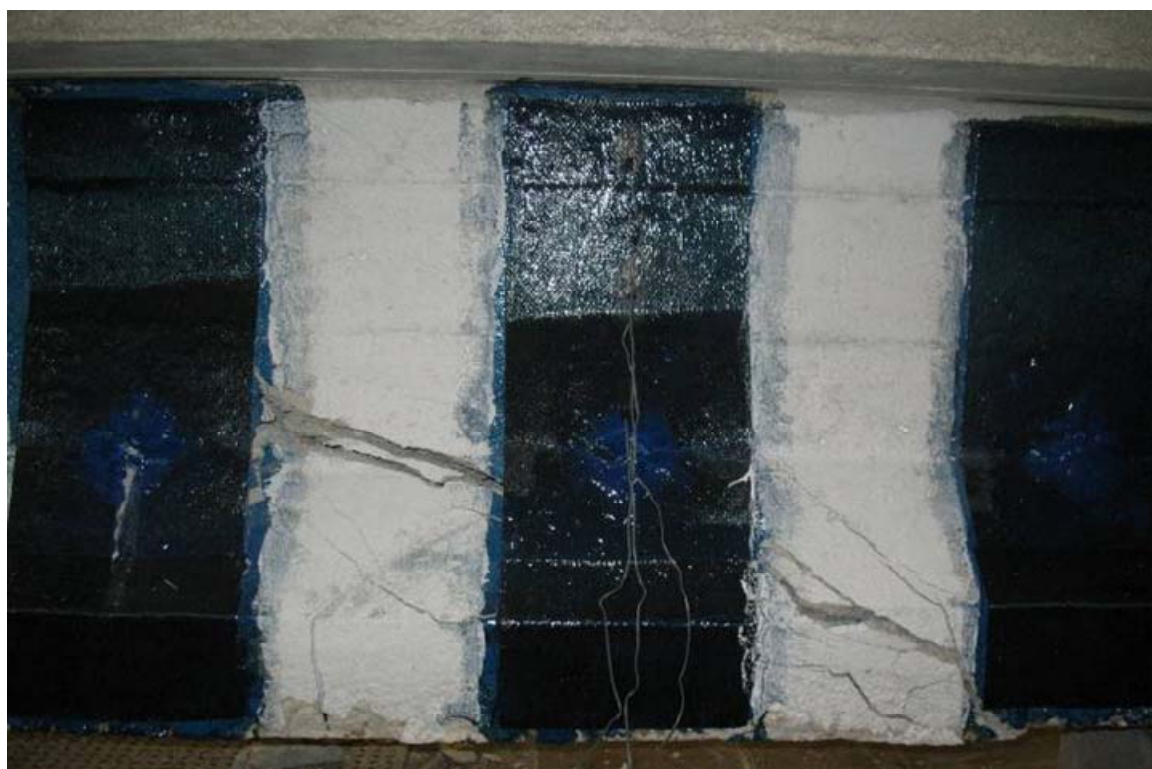
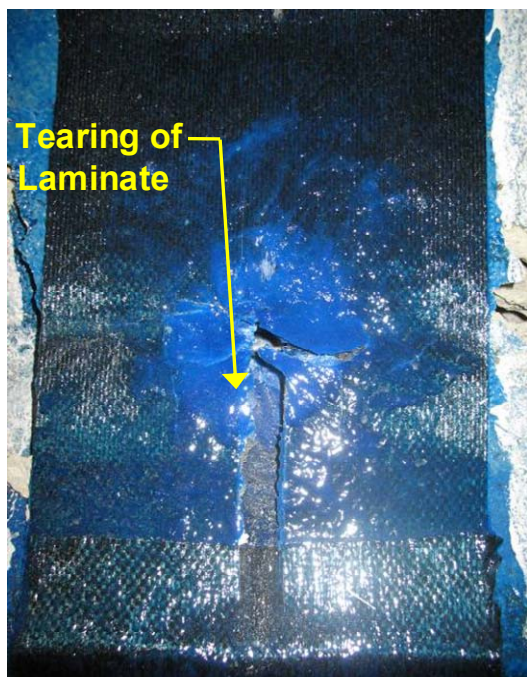
Figure 7.34 – B-4a Failed Section

**Figure 7.35 – B-4a Failed Laminate**

**Figure 7.36 – B-4a Spike Failure**

Failure of the specimen occurred due to straightening of the laminate and rupture of the GFRP spike at the flared end. During the test, straightening of the laminate was observed to have initiated along its edge and continued until it reached the general area of the GFRP spike. This was observed in both sides of the beam. Failure finally occurred once the maximum strain in the spike was reached causing it to rupture. Splitting, or tearing, of the two laminates closest to the loading point was also observed along with rupture of the spike. The reason for this was because since the spike ruptured at the flared end, part of the spike stayed attached to the laminate keeping it from debonding whereas the parts that broke free allowed the laminate to debond. This shows that failure of the laminate (and as a result the beam) is dependent on the rupture strength of the spike at the flared end. Figure 7.33 shows the crack pattern and Figures 7.34 through 7.36 illustrate the failure mode encountered.

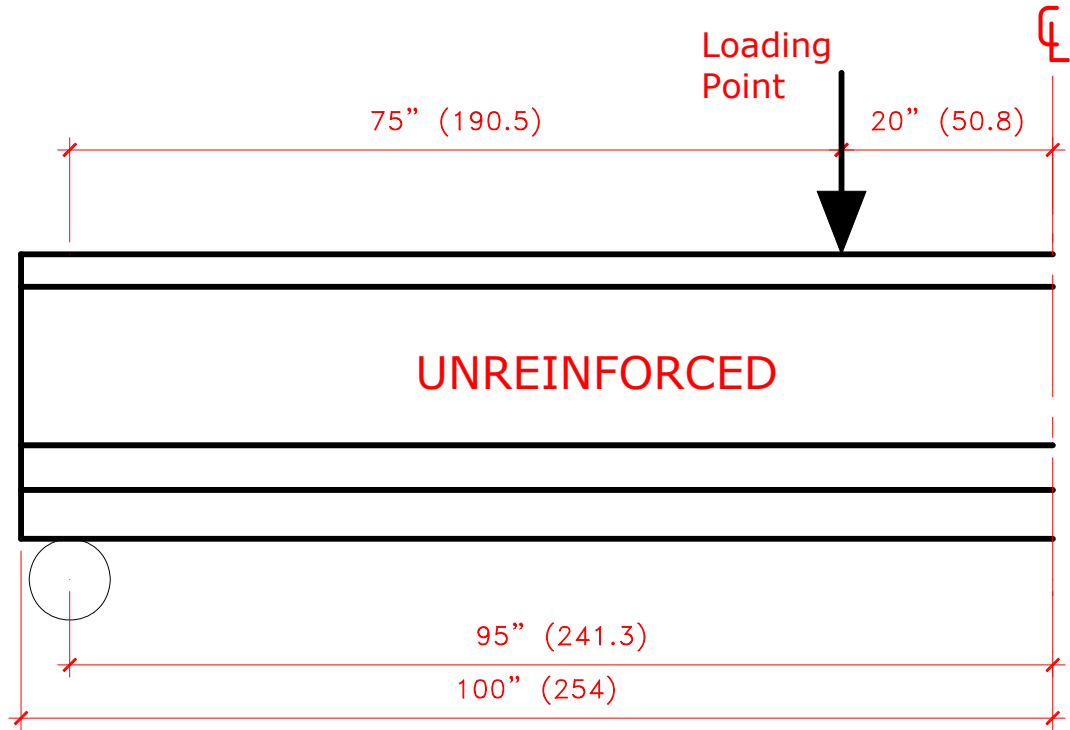
**Figure A.1 – Beam Elevation**  
**Note (SI conversion in cm)**
