Experimental validation of an integrated FRP and visco-elastic hardening, damping, and wave-modulating system for blast resistance enhancement of RC columns

A THESIS

MASTER OF SCIENCE IN CIVIL ENGINEERING

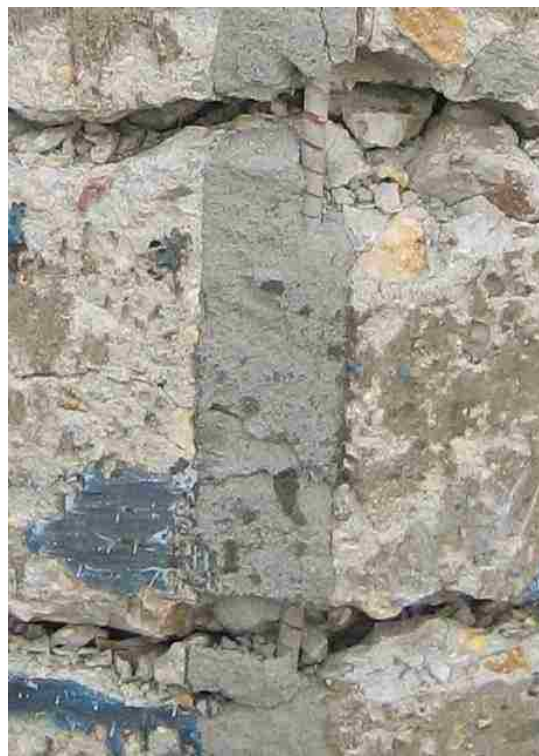
Figure 2.5. Separation of Steel Spirals in Two Cracks

The propagation time scale can be converted to distance along the cable by dividing by two and multiplying by the signal propagation velocity, which is based on the electrical properties of the cable. The reflected voltage can be converted to a dimensionless measure called reflection coefficient (Γ) by dividing it by the voltage of the original pulse signal. Once these conversions are made, the signal is then in the form of reflection coefficient as a function of distance along the cable. From this data, the locations of various cracks along the member are easily established. Figure 2.5 demonstrates how the sensors work in an actual structure. The cracks, of course, do not have to be as large as the ones shown in the picture for the sensor to work properly, but this figure illustrates the separation of the spirals around the sensor.

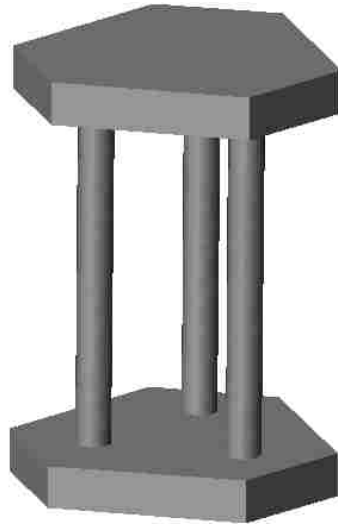
Figure 3.2. 3-D Rendering of Three-Column Specimen

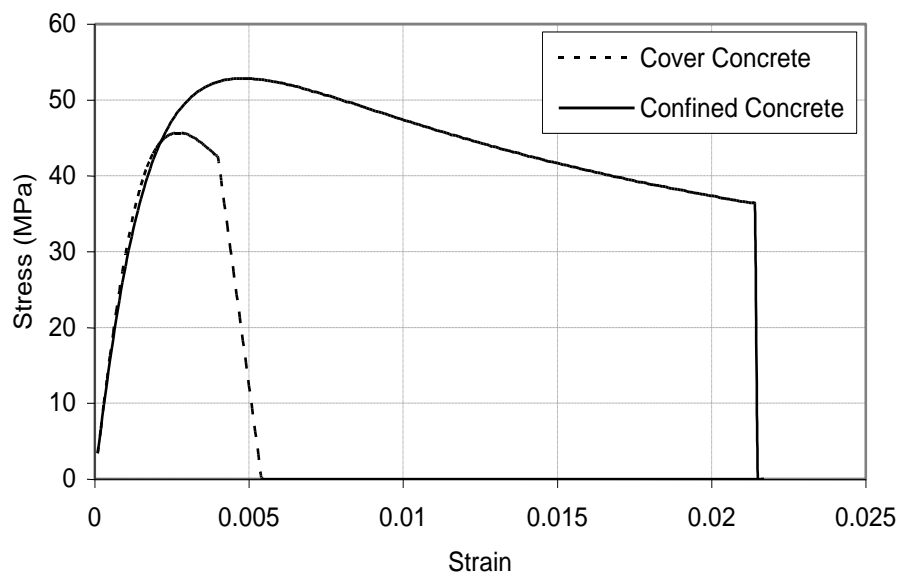
Figure 3.6. Stress-Strain Relationship for Concrete

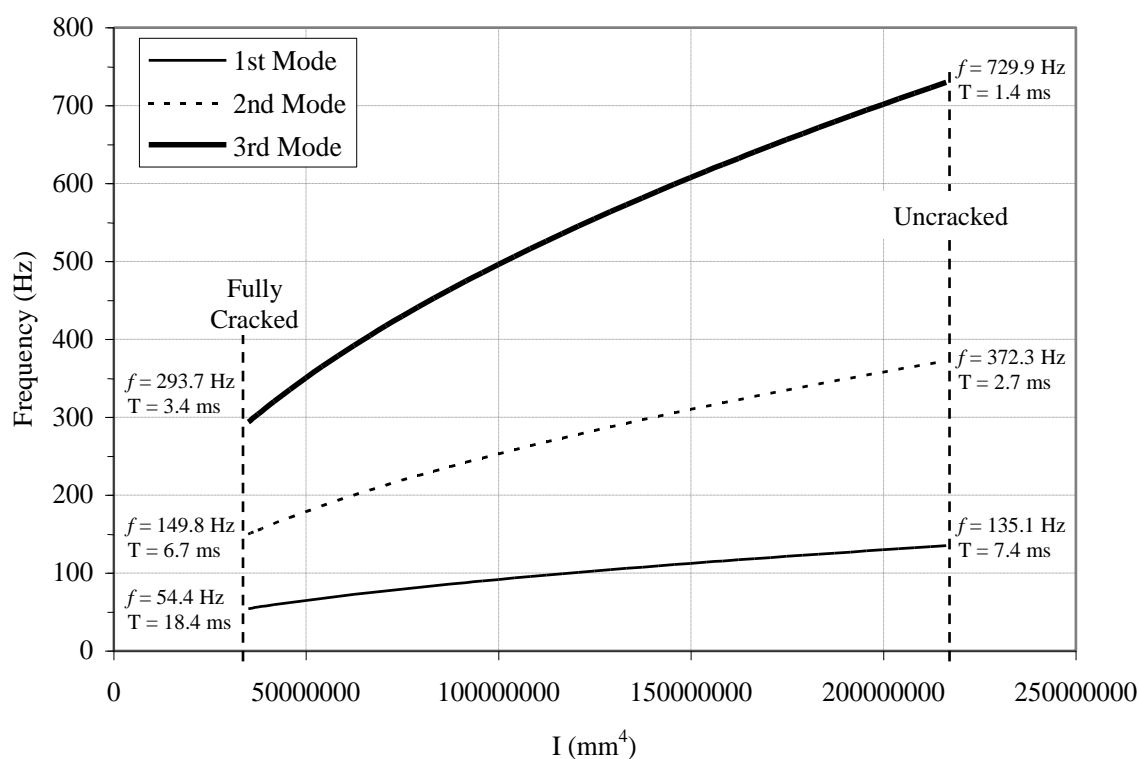
Figure 3.12. Variation of Modal Frequencies with Moment of Inertia

For an RC concrete section, the moment of inertia will have a value somewhere between that of an uncracked section and a fully cracked section. Even though the cross section is constant along the length of the column, the moment of inertia could actually vary along the length because of varying crack patterns. Methods for calculating the cracked moment of inertia can be found in MacGregor and Wight (2005). For the columns used in these experiments, the moments of inertia of the gross transformed section (uncracked) and fully cracked transformed section were calculated to be $2164 \times 10^5 \text{ mm}^4$ [520 in^4] and $349.6 \times 10^5 \text{ mm}^4$ [84 in^4], respectively. Figure 3.12 shows how each of the three frequencies varies as I changes from that of a fully cracked section to an uncracked section.

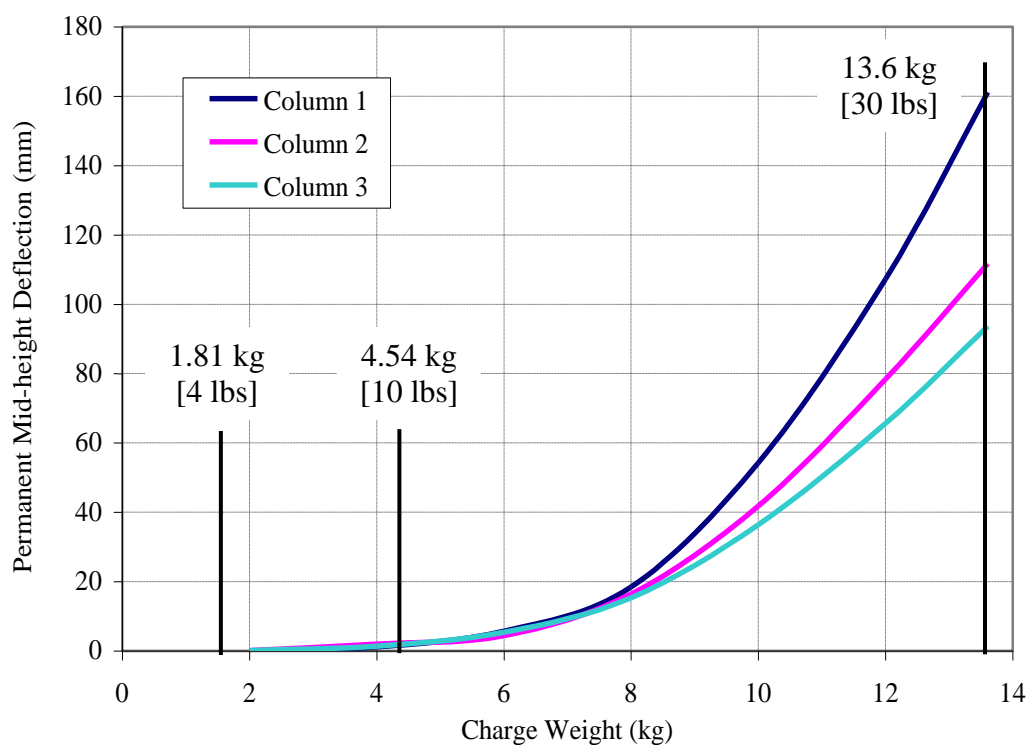
Figure 4.7. Permanent Mid-height Deflection for Varying Charge Weights

4.5.2. Permanent Displacement. For each of the three columns, several load cases were analyzed. Blast loads were calculated and applied to the columns with charge weights ranging from 1.81 to 13.61 kg [4 to 30 lbs], in increments of approximately 2 kg [4.4 lbs]. These results are shown in Figure 4.7 and a comparison to experimental results is given in Section 6. From these results, charge sizes were determined as 1.81 kg [4 lbs], 4.54 kg [10 lbs], and 13.6 kg [30 lbs] as shown in the figure. For simplicity, these charge sizes are hereafter referred to as the 4, 10, and 30 lbs blasts. The 4 lbs charge was expected to cause minimal damage. The 10 lbs charge was expected to cause significant damage to Column 1, and the 30 lbs charge was expected to fail all three Columns.

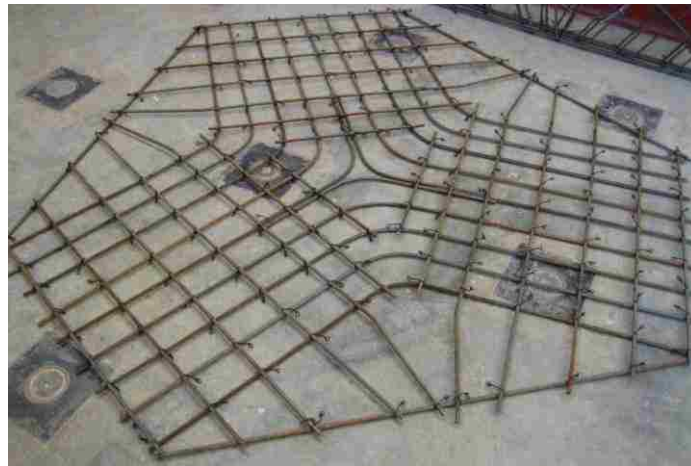
Figure 5.1. One Layer of Reinforcement for Footing and Slab

5.2.1. Footing. First, the steel cages that would be placed in the footing and top slab were constructed as shown in Figure 5.1. Each had two layers of reinforcement, and all reinforcement was designed to be symmetrical.

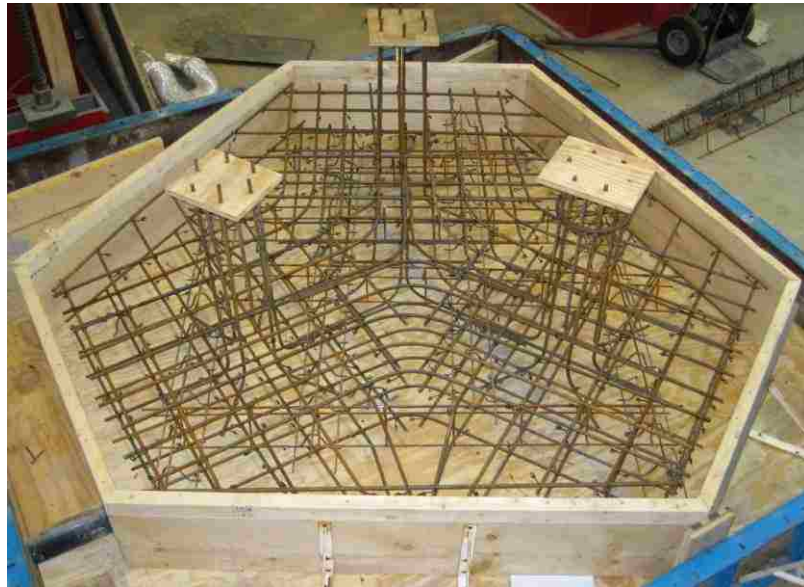
Figure 5.2. Formwork and Reinforcement for Footing

Once each layer of reinforcement was tied together, they were placed in the forms, and the reinforcement for the column-footing construction joints were tied in place as shown in Figure 5.2. As shown in the figure, standard 90° hooks detailed using ACI 318-05 were utilized at these joints.

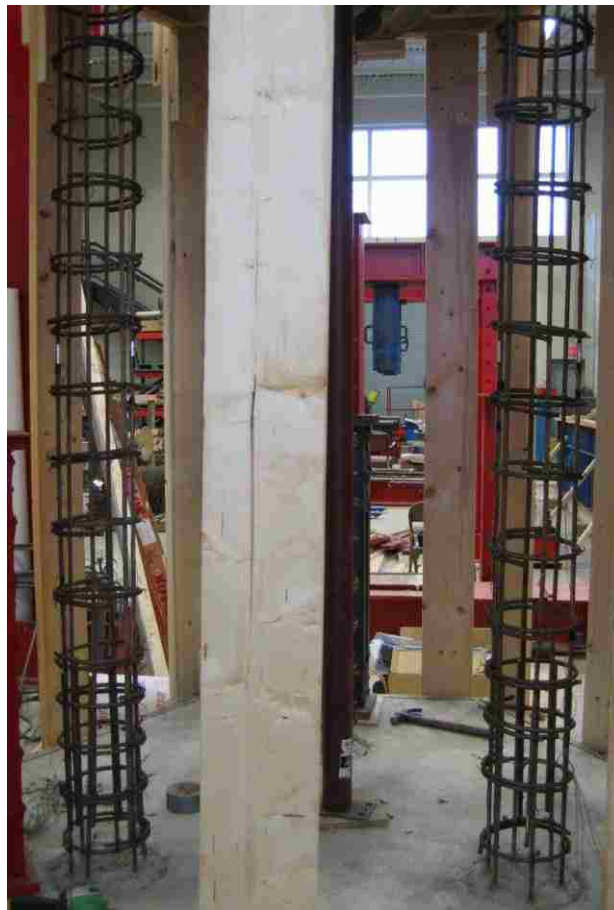
Figure 5.3. Column Reinforcement

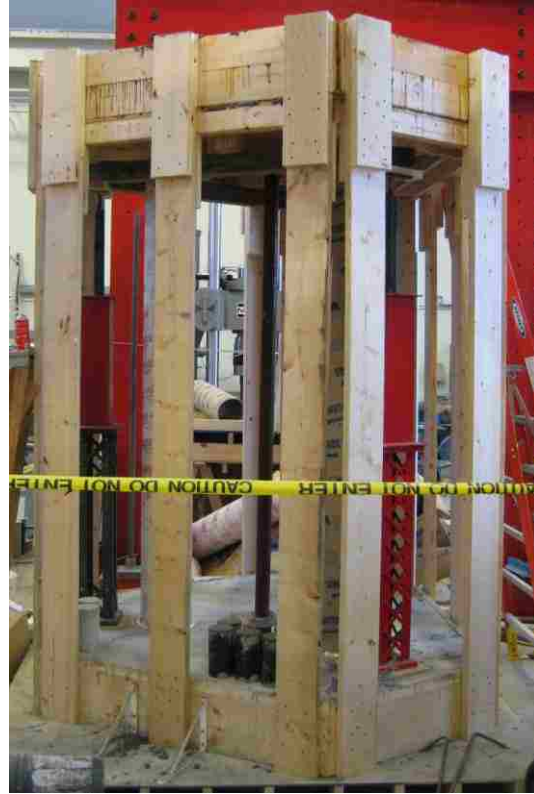
Figure 5.4. Shoring and Formwork for Slab

Once the column reinforcement was in place, the top slab was completed much in the same fashion as the footing, and a pipe was placed in the center of the slab so that the charges could be suspended from the top. Since the slab was only 305 mm [12 in] thick, the longitudinal column reinforcement had to be bent into 90° hooks to ensure proper development length. Figures 5.3 and 5.4 show the in-place column reinforcement before placing the forms, and the shoring and formwork for the slab, respectively.

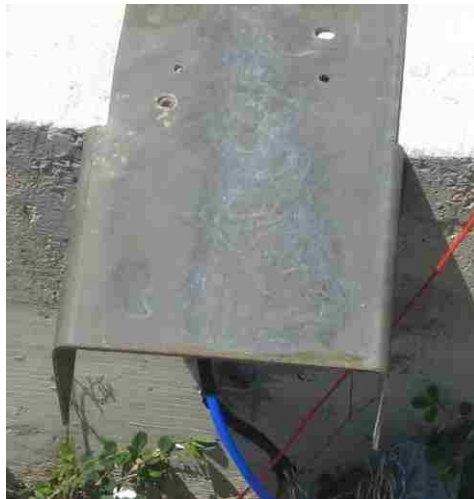
Figure 5.5. Steel Plate to Protect Sensor Connectors

the cable was bent at the base of the column and embedded in the top of the footing as well. To do this, a 13 mm [$\frac{1}{2}$ "] by 13 mm [$\frac{1}{2}$ "] groove was cut along the back of the column and in the footing that extended all the way to the edge of the footing. The sensor was then placed in the groove and grouted in using Carter Waters CW100 Precision Grout that was mixed to a dry-pack consistency. Following the first blast, a large portion of the grout was blown out of the column groove. It was determined that since the grout was mixed to a dry-pack consistency, it did not have a high enough water content to create a good bond to the base concrete. To solve this problem, all subsequent grout repairs were done by first brushing Sikatop Plus Component A bonding agent into the groove before packing the grout. This significantly improved the bond between the grout and the concrete. Finally, to protect the sensors' connectors from the blast pressure and debris, steel plates were fabricated and attached to the footing as shown in Figure 5.5.

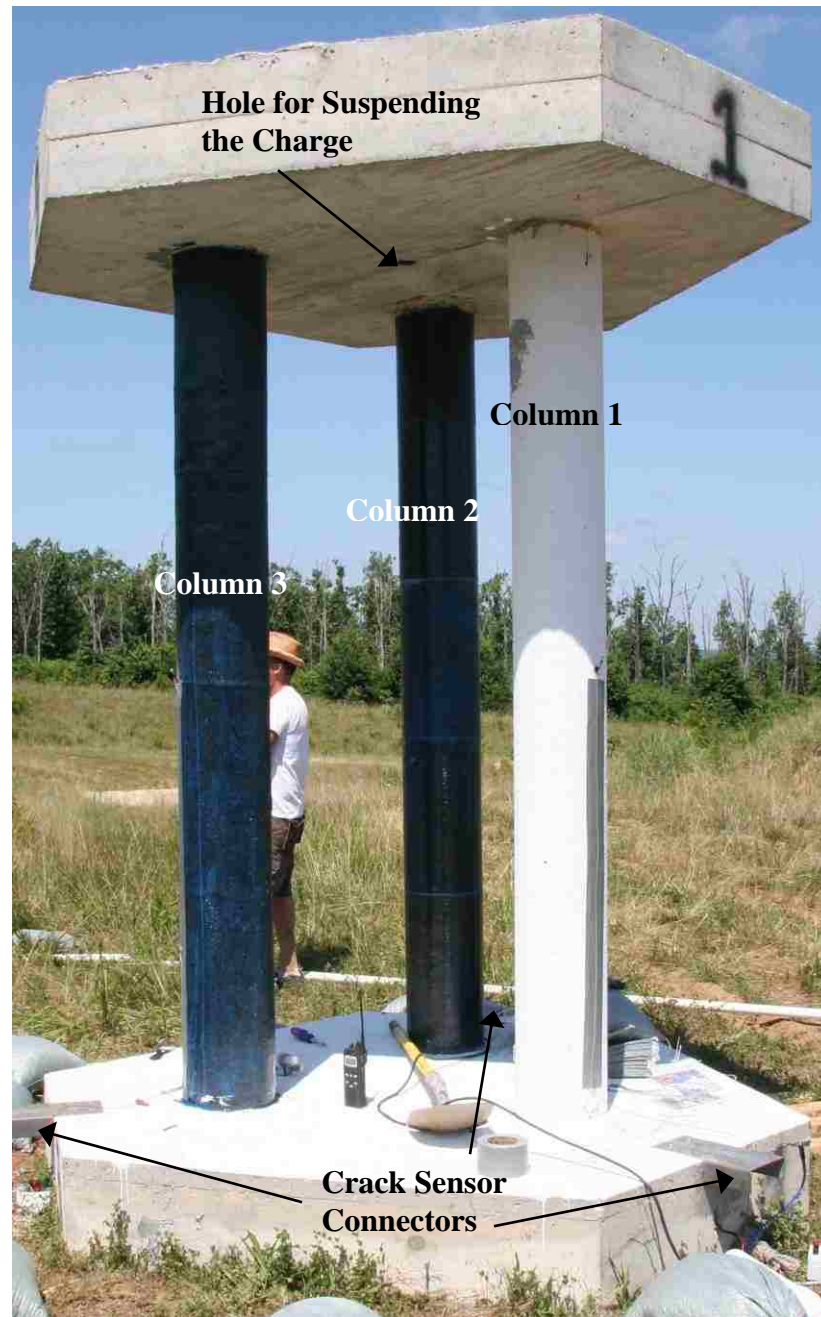
Figure 5.6. Final Column Specimen before Testing

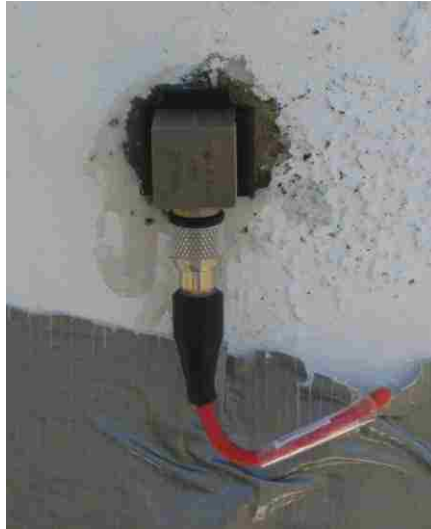
Figure 5.7. Accelerometer

On Columns 1 and 2, the clip was glued directly to the concrete and FRP wrap, respectively. On Column 3, a small hole was cut in the outer FRP and VE material so that the clip could be glued to the first layer of FRP. This was done to obtain the

acceleration of the column itself and to avoid a false acceleration from the much less stiff VE material. Figure 5.7 shows one of the accelerometers ready for measurement.

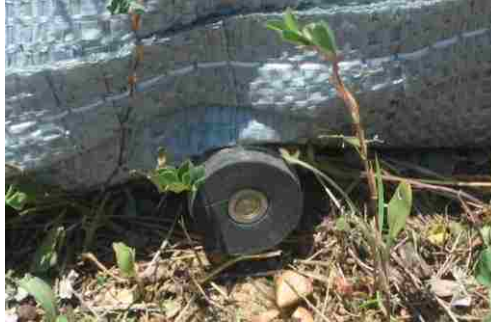
Figure 5.8. Pressure Transducer

Three pressure transducers were also used to verify the blast pressures calculated by various computer programs. They were placed 5.49 m [18 ft] from the center of the charge and were pointed directly towards it. This distance was selected based on the measurement range of the transducers and the maximum pressure that they would see during the largest blast. Each transducer was mounted in a pipe, embedded in the ground, and covered with a sandbag to ensure no movement occurred. Figure 5.8 shows one of the pressure transducers. Finally, a video camera was placed at a safe distance on top of a berm to record each blast.

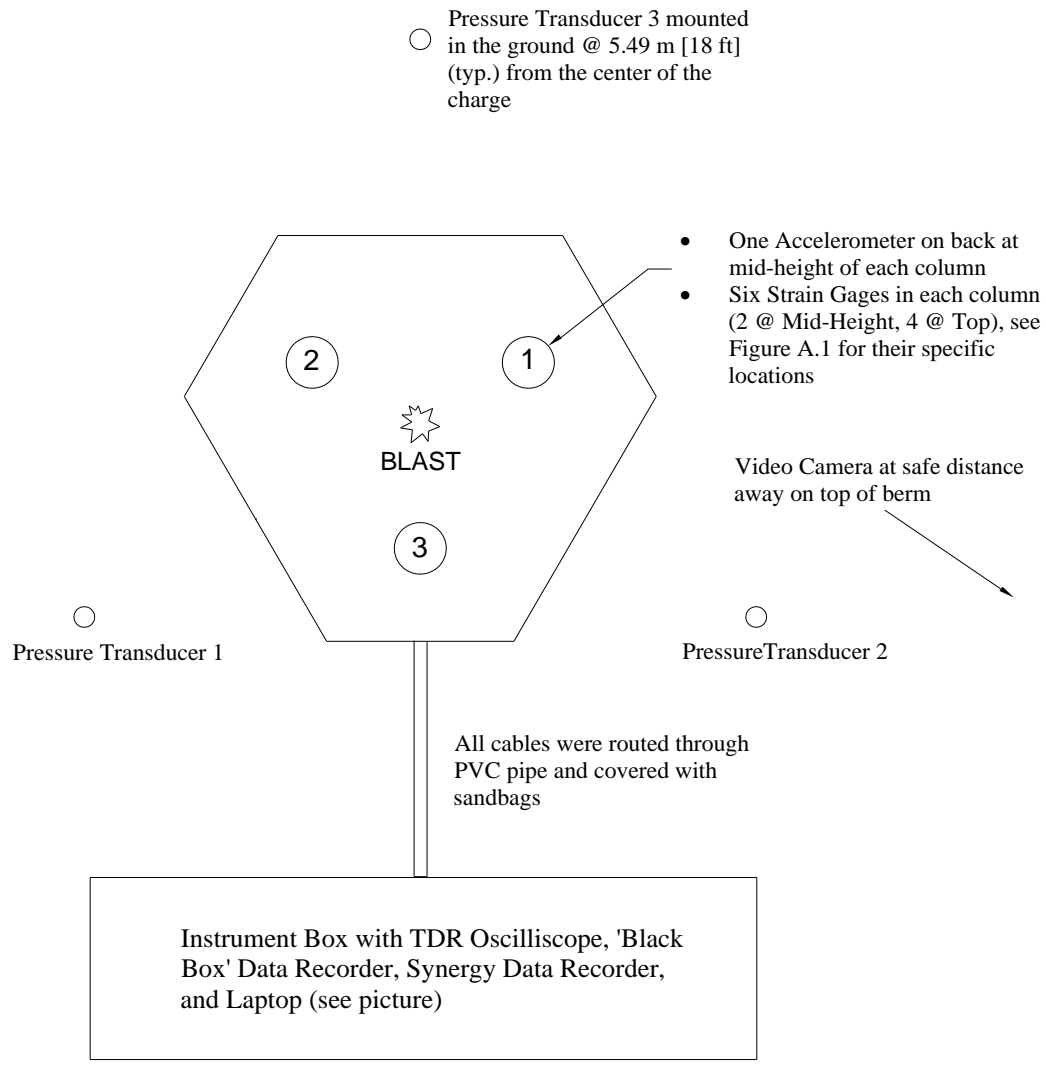
Figure 5.9. Instrumentation Layout

5.3.2. Data Acquisition. Several different systems were utilized for data acquisition. To acquire the strain and pressure data, a Synergy data recorder at very high sampling rates was used for the blast testing. For the accelerometers, a ‘Black Box’ data recorder was used. A sampling rate of 20 kHz was used for both the Synergy and ‘Black Box’ data recorders. For the crack sensors, a Digital TDR Oscilloscope was used along with a pulse generator which is used for dynamic measurements. The Oscilloscope only has one channel, so dynamic measurements were only taken from Column 1, but static measurements were taken on each column both before and after each blast. A laptop was also used to configure and record data from the Synergy and ‘Black Box’ data recorders. Finally, to protect all of the data acquisition systems from the blast, everything was placed in an aluminum box. The box was situated in a ditch next to the column specimen and covered with 6” x 6” timbers which were covered with plywood and sandbags. All of the cabling for the transducers was piped through PVC pipes which were secured with sandbags. Figures 5.9 and 5.10 show the layout of the instrumentation and the aluminum box containing all of the data acquisition systems, respectively, and Figure 5.11 is a picture of the test site.

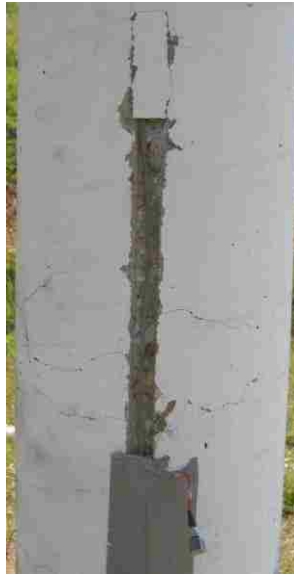
Figure 6.2. Damage to Sensor Grout on Column 1 after 1st 4 lbs Blast

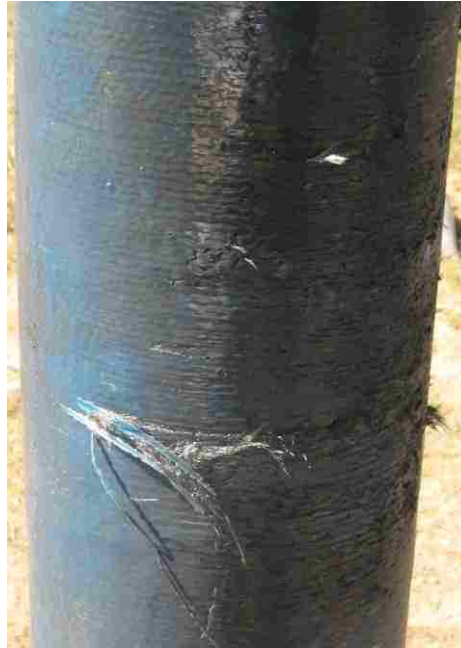
Figure 6.4. Damage Area of Column 2 after 1st 4 lbs Blast

Column 2, which was retrofitted with one layer of CFRP for confinement, sustained very little damage. Some of the MBrace saturant had been blown off on the front side of the column at the location of the blast, but most of the fibers were still intact. Figure 6.4 shows a side view of the damage area on Column 2.

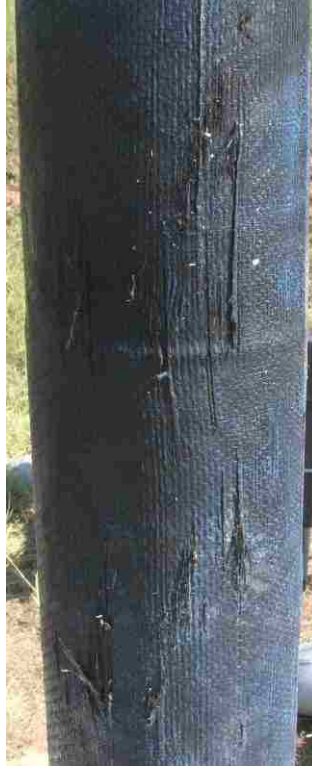
Figure 6.5. Damage to Front of Column 3 after 1st 4 lbs Blast

Column 3, which was retrofitted with the HDM system, sustained little damage as well. As mentioned previously, a Sonotube and a piece of plywood were used to elevate the charge to the mid-height of the columns. After inspecting the damage to Column 3, it was determined that most of the damage was caused by shards of plywood. This is evident by the fact that there were sharp pieces of wood embedded in the FRP and VE material after the blast. As with Column 2, almost all of the damage to Column 3 was concentrated at the mid-height. Figure 6.5 shows the damage on the front side of Column 3.

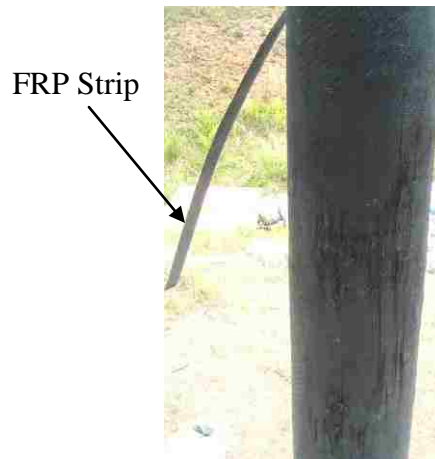
Figure 6.8. Damage to Column 3 after 2nd 4 lbs Blast

Column 3 sustained very little additional damage from the second blast. This perhaps validates the statement that the damage caused by the initial blast was mostly a result of the plywood debris impacting the FRP. There was a strip of FRP that started to peel down the side of the column, but this was minor damage that would not affect the integrity of the retrofit. The failure of this strip was not a result of the fibers rupturing. It merely separated in the direction parallel to the fibers. Figure 6.8 shows the damage to the front side of Column 3 and also the strip of FRP on the side of the column that started to peel off.

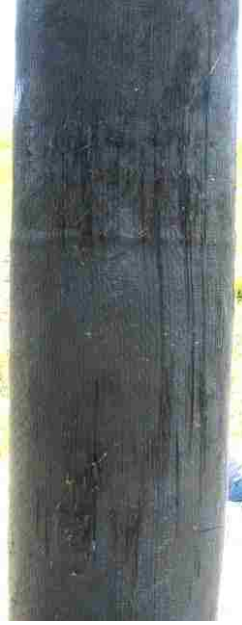
Figure 6.11. Damage to Front Side of Column 3 after 10 lbs Blast

Column 3 sustained a similar amount of damage as Column 2. A few of the FRP fibers were ruptured on the front side, but there was no damage on the back side of the column. Most of the damage to the FRP was limited to the separating of fibers at multiple locations. There was also no permanent deformation in the column, and it could be deemed structurally sound. Figure 6.11 shows the damage to the front side of Column 3.

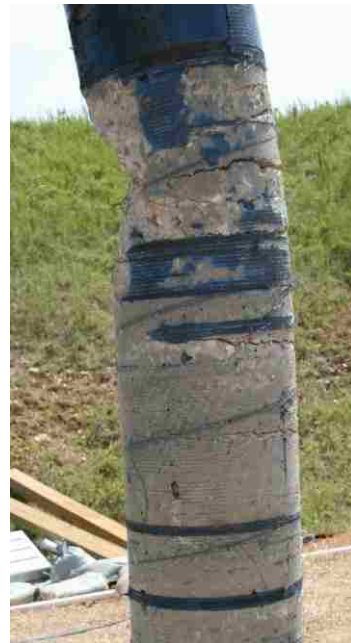
(b) Hinge at Mid-Height

conditions at the joint were the same as those at the base (except for the splice in the flexural reinforcement at the base). There were several cracks at the mid-height of the column as seen in Figure 6.15 (b), but they were all flexural cracks, and there were no diagonal or horizontal cracks like those seen on the benchmark column in Figure 6.6. Except for local damage on the front face of the column at the mid-height, all of the concrete was intact, and there was no sign of loose materials. This indicates that the FRP protected the concrete from spalling and from further cracking such as that seen on Column 1 in Figure 6.6.

Figure 6.15. Post-Test Inspection on Column 2

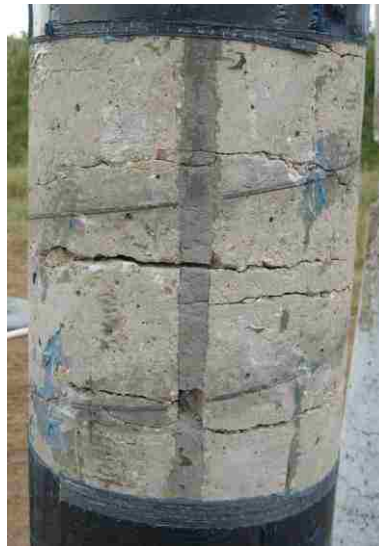
Figure 6.16. Back Side of Column 3

Removal of the FRP and VE materials from Column 3 led to similar findings. Most of the outer FRP and VE materials along the column were removed, but only the

inner layer of FRP that was around the failure hinge was removable because of its bond to the concrete. There was a small amount of spalling on the front of the column, but not enough to expose the reinforcement. The crack pattern on the back side of the failure hinge was similar to that of Column 2, but the cracks were narrower as shown in Figure 6.16.

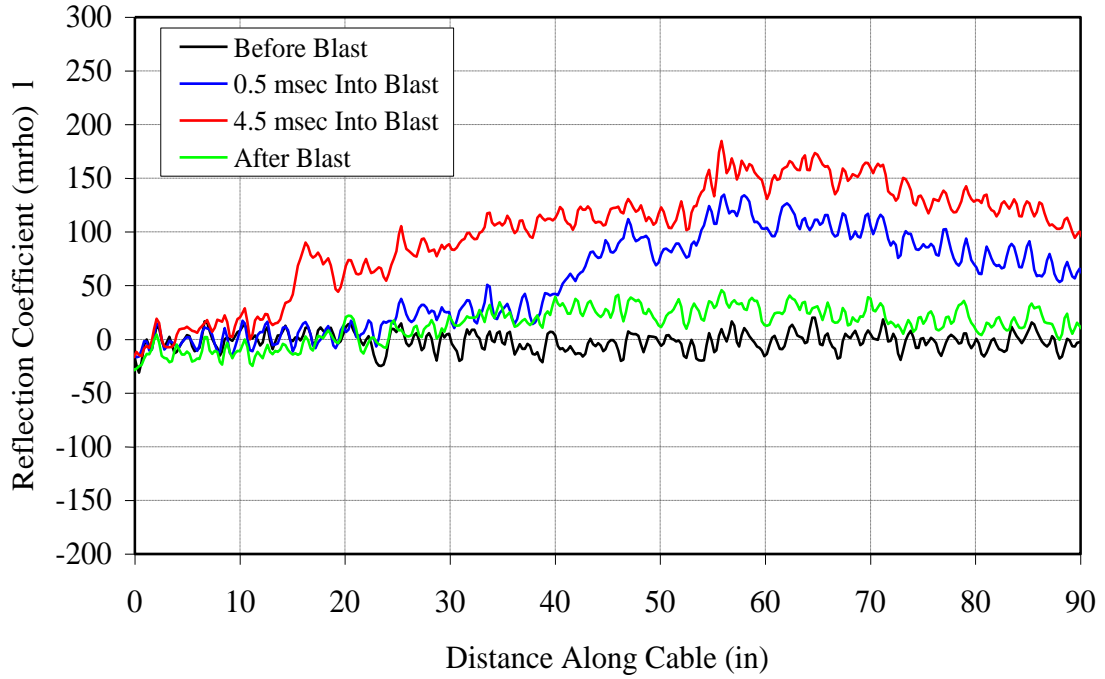
Figure 6.47. Dynamic Data from Column 1 during the 2nd 4 lbs Blast
