# Fatigue behavior of an advanced SiC/SiC composite at 1300° C in air and steam

**Fatigue Behavior of an Advanced SiC/SiC Composite at 1300° C in Air and Steam**

**FATIGUE BEHAVIOR OF AN ADVANCED SIC/SIC COMPOSITE WITH AN  
OXIDATION INHIBITED MATRIX AT 1300°C IN AIR AND IN STEAM**

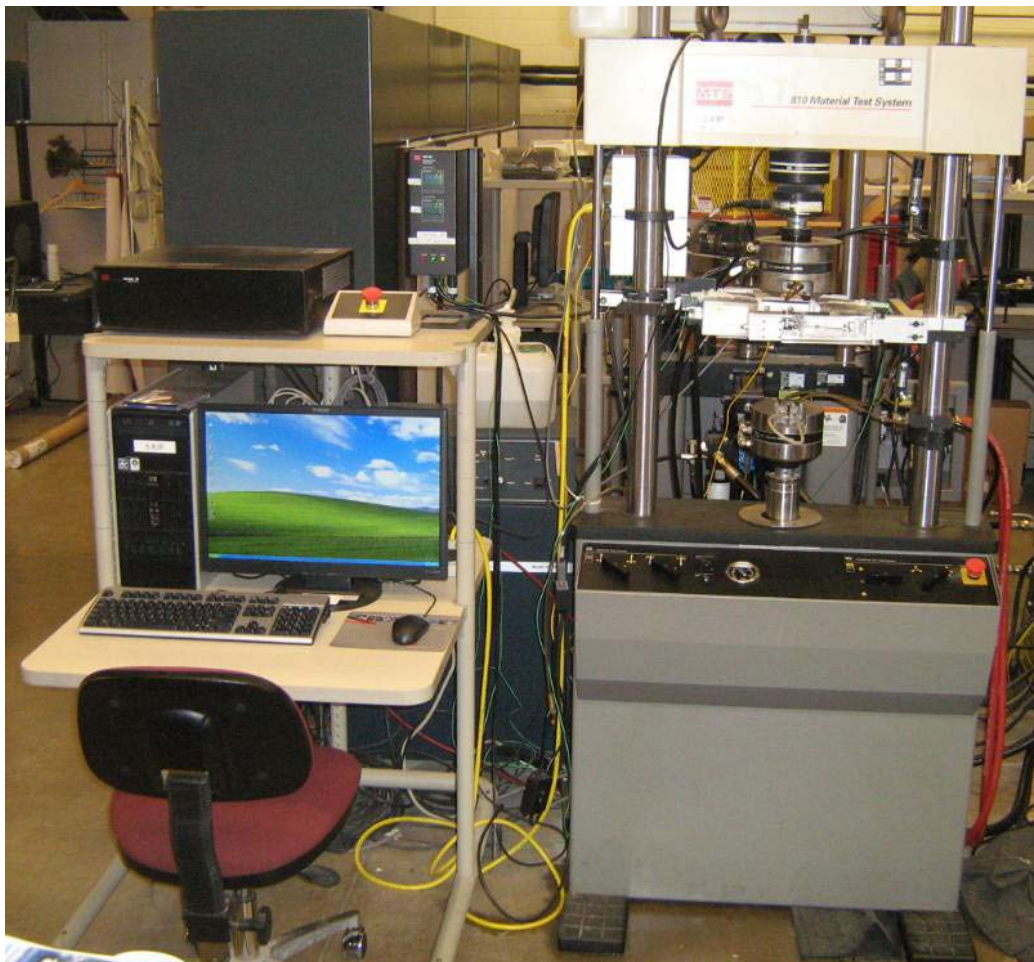
Figure 13. 5 Kip MTS machine.

A 5 kip hydraulic MTS mechanical testing machine was used for all tests. The MTS testing machine was equipped with water cooled collet grips and a two zone resistance heating furnace with a temperature control system for each zone. The machine is shown in Figure 13.

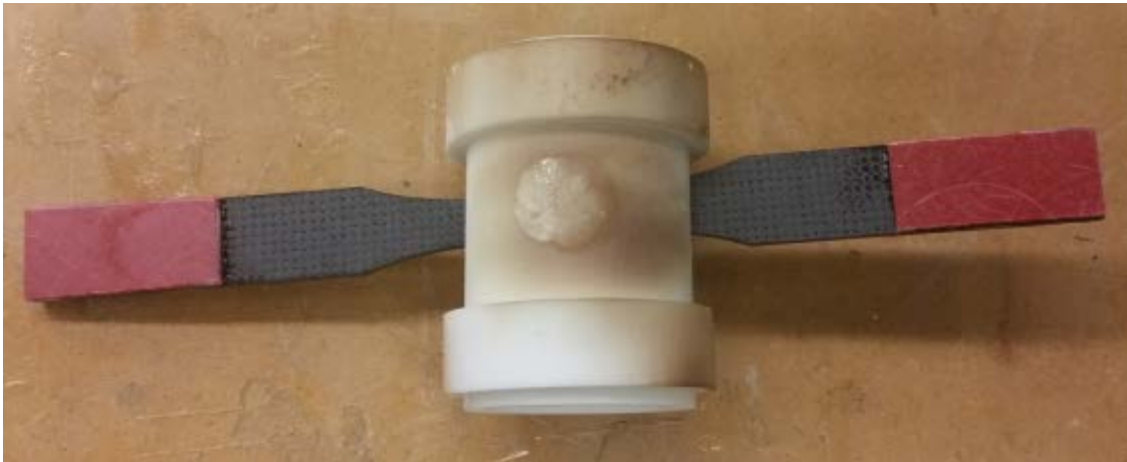
**Figure 14. Test Specimen with alumina susceptor.**

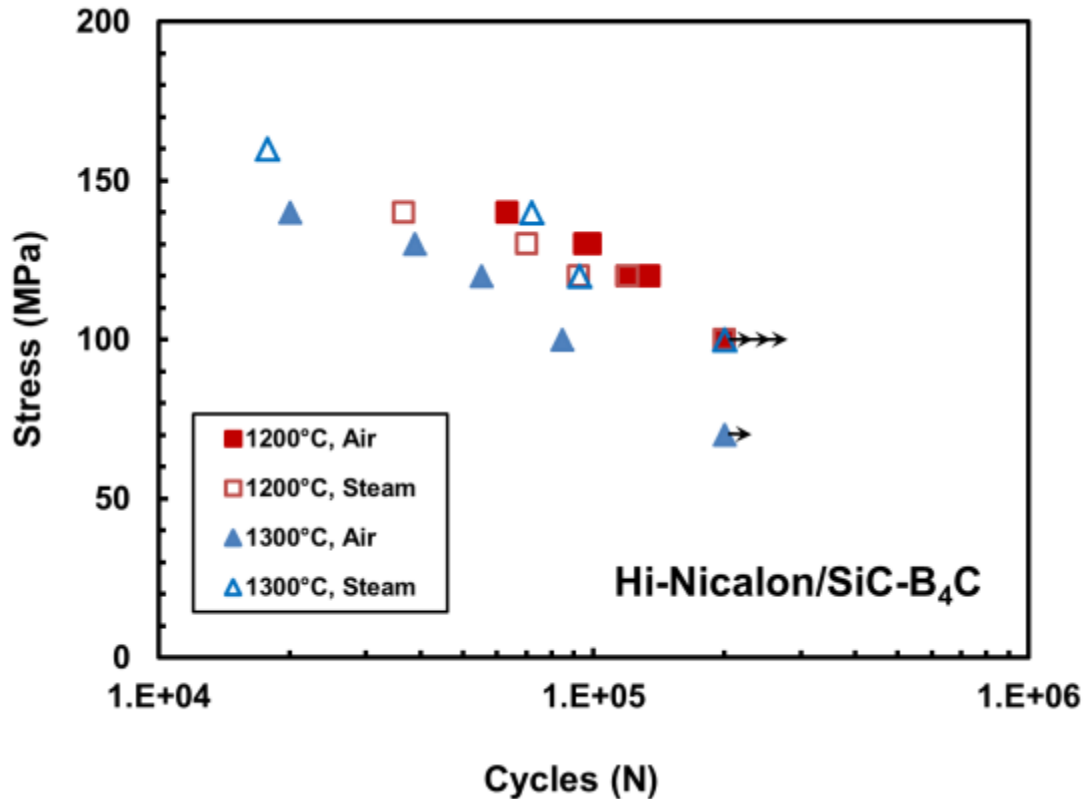
**Figure 21. Stress vs. cycles to failure for dogbone-shaped specimens of Hi-Nicalon/SiC-B<sub>4</sub>C ceramic composite at 1200°C and 1300°C in air and in steam. Data at 1200°C from Delapasse[10].**

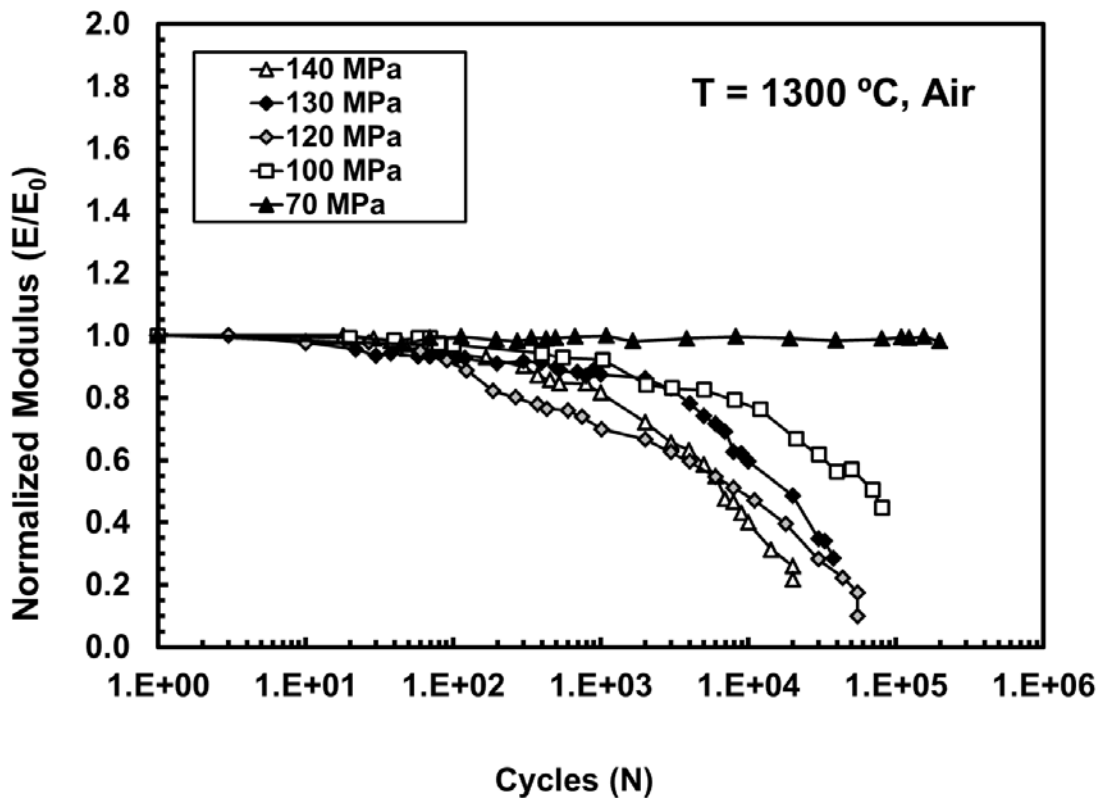
Figure 25. Normalized modulus vs. fatigue cycles for Hi-Nicalon/SiC-B<sub>4</sub>C at 1300°C in air.

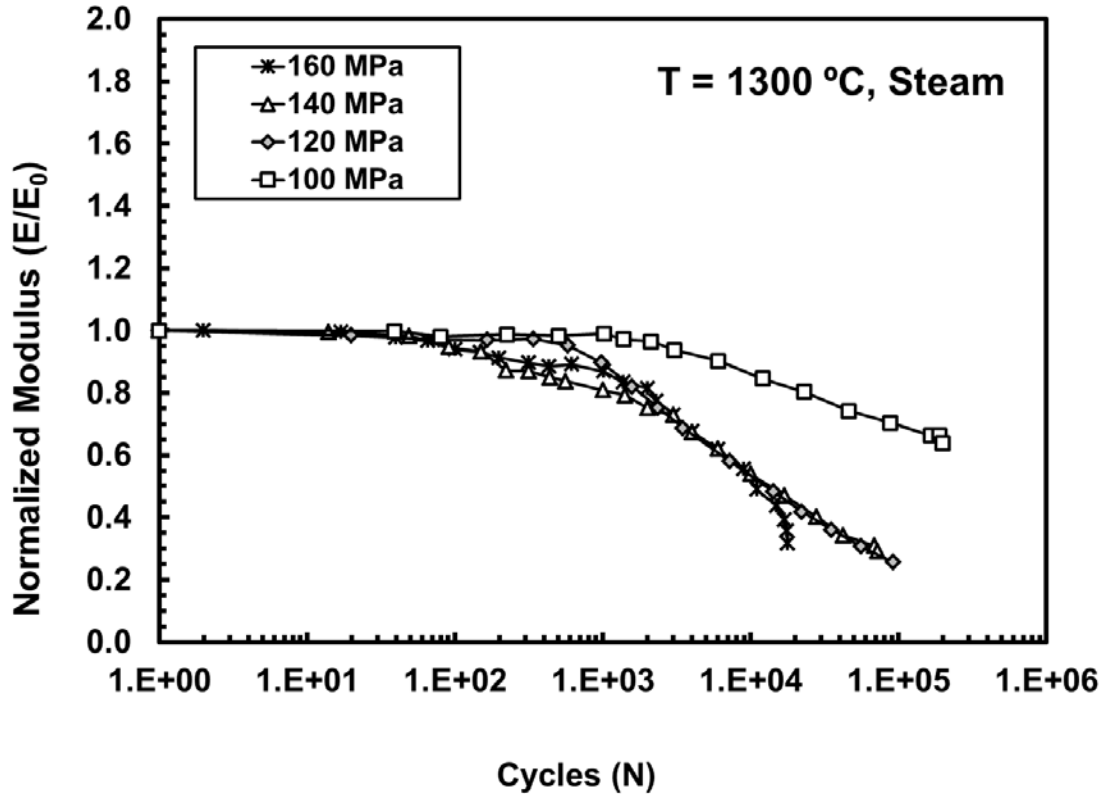
**Figure 26. Normalized modulus vs. fatigue cycles for Hi-Nicalon/SiC-B<sub>4</sub>C at 1300°C in steam.**

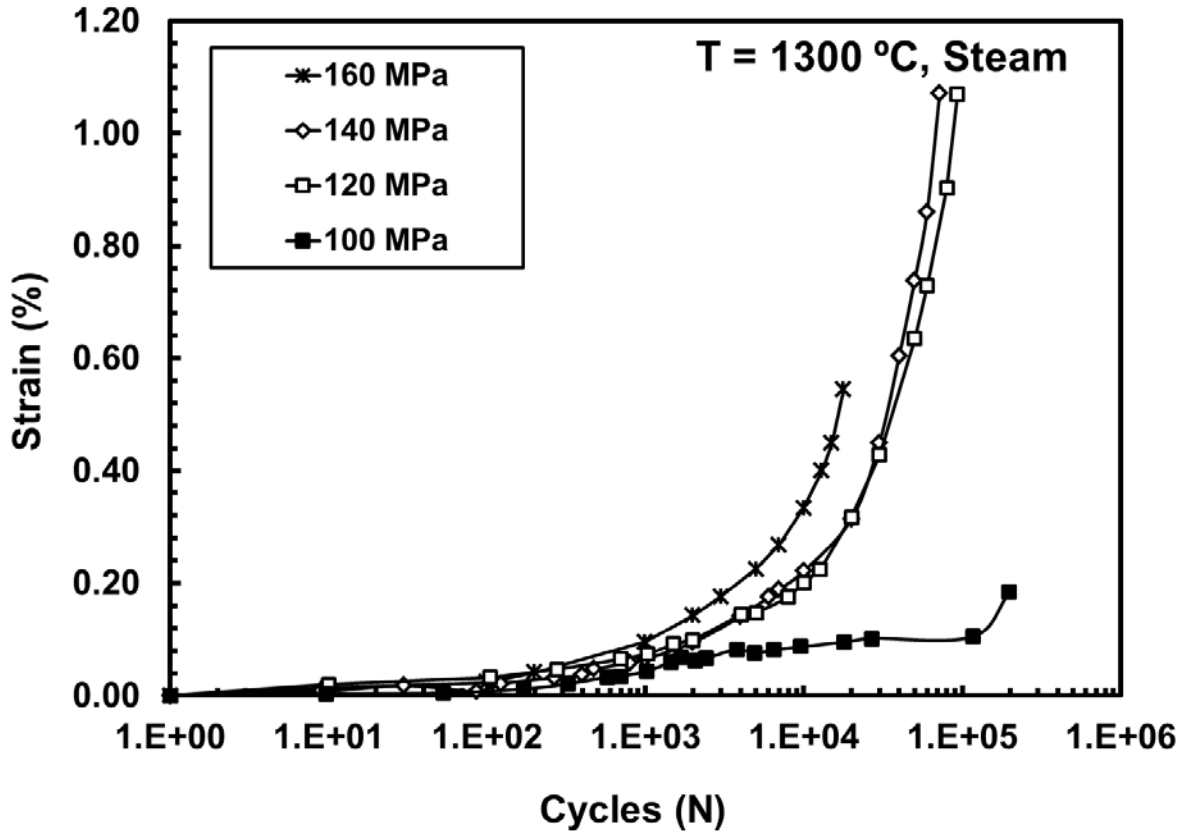
**Figure 30. Accumulated strain vs. fatigue cycles for Hi-Nicalon/SiC-B<sub>4</sub>C at 1300°C in steam.**

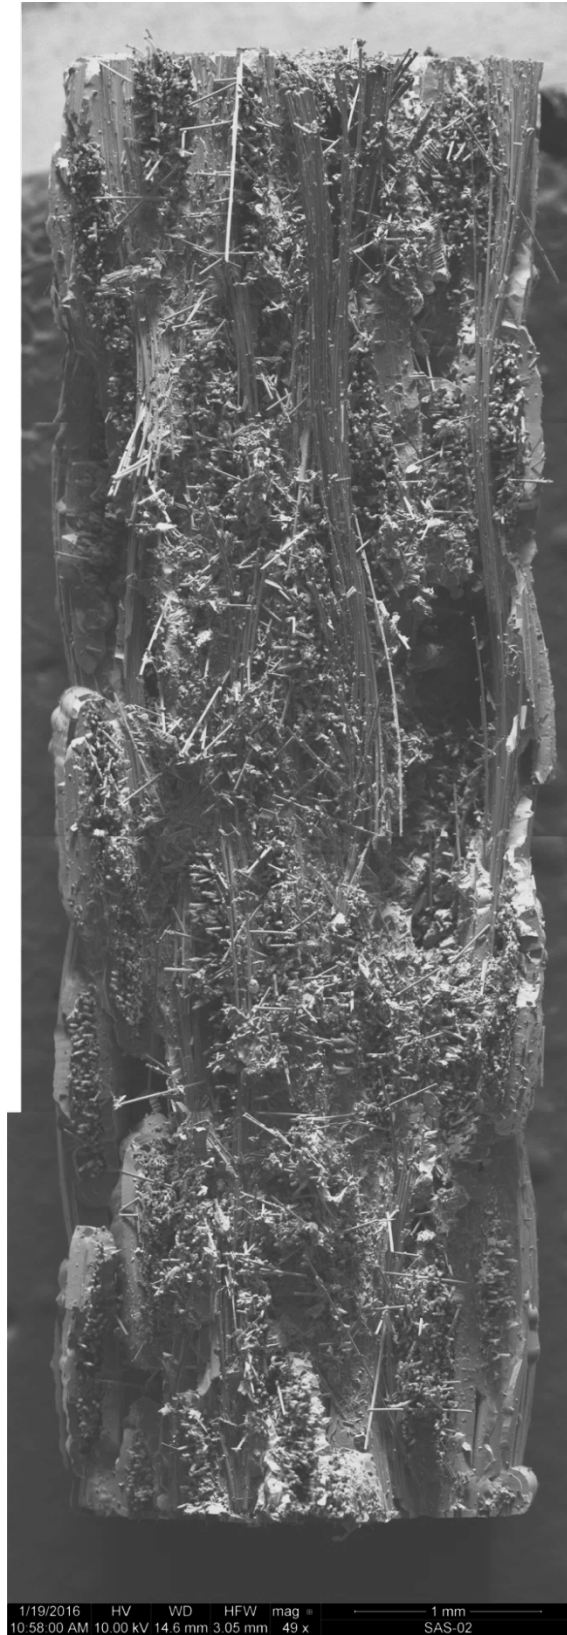
**Figure 37. SEM micrograph of fracture surface of the specimen tested in tension to failure at 1300 °C.**

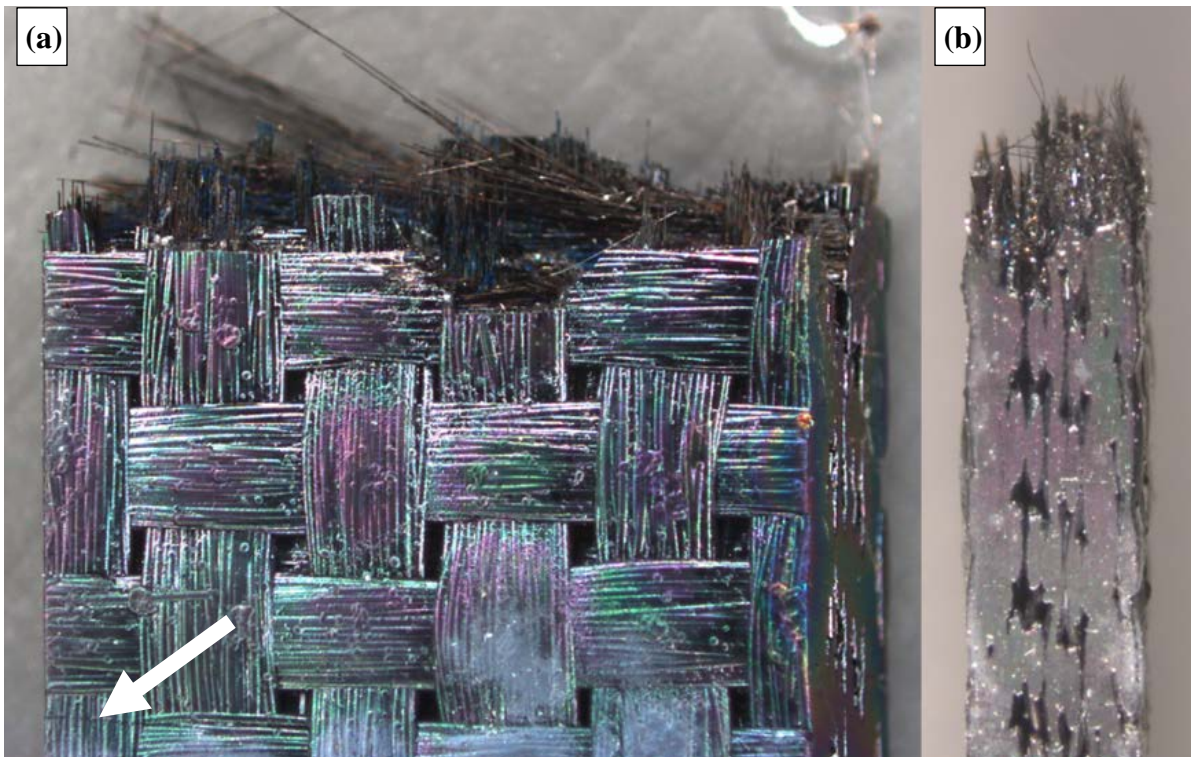
**Figure 42. Optical micrograph of fracture surface of the DB-shaped specimen tested in fatigue at 1300°C in steam.  $\sigma_{\max} = 160$  MPa,  $N_f = 17,811$ ,  $t_f = 4.9$  h. (a) front, (b) side.**

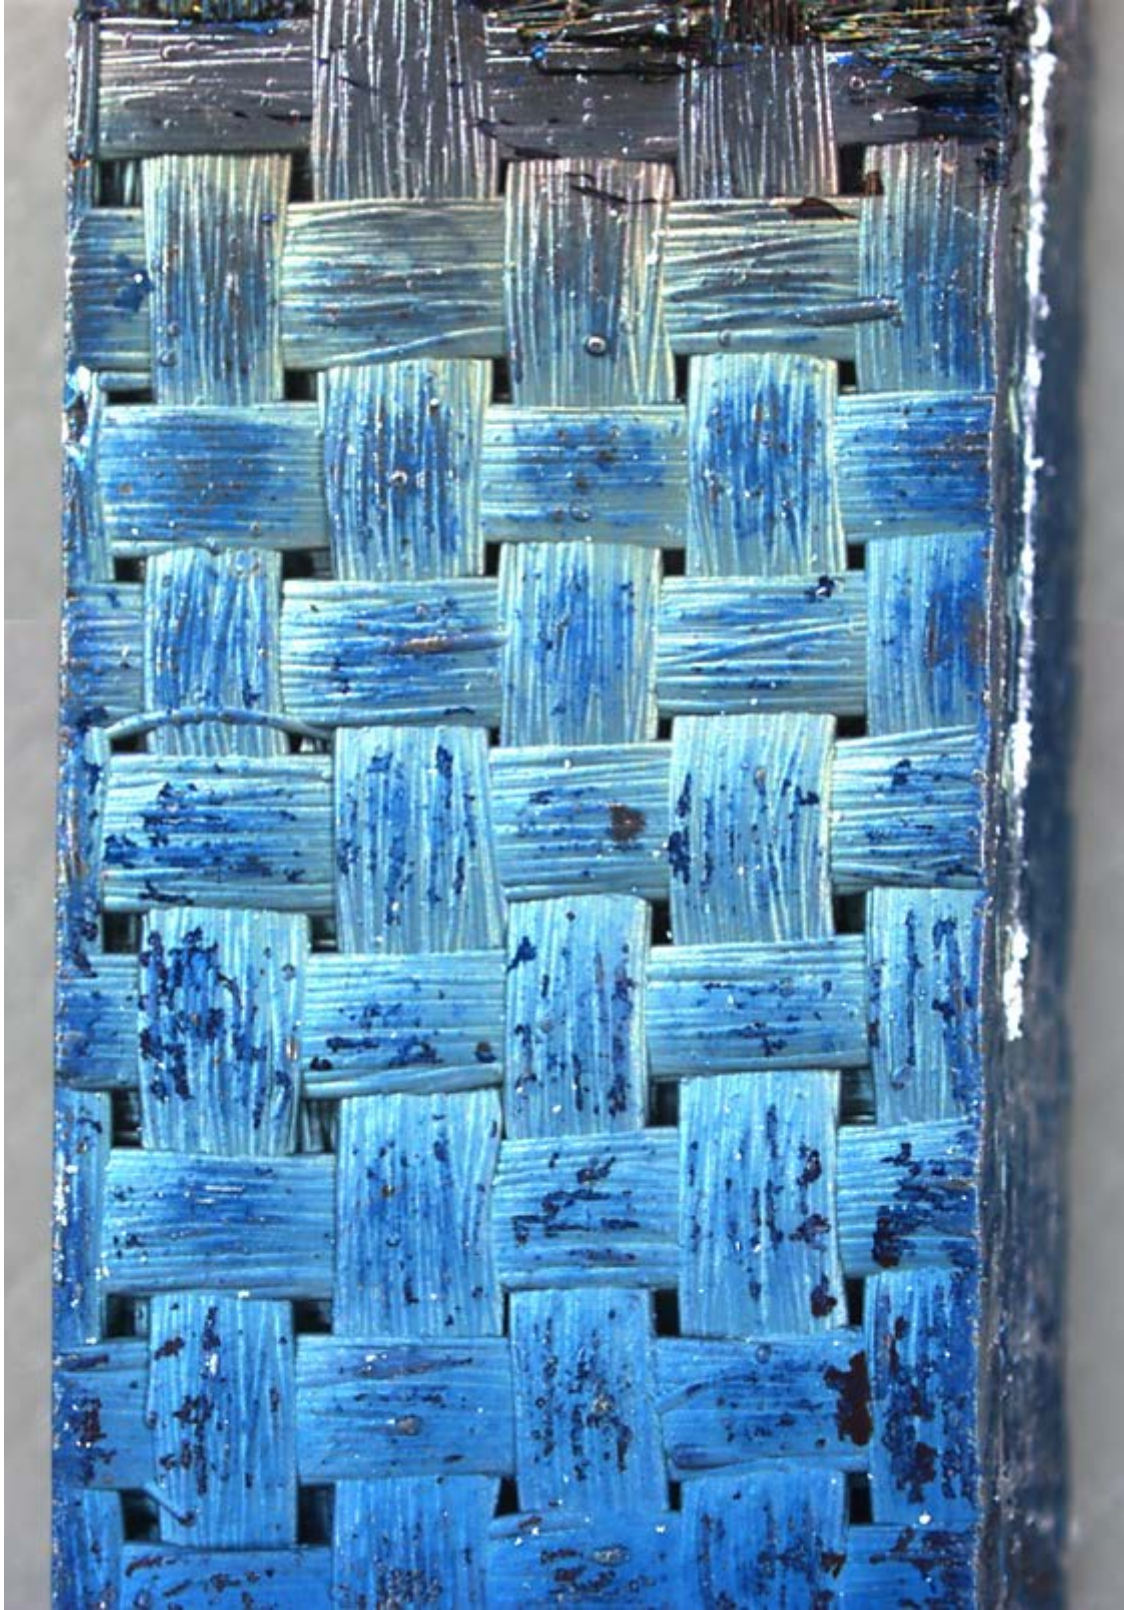
**Figure 46. Gage section of the DB-shaped specimen L97, tested in tension to failure at 0.05 mm/s at 1300°C in air.**

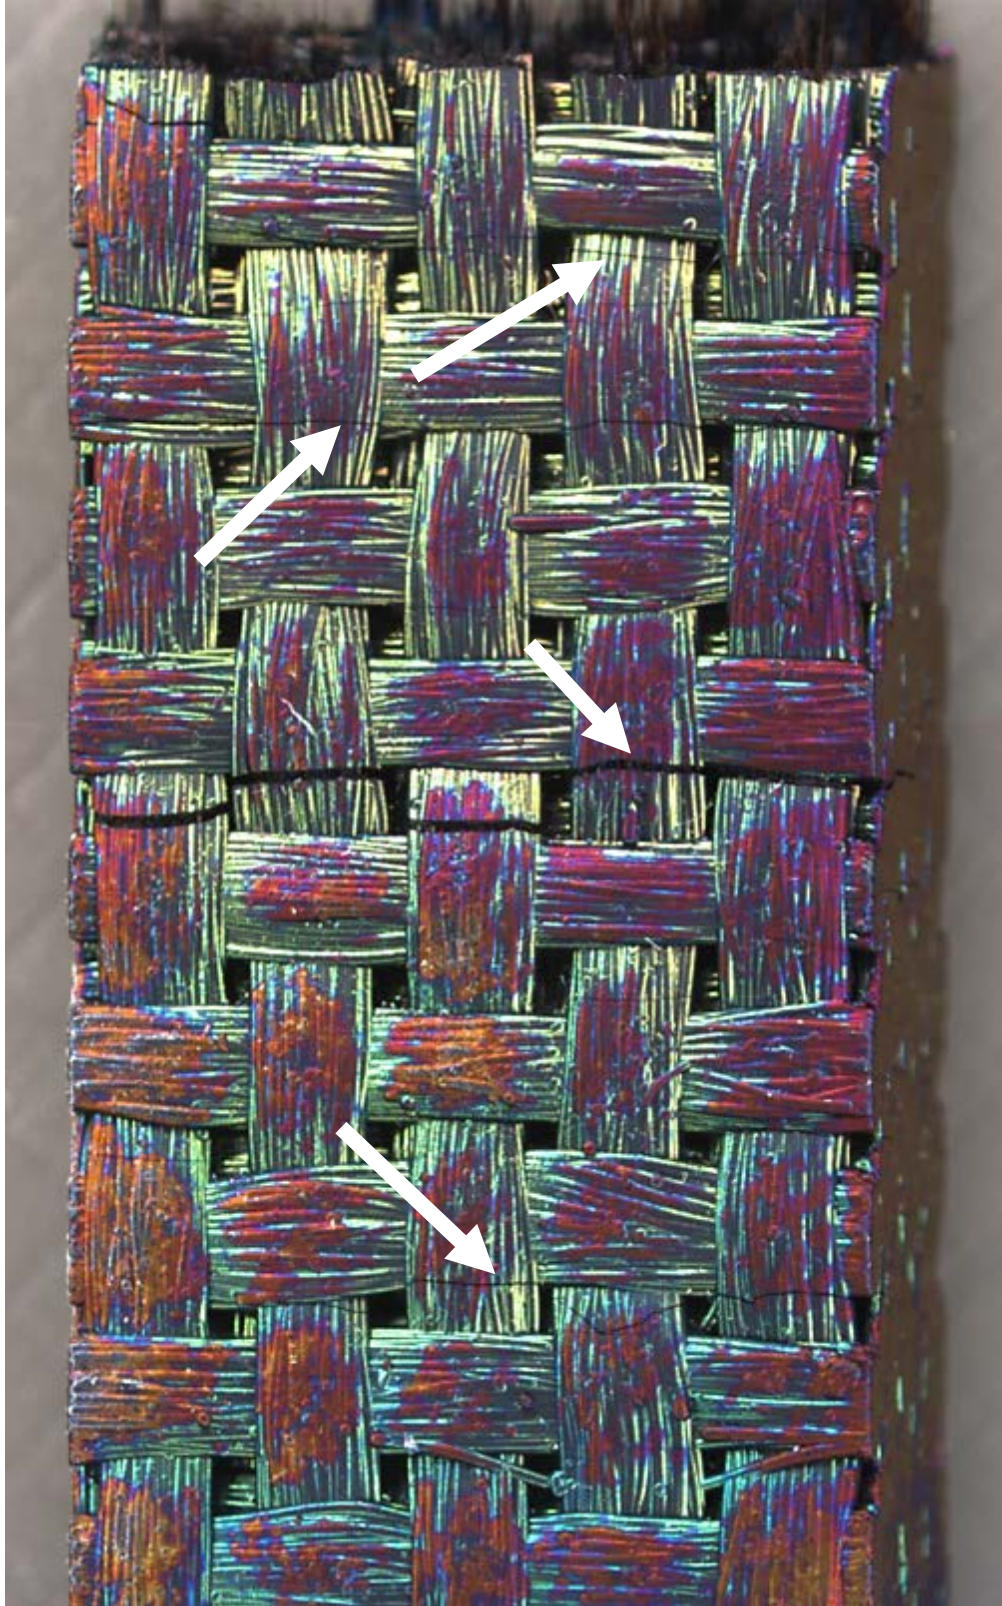
Figure 47. Gage section of the DB-shaped specimen tested in fatigue at 1300°C in air,  $\sigma_{\max} = 140$  MPa,  $N_f = 20,069$ ,  $t_f = 5.6$  h. Transverse cracks of the 0° fiber bundles are visible on the specimen surface.

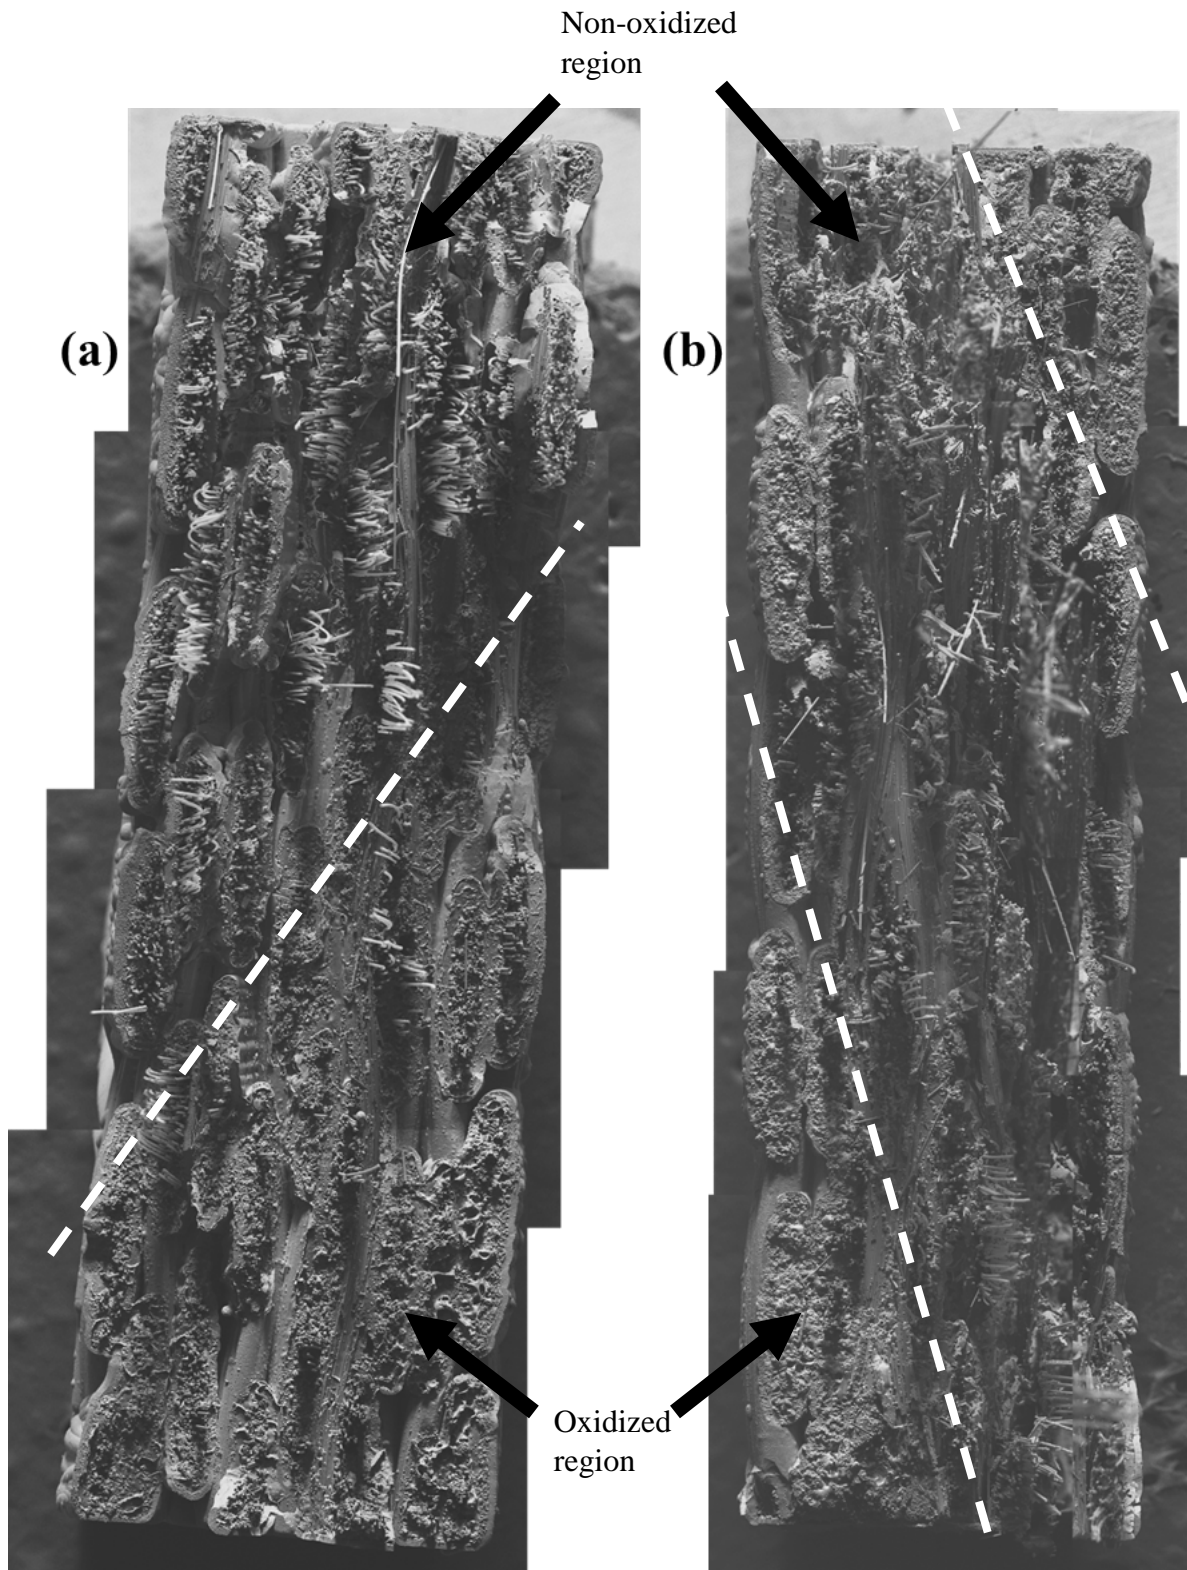
**Figure 53. Fracture surface of the DB-shaped specimens tested in fatigue at 1.0 Hz at 1300°C in steam. (a)  $\sigma_{\max} = 140$  MPa,  $N_f = 72,074$ ,  $t_f = 20.0$  h. (b)  $\sigma_{\max} = 100$  MPa,  $N_f = 200,000$ ,  $t_f = 55.6$  h**

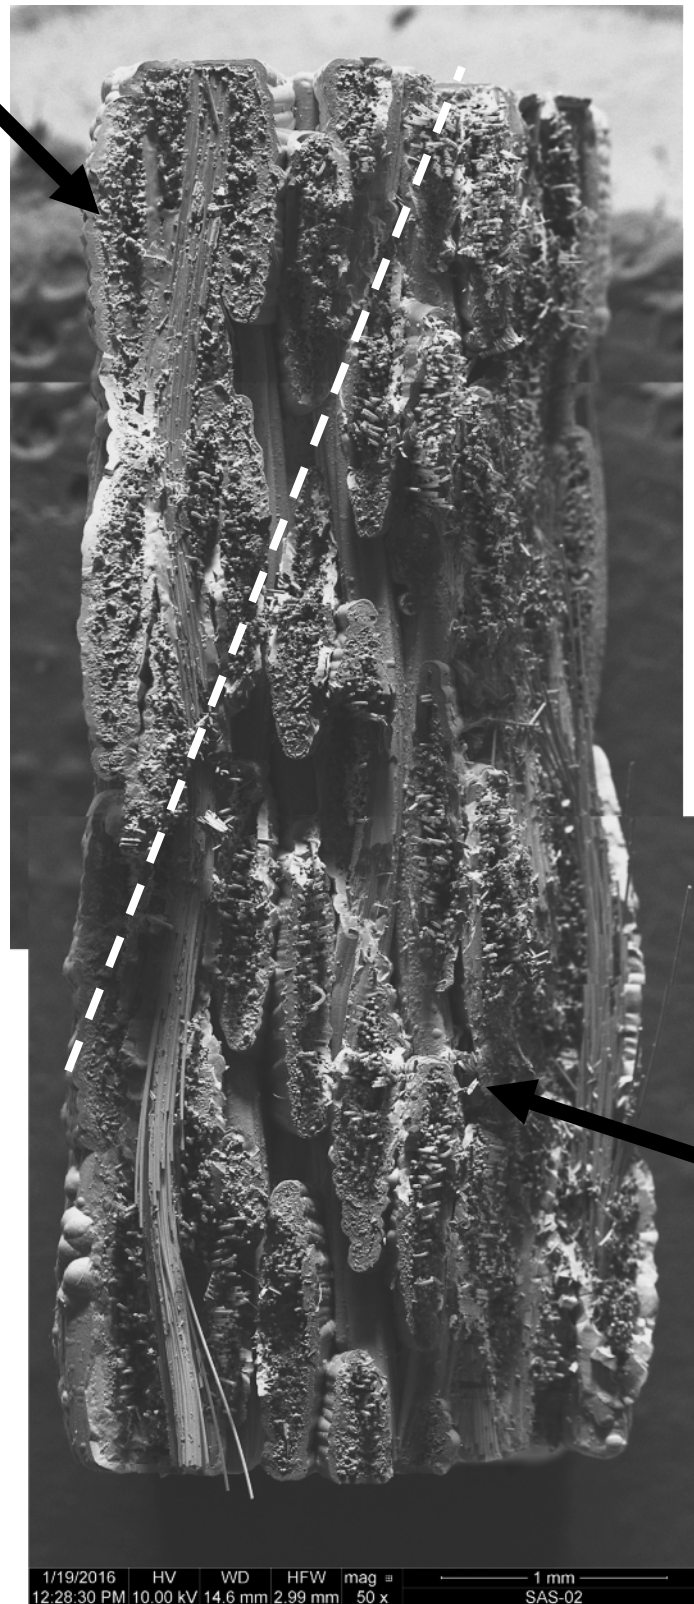
Oxidized region

Non-oxidized region

Figure 57. Fracture surface of the HG-shaped specimens tested in fatigue at 1.0 Hz at 1300°C in steam.  $\sigma_{\max} = 150$  MPa,  $N_f = 13,266$ ,  $t_f = 3.7$  h.

The representative fracture surfaces obtained for the HG-shaped specimens tested in air and in steam are presented in Figure 56 and Figure 57, respectively. The fracture surfaces in Figs. 56 and 57 exhibit distinctive signs of oxidation, although the oxidized regions are relatively

small. It is noteworthy that the fracture surfaces of the HG-shaped specimen tested in fatigue in air (Figure 56) is similar to that of the DB-shaped specimen subjected to fatigue in air (Figure 50a). Likewise, the fracture surfaces of the HG-shaped specimen (Figure 57) and of the DB-shaped specimen (Figure 53 (a)) tested in fatigue in steam exhibit similar morphology. The morphology of the fracture surface is influenced by test environment and test duration, but is little affected by specimen geometry. Higher magnification images showing different features of the fracture surfaces of the HG-shaped specimens tested in fatigue in air and in steam are provided for Figure 58 and Figure 59, respectively. We note once more that the typical features seen in the fracture surface of the HG-shaped specimen tested in air (Figure 58) are similar to those seen in the fracture surface of the DB-shaped specimen tested in air (Figure 53). Likewise the higher magnification images of the fracture surface of the HG-shaped specimen tested in steam (Figure 59) display features similar to those seen in the fracture surface of the DB-shaped specimen tested in stem (Figure 54). While all the specimens that failed in fatigue had similar fracture surfaces, the slightly increased fatigue life of the specimens in steam is supported by the presence of large oxidized regions along the fracture surface. This glassy phase would have been generated along propagating cracks sealing the interior of the specimen from further oxidation.

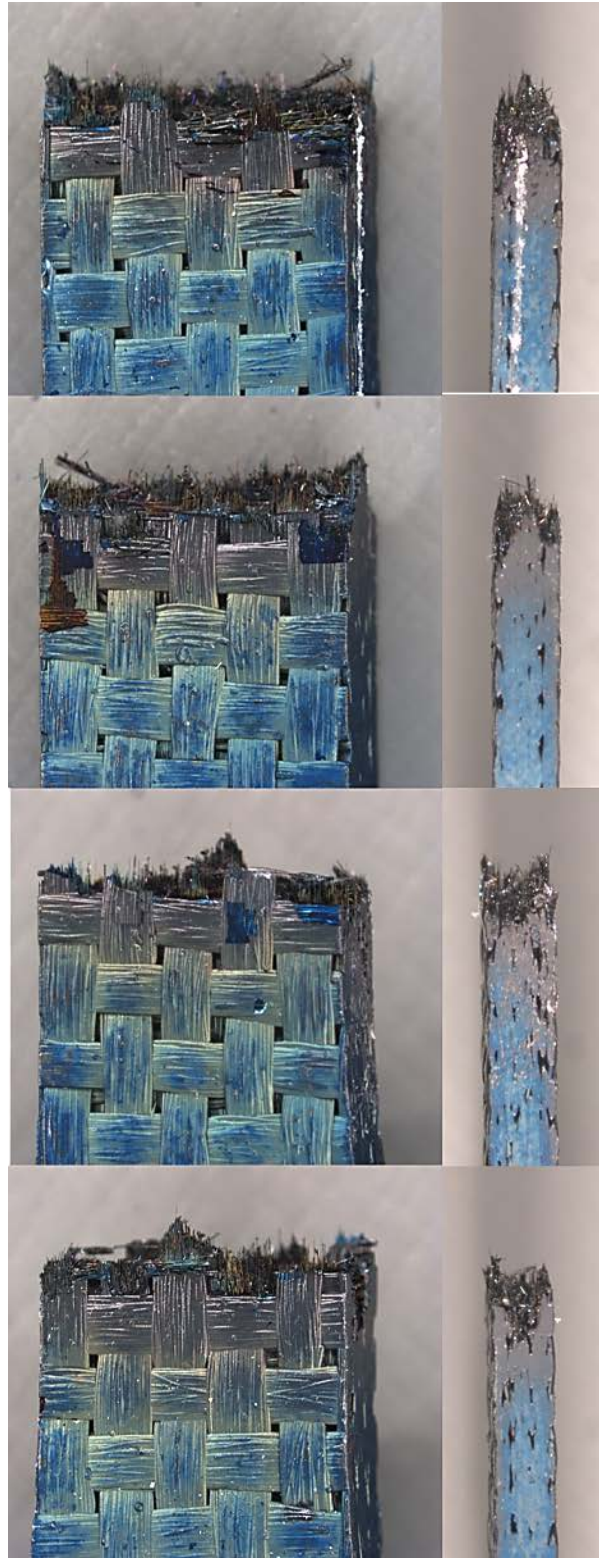
**Figure 60: Fracture surface of the specimen tested in tension to failure at 1300 °C in air, 0.05 mm/s.**

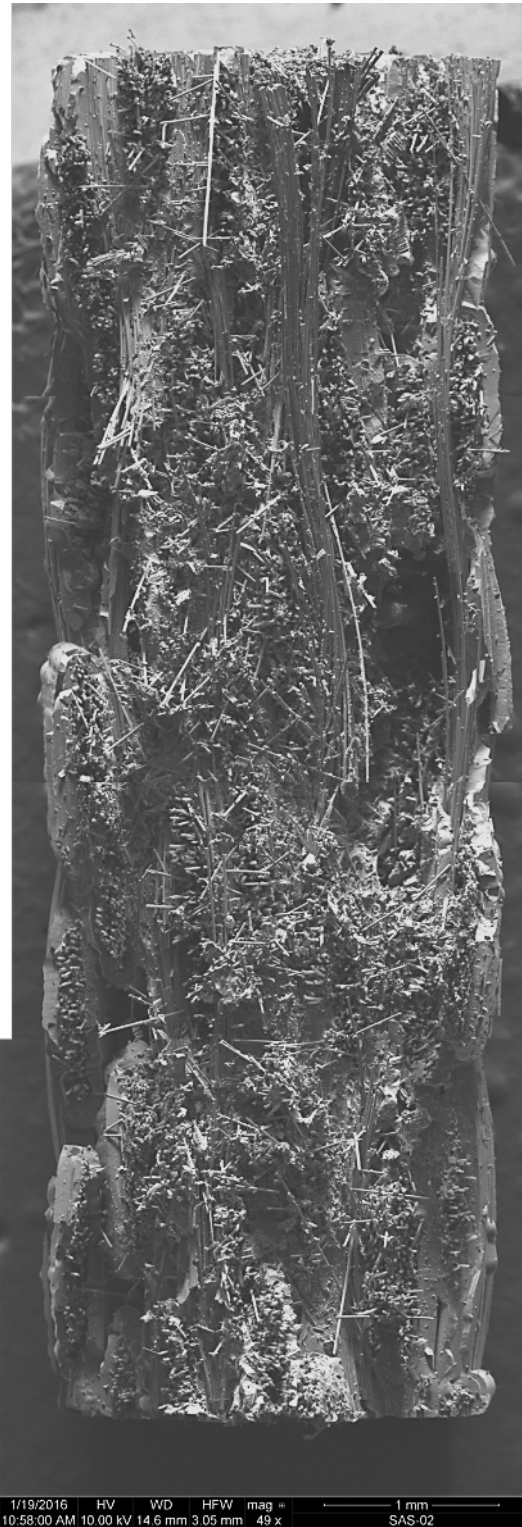
Figure 80: Fracture surface of the specimen tested in tension to failure at 1300 °C.

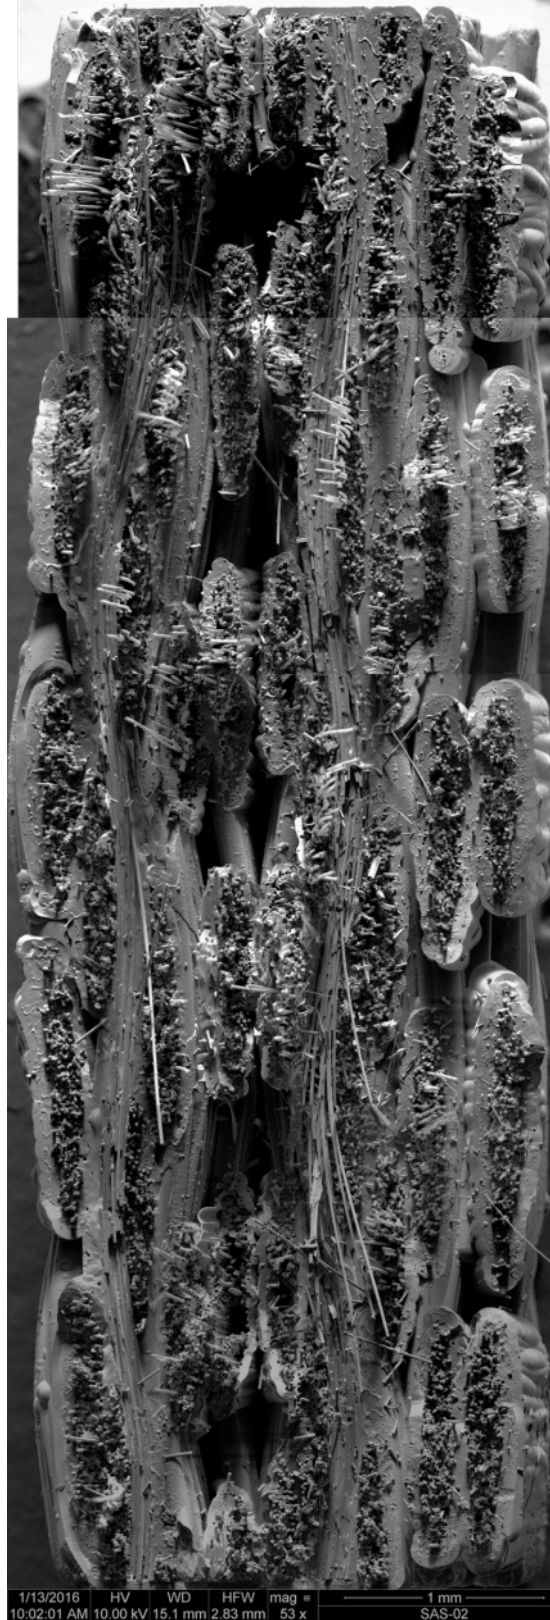
**Figure 82: Fracture surface of the DB-shaped specimen tested in fatigue at 1300°C in air,  $\sigma_{\max} = 140$  MPa,  $N_f = 20,069$ ,  $t_f = 5.6$  h. Oxidation visible around the longitudinal fiber tows.**

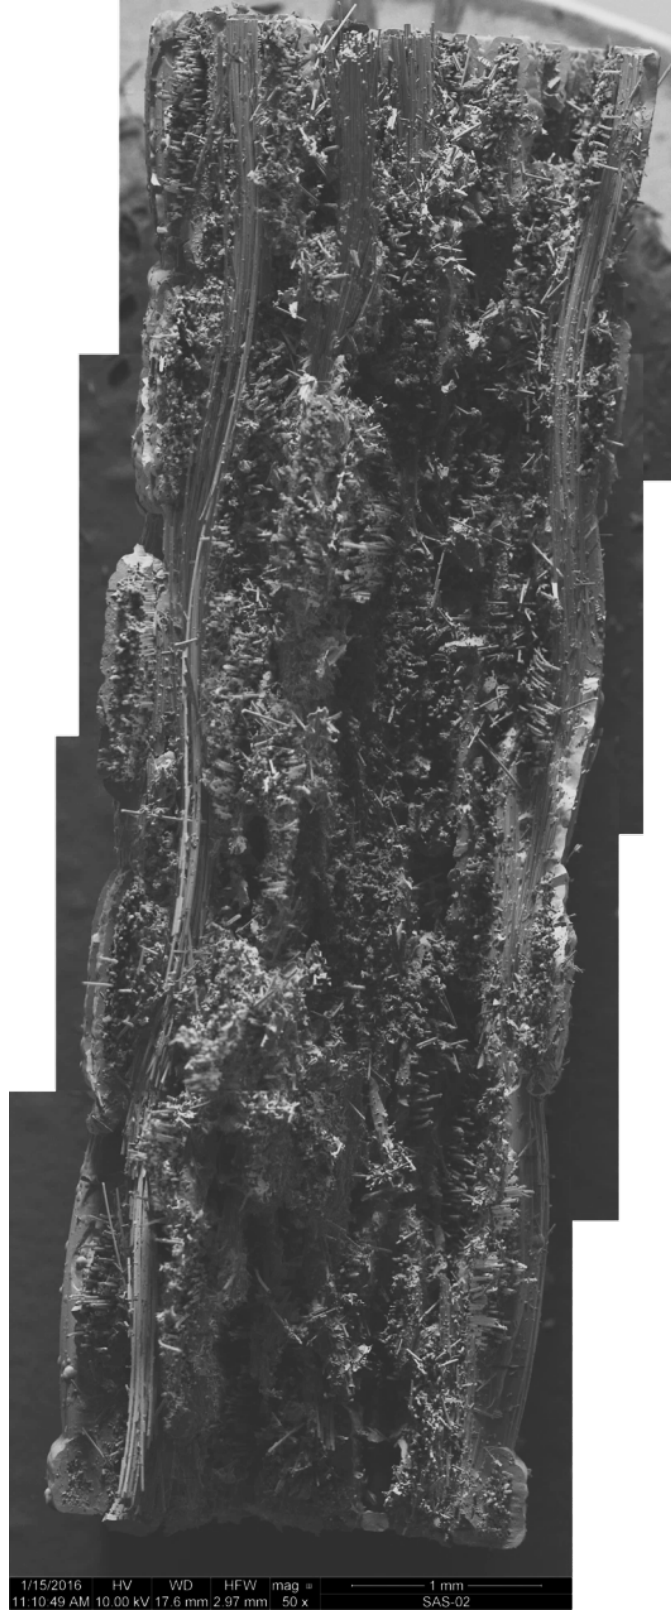
**Figure 90: Fracture surface of the DB-shaped specimen tested in fatigue at 1300°C in air,  $\sigma_{\max} = 70$  MPa,  $N_f = 200,000$ ,  $t_f = 55.6$  h.**

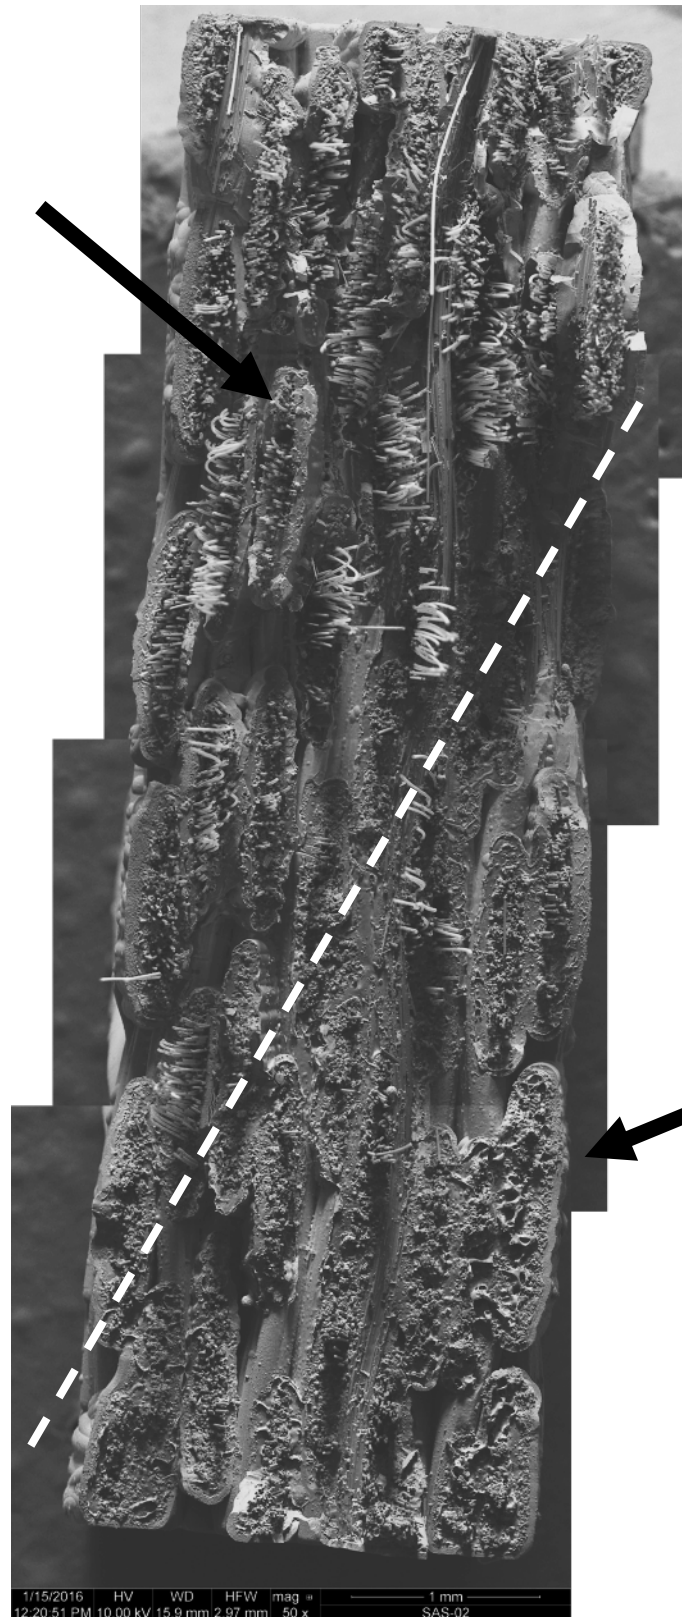
Non-oxidized region

Oxidized region

**Figure 94: Fracture surface of the DB-shaped specimen tested in fatigue at 1300°C in steam,  $\sigma_{\max} = 140$  MPa,  $N_f = 72,074$ ,  $t_f = 20.0$  h.**

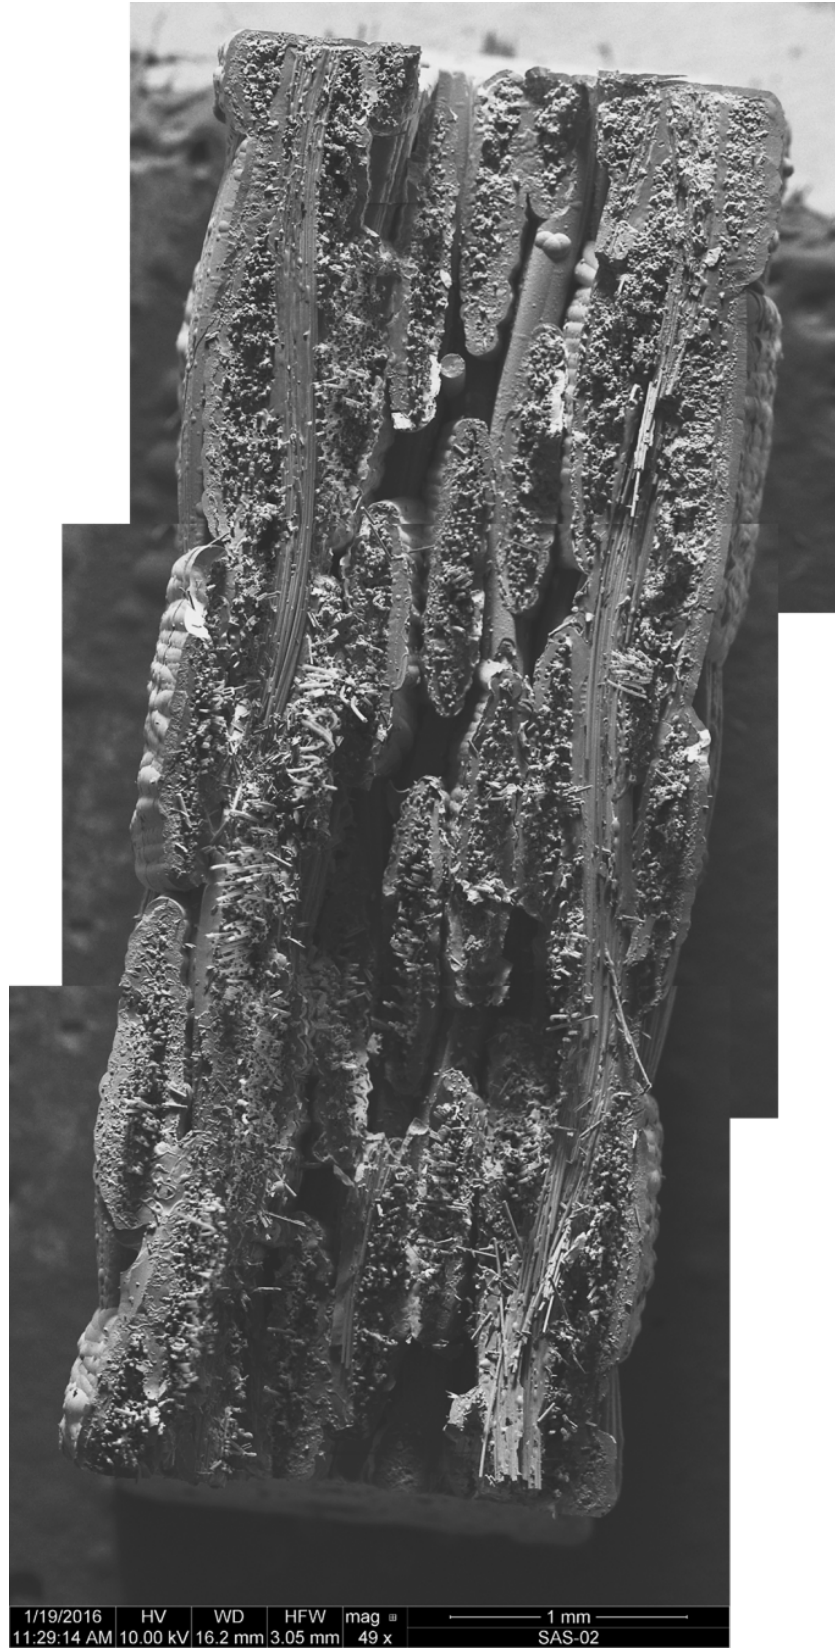
Figure 100: Fracture surface of the HG-shaped specimen tested in fatigue at 1300°C in air,  $\sigma_{\max} = 145$  MPa,  $N_f = 68,831$ ,  $t_f = 19.1$  h.

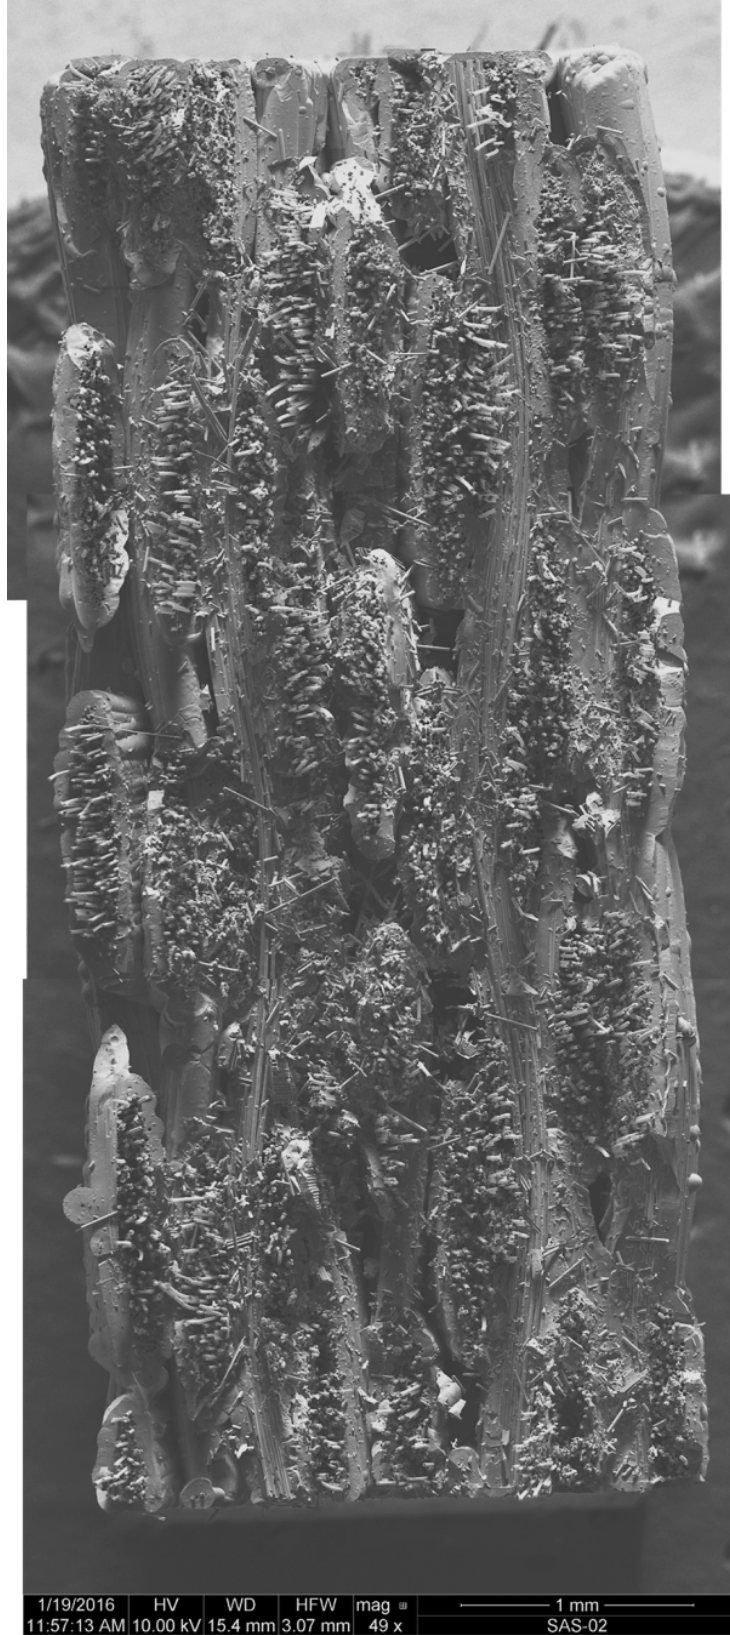
**Figure 102: Fracture surface of the HG-shaped specimen tested in fatigue at 1300°C in air,  $\sigma_{\max} = 80$  MPa,  $N_f = 200,000$ ,  $t_f = 55.6$  h.**

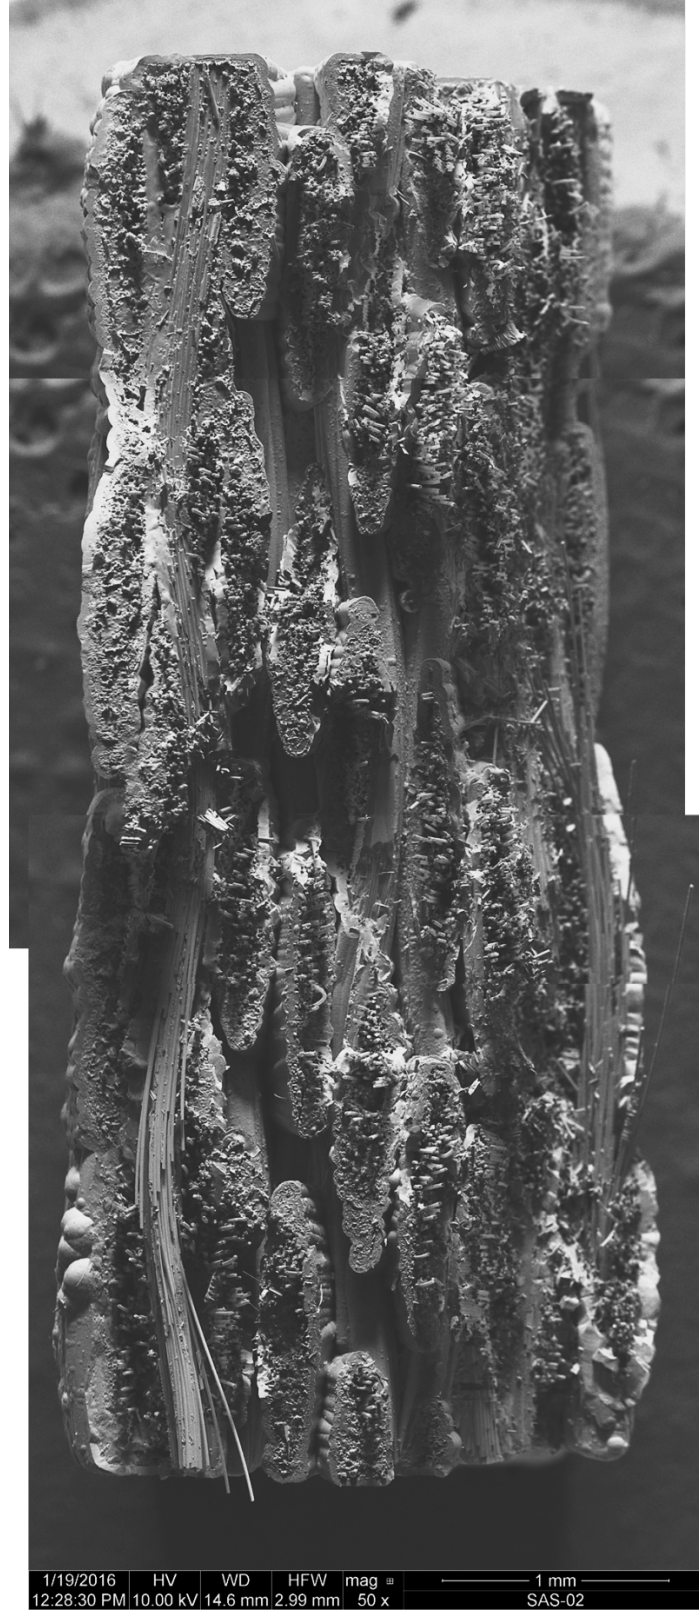
**Figure 104: Fracture surface of the HG-shaped specimen tested in fatigue at 1300°C in steam,  $\sigma_{\max} = 150$  MPa,  $N_f = 13,266$ ,  $t_f = 3.7$  h.**
