# Fatigue behavior of an advanced SiC/SiC composite at 1300° C in air and steam

**Fatigue Behavior of an Advanced SiC/SiC Composite at 1300° C in Air and Steam**

**FATIGUE BEHAVIOR OF AN ADVANCED SIC/SIC COMPOSITE WITH AN  
OXIDATION INHIBITED MATRIX AT 1300°C IN AIR AND IN STEAM**

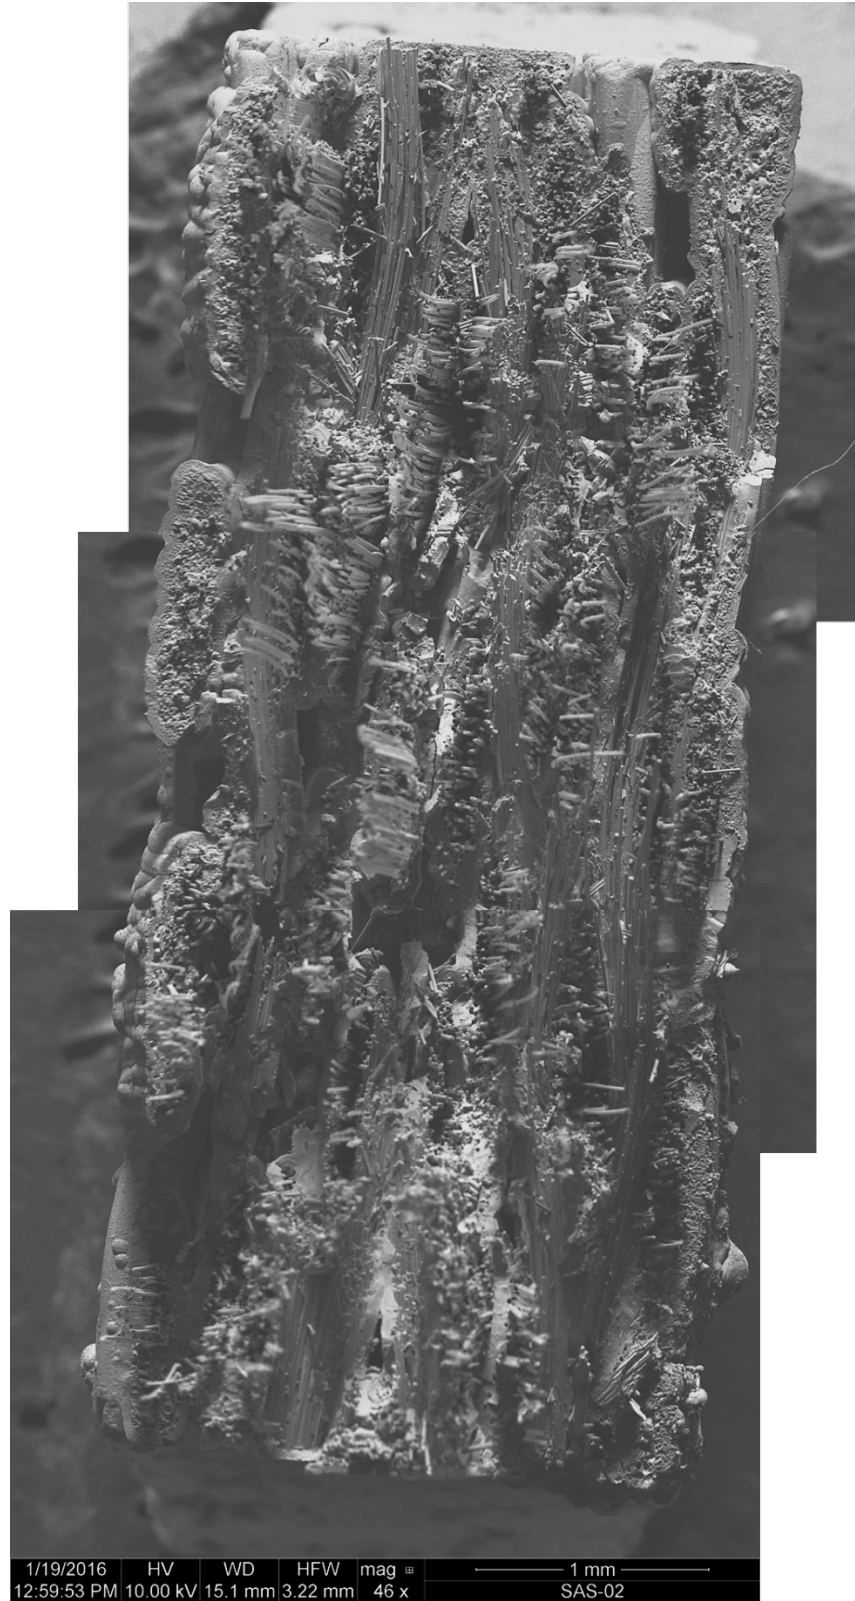
**Figure 106: Fracture surface of the HG-shaped specimen tested in fatigue at 1300°C in steam,  $\sigma_{\max} = 100$  MPa,  $N_f = 200,000$ ,  $t_f = 55.6$  h.**
