# Field testing of multiple span railroad flatcar bridges on low volume roads

A thesis submitted to the graduate faculty  
in partial fulfillment of the requirements for the degree of  
MASTER OF SCIENCE

Major: Civil Engineering (Structural Engineering)

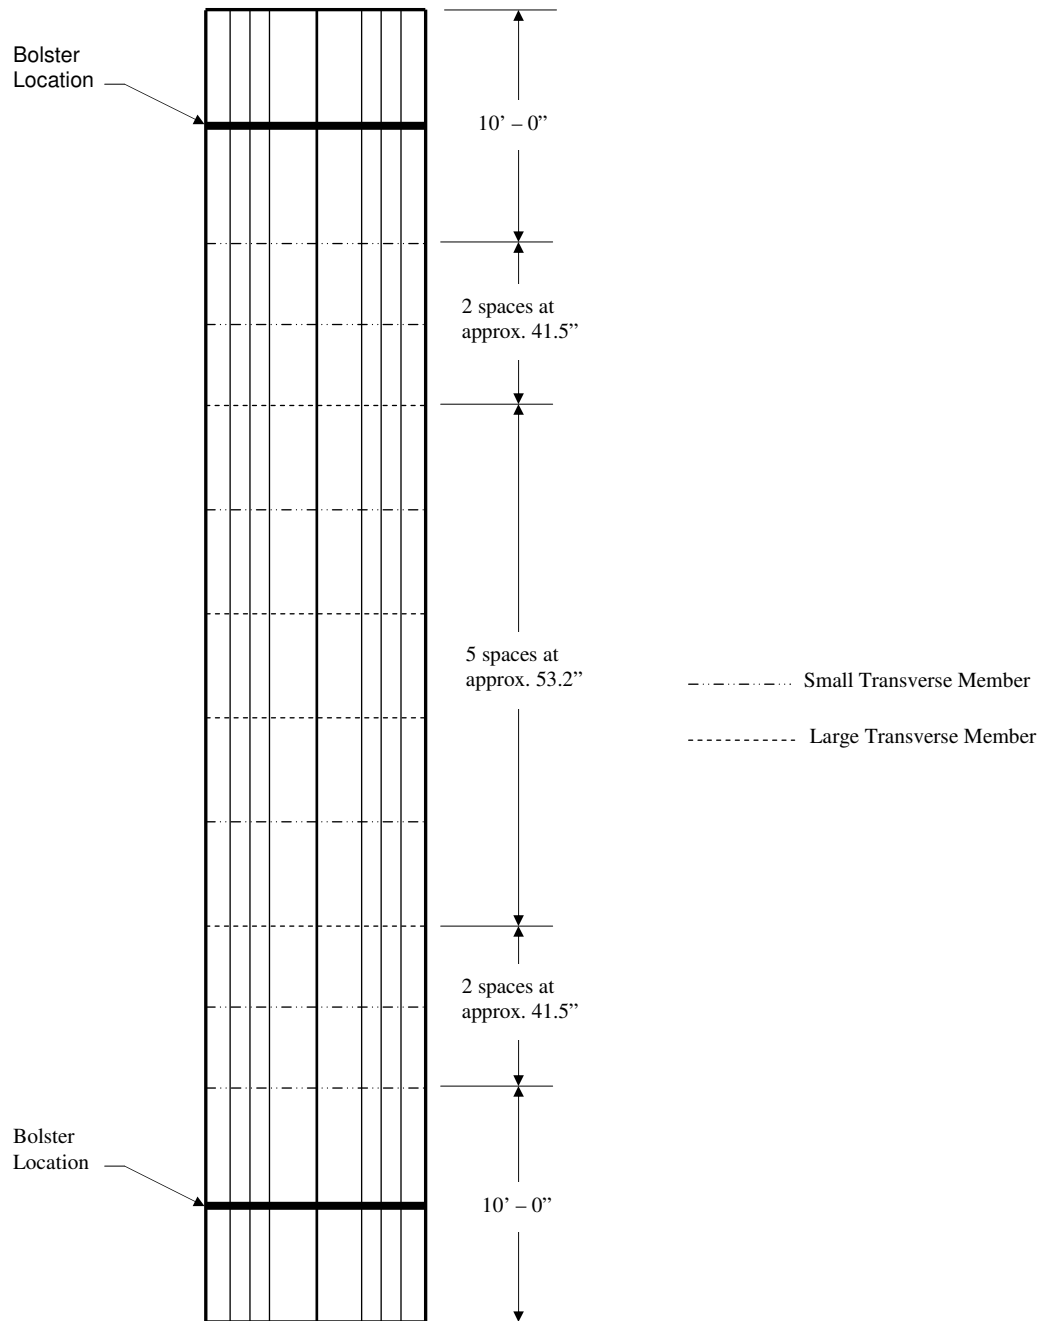
f. Locations of small and large transverse members

Figure 1.1. Continued.

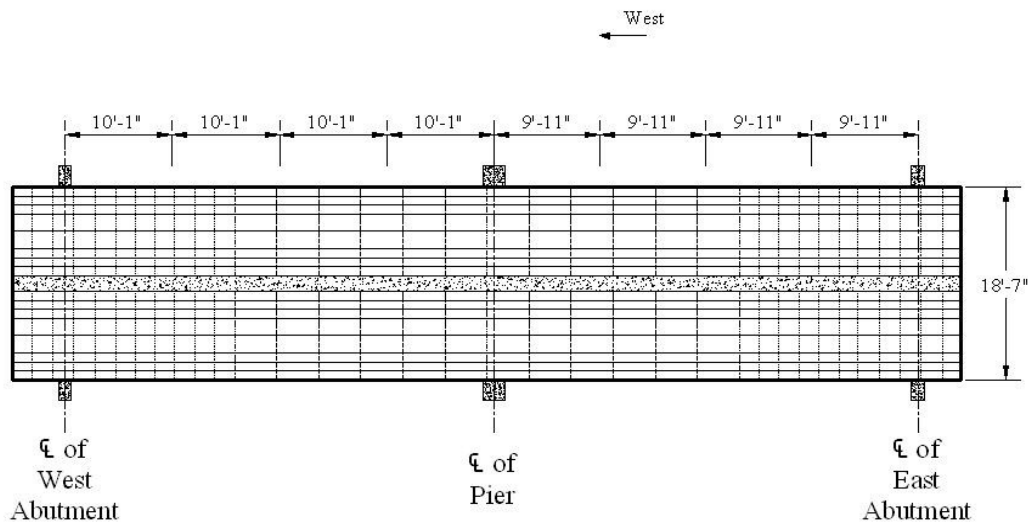
a. Idealized Plan View

Two 89-ft RRFCs were used in the construction of BCB4. The existing bridge single span was significantly longer than the maximum single span length (66 feet) that could be accommodated using RRFCs. Therefore, a new pier was constructed slightly offset from the middle of the span to compliment the existing abutments. The pier is supported by five HP 10x42 piles driven to refusal (approximately 30 feet). Although the existing bridge abutments were used for BCB4, a slight modification was needed. The seat of the abutments needed be raised approximately fourteen inches to facilitate the use of the RRFCs in conjunction with the new pier support. An idealized layout of the bridge with the 1/4 span locations dimensioned is shown in Figure 2.2.

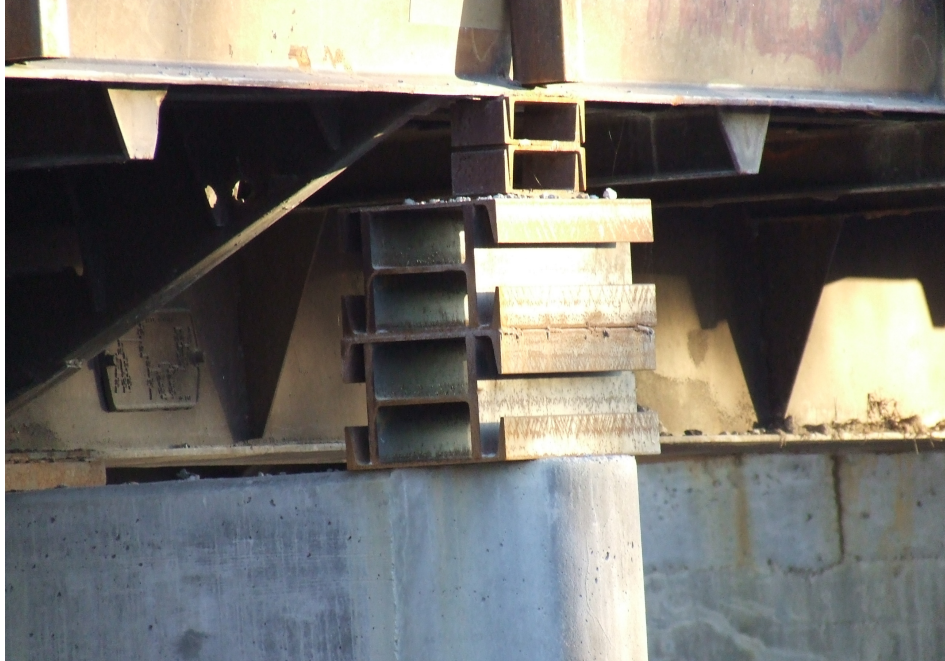
There is no structural connection between the bridge and the concrete supports – the flatcars simply rest on the supports. At the abutments and piers, the interior girders of the bridge are supported by bearing plates. At these same locations, the exterior girders are supported by a stack of W-sections confined by inverted channels as shown in Figure 2.3.

**Figure 2.3. Miscellaneous I-shapes used as exterior girder support.**

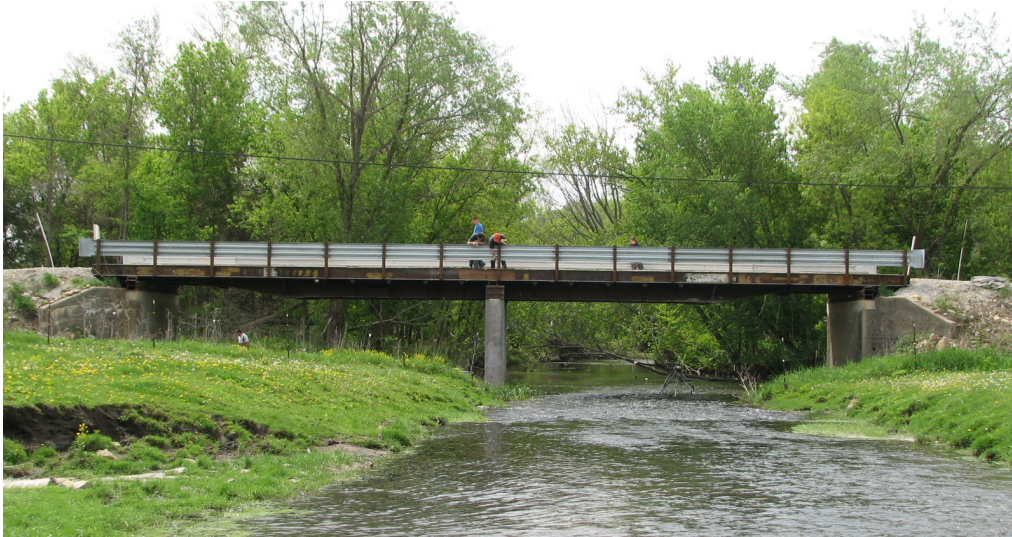
After the flatcars were placed and the longitudinal connection constructed, a layer of non-woven geo-textile fabric was laid over the top surface of the RRFCs to prevent the gravel driving surface from falling through small holes that were in the deck of the RRFC. Approximately four inches of gravel was then added for the driving surface of the bridge after which a guardrail was attached. The finished bridge is shown in Figure 2.4.

**Figure 2.4. Completed Buchanan County RRFC Bridge 4 (BCB4).**

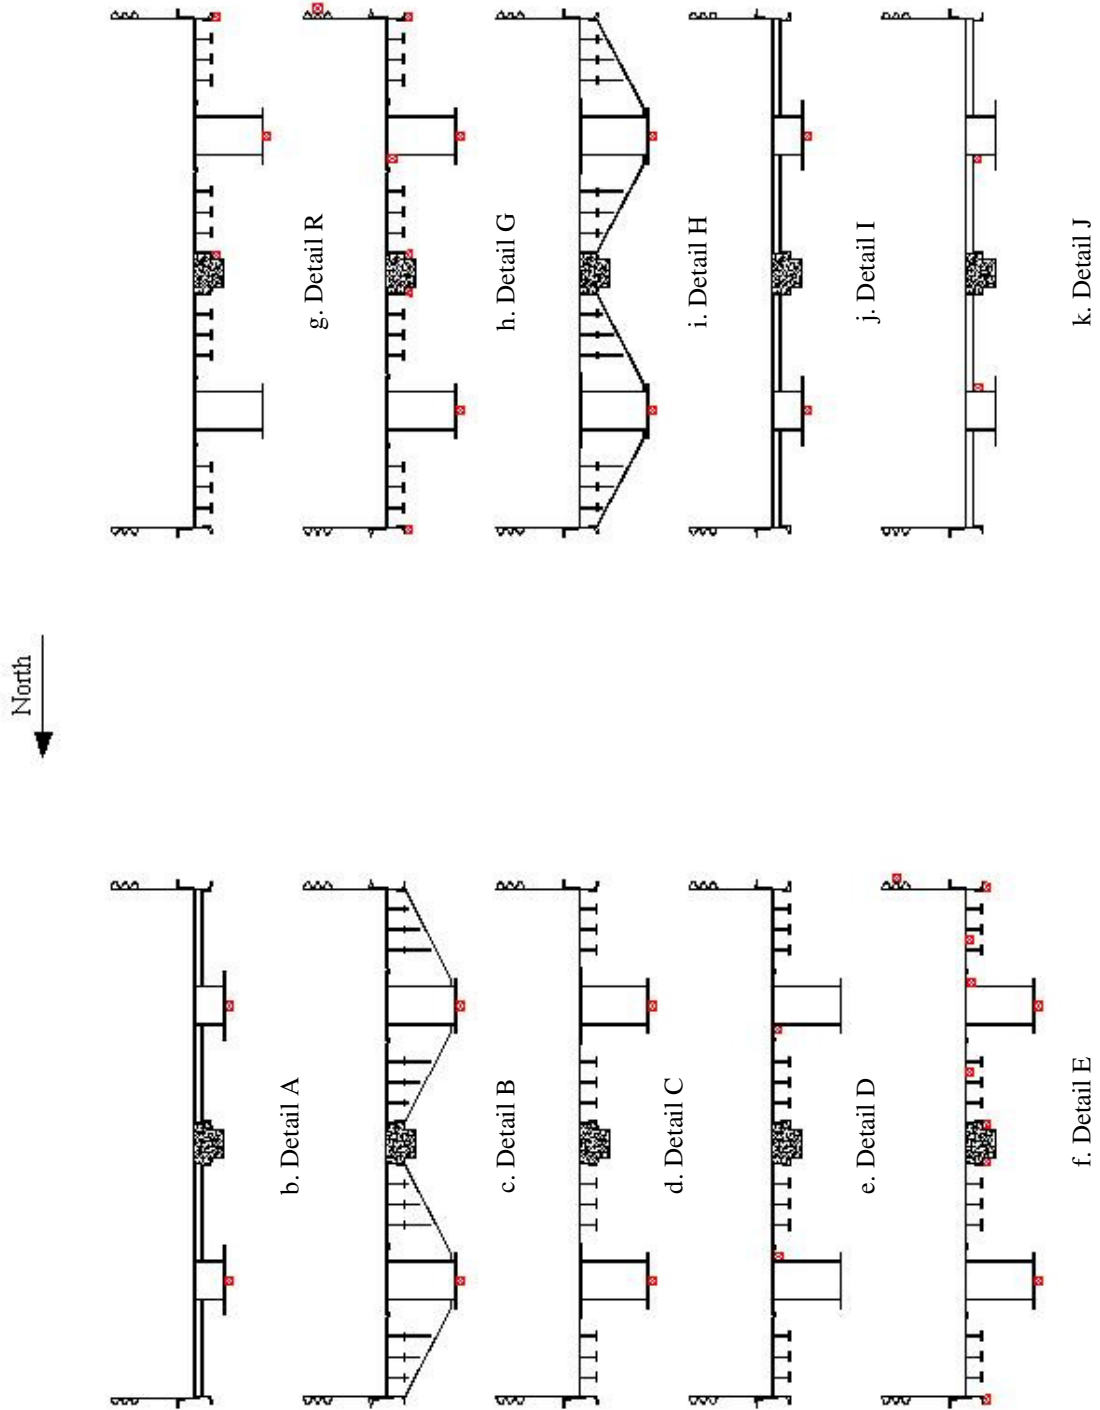
The instrumentation plan for BCB4 is presented in Figure 2.6. As shown in Figure 2.6, 36 BDIs were placed at ten different cross sections along the bridge; sixteen string potentiometers were located on four cross sections along the bridge, as also shown in the figure.

a. Strain Instrumentation

Figure 2.6. BCB4 instrumentation plan.

1. Deflection Instrumentation

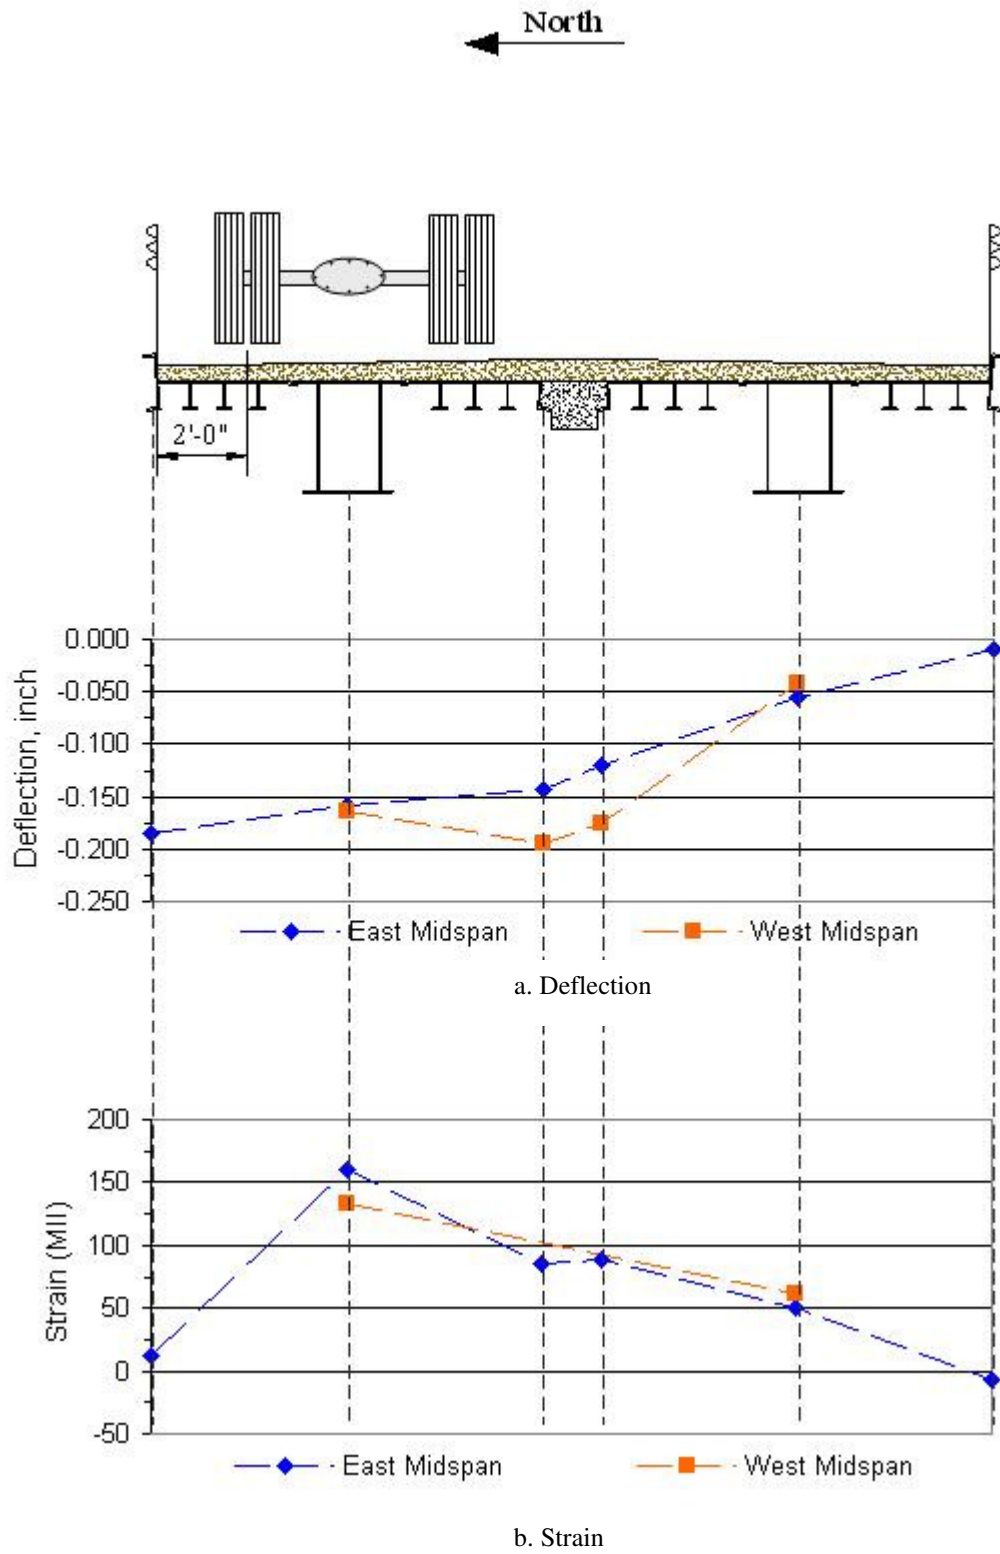
Figure 2.11. BCB4 Lane 1 midspan live load deflections and strains.

The maximum midspan live load deflection for the test vehicle was 0.202 inches, which occurred in the west span of the bridge. The AASHTO *LRFD Bridge Design Specification* recommends a maximum allowable live load deflection of span/800 for legal truck loads [5]. Using this approach, the maximum allowable live load deflection for the west span of BCB4 is 0.596 inches.

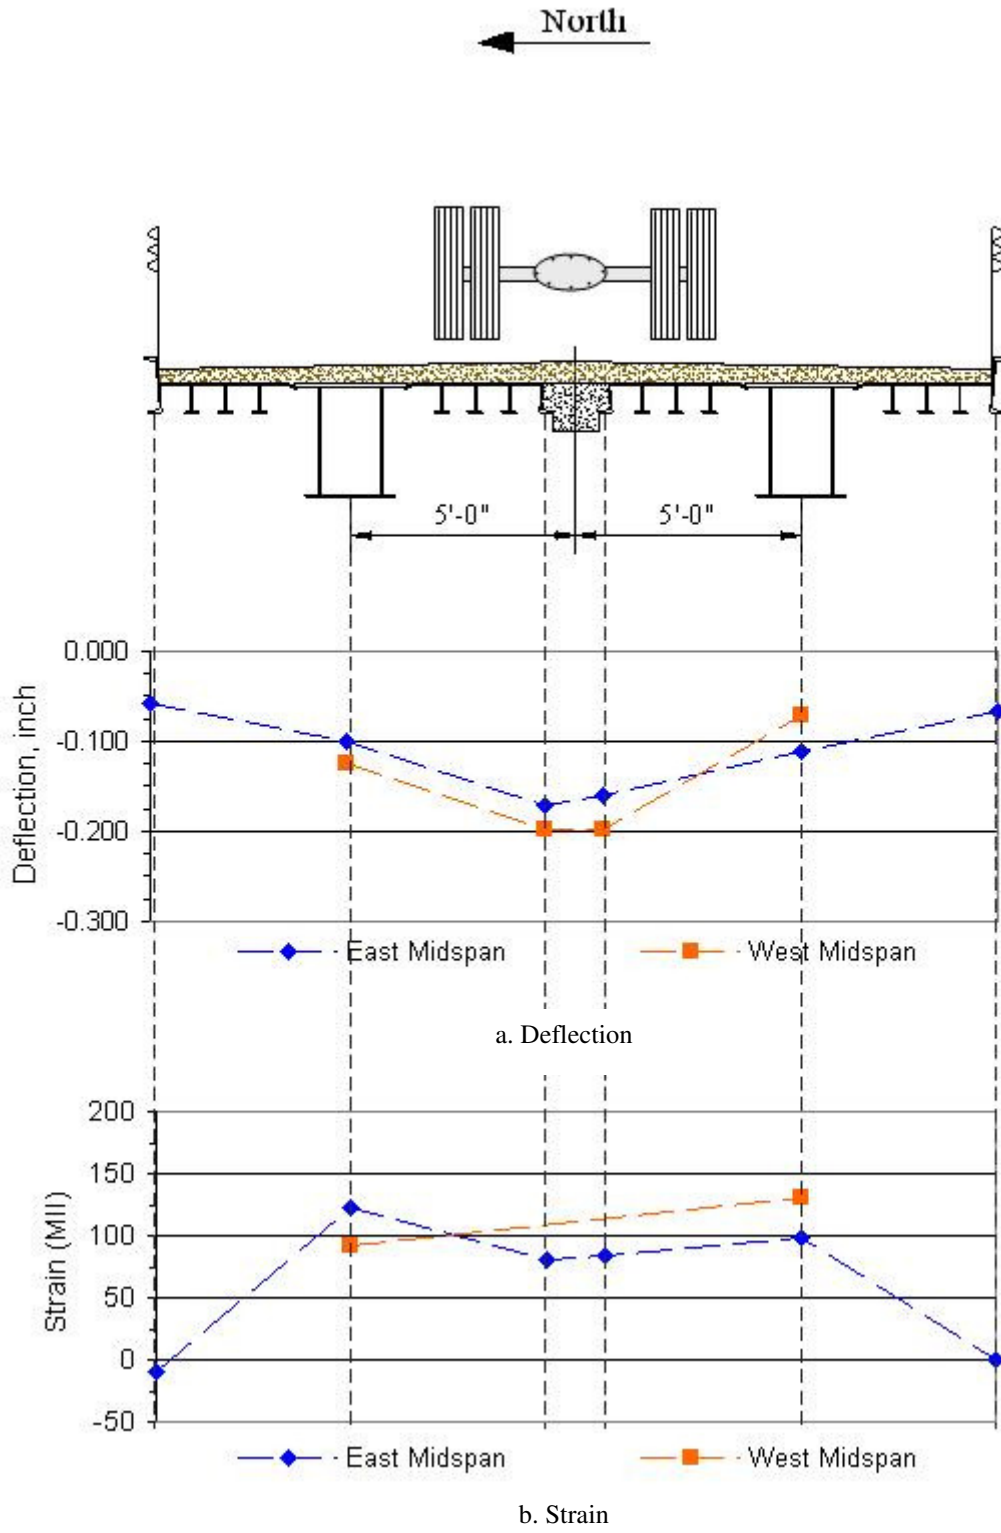
Figure 2.12. BCB4 Lane 2 midspan live load deflections and strains.

After comparing the results presented in Figure 2.12 and 2.14, a discrepancy was discovered in the deflections recorded at the west midspan during the BCB4 field load test. This discrepancy is most evident in Figure 2.14, which has the test vehicle positioned directly over the instrumentation recording the questionable data. At this point, the string potentiometer below main girder of the south RRFC does not agree with corresponding strain data – the strain increases, but the deflection

decreases from the other lane positions. After review of the BCB5 data, a similar discrepancy in the deflection data was discovered. Considering the BCB4 discrepancy, in addition to the similar disagreement with the BCB5 data, an instrumentation problem is believed to be the likely cause of the inconsistent behavior even though no apparent problem was found with the suspected transducers after they were reviewed by the laboratory manager. The BCB5 discrepancy is discussed in further detail in Section 3.5.1.

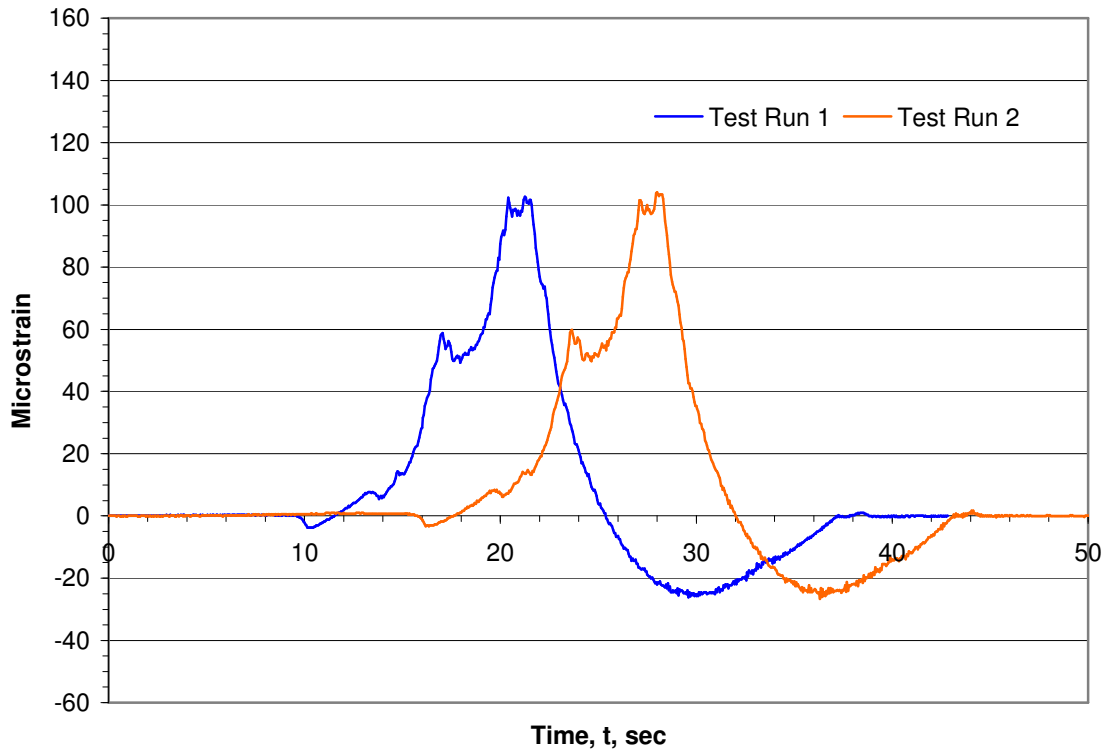
a. BCB4 South Girder Static Strain at East Midspan

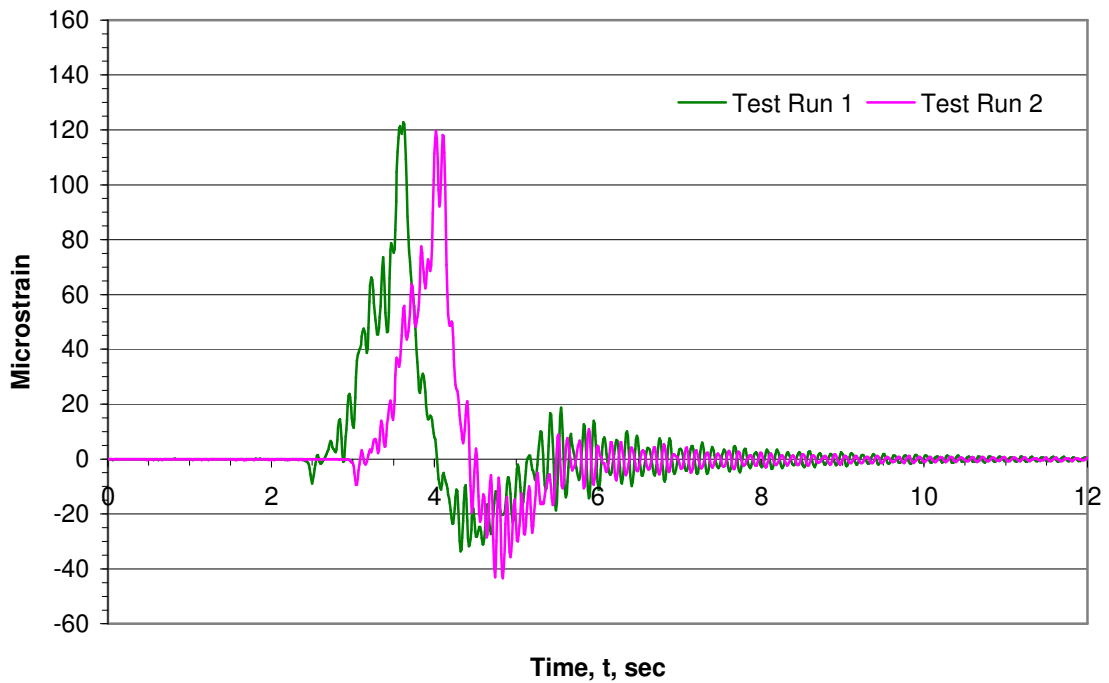
b. BCB4 South Girder Dynamic Strain at East Midspan

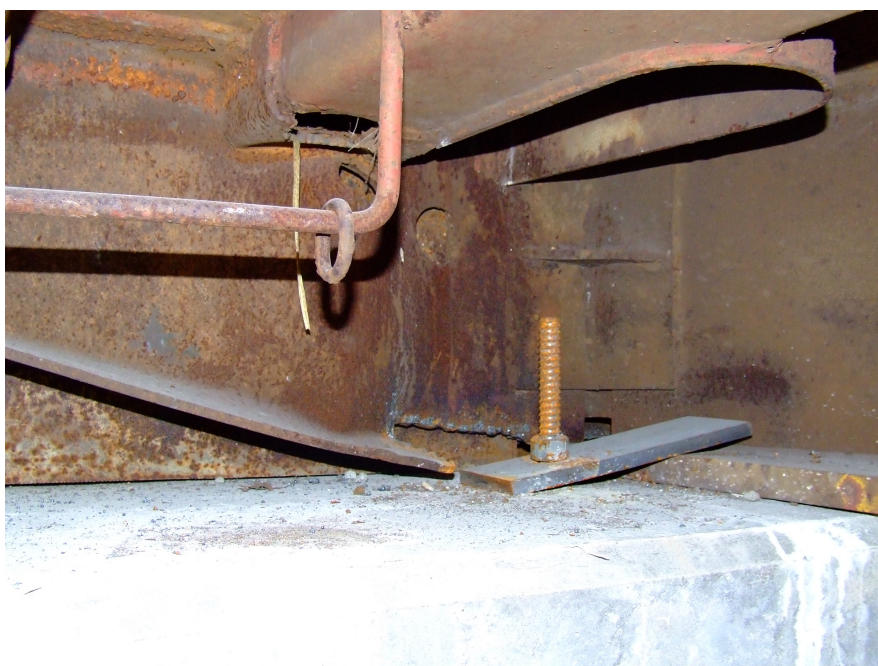
the main girders of the bridge to the supports (Figure 3.3). At the pier, the interior girders are supported on approximately one inch thick neoprene bearing pads while the exterior girders are supported by a single W-section (Figure 3.4). At the abutments, the flatcars rested directly on the concrete, with steel shims as necessary to level the cars.

**Figure 3.3. Clip angle to attach RRFC to abutment.**

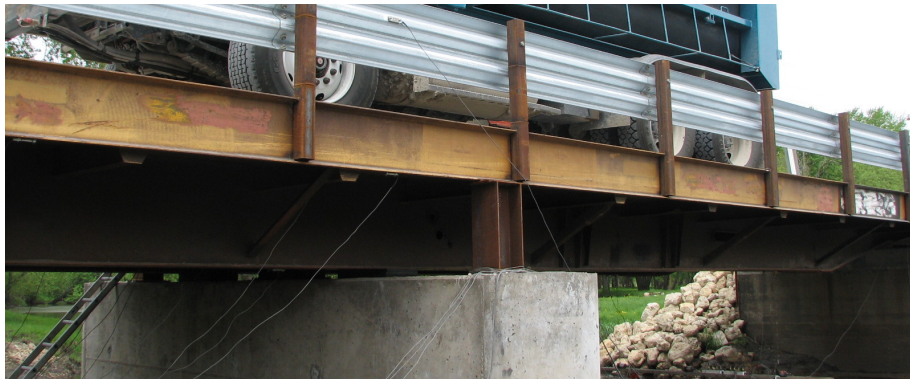
a. 1-inch Neoprene Bearing Pad under Interior Girder at Pier

b. I-shaped Support at Exterior Girder

**Figure 3.4. BCB5 pier support conditions.**

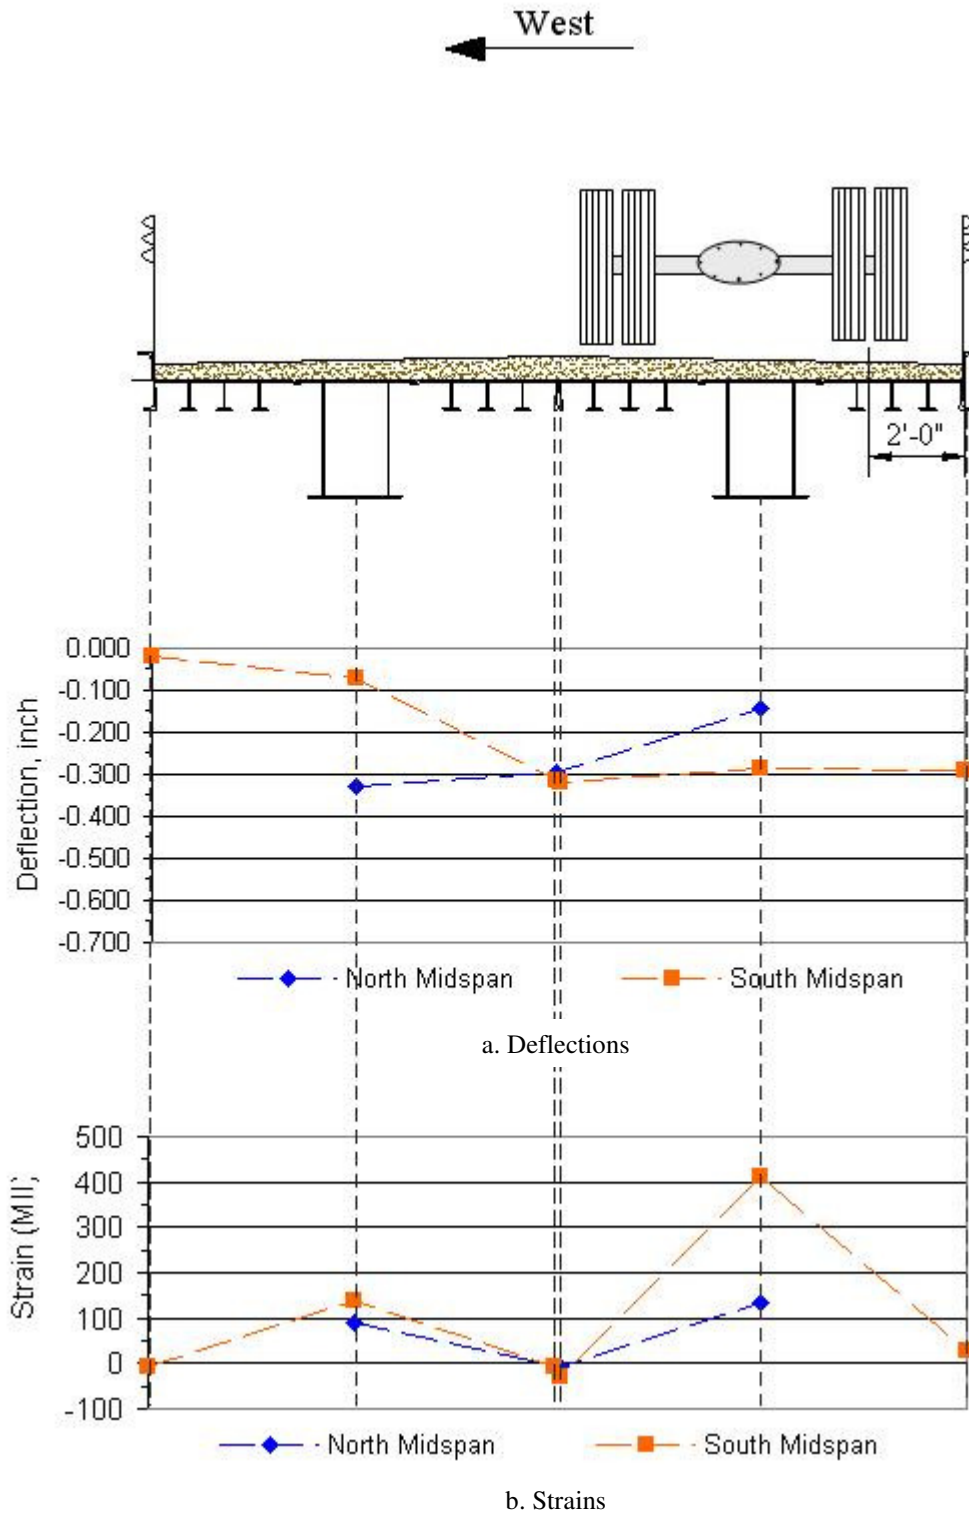
The strains and deflections measured for each midspan locations are presented in Figures 3.12 – 3.14 for each of the three test lanes. Dashed lines have been added to provide a hypothetical linear trend line between the data points. The maximum midspan live load strain that occurred as a result of the field load test was 412 microstrain (11.9 ksi). Adding the dead load strain (stress) value of 70

Figure 3.14. BCB5 Lane 3 midspan live load deflections and strains.

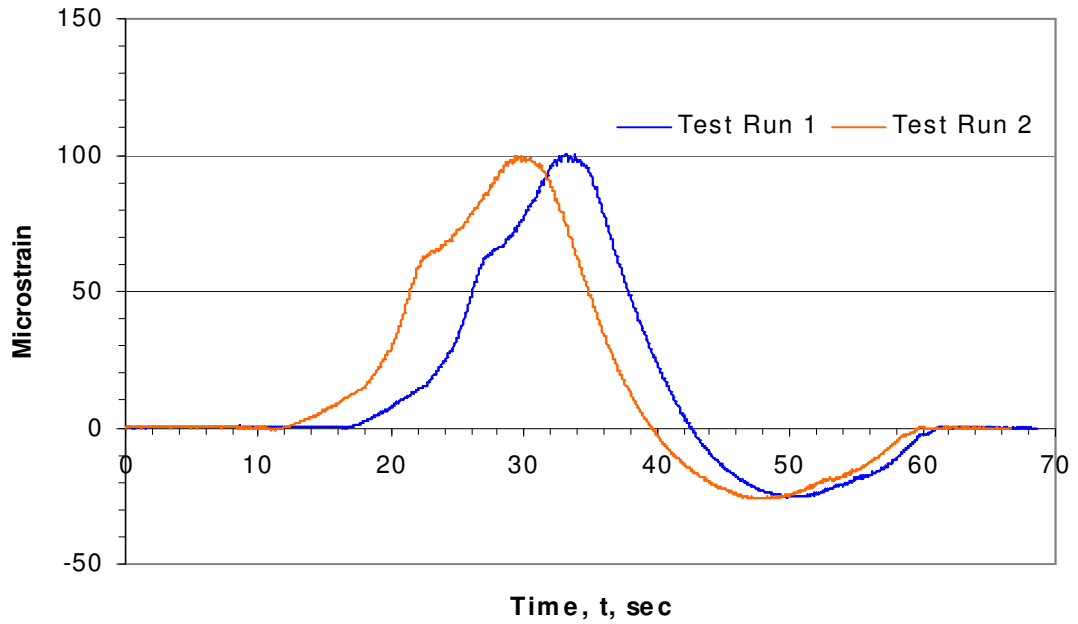
The dynamic amplification was calculated by comparing the maximum strains for the main girders in each span. The resulting dynamic amplification for BCB5 was determined to be approximately 10%. Figure 3.15 shows the dynamic amplification of strains for the East girder at the North midspan location.

a. BCB5 East Girder Static Strain at North Midspan

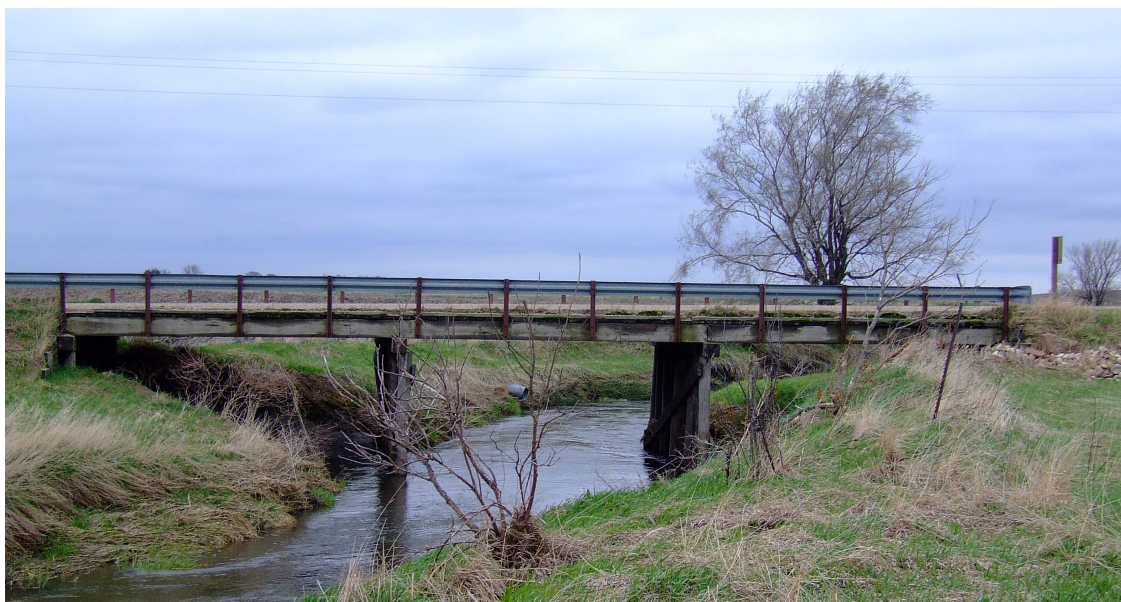
The third RRFC bridge in Winnebago County, Iowa (WCB3) tested by the Bridge Engineering Center is located four miles south of Buffalo Center, Iowa on 390<sup>th</sup> Street over Little Buffalo Creek (Figure 4.1). The previous bridge at this location (constructed in 1979) was a three span timber bridge 69'-0" in length that was supported on timber piles (Figure 4.2).

**Figure 4.2. Previous bridge at WCB3 site.**

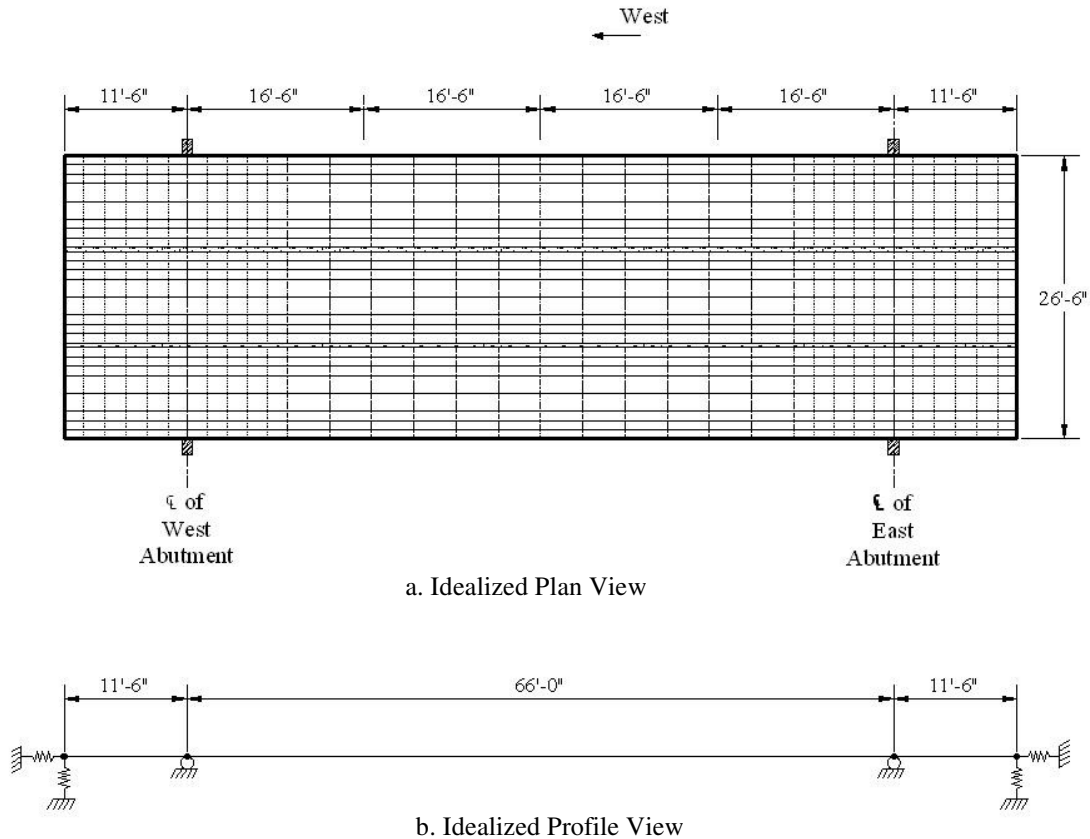
constructed as stated in the previous paragraph. An idealized layout of the bridge with the 1/4 span locations dimensioned is provided in Figure 4.3. The springs shown in Figure 4.3b represent the unknown restraint conditions caused by the sheet pile abutments.

**Figure 4.3. Idealized layout of WCB3.**

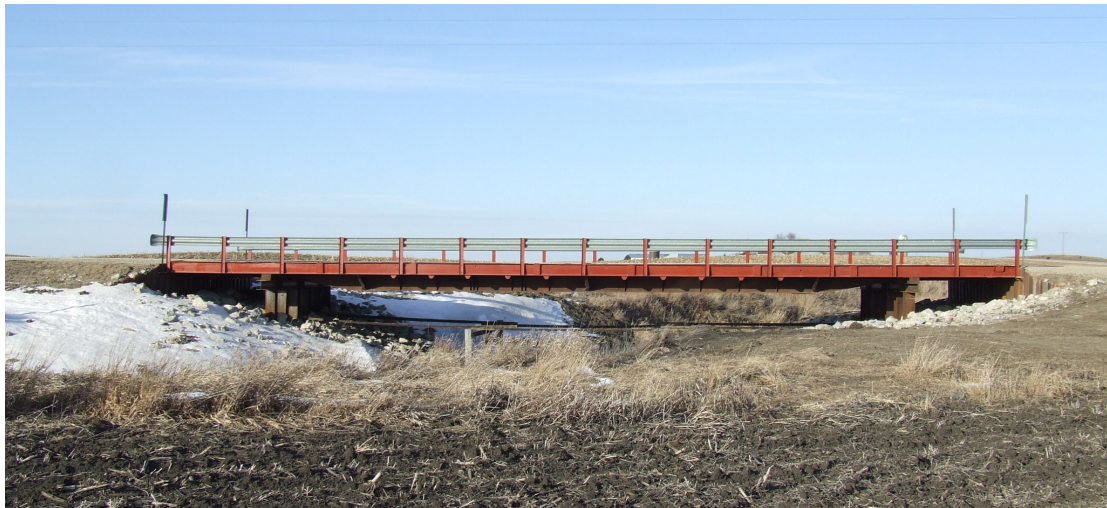
After the flatcars were placed and the longitudinal connection constructed, four inch by twelve inch wooden timbers held in place by angles welded to the exterior girders of the bridge were placed on the bridge deck to provided additional load distribution. Approximately two inches of gravel was then added for the driving surface on the bridge after which a guardrail was attached to the bridge. The finished WCB3 is shown in Figure 4.5.

**Figure 4.5. Completed Winnebago County RRFC Bridge 3 (WCB3).**

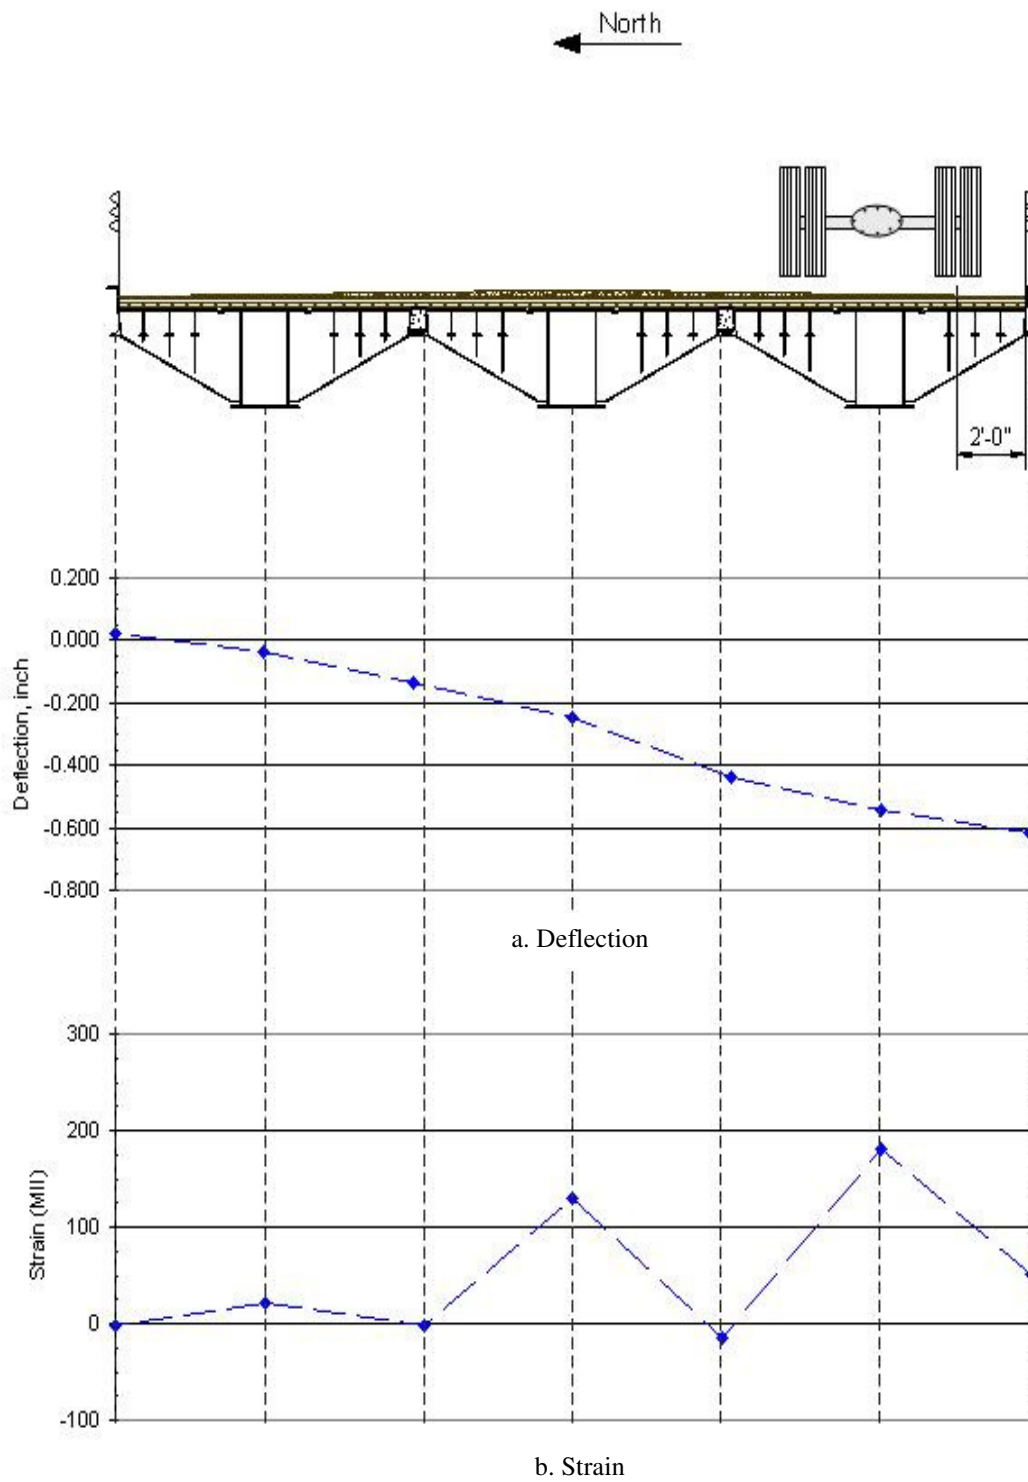
Figure 4.12. WCB3 Lane 3 midspan live load deflections and strains.

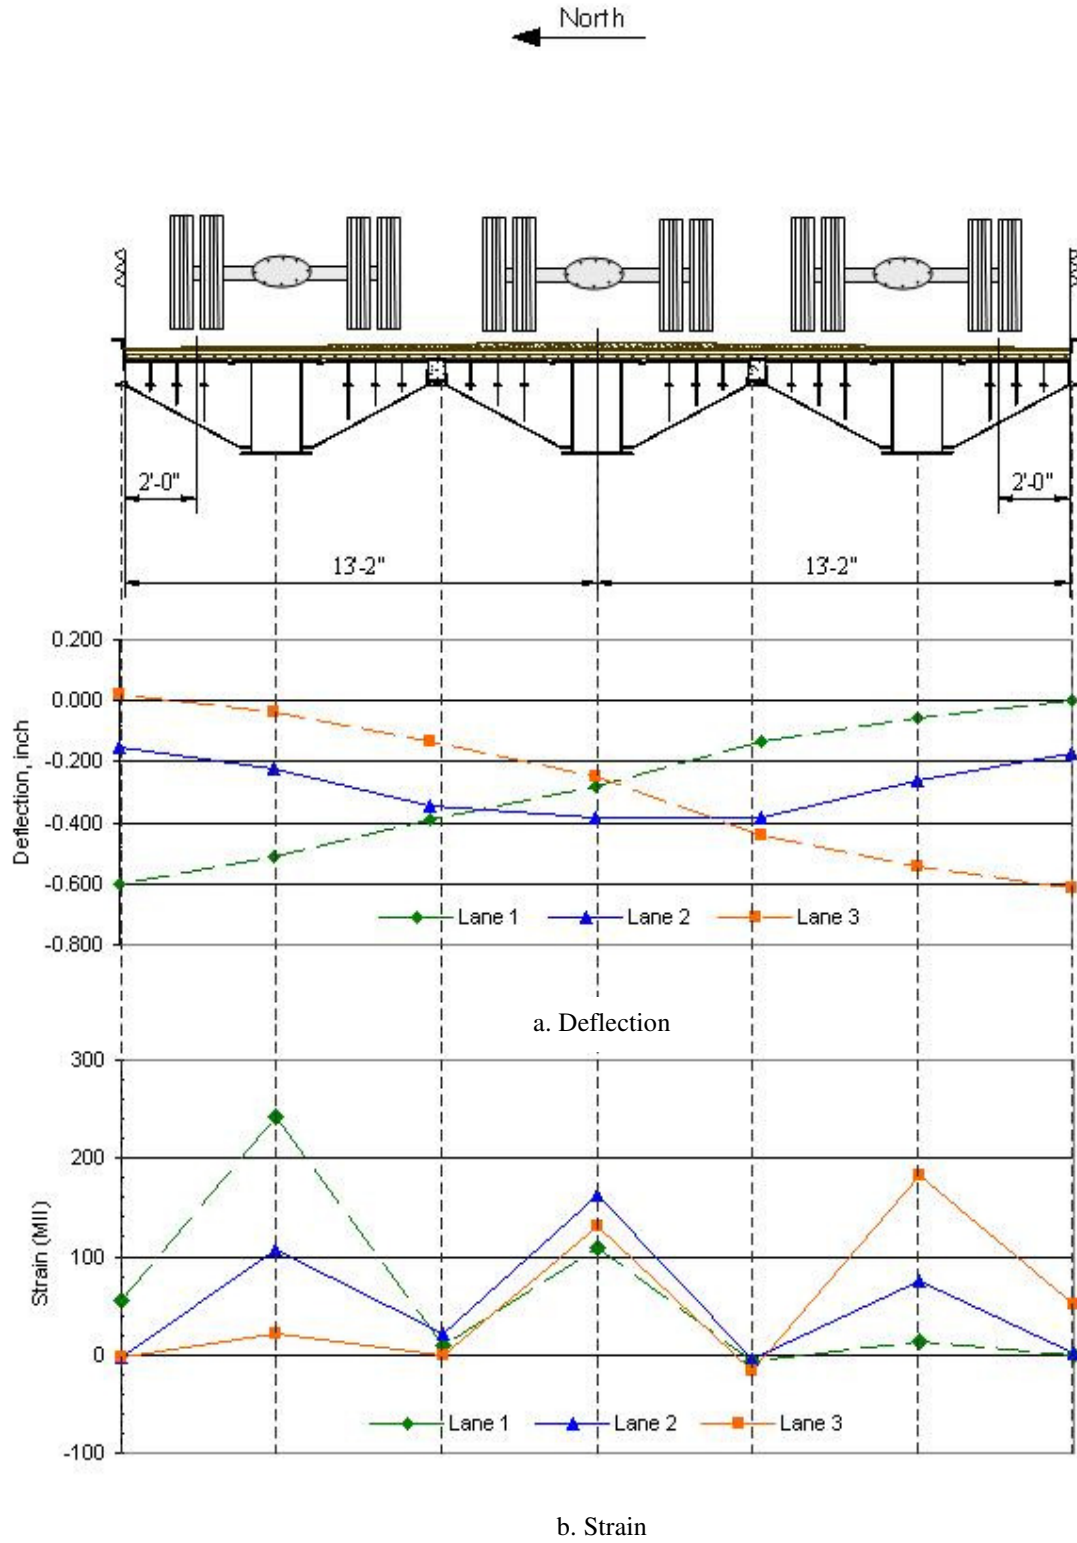
Figure 4.13. WCB3 load distribution symmetry.

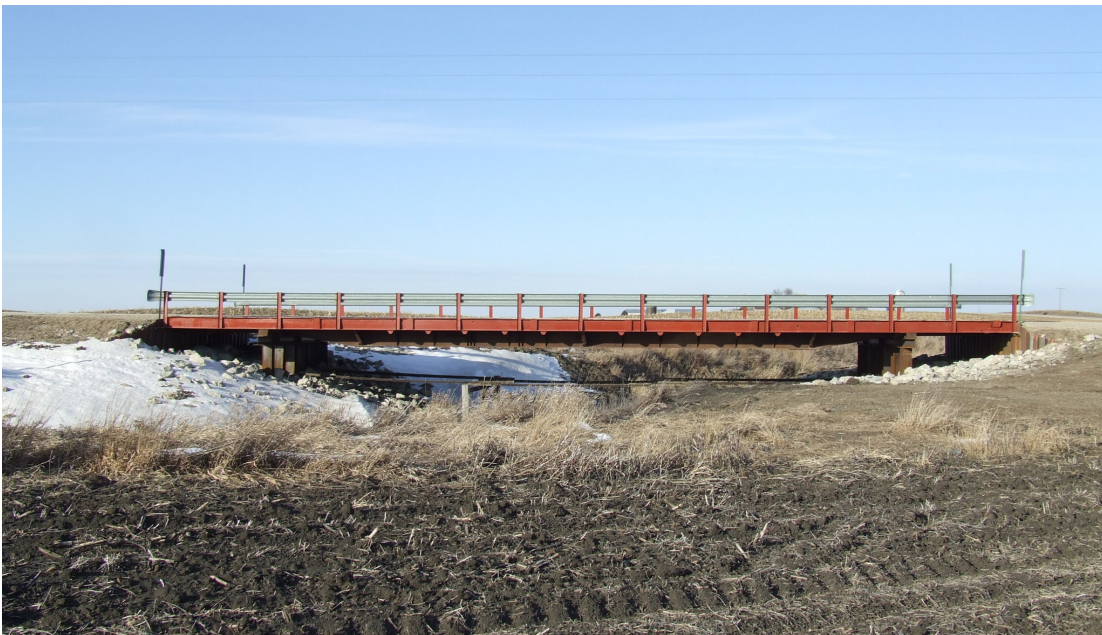
The Winnebago RRFC Bridge 3 (WCB3) is located four miles south of Buffalo Center, Iowa on 390<sup>th</sup> Street over Little Buffalo Creek (Figure 4.1). Three 89-ft RRFCs were used to construct WCB3 (see Figure A.1.1). The bridge has a 66'-0" main span and 11'-6" end spans. Sheet pile abutments were designed based on soil borings from both the east and west abutment locations, taking into account both soil retention and the transfer of the bridge bearing forces to the underlying soil.

**Figure A.1. Winnebago County RRFC Bridge 3 (WCB3).**

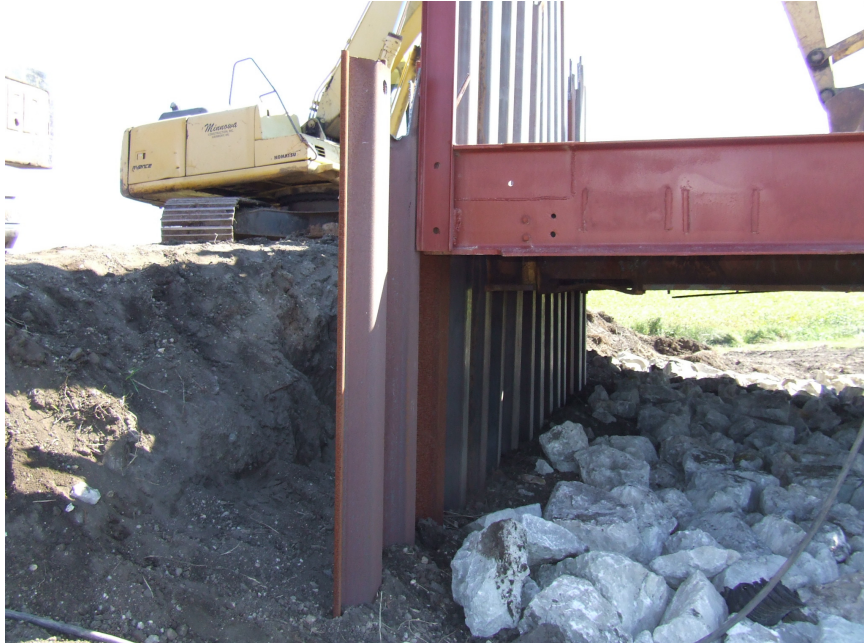
**Figure A.4. Sheet pile abutment construction with no expansion joint provided.**

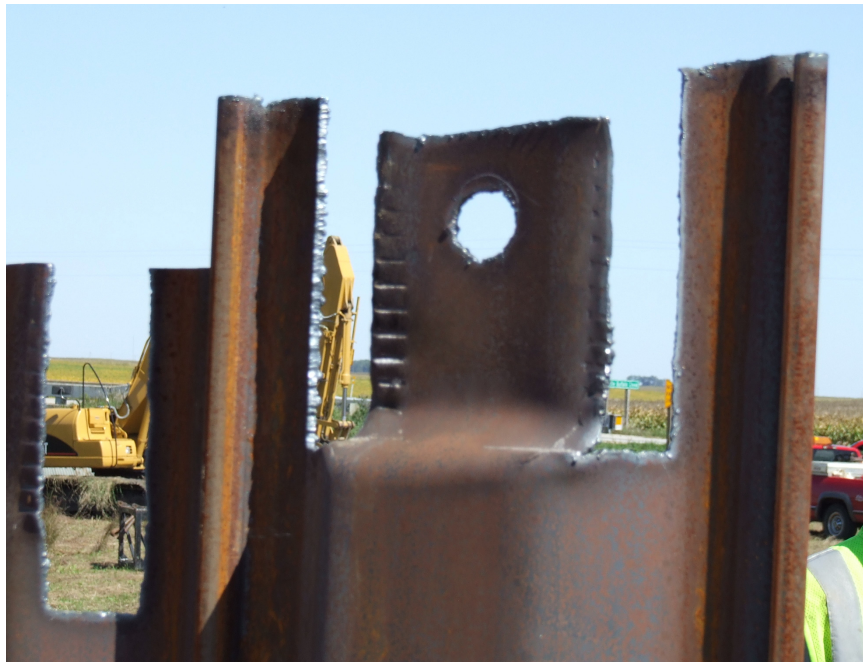
**Figure A.5. Buckled sheet pile section due to driving equipment.**

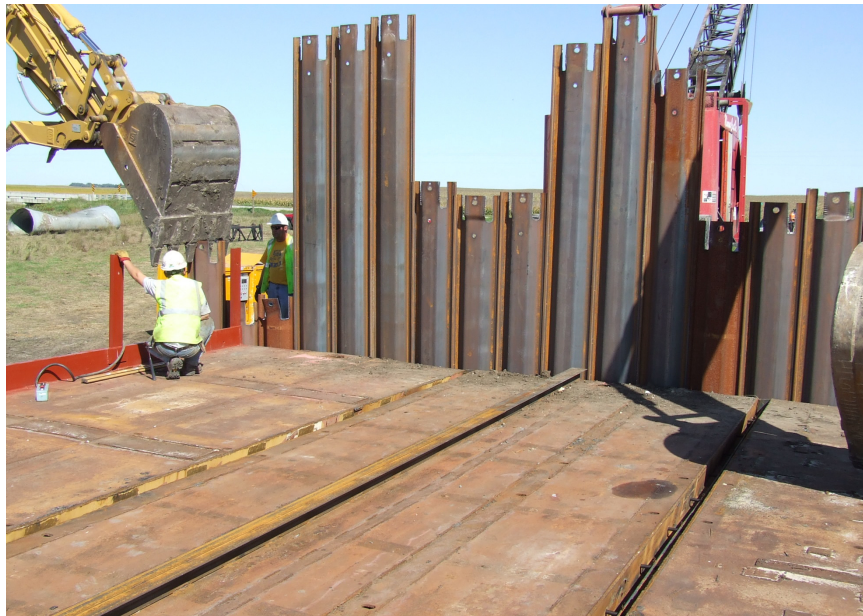
**Figure A.6. East abutment after driving.**

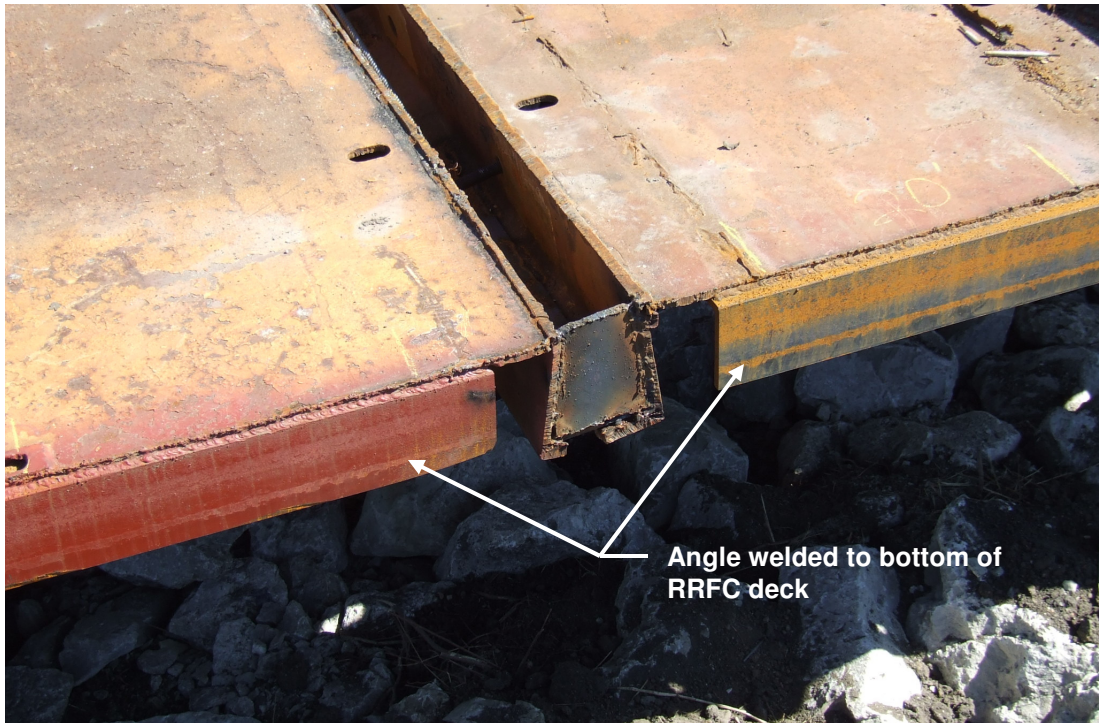
Due to a misunderstanding between the parties involved, a 5 inch x 3 inch x 1/2 inch angle was welded to the bottom of the deck of the RRFCs (Figure A.2.4) before the placement of the flatcars. This angle was proposed to represent the connection between the bridge superstructure and the abutments. However, after review by Iowa State University, additional stiffened angles 4 inch x 4 inch x 1/2 inch were added below the main bearing points (girders and longitudinal connections) as shown in Figure A.8. These angles were smaller than the angles discussed in Section A.1.4 because the top angle took a portion of the load. No connection was made between the additional angles and the bridge superstructure.

**Figure A.7. Angle welded to bottom of RRFC deck.**
