# Field testing of multiple span railroad flatcar bridges on low volume roads

A thesis submitted to the graduate faculty  
in partial fulfillment of the requirements for the degree of  
MASTER OF SCIENCE

Major: Civil Engineering (Structural Engineering)

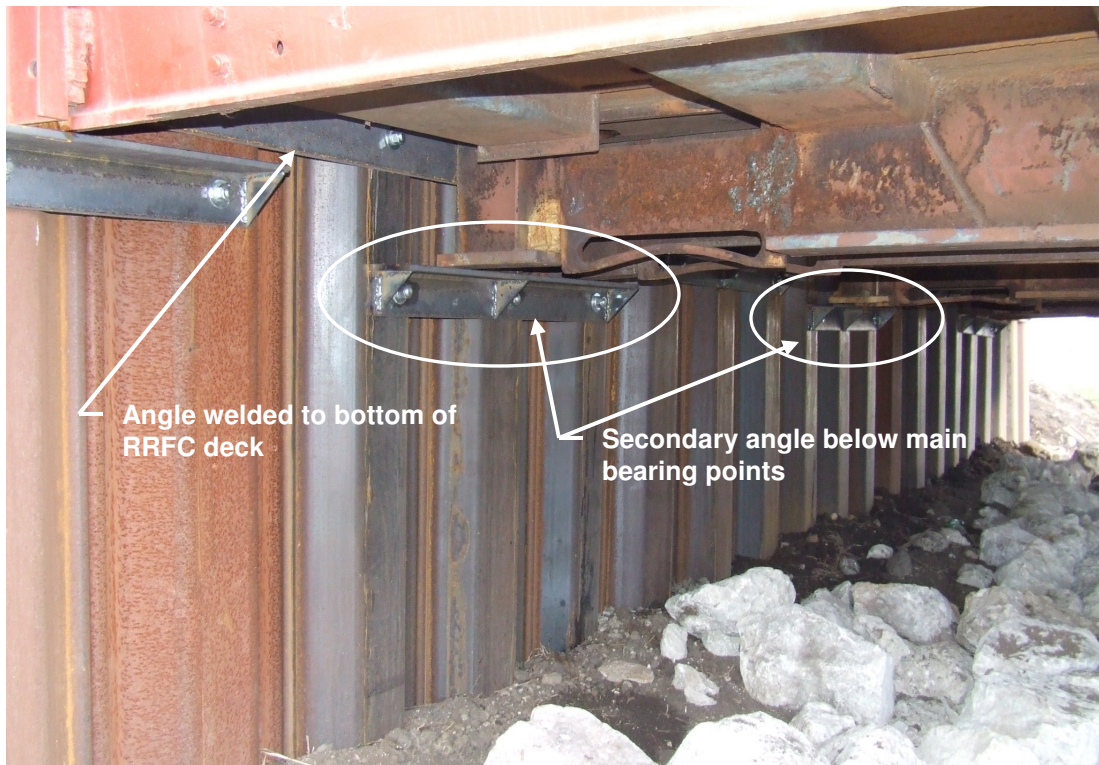
**Figure A.8. Secondary angle attached below main bearing points.**

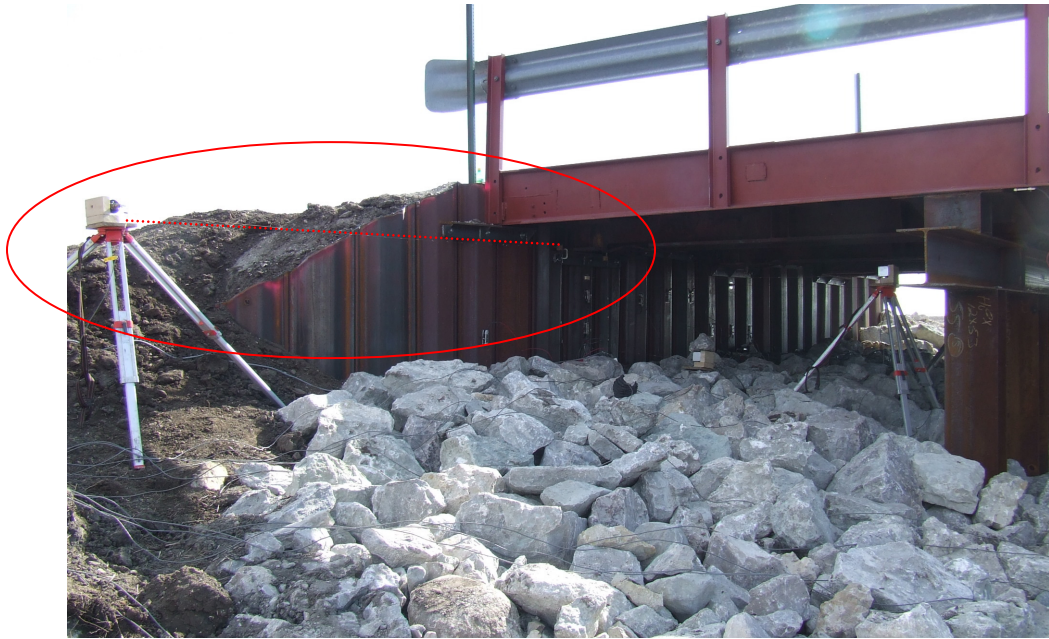
**Figure A.11. Instrumentation measuring displacement perpendicular to traffic.**

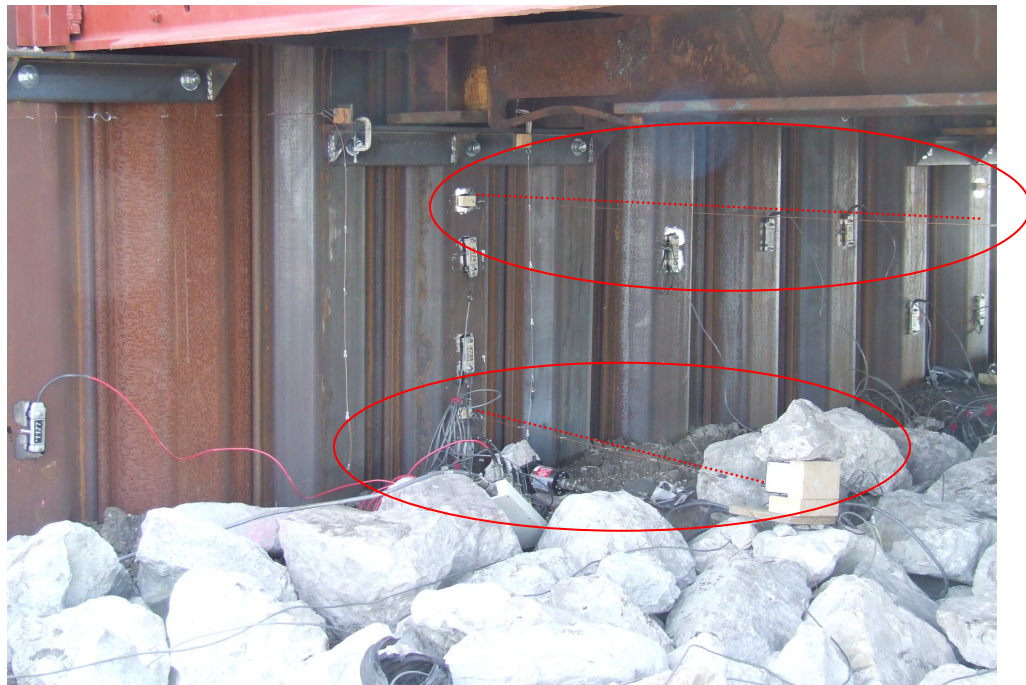
**Figure A.12. Instrumentation measuring displacement in the direction of the bridge.**

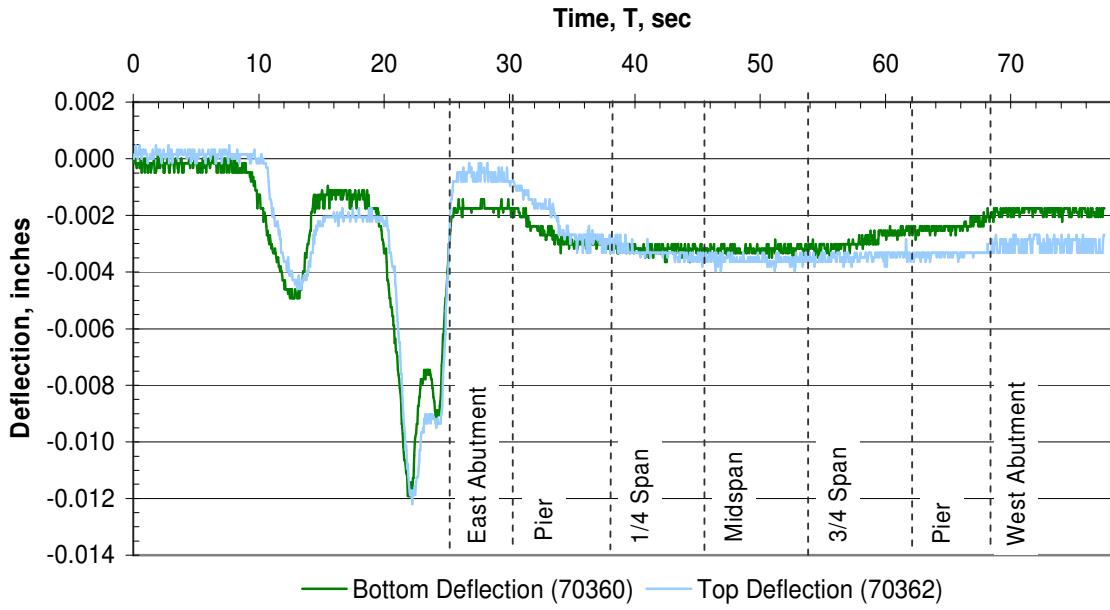
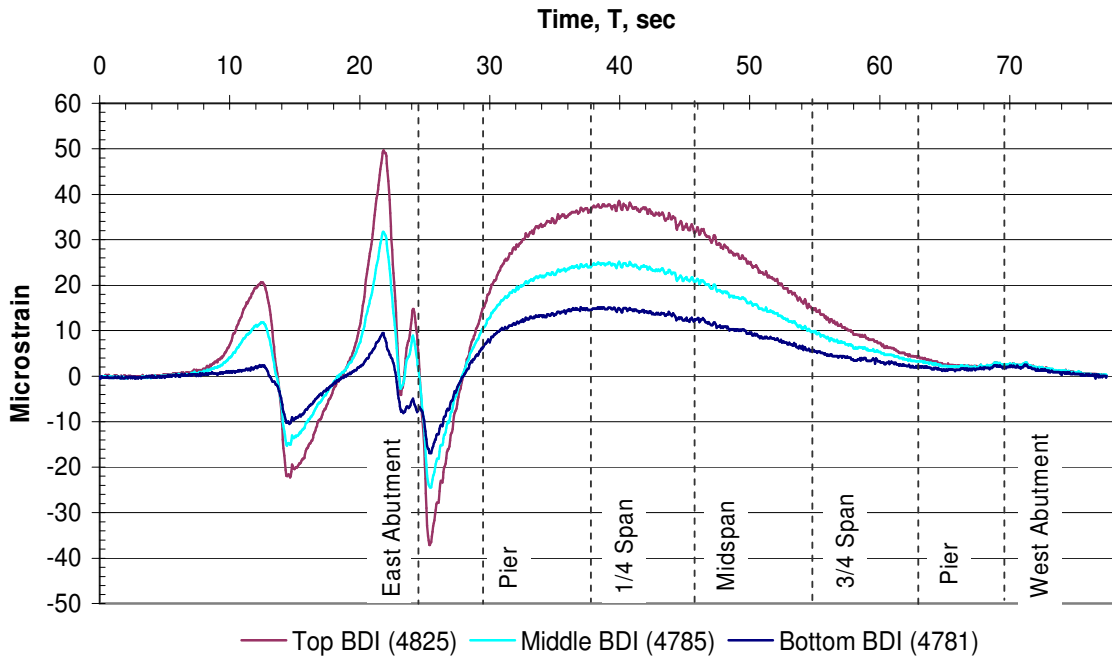
After reviewing the WCB3 abutment field load test data, several behavioral attributes were observed. First, a "soil push" phenomenon was observed at the east abutment. As the test vehicle approached the abutment (but was not yet on the bridge), the truck "pushed" the underlying soil in the direction that the truck was moving, which in turn flexed the abutment. Figure A.14 displays the soil push displacing the abutment inward as well as the corresponding strains as the truck approaches the bridge. As the front axle of the truck approached the abutment, the abutment flexed in the direction the truck was moving. The resulting displacement and tensile strain (which indicates that the abutment is flexing and not moving as a rigid body) are indicated by the first spike in the data trend,

a. Lane 1 longitudinal deflections

b. Lane 1 microstrain

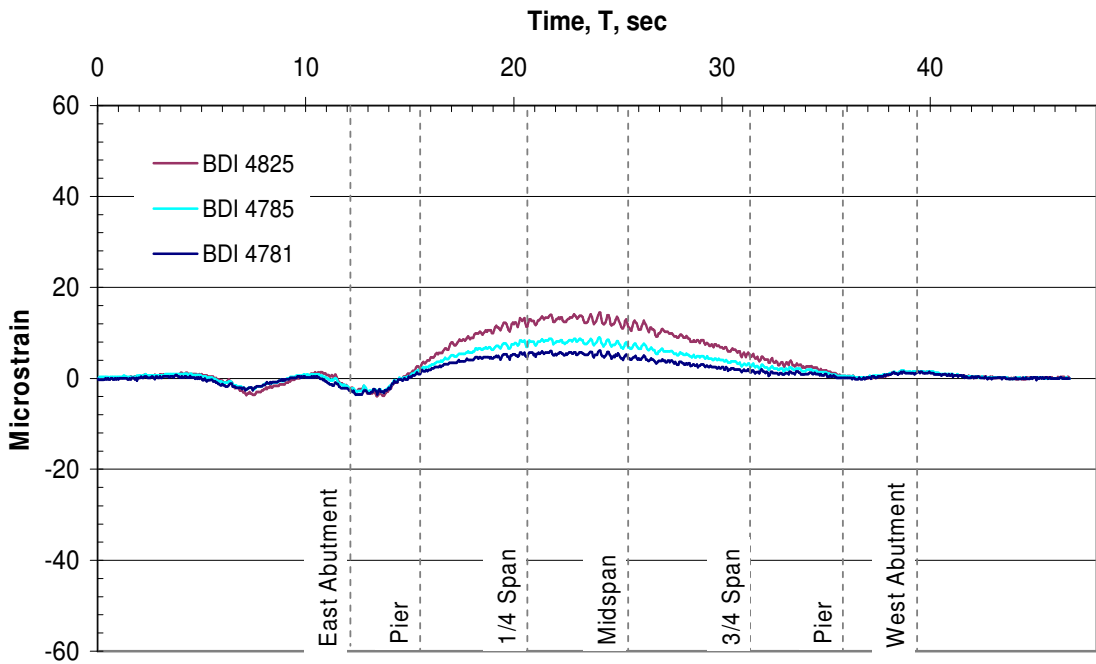
To investigate the horizontal load distribution, three lines of horizontally spaced BDI strain transducers were analyzed. At the east abutment, two horizontal lines of strain transducers existed – one below the north longitudinal connection and one below the main girder of the middle RRFC. For the instrumentation group below the north longitudinal connection, the strain transducer that was closest to the loaded RRFC experienced the largest strain, with the other strain transducers experiencing lesser amounts of strain (See Figure A.16). For the instrumentation group below the middle RRFC, as shown in Figure A.17, the middle strain transducer (BDI 4782 in Figure A.9) in the instrumentation group experienced the largest strain due to the load path of the RRFCs. Strains measured by the transducers on either side of the center transducer (BDI 4829 and 4703 in Figure A.9) were of similar magnitude, indicating symmetry of the load distribution. Strains at the west abutment exhibited comparable behavior and thus are not presented.

a. Sheet pile vertical load distribution – Single truck in Lane 1

b. Sheet pile vertical load distribution – Single truck in Lane 2

Figure A.15. Sheet pile vertical load distribution at east abutment.

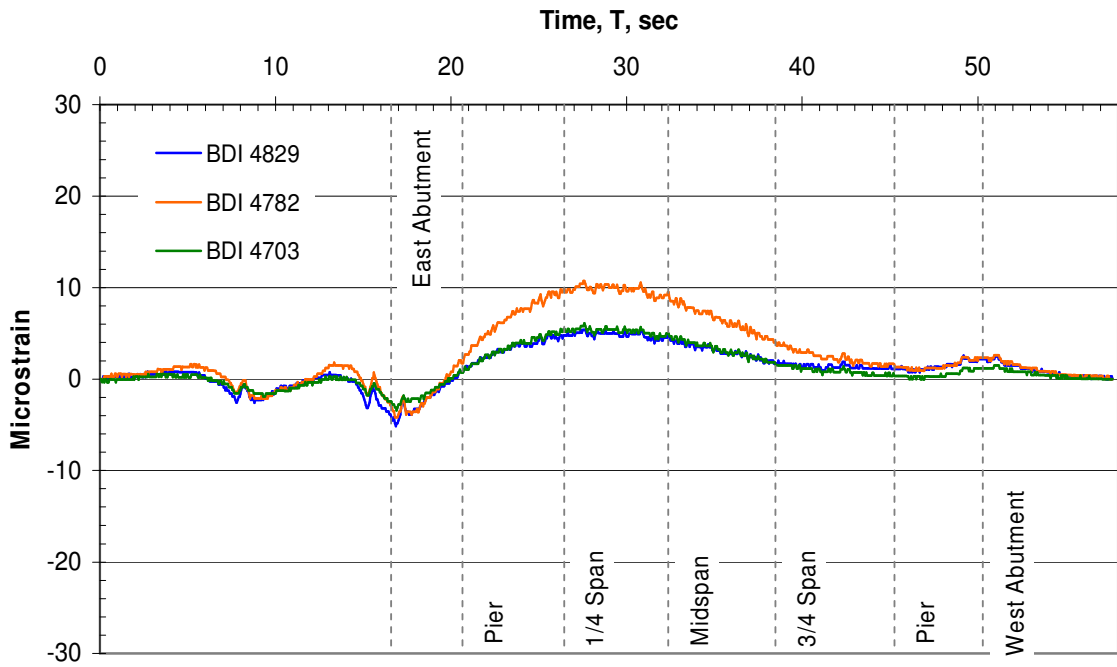
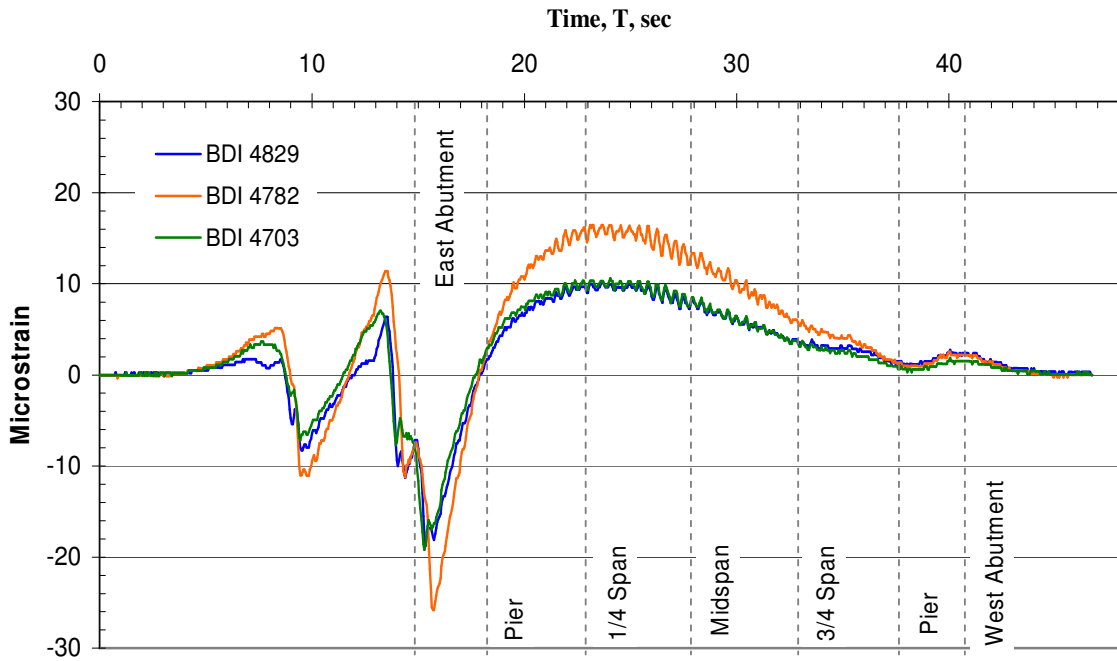
a. Sheet pile horizontal load distribution – Single truck in Lane 1

b. Sheet pile horizontal load distribution – Single truck in Lane 2

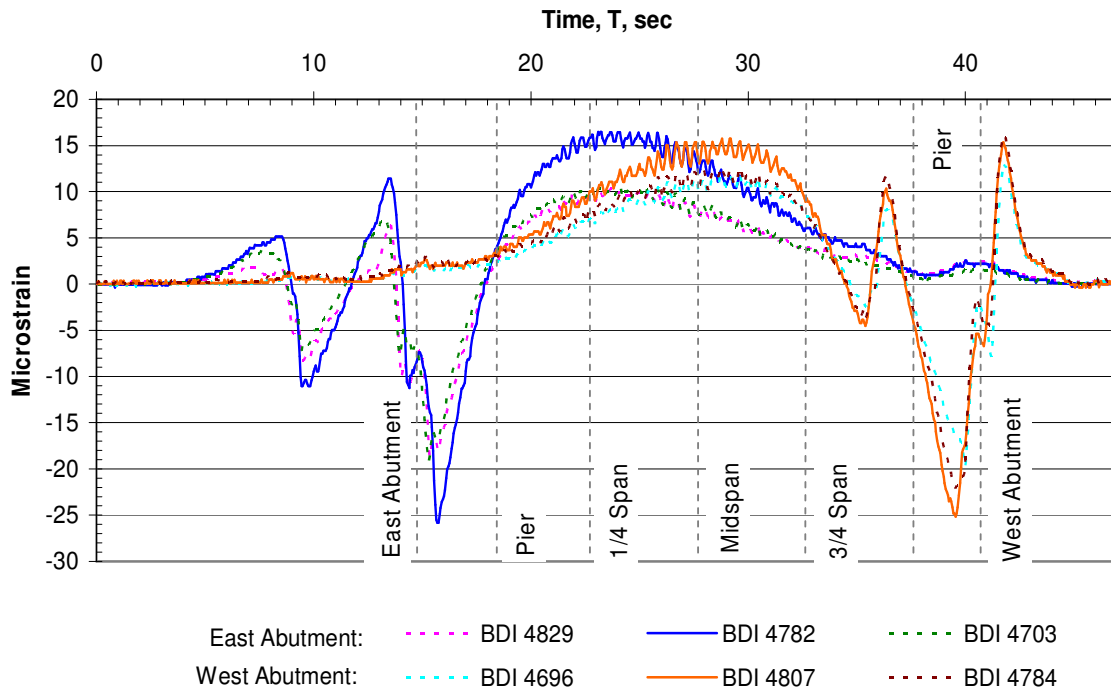
A comparison in the strain trends was also made, comparing the east and west abutments. Presented in Figure A.18 are the strain trends for three transducers below the main girder of the middle RRFC for both the east and west abutments (BDI 4829, 4782, and 4703 at the east abutment and BDI 4696, 4807, and 4784 at the west abutment). At both abutments, good agreement existed between the strain magnitudes as well as the strain data trends.

**Figure A.18. Strain comparison for east and west abutments.**
