# **Field testing of railroad flatcar bridges**

A thesis submitted to the graduate faculty  
in partial fulfillment of the requirements for the degree of  
**MASTER OF SCIENCE**

Major: Civil Engineering (Structural Engineering)

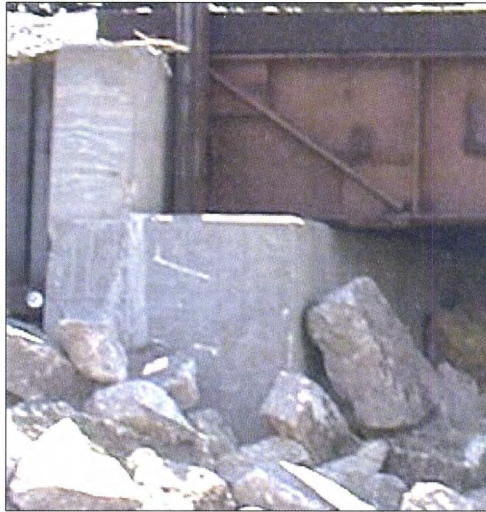
c. Side view of concrete abutment

Figure 2.3. Continued.

The BCB2 abutments are nearly identical to the BCB abutments, which were designed for the demonstration project, TR-444 [4]. The concrete abutments are composed of a 3-ft by 3-ft cap beam with a 1-ft deep, 2-ft high backwall and are reinforced as shown in Figure 2.3a. Each concrete abutment is supported by three HP10x42 piles spaced on 9 ft – 10 1/2 in. centers. The RRFCs are positioned on the abutments as shown in Figure 2.3b, and a photograph of the side view of an abutment is shown in Figure 2.3c. One difference between the BCB abutments and the BCB2 abutments is the type of joint at the abutments. Both BCB2 abutments have expansion joints while the BCB has one integral abutment and

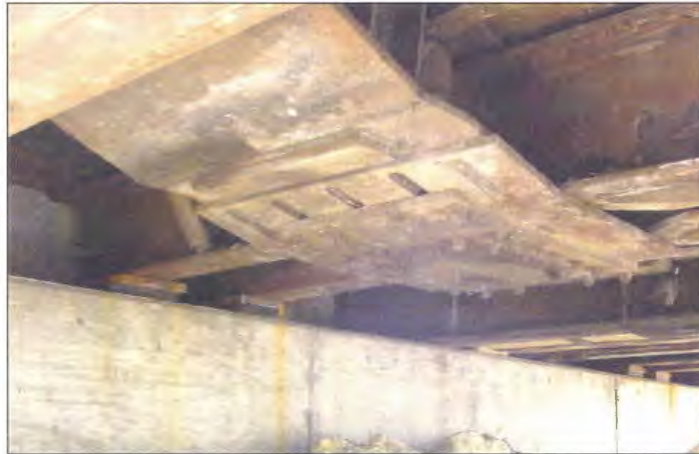
b. View of interior girder resting on abutment cap beam

Figure 2.4. Details of BCB2 abutment cap beam.

Another difference between the abutments of the two bridges is the interior girder support at the abutments. As shown in Figure 2.4a, both the interior and exterior girders rest on bearing plates; however, at the abutments, the elevation of the bottom flanges of the interior girders is 1 1/2 in. higher than that of the bottom flanges of the exterior girders. Based on a recommendation in the demonstration project, TR-444, additional 1-in. plates were placed beneath the interior girders at the BCB2 abutments as seen in the photograph in Figure 2.4b. At the BCB abutments, the interior girders rest on a concrete seat rather than additional bearing plates [4]. This detail was modified for ease of construction.

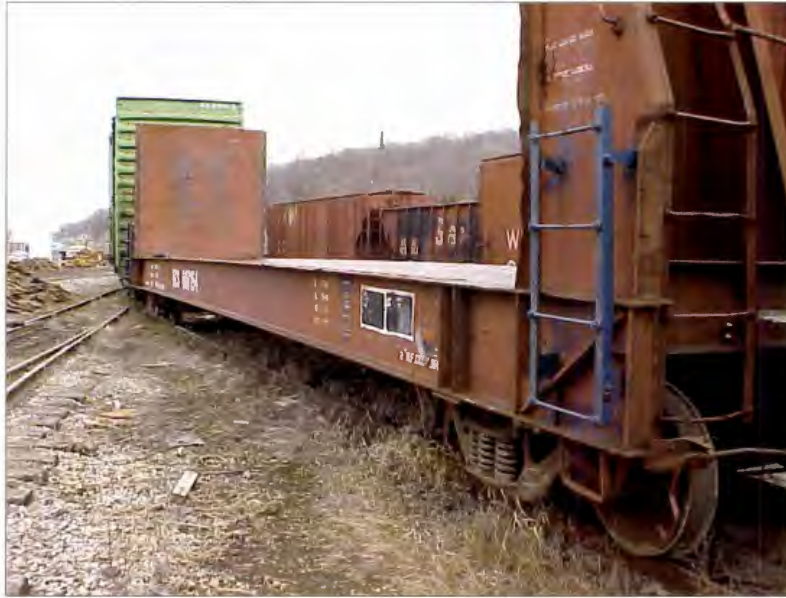
a. The 56-ft V-deck RRFC prior to trimming

Figure 2.6. Photographs of the 56-ft V-deck RRFC.

As shown in Figure 2.6a, the 56-ft V-deck RRFCs have protrusions above the deck; however, in order for the RRFCs to be used in a bridge, the protrusions must be removed. Therefore, before the RRFCs were shipped to Buchanan County for use in the BCB2, the protrusions were trimmed off. A photograph of a 56-ft V-deck RRFC without the protrusions is shown in Figure 2.6b.

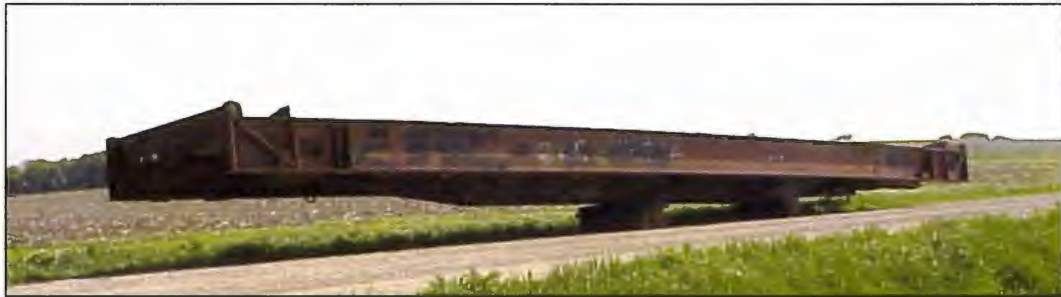
b. The 56-ft V-deck RRFC after trimming

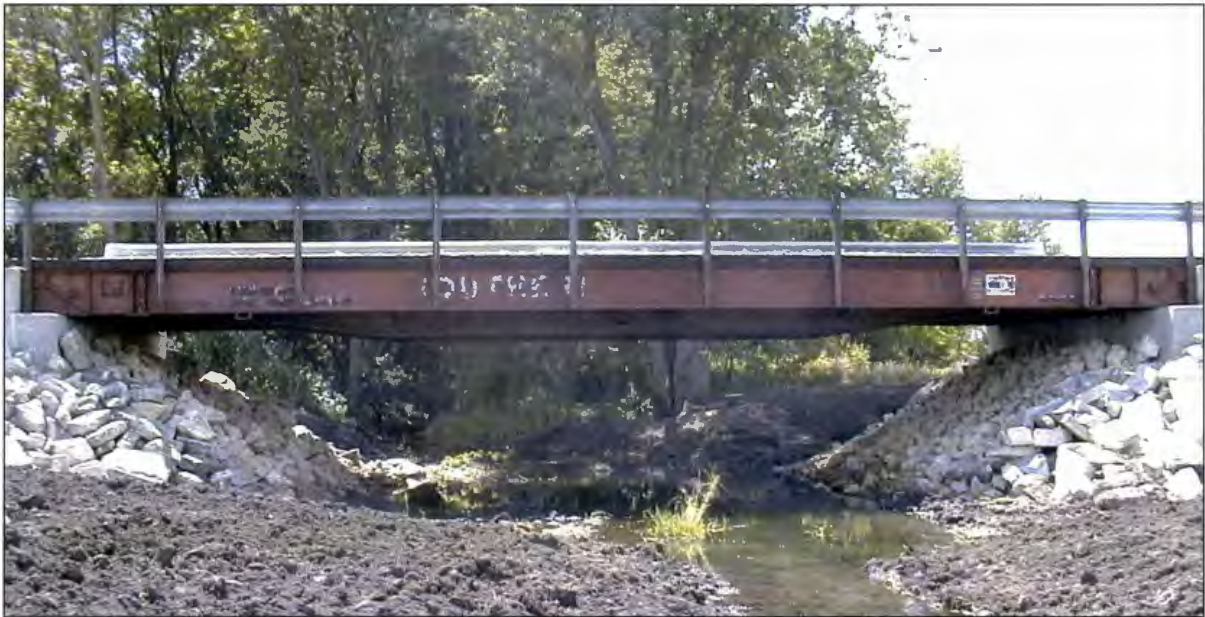
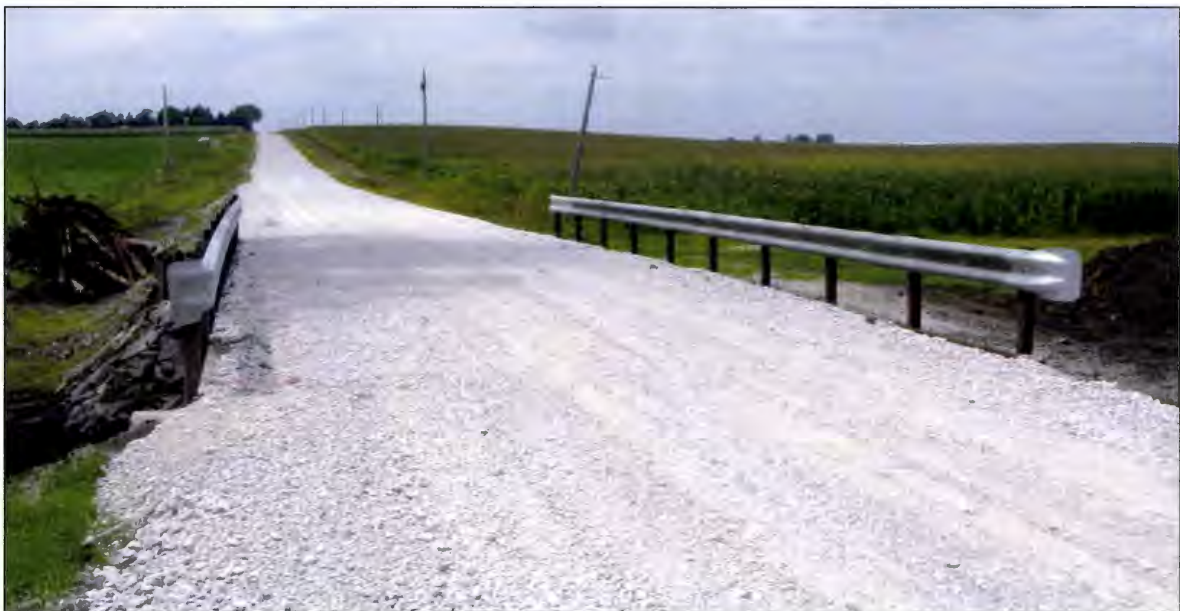
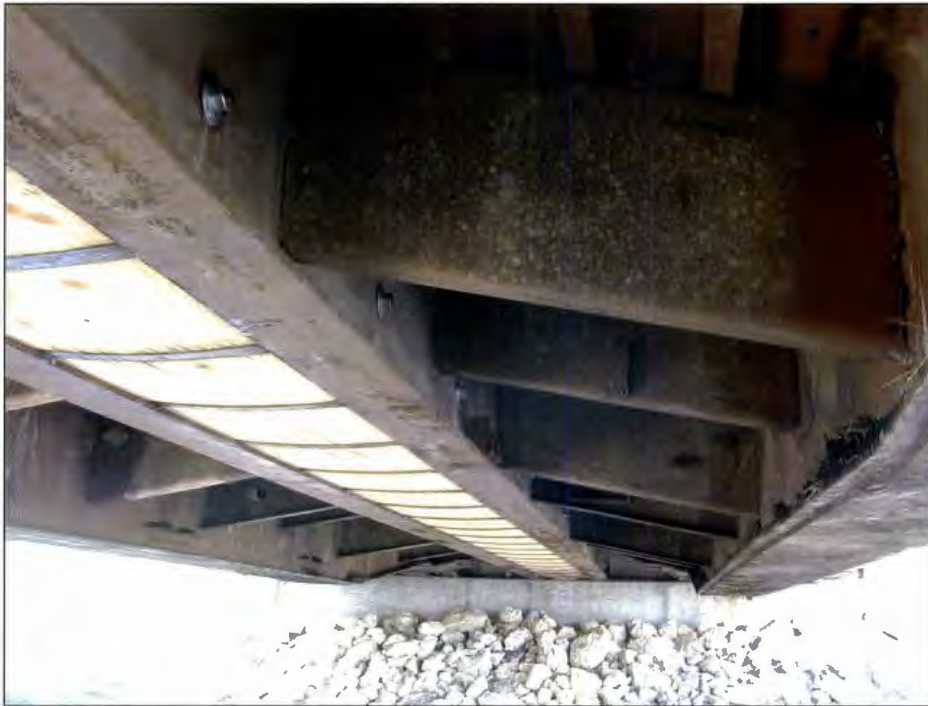
a. Side view of BCB2

b. End view of BCB2

Figure 2.7. Completed BCB2.

c. Underneath BCB2

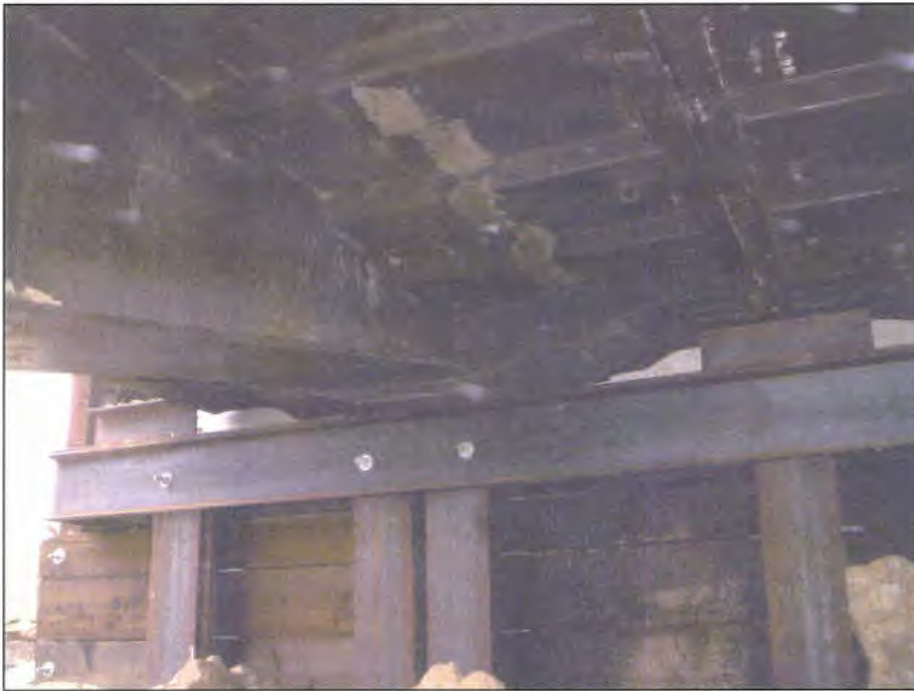
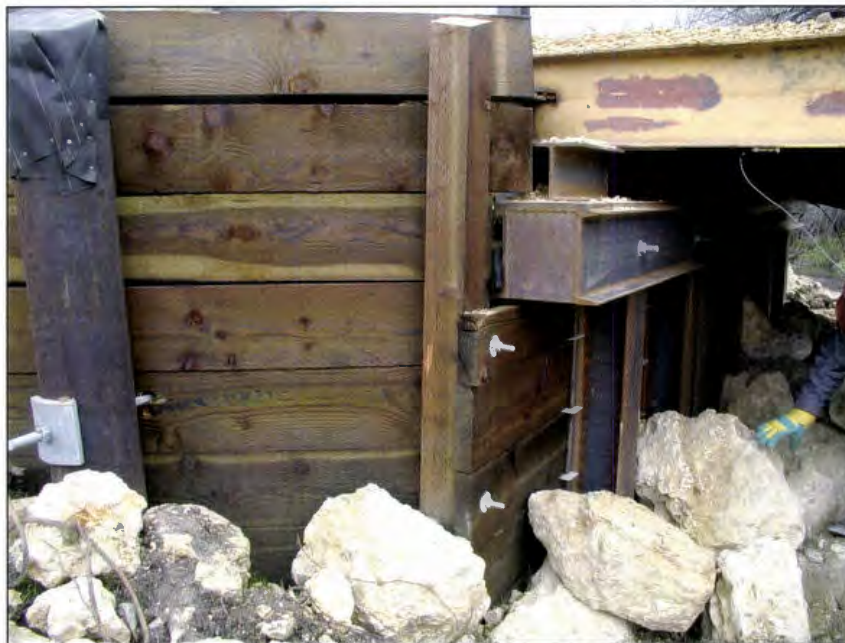
b. Photograph of abutment and backwall

b. Photograph of wing wall and side view of cap beam

Figure 2.10. Photographs of DCB abutments.

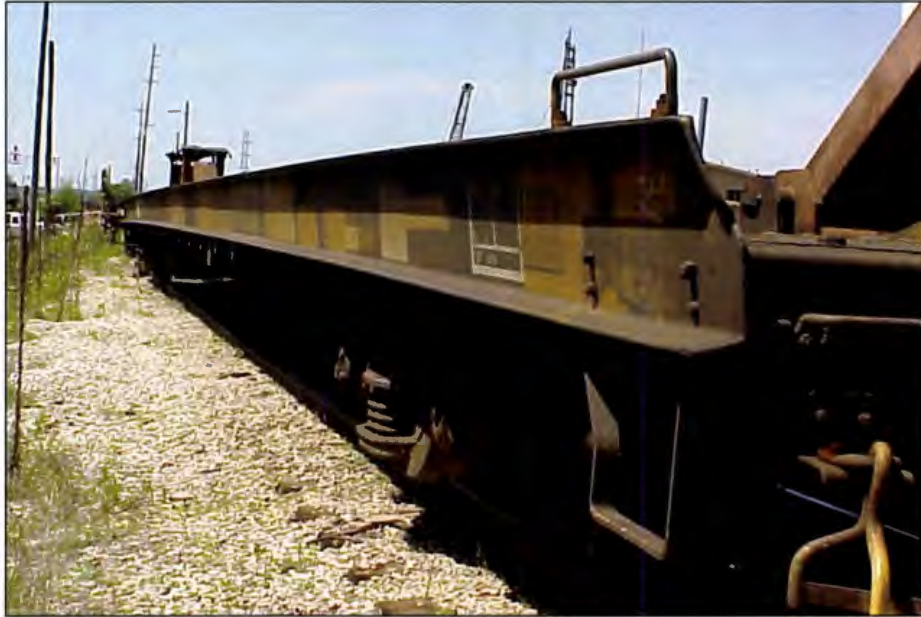
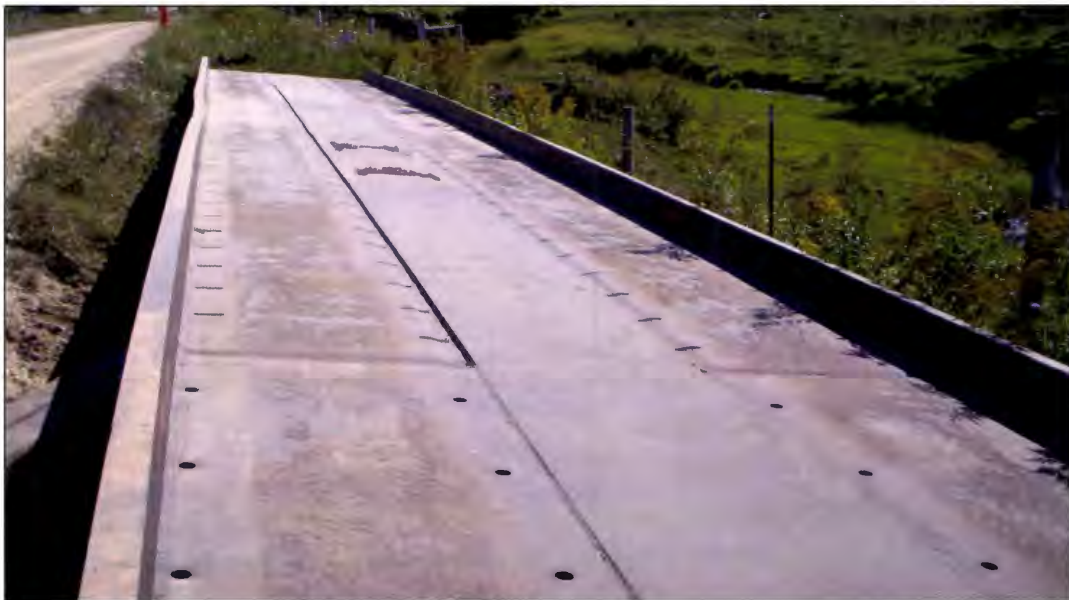
a. The 89-ft RRFC prior to trimming

b. The trimmed 89-ft RRFC

Figure 2.12. Photographs of the 89-ft RRFC.

As shown in Figure 2.12a, the 89-ft RRFCs have protrusions above the deck; however, in order for the RRFCs to be used in a bridge, the protrusions must be removed. Therefore, before the RRFCs were shipped to Delaware County for use in the DCB, the protrusions were trimmed off. The 89-ft RRFCs were also cut to the required 67 ft – 6 in. sections before being shipped to Delaware County. A photograph of a trimmed 89-ft RRFC without the protrusions is shown in Figure 2.12b.

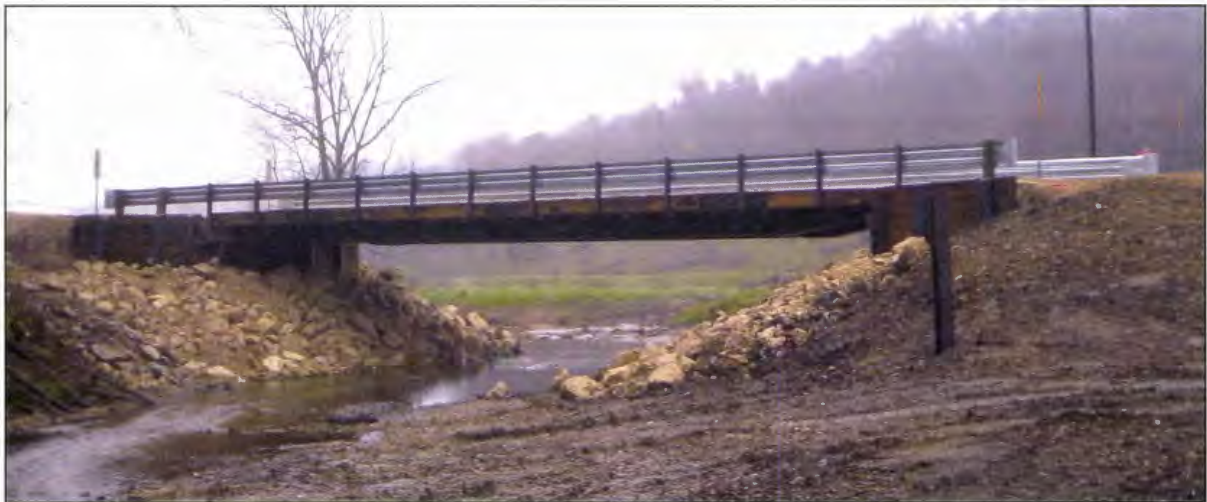
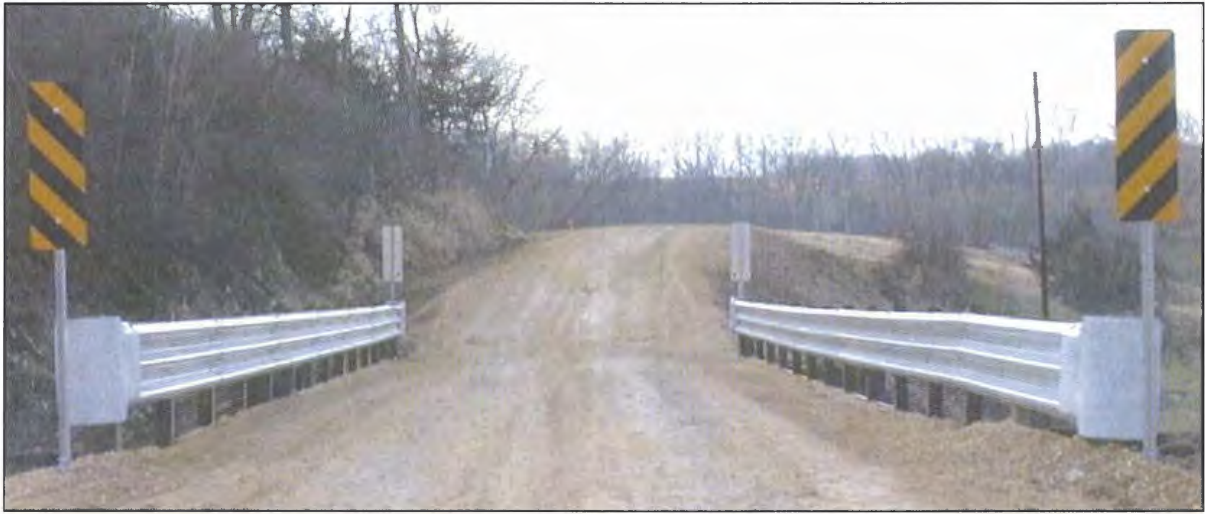
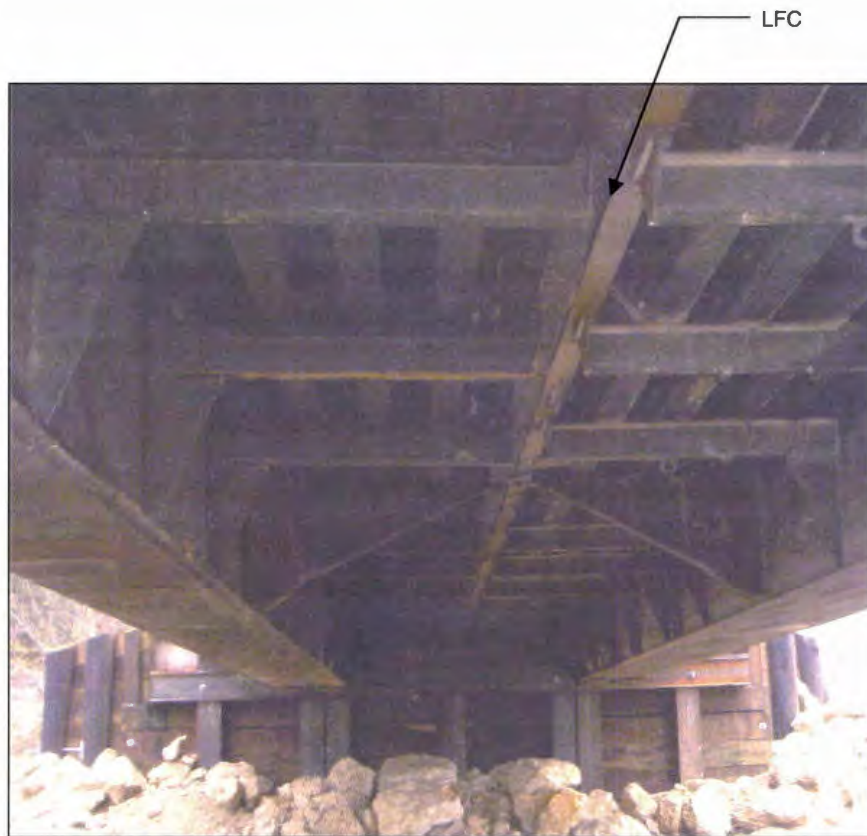
a. Side view of DCB

Figure 2.13. Completed DCB.

b. End view of DCB

c. Underneath DCB

As described in further detail in the final report for the demonstration project, the abutments were first constructed, and then the RRFCs were positioned on the abutments as described in Section 2.2.1. Once the RRFCs were in place, the 14-in. by 1/2-in. plate was welded over the trimmed exterior girders to form the LFC. After the LFC was completed, a fabric liner was placed over the RRFC deck to prevent gravel from falling through small holes in the deck. A layer of gravel was then placed over the fabric liner for the driving surface. The layer of gravel has a 3-in. crown; the thickness of the gravel layer is 10 in. along the center of the bridge and 7 in. along the edges of the bridge. Finally, a guardrail system was installed. The DCB guardrail system consists of guardrail posts welded on 6-ft intervals to the flanges of the exterior girders with a thrie beam attached to the guardrail posts. The completed DCB is shown in Figure 2.13.

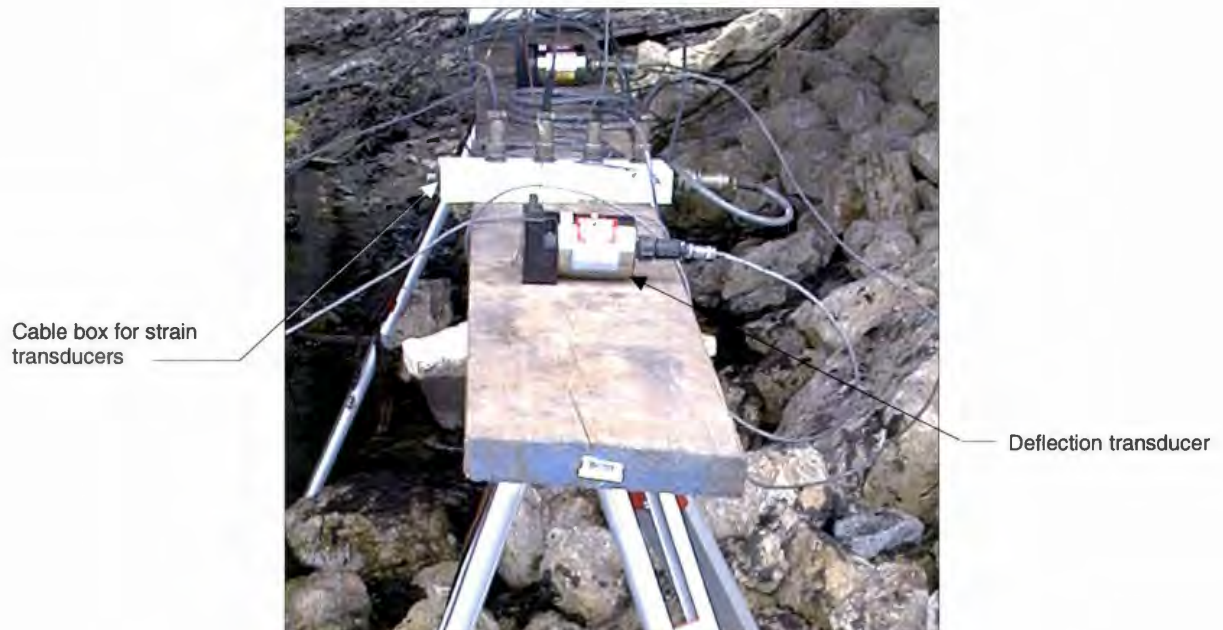
a. Strain transducer 8 on the bottom flange of the exterior girder

b. Deflection transducer for the exterior girder at the 1/4 span

Figure 3.3. Instrumentation used on BCB2.

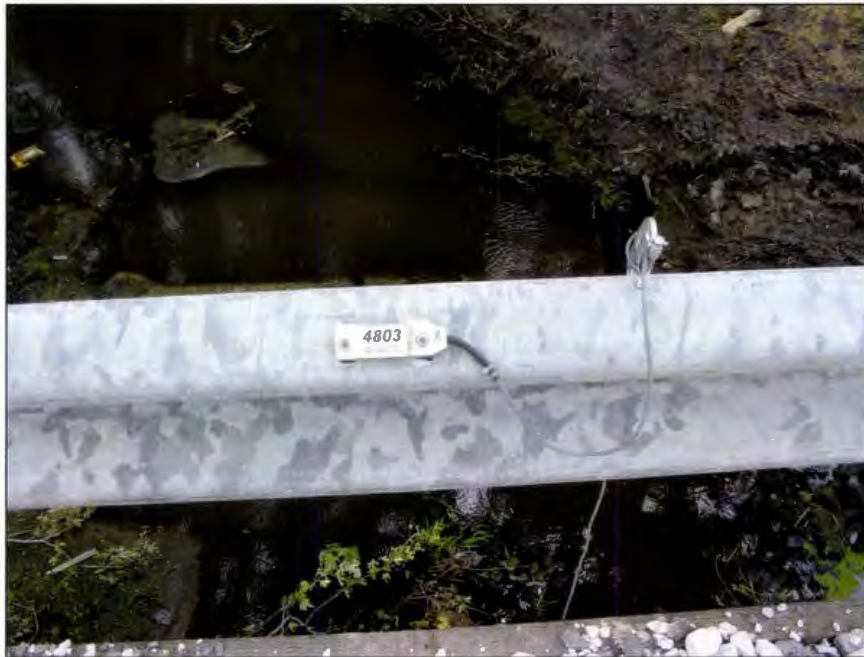
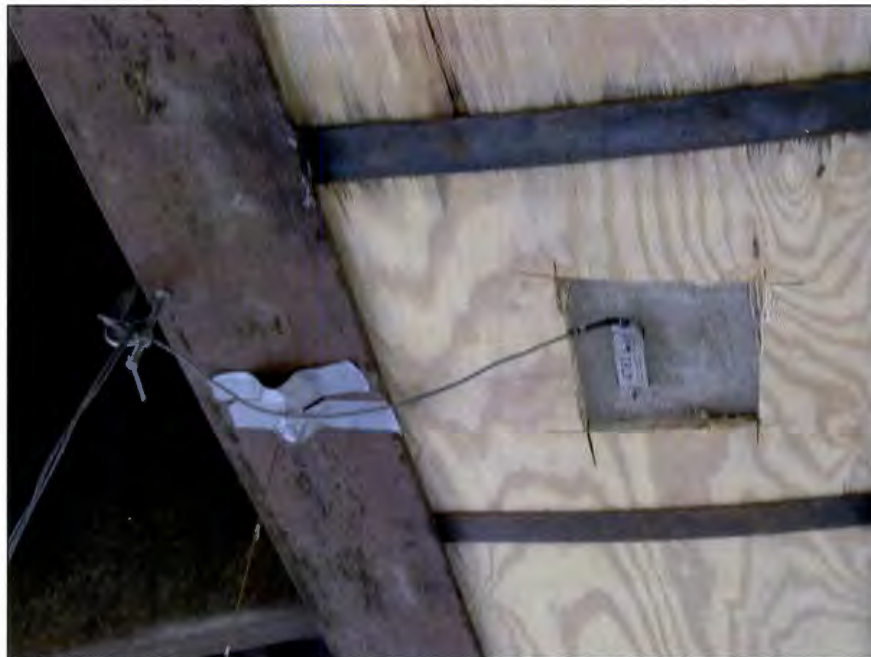
a. Strain transducer at midspan on the south guardrail

b. Strain transducer on the concrete LFC

Figure 3.4. Strain transducers used on BCB2.

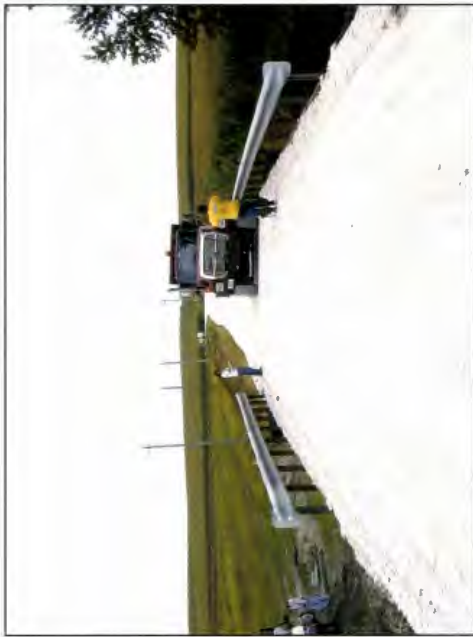
a. Loading BCB2 with truck on south RRFC (Lane 3)

Figure 3.6. Photographs of the truck used in the BCB2 tests.

The BCB2 was divided into three lanes as shown in Figure 3.5 to determine the behavior of the bridge under different load conditions. As may be seen in Figures 3.5a and 3.5c, when in Lanes 1 or 3, the truck was positioned with the edge of the double tires 2 ft from the north or south edge of the bridge, respectively. With the truck positioned on the edge of the bridge, an eccentric load condition is created. The results from the test with the truck positioned in Lane 1 can be compared to the results from the test with the truck positioned in Lane 3 in order to verify transverse symmetry in the BCB2. The results from the tests with an eccentric load condition can also be used to determine the effectiveness of the LFC. A photograph of the test truck positioned in Lane 3 is shown in Figure 3.6a. As may be seen in Figure 3.5b, the truck was centered transversely on the bridge when in Lane 2. The results from the test with a centered load condition can be used to verify transverse symmetry. A photograph of the test truck positioned in Lane 2 is shown in Figure 3.6b.

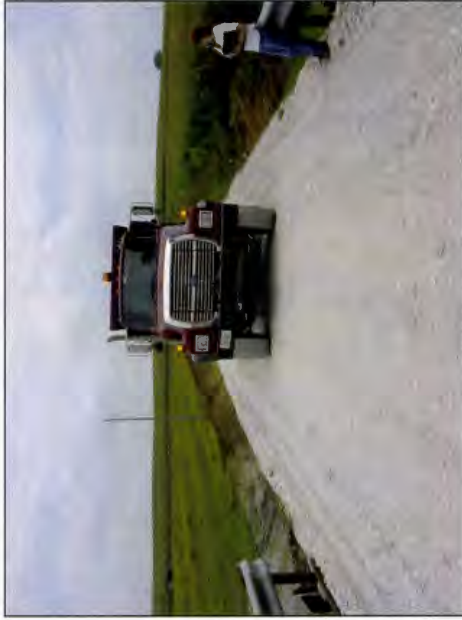
b. Truck centered on BCB2 (Lane 2)

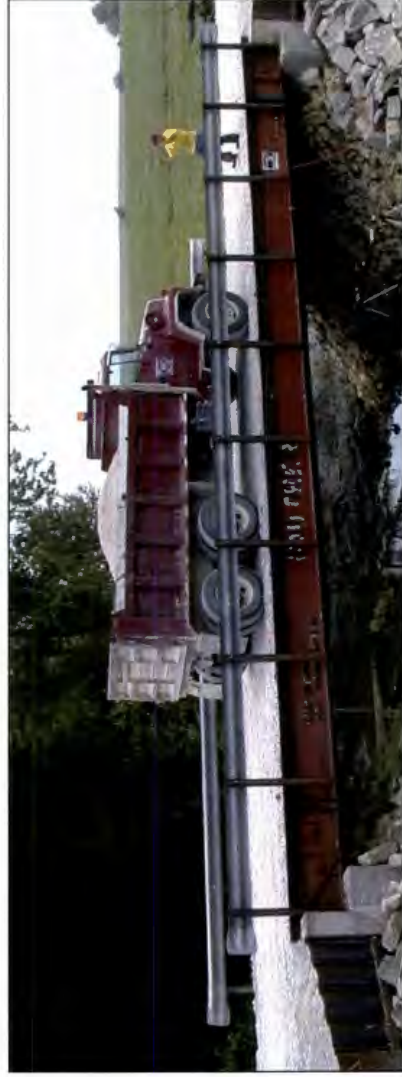
c. Photograph of BCB2 test truck

For the field load tests, the truck, shown in Figure 3.6c, was driven slowly across the bridge in each of the three lanes while the data acquisition system recorded the strains and deflections measured by the strain and deflection transducers. The tests on the BCB2 were

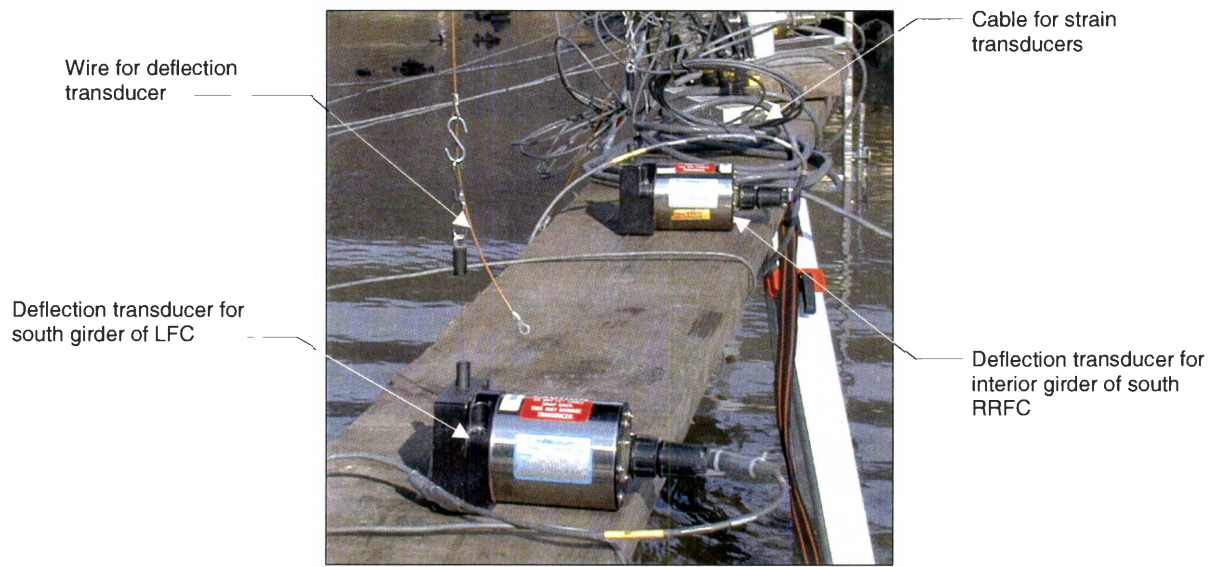
Figure 3.8. Deflection transducers used on DCB.

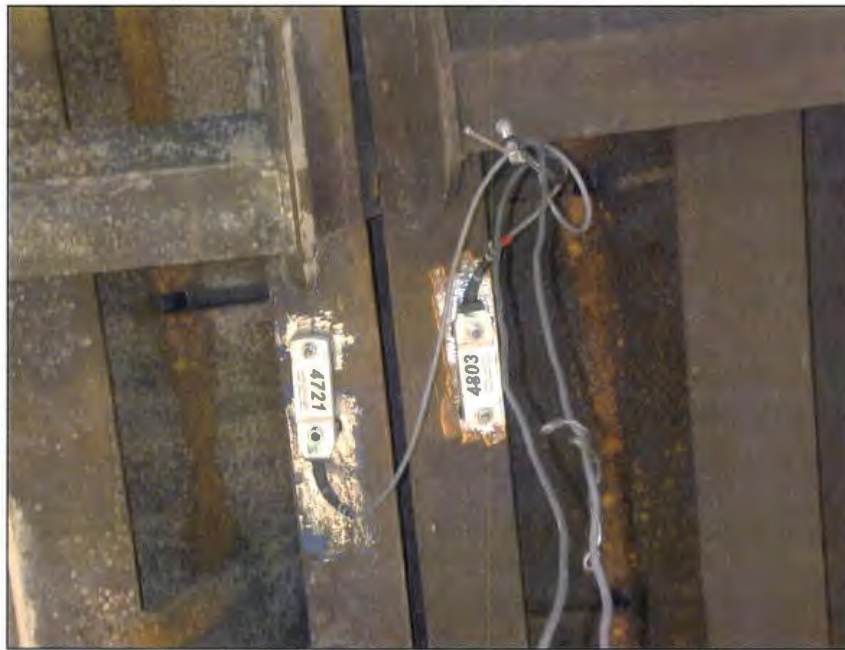
a. Strain transducers 16 and 17 on bottom flanges of girders at LFC

b. Strain transducer 7 on bottom flange of interior girder

Figure 3.9. Strain transducers on the DCB LFC.

through 19. Photographs of strain transducers 16 and 17 at the midspan of the two girders at the LFC and strain transducer 7 on the interior girder are shown in Figure 3.9. In addition to the bottom flanges, the top flanges of the interior girder of the north RRFC and the exterior girder on the north edge of the DCB were instrumented with strain transducers, identified as transducers 20 and 21 in Figure 3.7f. The top and bottom flanges of the interior girder of the north RRFC and the exterior girder on the north edge of the bridge were instrumented with transducers 18 through 21 to determine the neutral axis of each girder.

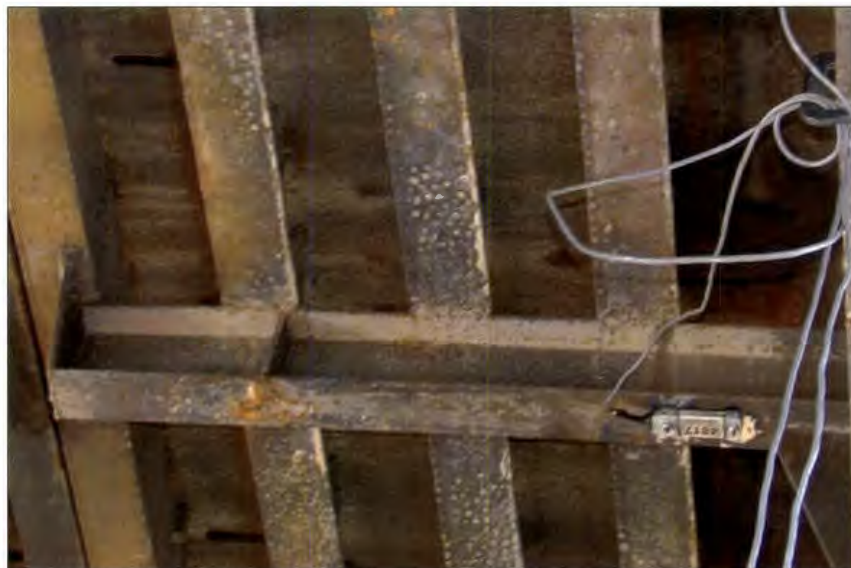
a. Strain transducer 13 on a secondary member

b. Strain transducer 11 on an S-shaped transverse member

Figure 3.10. Photographs of strain transducers used on DCB.

In addition to the primary girders, two secondary members and one S-shaped transverse member were instrumented with strain transducers to determine the strains in the secondary and S-shaped transverse members. As seen in Figure 3.7e, strain transducers 12 and 13 were mounted on the secondary members that were located 7 ft – 9 in. and 9 1/2 in. from the north edge of the DCB, respectively. The longitudinal position of the strain transducers, identified as Detail D in Figure 3.7a, is 8 in. west of the midspan. A photograph of strain transducer 13 on the secondary member is shown in Figure 3.10a. The transverse member that was instrumented is identified as Detail C in Figure 3.7a and was approximately 4 ft west of the midspan. As shown in Figure 3.7d, the strain transducer on the transverse member, transducer 11, is mounted 12 in. south of the web of the interior girder of the north RRFC. In Figure 3.10b, a photograph of strain transducer 11 on the S-shaped transverse member is shown.

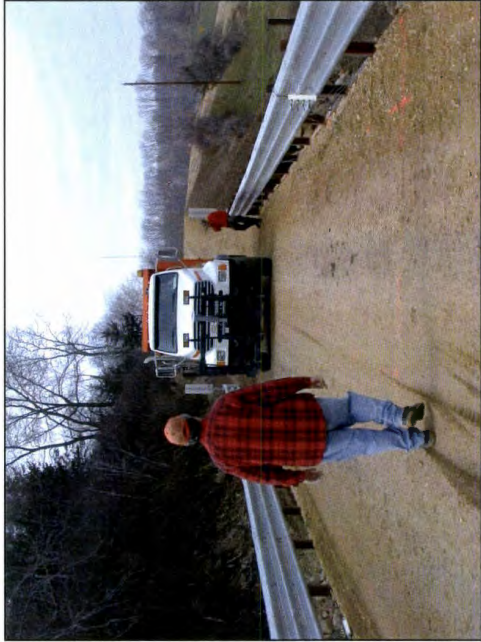
a. Truck centered on DCB (Lane 2)

Figure 3.12. Photographs of the truck used in the DCB tests.

As with the BCB2, the DCB was divided into the three lanes shown in Figure 3.11 to determine the behavior of the bridge under different load conditions. As may be seen in Figures 3.11a and 3.11c, when in Lanes 1 or 3, the truck was positioned with the center of one set of the double tires 2 ft from the south or north edge of the bridge, respectively. With the truck positioned in Lane 1 or 3, an eccentric load condition is created. The results from test with the truck positioned in Lane 1 can be compared to the results from the test with the truck in Lane 3 in order to verify transverse symmetry in the DCB. The effectiveness of the LFC can also be determined with the results from the tests with an eccentric load condition. As may be seen in Figure 3.11b, the test truck was centered transversely on the DCB when in Lane 2, creating a centered load condition. The results from the test with a centered load condition can be used to verify transverse symmetry. Photographs of the test truck positioned in Lanes 2 and 3 are shown in Figures 3.12a and b, respectively.

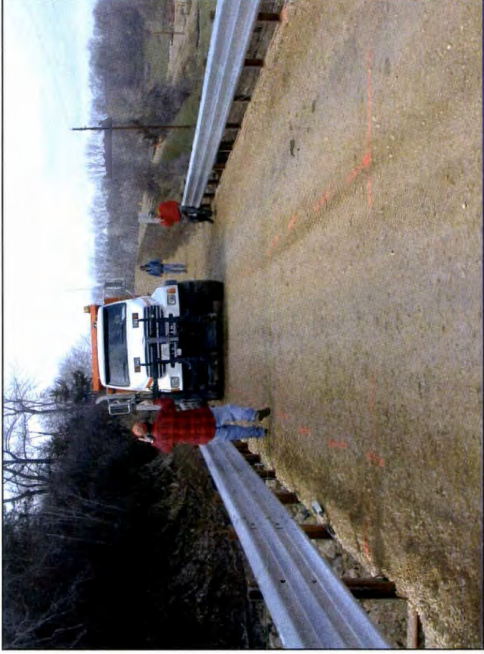
b. Loading DCB with truck on north RRFC (Lane 3)

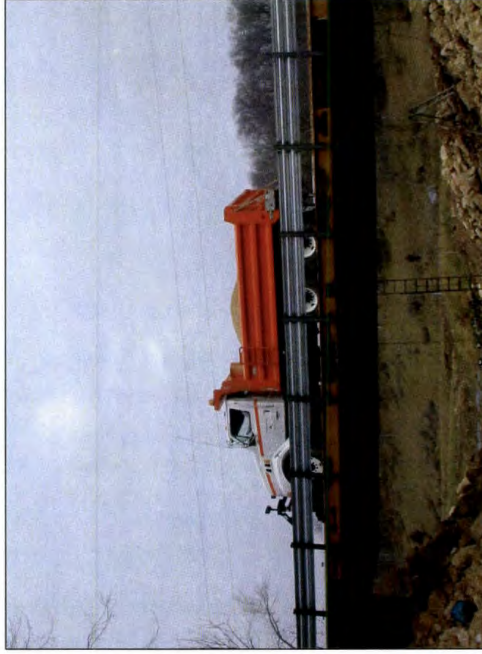
c. Photograph of DCB test truck

For the static field load tests, the truck, shown in Figure 3.12c, was driven slowly across the bridge in each of the three lanes while the data acquisition system recorded the strains and deflections measured by the strain and deflection transducers. The tests were considered static because when traveling at a slow speed, the truck did not cause significant dynamic effects to occur in the bridge.
