Fluvial erosion measurements of streambank using Photo-Electronic Erosion Pins (PEEP)

FLUVIAL EROSION MEASUREMENTS OF STREAMBANK
USING PHOTO-ELECTRONIC EROSION PINS (PEEP)

A thesis submitted in partial fulfillment
of the requirements for the Master of
Science degree in Civil and Environmental Engineering
in the Graduate College of
The University of Iowa

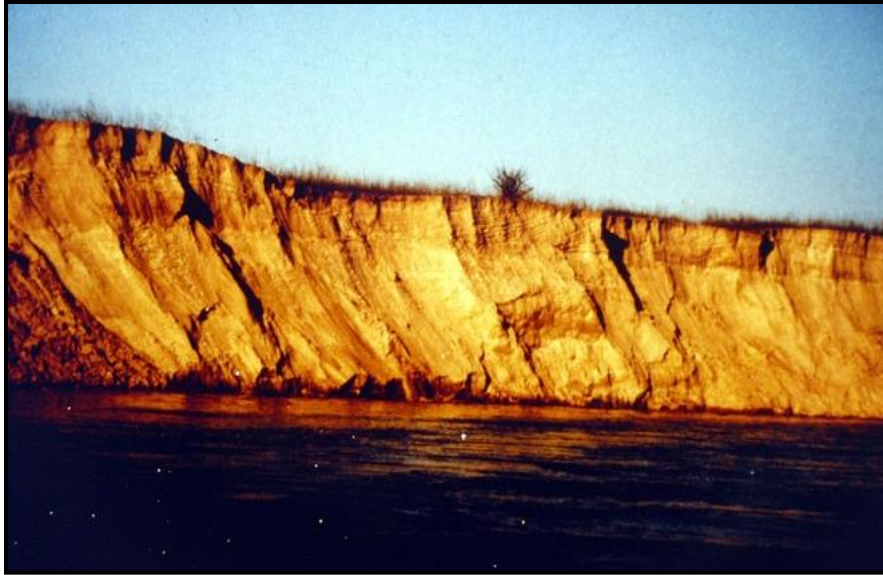
Figure 1.2 : Planar failure (Thorne et al., 1997)

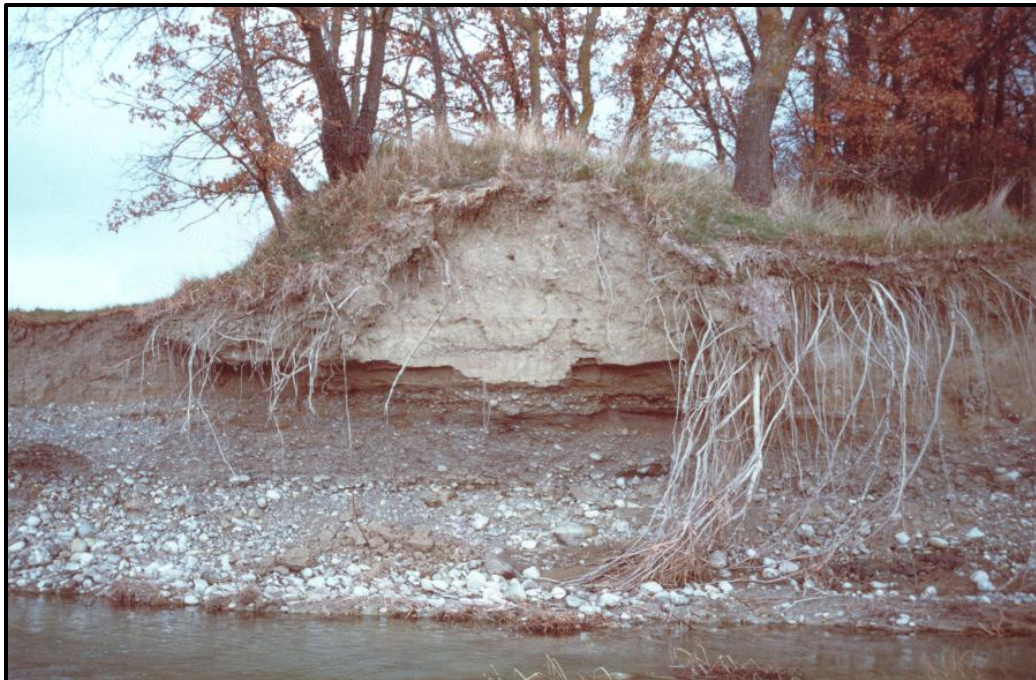
Figure 1.3: Cantilever blocks reinforced by roots in Cecina River Italy (Papanicolaou et al., 2006)

The removal of the riparian vegetation affects the bank soil properties (e.g., moisture, porous structure) and reduces the critical erosional strength of soil by a factor of 3 making the bank soil more susceptible to the action of the hydraulic forces (i.e., drag and lift forces) (Millar, 2000; Papanicolaou and Hilldale, 2001). It is the pioneering work of Wolman (1959) which demonstrated the interconnection between bank vegetation and soil properties. The modification of the vegetation patterns affects the soil properties of banks (such as soil wetness) and makes the impacts of the freeze/thaw cycle (discussed in section 1.2.4) on the reduction of soil strength more pronounced (Van Klaveren and McCool, 1998). Figure 1.3 shows cantilever blocks reinforced by the presence of roots in the Cecina River (Italy).

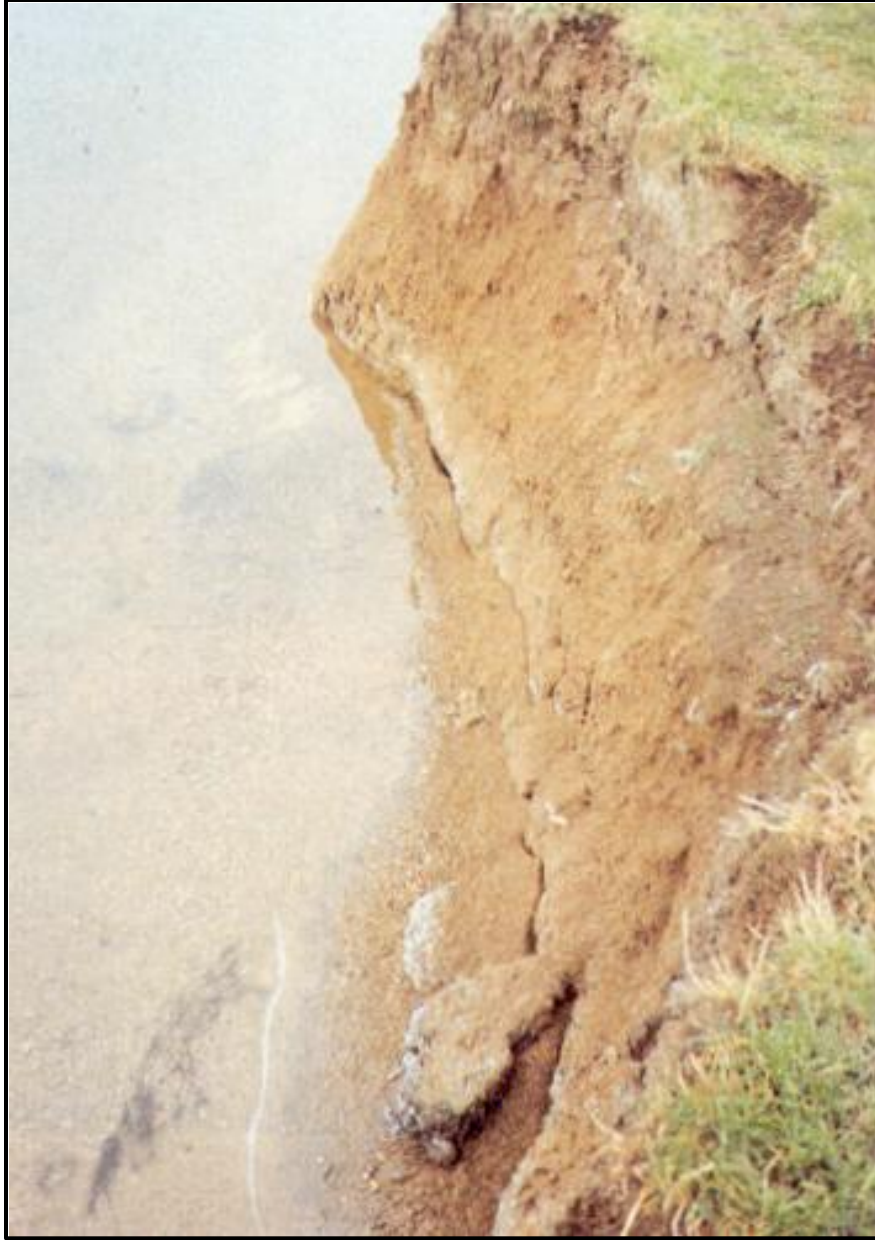
Figure 1.4: Sub-aerial processes: freeze/thaw (Thorne et al., 1997)

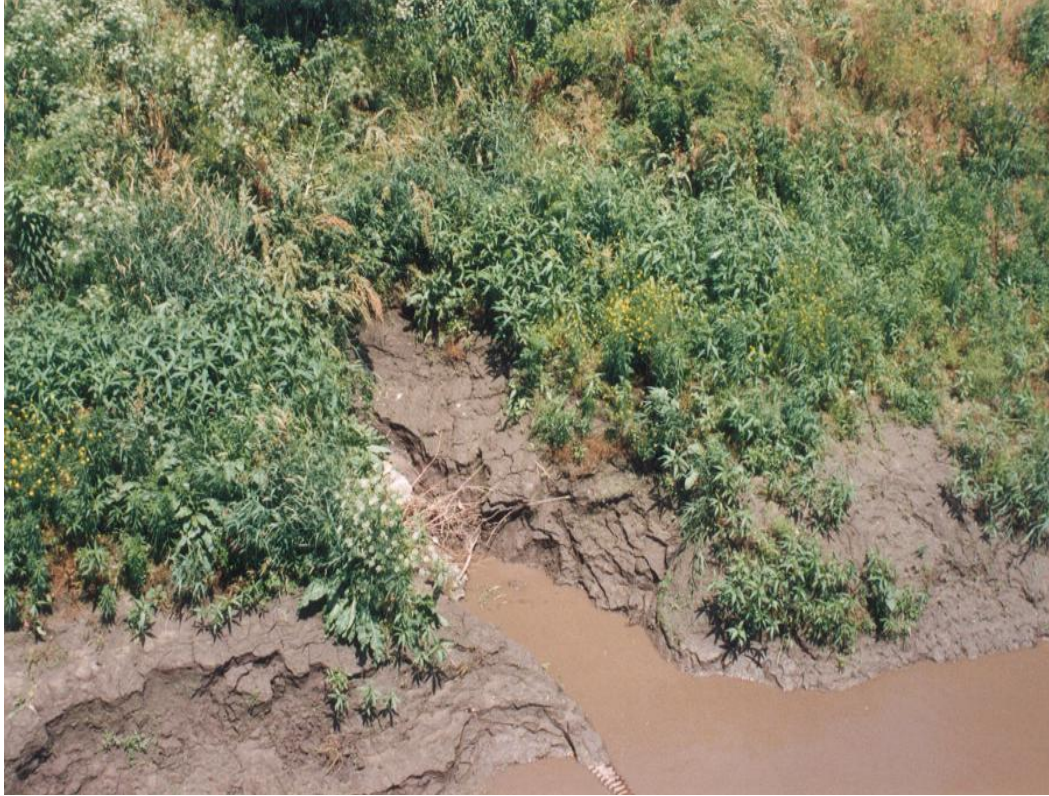
Figure 1.5: Pop-out failure in a cohesive lower bank (Midwestern US) (Papanicolaou et al., 2006)

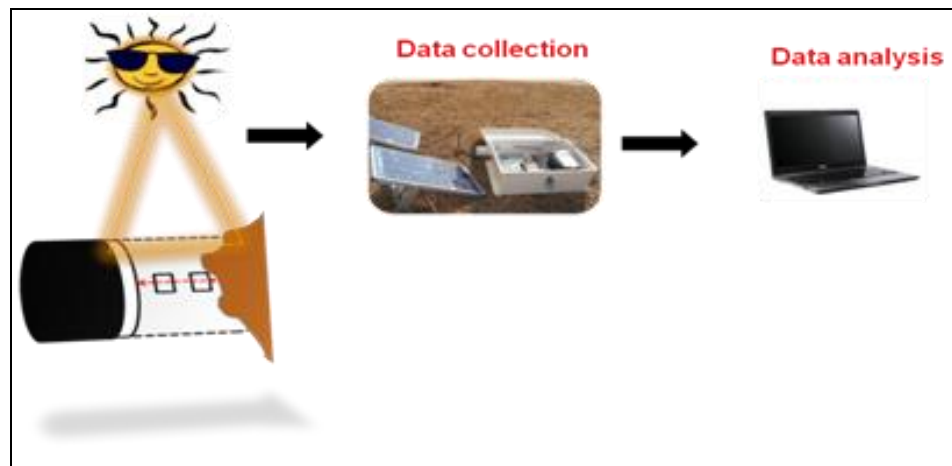
Figure 3.8: Illustration of the principle of operation of the PEEP.

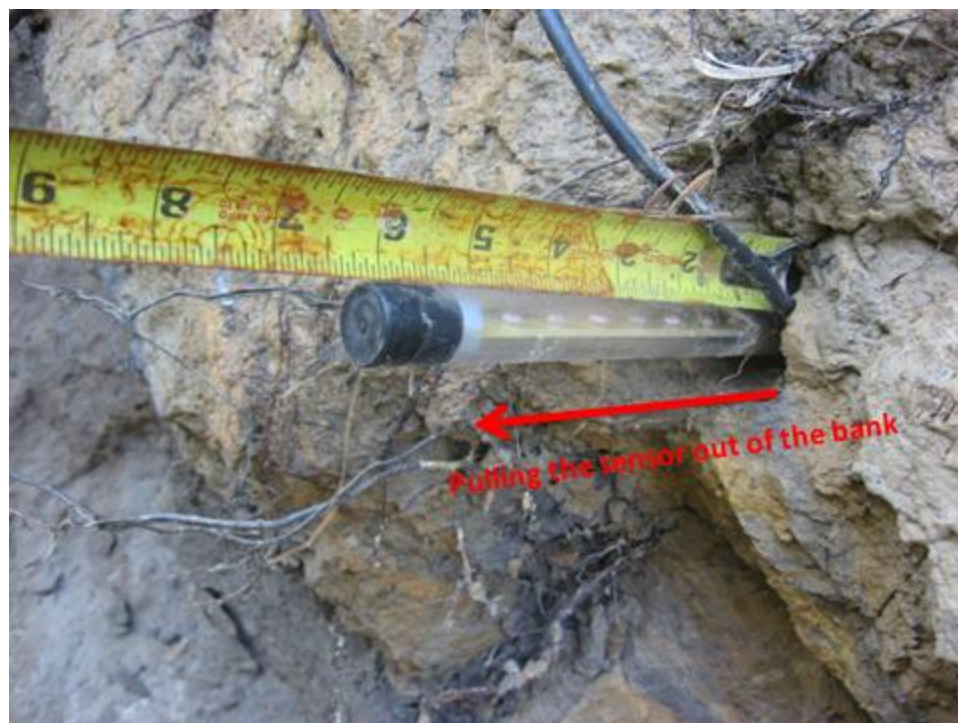
Figure 3.11: In-bank calibration of the PEEP.

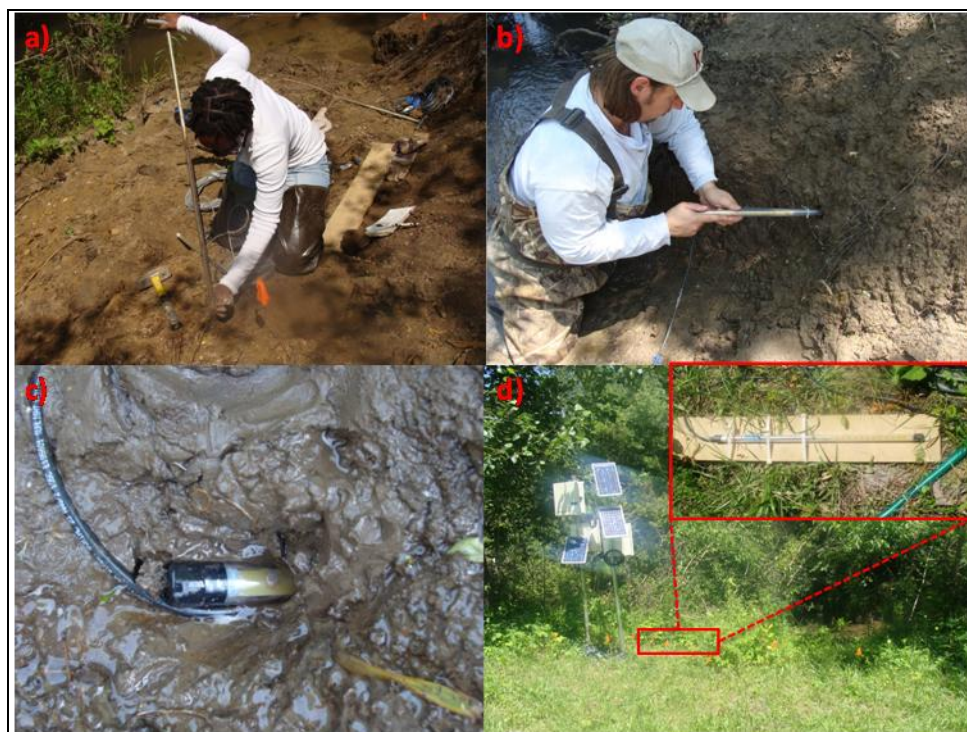
Figure 3.13: Installation procedure for the PEEPs.

The recommended procedure for installing the PEEPs calls for drilling two 16-mm diameter holes. The first hole is into the bank face, parallel to the water surface. The second hole must be vertical from the top of bank some distance from the edge to avoid disturbing the bank. The two holes must intersect perfectly so that the PEEP cable can be passed through the holes. This technique proved difficult and was modified.

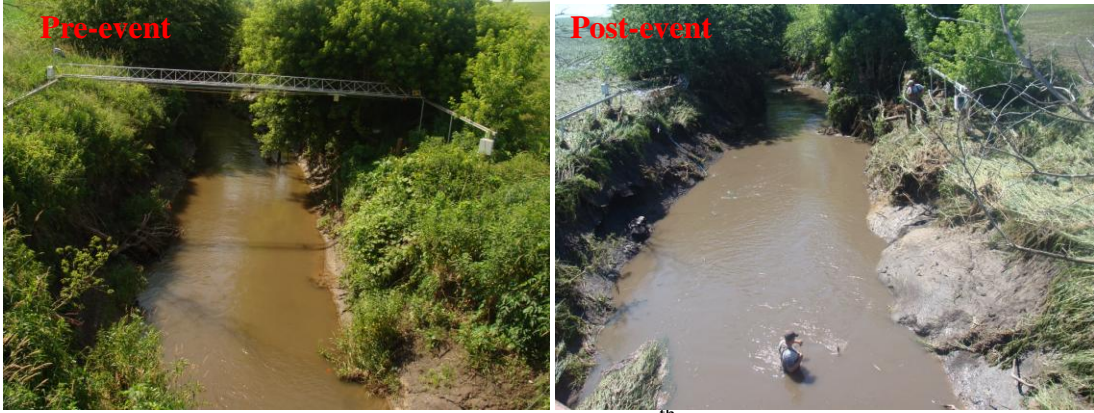
b) Picture of the PEEPs cross-section pre- and post event

Figure 4.3: South Amana before and after the June 19th event.
(a) PEEP cross-section pre-event and post-event. The bank profile is delimited using the survey data of May 28th and June 23rd 2009.
(b) Plan view of the study reach pre- event and post- event. Facing downstream, “RB” stands for Right bank and “LB” for left bank.
