Fracture of Type 347 stainless steel

A Thesis Submitted to the
Graduate Faculty in Partial Fulfillment of
The Requirements for the Degree of
MASTER OF SCIENCE

Major Subject: Nuclear Engineering

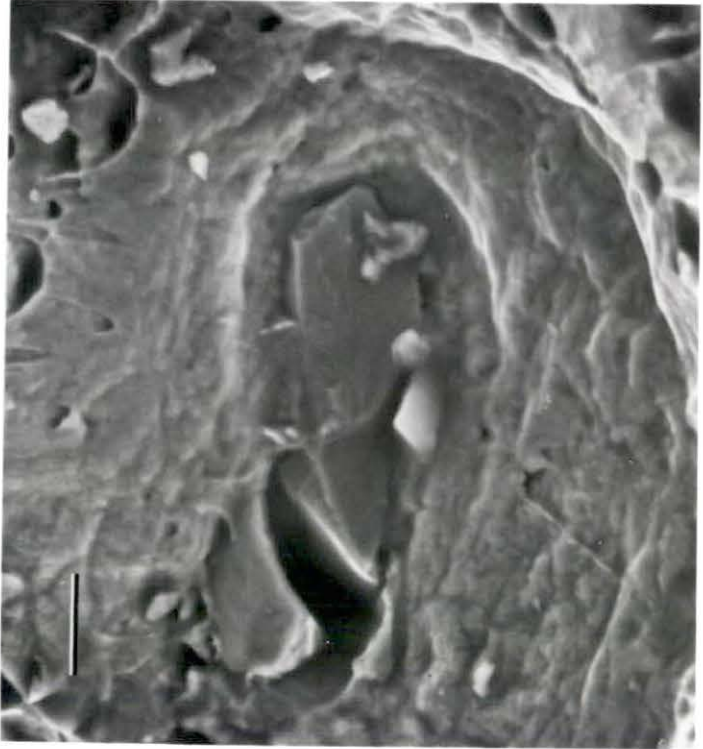
Figure 9b. The SEM micrograph shows a dimple with an inclusion located inside the dimple, on a fracture surface. Note the tear features associated with the dimples approximately $0.4\mu\text{m}$ in diameter. The rolling direction is perpendicular to the plane of the micrograph. The length of the scale bar represents $5\mu\text{m}$

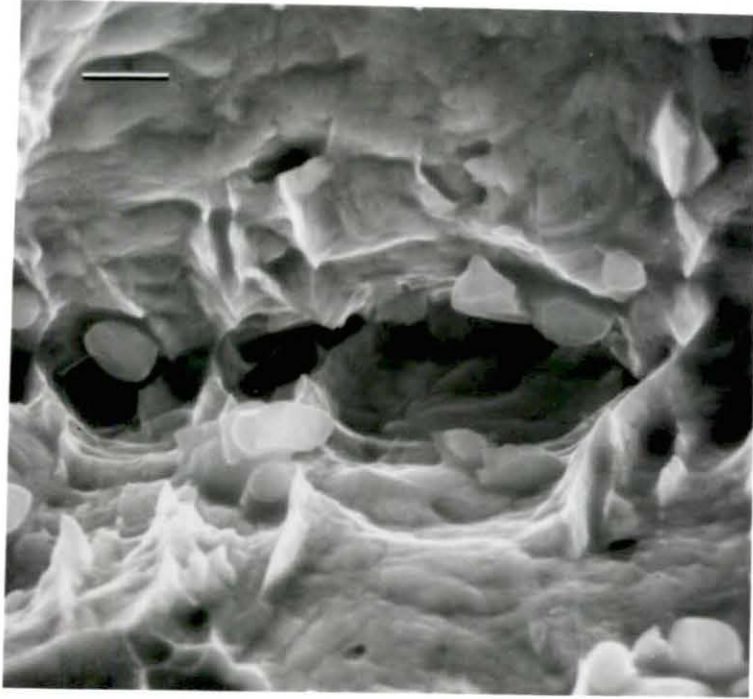
Figure 14a. The SEM micrograph indicates the process of void coalescence for an area of a fracture surface. The rolling direction is parallel to the horizontal edge of the micrograph. The length of the scale bar is $2\mu\text{m}$

Figures 14a and 14b assist in understanding the process of void coalescence of the larger voids. Figure 14a shows the stages of void coalescence for a string of particles. On the right hand side of the Figure a particle is seen in a dimple. The dimple has not yet grown together with the larger dimple to the left. The wall between the large dimple and the smaller dimple has started to separate or rupture. To the left of this region in the field of view there are examples of voids which have completely ruptured. Rupture ridges remain on the sides of the dimple. Figure 14b also shows clear evidence of void coalescence. There are rupture ridges on both sides of the dimple. Figure 10a shows an excellent view of rupture ridges. These mark the boundary or walls that once divided the particle seen in the dimples.

Figures 14a and 14b show several particles in these larger voids. There are two explanations for a number of particles in one dimple: 1) a large particle was broken earlier in the process of fracture and 2) many particles of the same cluster or group have formed these larger voids. The evidence of void coalescence in Figure 14b suggests the

Evidence of void coalescence is present in Figures 14a and 14b. In Figure 14b, ridges on each side of the dimple are present. These ridges are the remains of the rupture of the walls that once separated the voids earlier in the fracture process. In Figure 14a, coalescence is seen in several stages. On the left a group of voids have already coalesced. On the right side of the micrograph, dimples are shown in different stages of coalescence. Note ridges on each side of the dimples. Another possible mechanism of void coalescence is the formation of smaller voids which form a crack. This crack connects the larger particles. Limited evidence of this was observed on the fractures surfaces. In the upper central area of Figure 13a, there is a large dimple which has been formed due to the interconnection of large voids by forming a smaller network of voids. Void coalescence will be greatly enhanced if particles are closer to one another. An example of this is shown in Figures 13a and 11. The strings of

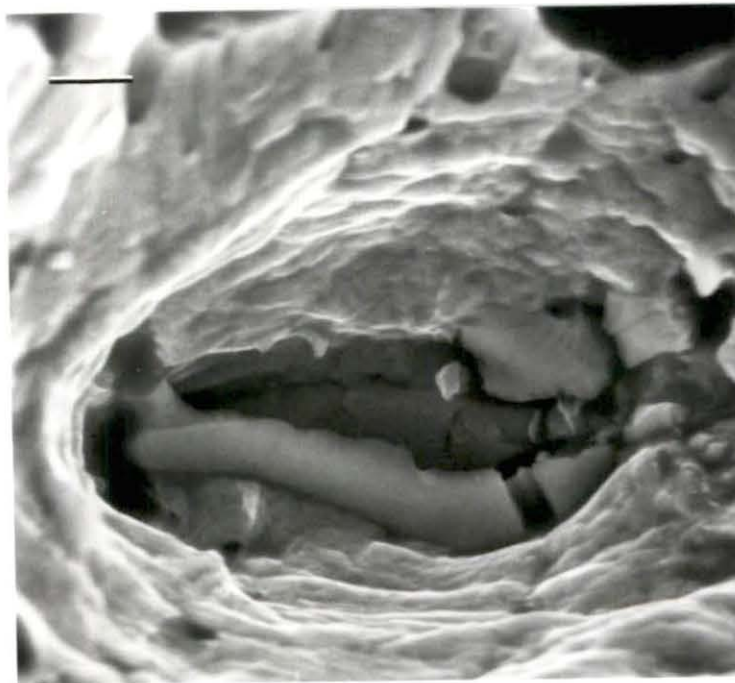
Figure 15b. The SEM micrograph shows a fractured inclusion on a fracture surface. The rolling direction is the same as in the above micrograph. The length of the scale bar is $1\mu\text{m}$

second explanation. However, there is evidence to support the first explanation in Figures 15a, 15b, and 9a as well. Figure 15b shows evidence of the inclusion-matrix bond being separated. There is also evidence of cracks in this particle. The mechanism of forming these cracks is cleavage fracture. Inclusions in Figure 15a and 9a appear to still be bonded to the matrix on the sides of each inclusion. The inclusion in 15a appears to have been pulled apart and broken in several places. From these micrographs the process of fracture by microvoid coalescence can be better understood.
