# Geomorphic approach to predicting degradation of streams in western Iowa

A Thesis Submitted to the  
Graduate Faculty in Partial Fulfillment of the  
Requirements for the Degree of  
MASTER OF SCIENCE

Department: Civil Engineering  
Major: Geotechnical Engineering

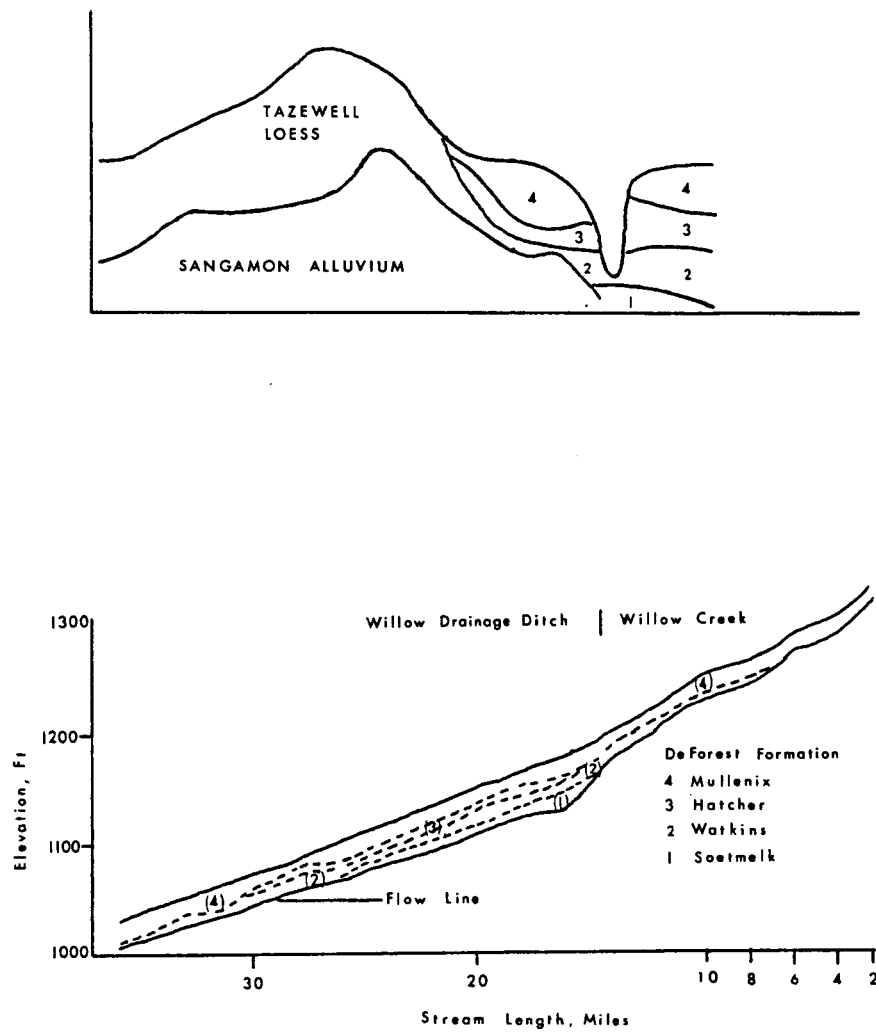
Figure 14. Stratigraphic relationships between members of the DeForest Formation and Willow Creek channel. After Daniels and Jordan (1966)

A depiction of the stratigraphic relationship of these units to each other and to the Willow Creek channel is shown in Figure 14. From oldest to youngest, the DeForest Formation consists of the Soetmelk, Watkins, Hatcher, Mullenix and Turton members. The Mullenix, Hatcher and Watkins members are the thickest in the formation, and the ones most commonly exposed in the channel; the lower Soetmelk is in most cases not cut by the channel, or only exposed at the very bottom. The upper Turton member is not as laterally extensive as the other units. Daniels and Jordan reported finding Turton disconformably overlying Mullenix or Hatcher at various locations along the channel.

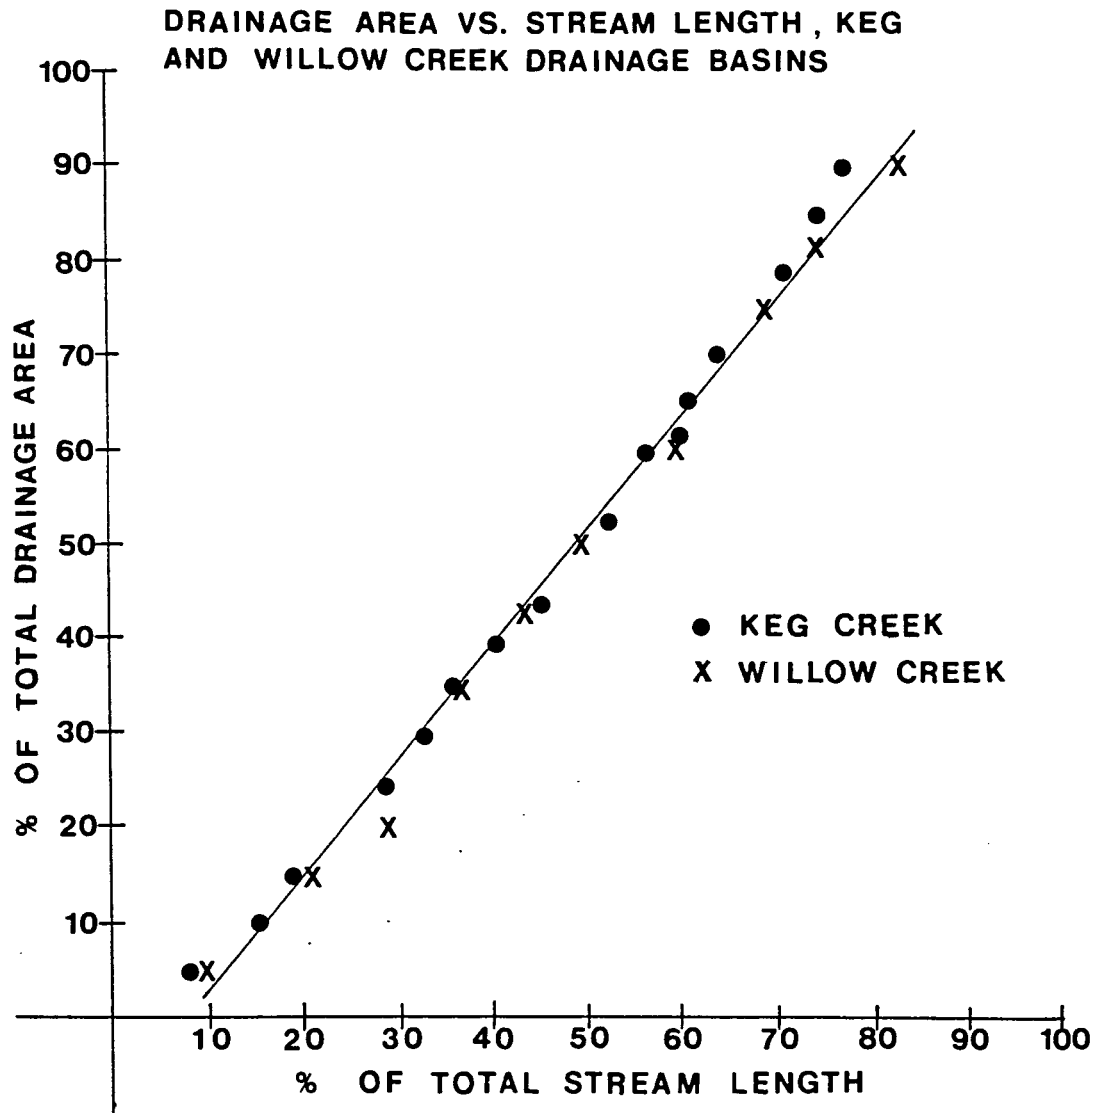
Figure 16. % of drainage area vs % of stream length, Keg and Willow Creek drainage basins

In Figure 16, drainage area is plotted versus stream length for several locations on Keg and Willow Creeks. Points from both streams fit on the same linear trend, indicating that both collect drainage area in about the same proportion per unit length of stream. However, it was noted above that Willow Creek has fewer tributaries per unit stream length than Keg Creek, and 4 of the 7 major tributaries to the Willow join it within a stream distance of only 4.4 miles in middle Harrison County. Using the Lara equations discussed earlier to predict the average discharge

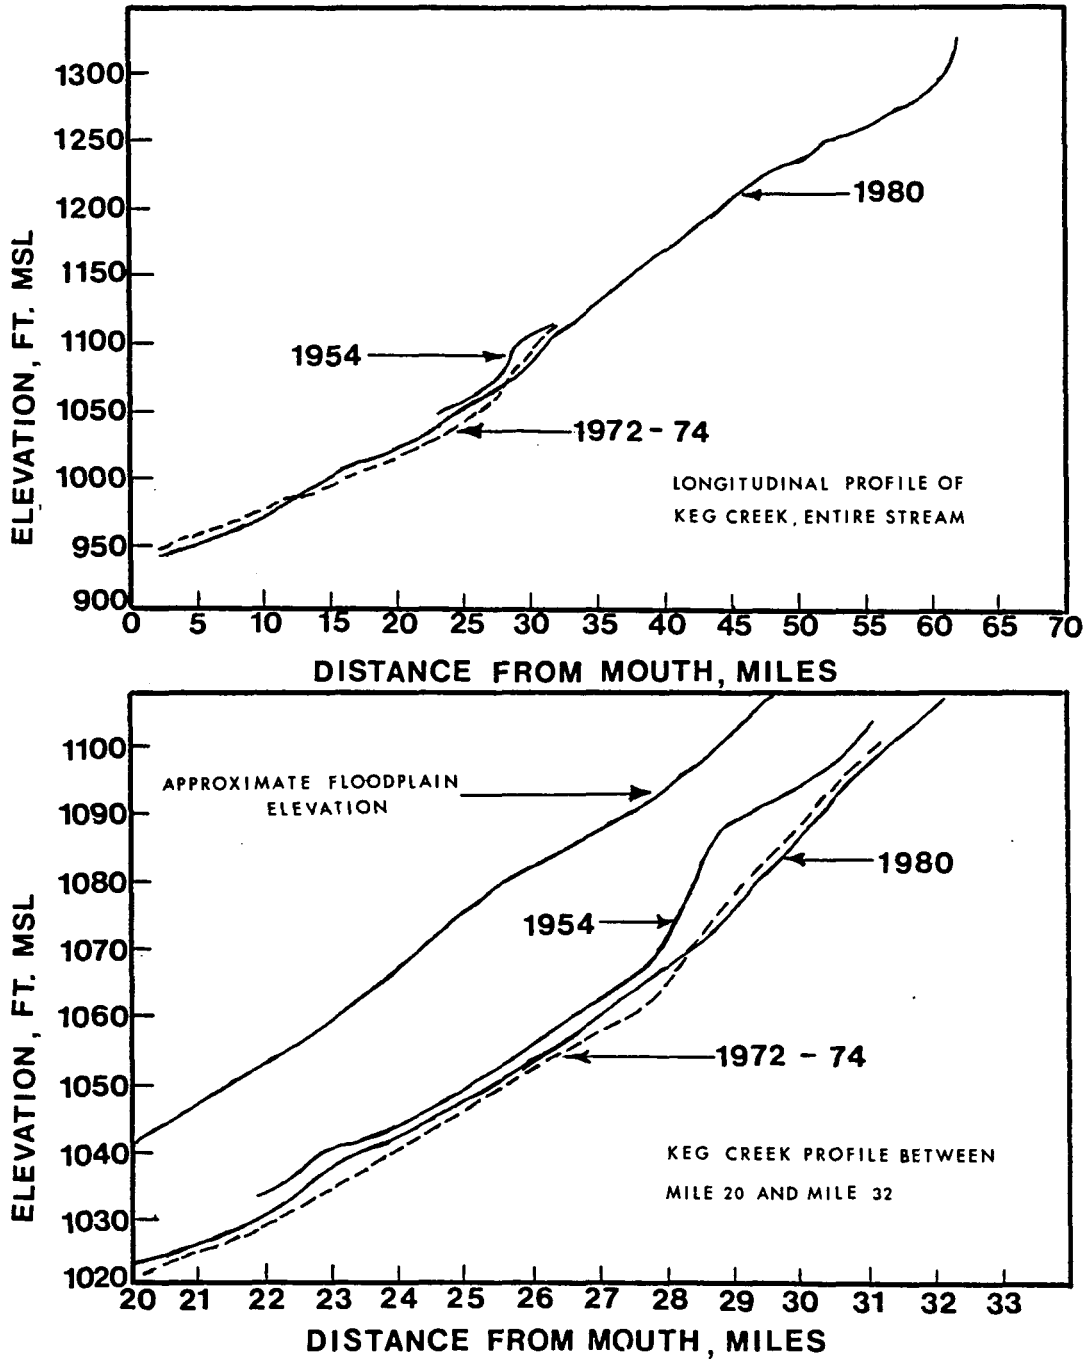
Figure 18. Changes in the longitudinal profile of Keg Creek After Lohnes et al. (1980)

Table 12 summarizes the data presently available on the degradational history of Keg Creek and the Willow drainage ditch since the turn of the century. Figure 17 shows the changes that have taken place in the longitudinal profile of the Willow over this time period; Figure 18 shows a similar plot for the entire length of Keg Creek.

With the use of bridge plans and Iowa D.O.T. inspection reports, historical data on the degradation of Keg Creek were gathered and plotted in relation to the 1980 longitudinal profile of the stream. Inspection of Figure 18 shows that the 1972 profile is 2 to 3 feet above the 1980 profile to mile 14.5, but that past this point the 1972 profile is 1 to 3 feet below the 1980 profile. Where data were available in the reach from mile 22 to mile 27.8, it was found that the 1954 profile was 1 to 2.5 feet above the 1980 profile. Lohnes et al. (1980) concluded that the reach of the stream below mile 14.5 has been relatively stable since at least 1954, but that active degradation (as much as 10 feet) had been taking place between mile 28.5 and mile 31 during the same period. In the upper reaches

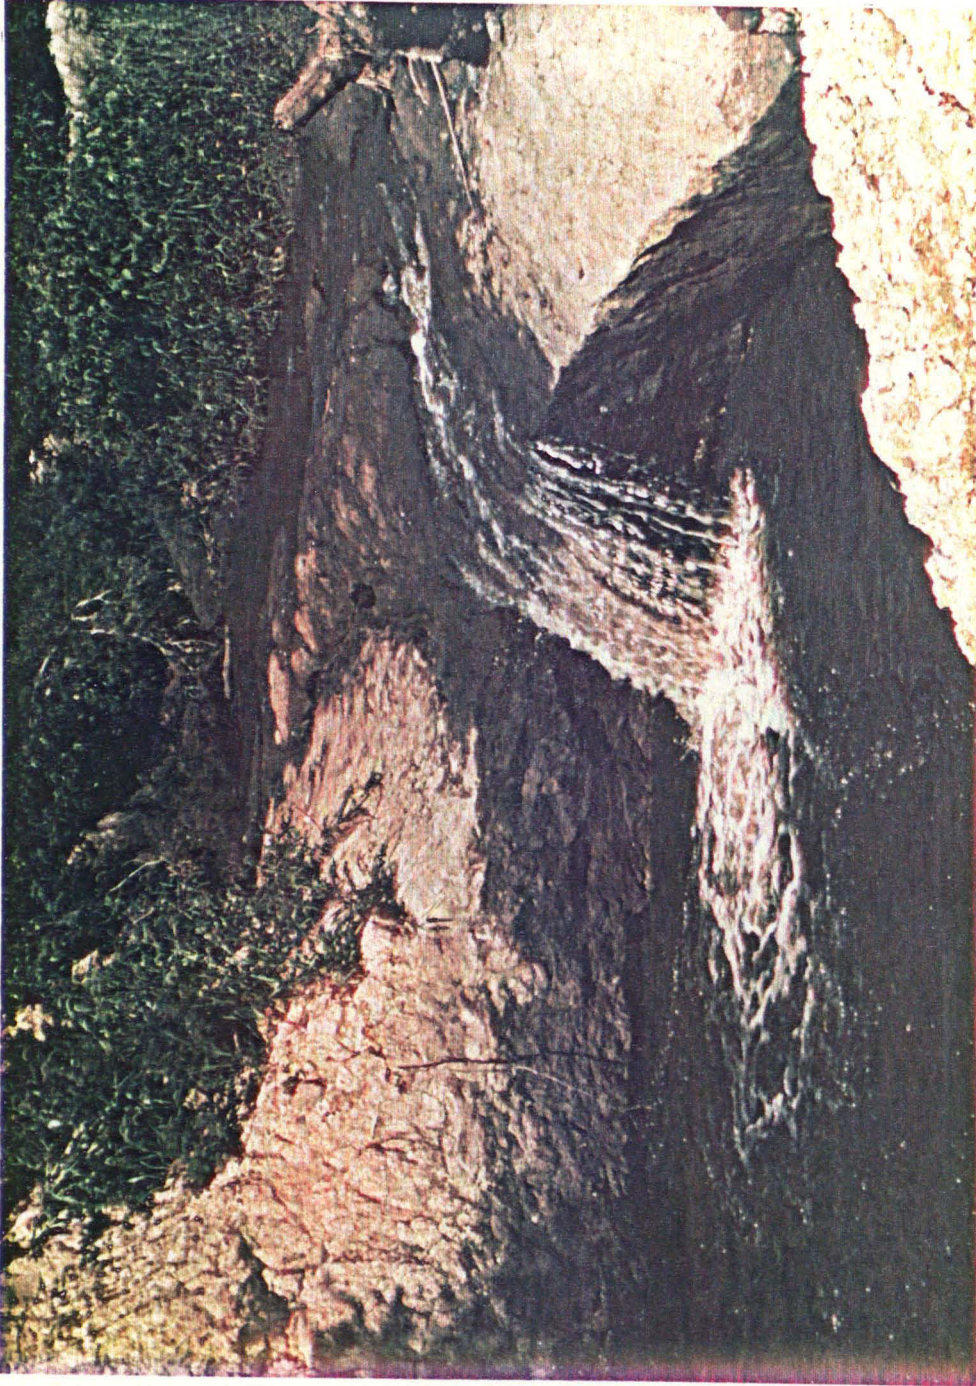
Plate 1. A knickpoint in a Fremont County stream

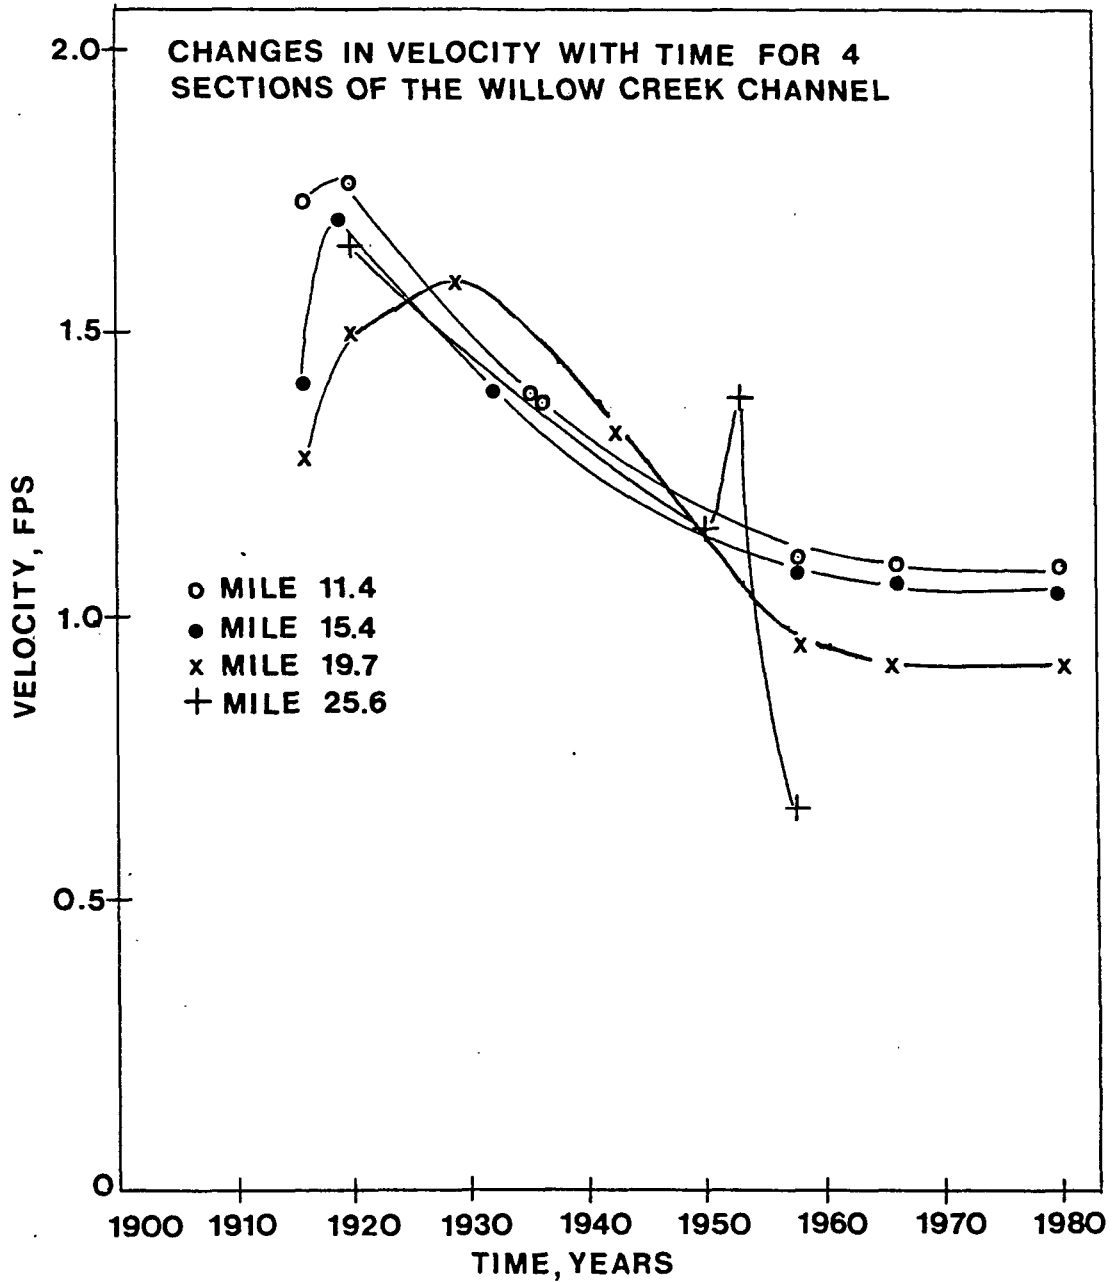
Figure 22. Velocity variation with time for 4 sections of the Willow drainage ditch. Modified from Lohnes et al. (1980)

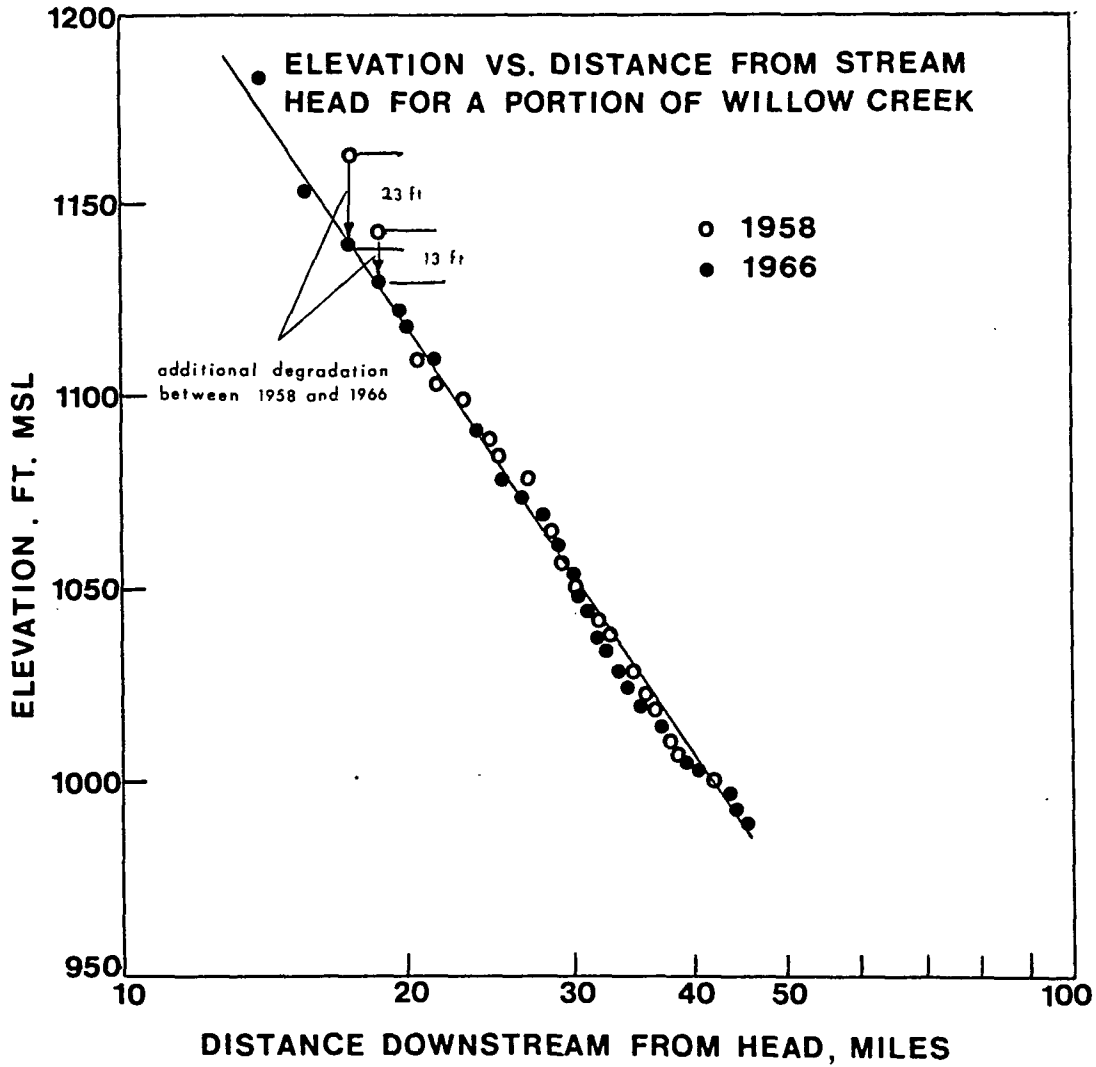
Figure 27. Longitudinal profile of Willow Creek on semi-log plot.  
After Lohnes et al. (1980)

In Figure 27, the semi-log plot of the 1966 channel profile for the lower 33 miles of Willow Creek is compared to the 1958 profile. Points from the 1966 profile fit the line representing the average 1958 profile, except for the upper 8 miles of the section. This confirms the Daniels and Jordan prediction, and indicates that further degradation could have been expected after 1958. The installation of 3 grade stabilization structures after 1966 altered the profile of Willow Creek, and comparison

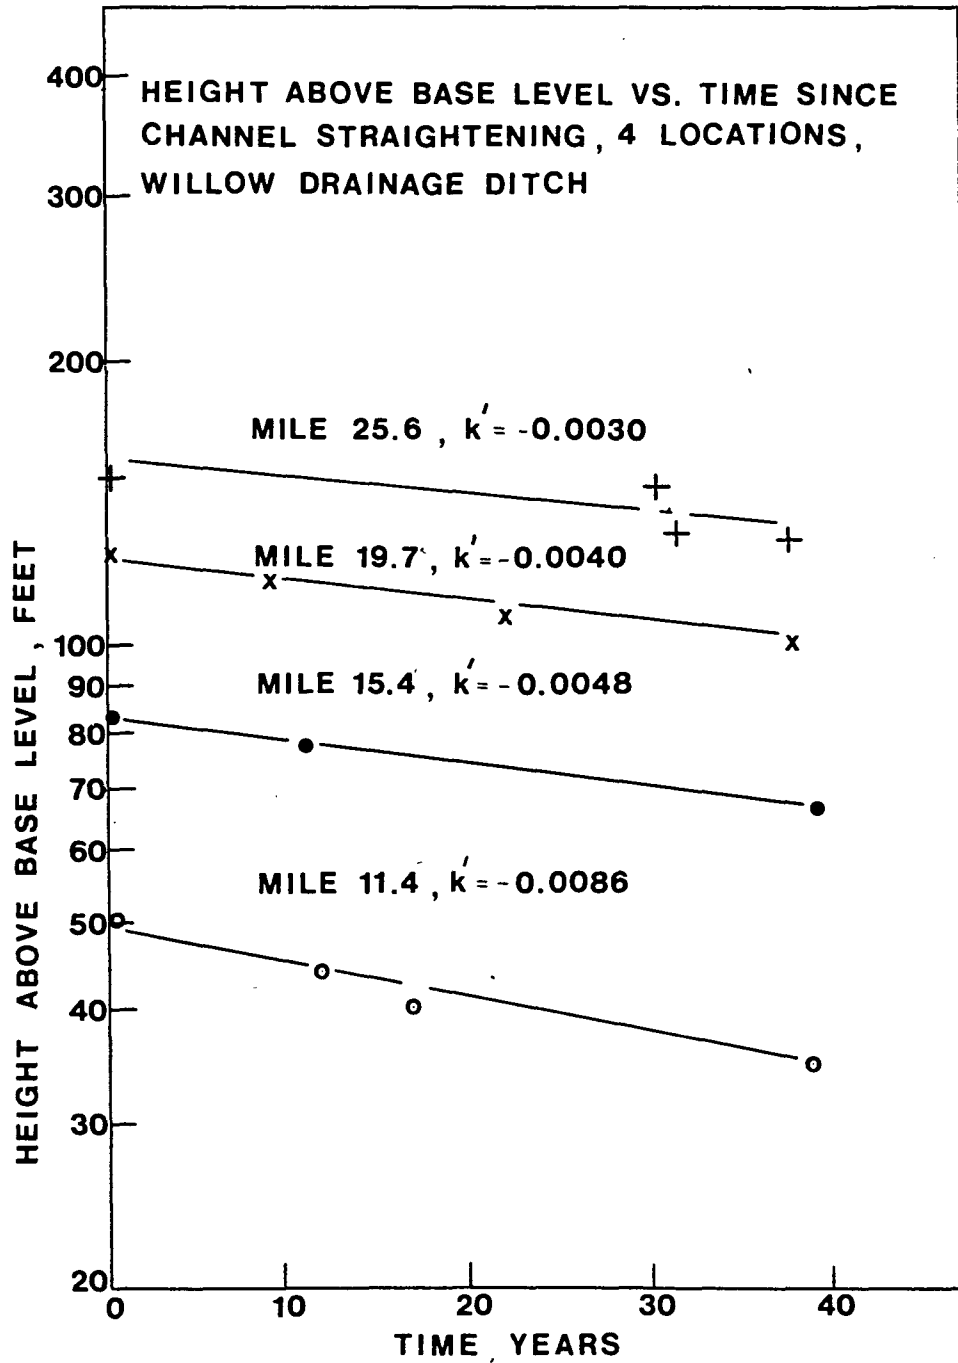
Figure 31. Time versus log height above base level for 4 reaches of the Willow drainage ditch. Modified from Lohnes et al. (1980)

From Figure 31, note that the values of  $k'$  increase with decreasing distance from the drainage divide. This suggests a relationship between  $k'$  and some parameter associated with the drainage basin. Lohnes et al. (1980) proposed that the value of  $k'$  should be proportional to the discharge at the reach of the stream under study. Figure 32, a log-log plot

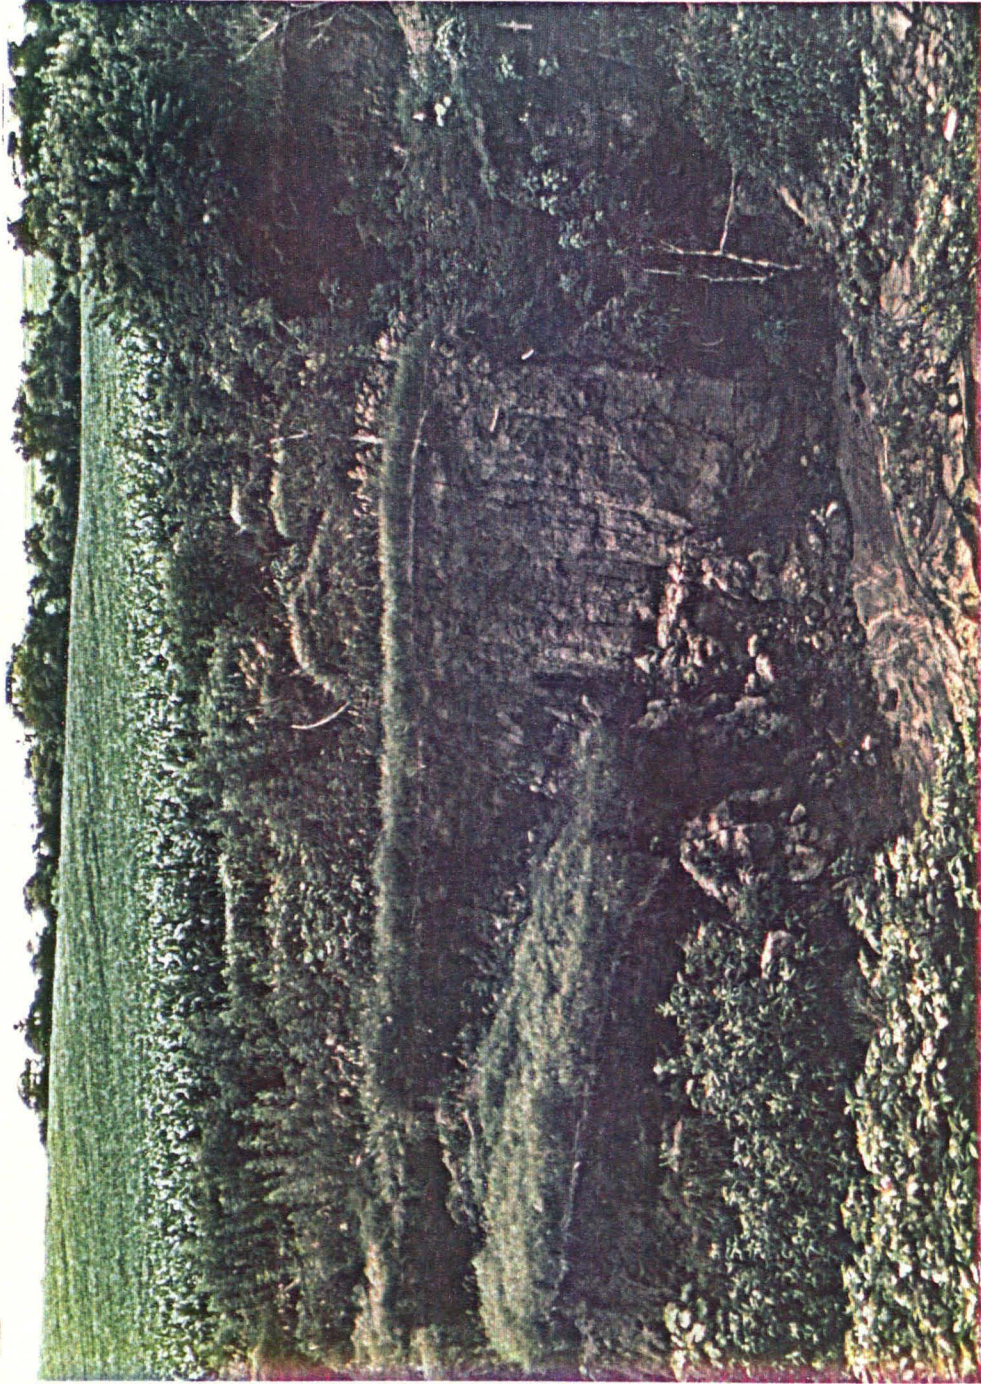
Plate 2. Slump blocks on a Western Iowa stream channel

Vertical or near-vertical slope components greater than 15 feet in height were observed at 7 of the 12 locations. Large slump blocks that have separated from the upper bank but moved only a short distance can be observed at these and many other locations along the degrading portions of stream channels in western Iowa (Plate 2). During this study, blocks as thick as 10 feet have been observed, but Daniels (1960) reported observing blocks as thick as 30 feet in the Willow Creek Channel. These observations suggest that the steep slope components
