Horizontal shear capacity of composite concrete beams without interface ties

A Thesis

Structural Engineering

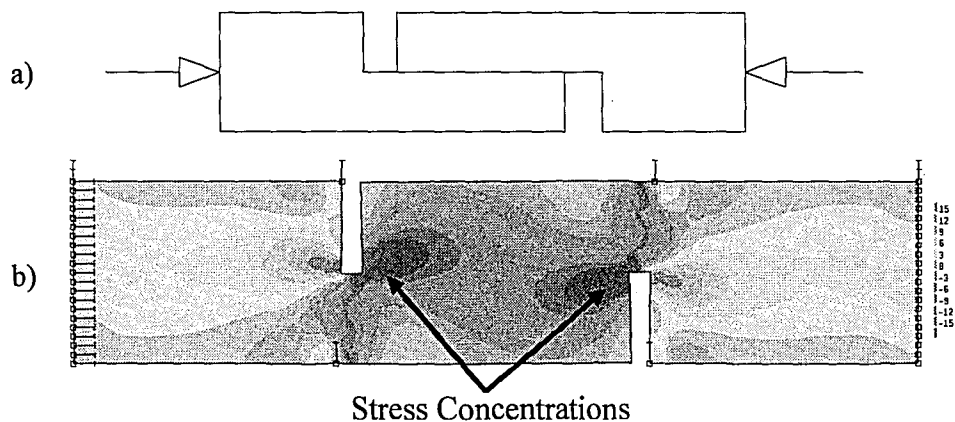
Figure 3-2: Push-off Test Specimen: a) Concentric loading; b) Non-uniform shear stress

The push-off specimen can also experience areas of high stress concentration. A standard push-off specimen is shown in Figure 3-2a. Depending on the accuracy of the setup and boundary conditions, stress concentrations can occur resulting in a non-conservative estimate of the horizontal shear capacity. The stress concentrations are demonstrated by the finite element model shown in Figure 3-2b.

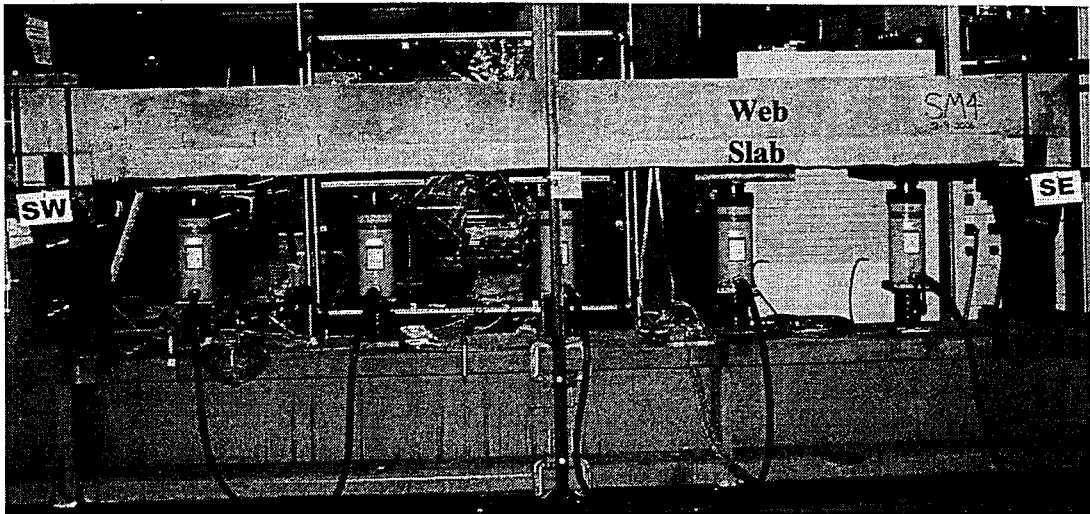
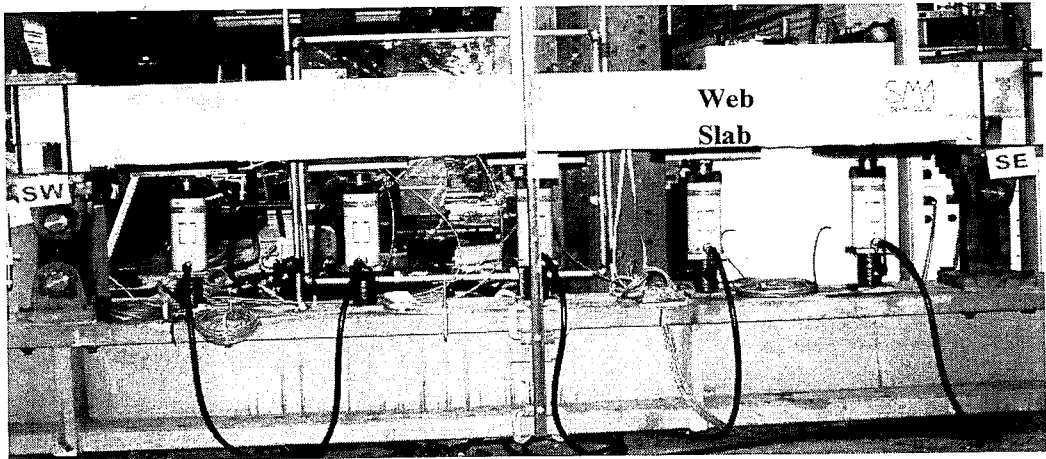
Figure 5-7: Five Point Load Configuration

The beams were inverted and placed in a simply supported self-reacting test setup. Two or five equal loads were then applied at a quasi-static rate to the specimens through the use of thirty ton jacks serviced by a single hydraulic pump (Figure 5-7 and Figure 5-8). The applied load was paused every five kips in order to inspect the beam and the composite interface. The test was stopped once the specimen failed.

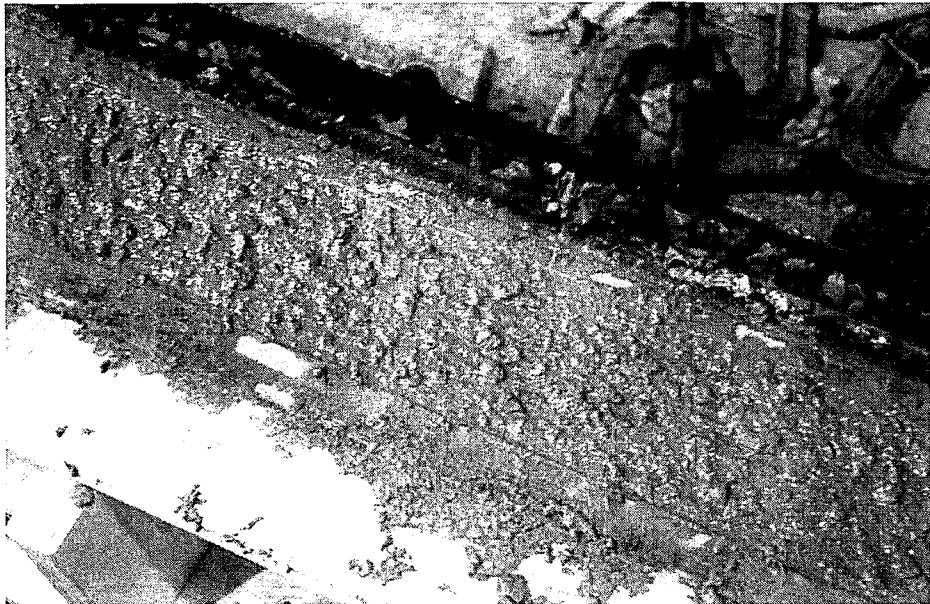
Figure 7-7: As-Placed Surface Finish

As implied by the name, the surface finish for the as-placed beams were left as is after the pour. The concrete is leveled out and not disturbed while it cures. The resulting finish allows for aggregate to protrude for the web providing a roughened surface as shown in Figure 7-7.

As implied by the name, the surface finish for the as-placed beams were left as is after the pour. The concrete is leveled out and not disturbed while it cures. The resulting finish allows for aggregate to protrude for the web providing a roughened surface as shown in Figure 7-7.

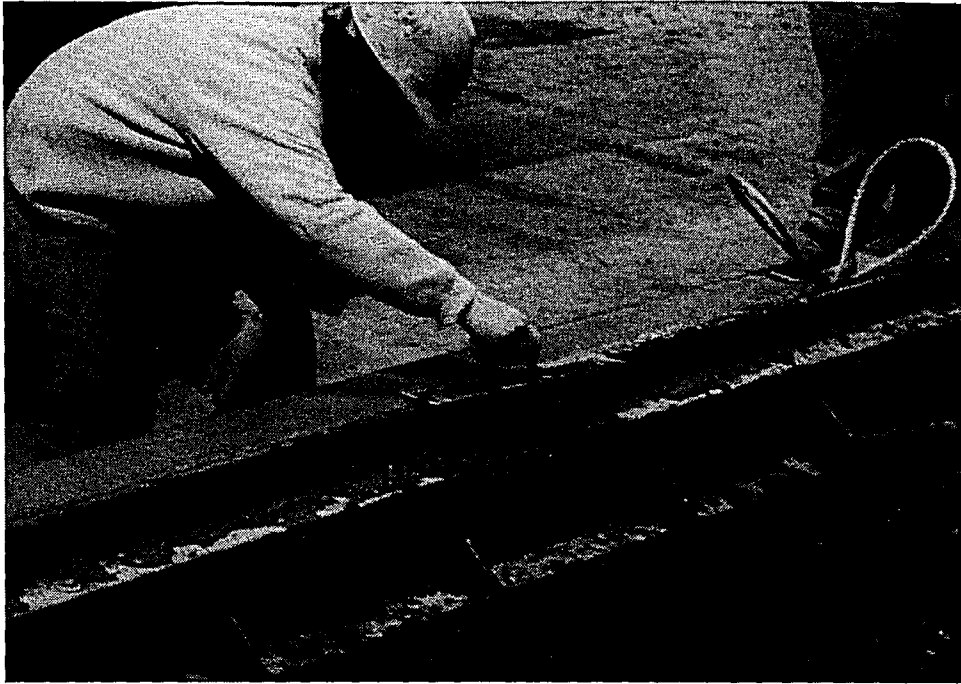
Figure 7-8: Applying a Smooth Surface Finish with a Hard Trowel

For the application of the smooth surface finish, the concrete was first spread evenly during the pour. A short time later, a hard trowel was run across the surface to smooth it out (Figure 7-8). However, the concrete was sticking to the trowel and tearing the surface. The only way to rectify this problem was to apply a chemical called Confilm to the surface before using the trowel. Confilm is an evaporation reducer which also aids with surface finishes. A smooth surface finish was achieved as seen in Figure 7-9.

For the application of the smooth surface finish, the concrete was first spread evenly during the pour. A short time later, a hard trowel was run across the surface to smooth it out (Figure 7-8). However, the concrete was sticking to the trowel and tearing the surface. The only way to rectify this problem was to apply a chemical called Confilm to the surface before using the trowel. Confilm is an evaporation reducer which also aids with surface finishes. A smooth surface finish was achieved as seen in Figure 7-9.

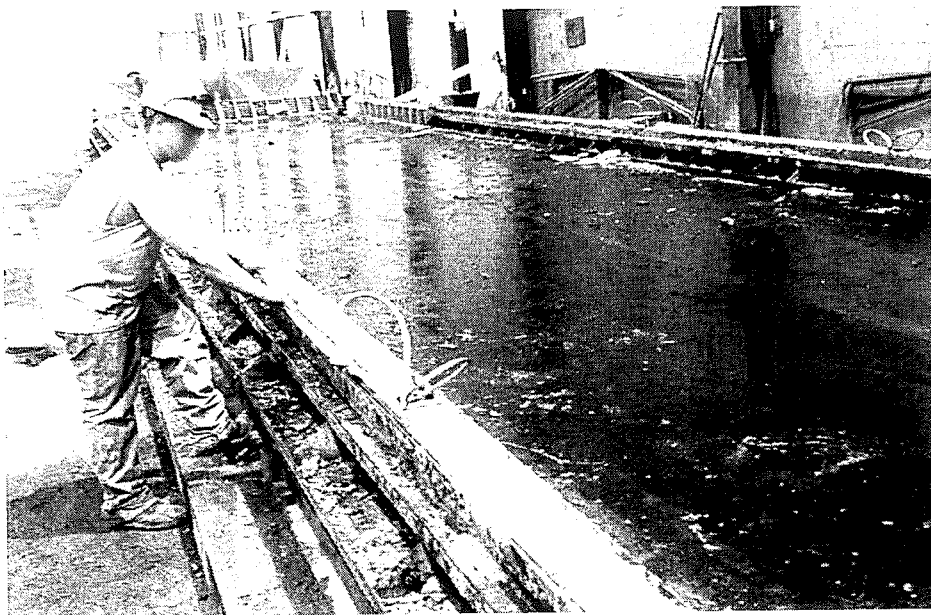
Figure 7-10: Applying the Broom Surface Finish

the workability while smoothing it with a trowel. A broom finish was then applied by running a stiff bristle broom across the surface transverse to the beams length (Figure 7-10 and Figure 7-11).

the workability while smoothing it with a trowel. A broom finish was then applied by running a stiff bristle broom across the surface transverse to the beams length (Figure 7-10 and Figure 7-11).

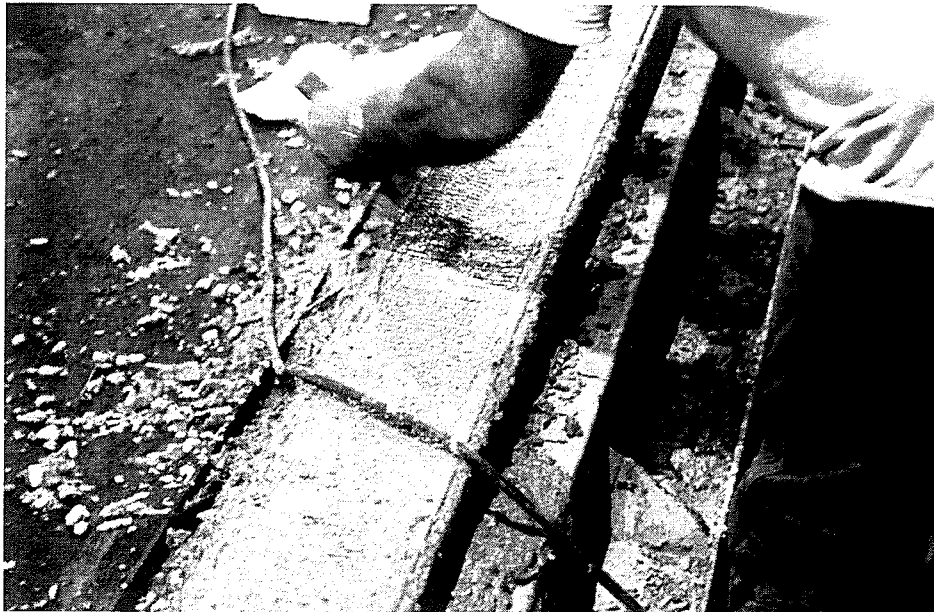
Figure 7-12: Applying the Rake Surface Finish

This surface finish was achieved using a ¼” rake. The surface finish was applied approximately a half hour after the pour. It was important to apply the finish at the proper time. If the finish was applied too early, the concrete would run back together after it was raked; if applied too late, the concrete would be too stiff and cause the concrete to tear. The finish was applied as consistently as possible by running a rake across the surface transverse to the beams length (Figure 7-12). The resulting rake surface finish can be seen in Figure 7-13.

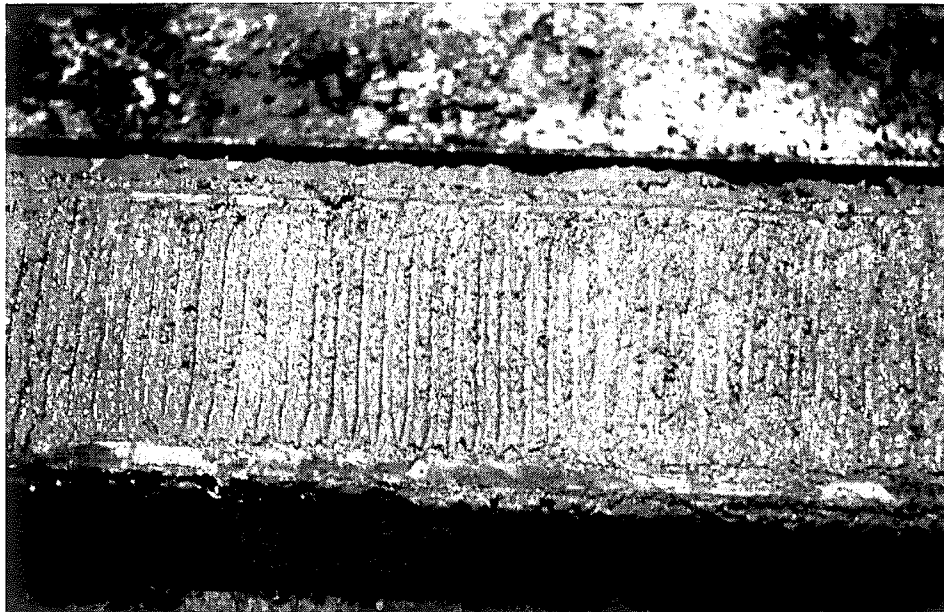
Figure 7-13: Rake Surface Finish

This surface finish was achieved using a ¼" rake. The surface finish was applied approximately a half hour after the pour. It was important to apply the finish at the proper time. If the finish was applied too early, the concrete would run back together after it was raked; if applied too late, the concrete would be too stiff and cause the concrete to tear. The finish was applied as consistently as possible by running a rake across the surface transverse to the beams length (Figure 7-12). The resulting rake surface finish can be seen in Figure 7-13.

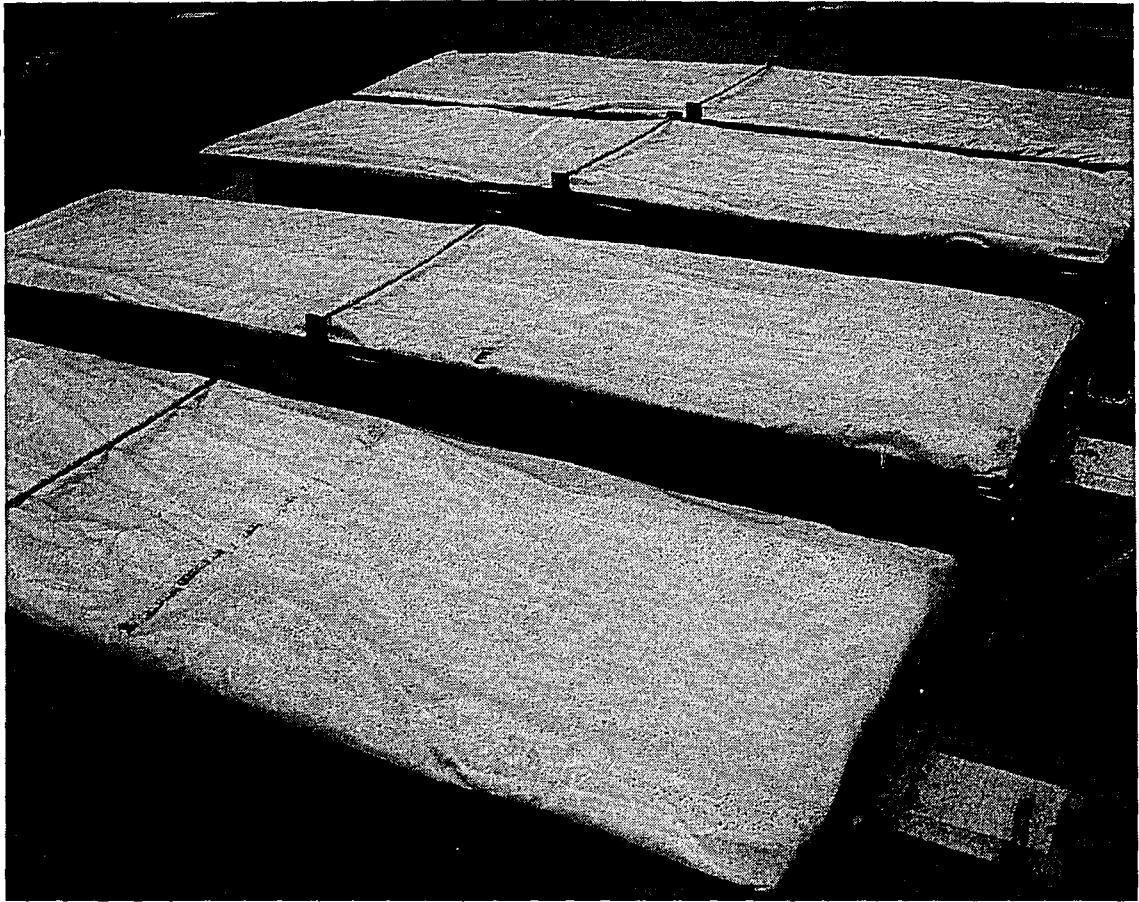
Figure 7-24: Slab Concrete Moist Curing

concrete bucket. The placement of the concrete in the forms began over the interface in order to ensure its integrity. The concrete was then spread to the outer edges of the form and vibrated. While the pour was taking place, 4x8 and 6x12 cylinders were being made in accordance to ASTM C 31. Once the pour was finished, the concrete was allowed to set for a couple hours before applying a smooth finish to the top (Figure 7-23). Subsequently, burlap was soaked in water and draped across the top of the slabs. Plastic was laid over the burlap and taped down so that no moisture would escape (Figure 7-24).

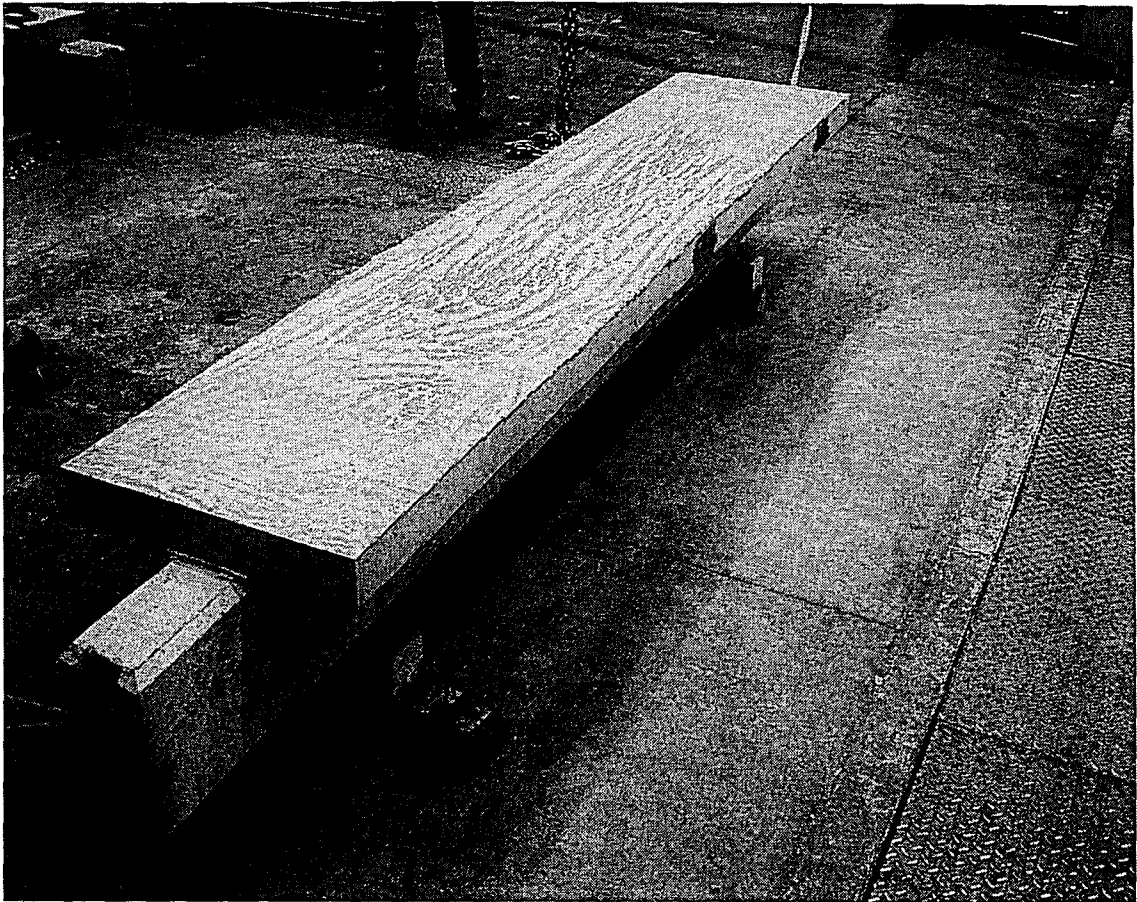
Figure 7-25: Final Fabricated Test Specimen

The slabs were moist cured for approximately seventeen days so that the concrete would reach an adequate strength before removing the forms. The beams along with the 4x8 and 6x12 concrete cylinders were then released and allowed to air dry for roughly ten days (Figure 7-25). At this point the specimens would be ready to test.
