Hydrogeological Assessment for a Suitable Location of a Reservoir Lake in George County, Mississippi

Hydrogeological assessment for a suitable location of a reservoir lake in George County,
Mississippi

A Thesis
Submitted to the Faculty of
Mississippi State University
in Partial Fulfillment of the Requirements
for the Degree of Masters of Science
in Geosciences
in the Department of Geosciences

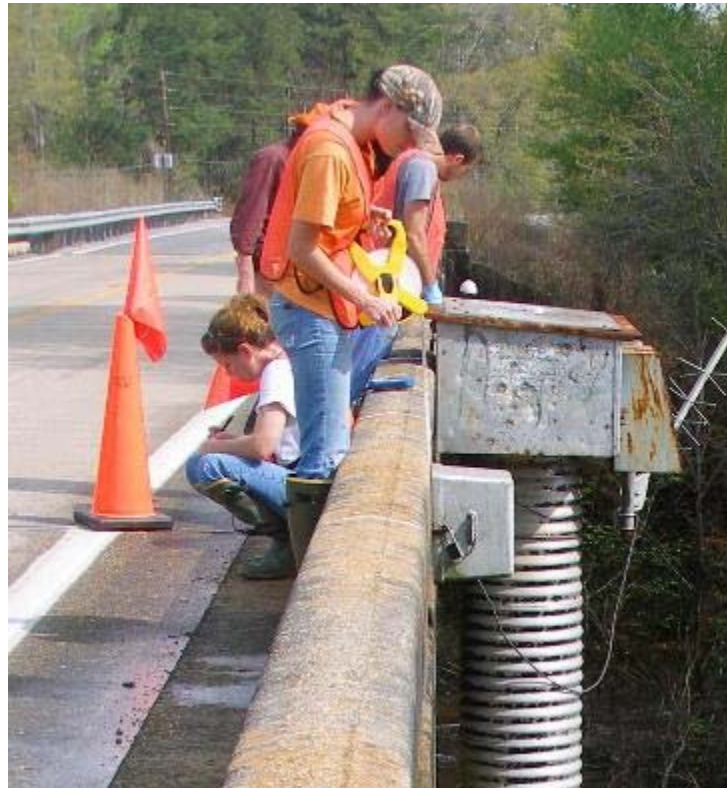
Figure 10 Measuring tape being used to measure stream stage from bridge railing

Stream stage gauge measurements were taken at each site at designated points on bridge crossings for later use in the construction of stage versus discharge hydrographs (Figure 10). Stage gauging points were clearly marked with orange paint near the middle of the stream channel on the downstream portion of culverts or bridge railings. Stage measurements were taken with the use of a DeWalt 100 foot fiberglass long tape measure attached by a carbiner to a weighted PVC pipe, allowing for more effective measurements in flowing stream settings. The weighted PVC pipe attachment required an addition of 1.2 feet to all stage measurements.

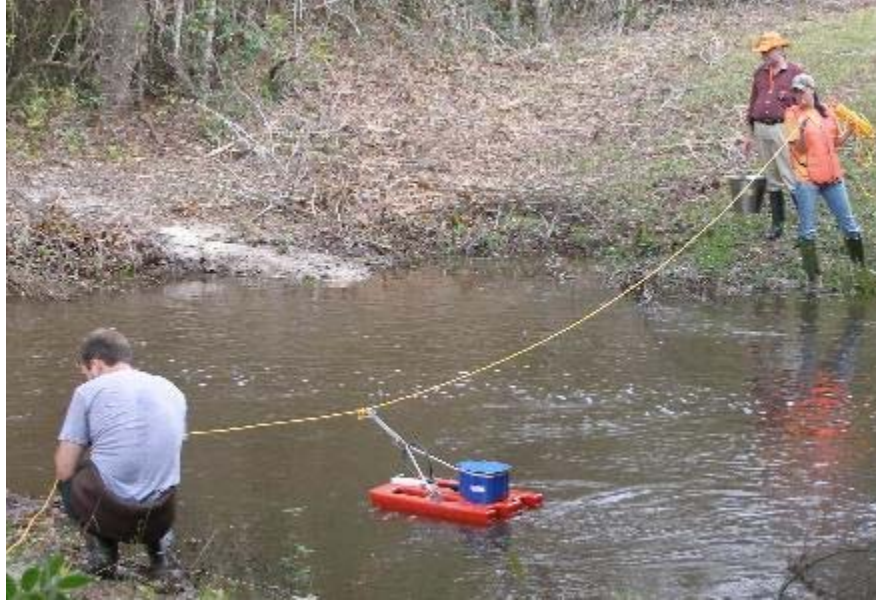
Figure 11 StreamPro RDI Doppler Unit at use in the field

Discharge measurements were taken from cross-sections of the stream channels at each site. Three techniques for discharge measurement were used according to stream channel depth. The StreamPro RDI Acoustic Doppler unit, by Teledyne Instruments, and a Bluetooth enabled HP iPAQ Pocket PC equipped with StreamPro ADCP software was used for larger streams having a water depth not less than two feet. The Doppler unit was operated according to guidelines found in the equipment handbook (Teledyne RD Instruments, 2008). The Doppler unit uses “bottom tracking” technology to obtain stream information such as discharge, velocity, channel width, and cross-sectional area, which is recorded as files through the StreamPro ADCP software on the HP iPAQ Pocket PC (StreamPro ADCP Operational Manual, 2008). Collected data were based on the standards of four successful cross-sectional readings within 5% error or a count of eight cross-sectional readings not exceeding a 100% error. The Doppler unit was operated on the downstream portion of culverts and bridges. Figures 11 and 12 show the Doppler unit at work in the field. Files recorded on the HP iPAQ Pocket PC were later transferred to a Dell laptop PC equipped with Teledyne RDI WinRiver II software. The files were used with the WinRiver software to generate tables of the cross-sectional readings and stream channel profiles such as shown in Figures 13 - 16.

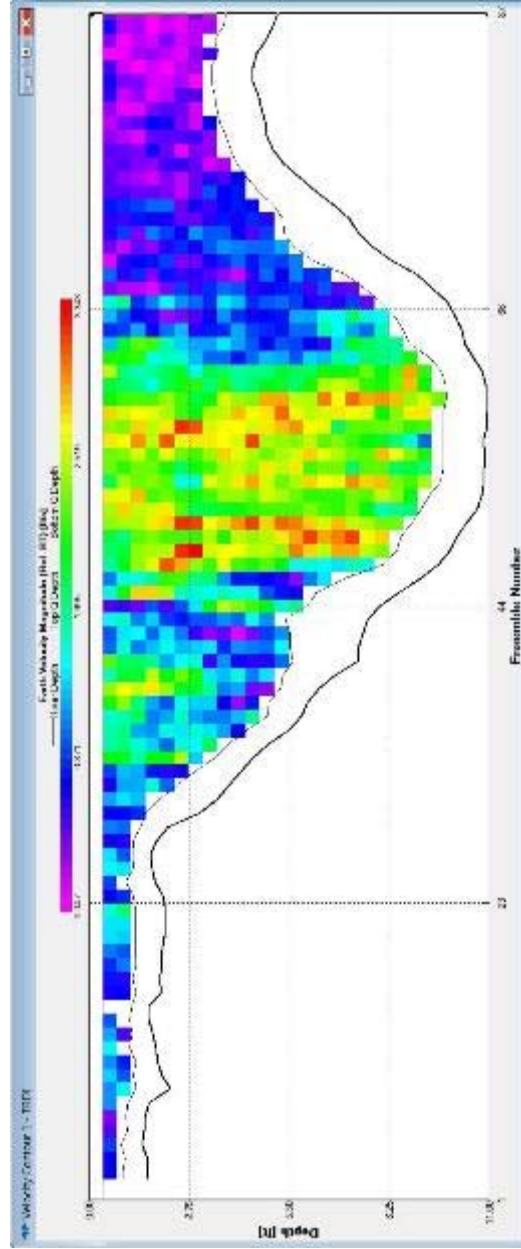
Figure 15 Graphical illustration of water flow velocity data collected for a cross-section of a stream

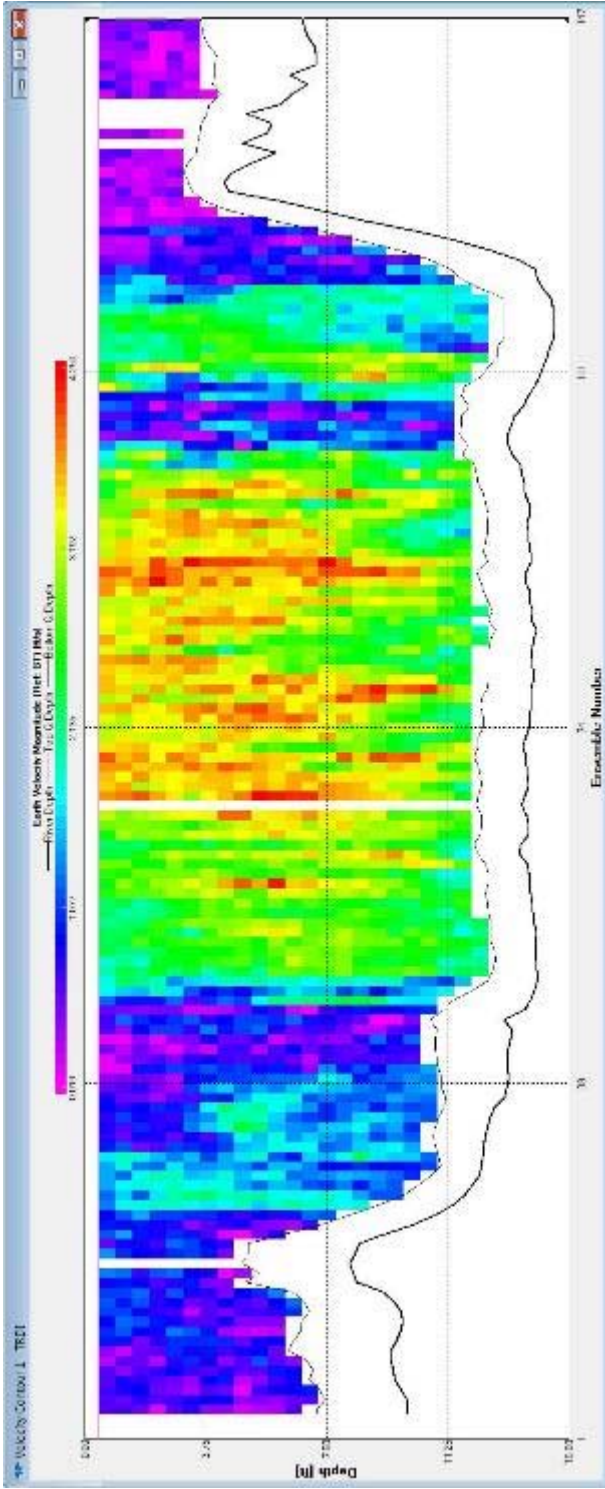
Figure 16 Graphical Illustration of water flow velocity data collected as a cross-section of a stream

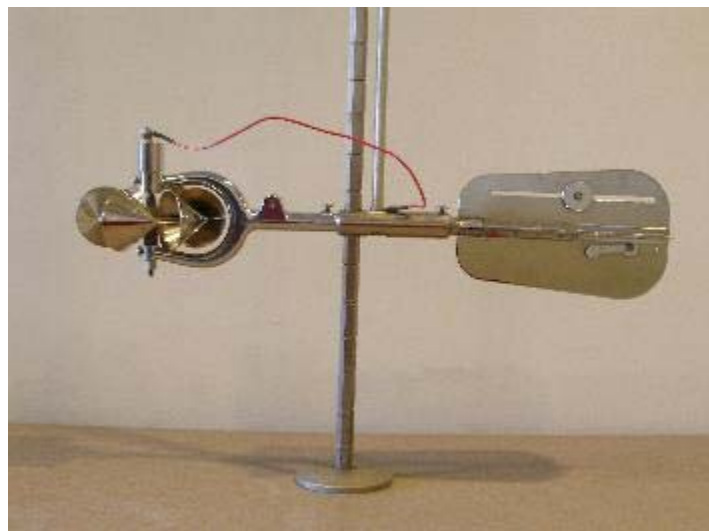
Figure 17 Price AA Current Meter mounted on a wading rod

In shallower streams, where the Doppler unit would not be effective, the Price AA Current Meter was used. During operation, the current meter was mounted onto a wading rod (Figure 17) and attached to a Rickly Hydrological AquaCount Digitizer (Figure 18). Instructions recommended by the United States Geological Survey were followed for collecting discharge measurements with the current meter. Current meter flow velocity measurements were taken at 10% intervals across the total stream width. A measuring tape was stretched across the stream channel to determine the total stream width and to ensure proper location of each 10% interval. Using the wading rod depth markings (Figure 19), the current meter was adjusted to the 6/10 position of the water depth at each interval location before performing a flow velocity measurement. Depth, width, and velocity values of each 10% interval were multiplied to obtain interval discharge values, which were then summed together to calculate the total discharge of the stream (Buchanan and Somers, 1969). Figure 20 shows the current meter at work in the field.

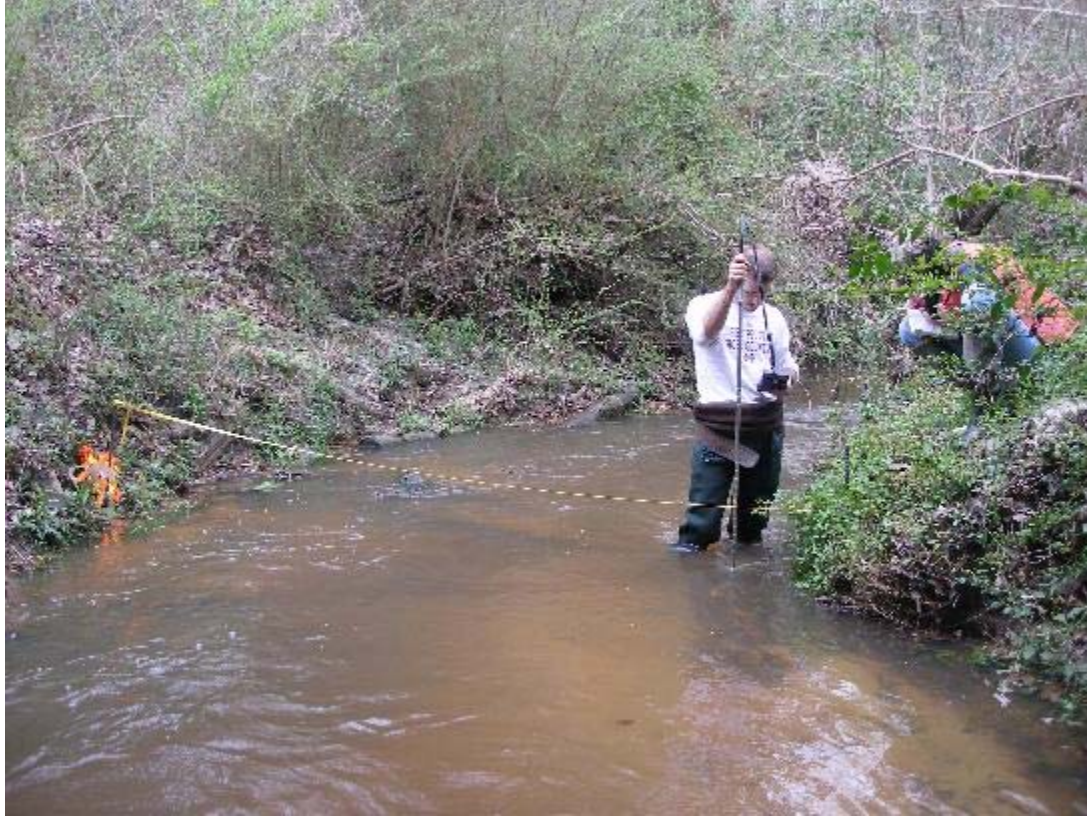
40 Figure 20 Price AA Current Meter being used in the field

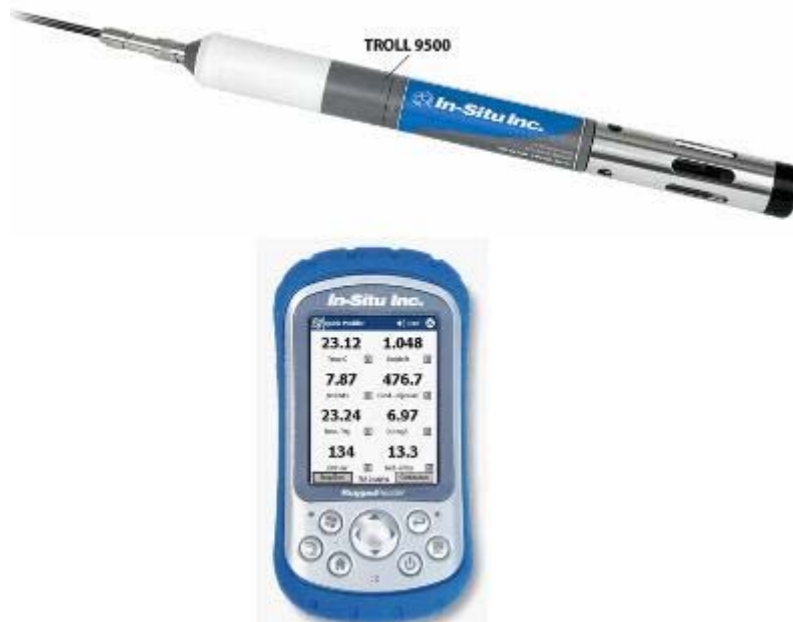
For field analysis of water quality and chemistry, the equipment, as shown in Figure 21, consisted of an In-Situ Troll 9500 multi-parameter sonde connected by a 50

foot cable to an In-Situ Ultra RuggedReader installed with Pocket-Situ 4 software. The Troll 9500 provided in-situ readings of temperature (°F), pH (s.u.), specific conductivity ($\mu\text{S}/\text{cm}$), dissolved oxygen (mg/L), turbidity (NTU). Prior to field measurement events, calibrations were performed for pH, specific conductivity, dissolved oxygen, and turbidity. A three point calibration was performed for pH, using buffer solutions of 4.0, 7.0, and 10.0. Conductivity was calibrated with a $147\mu\text{S}/\text{cm}$ solution standard. Turbidity was calibrated with standards of 0 NTU (i.e. distilled water), 10 NTU, and 100 NTU. Dissolved Oxygen was calibrated using tap water according to the air saturated with water method. The field parameters were measured from the stream channel at each of the 18 sites. The measured parameters were saved as files on the RuggedReader using the snapshot feature. Following field measurement events, the RuggedReader was docked to a desktop PC in order to download the data files.

Figure 21 In-Situ, Inc. Troll 9500 multi-parameter sonde and handheld Rugged Reader

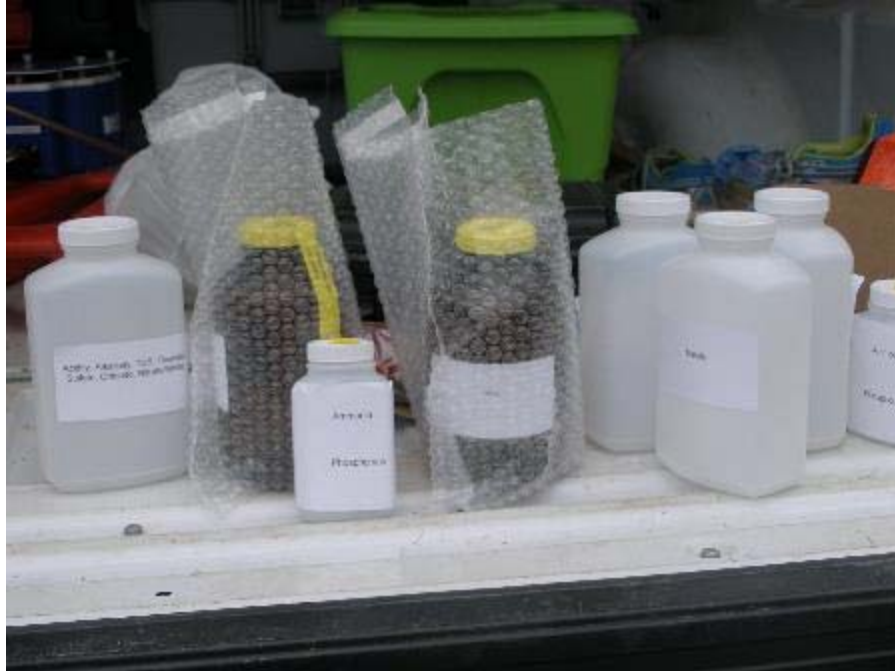
Figure 22 Stream water sampling bottles for laboratory water quality analysis

In addition to field measurements, stream water samples were collected and delivered to a chemical laboratory near Ocean Springs, Mississippi where they were analyzed for Acidity, Ammonia as N, Total Alkalinity, Chloride, Fluoride, Nitrate as N, Nitrite as N, Phosphorus, Sulfate as SO₄, Total Kjeldahl Nitrogen, Total Dissolved Solids, Iron, Lead, Potassium, and Sodium. The laboratory provided labeled sampling bottles (Figure 22) with sample preservatives, ice chests, and chain of custody forms. Water samples were collected by an individual standing in the water on the upstream portion of the culvert or bridge at each sampling site. The sample bottles containing preservatives were filled by pouring stream water from a clean sample bottle without preservatives. For streams that did not permit in-stream sampling, a stainless steel pale and nylon rope was used to allow an individual to collect stream water while standing on the bridge. The collected stream water was poured from the stainless steel pale into the sampling bottles as shown in Figure 23. To prevent contamination of water samples, the stainless steel pale was rinsed with stream water before use, and for all sampling events, rubber medical gloves were worn by the individual collecting the water samples. After samples were collected, the bottles were placed in plastic bags and stored on ice in the ice chests until delivery to the chemical laboratory. The water quality results obtained via field measurements and laboratory analysis were evaluated according to applicable surface water quality standards issued by Mississippi Department of Environmental Quality and United States Environmental Protection Agency as shown in Table 3 (MDEQ, 2012; USEPA, 2012; USEPA, 2013).

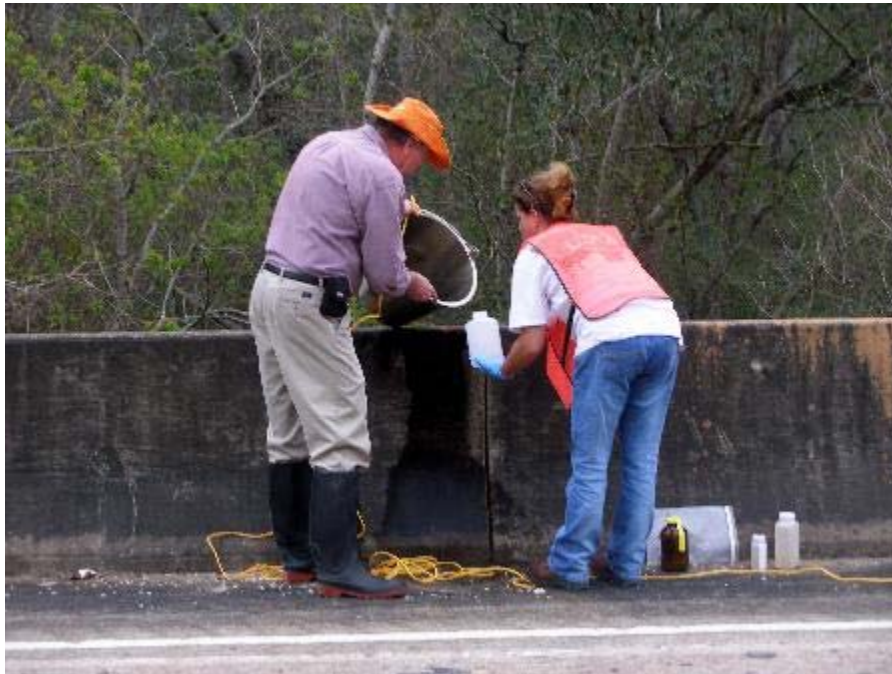
Figure 23 Stream water samples being taken from bridge-side using a stainless steel pale

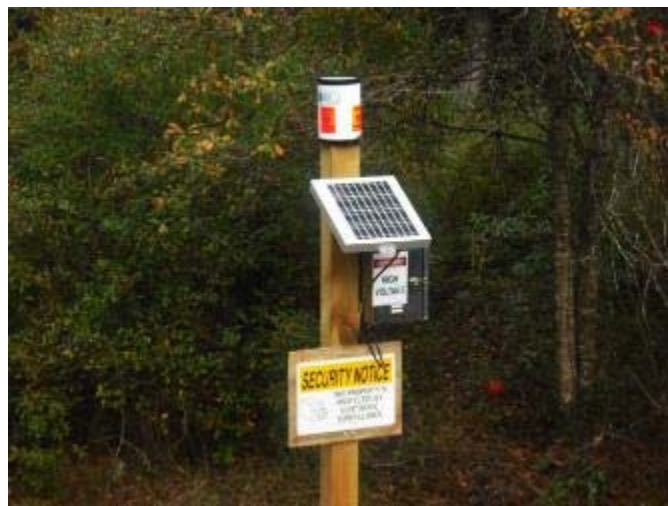
In addition to the surface water quantity measurements, two stationary stream monitoring stations were installed at the furthest downstream sampling site (i.e. B6, CB5) of the Big Creek and Cedar Creek watershed. The monitoring stations assisted in coordinating sampling events with respect to times of low flow, peak flow, and rainfall. The equipment for the monitoring system was installed on a 14 foot, 6x6 inch wooden post concreted in place, three feet within the ground. The installation setup of the two systems is shown in Figures 24 - 25. The monitoring system consist of the following: Morningstar SunSaver 6 solar controller panel, 12 volt battery, Teledyne ISCO 2150C telemetry modem, In-Situ Leveltroll 500 sensor, and a tipping bucket rain gauge. The Leveltroll sensor and cable (attached to the modem) was encased in 2 inch PVC pipe.

The pipe was buried underground until reaching the stream channel, at which PVC elbow joints were implemented to angle the encased sensor downstream into the water column. The PVC pipe was secure in place at the stream channel by metal T-posts and wire. The PVC pipe was perforated at the location of the Leveltroll in order to allow exposure to water. The monitoring system collected continuous real-time readings of precipitation, water column depth, water temperature, and battery voltage in 15 minute intervals and reported them hourly to a secure website via wireless phone service. C.C. Lynch and Associates of Pass Christian, MS and Mississippi State University Department of Geosciences were both responsible for installation and maintenance of the equipment and website.

Figure 24 Continuous real-time monitoring station installed at site B6

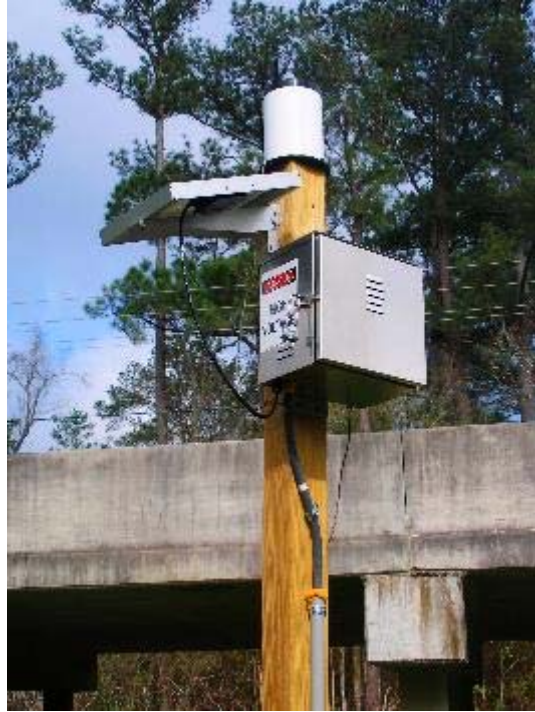
Figure 25 Continuous real-time monitoring station installed at site CB5

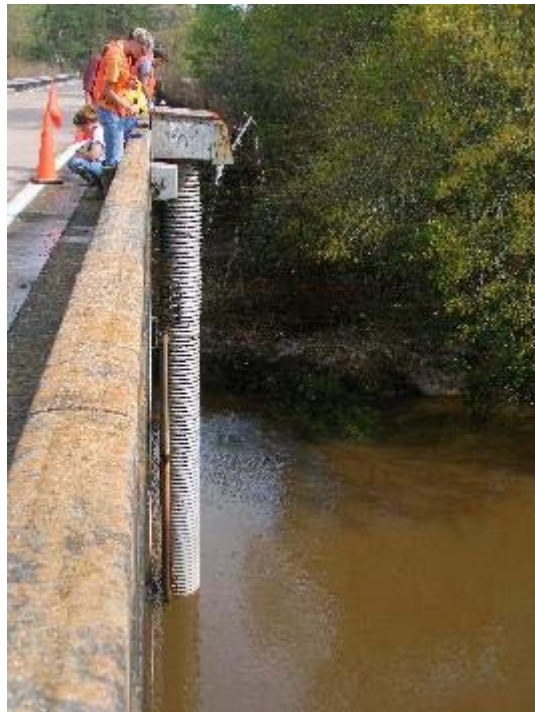
45 At the start of the field study, the Escatawpa River was previously equipped with a USGS sampling station at the location of site E1, as shown in Figure 26. The USGS station reported hourly stage and discharge measurements and made available on the USGS website.

Figure 26 USGS continuous monitoring station at site E1

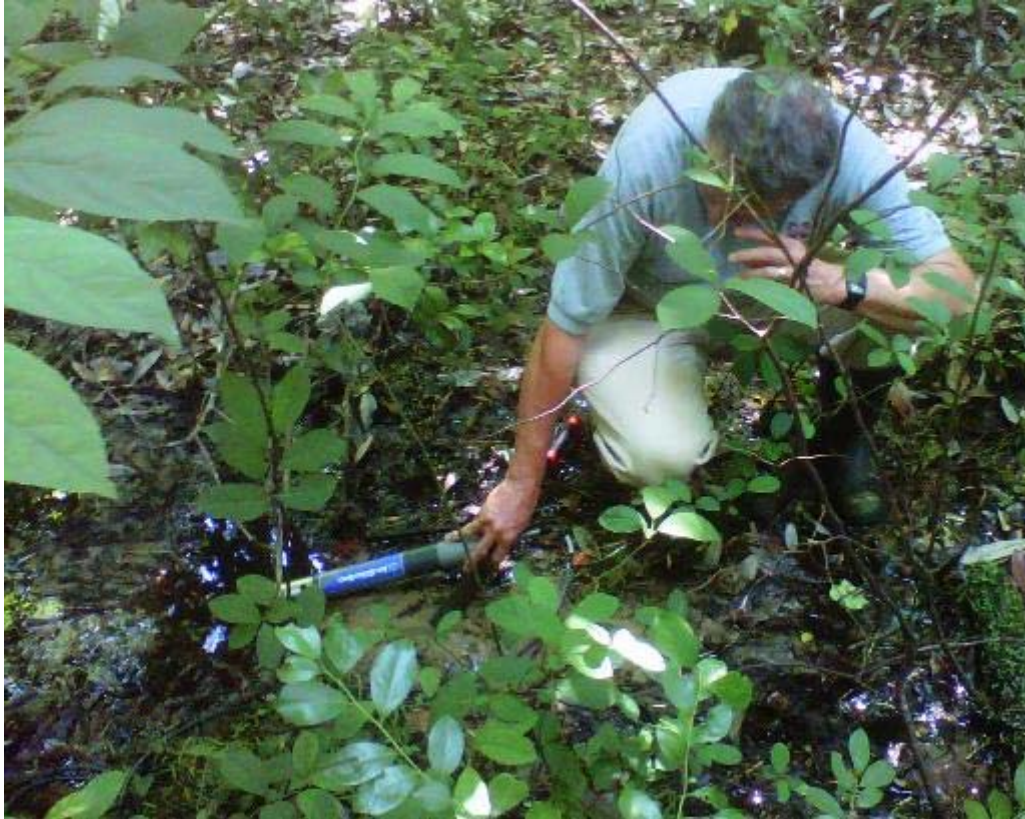
Similar to methods used for the stream water quality measurements, the spring water quality was analyzed by the field parameters, temperature (°F), pH (s.u.), specific conductivity ($\mu\text{S}/\text{cm}$), dissolved oxygen (mg/L), and turbidity (NTU) using the In-Situ Troll 9500 multi-parameter sonde connected to an In-Situ Ultra RuggedReader installed with Pocket-Situ 4 software. Water quality measurements were analyzed according to the surface water quality standards issued by MDEQ and EPA (MDEQ, 2012; USEPA, 2012;

USEPA, 2013). Figure 27 shows the equipment at work in the field, analyzing spring water quality.

Figure 27 In-Situ, Inc. Troll 9500 multi-parameter sonde being used to measure field water quality parameters of a spring

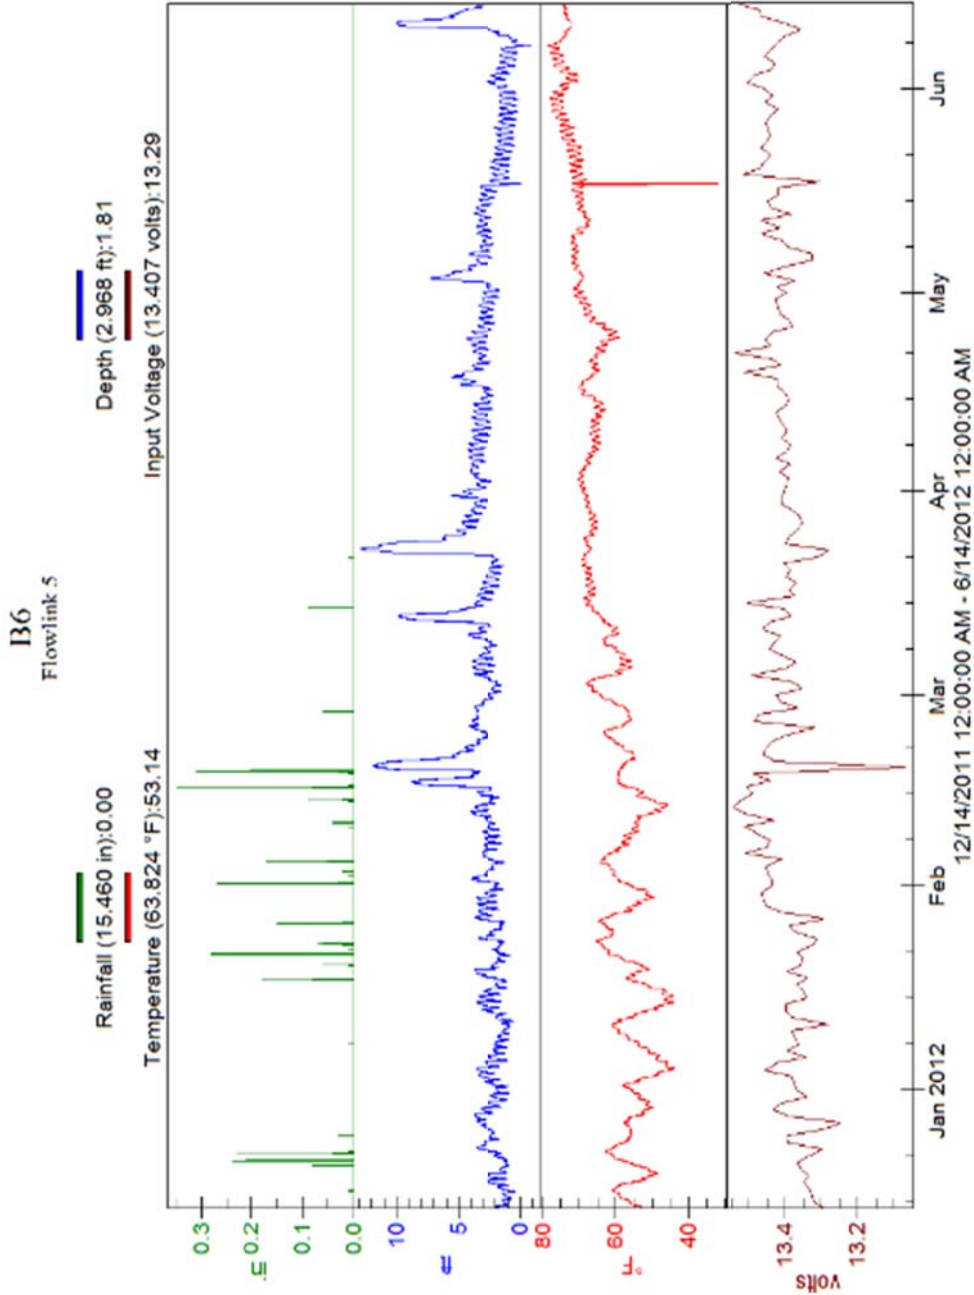
Figure 28 Rainfall, water column depth, temperature, and battery voltage data collected by site B6 monitoring station from 12/14/2011 – 6/14/2012

near the west border of Mississippi. The wireless signal and power was restored with data collection resumed on October 19, 2012. The station downtime created an obvious anomaly in the line graphs of Figure 31. Station CB5 experienced an additional recording error on November 12, 2012, resulting in false peaks in the line graphs of Figure 31. The recording error is reflected by the extremely low temperature peak graphed in Figure 31. At the start of the field study in July 2011, sampling site E1 of the Escatawpa River was previously equipped with a USGS sampling station, which recorded continuous stage and discharge measurements hourly and made available on the USGS website. Hourly stage and discharge measurements of site E1 were retrieved from USGS archives for the complete time span of the field study (USGS, 2013).

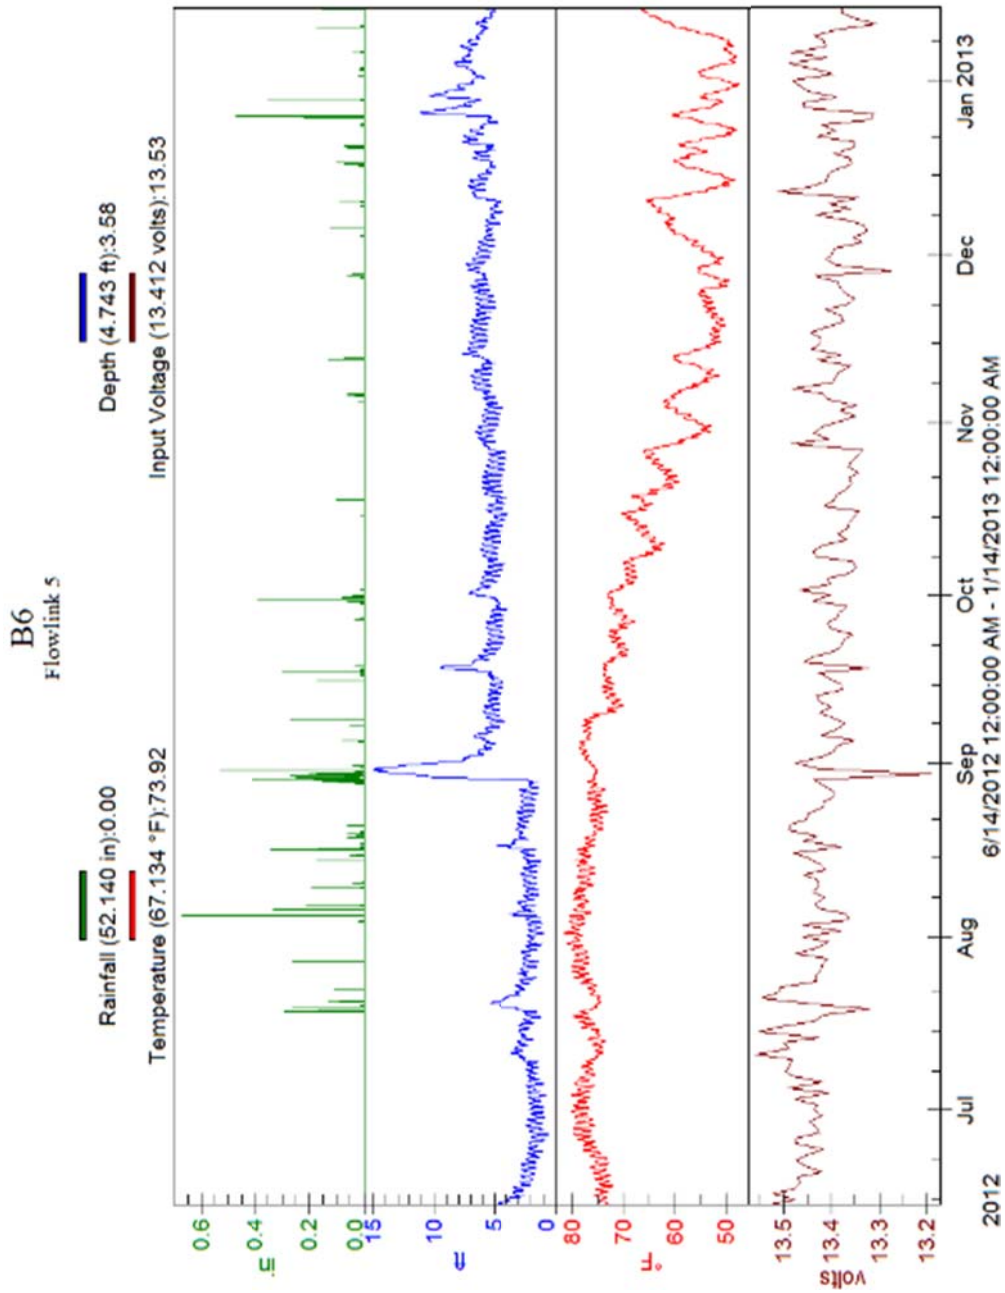
Figure 29 Rainfall, water column depth, temperature, and battery voltage data collected by site B6 monitoring station from 6/14/2012 – 1/14/2013

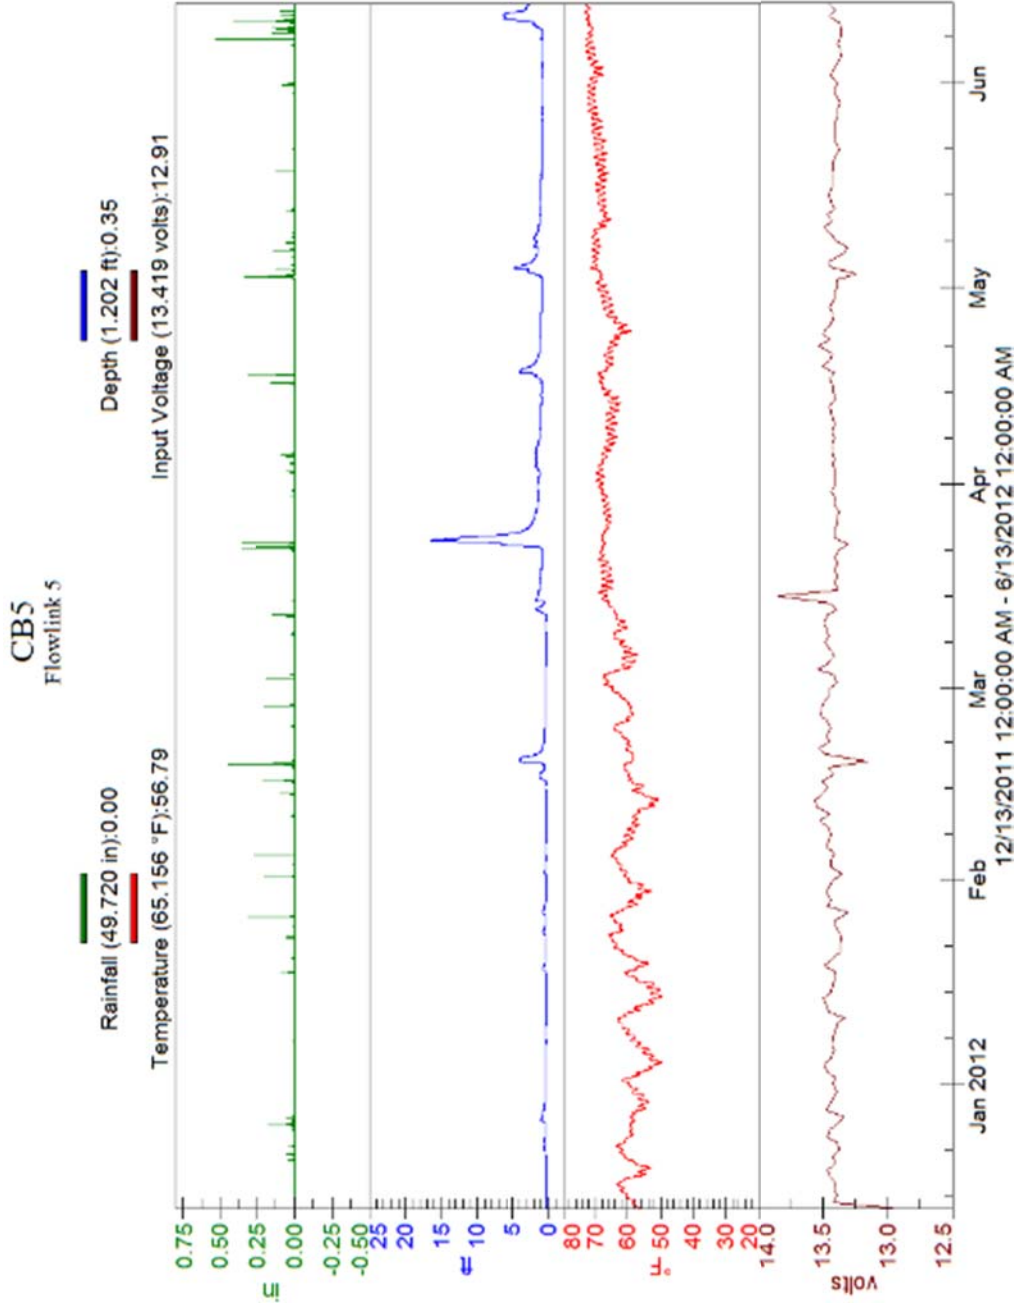
Figure 30 Rainfall, water column depth, temperature, and battery voltage data collected by site CB5 monitoring station from 12/13/2011 – 6/13/2012

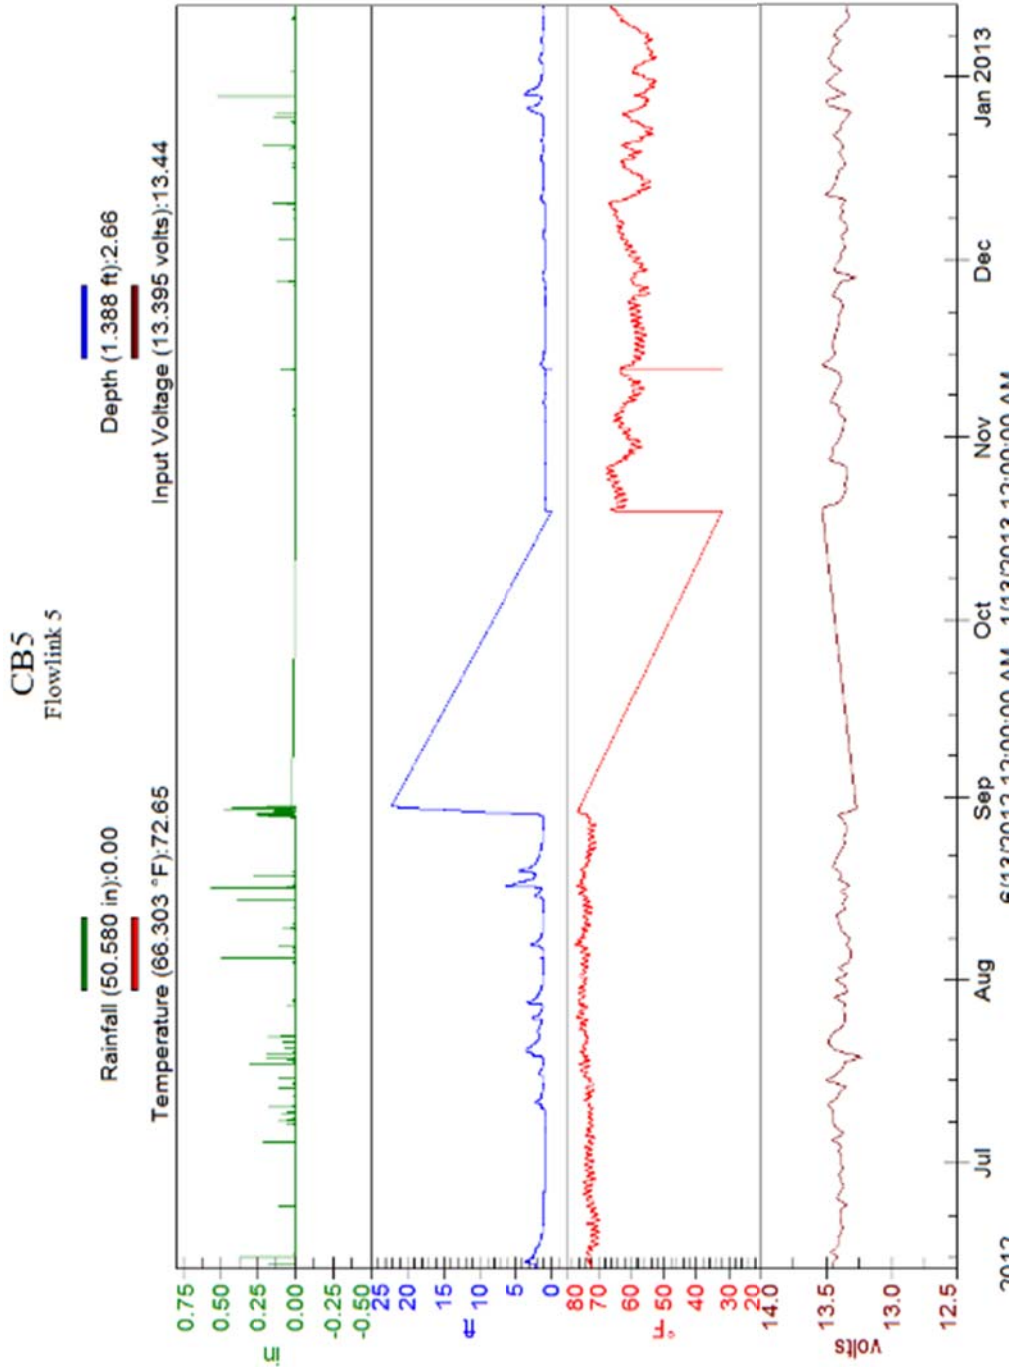
Figure 31 Rainfall, water column depth, temperature, and battery voltage data collected by site CB5 monitoring station from 6/13/2012 – 1/13/2013

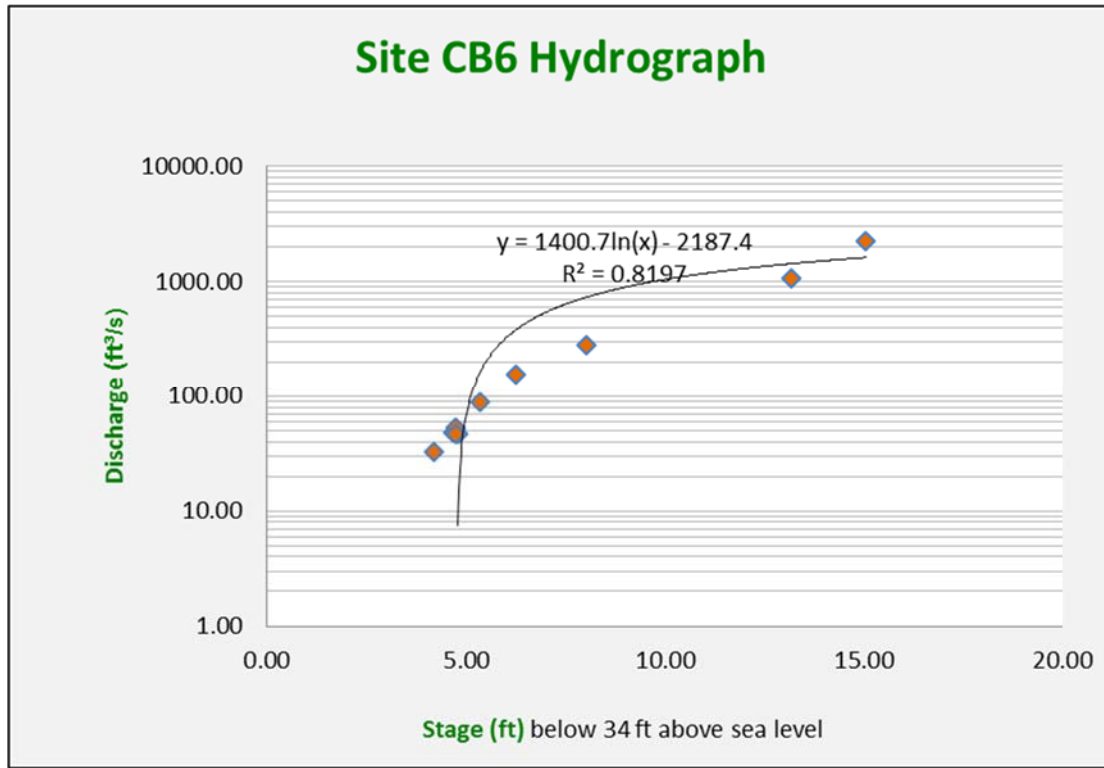
Figure 32 Hydrograph for site CB6 depicting discharge versus stage

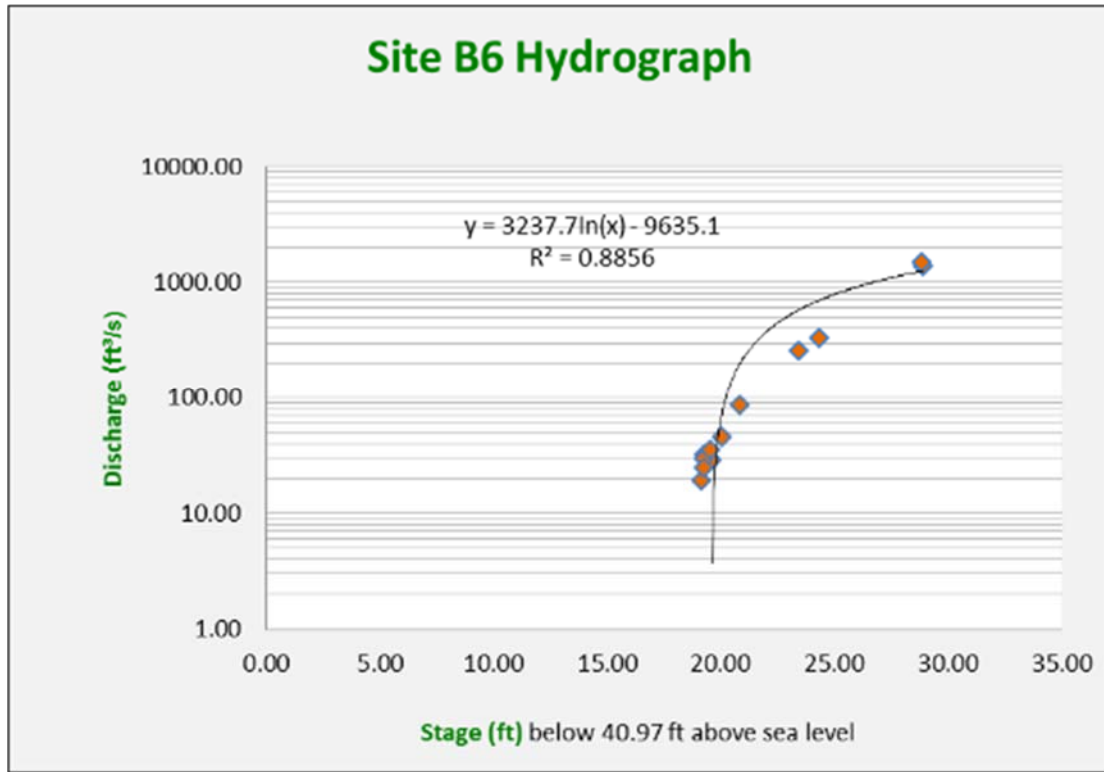
Figure 33 Hydrograph for site B6 depicting discharge versus stage

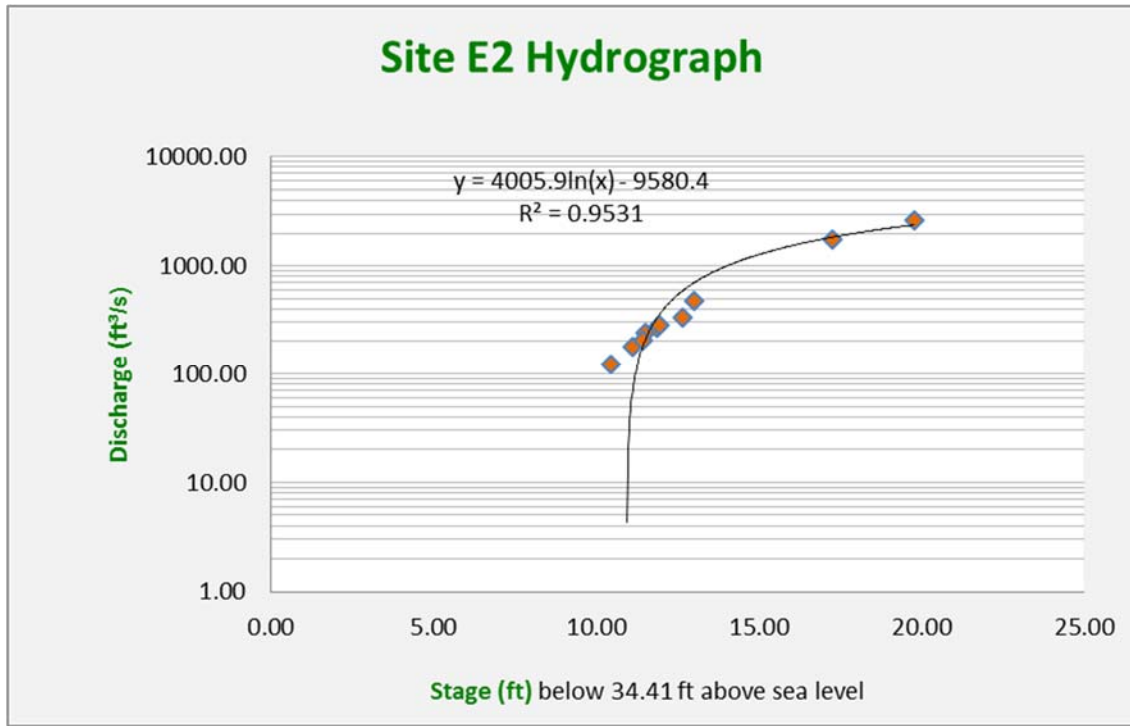
Figure 34 Hydrograph for site E2 depicting discharge versus stage

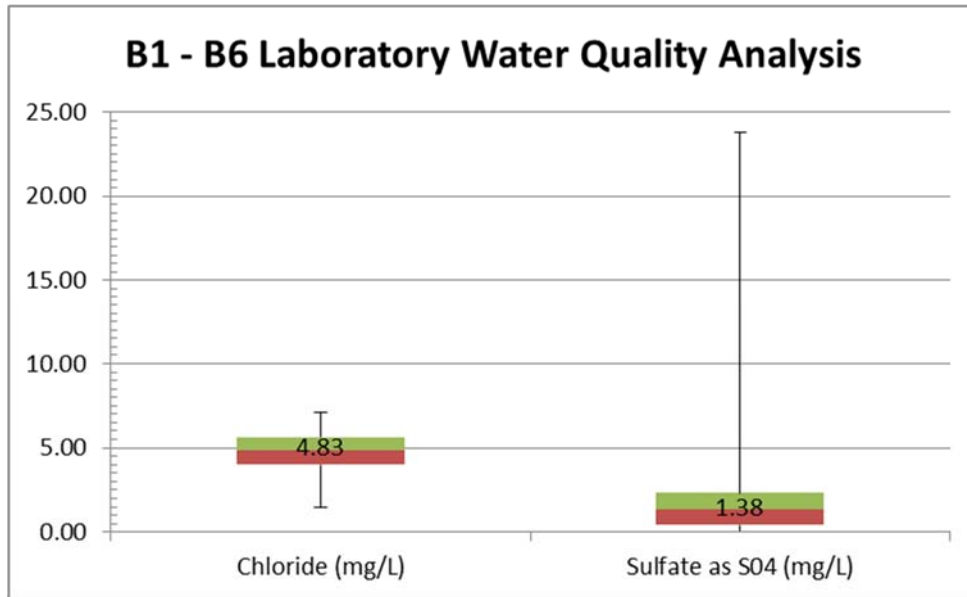
Notes: Error bars depict maximum and minimum values measured for each parameter

Figure 37 Graphical representation of composite averages of laboratory water quality measurements for the Big Creek watershed

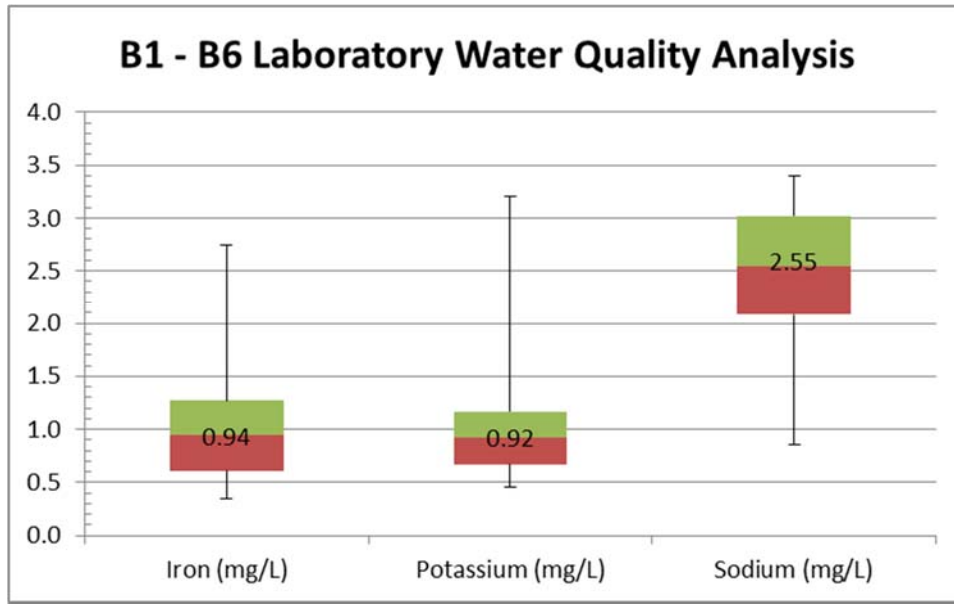
Notes: Error bars depict maximum and minimum values measured for each parameter

Figure 39 Graphical representation of composite averages of laboratory water quality measurements for the Big Creek watershed

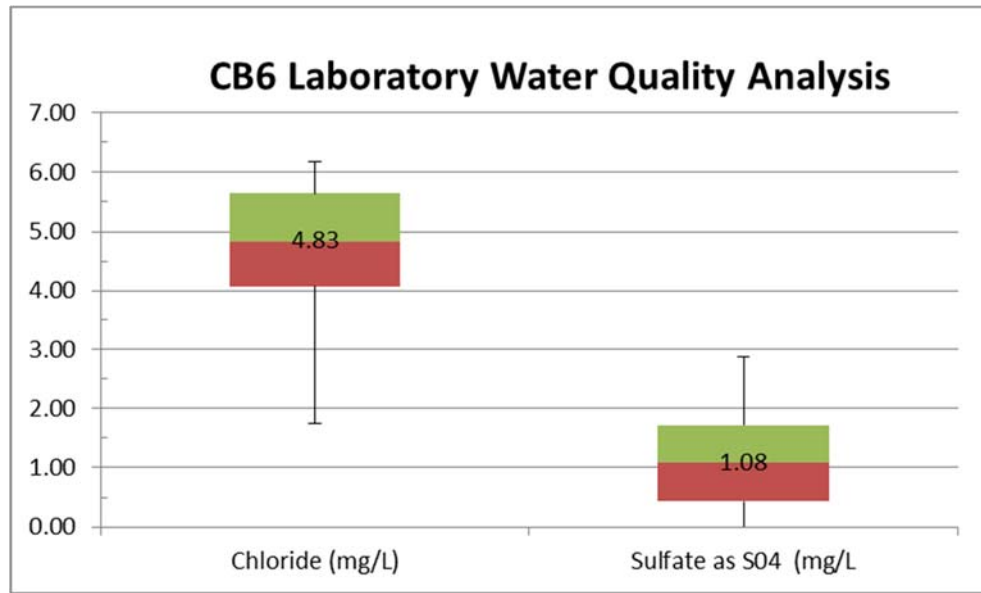
Notes: Error bars depict maximum and minimum values measured for each parameter

Figure 50 Graphical representation of composite averages of laboratory water quality measurements for the furthestmost downstream sampling site (CB6) of Big Cedar Creek watershed

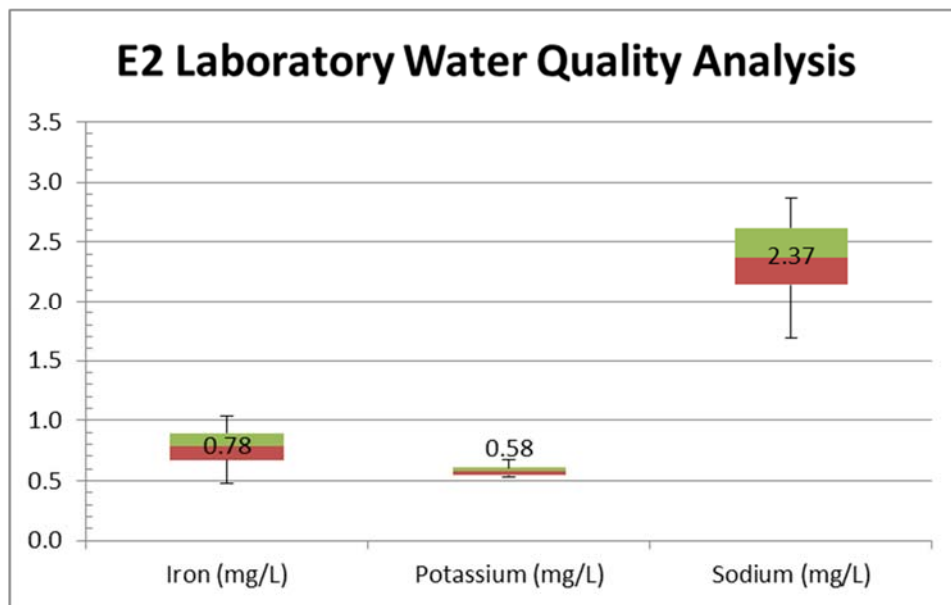
Notes: Error bars depict maximum and minimum values measured for each parameter

Figure 56 Graphical representation of composite averages of laboratory water quality measurements for the furthestmost downstream sampling site (E2) of the Escatawpa River watershed

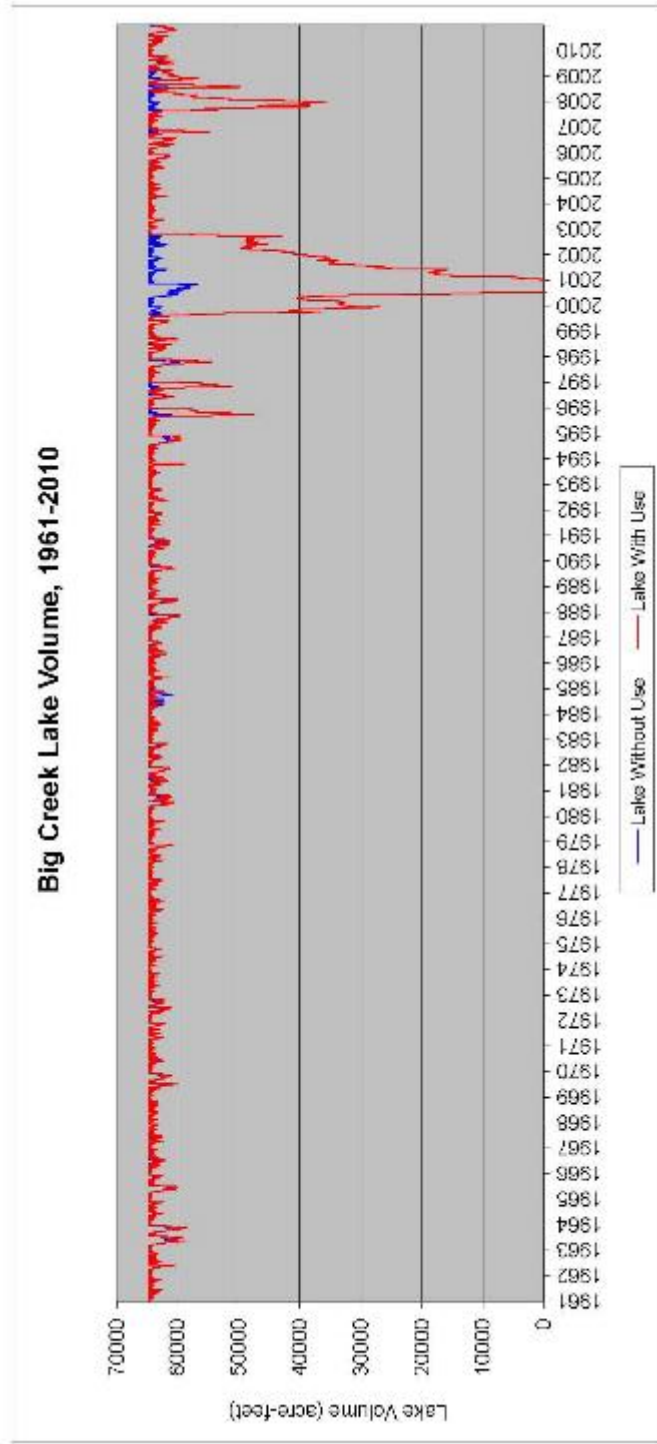
Figure 61 Daily water storage model for Big Creek lake footprint

Notes: The model is for a 120 feet elevation footprint and a volume of 64,717 acre-feet
