Hydrogeological Assessment for a Suitable Location of a Reservoir Lake in George County, Mississippi

Hydrogeological assessment for a suitable location of a reservoir lake in George County,
Mississippi

A Thesis
Submitted to the Faculty of
Mississippi State University
in Partial Fulfillment of the Requirements
for the Degree of Masters of Science
in Geosciences
in the Department of Geosciences

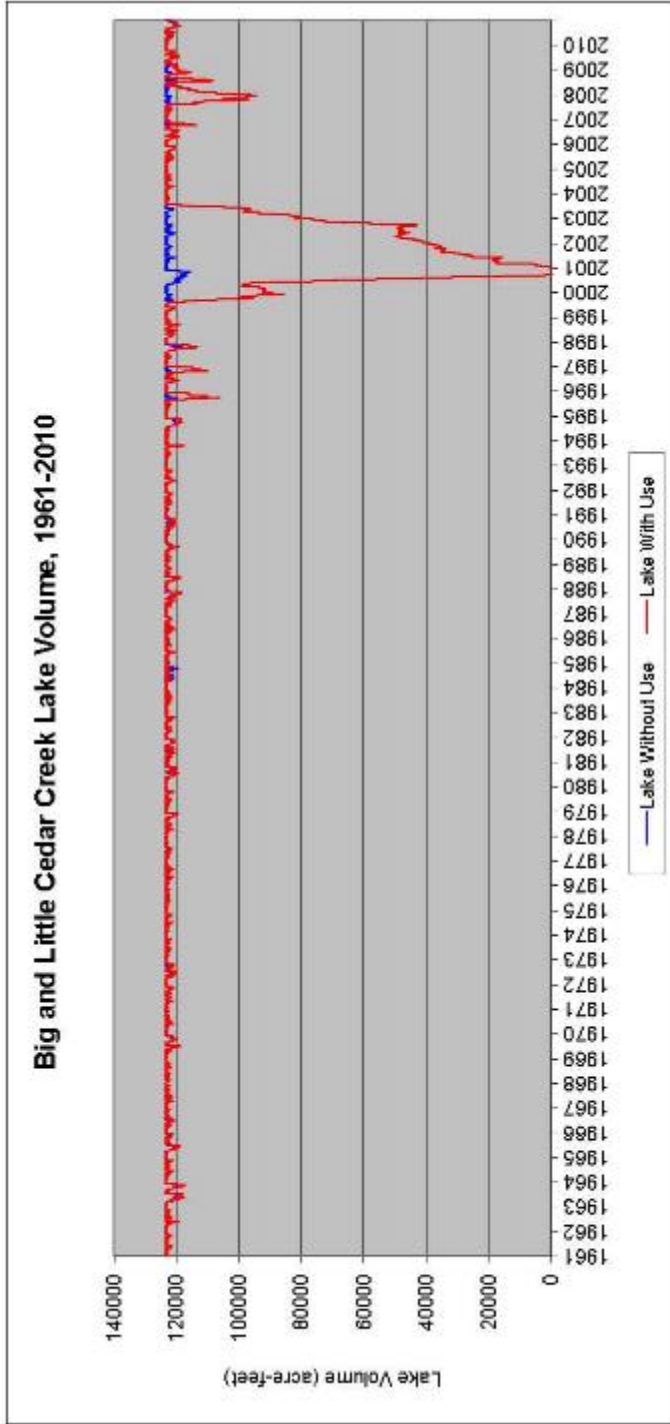
Figure 62 Daily water storage model for Big and Little Cedar Creek lake footprint

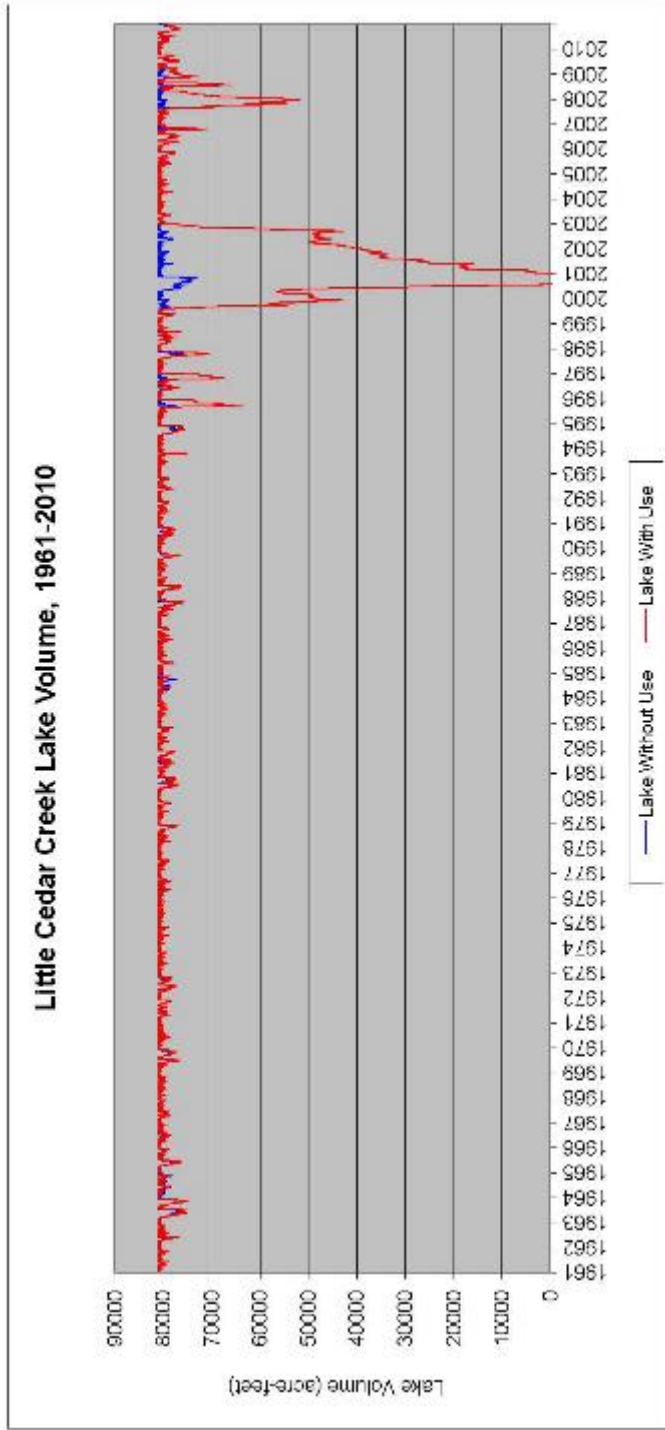
Figure 64 Daily water storage model for Little Cedar Creek lake footprint

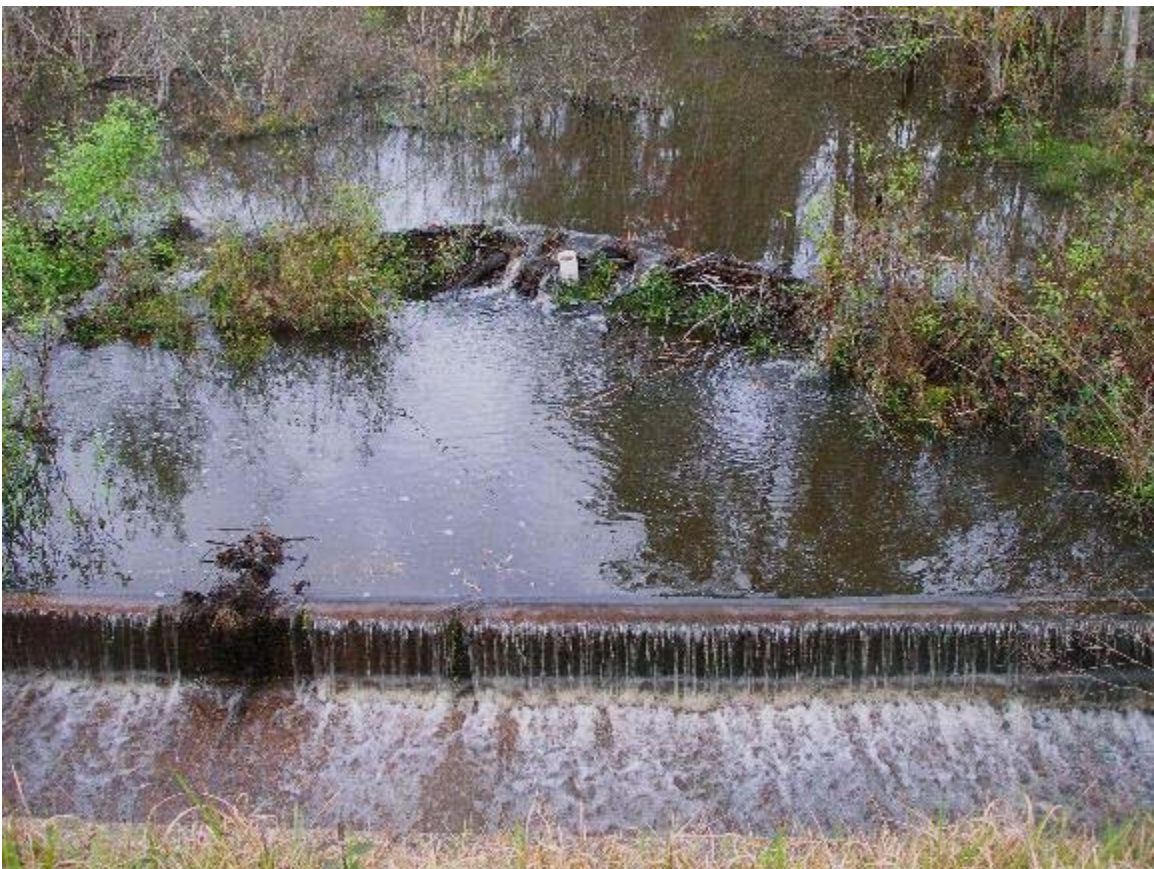
Figure 65 Upstream portion of sampling site CB1 featuring a cement overflow wall and beaver damming

upstream side as shown in Figure 108. Consequently, the cement impoundment prevents the stage readings from having expected fluctuations with the measured discharges. In general, the hydrographs of the Big Creek, Big and Little Cedar Creek, and Escatawpa River watershed proved that discharge increases in order of upstream to downstream site location. No consistent or substantial water losses were recorded between sampling sites that would infer a loss of water to the subsurface.

All sites except B3, E1, and E2 produced dissolved oxygen (DO) values that were occasionally below the minimum standard of 4.0 mg/L. Much of the incompliant DO readings correlated with discharge measurements near base flow. The correlation implies that at low flow stream conditions, DO levels decrease because of the lack of rejuvenating higher energy water flow, rainfall, or surface runoff. There were some cases of beaver damming along the measured streams, creating moderately stagnant flow conditions. The explanation for the incompliant DO values is supported by the character of sampling site CB1. Site CB1 produced incompliant DO readings for 5 of the 14 sampling events, the most incompliant readings of all sites. It is reasoned that the incompliant DO readings at site CB1 were a result of Big Cedar Creek being impounded by a concrete overflow wall on the upstream portion of the concrete culvert through which the stream flowed (Figure 65). Furthermore, beaver dams were present upstream and downstream locations adjacent to the concrete overflow wall.

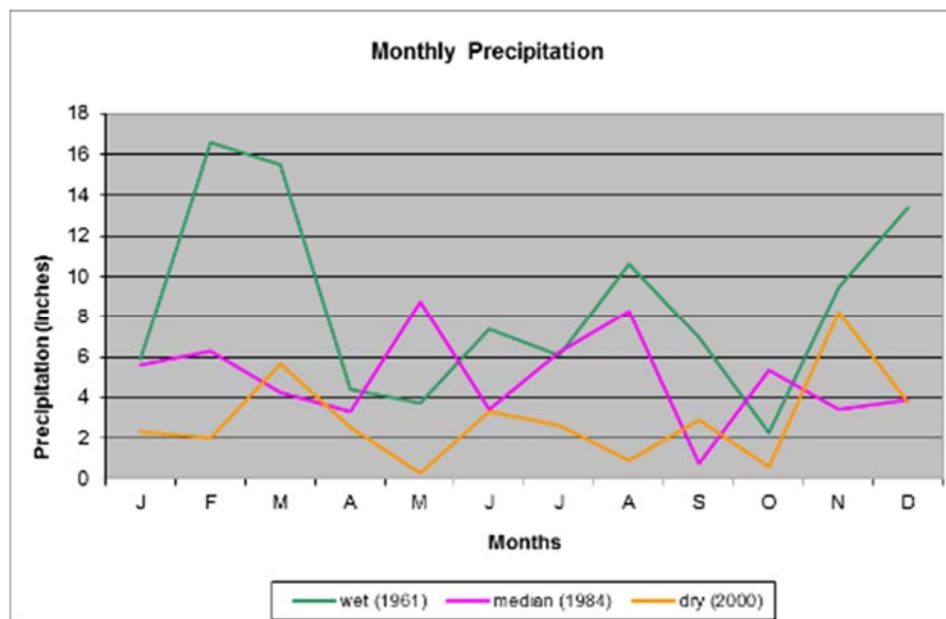
Figure 66 Graphical representation of driest, median, and wettest precipitation years of the 50 year (1961 – 2010) daily water storage model

days of depleted water storage was performed by dividing the number of days of depleted storage by the total number of days in the 50 year period (18,250 days). This analysis generated a frequency percent of the amount of time that each reservoir could be expected to be depleted of all water storage. Statistically, the Big and Little Cedar Creek lake, Little Cedar Creek lake, and Big Creek could be expected to be depleted of all water 0.62%, 0.88%, and 0.98% according to the 50 year period of 1961 – 2010. In a qualitative comparison of the daily productivity of water supply, the three reservoirs ranked in descending order: Big and Little Cedar Creek at 100 foot elevation, Little Cedar Creek at 110 foot elevation, Big Creek at 120 foot elevation. In a qualitative comparison of the daily productivity of water supply, the three reservoirs ranked in descending order: Big and Little Cedar Creek at 100 foot elevation, Little Cedar Creek at 110 foot elevation, Big Creek at 120 foot elevation.

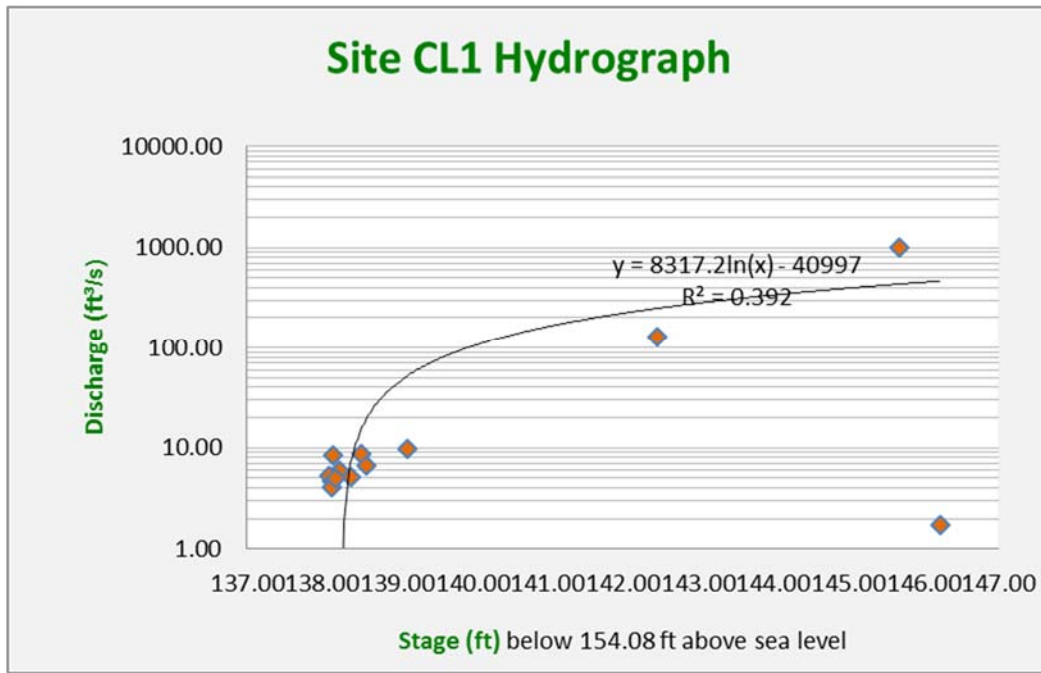
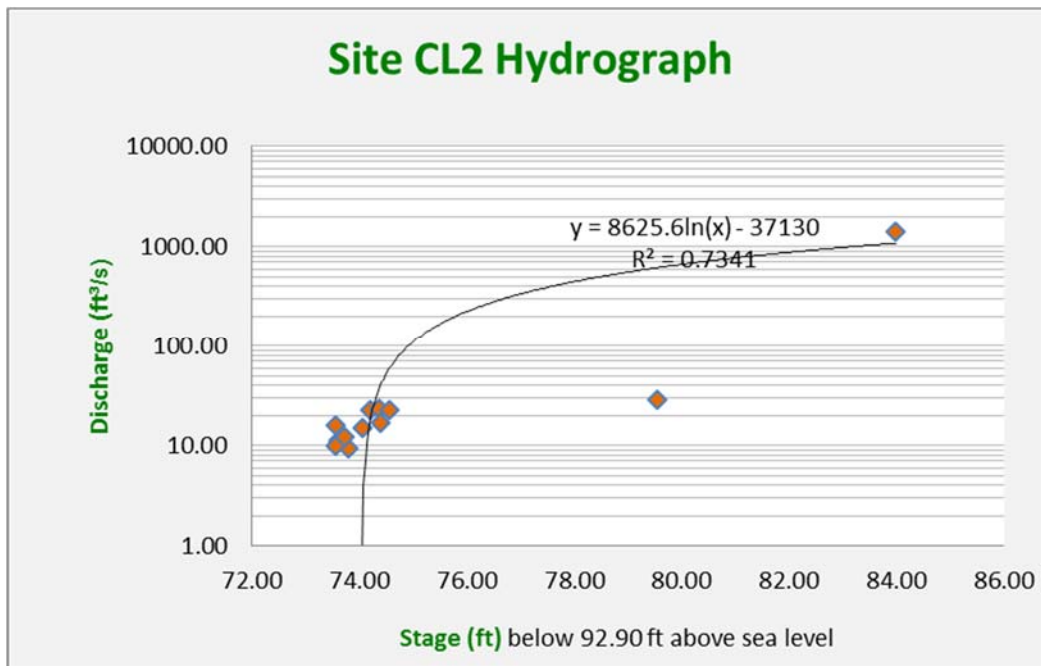
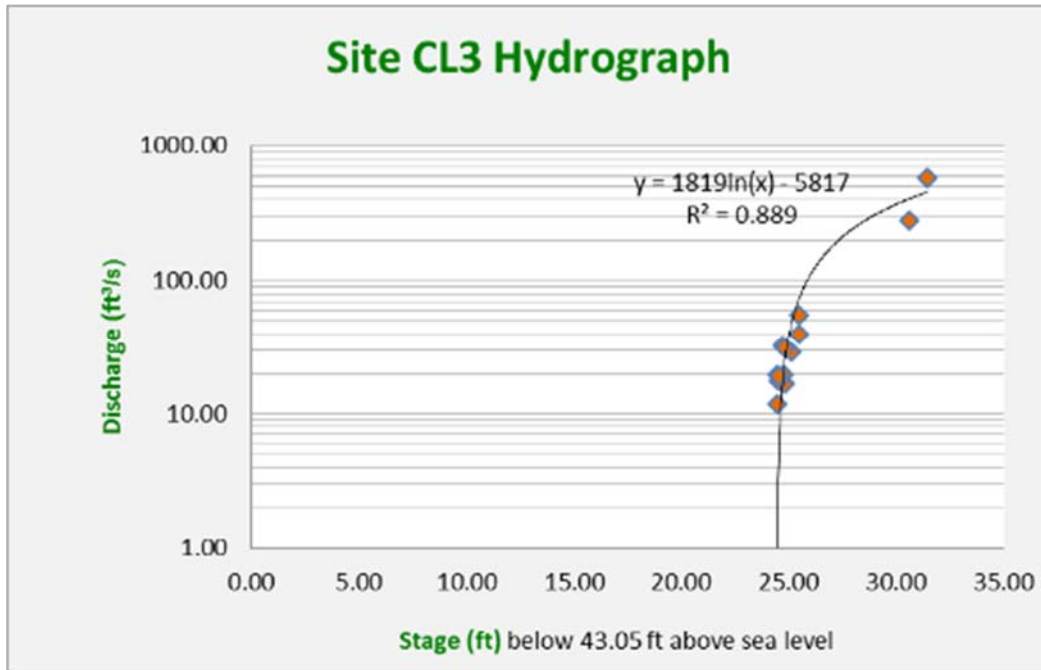
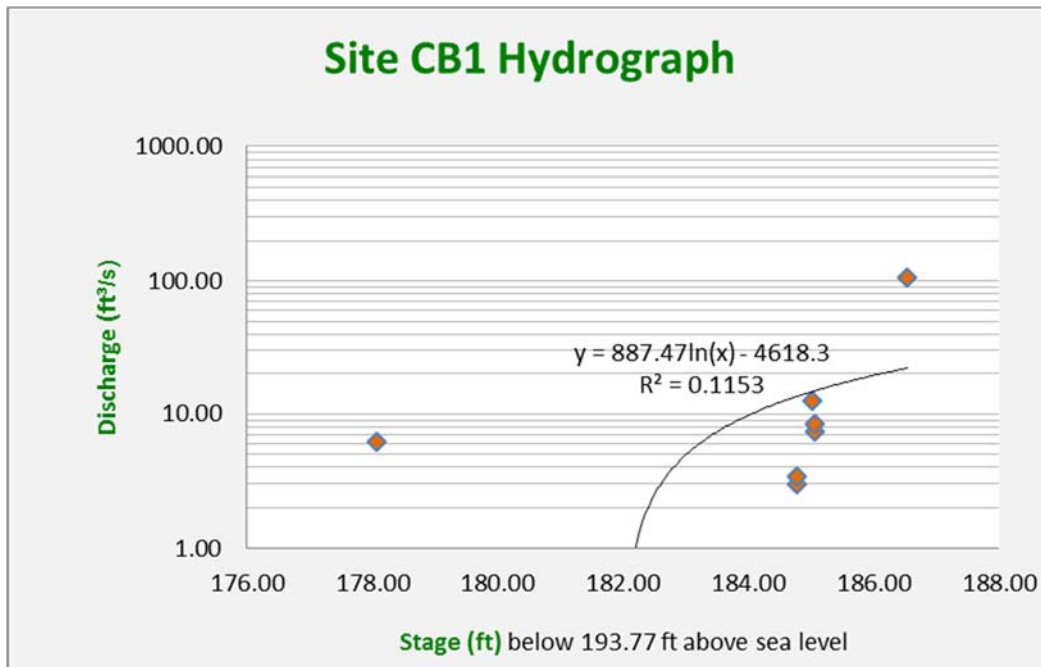
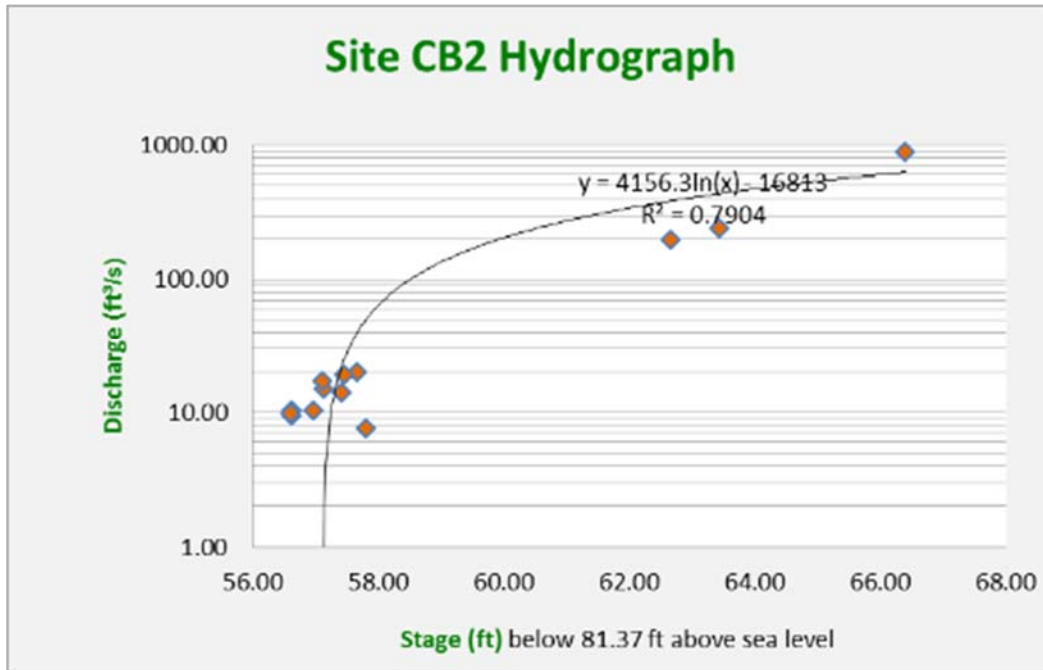
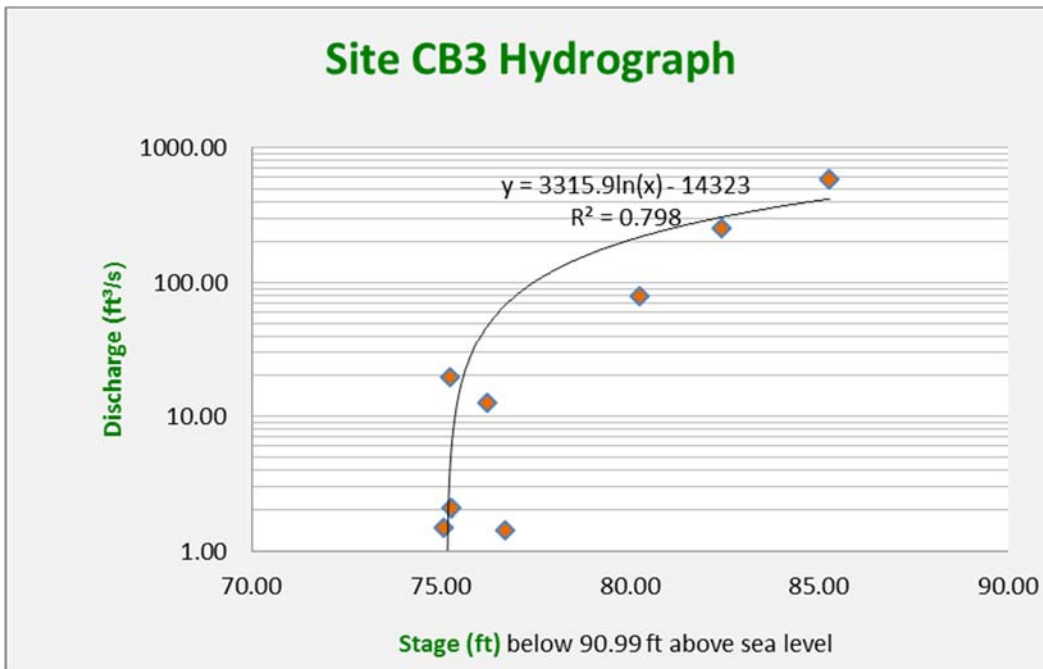
Figure 67 Hydrograph of site CL1 depicting discharge versus stage

Figure 68 Hydrograph of site CL2 depicting discharge versus stage

Figure 69 Hydrograph of site CL3 depicting discharge versus stage

Figure 70 Hydrograph of site CB1 depicting discharge versus stage

Figure 71 Hydrograph of site CB2 depicting discharge versus stage

Figure 72 Hydrograph of site CB3 depicting discharge versus stage

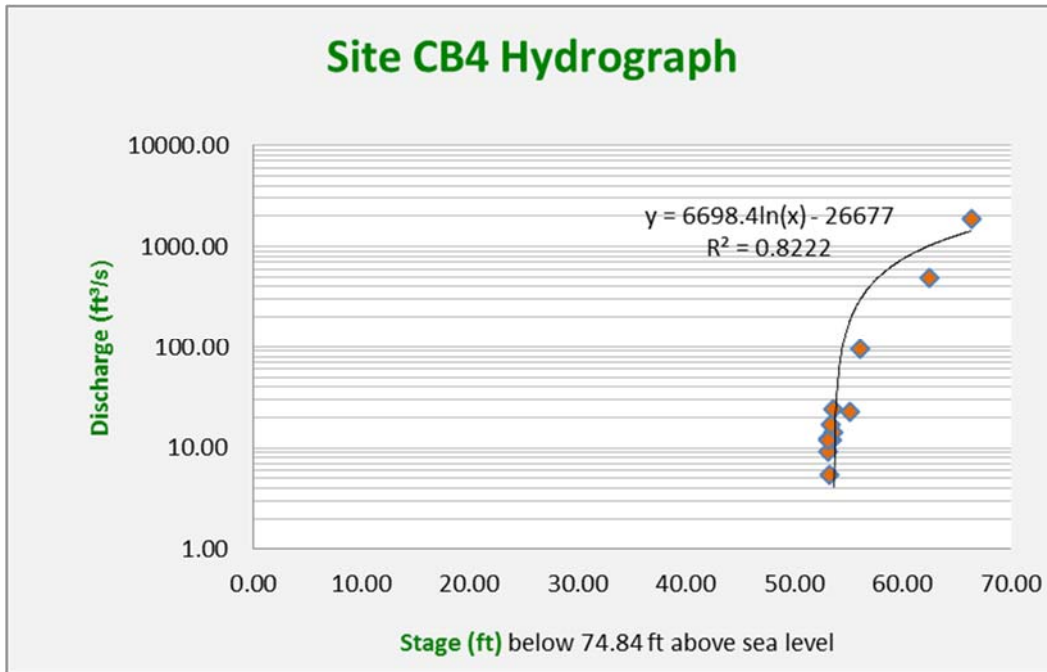
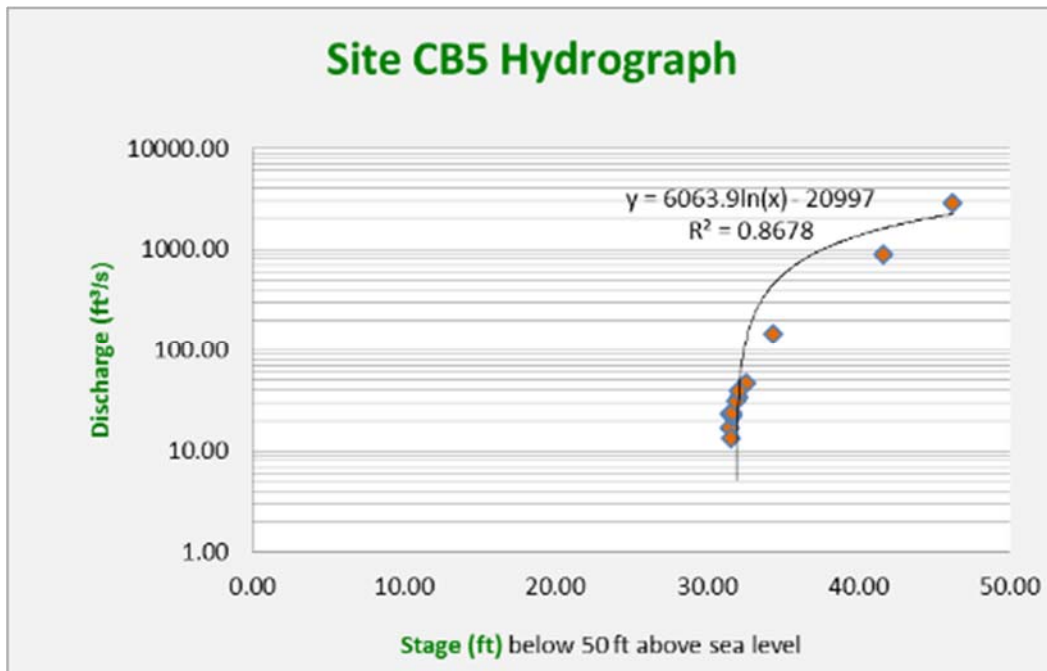
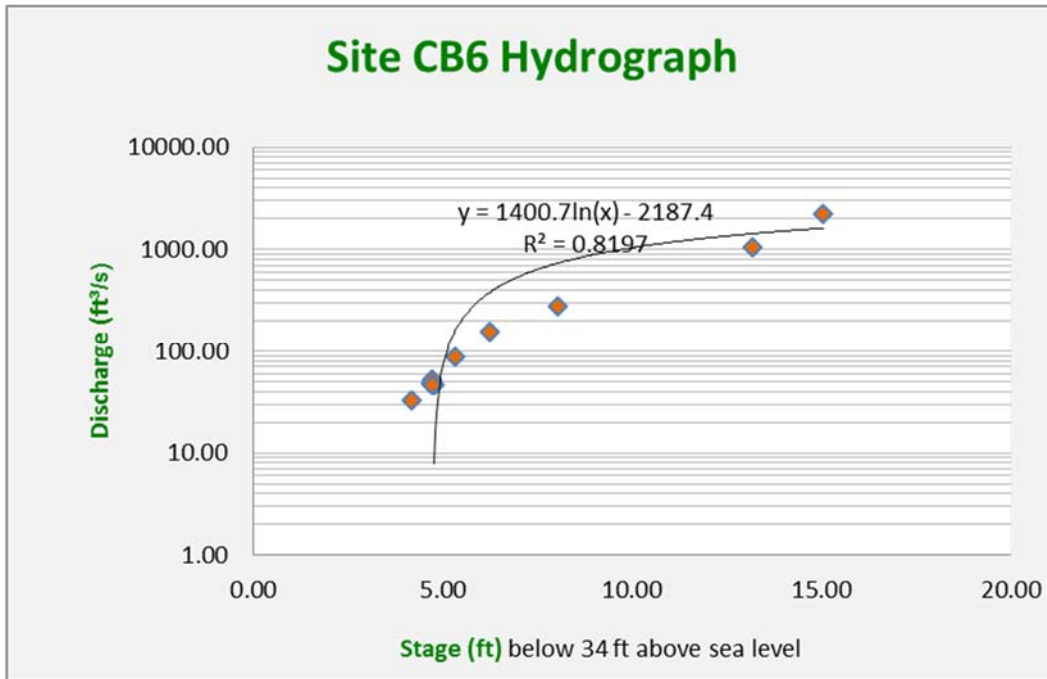
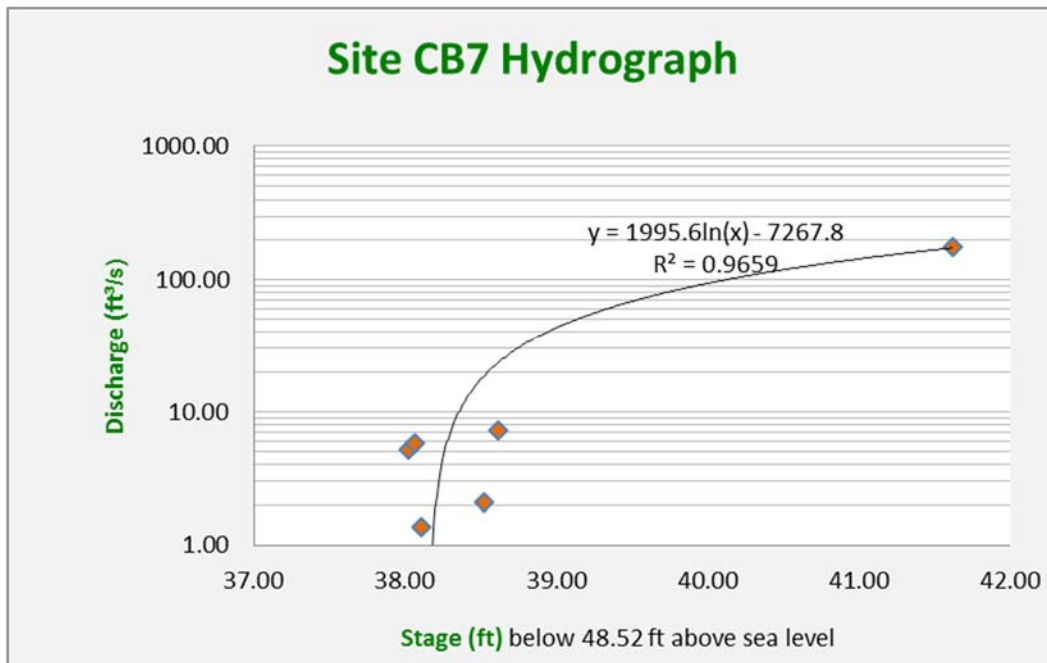
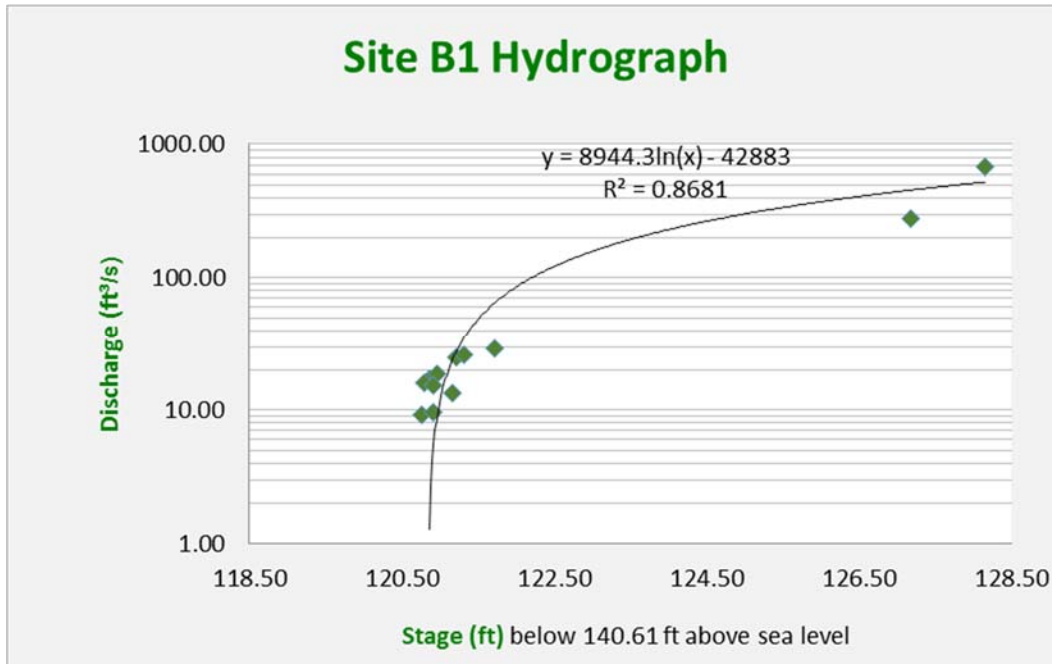
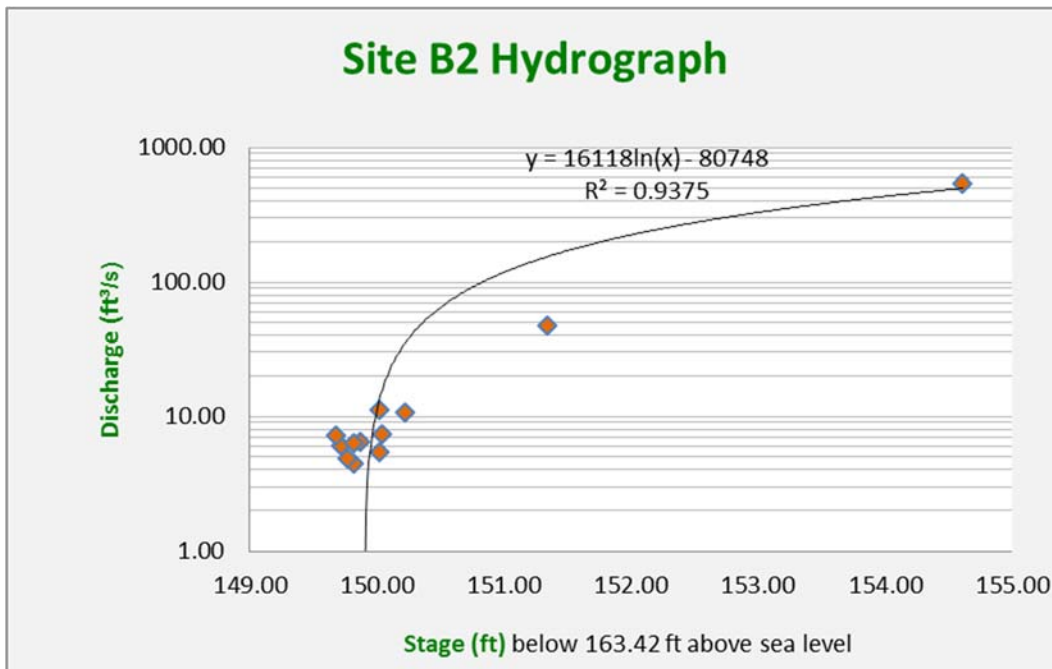
Figure 73 Hydrograph of site CB4 depicting discharge versus stage

Figure 74 Hydrograph of site CB5 depicting discharge versus stage

Figure 75 Hydrograph of site CB6 depicting discharge versus stage

Figure 76 Hydrograph of site CB7 depicting discharge versus stage

Figure 77 Hydrograph of site B1 depicting discharge versus stage

Figure 78 Hydrograph of site B2 depicting discharge versus stage

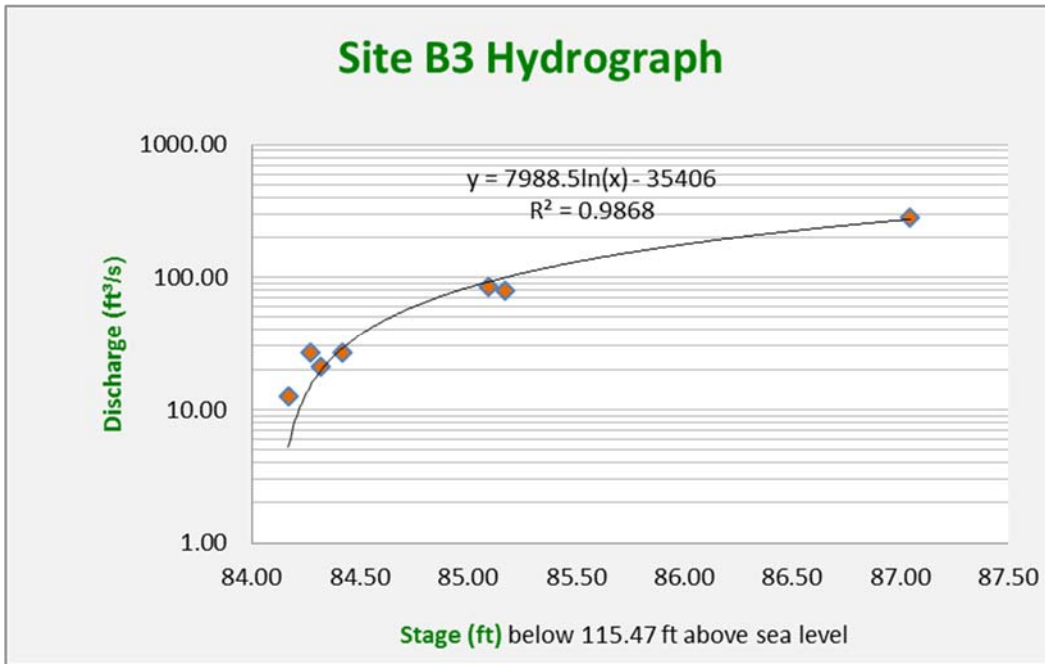
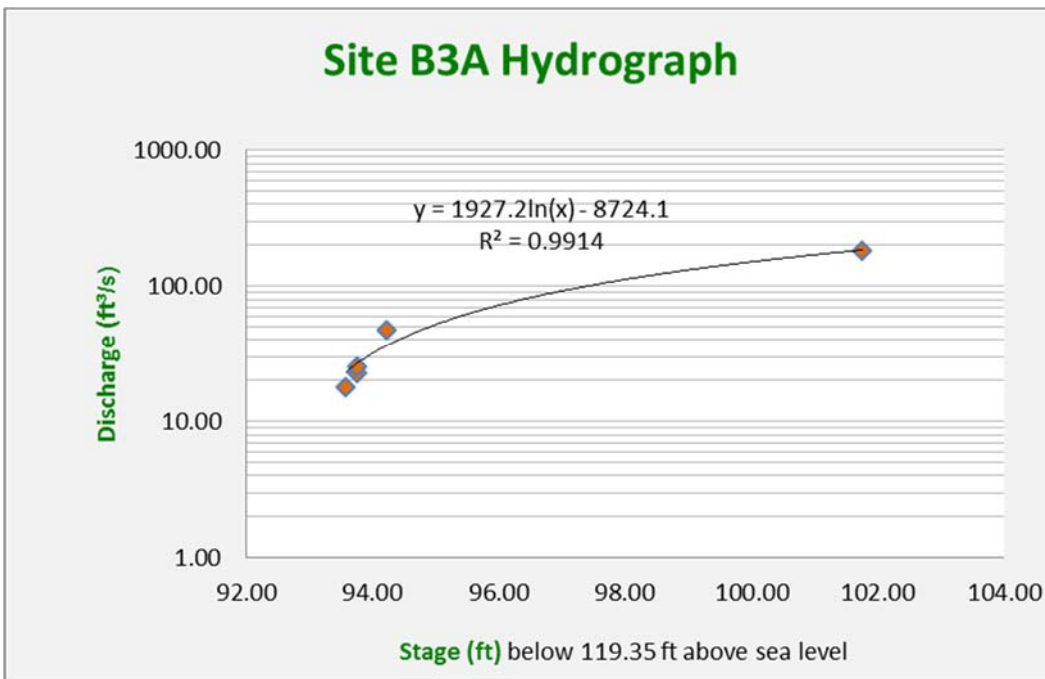
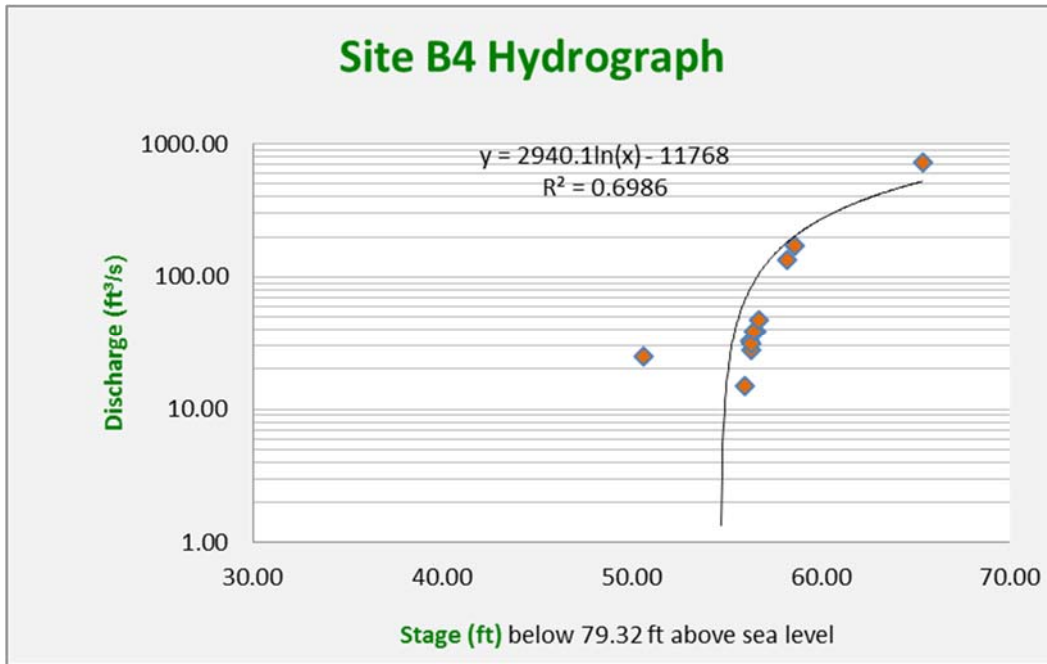
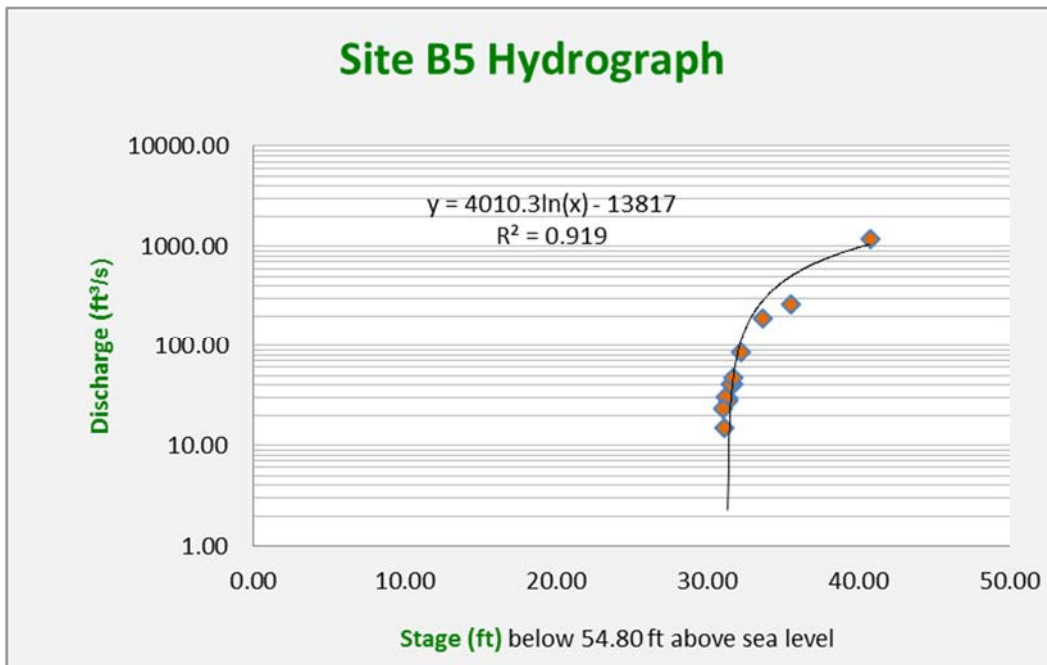
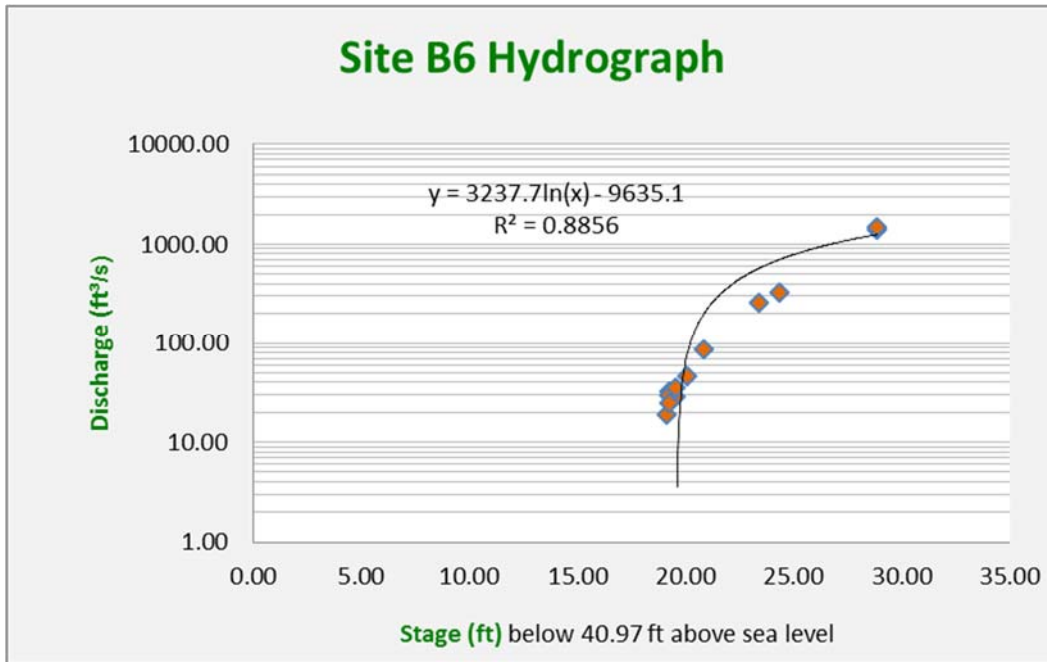
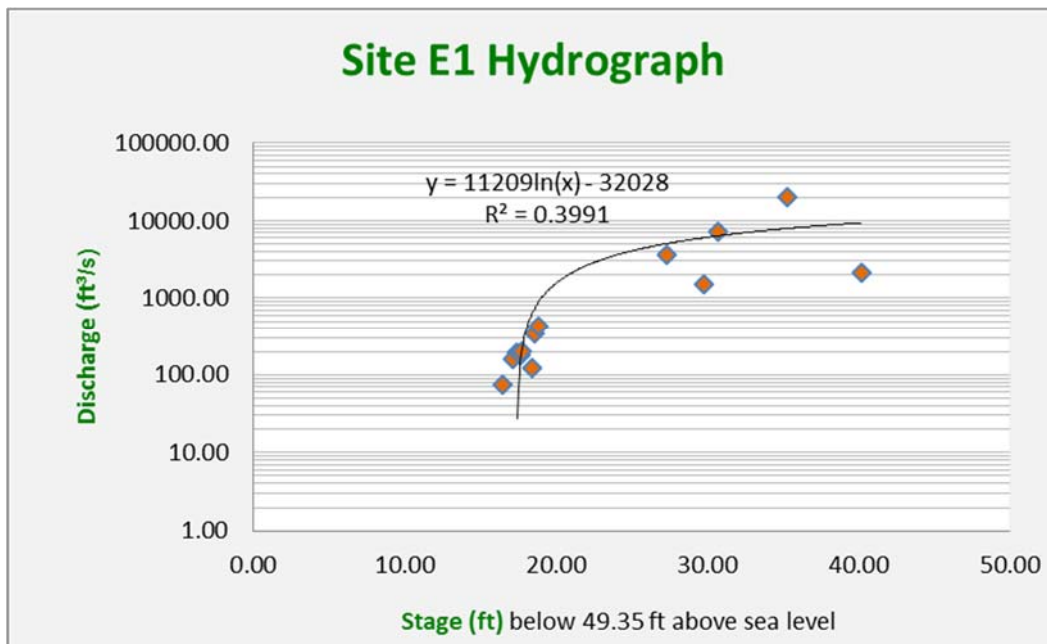
Figure 79 Hydrograph of site B3 depicting discharge versus stage

Figure 80 Hydrograph of site B3A depicting discharge versus stage

Figure 81 Hydrograph of site B4 depicting discharge versus stage

Figure 82 Hydrograph of site B5 depicting discharge versus stage

Figure 83 Hydrograph of site B6 depicting discharge versus stage

Figure 84 Hydrograph of site E1 depicting discharge versus stage

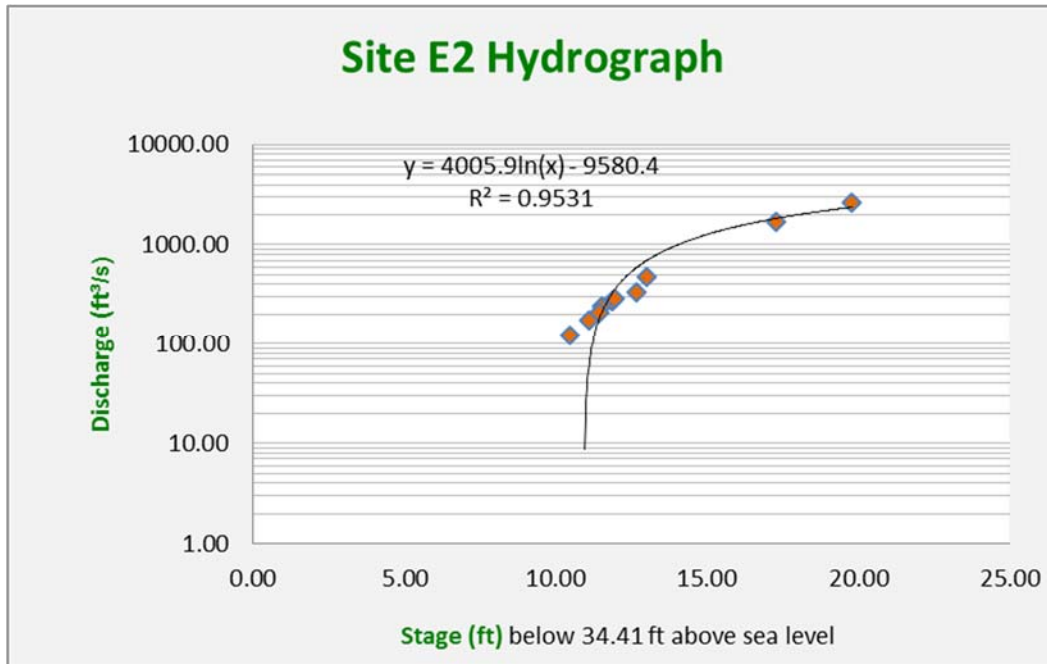
Figure 85 Hydrograph of site E2 depicting discharge versus stage
