IMPACTS OF WATER AND SALINE BRINE FLOW ON FRACTURED WELLBORE CEMENT

THESIS

Master of Science Civil Engineering

The University of New Mexico Albuquerque, New Mexico

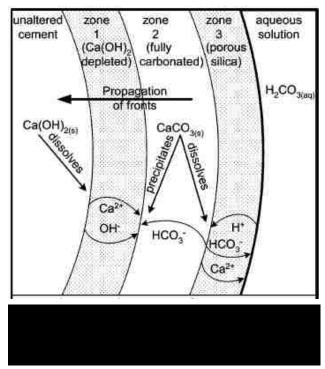
Acidic brines, however, such as those associated with CO₂ sequestration, induce reaction zones (Figure 1.1) in cement that alter its mechanical properties [Walsh et al., 2014; Huerta et al., 2012; Kutchko et al., 2007]. These reaction zones are commonly referred to

as: portlandite-depleted, fully carbonated zone, and a porous silica [Kutchko et al., 2007]. In an acidic brine environment, typical dissolution rates of portlandite occur up to four orders of magnitude faster than decalcification of C-S-H [Baur et al., 2004; Marty et al., 2009]. The reaction fronts tend to produce a lower elastic modulus than unreacted cement, with the exception of the fully carbonated layer where stiffness and yield strength are found to be at least equal to unreacted cement [Walsh et al., 2014].

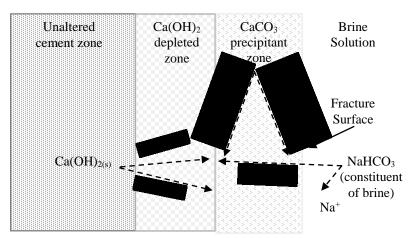
Figure 1.2 Reactions between cement's portlandite and non-acidic brine that leads to a zone of decreased portlandite and a zone of calcite precipitation.

Figure 1.2 represents the anticipated reactions between cement and non-acidic brine that will lead to dissolution of portlandite (Equation 4), precipitation of calcite (Equation 5), decreased hardness of cement fracture surface, and decreased permeability of the fracture.

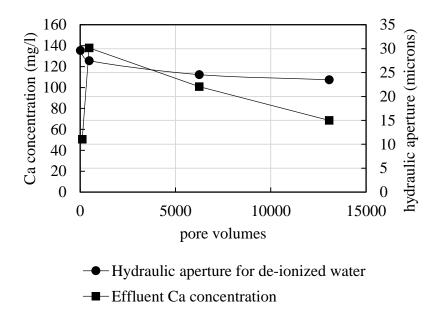
Figure 3.3 Calcium concentration of effluent and hydraulic aperture response under sustained confining stress of 11 MPa versus injected pore volumes of deionized water.

13,000 pore volumes (Figure 3.3). The decrease seen in calcium concentration of the effluent is attributed to significant reduction in porosity from calcite precipitation which clogs pores and prevents further acid penetration [Brunet et al., 2013].

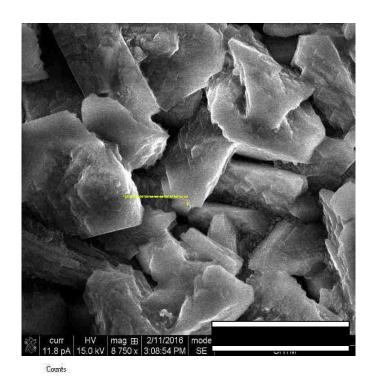
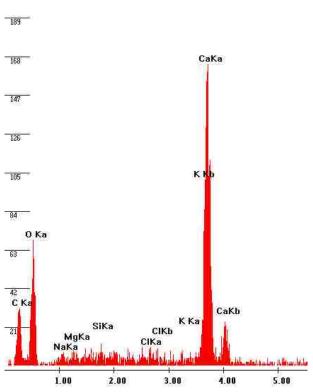
3.4	SEM Image and EDX Spectra for and unreacted fracture cement surface	e.
	SEM image shows distinct shapes that can be compared to reacted	
	surfaces. EDX identify calcium to be the predominant species	29

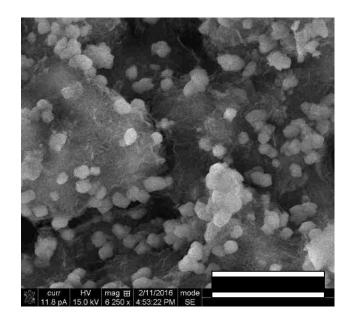
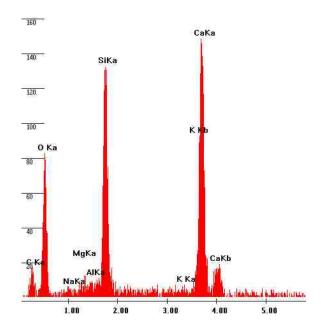
3.5	SEM Image and EDX Spectra of a 'hard' region of fractured surface	
	reacted with a de-ionized water. SEM image shows small crystals formi	ing
	along the cement. Predominant species is calcium and silica in the EDX	
	spectra.	30

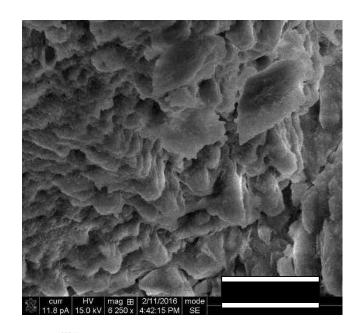
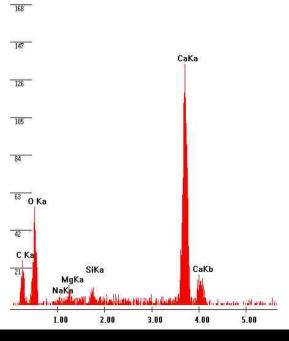
3.6	SEM Image and EDX Spectra of a 'soft' part of fracture reacted with de-	-
	ionized water. Spectra indicates calcium as predominant species	31
3.7	Calcium concentration of effluent and hydraulic aperture response unde	r
	sustained confining stress of 11 MPa versus injected pore volumes of	
	brine	34

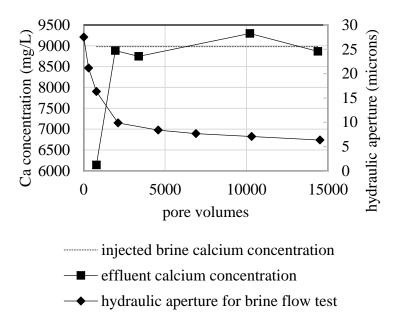
Figure 3.7 Calcium concentration of effluent and hydraulic aperture response under sustained confining stress of 11 MPa versus injected pore volumes of brine.

pore volumes of injection yielded a hydraulic aperture decrease from 28 µm to 10 µm. This decrease in hydraulic aperture and initial drop in calcium concentration in effluent suggests that calcium precipitates out of the solution along the fracture. The decrease of hydraulic aperture may also be the precipitant development leading to the forming of preferential pathways. After the first significant decrease in hydraulic aperture, continued injection of brine corresponded to a gradual decrease to 6 µm.

Calcium concentration in the effluent stabilized (the effluent concentration is approximately equal to the injected concentration) after approximately 2000 pore volumes. However the hydraulic aperture after injecting 2,000 pore volumes decreases from 10 μ m to 6 μ m at nearly 15,000 pore volumes. During this period it is not evident whether precipitation is causing the decrease in aperture or if the cement's composition and mechanical properties are allowing the fracture to become more compressible. As

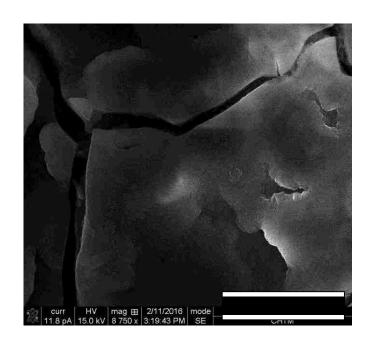
3.8	SEM image and EDX Spectra of a 'hard' fracture surface reacted with	
	brine. Image reveals large sheet-like precipitants that cover cement.	
	Predominant species are calcium, silica, and carbon	38

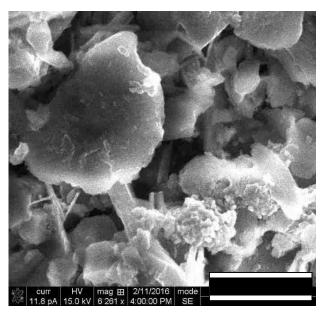
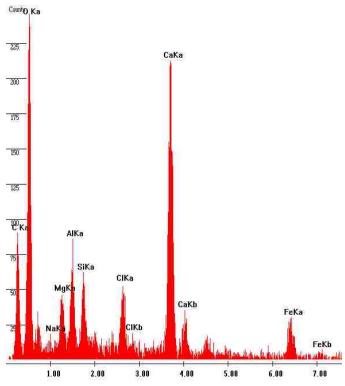
3.9	SEM Image and EDX Spectra of a 'soft' fracture surface reacted with	
	brine. Image shows dissimilar and non-uniform shapes along the surface	e.

unreacted cement and fracture surfaces reacted with de-ionized water. BR sample has unique crystal structures and shapes that were not seen in unreacted and DI samples (Figure 3.9).
