INVESTIGATION OF A MACHINE-PLANT INTERFACE FOR EXTRACTING ROOTED INVASIVE AQUATIC PLANTS

A REPORT

In Mechanical Engineering

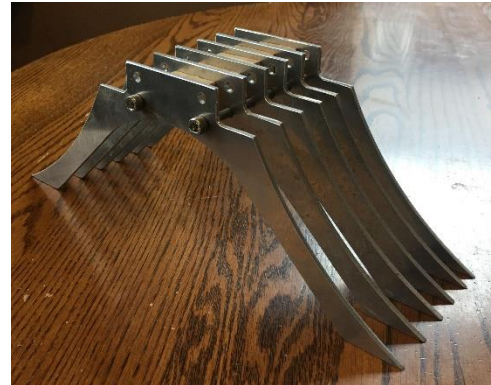
Figure 1. More research will be performed on the configuration and geometries of an end effector similar to the Senior Capstone Design Team 11 end effector, seen here.

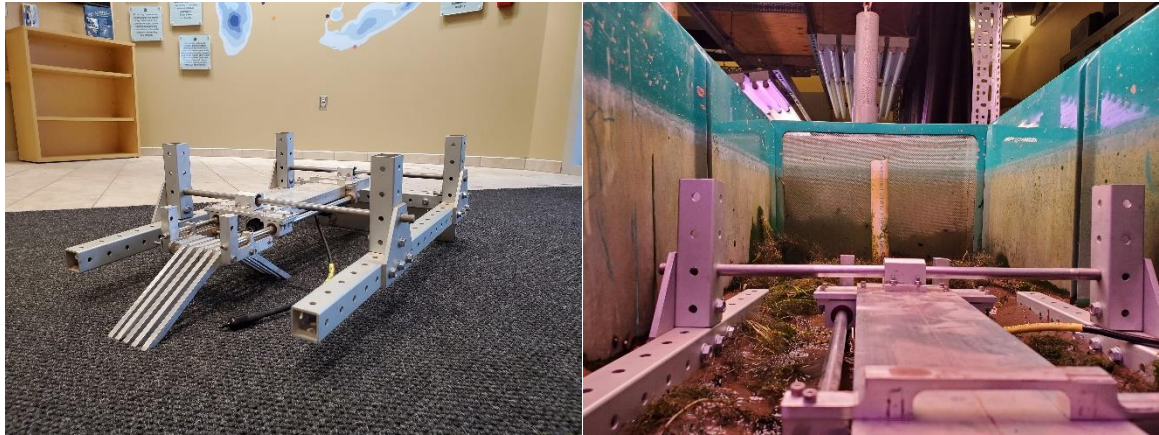
Figure 5. The tines and fin protruded below the test fixture frame (l), and the test fixture frame sat on top of the substrate (r)

As seen in Figure 5, the frame of the test fixture rested on the substrate, and the tines and fin protruded below the test fixture frame.

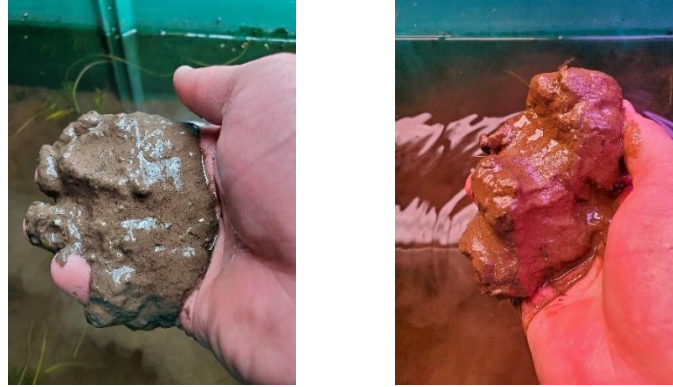
Figure 6. Muck (l) and muck/sand mix (r) substrate types were used for testing. The bulk density of muck was 36% less than the bulk density of the muck/sand mix.

The bulk density of the muck was 36% less than the bulk density of the muck/sand mix. The plants received nine hours of full-spectrum lighting each 24-hour period. Twice per month, algae were manually removed from the plants, half of the tank water was replaced, and the plants were agitated. These treatments attempted to simulate a natural ecosystem with waterflow and wave action. The water in the tanks was from the Keweenaw Waterway. Muck was collected from Chassell Bay, part of the Keweenaw Waterway. Sand was collected from the Pike River in Chassell Township. Figure 6. includes pictures of the tank substrates. *M. Heterophyllum* was purchased through an aquarium supply company, and *M. Spicatum* fragments were gathered from the Keweenaw Waterway. As shown in Figure 7, The plants were typically spaced 120 – 150mm apart after five months of growth. The water depth during growth was between 280mm and 320mm.

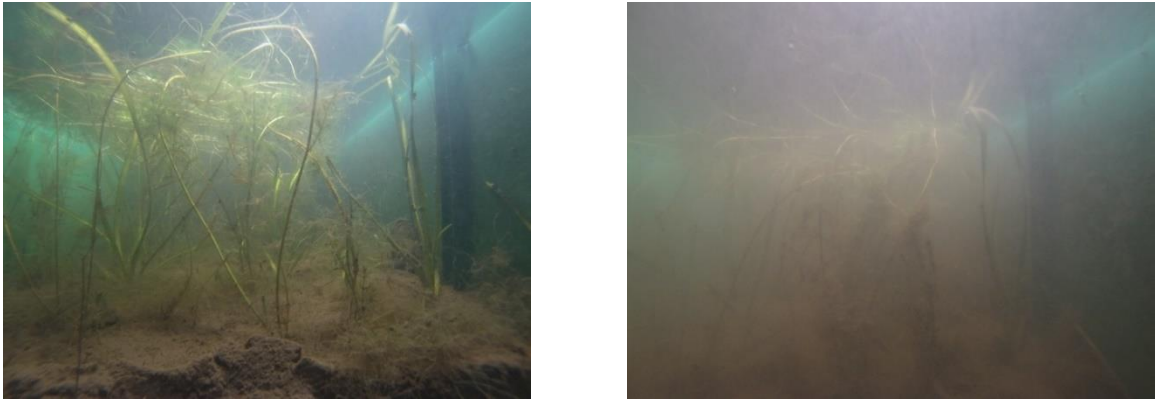
Figure 9. *M. Spicatum* in 4 NTU water (l) and 12 NTU water (r). The camera was one foot away from the plants. It is impossible to distinguish between plant species in the 12 NTU image. Clear underwater images can be taken in water up to around 8 NTU.

maximum turbidity increase outside of the tine path occurred around the end of the tine path, as shown in Figure 4. Testing showed that the upper limit for clear, underwater imaging lies around 8 NTU, as demonstrated by Figure 9.

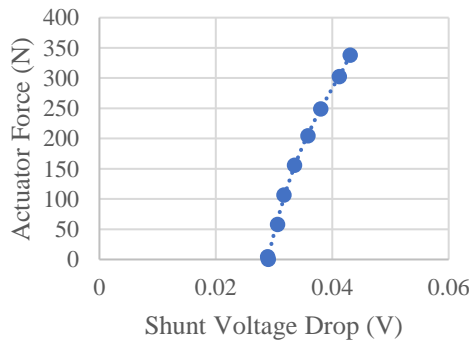
Figure 10. The first relationship between the force produced by the actuator and the voltage drop across a shunt applied to tests 1-4 and 7-8.

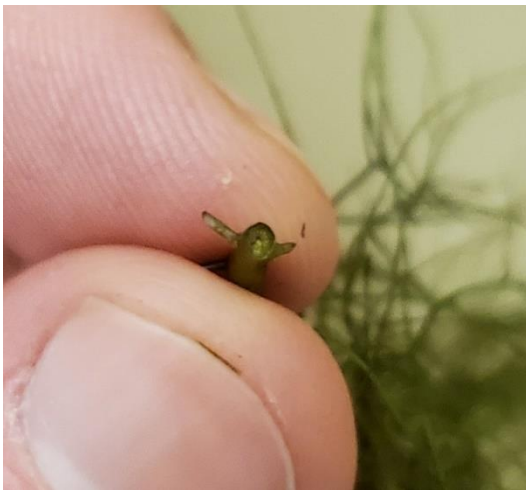
Figure 17. Fragmented *M. Spicatum* Stem. Each removed plant was inspected for fragmented zones.

Plant removal capability was assessed qualitatively. The substrate region impacted by the tines was inspected before and after the tines were retracted. Trials in clear water were filmed and photographed to aid judgement of how the tines were interacting with the substrate and plants. Root position and soil position around the tines was inspected and measured, respectively. Measurements x, y, and z, as indicated in Figure 12, were taken for each trial. The number of loose plants, the number of fragment zones, and the number of plants in the tine path, but not removed (“missed”), were recorded. Plants that were not firmly anchored were removed by pulling on the stem. They were then photographed. The invasive aquatic plant extractor will separate the plants from the substrate with suction, so pulling by the stem was a relatively representative method of removal. Figures 13 through 18 show the difference between a complete plant and a fragmented zone for both species.

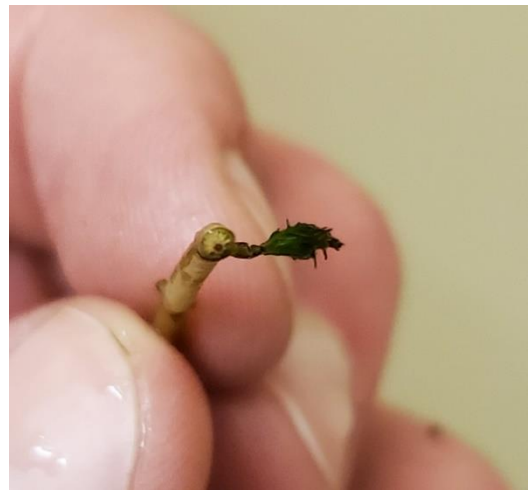
Figure 18. Fragmented *M. Heterophyllum* Stem. Each removed plant was inspected for fragmented zones.

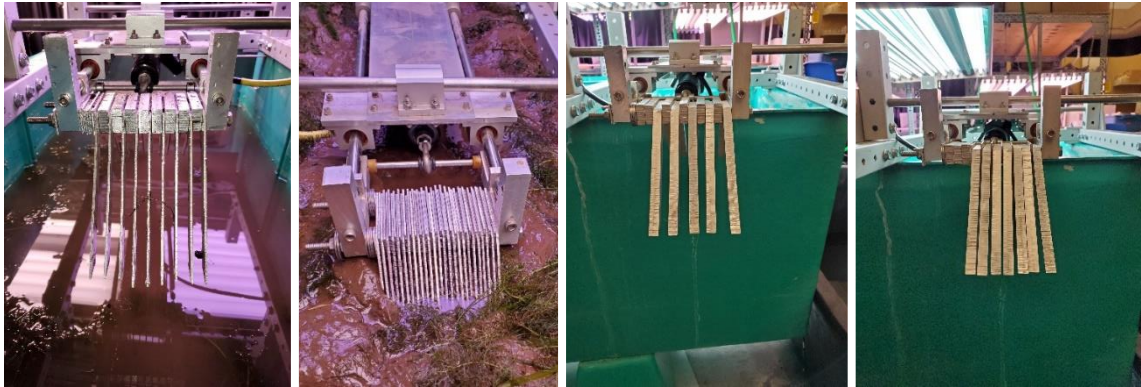
Figure 19. From left to right, nine 2.03mm tines with 9.53mm spacing, 25 2.03mm tines with 2.03mm spacing, five 9.53mm tines with 9.53mm spacing, and 9.53mm tines with 2.03mm spacing. Although the picture here contains just seven tines, the 9.53mm tines/2.03mm spacing configuration was tested with eight tines.

Tests 1-4, detailed in Table 3, tested edge width and tine spacing. The number of tines for each configuration was the maximum that could fit in the 100mm space. Figures 19 and 20 show the four tine configurations, which are made up of 2.03mm- and 9.53mm-wide tines and spacers. 9.53mm is approximately 4.5 times 2.03mm, which was assumed to be a large enough width difference for there to be differences in configuration performance.

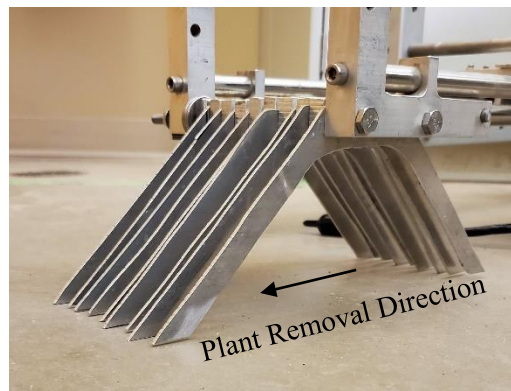
Figure 20. 9 2.03mm tines with 9.53mm isometric view.

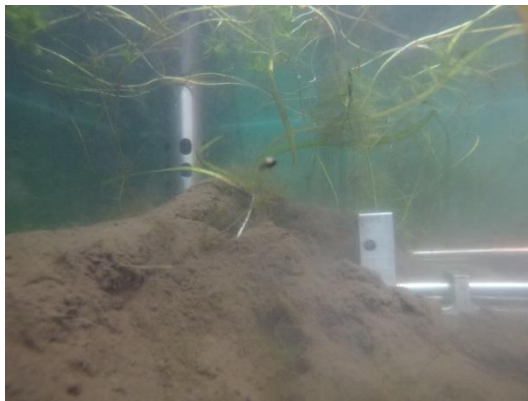
Figure 24. Substrate pile in front of tines after a trial. Trials had been performed along the width of the tank prior to the taking of this picture. The substrate mound is wider in this figure than in Figure 23.

Figures 12 and 23 – 25 illustrate the typical substrate buildup around the tines after a trial. The tines pushed the substrate forward, raising a portion of substrate in front of the tines, denoted by measurement x in Figure 12, and leaving a trough behind the tines, denoted by measurement z in Figure 12. The plants in the path would move with the tines if they were loosened and contacted by the tines. There was a space beneath the tines which was void of substrate in about 25% of trials, denoted by measurement y in Figure 12.
