UNIVERSITY OF TENNESSEE HEALTH SCIENCE CENTER

MASTER OF SCIENCE THESIS

**Iatrogenic Electrocautery Damage and  
Cellular-Based Corrosion of Total Joint  
Arthroplasty Biomaterials**

*July 2021*

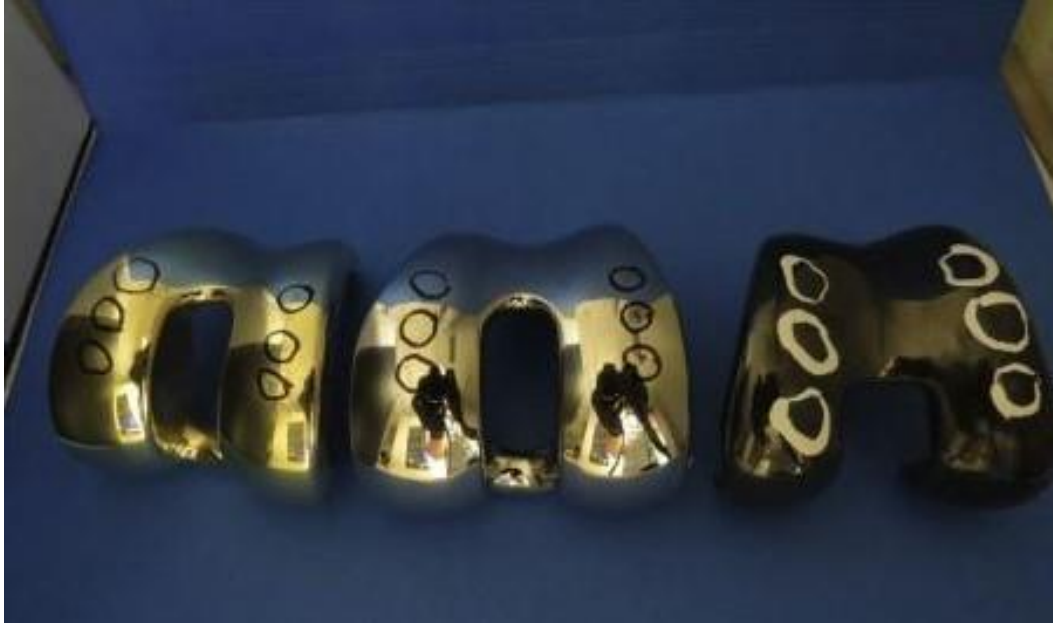
**Figure 2-1. Damaged Areas Shown on ZrN-, CoCr-, and Oxinium-Bearing Surfaces**  
Left to Right: ZrN-Bearing Surface, CoCr-Bearing Surface, and Oxinium-Bearing Surface

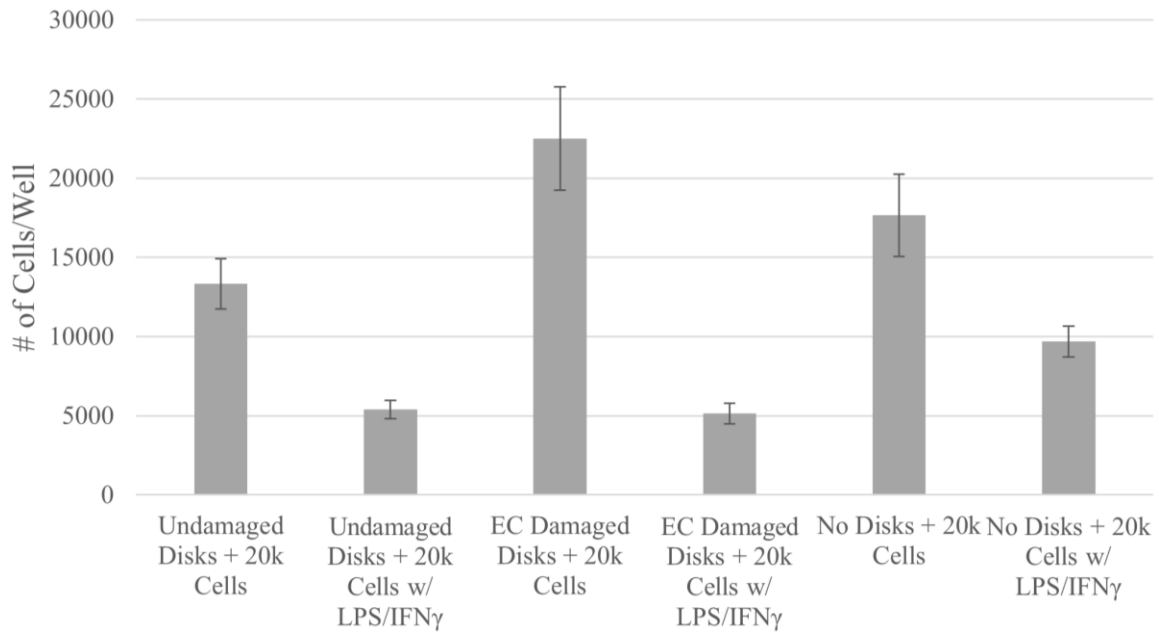
**Figure 3-2. Cell Count on Day 30 of the Experiment**  
 Error bars represent  $\pm$  one standard deviation

The number of cells were counted following the end of the 30-day experiment (**Figure 3-2**). A statistically significant difference was seen between all cell groups ( $P<0.001$ ) except when comparing the Undamaged Disks with Activated Cells versus the EC Damaged Disks with Activated Cells.

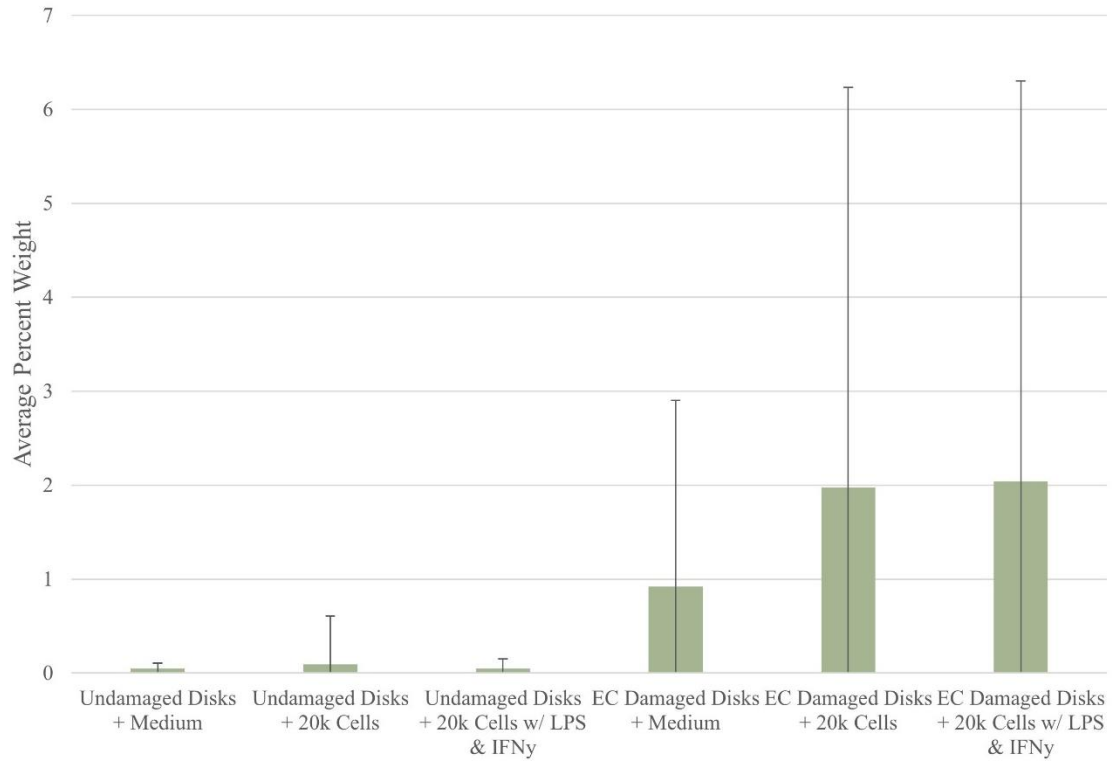
**Figure 3-7. Fe/C Backscatter Ratio of the CoCr Disks**  
 Error bars represent  $\pm$ one standard deviation
