Identifying Damage, Predicting Expansion, and Determining the Effectiveness of Sealers on
Concrete Affected by Alkali-Silica Reaction and Freeze-Thaw

A thesis submitted in partial fulfillment
of the requirements for the degree of
Master of Science in Civil Engineering

Matthew Waidner
University of Arkansas
Bachelor of Science in Civil Engineering, 2015

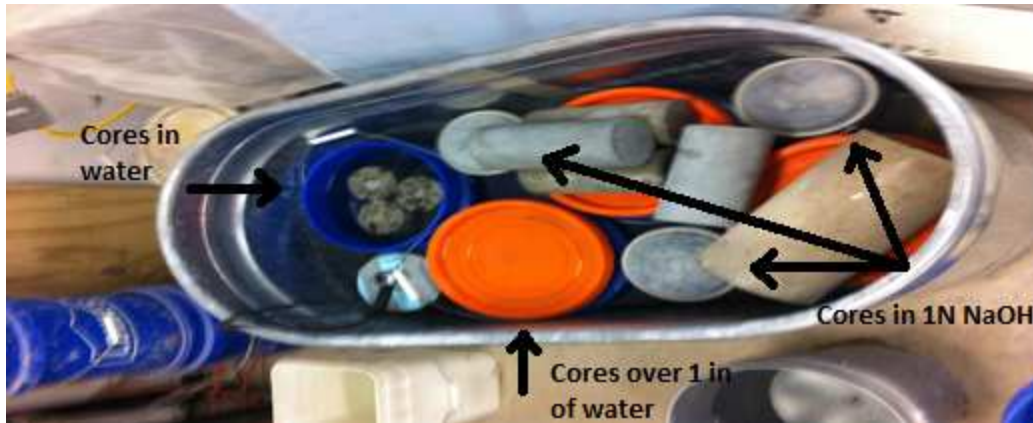
Figure 3.3. Water Bath

A water bath was prepared using a 100 gal watering trough. The water temperature was measured and controlled using an electric thermometer connected to a heater. The water bath was maintained at 100°F. All the buckets and cylinder molds were kept in the water bath throughout the testing. The buckets were not submerged in the water bath, but the water came up to just under the lid for the buckets, which is shown in Figure 3.3. The two extra buckets in Figure 3 were for another project not discussed in this paper.

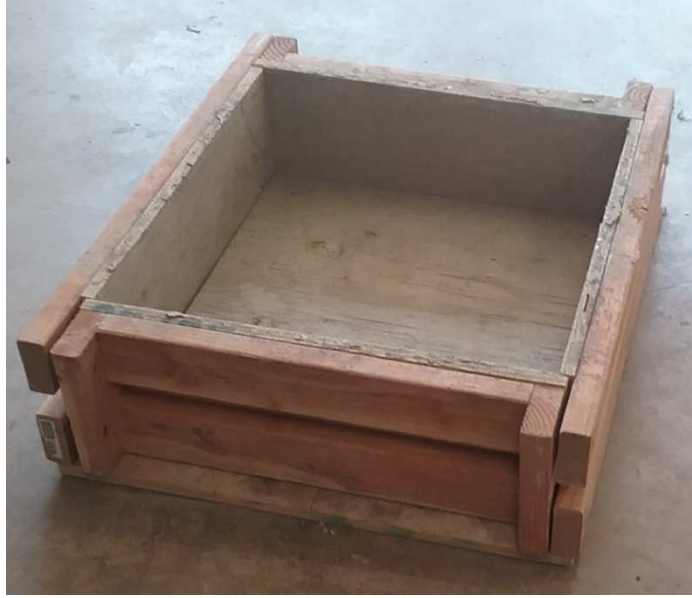
Figure 3.5. Formwork

The concrete was mixed and placed into two forms that were two feet by two feet by eight inches deep as shown in Figure 3.5. The bottom of the forms was made of plywood with four holes, so that gage studs could be placed into the concrete. As the concrete was placed into the forms, it was rodded and consolidated. After the concrete was placed, the surface was finished with a trowel.
