Impact of Beam Strength on Seismic Performance of Chevron Concentrically Braced Frames

A thesis

Master of Science in Civil Engineering

University of Washington

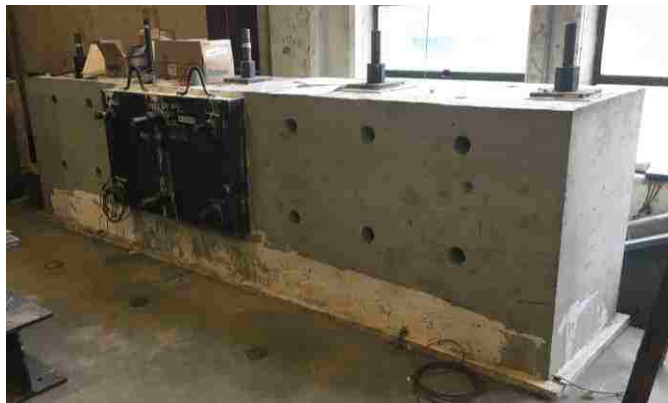
Figure 3.2: Reaction block used for N column anchorage.

The new reaction block, shown in Figure 3.2, is the same width as the strong wall and is secured to the strong floor with 5 2-inch diameter threaded rods each tensioned to 200 kips. A layer of Hydrostone was placed under the entire block and on top of the block underneath the rod bearing plates to ensure proper bearing surface area. Embedded conduits are placed in an 18-inch grid, offset 9 inches from the strong floor and strong wall grid because those spots were occupied by the threaded rods used to clamp the block to the strong floor. The conduits were designed to mimic those in the strong wall so that the connections between the columns and the reaction components would be consistent. A detailed drawing of the block and its reinforcing steel is in Appendix 1.

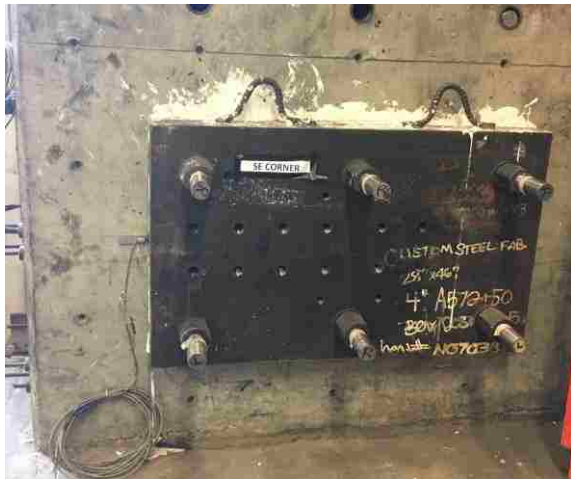
Figure 3.7: Interface plate attached to strong wall.

An anchorage system was designed to connect the columns to the reaction block and strong wall. It was decided that the columns would be restrained at the base to avoid uplift of the columns and to simulate boundary conditions for the lower story of a braced frame. A column base plate and an interface plate to connect the base plate to the concrete block and wall were designed in tandem; Figure 3.7 and 3.8 shows photos of these components and detailed drawings are in Appendix 1. The interface plate was needed because the only means of attaching components to the strong wall and reaction block is through the conduits which are spaced 18 inches apart, and the thick interface plate transfers reactions from the smaller base plate to the reaction block and strong wall. The interface plate was connected to the reaction block and strong wall via the embedded conduits, and it had threaded holes in an efficient layout to attach the column base plate. The interface plates were reused but the columns and base plates were replaced for each test.

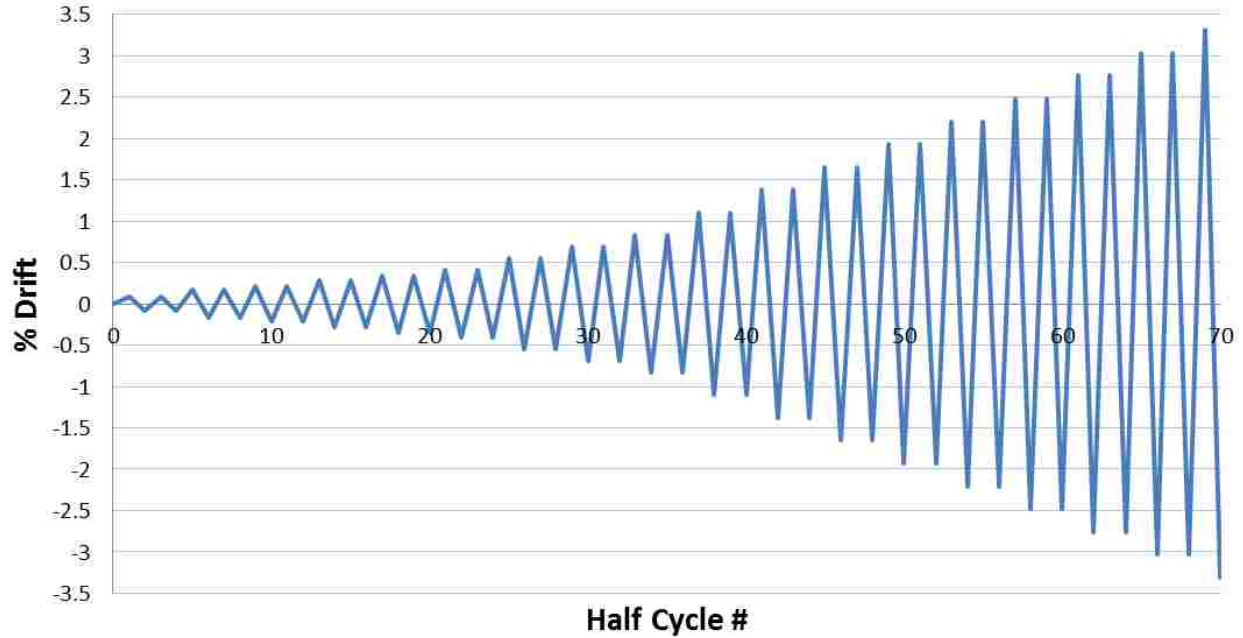
Figure 3.33: Main displacement protocol.

The main test consisted of pushing the frame back and forth at increasingly larger displacements until failure, as shown in Figure 3.33. The frame was first pushed to a positive target displacement (corresponding to the North brace in compression; North is labelled in the experimental setup diagram in Fig. 3.1) and then the same target displacement in the negative direction (South brace in compression). Two full cycles were run at each target displacement in order to capture cyclic strength degradation. The target displacements were set as multiples of the yield displacement, i.e. $0.5\Delta_y$, Δ_y , $2\Delta_y$, $3\Delta_y$, $4\Delta_y$ and so on.

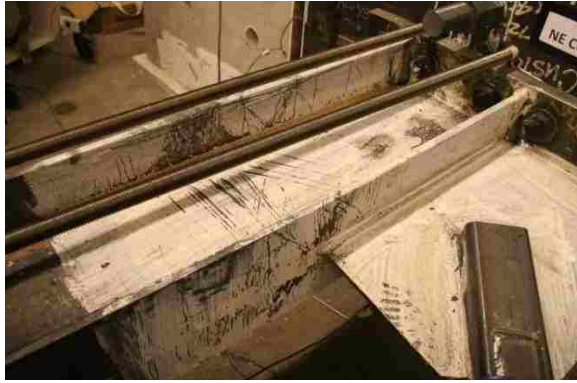
Figure 4.13: N col. moderate yielding at +1.9% drift (Y2-PH).

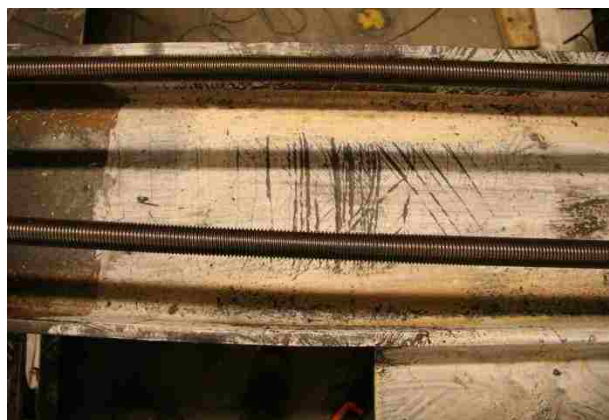
Figure 4.17: Initial local buckling in N (left) and S (right) column flanges at $+2.2\%$ drift (LB1-OF/IF).

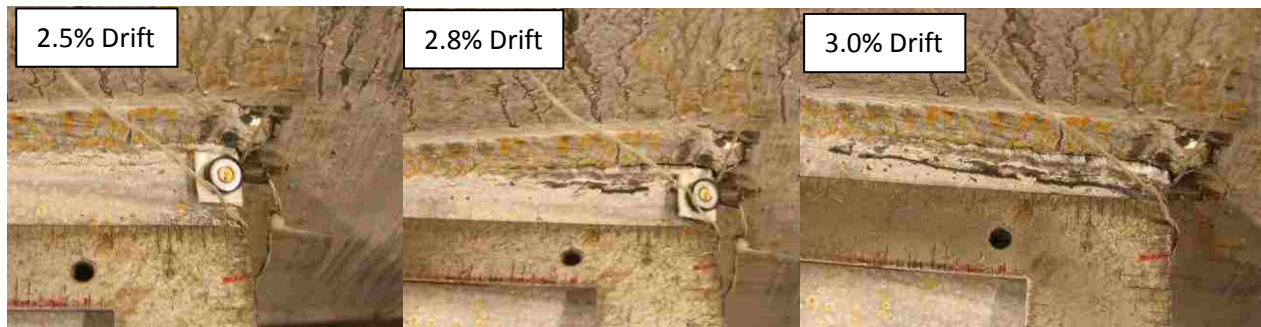
Figure 4.18: Crack propagation in N toe of mid-span gusset-to-beam weld (WT1,2).

Half Cycle #	Drift (%)	N mid-span gusset-to-beam	S mid-span gusset-to-beam	NE gusset-to-column	SE gusset-to-column
49	1.93	1/4"	-	-	-
53	2.2	1"	-	-	-
57	2.48	2"	-	2"	-
58	-2.48	2"	-	2"	1/4"
60	-2.48	2"	-	2"	1/2"
61	2.76	2-3/4"	-	3-1/4"	1/2"
63	2.76	2-3/4"	-	3-1/2"	1/2"
64	-2.76	2-3/4"	7/8"	3-1/2"	1/2"
65	3.03	3"	7/8"	4"	1/2"
66	-3.03	3"	1-1/2"	4"	1/2"
67	3.03	3-1/2"	1-1/2"	4-1/2"	1/2"
69	3.31	4"	1-1/2"	5"	1/2"

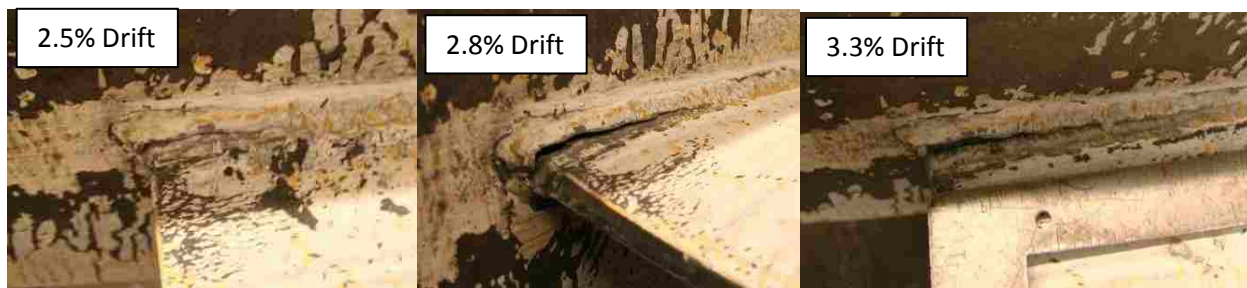
Figure 4.19: Crack propagation in NE corner gusset-to-column weld (WT1,2,3).

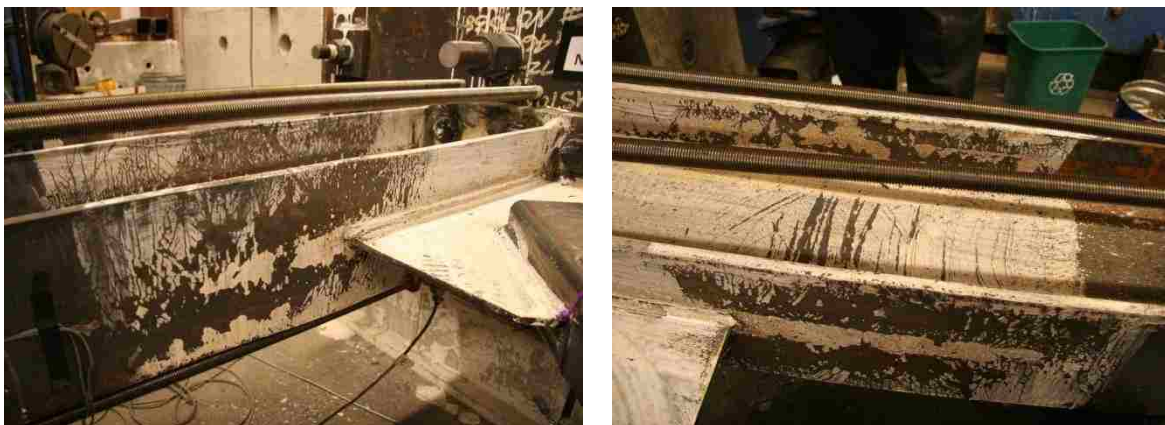
Figure 4.22: Severe yielding in N col. (left) and S col. (right) at 2.76% drift (Y3-PH).

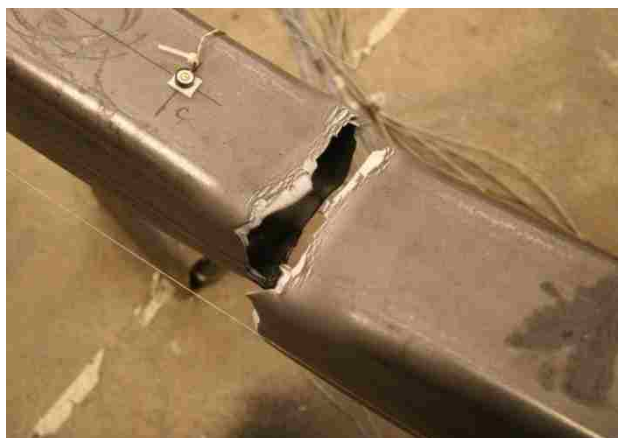
Figure 4.24: S brace fracture at second cycle of +3.0% drift (B4-BF).

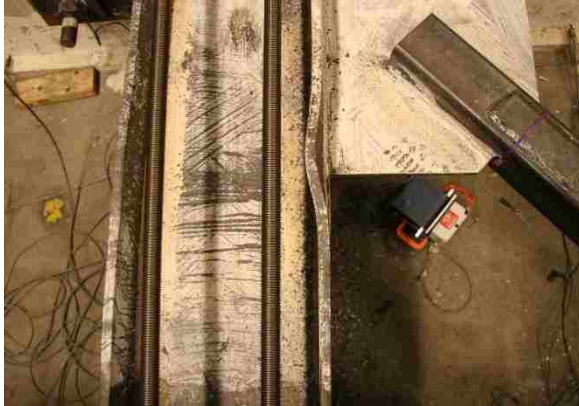
Figure 4.26: N column moderate local buckling at -3.3% drift (LB2-IF).

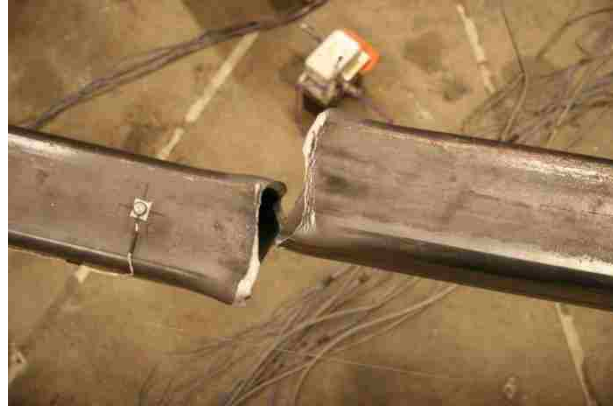
Figure 4.27: N brace fracture on second cycle at -3.3% drift (B4-BF).

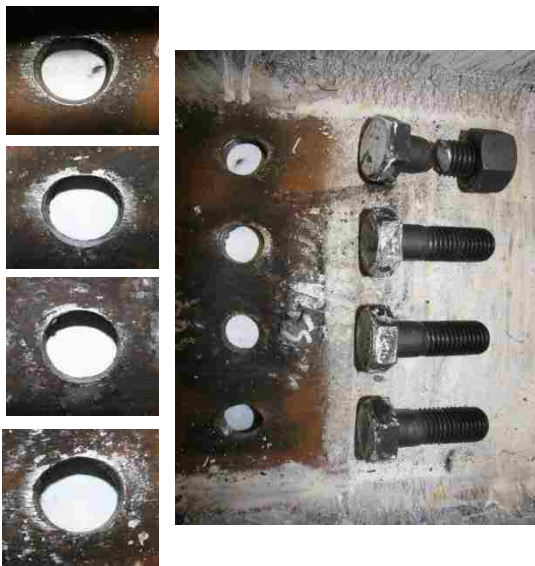
Figure 4.28: S beam web bolt hole elongation.

The frame was cycled to $\pm 5\%$ drift after both braces had fractured. The columns continued to yield and undergo local buckling, reaching the performance state of severe local buckling (LB3). After the test the frame was disassembled and it was noted that bolt hole elongation had occurred in the beam web, as shown in Figures 4.28 and 4.29.

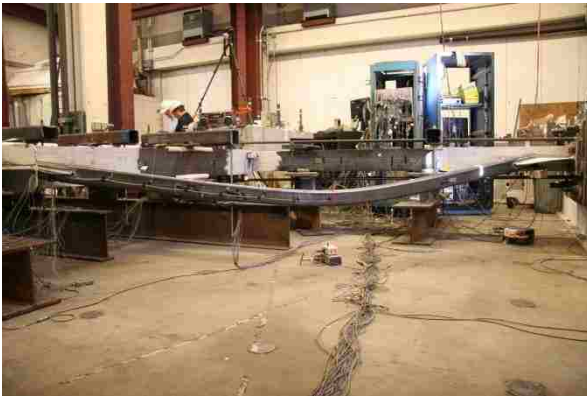
Figure 4.37: N brace buckling at $+1.1\%$ drift (B1).

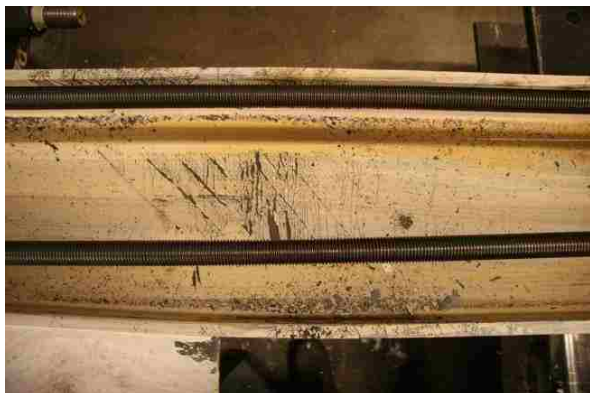
Figure 4.45: Initial col. local buckling at 2.2% drift (LB1-OF/IF).

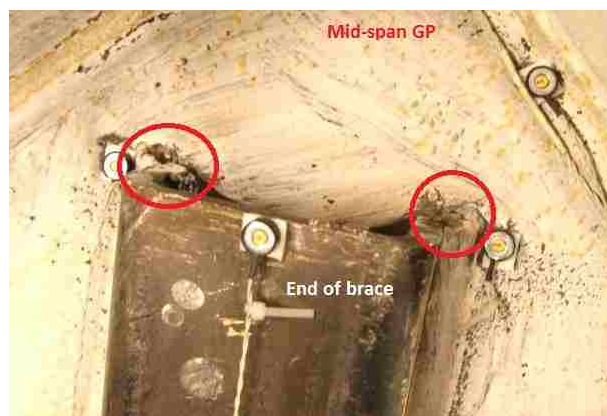
Figure 4.48: Plate cracking at toe of brace-to-mid-span gusset weld (PC1).

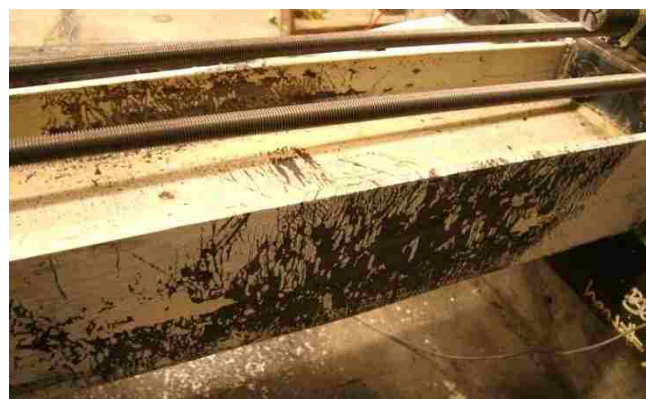
Figure 4.49: S col. severe yielding at 2.8% drift (Y3-OF/IF).

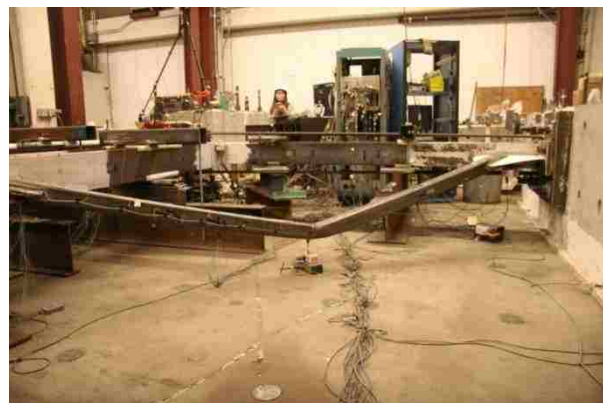
Figure 4.53: N brace buckling at 3.3% drift (B3-PH).

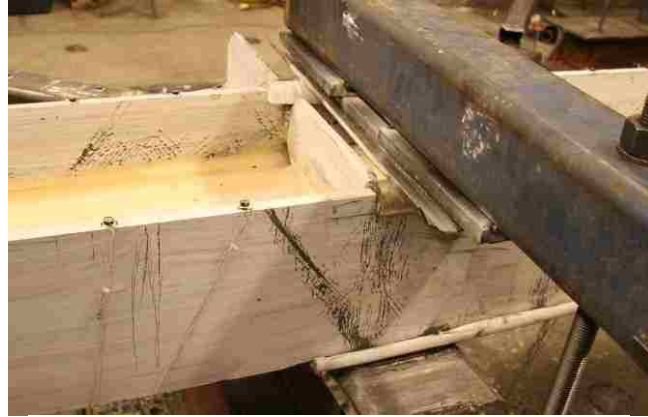
Figure 4.55: Extent of beam yielding at end of test (Y1-OF/IF).

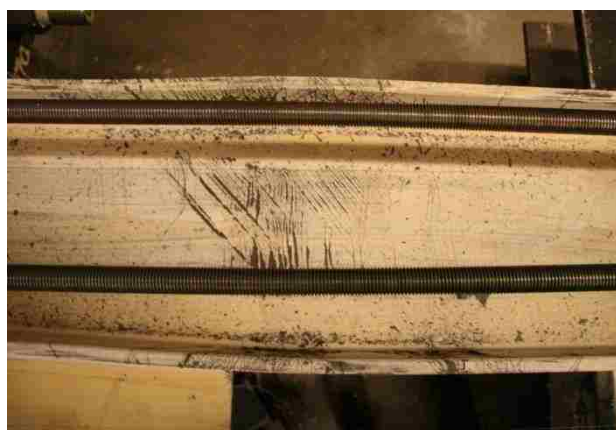
Figure 4.74: Initial S col. local buckling at +2.2% drift (LB1-IF/OF).

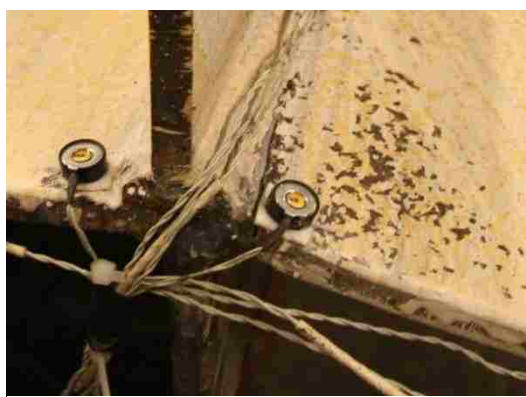
Figure 4.80: Plate crack at N mid-span gusset-to-stiffener weld at 3.3% drift (PC2).

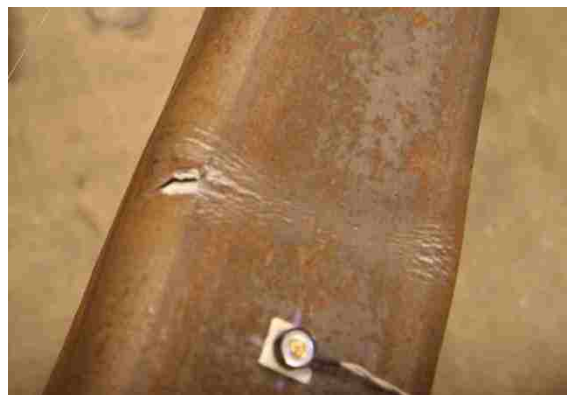
Figure 4.81: N brace crack/striations at -3.3% drift.

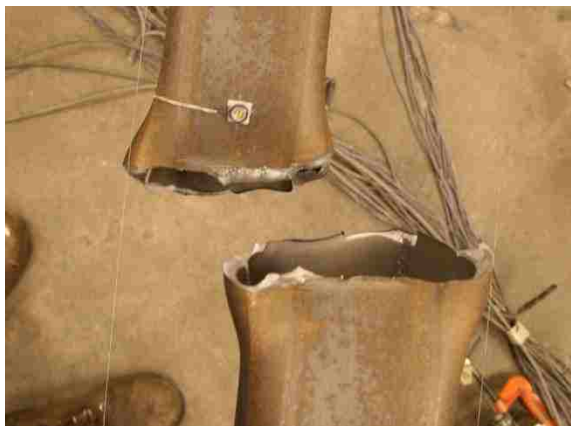
Figure 4.88: N brace fracture at -3.6% drift (B4-BF).

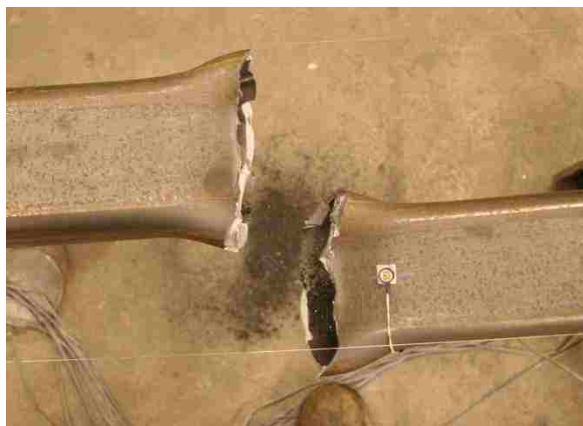
Figure 4.89: S brace fracture at +3.6% drift (B4-BF).

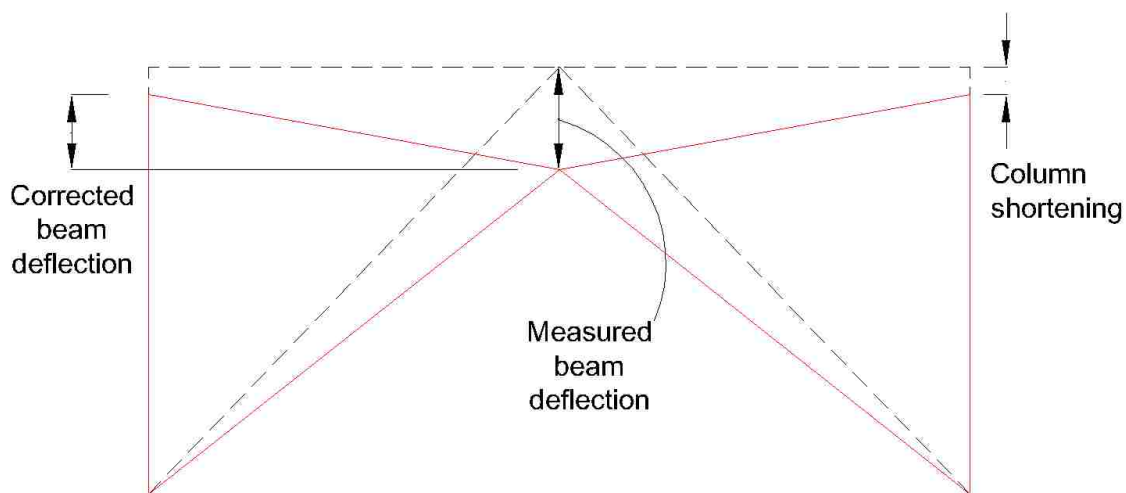
Figure 5.25: Beam deflection correction for column shortening.
