Implications of Pyrite Oxidation for Engineering Works

A. Brian Hawkins
University of Bristol
Bristol
UK

In the last decade, major problems have occurred in numerous buildings in the Dublin area which were constructed on fill containing pyrite/pyrrhotite. This paper provides a background to the process by which the oxidation of iron sulphides can lead to distress in structures, with particular reference to the problems which have occurred in the Dublin area in the 2000s. It discusses the formation of pyrite and pyrrhotite and the chemical processes involved in their oxidation, the effects of the oxidation process, and how its by-products can lead to both heave and/or the degradation of concrete.

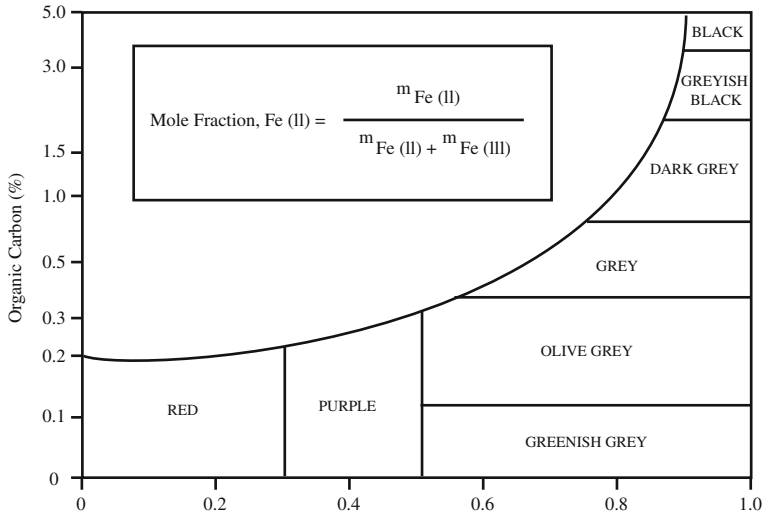
Fig. 2 The colour of mudrock as a function of the organic content and the Fe^{2+}/Fe^{3+} contents (after Potter et al. 1980)

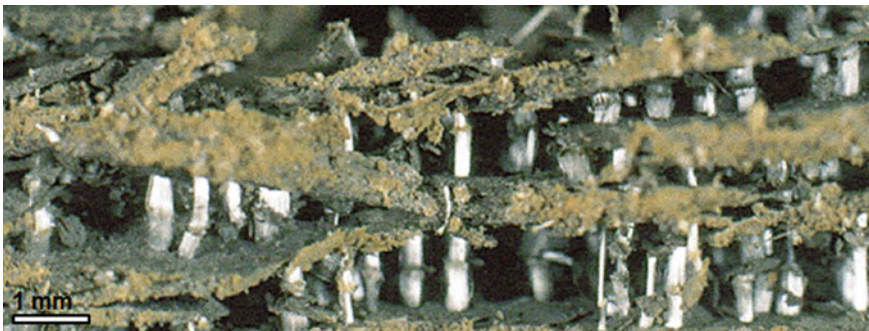
Fig. 34 Fibrous crystals with pronounced median line which developed when a sample of Carboniferous mudrock was kept in a humid oven at 30 °C

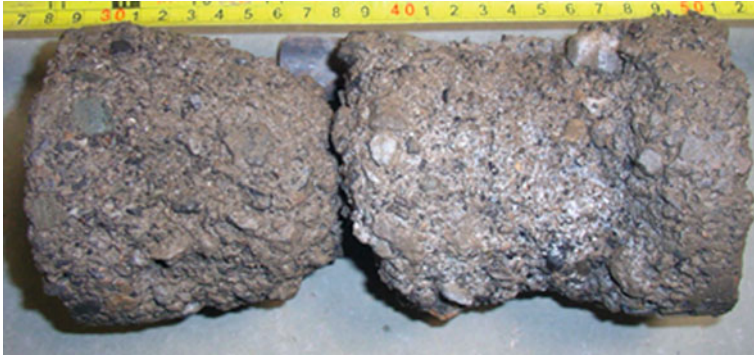
Fig. 61 Degraded concrete with thaumasite developed in poor quality block in a rising wall

the inside face. Figure 60 shows thaumasite has developed at a depth of 9.4 mm into a concrete block where the sulphate content was up to 19.4 % SO₄. Figure 61 shows a core from a flat-lying concrete block which indicates significant deterioration of the concrete had taken place within five years of placement. It was not possible to obtain a good quality core either because of a lack of cement in the middle part of the block and/or the presence of thaumasite which weakened/disintegrated the material.

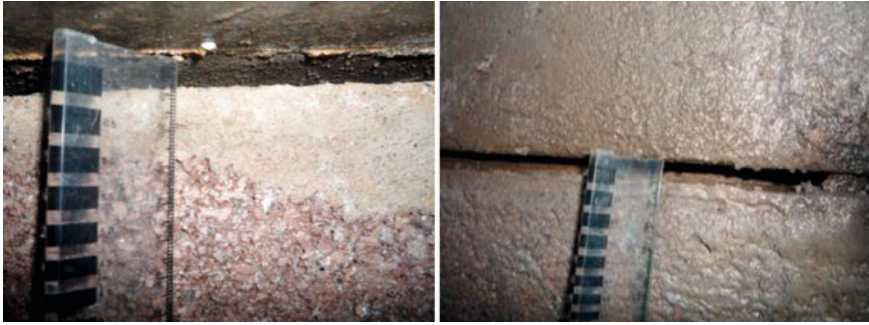
Fig. 73 Rise of a manhole biscuit/cover slab of up to 13 mm due to the expansion of the surrounding pyritiferous fill (*left*). In the manhole wall itself gaps of up to 10 mm were noted (*right*) where the upper wall remained cemented to the biscuit

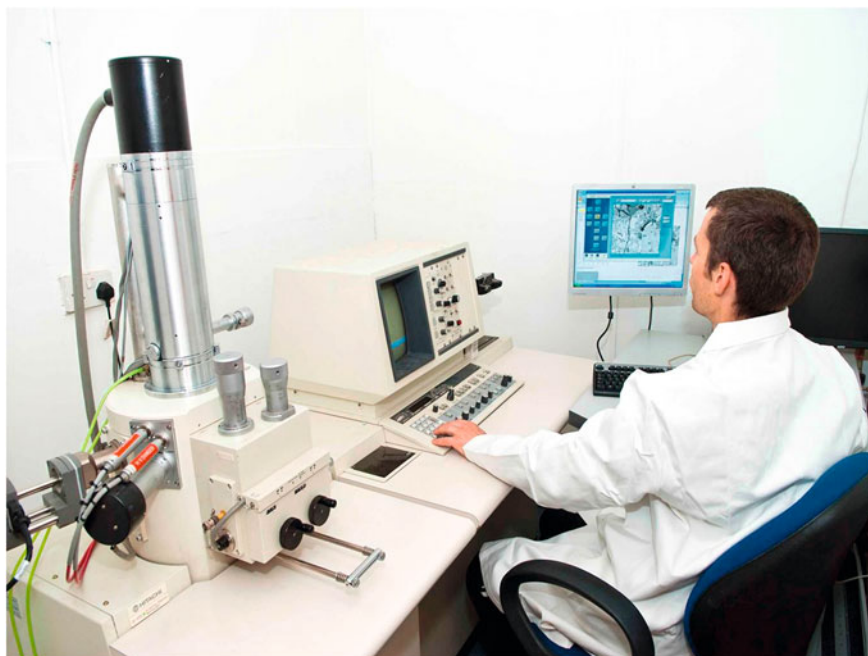
Fig. 10 Scanning electron microscope fitted with an energy dispersive X-ray microanalysis system for making chemical analyses

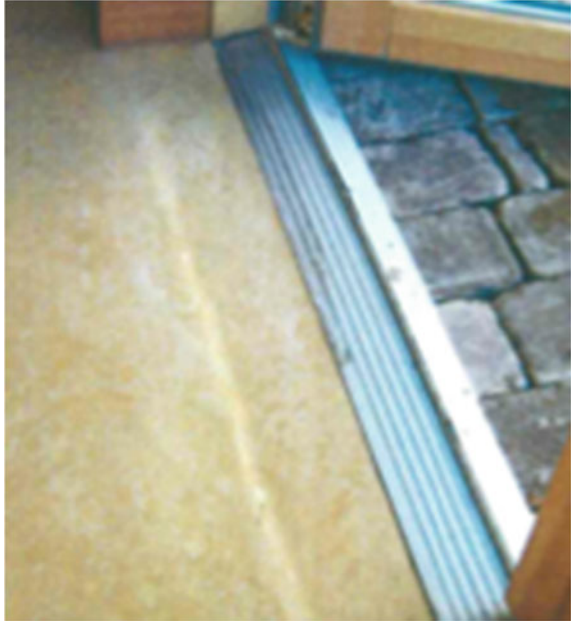
Fig. 17 Rise of floor against the threshold into the stairwell (November 2007)

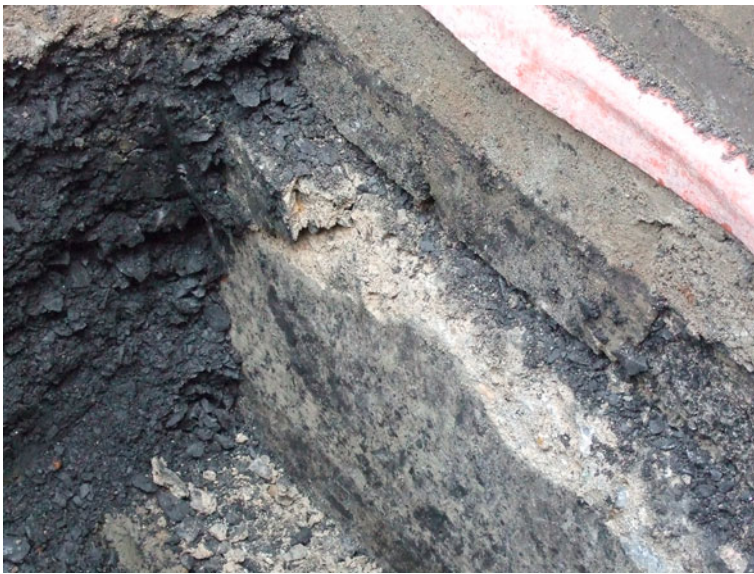
Fig. 28 Deterioration of concrete at the top of the beam, TP 11, and the nature of the dark deleterious fill adjacent to it

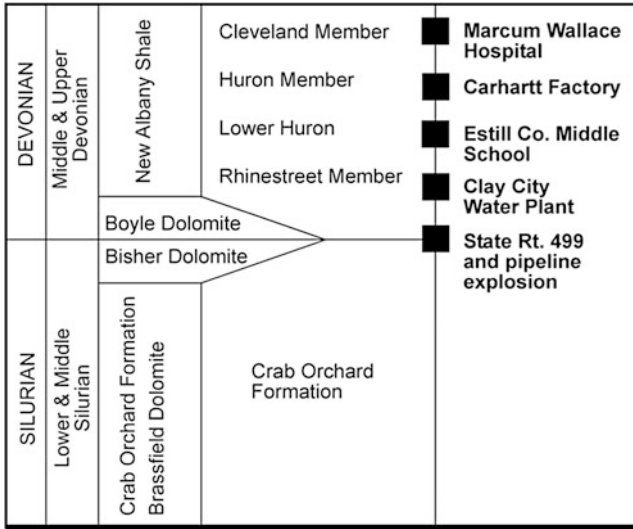
Fig. 4 Stratigraphic column showing pyrite zones within the Cleveland or Huron Member of the New Albany (Chattanooga and Ohio) Shale, which are a common factor in the foundation problems

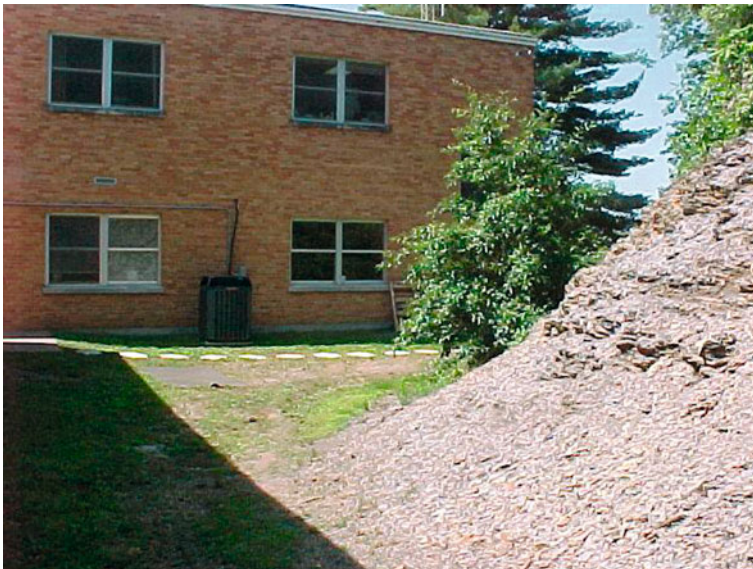
Fig. 26 Exterior of the Marcum and Wallace Hospital office wing and an adjacent outcrop of the Cleveland Member of the Chattanooga (Ohio) Shale. Note the absence of cracks or offsets in the load bearing walls and exterior brickwork of rooms with heaved floor slabs
