Improved pretensioning procedures for anchor bolt connections in sign, luminaire, and traffic signal structures

A thesis submitted to the graduate faculty
in partial fulfillment of the requirements for the degree of
MASTER OF SCIENCE

Major: Civil Engineering (Structural Engineering)

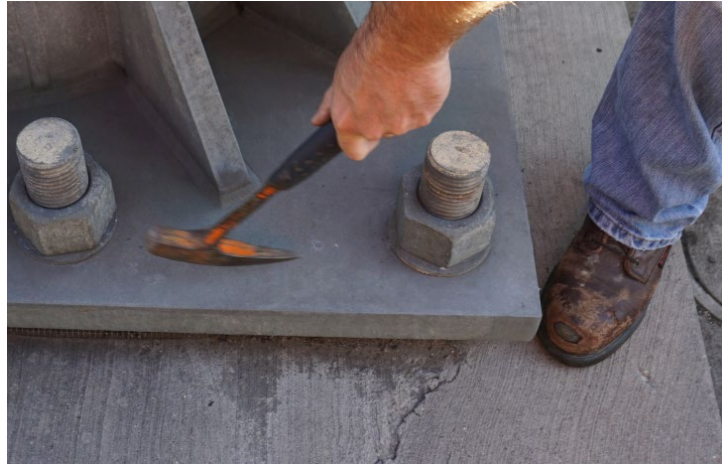
Before any maintenance on the structure, the connection is checked for inadequate clamping force by striking two opposite edges of the top and leveling washer with a pick (Figure 3.1.1).

Figure 3.1.1. Checking for clamping force in connection

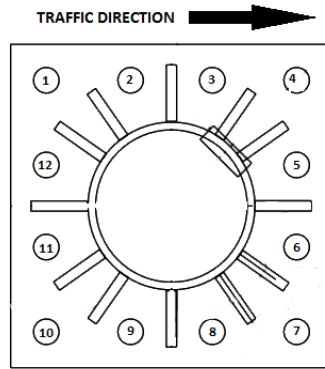
The notation for referring to anchor rod numbers is based on traffic direction. Facing traffic perpendicularly, numbering starts at the top left anchor rod and goes around clockwise. Figure 3.1.2 illustrates an example for a 12-rod structure.

Figure 3.1.2. Example of anchor rod numbering notation on a 12-rod baseplate

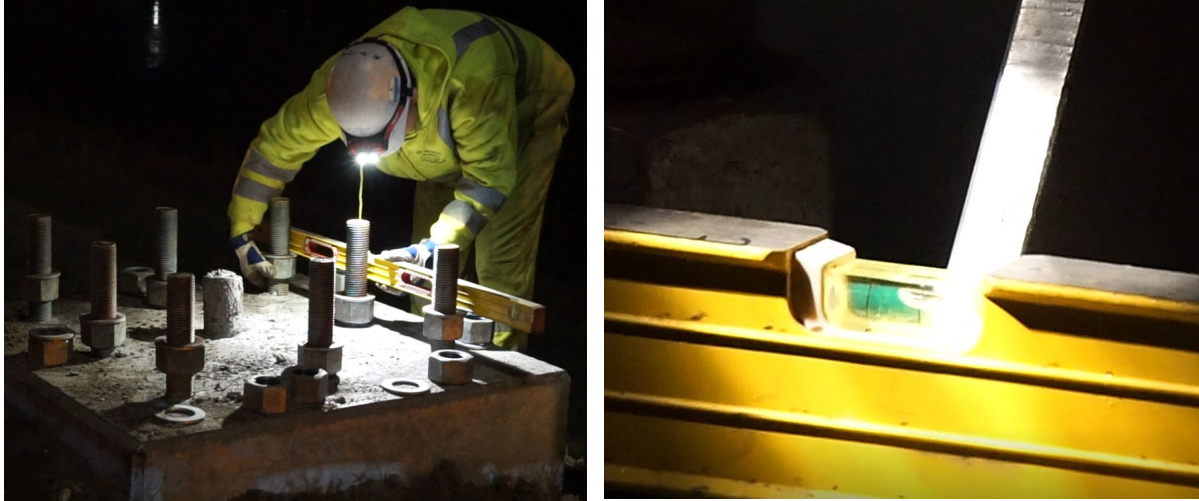
Grade 55 anchor rods were used in both installations. Both of the structures were installed by Global Specialty Contractors of Eagan, Minnesota. Both structures were installed at night due to traffic control requirements. Before the installation of the posts, the leveling nuts were leveled as illustrated in Figure 3.2.2.

Figure 3.2.2. Leveling nuts on sign truss structure (left) and final installation of COSS out of plumb (right)

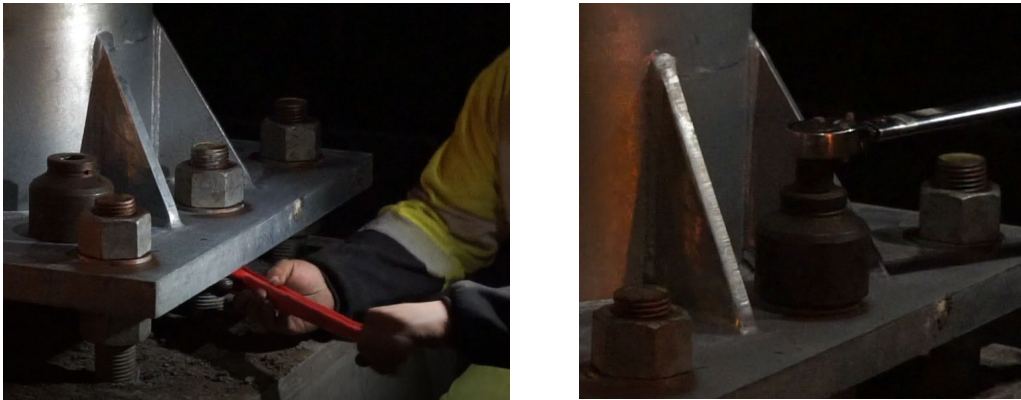
After lubrication, the leveling nuts were approximately snugged with a pipe wrench (Figure 3.2.4 left).

Figure 3.2.4. Tightening leveling nuts with pipe wrench (left) and snugging top nuts with a calibrated wrench (right)

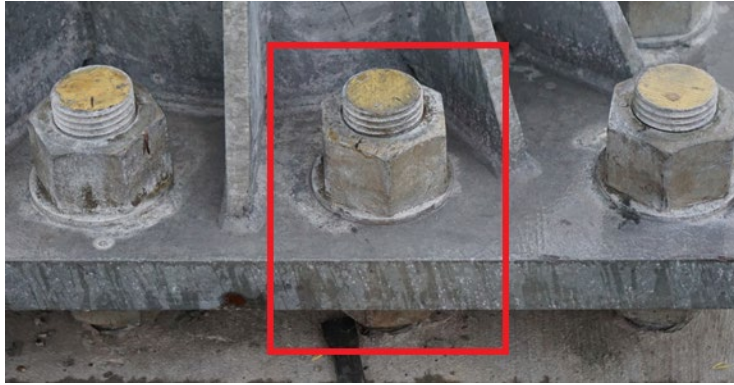
During July 2019, both of the OH sign structures observed in October of 2018 were inspected to ensure that no nuts had come loose with the new procedures. The full-span truss sign I-94-689 was found to have no loose nuts after checking both the top and leveling nuts. On the COSS OH 280-023, all of the nuts were tight, but, after inspection of the leveling nuts, it was found that nut 8 was slightly angled with the rod itself out of plumb (Figure 3.2.6), likely causing the issue.

Figure 3.2.6. Out-of-plumb anchor rod on COSS OH 280-023

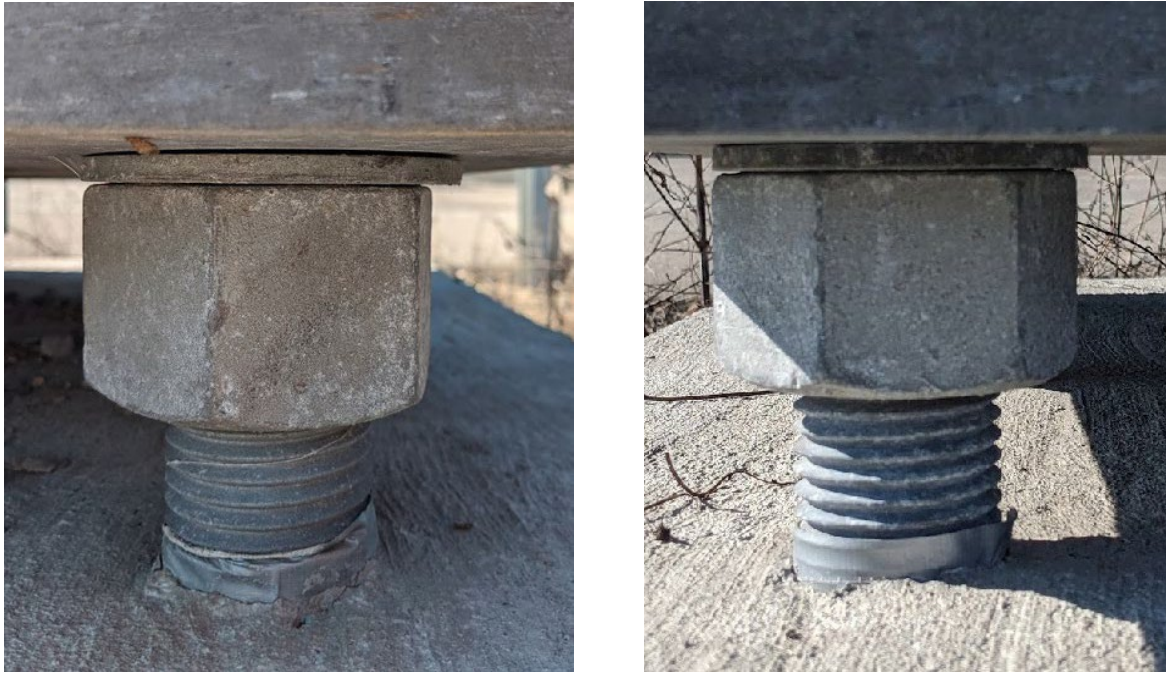
In October 2018, three additional overhead signs that were installed with the new procedures were inspected. While more signs were installed than inspected, these three were visited given accessibility. All three of the signs had sufficient pre-tension in the anchor rods, but rod #5 on OH I-35-318 was slightly out of plumb. In Figure 3.2.7 (left), the leveling washer of rod #5 appeared to have space between it and the baseplate when compared to Figure 3.2.7 (right), which is rod #8 on the same structure. Note that the space between the washer and the nut is due to the geometry of the nut.

Figure 3.2.7. Gap between baseplate and washer #5 out of plumb (left) and bolt #8 plumb for reference (right)

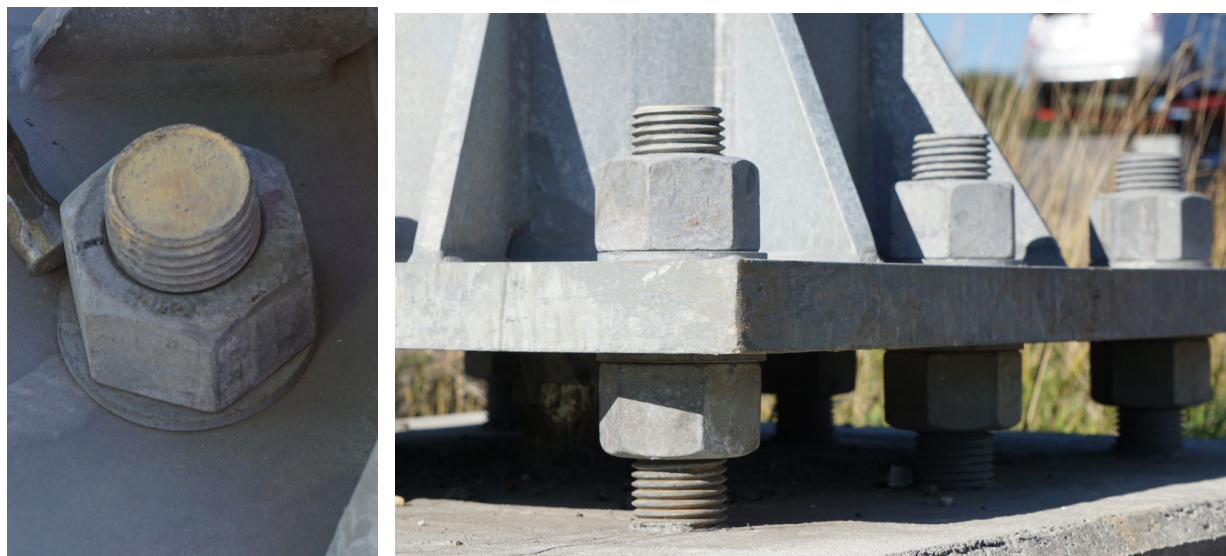
The rest of the installations completed without observation by the research team were in good condition. As an example of an ideal structure, OH I-94-688 was installed exactly to specification, even with the turn-of-nut marks still visible on the nuts (Figure 3.2.8).

Figure 3.2.8. Turn-of-nut marks on nut (left) and baseplate of OH I-94-688 (right)

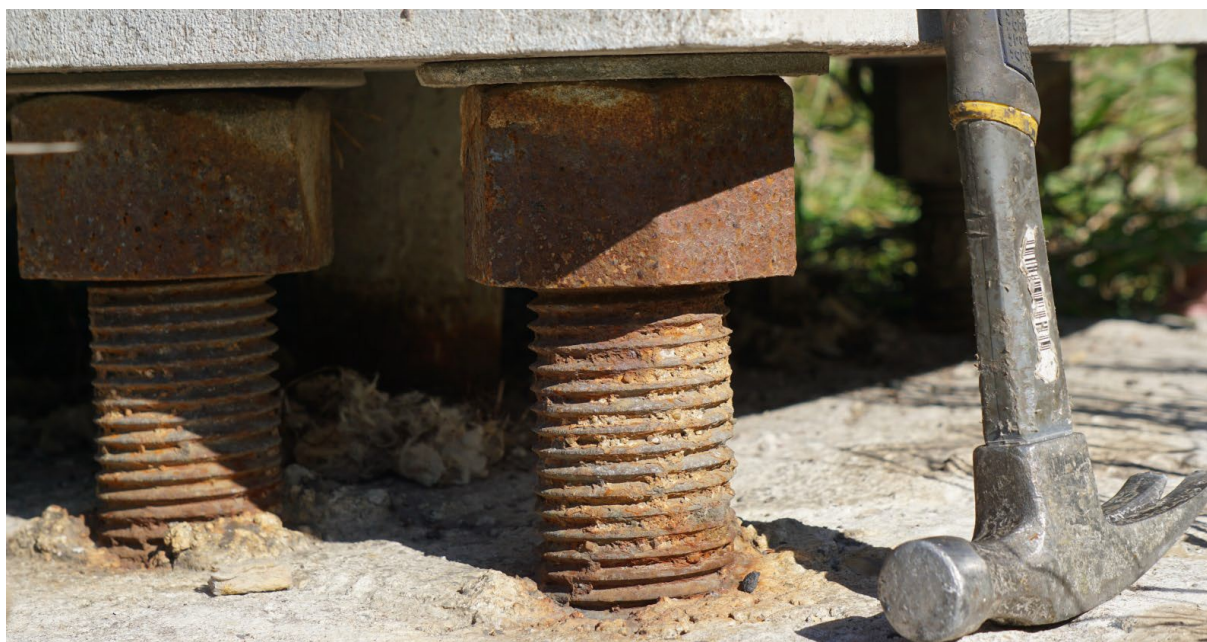
Conditions were also noted during inspections of the existing signs. For most, the installations were fairly new and in good condition. The I-494-153 sign truss structure was in slightly worse condition than the other observed structures and is an older design as indicated by the 8x2 rod layout pattern. Figure 3.2.9 shows the standoff distance issues that were found during inspection.

Figure 3.2.9. Large standoff distance on I-494-153 structure

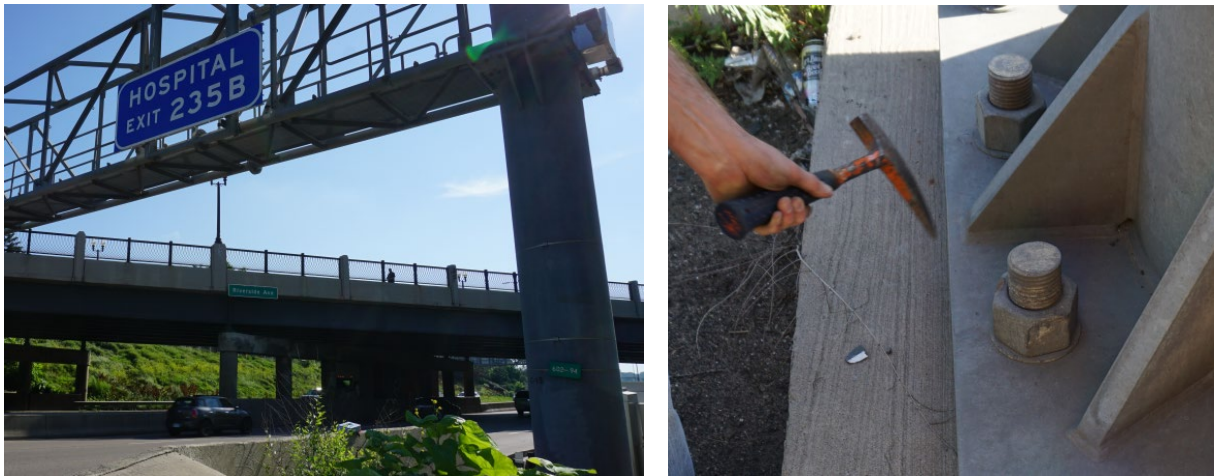
Inspection and maintenance for this structure took longer than the first, due to the new procedure being used. While striking the washers, concerns were voiced by MnDOT maintenance personnel about whether a washer was pushed up against the rod, so it would likely be beneficial to strike opposite sides of the washer when checking for looseness, as demonstrated in Figure 3.2.11 (right).

Figure 3.2.11. Full truss OH sign I-94-602 (left) and inspecting rod pre-tension force (right)

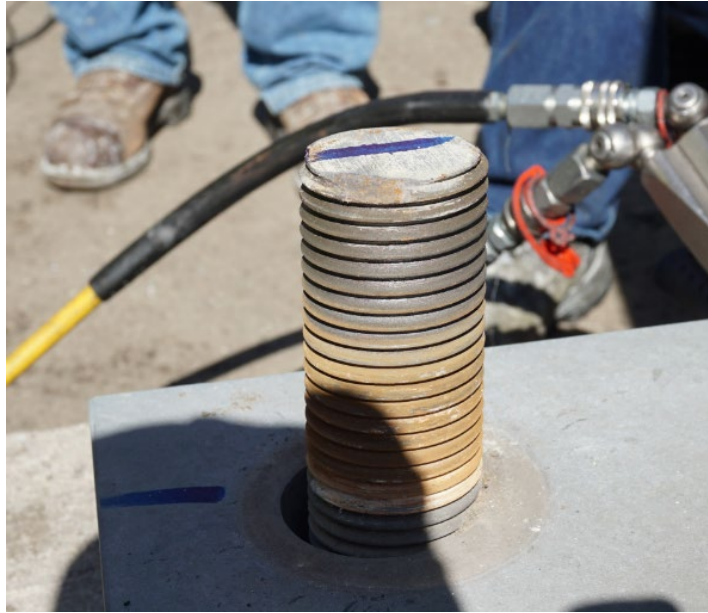
After inspection, nuts 1, 2, 3, 8, 9, and 10 were found to be loose, so the new procedure was used for retightening. While taking off the nuts, it was discovered that many were rusty or corroded on the interior of the threads. The condition of the threads was likely due to chlorides from deicing salt infiltrating through small gaps, but was somewhat unexpected considering that the threads are completely covered by the nuts and washers. Rod 10 was found to be out of plumb (Figure 3.2.12), which led to a much higher turn-of-nut value than expected that possibly did not develop the full tension in the rod.

Figure 3.2.12. Rod 10 out of plumb and misaligned

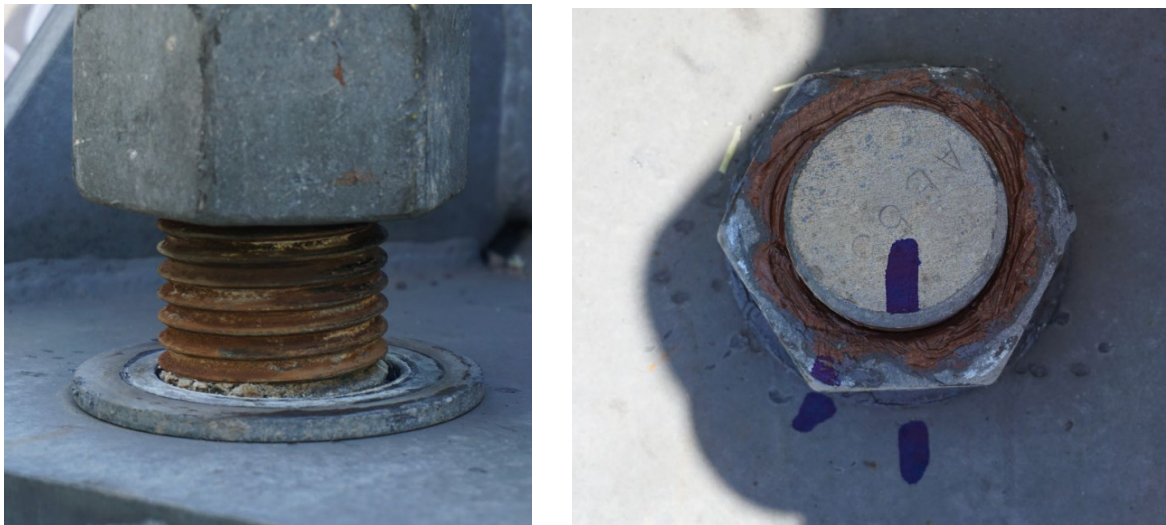
Only one rod, #3, was found to be loose, but the procedure was still followed to take all of the nuts off and lubricate to reset the installation. Much like the previous structure, rod threads were fairly corroded on the inside of the nut (Figure 3.2.13 left).

Figure 3.2.13. General condition of anchor rods (left) and sample turn-of-nut verification (right)

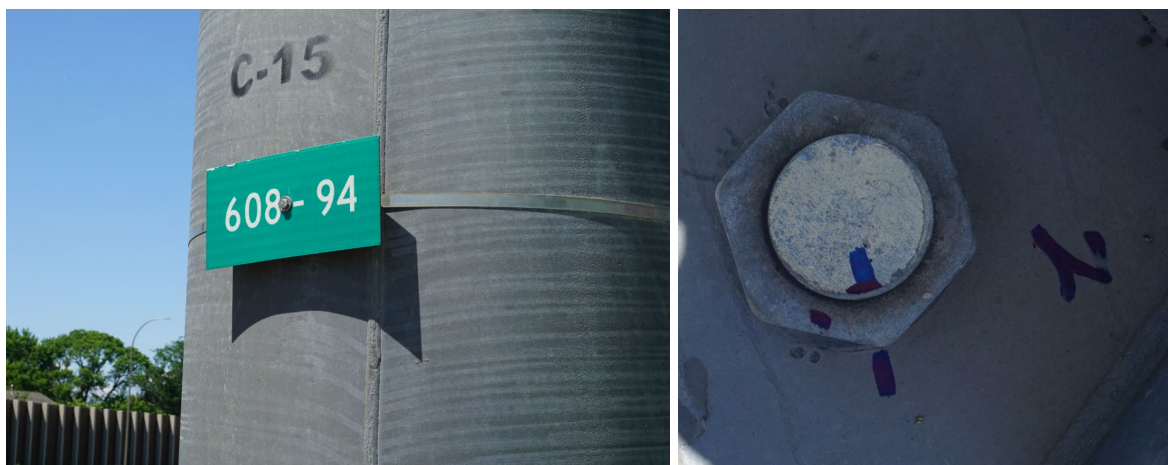
On this structure none of the washers moved when struck, so it served as another control variable where all of the nuts were brought to 110% T_v in a star pattern. In Figure 3.2.14 (left), the post has a tag marking the designation and a C-15 marking painted on.

Figure 3.2.14. I-94-608 Post (left) and 1/12 turn on nut #8 (#2 in star pattern) (right)

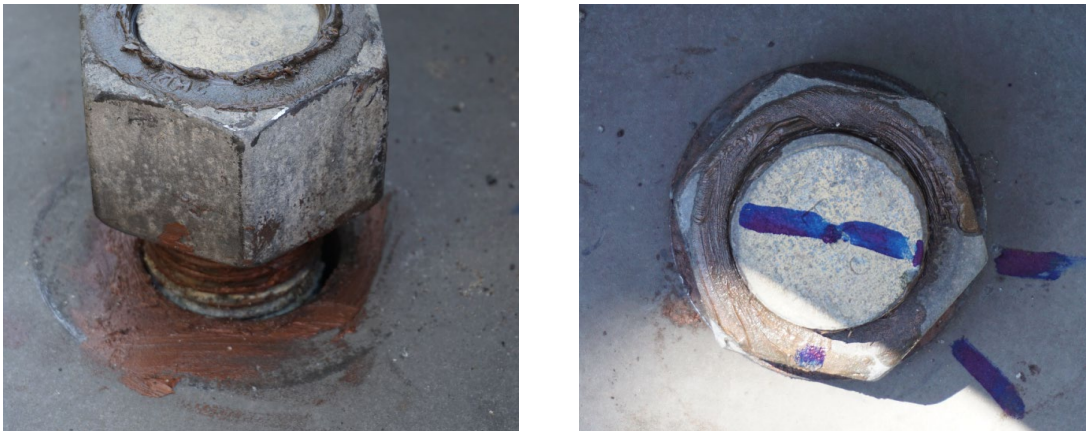
On this structure, nuts 7, 11, and 12 were found to be loose and rod 8 was missing a top washer (Figure 3.2.15 left).

Figure 3.2.15. Missing washer on rod 8 (left) and excessive turn of nut on rod 11 (right)

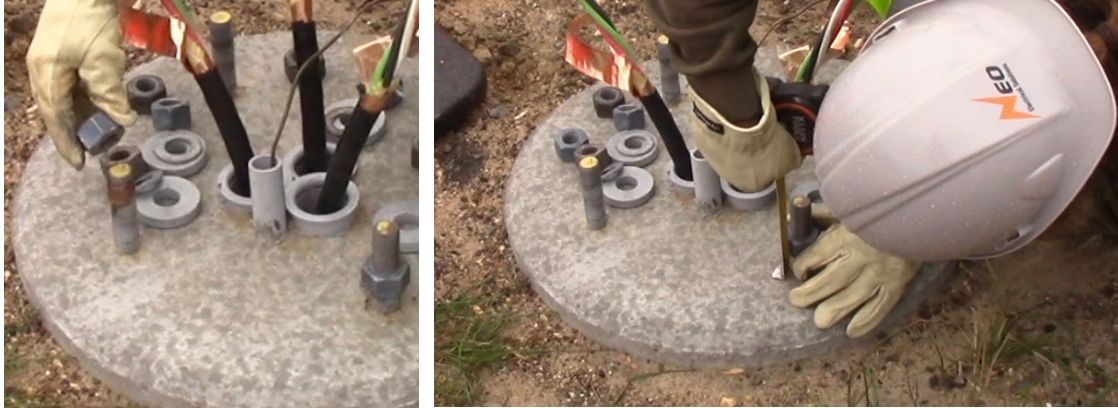
The contractor lubricated the bearing surfaces of the leveling nuts and washers and the threads of the anchor rods. As the leveling nuts were turned down onto the anchor rods, the inside threads of the nuts were also lubricated, as shown in Figure 3.3.1 (left).

Figure 3.3.1. Placing leveling nuts (left) and verifying standoff distance (right)

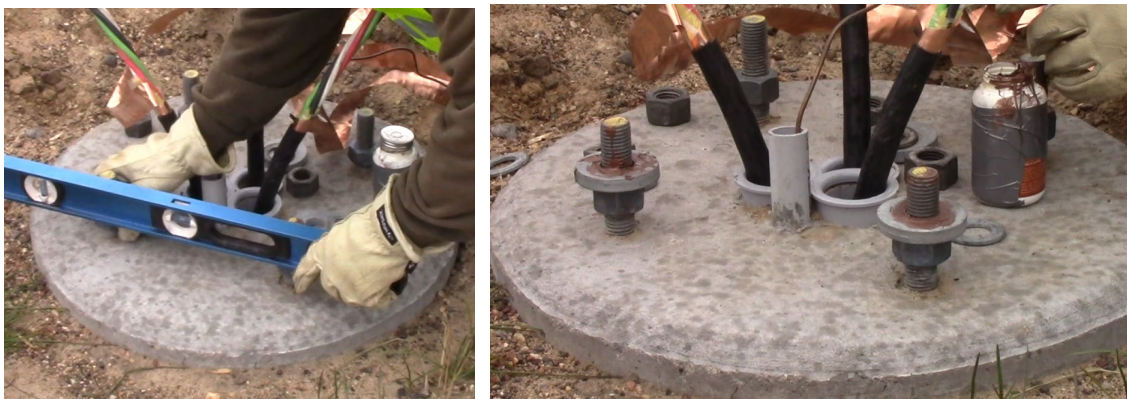
The contractor used a level to level the leveling nuts (Figure 3.3.2 left).

Figure 3.3.2. Leveling process (left) and improper lubrication of leveling nuts (right)

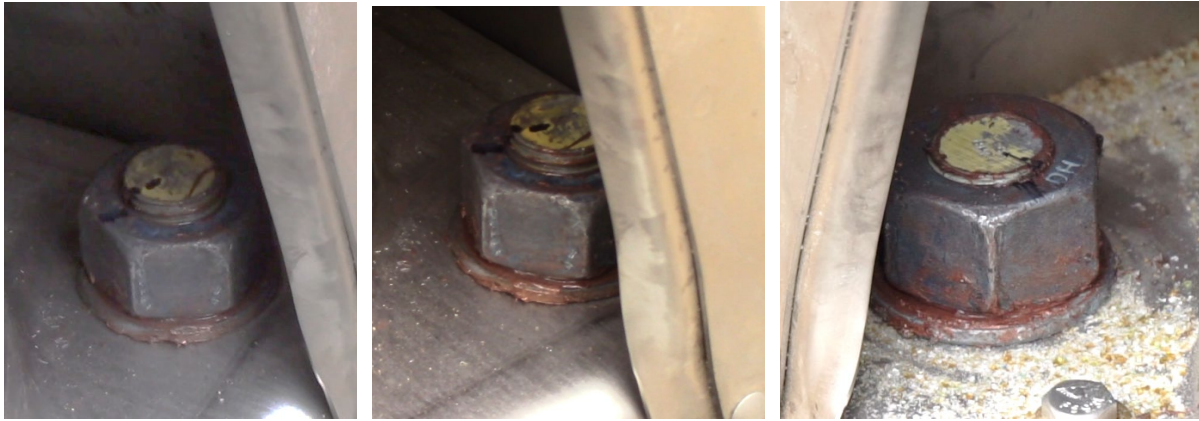
Figure 3.3.4 (left to right) shows examples of one nut before, at a second step, and after the contractor completed turn-of-nut pre-tensioning, respectively.

Figure 3.3.4. Nut turns at initial, second step, and final values (left to right)

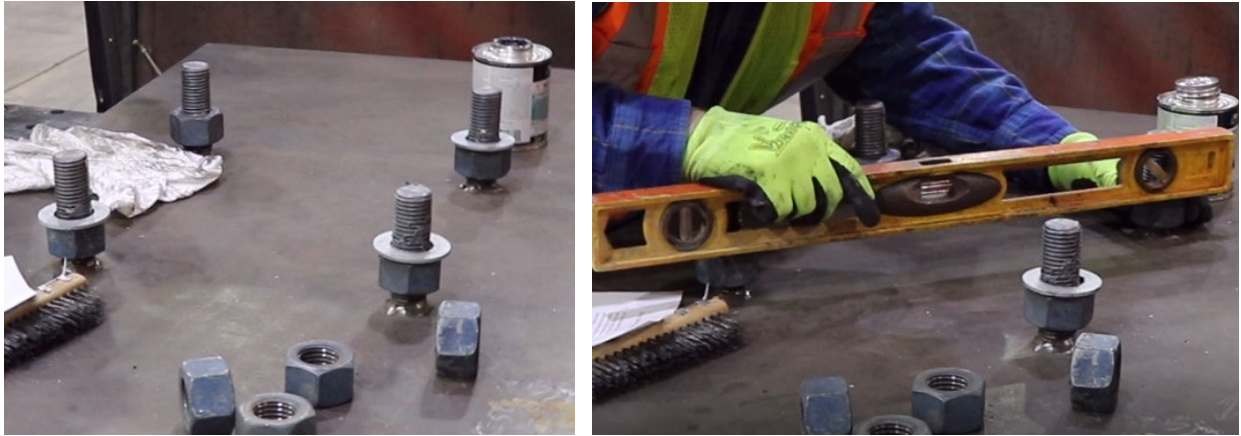
The Grade 55 anchor rods were welded onto a steel plate for demonstration purposes. The initial installation was done correctly, without lubrication on the top of the leveling nut washers, as shown in Figure 3.3.6 (left).

Figure 3.3.6. Correctly installed leveling nuts and washers (left) and leveling installation (right)

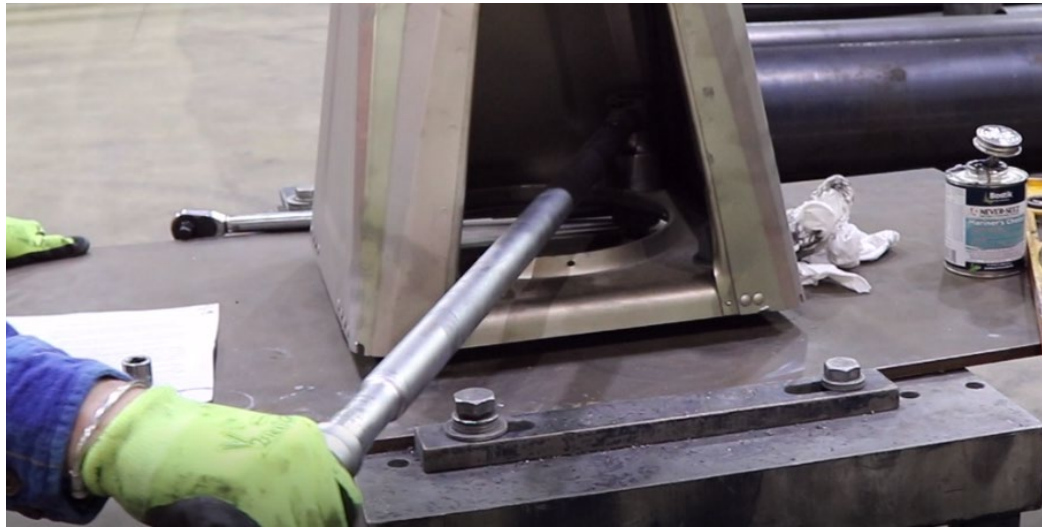
Finally, the anchor rods were immediately stressed to the full 400 ft-lbs in one step with a calibrated torque wrench (Figure 3.3.8).

Figure 3.3.8. Final verification torque on the structure installation

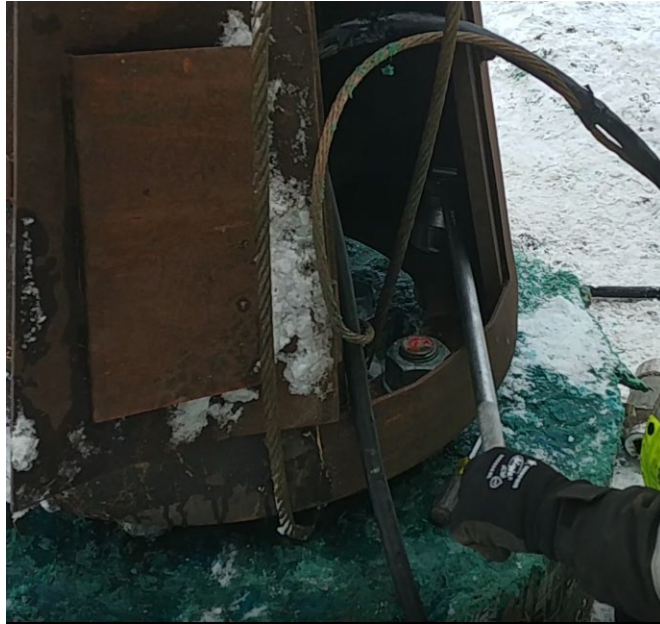
Figure 3.3.10. Manual wrench installation tightening of HMLT anchor rods

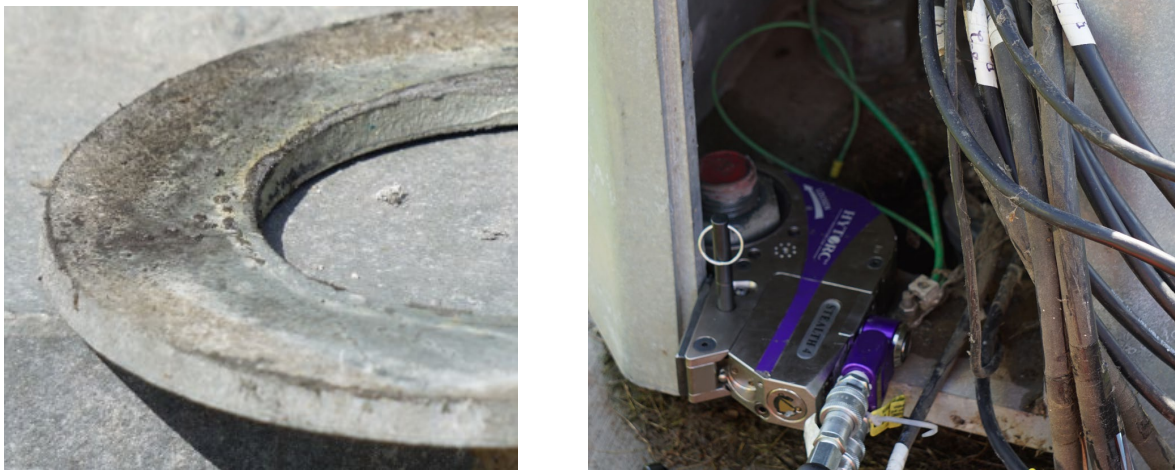
Figure 3.3.13. Galvanizing dimples on washer (left) and moved grounding wire (right)

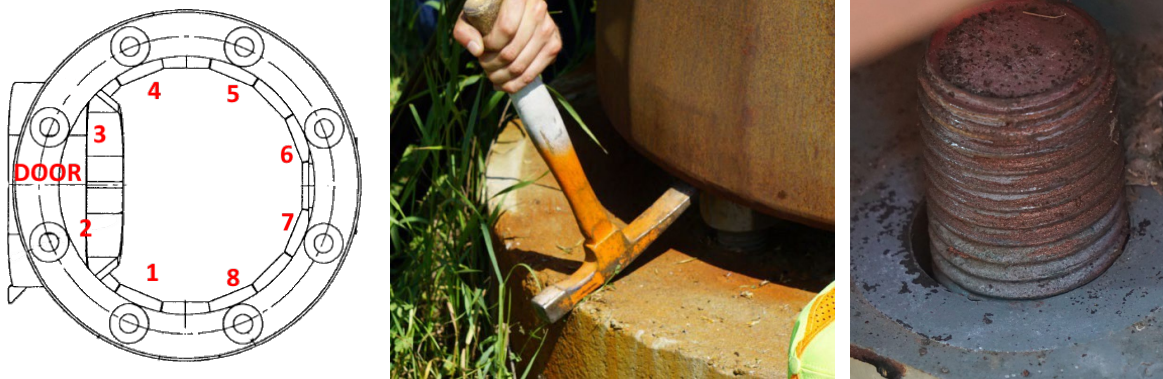
Figure 3.3.16. Rod numbering (left), checking washers for looseness (center), and prior copper anti seize lubrication on rod (right)

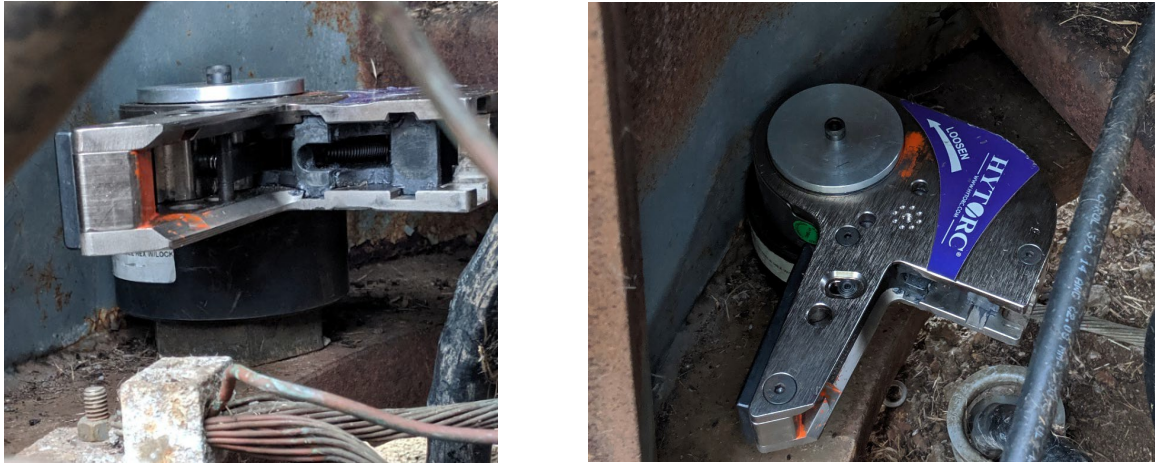
Figure 3.3.17. HYTORC Stealth 4 hydraulic wrench with stack socket

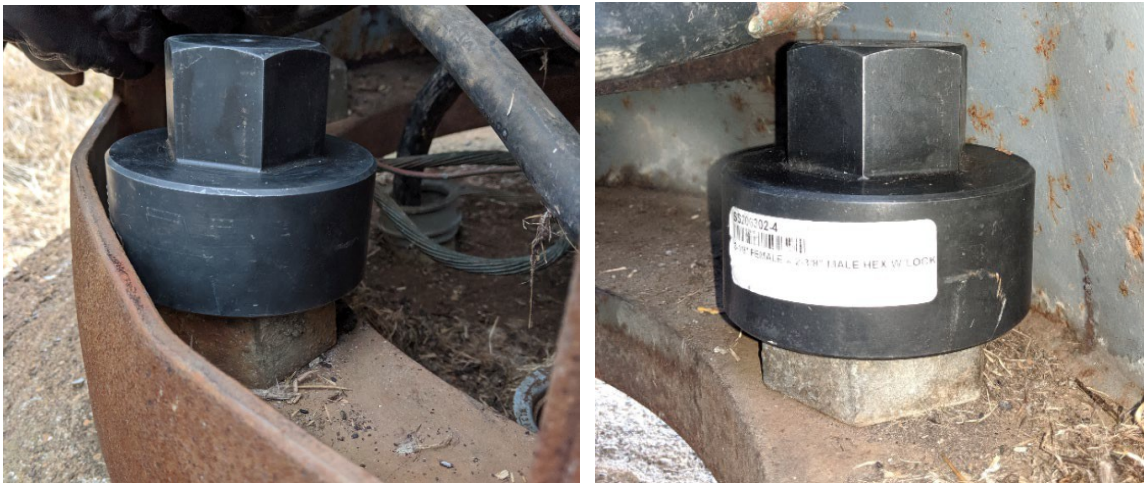
Figure 3.3.18. Wedging on door frame (left) and socket raised into wall by nut protrusion (right)

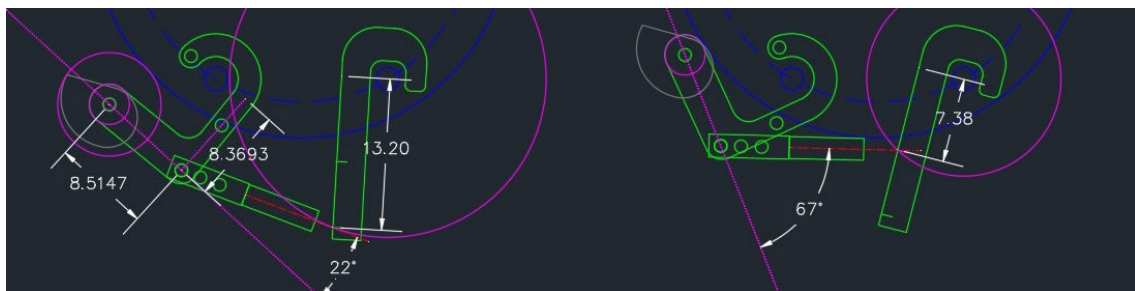
Figure 3.3.23. CADD model of Millerbernd wrench geometry and operations

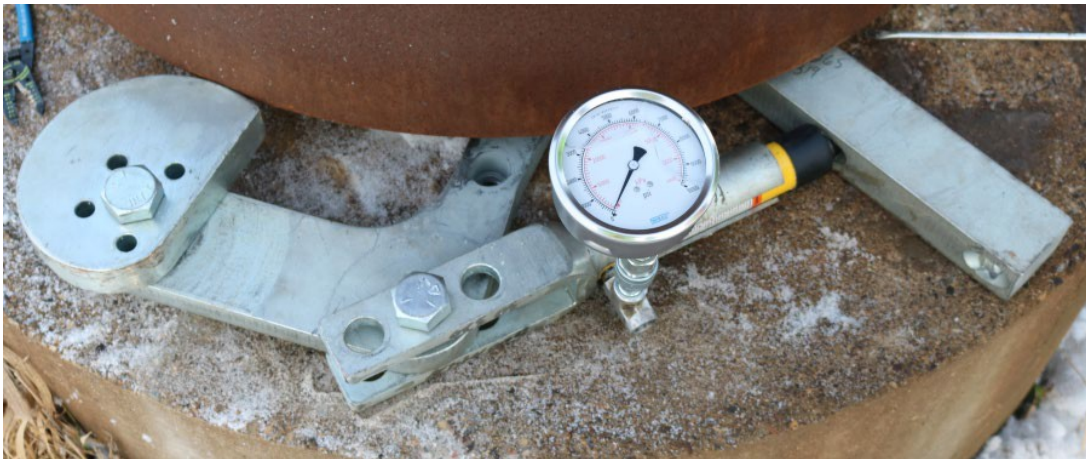
Figure 3.3.24. Millerbernd wrench operation at closest setting

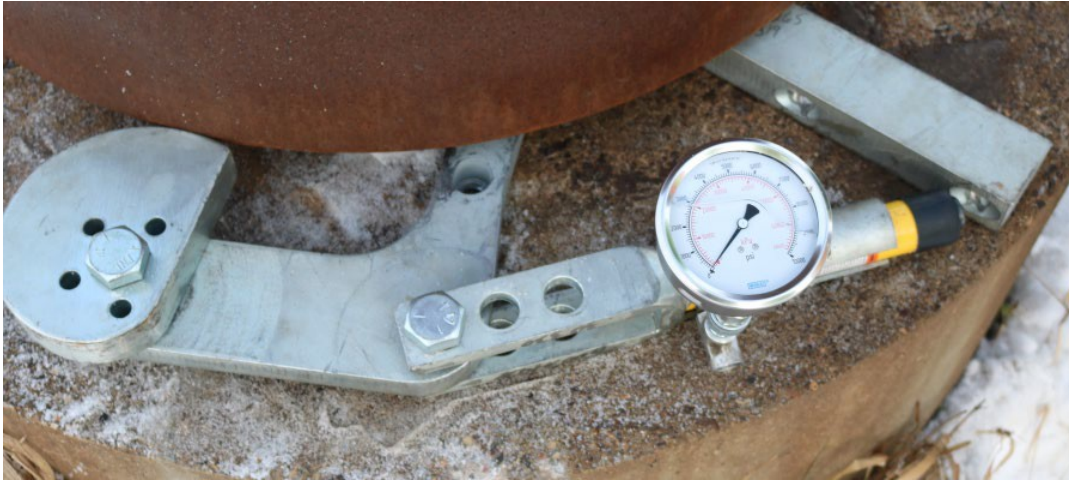
Figure 3.3.25. Millerbernd wrench operation at farthest setting

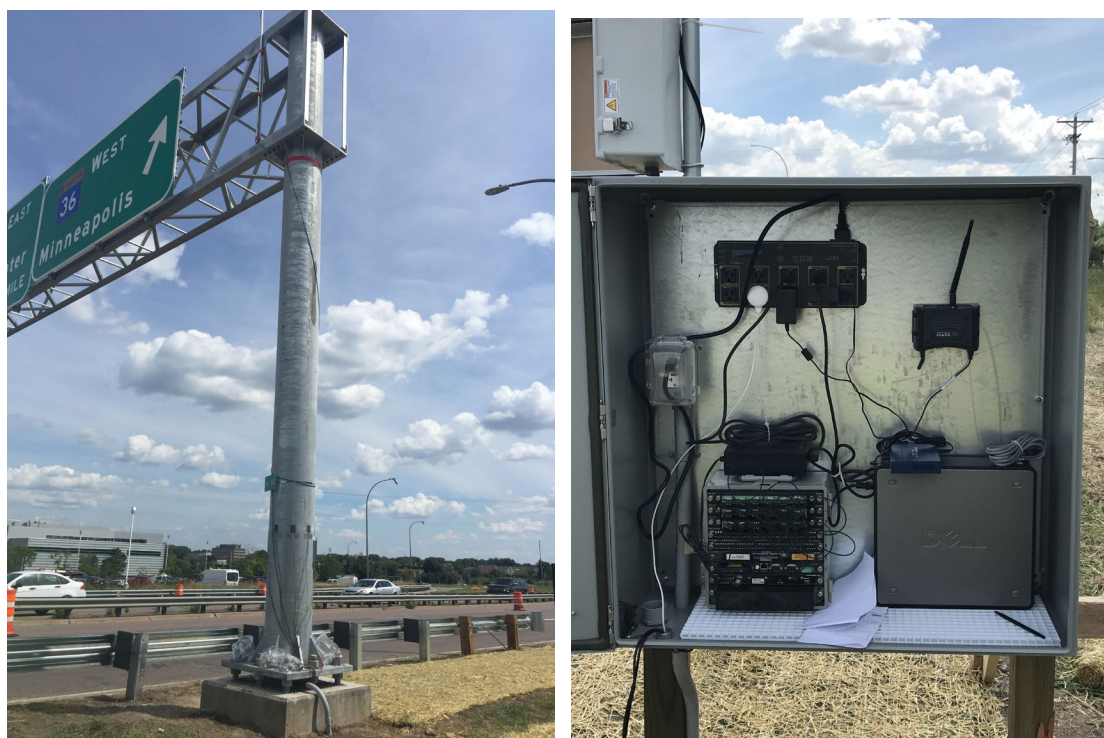
Figure 4.1.1 Instrumented sign post (left) and data logger cabinet (right)

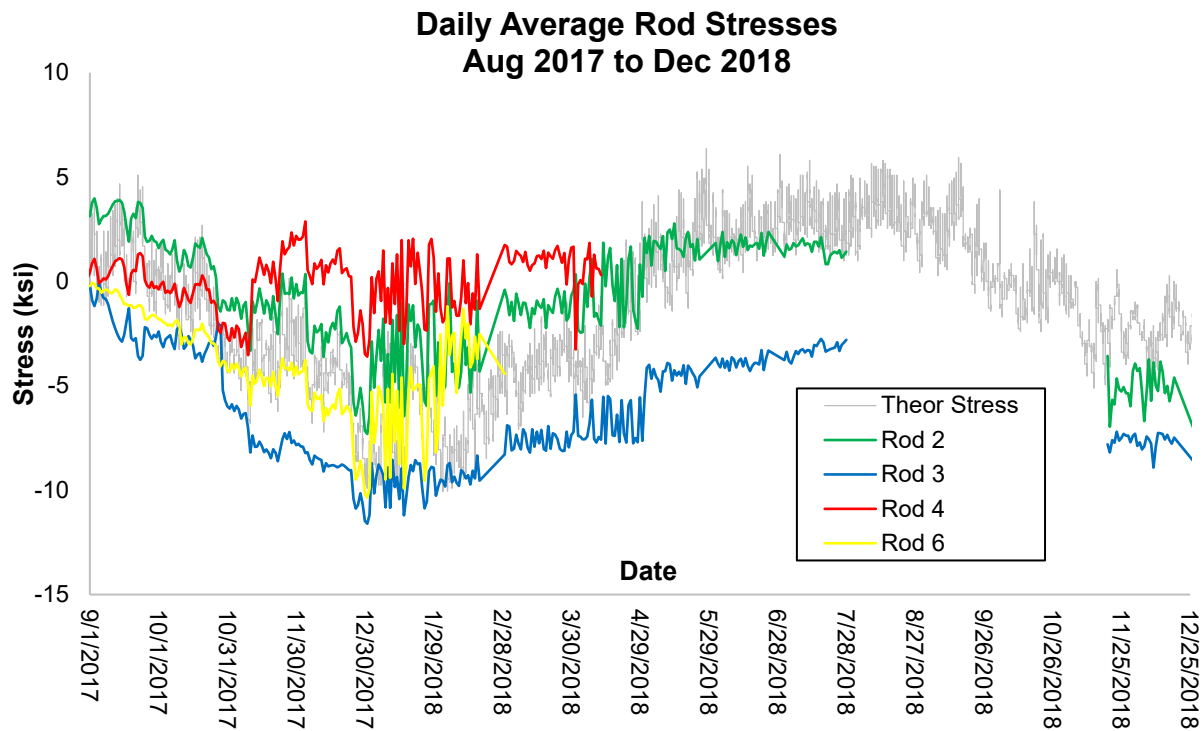
Figure 4.2.1. Long-term anchor rod stresses 8/2017–12/2018

For clarity, data are not included when anchor rod gauges failed. Another observation from the long-term rod stresses is that there is increased scatter in winter months and many gauges were observed to fail during this time period. It is hypothesized that the scatter is likely from snow and ice accumulating on the anchor rod gauges in addition to snow impacting gauges when a plow passed the installation. Enforcing this theory is the fact that all of the north facing gauges, which coincided with rods 5 and 6, failed first during the winter of 2017–18. The north facing part of the pole received the greatest snow impact from snowplows and likely resulted in premature failure of the rod-mounted gauges. Finally, the rod strain data does appear to drift away from the theoretical data. While this behavior could be due to relaxation or pre-tension loss, it is also likely that the resistance gauges are drifting over a long period of time and needs to be tested further in a laboratory environment to confirm any long-term loosening impacts.

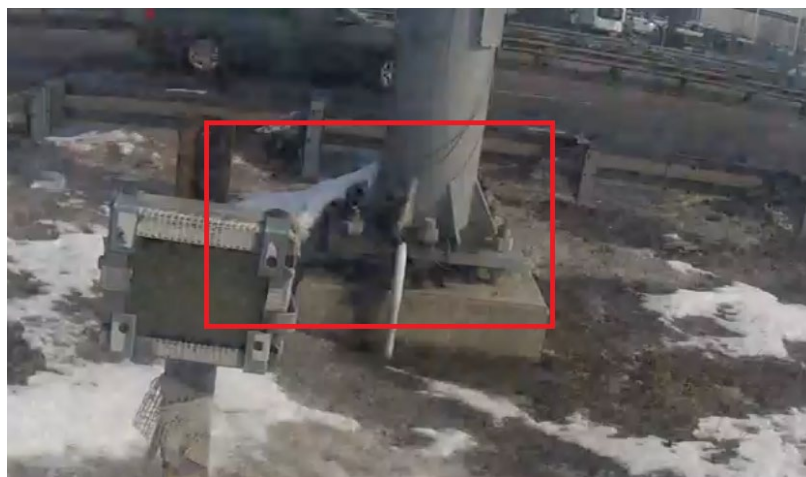
Figure 4.2.5. Snow and ice piled on anchor rod gauges

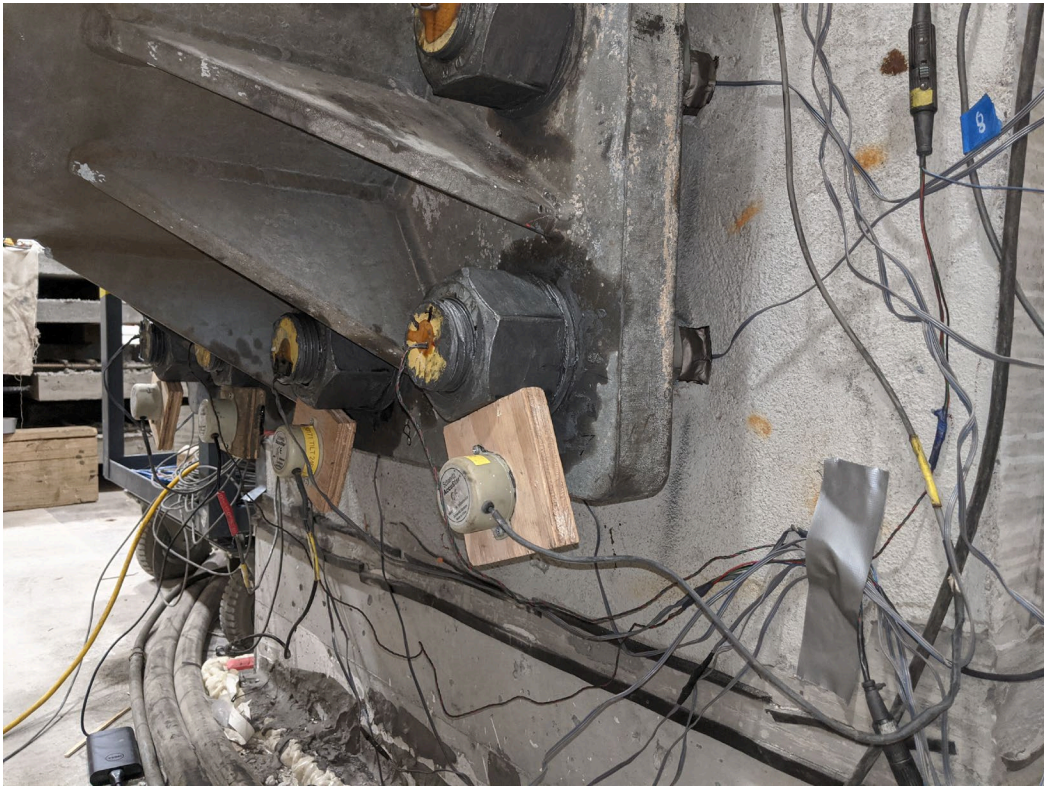
Figure 5.1.3: Lower Post Instrumentation

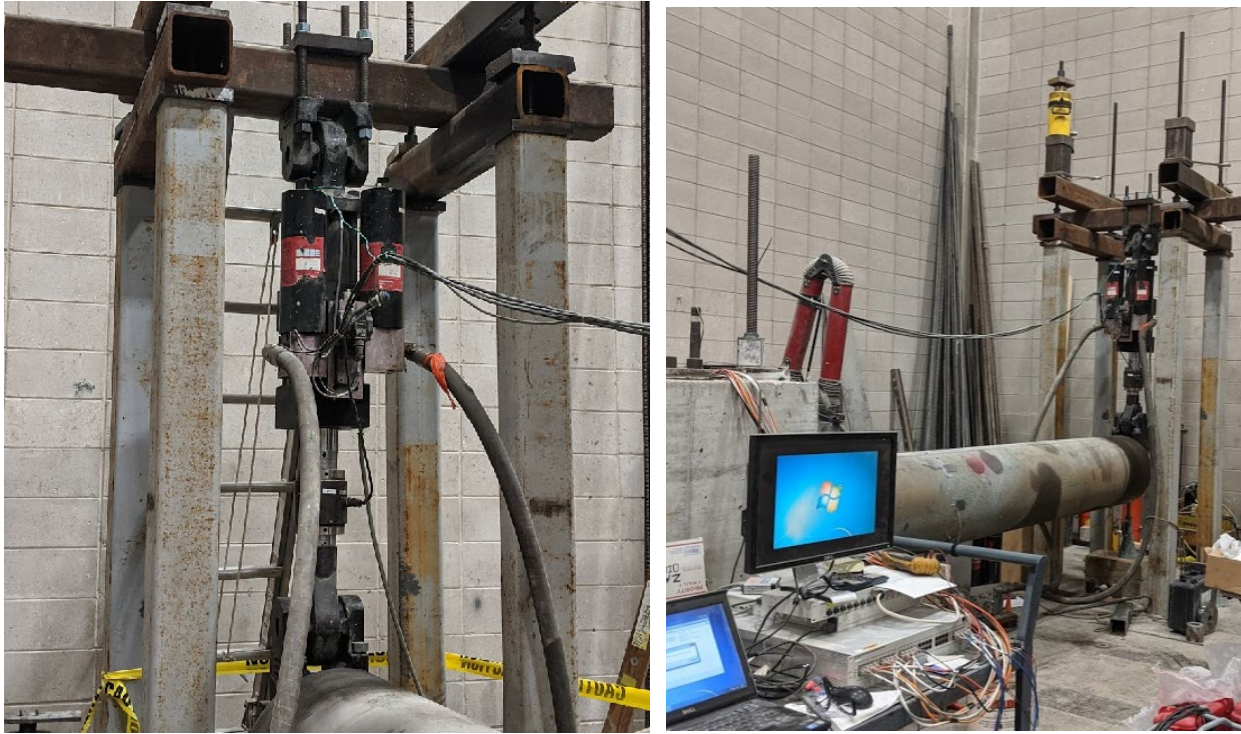
Figure 5.1.5: (Left) MTS Hydraulic Actuator and (Right) Data Acquisition System and Loading Frame

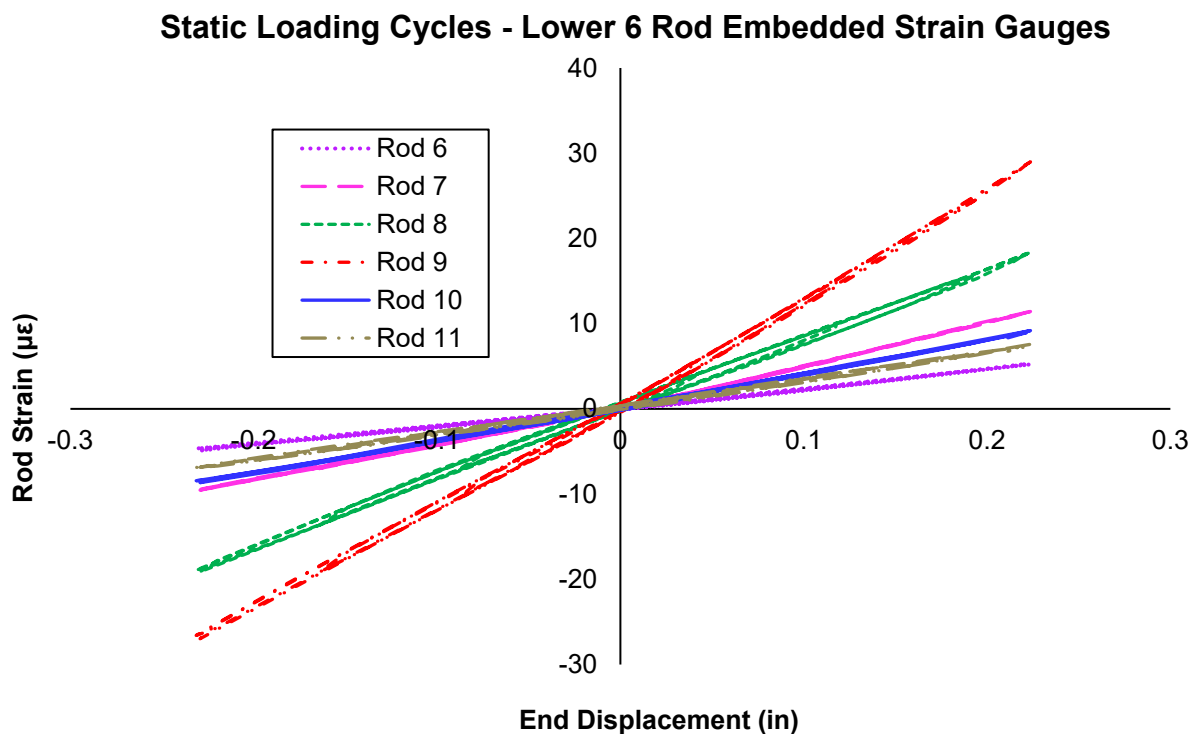
Figure 5.1.6: Anchor Rod Response to Static Loading

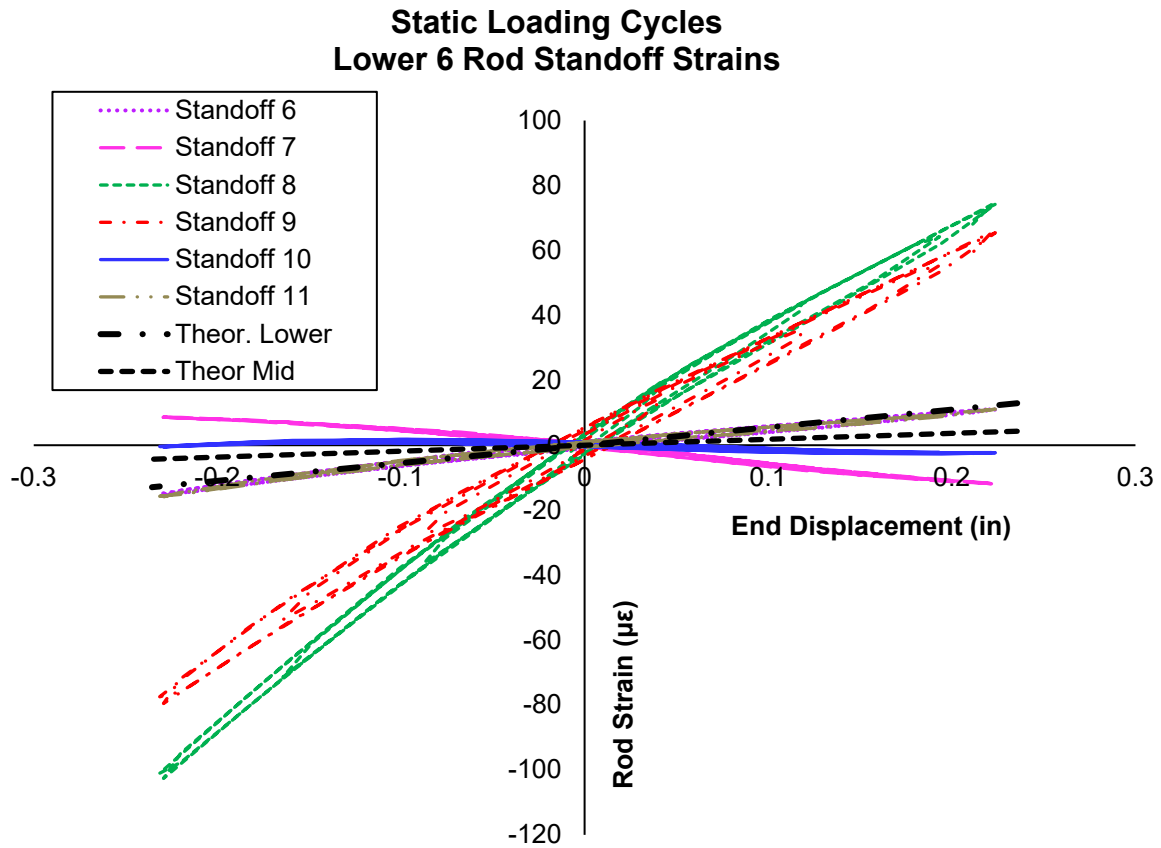
Figure 5.1.7: Standoff Strains Response from Static Loading
