Improving predictions of instantaneous camber for prestressed concrete bridge girders

A thesis submitted to the graduate faculty

Major: Civil Engineering (Structural Engineering)

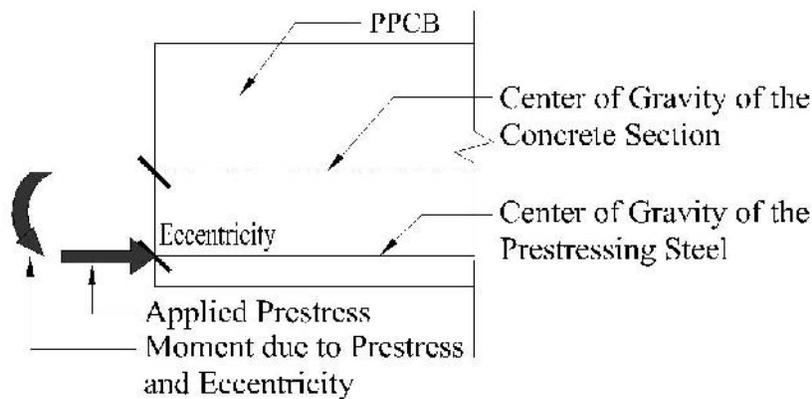
Figure 1-1: Elevation View of a PPCB with Prestressing Applied with an Eccentricity

Stresses induced in PPCBs can reduce problems associated with deflection requirements at the service limit state. When an eccentric prestress force is applied, an end moment can cause an upward displacement at midspan called camber. The camber produced allows the PPCB to stay within the deflection limitations that may be present due to live and dead loads including self-weight.

Eccentric prestressing steel about the center of gravity of the section produces a bending moment that can cause a girder to deflect upward (Figure 1-1). The upward deflection is dependent on the reinforcing strand placement and the amount of initial prestressing force that is applied. The self-weight deflection will cause a downward deflection in the girder. The self-weight deflection is dependent on the length of the member along with the geometry and material properties. Subtracting the self-weight deflection of the member from the upward deflection results in camber if the final value is positive.

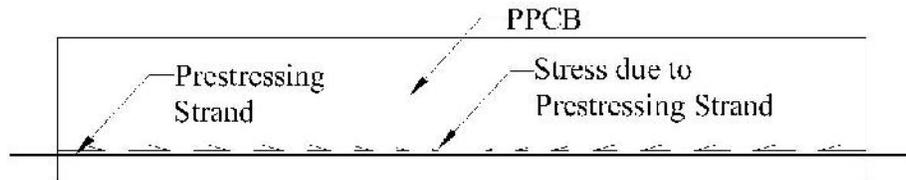
Figure 1-3: Stresses from Prestressing Strands shown along the Length of a PPCB

An additional benefit of prestressed concrete is reducing the ability for the cross section to crack. Prestressed reinforcement will exert an axial force on a PPCB which will provide compressive stresses throughout the length of the member. The compressive stresses resulting from the prestressed reinforcement will allow the section to remain uncracked. Reducing or eliminating the cracks due to prestressing will increase the service life of a structure by eliminating spaces for contaminants to penetrate the surface and corrode reinforcement.

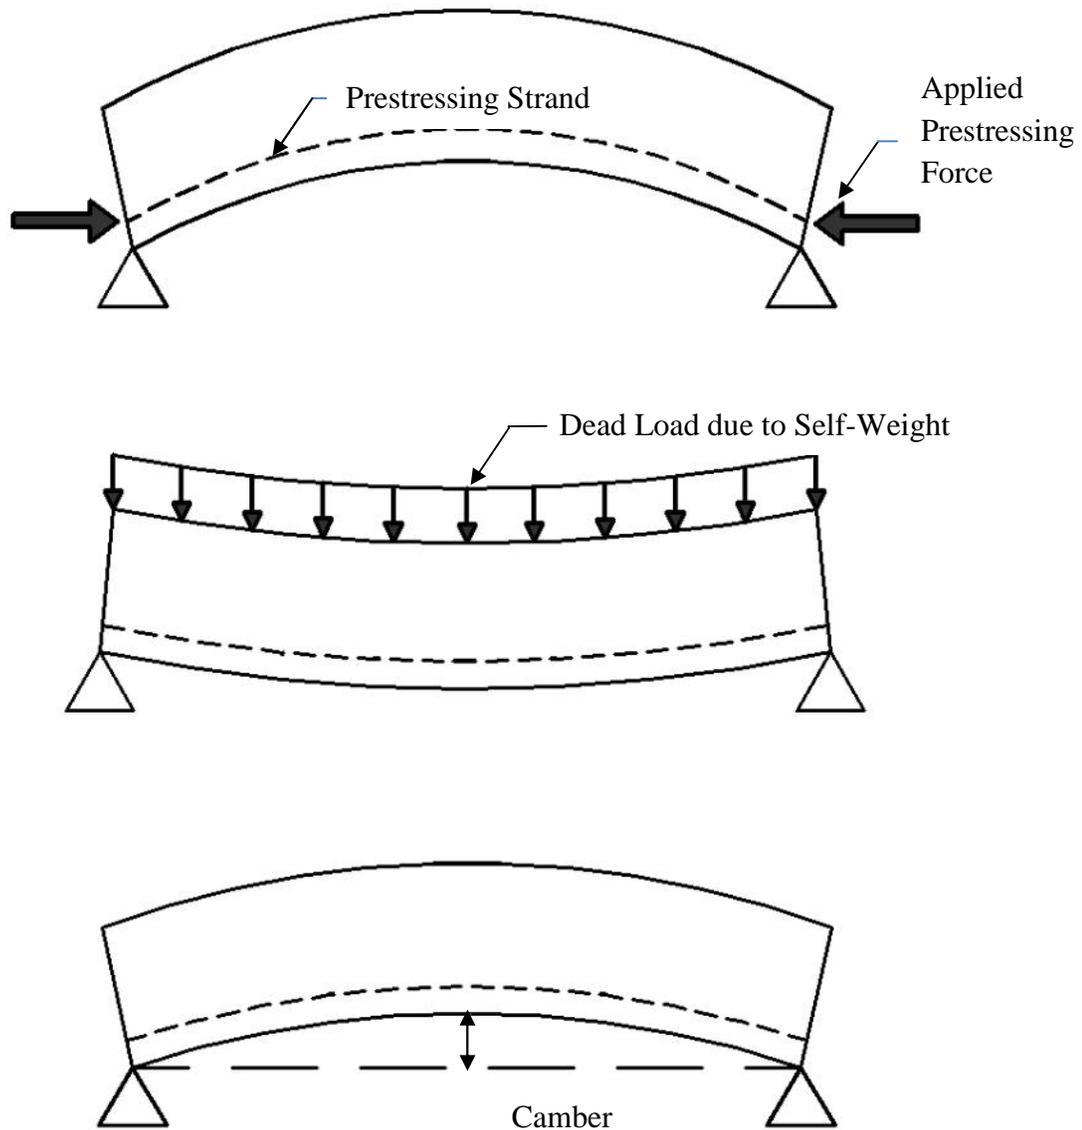
Figure 1-5: Camber Resulting from the Net Deflection between the Upward Deflection caused by Prestressing and Downward Deflection caused by the Beam Self-Weight

Camber is the net deflection caused by the upward deflection due to the applied prestress force and downward deflection due to the self-weight of a PPCB (Equation 1-1), which typically occurs from the time the prestress is transferred to PPCBs.

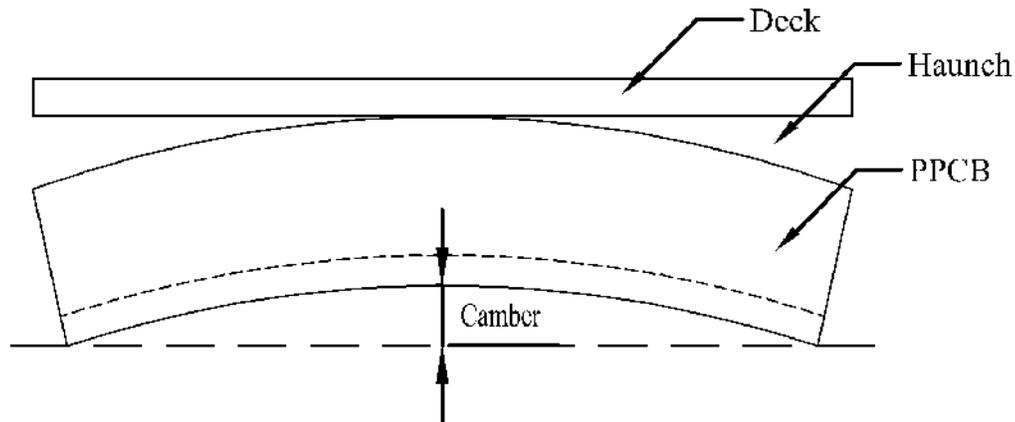
Figure 1-6: Schematic View of a PPCB Showing the Formation of the Haunch

The majority of the problems associated with inaccurate camber relates to placing the bridge deck at the jobsite. A minimum deck thickness requirement needs to be fulfilled throughout the entire length of the bridge. Different elevations that are inconsistent along the length of the girder are typically present due to camber in the girders. For example, the elevation of a prestressed girder at the midspan is typically higher than the elevation at the ends of the girders (i.e. Figure 1-6). Due to the effect of different elevations along the length of the girders, haunches are required to be built. A haunch is defined by the Subcommittee on Transportation Communications (2005) as the space between the bottom of the slab and the top of the top flanges of the beams (i.e. Figure 1-6). The purpose of a haunch is to maintain a uniform deck thickness along the length of the girders and to meet the desired bridge profile. It should be recognized that haunches vary over the length of the girder in order to account for the change in elevation over the length of the beam. Adding and adjusting haunches has been proven to be labor intensive, can add construction delays, and will increase the dead load without the addition of strength. The effects of adding and adjusting haunches can increase the cost through added labor that is unaccounted for, the possibility of liquidated damages if the project runs over the allotted time that was budgeted, and can result in serviceability issues due to the larger dead load from additional concrete that was originally unaccounted.

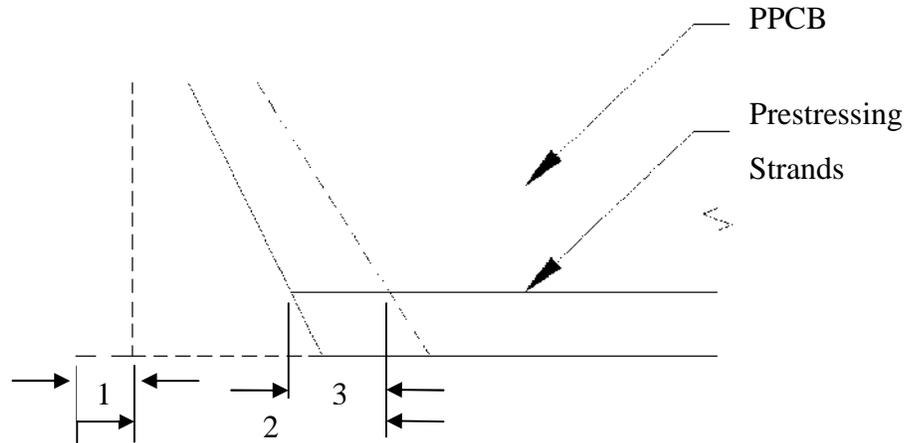
- where
- 1 = Girder shortening due to applied prestress force.
 - 2 = Girder shortening due to the application of prestress at the centroid of the prestressing strands.
 - 3 = Increase in girder length due to self-weight.

When prestress is transferred to a PPCB, the prestressing strands exert a prestress force that acts along the length of the beam. This force will cause the beam to shorten from its original length by a small amount. Due to the bonding between the prestressing strands and the concrete, the prestressing strands shorten as well. As a result, there is a reduction of the amount of initial prestress strain in each strand and thus the overall prestress force of the beam is reduced. Conversely, if a beam cambers upward, the self-weight of the beam causes an increase in the strain of the prestressing strands that are located below the neutral axis. The sum of the three components is referred to as elastic shortening and is further discussed in Chapter 4.3.3.

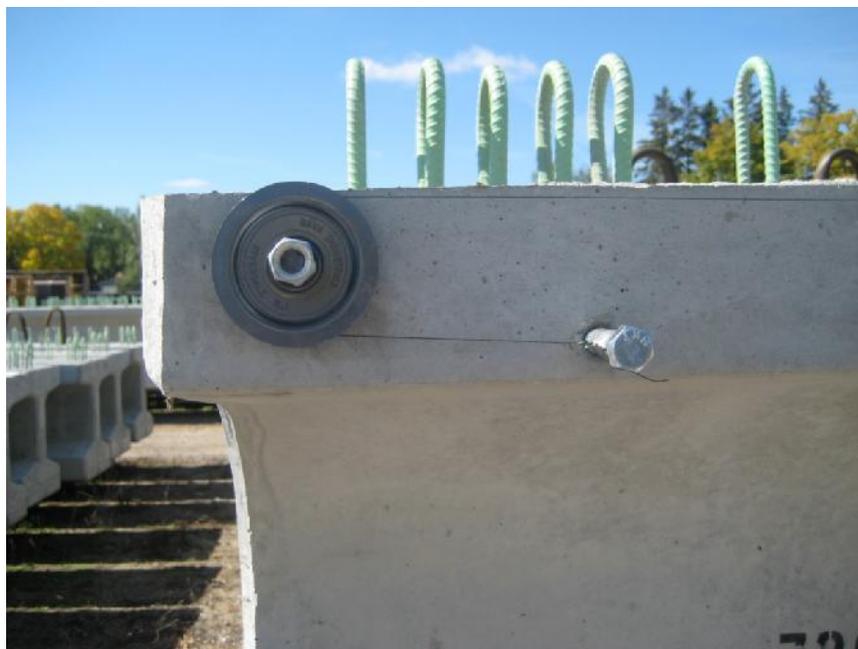
Figure 2-3: Anchored End with a Pulley of Wire Used for the Stretched-Wire System (O’neill et al. 2012)

Anchoring the string at each end of the girder was done multiple ways. The most common way to attach the string to the girder end is by an anchor bolt that is attached to the beam. Anchor bolts can be embedded or drilled into the concrete surface. Figure 2-3 shows the string being connected to the end of a beam using an anchor bolt. In Figure 2-3, the pulley that is shown was also used to position the string at the correct height at the anchored end. Another alternative to using anchor bolts to connect the string to the ends of the beam is embedding pieces of rebar. Rizkalla et al. (2011) attached the string to the end of the beam by embedding a piece of rebar on each end with a notched surface (Figure 2-1). The notched surface was a specified distance above the end of the top flange to ensure that end elevations will be equal. If unequal end elevations were present, the measured camber would not represent the camber accurately.

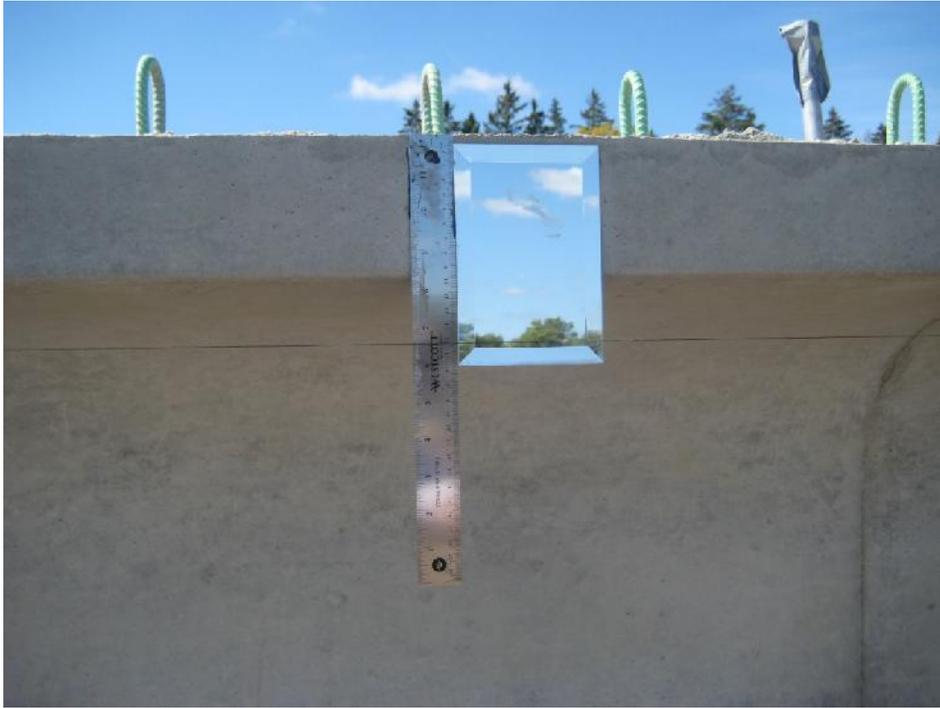
Figure 2-4: Ruler and Mirror Located at Midspan (O'Neill et al. 2012)

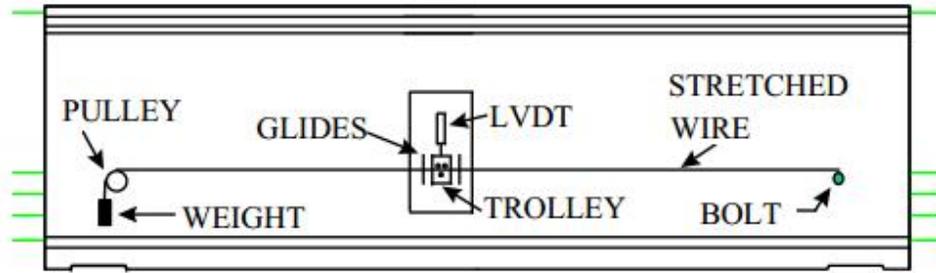
Figure 2-6: Stretched Wire System with a Weighted Trolley at Midspan (Barr et al. 2000)

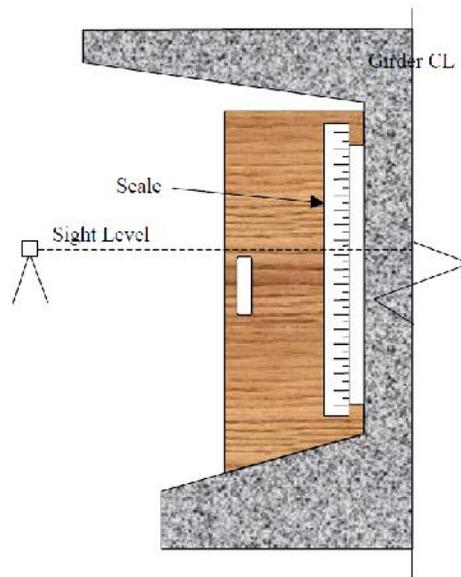
Figure 2-7: Camber Measuring Template (Rosa et al. 2007)

The location of the camber measurement when taken with survey equipment has been observed to differ with past studies. Rosa et al. (2007) took camber measurements from the web of the beam using a wooden template to reduce errors. A template was made and fitted to the web with a ruler attached (Figure 2-7). Survey readings of the ruler were able to be taken at the ends and at the midspan of the girder to determine camber. The discrepancy between the web and the bottom flange of the girder due to inconsistencies in the beam depth were observed to be within the range of ± 0.25 inches which resulted in a 7.1 percent difference. Measuring camber from the bottom flange using a laser level was conducted by Hinkle (2006). A template was made that fit on the top of the bottom flange (Figure 2-8). This ensured that the measurement consistently occurred from the same location on the bottom flange. Similarly, Woolf et al. (1998) measured camber using a grade rod that was fabricated to have a 90 degree angle that extended below the bottom flange to obtain the camber.

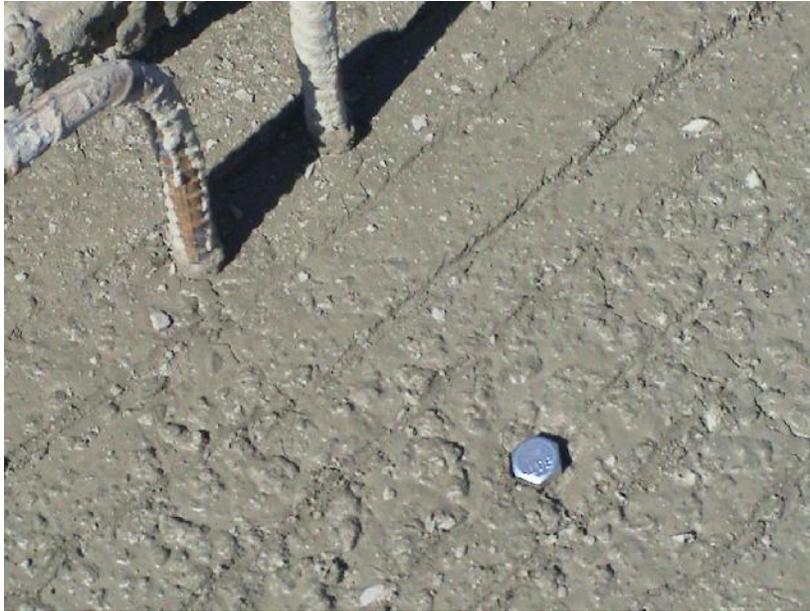
Figure 2-9: Camber Measurement Marker (Johnson et al. 2012)

Measurements from the top flange were also taken by Johnson et al. (2012). In this study, bolts were embedded into the surface so that elevation measurements were taken from the same location at various times throughout the girders life (Figure 2-9).

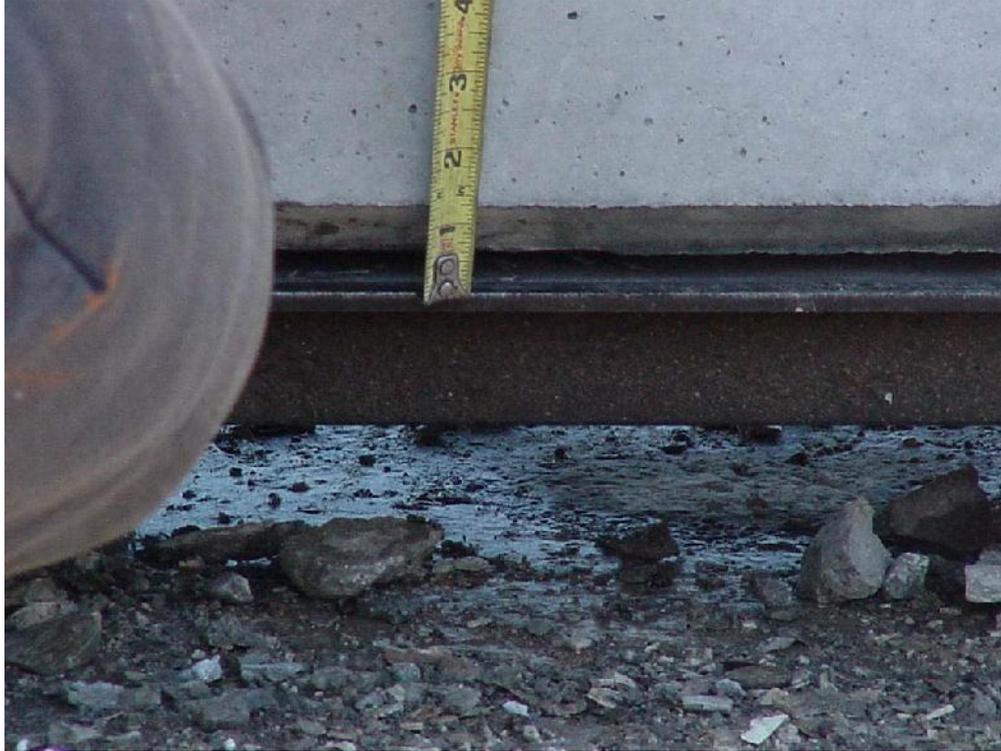
Figure 2-10: Camber Measurement with a Tape Measure at Midspan of a PPCB (Iowa DOT Prestress Inspection, 2013)

Using a tape measure to determine camber is one of the simplest ways to measure camber. Precasters typically measure the camber of the girders while they rest on the precasting bed or while they are suspended by a travel crane. In this method, instantaneous camber measurements are taken by reading the midspan elevation relative to the precasting bed with a tape measure (Figure 2-10).

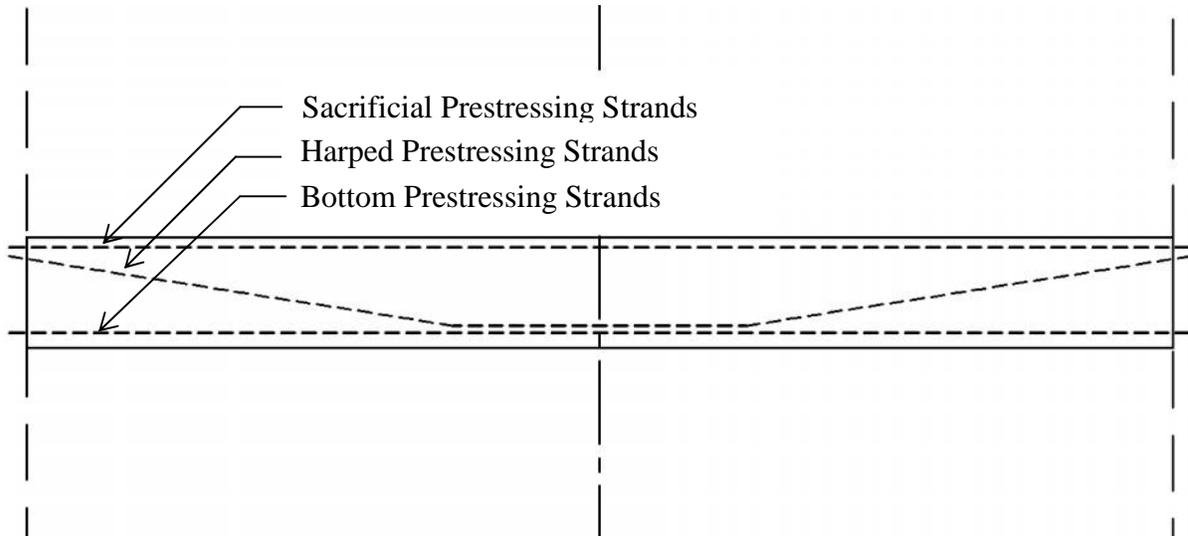
Figure 2-11: PPCB with Sacrificial, Harped, and Bottom Prestressing Strands

provide the moment diagram at a specific location of the beam (Figure 1-1). Since the profile of prestressing strands is usually composed of straight bottom strands, sacrificial top strands, and harped layouts, the moment for each set of strands is determined independently. Taking the sum of the moments caused by the straight bottom strands, sacrificial top strands, and harped strands will give the total moment due to prestressing at certain locations of the beam.

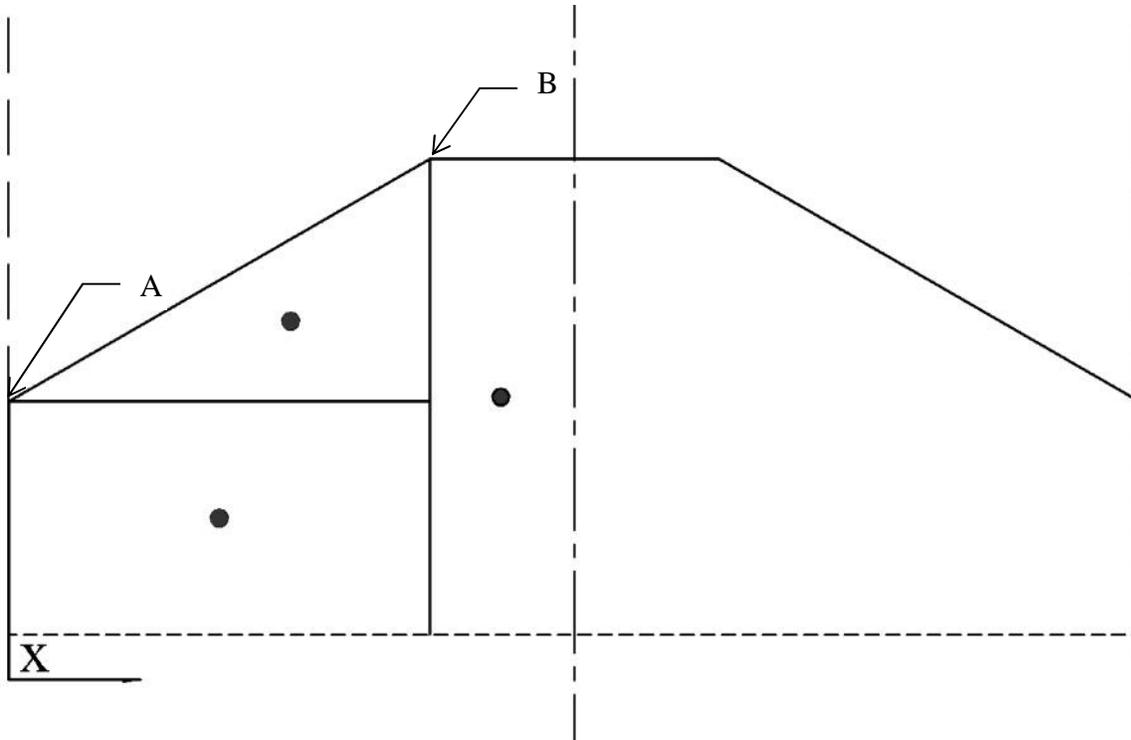
Figure 2-12: Moment Diagram due to Sacrificial, Harped, and Bottom Prestressing Strands

Once the moment diagram is established, it is integrated. This integrated area is multiplied by the distance from the end of the beam to the centroid of the section of interest. In order to simplify calculations, various sections of the moment diagram can be broken into different areas as seen in Figure 2-12. Taking the product of the area and distance to the centroid of the section on the moment diagram will give the moment (M) of the beam. Dividing the moment (M) by the product of the modulus of elasticity (E) and the moment of inertia (I) will give the upward deflection due to the prestressing.

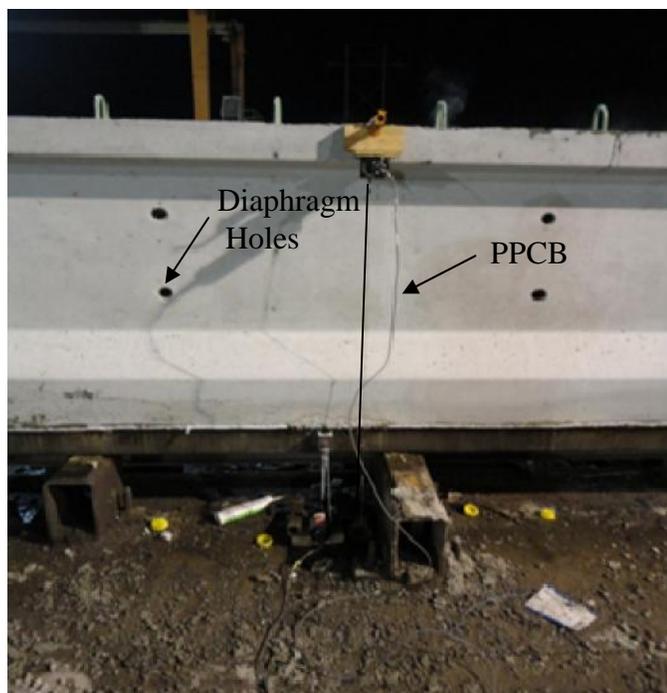
Figure 3-1: PPCB with Two Cylindrical Holes for Interior Diaphragm

It has been observed that a foreman, quality control manager, or construction engineer is the person who measures camber from the bottom flange at the midspan of the girder at the transfer of prestress. The person measuring camber after the transfer of prestress typically found the center of the beam by a centerline mark made on the precasting bed or by estimating where midspan will be relative to the cylindrical holes used for the interior diaphragms of the beam. The cylindrical holes used to attach the interior diaphragms were located in the web of the beam and the placement was determined by the designer (see Figure 3-1). The project team observed that diaphragm placement was typically anywhere from 1-1/2 ft. to 20 ft. from the centerline of the beam. Approximating where the midspan is located on a girder based on the diaphragm holes can allow precast personnel to measure camber at an incorrect location on the PPCB.

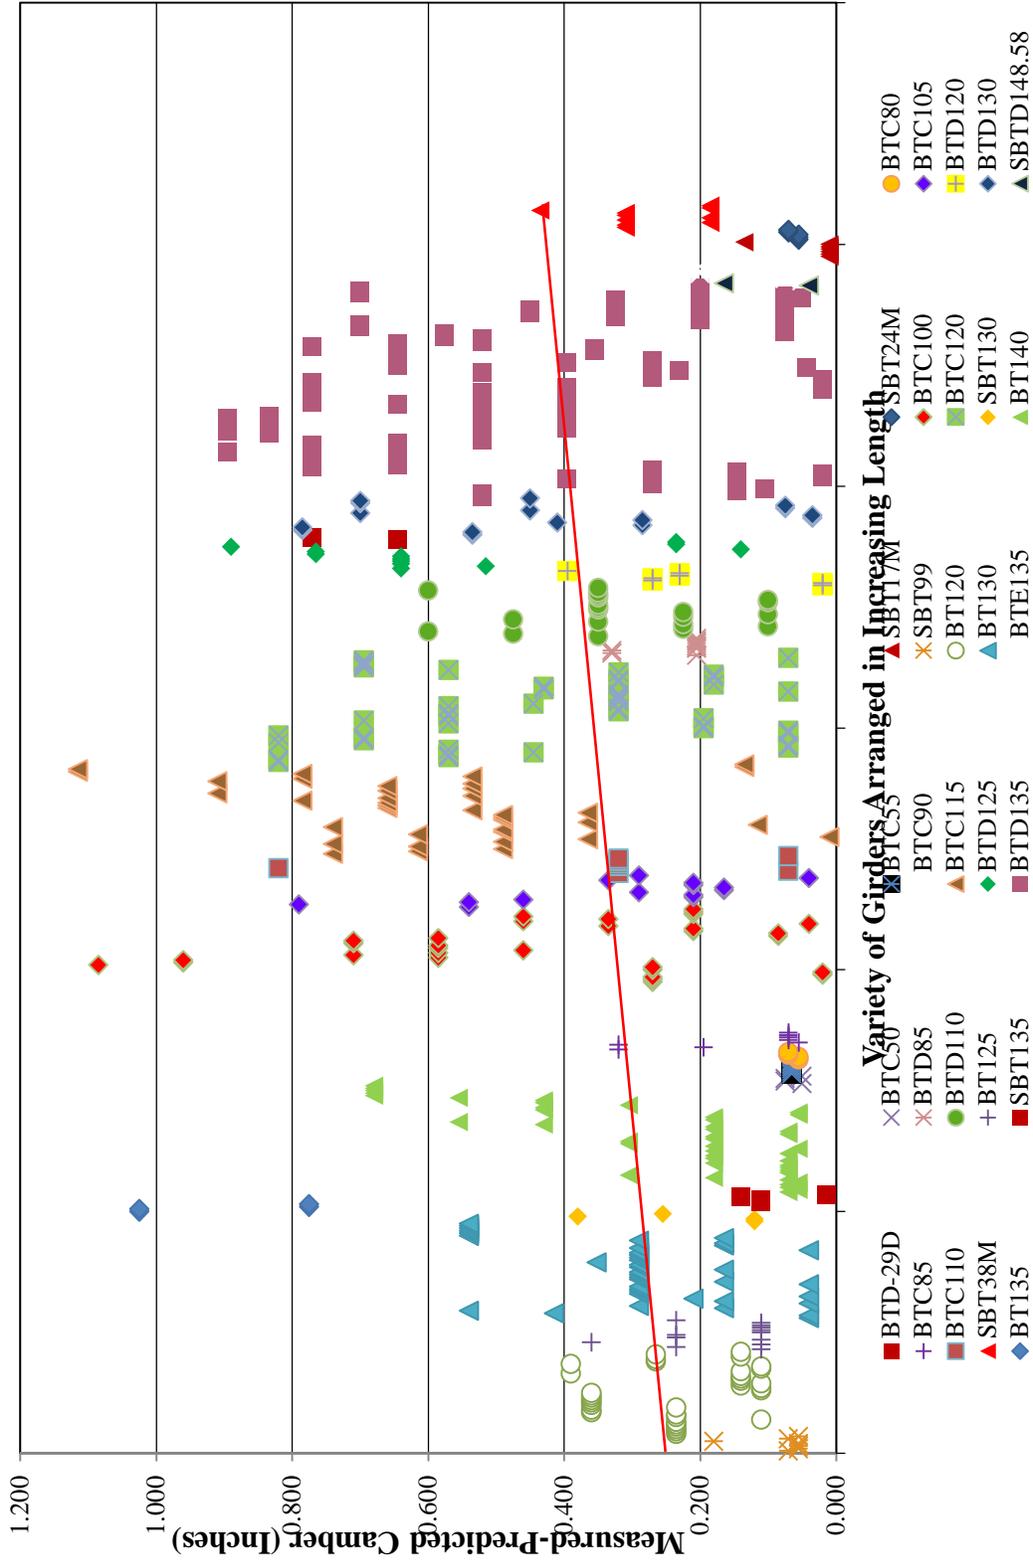
Figure 3-4: Difference in Measured and Predicted Industry Practice Camber Data vs. Length of PPCB

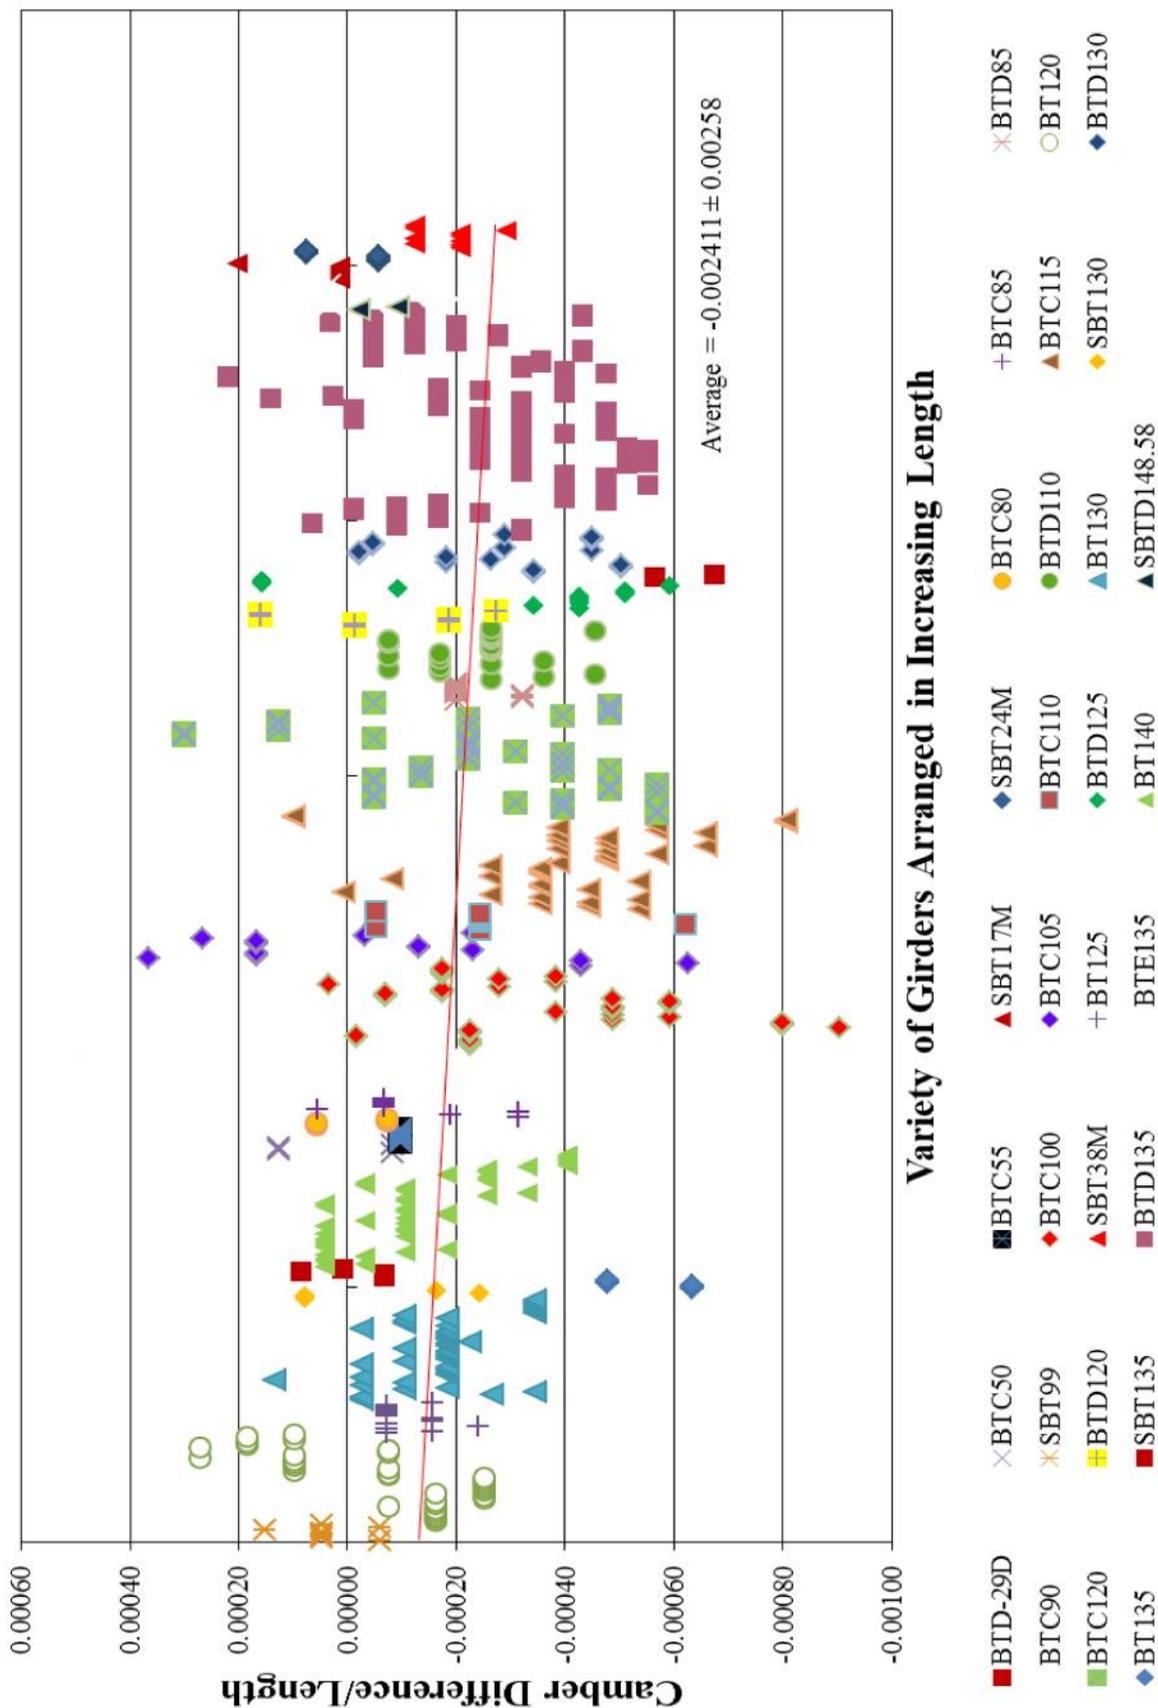
Figure 3-5: Difference in Camber/Length of Industry Practice Data Arranged in Increasing Beam Length

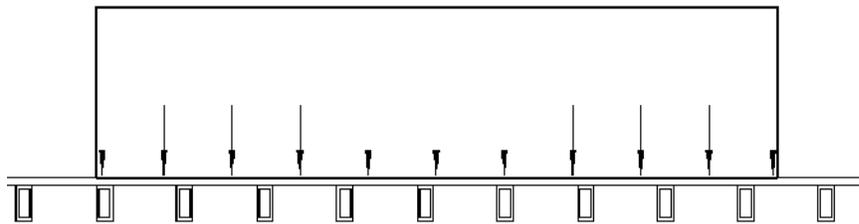
Figure 3-6: PCB before the Transfer of Prestress Generating a Uniform Load on the Bed

A prestressed concrete beam that has not been released exerts a uniformly distributed load along the length of the bed due to its self-weight (Figure 3-6). When the prestressing strands are released, prestress force that is applied to the beam may cause the beam to camber. When camber is present, the weight of the beam shifts from being uniformly distributed load along the length of the bed to two point loads at the girder ends (Figure 3-7). Shifting of the beam's weight to the ends produces downward bed deflections at the ends of the beam and upward rebounding of the bed at midspan, which will cause a discrepancy between the measured and actual camber. The magnitude of the bed deflection will depend on where the girder ends are situated in relation to the precasting bed supports.

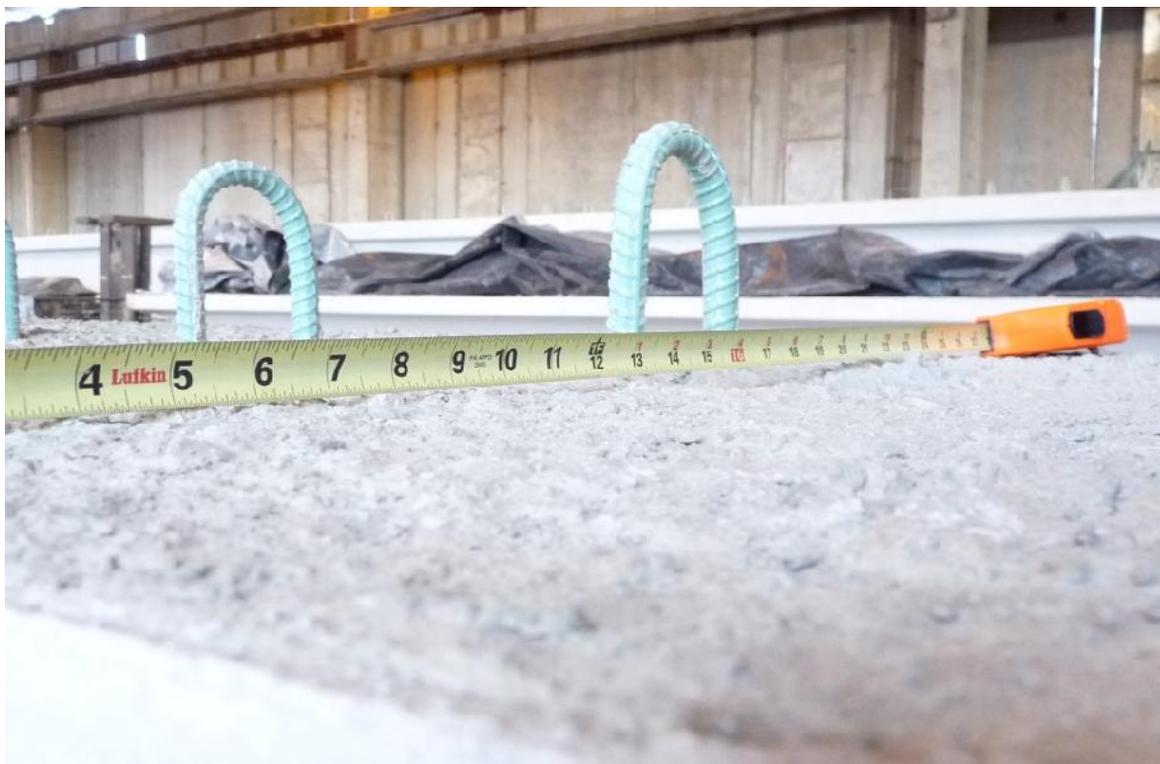
Figure 3-8: Inconsistent Top Flange Surface of a PPCB Due to Local Inconsistencies

local inconsistencies is dependent on the workers applied finish and has been observed to be consistent despite different beam lengths. The rises and falls in the surface of the beam and pose a problem when taking camber measurements from the top flange. A smooth surface is applied along the edge of the top flange surface in an attempt to remove local inconsistencies (Figure 3-9). Although this surface is applied to nearly every beam, it is often failed to be utilized as a measurement location by contractors in the field.

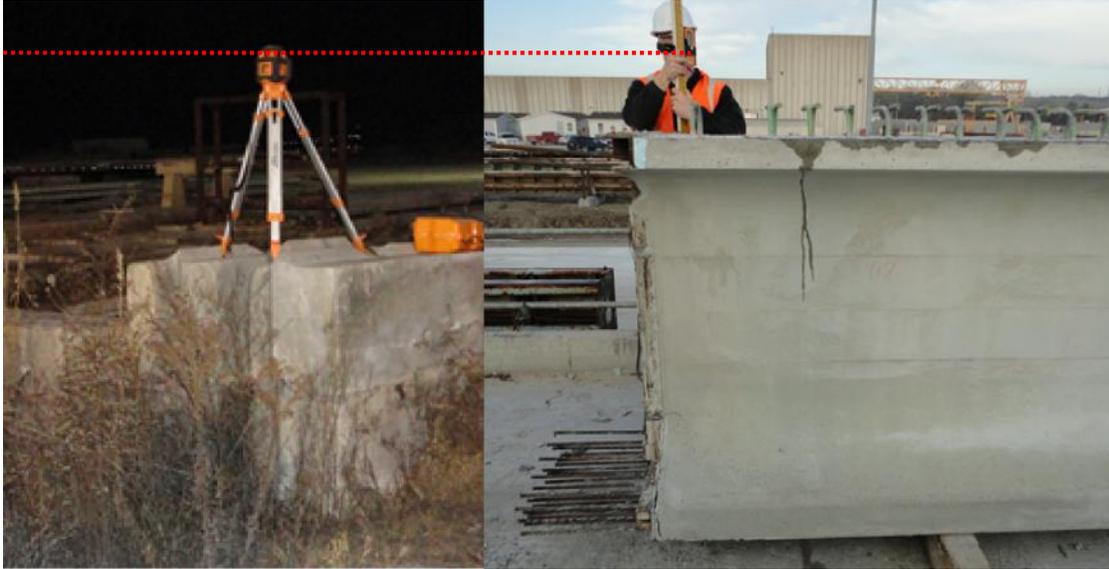
Figure 3-11: Rotary Laser Level

A rotary laser level was also used to take camber measurements on PPCBs. The rotary laser level operates by projecting a horizontal laser beam that can be detected by a receiver. The receiver mounts on a grade rod which can be read to determine elevations with respect to the laser level. Since the laser level is stationary during the whole process, any differences in measurements can be related to deflections of the beams or precasting bed. The manufacturer's reported precision for the rotary laser level device used in the study was $\pm 1/16$ inch at 100 feet.

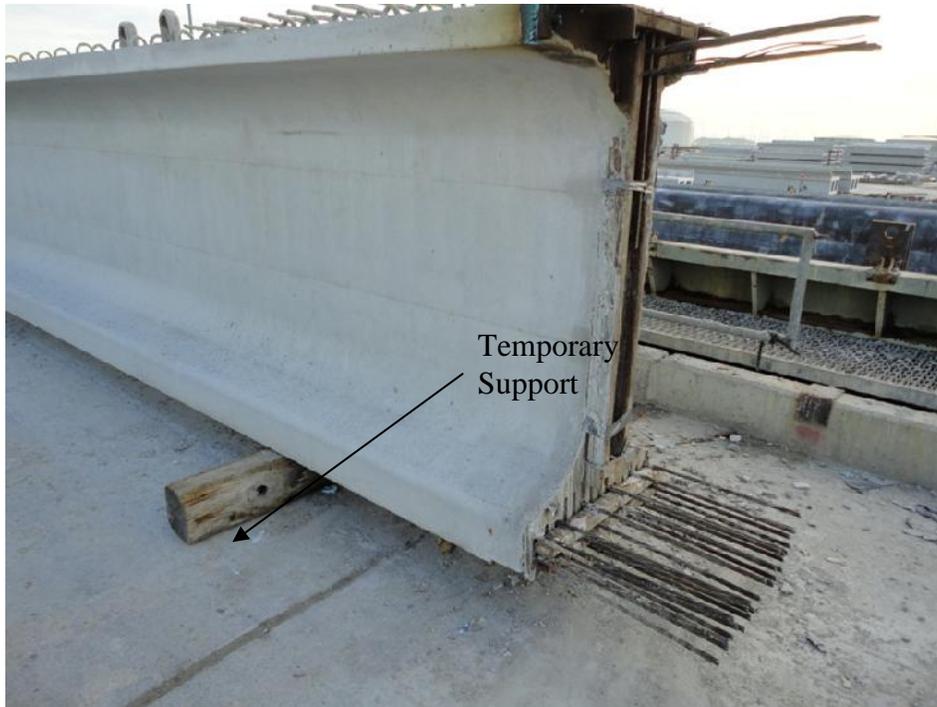
Figure 3-15: End of a PPCB on a Temporary Wooden Support

Problems are introduced if precasters are not able to lift and set the beams on the precasting bed to dissipate the force of friction in PPCBs. It has been observed that precasters tend not to lift and set down the PPCBs on the precast bed to eliminate friction. This is due to the risk of damaging the newly cast beam and the precasting bed along with the schedule and economic issues related to lifting a precast beam multiple times. Instead, precasters prefer to lift the beams from the precasting bed and place them on temporary supports in a storage yard until they can be shipped to the jobsite. The supports are placed anywhere from the edge of the PPCB to several feet in from the end of the beams. When PPCBs have the supports placed in from the ends, measured camber will be greater due to an elastic deformation.

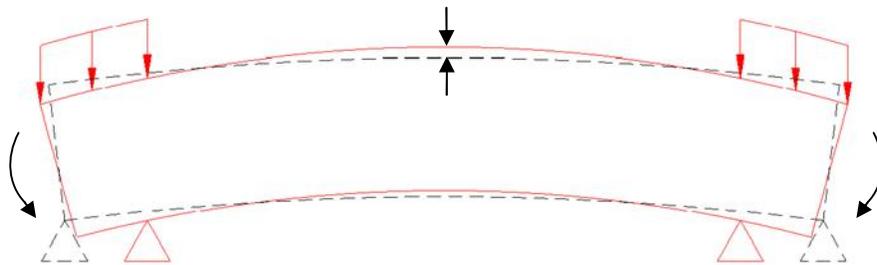
Figure 3-16: PPCB with Increased Midspan Deflection Caused by the Moment from the Overhang

The increase in camber due to shifting of supports can be quantified by three components. One component is the added moment at the support from the overhanging end of the beam (Figure 3-16). This moment acts to increase the camber at the midspan. The second component is the reduced clear span length (Figure 3-17). While the beam is resting on the precasting bed, the clear span length is assumed to be the length of the beam. When supports are placed in from the ends, the clear span is reduced. A smaller clear span length will result in smaller self-weight deflections at midspan. In simple, elastic beam formulas, the clear span length is typically multiplied to the fourth power, which changes the final deflection. The third component is from the deflection at the end relative to the support caused by the cantilever section (Figure 3-18). Although this deflection is typically small, it should be recognized for research purposes.

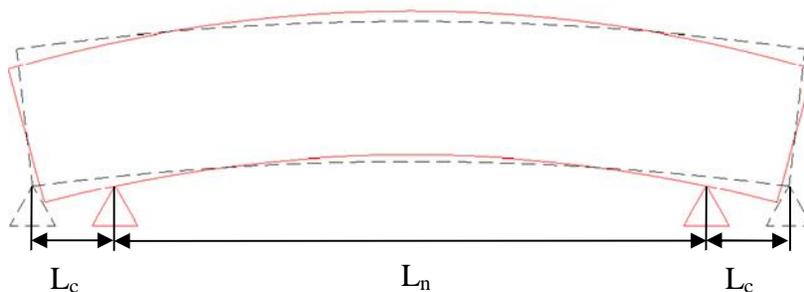
Figure 3-17: PPCB with Increased Midspan Deflection due to Self-Weight caused by the Reduced Clear Span

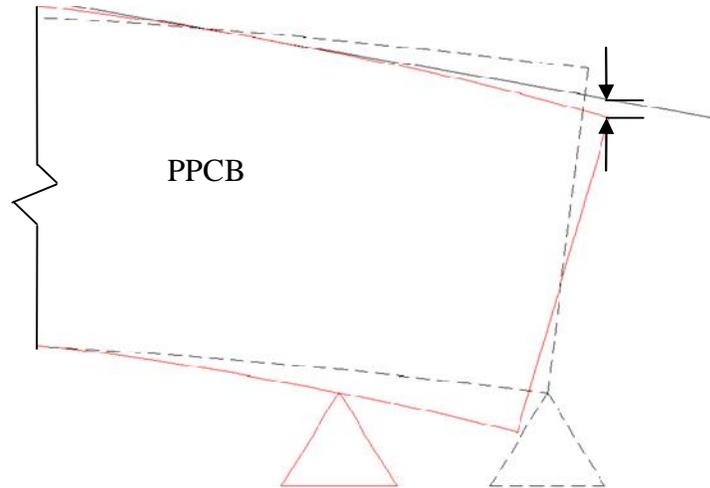
Figure 3-18: Increased Deflection of a PPCB Relative to the Support Caused by the Overhang

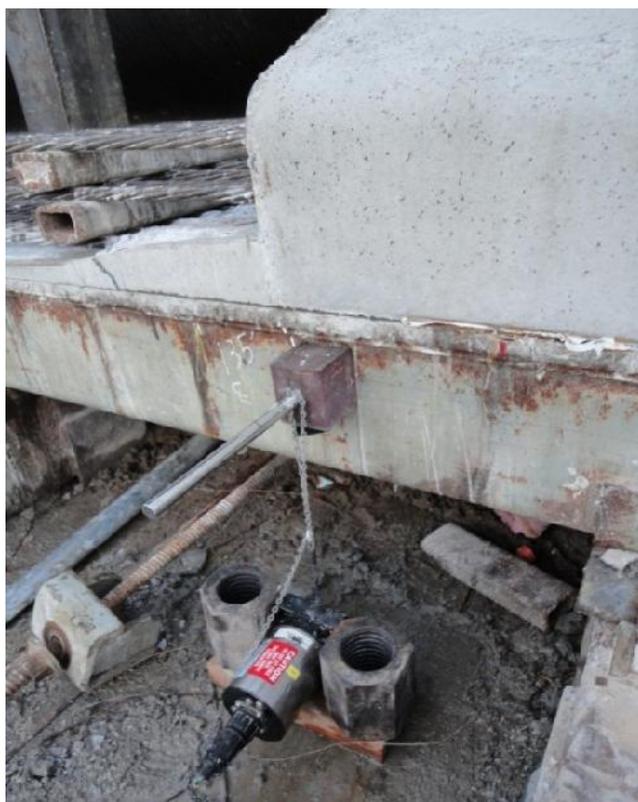
Figure 3-21: String Potentiometer Attached to the Precasting Bed at the End of a PPCB

When monitoring the precasting bed for deflections, a different method was used to attach and instrument the string potentiometers. String potentiometers were attached to a wood block that was anchored to the ground by weights. A magnet was attached to the precasting bed with a rod that extended out (Figure 3-21). Connecting a small chain from the rod to the string potentiometer resting on the ground gave valuable information about the upward and downward precasting bed displacements that were present at the midspan and ends of the girder respectively during the transfer of prestress.

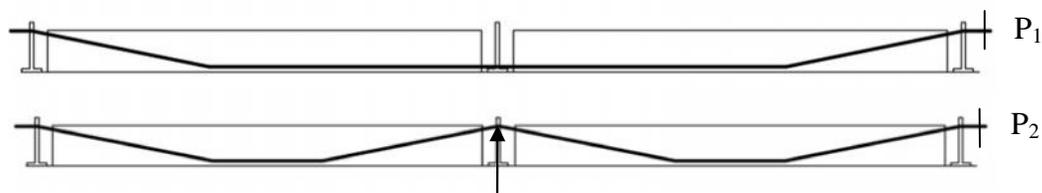
Figure 4-1: Initial and Final Positions of Harped Prestressing Strands when Tensioning

In the tensioning process, top sacrificial prestressing strands were completed first. The number of top sacrificial prestressing strands were determined by the beam specifications but can range from 2-6 strands that were tensioned with a single jack to the pressure of 3 to 5 kips in each strand. Once the top sacrificial strands are tensioned, the harped strands, if any, are laid out along the length of the bed. Initially, the harped strands are positioned to the elevation of the final height near the end of the beam line. An example of this can be seen in Figure 4-1. While in this position, the strands are tensioned to an initial value which is less than the final prestress force (P_1 in Figure 4-1). Mechanical means of raising the interior harped strands at the end of every beam were then completed.

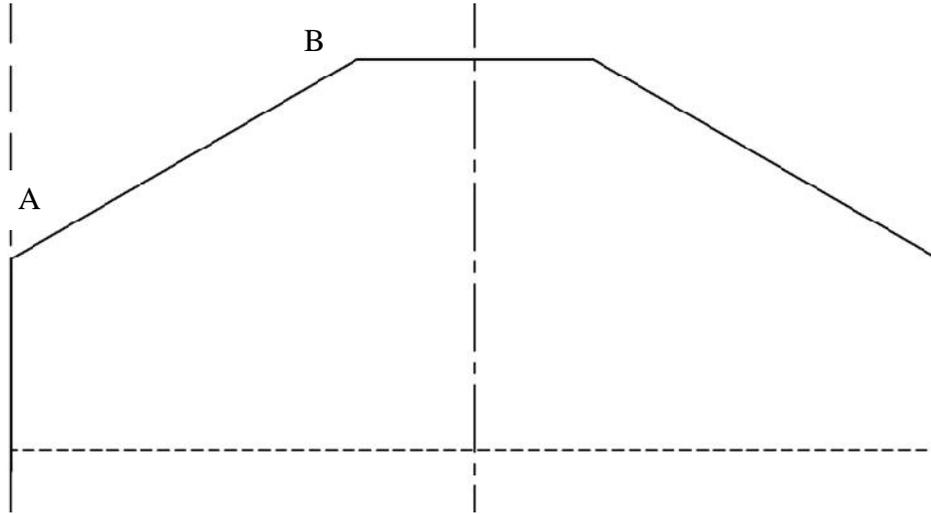
Figure 4-8: Moment Diagram of a Prestressed Concrete Beam without Transfer Length

Combining the moment produced by the harped, straight, and sacrificial strands will produce a graph similar to Figure 4-8. After the moment diagram due to prestressing is produced, points A and B in Figure 4-8 are determined. Finding the magnitude of point A and B is necessary for determining the area and centroid of the moment diagram.

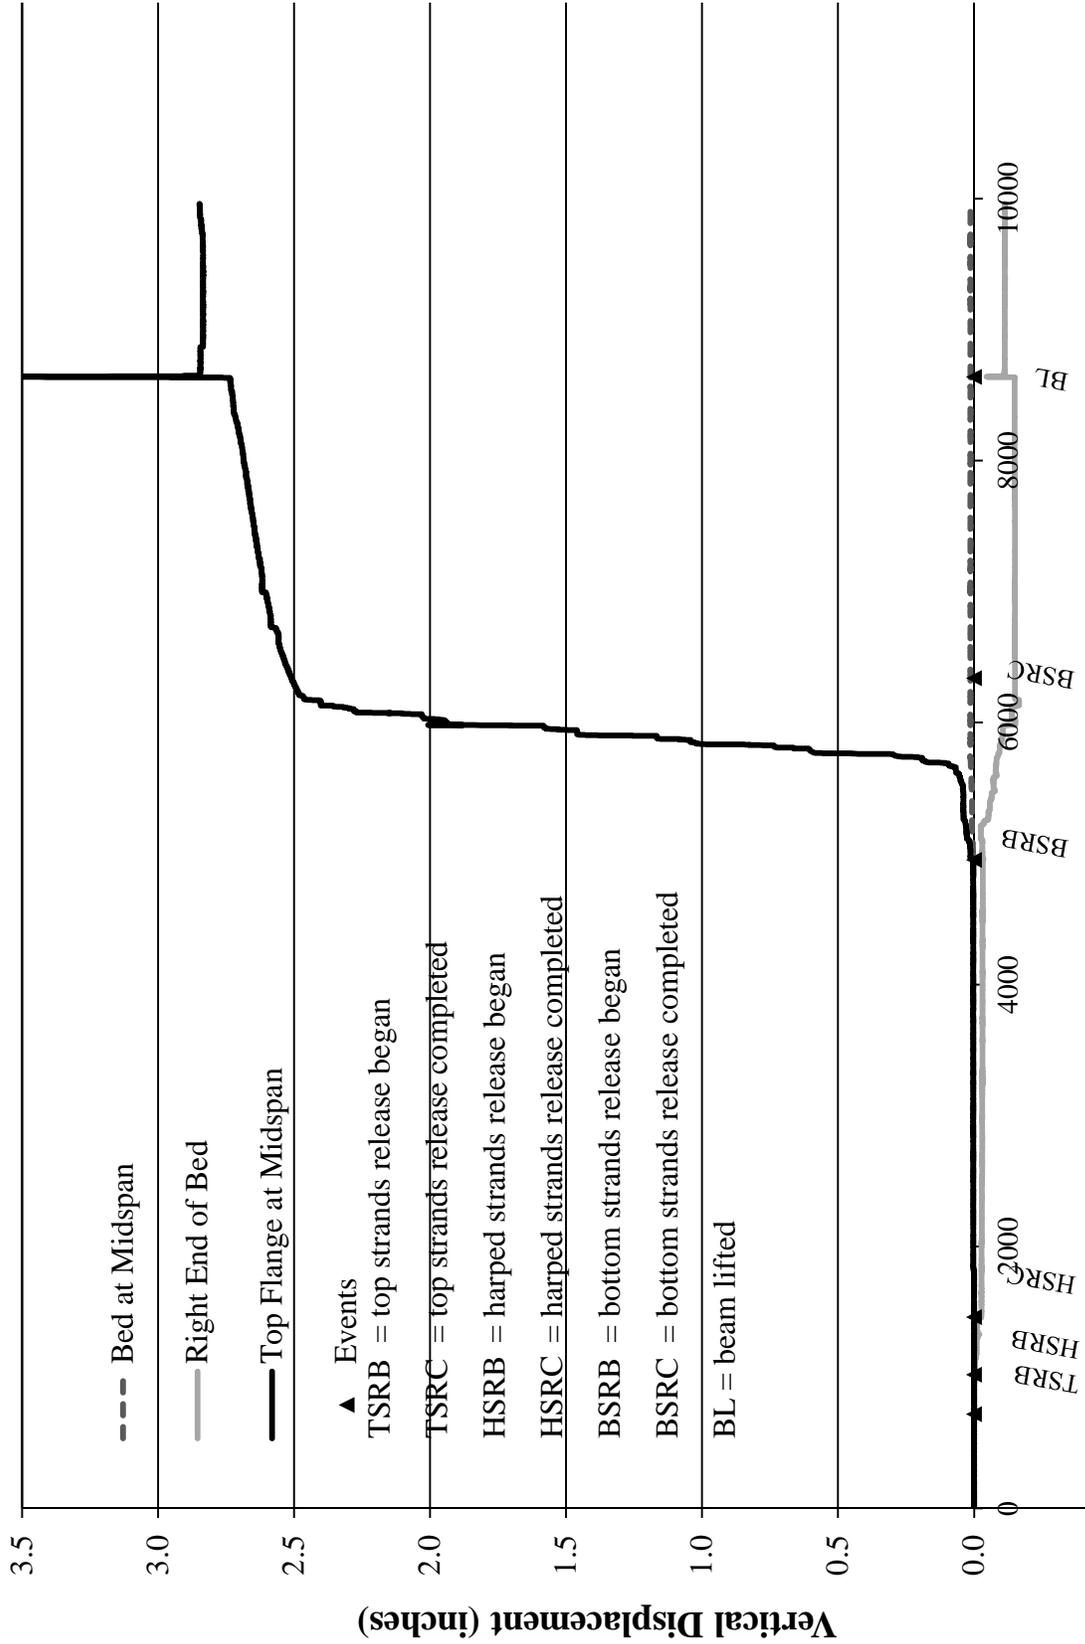
Figure 5-1: Time vs. Vertical Displacement of at BTB 100 PPCB
