Improving predictions of instantaneous camber for prestressed concrete bridge girders

A thesis submitted to the graduate faculty

Major: Civil Engineering (Structural Engineering)

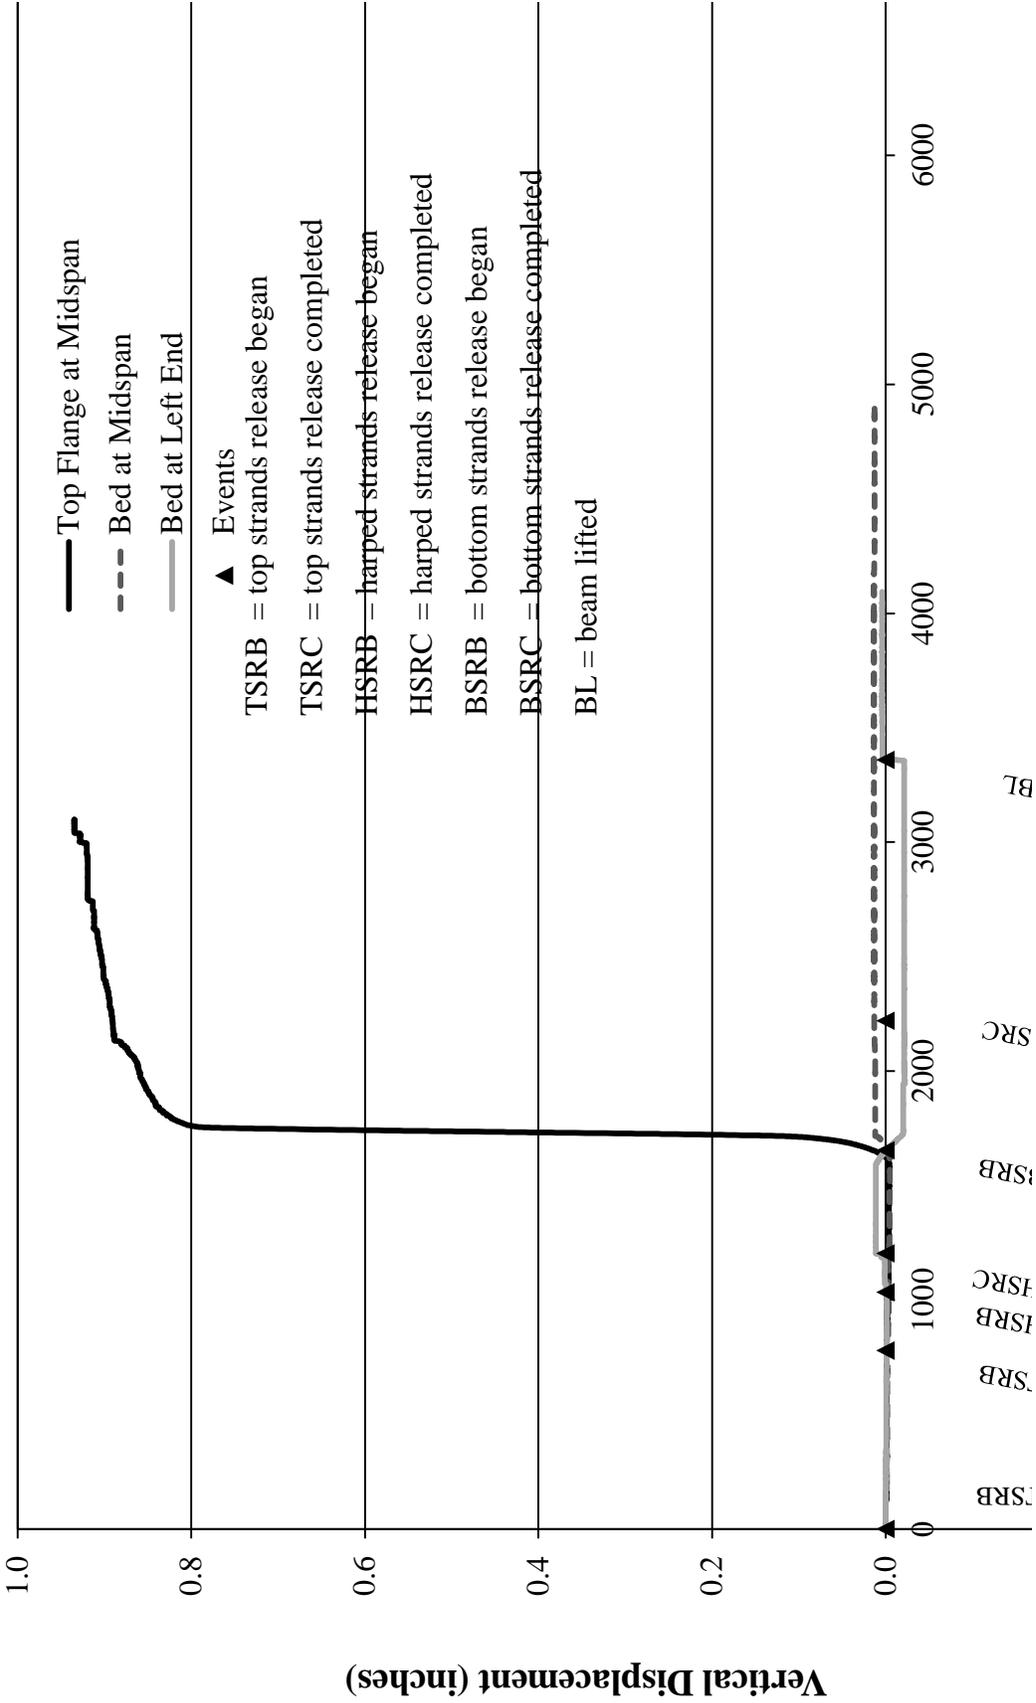
Figure 5-2: Time vs. Vertical Displacement of at BTE 110 PPCB

There was still a small increase in camber as a function of time due to the beam overcoming friction between the precasting bed and the beam. Figure 5-2 shows small discontinuities in the increase in vertical displacement after the bottom strands were released. This can be attributed to the precaster's lifting adjacent PPCBs off the precasting bed. In Figure 5-1, precasters were able to lift the PPCB and place it down on the precasting bed after the last prestressing strands were released. At the time the beam was lifted (LB), there is a large vertical increase shown in Figure 5-1. The lift released the remaining friction that is present and allowed the beam to reach its full instantaneous camber. After the beam was set down, there was a slight decrease in camber. This could be due to the beam readjusting on the precasting bed or could be due to the effects of reverse friction. Precasters from Figure 5-2 were unable to lift/set the beam because of manufacturing time constraints and the potential for damaging the newly cast beam. There is believed to be an additional upward displacement that would take place at the ending time due to the release of friction; however, recording data was terminated before the precaster transported the beam to the storage yard. Continuing to instrument PPCBs with string potentiometers and also take laser level readings made it possible to verify the behavior of beams and quantify the magnitude of bed deflections, inconsistent top flange surfaces along the length and due to local effects, and friction.

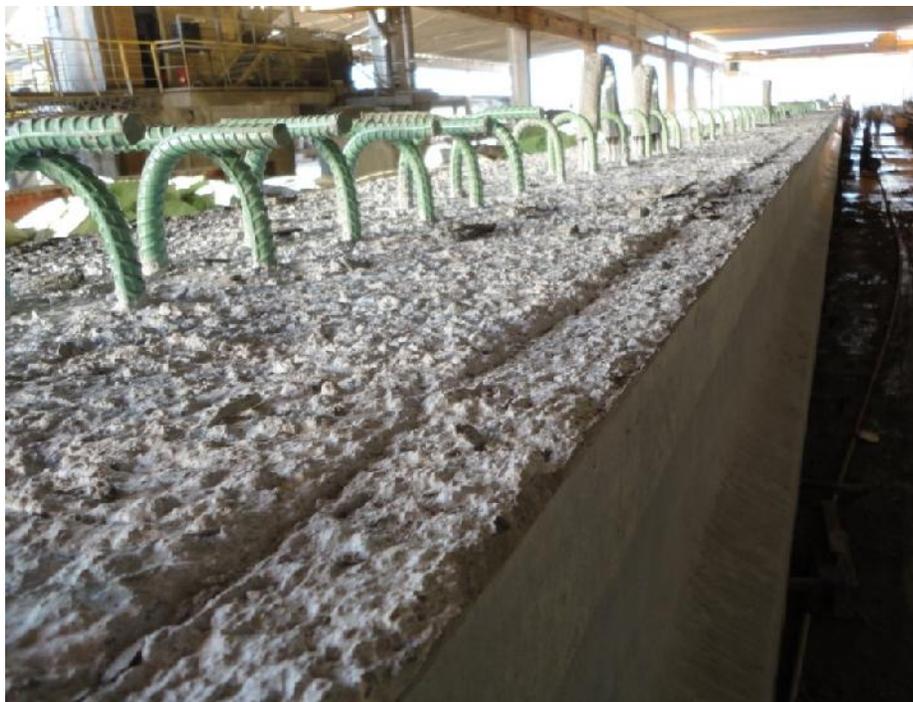
Figure 5-7: Inconsistent Troweled Surface Along the Length of the Beam

The finish that is applied by workers can contribute to the inconsistent depth of the beam along the length. After the concrete is placed in the form, workers tend to evenly distribute the concrete so that the top flange surface maintains a constant thickness. The ability for workers to uniformly finish the beam is often impeded by the stirrups that protrude from the top flange. Finishing the concrete around the stirrups along the length of the beam can cause rises and falls in the surface. Consistently keeping a uniform thickness along the length is directly related to finishing practices.

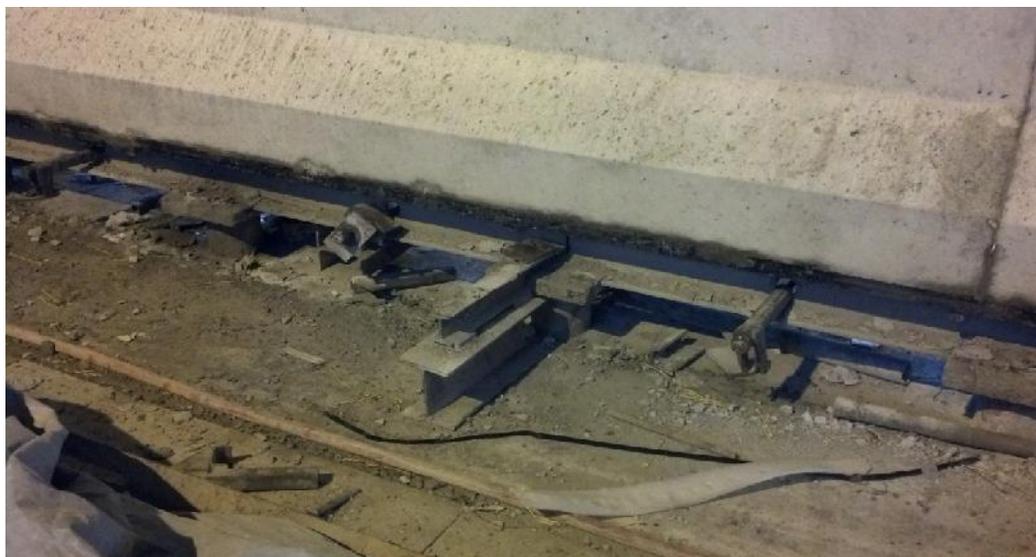
Figure 5-8: Temporary Support used for Supporting a PPCB Form

In one plant, free standing forms are put into place by a crane. The forms are placed on movable metal supports that lie every 10-20 feet. A string is strung along the length of the top flange of the beam. Bends from adjacent forms are adjusted based on the distance from the form to the string. After the bends are taken out of the forms, workers take measurements from the top of the precasting bed to the top of the form. This is typically done every 10-20 feet. If adjustments need to be made to the height of the form, workers can shim the forms up or down to meet the correct elevations. Workers will then place intermediate supports along the length of the beam similar to Figure 5-8 and secure the forms.

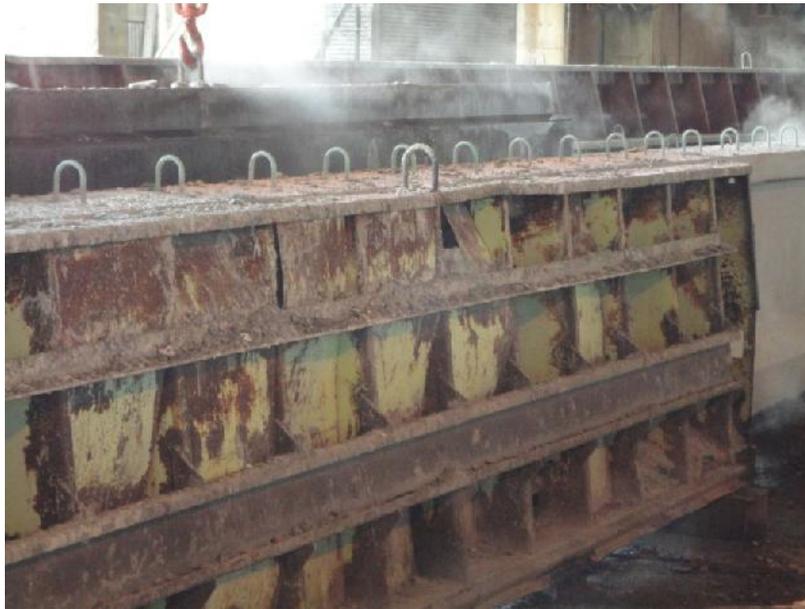
Figure 5-9: Forms on a PCB

The third plant uses free standing forms that are placed by a travel lift crane on the bed supports. The longitudinal length of the precasting bed requires multiple sets of forms to be placed along the length of the bed. The multiple sets of forms can have slight bends along the length of the precasting bed. Similar to the first plant, a string is tightly strung between the lift up hooks on the beam. This string lies in the center of the top flange of the beam. Workers can measure the distance between the string and the top of the form to make sure the distances are uniform along the length of the beam. If distances from the top of the form and string are different along length of the beam, workers use a small hand jack to raise the bottom of the form on the opposing side so that the top of the form rotates into place. Once the forms are slightly adjusted, they can be secured into place by tightening the clamps at the bottom of the form.

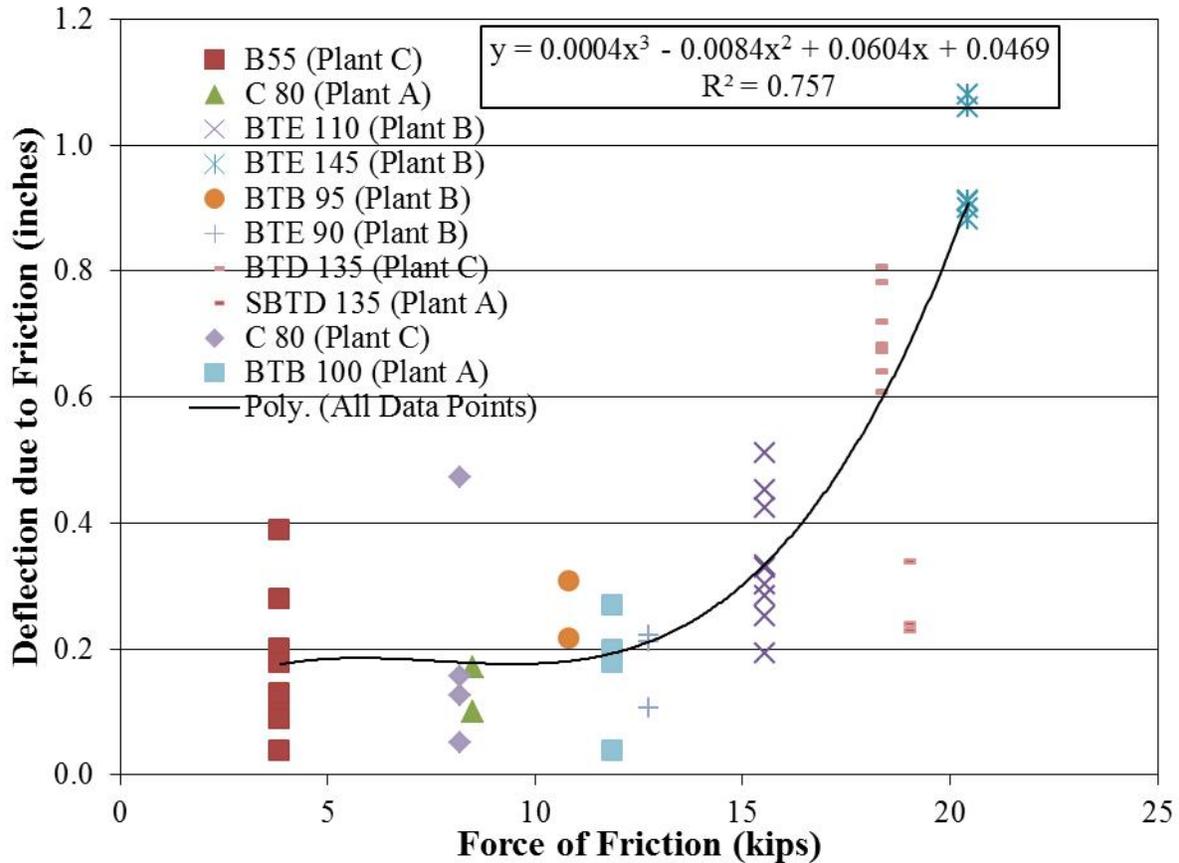
Figure 5-10: Force of Friction vs. Deflection due to Friction for Multiple PPCBs

Figure 5-10 displays the force of friction obtained from Equation 5-2 vs. the measured deflection due to friction. Results show scatter throughout all values of the force of friction, which is due to the wide variety of beams produced at three different plants. While plants have similar bed dimensions and procedures, it should be noted that small discrepancies may be present due to coefficient of friction and precasting bed geometry specific to each plant.

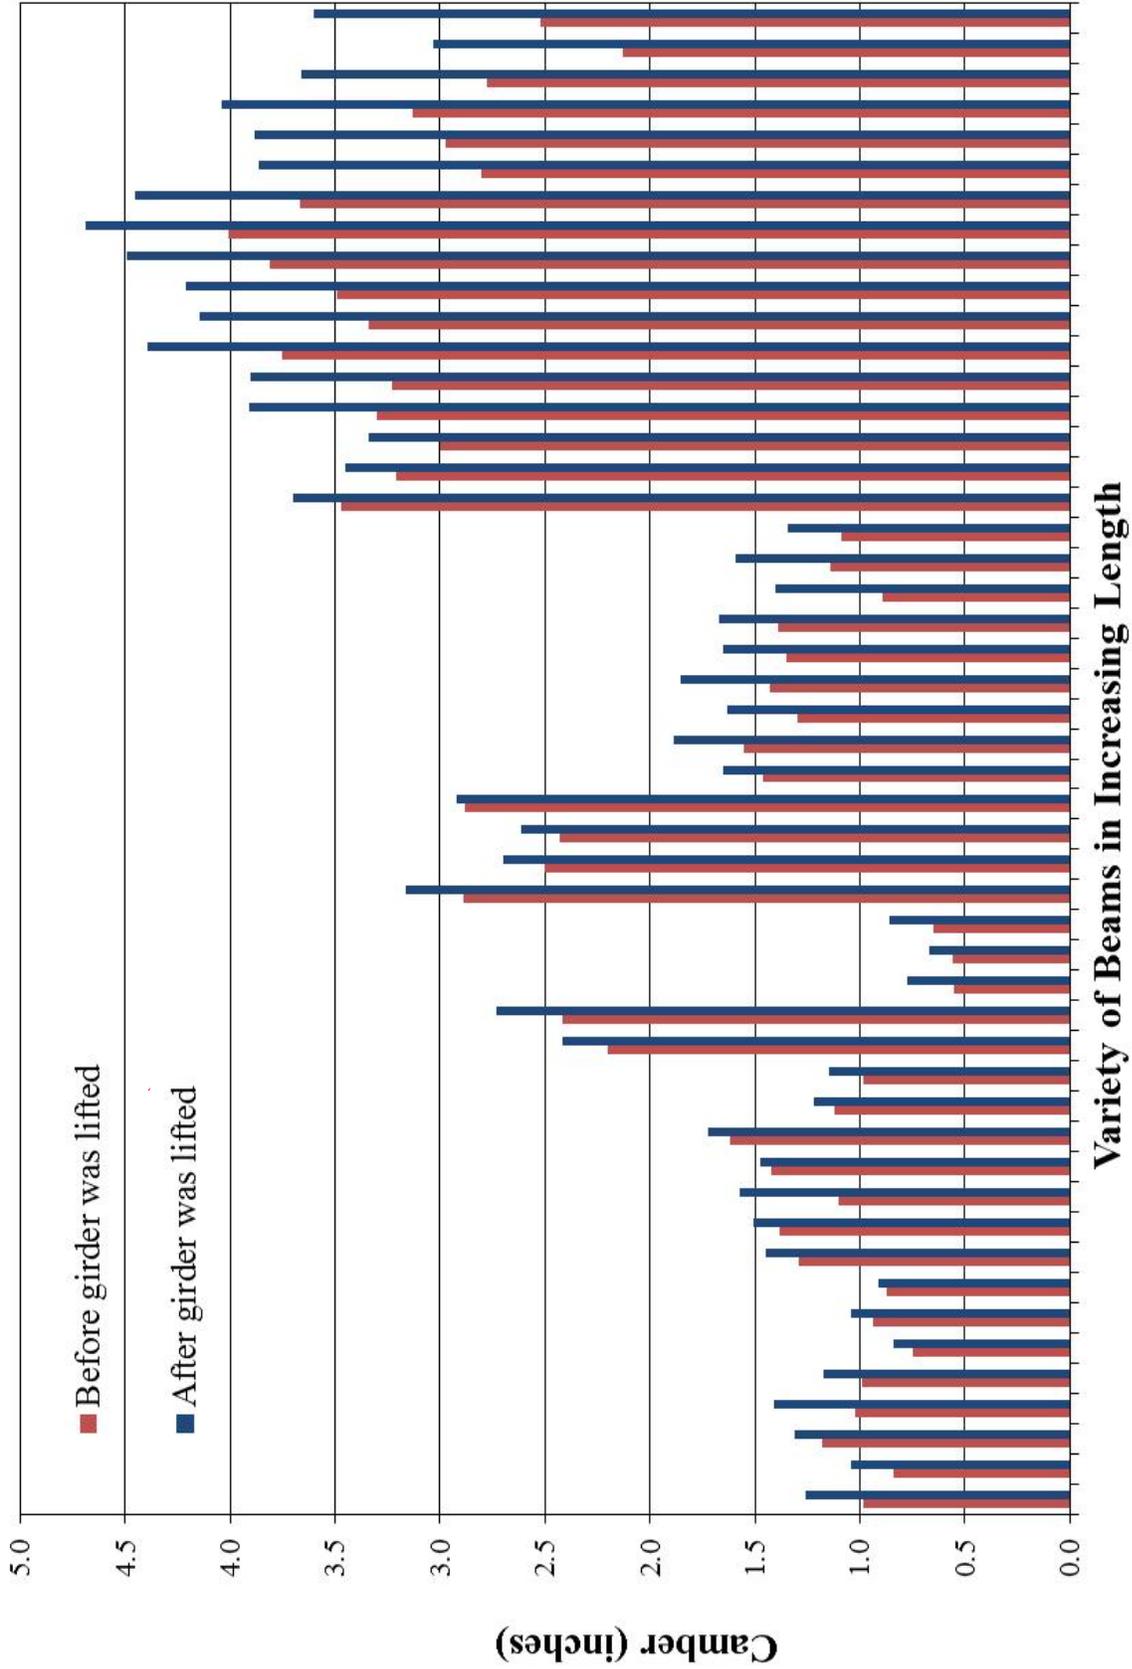
Figure 5-11: Effect of Friction on Camber Measurements for Different Types and Lengths of Beams

Taking rotary laser level measurements before and after the beam was lifted made it possible to quantify the contribution of friction on PPCBs (Figure 5-11). The lengths of the beams that friction was measured vary from 56 feet to 146.33 feet and consisted of beam types A-D and Bulb-Tee beams. As Figure 5-11 shows, lifting the beam immediately after detensioning can produce up to 1.08 in. increase in measured camber. Out of 50 PPCBs that were studied for friction, there was an average of 17% difference between camber measured before lifting the girders and after lifting the girders.

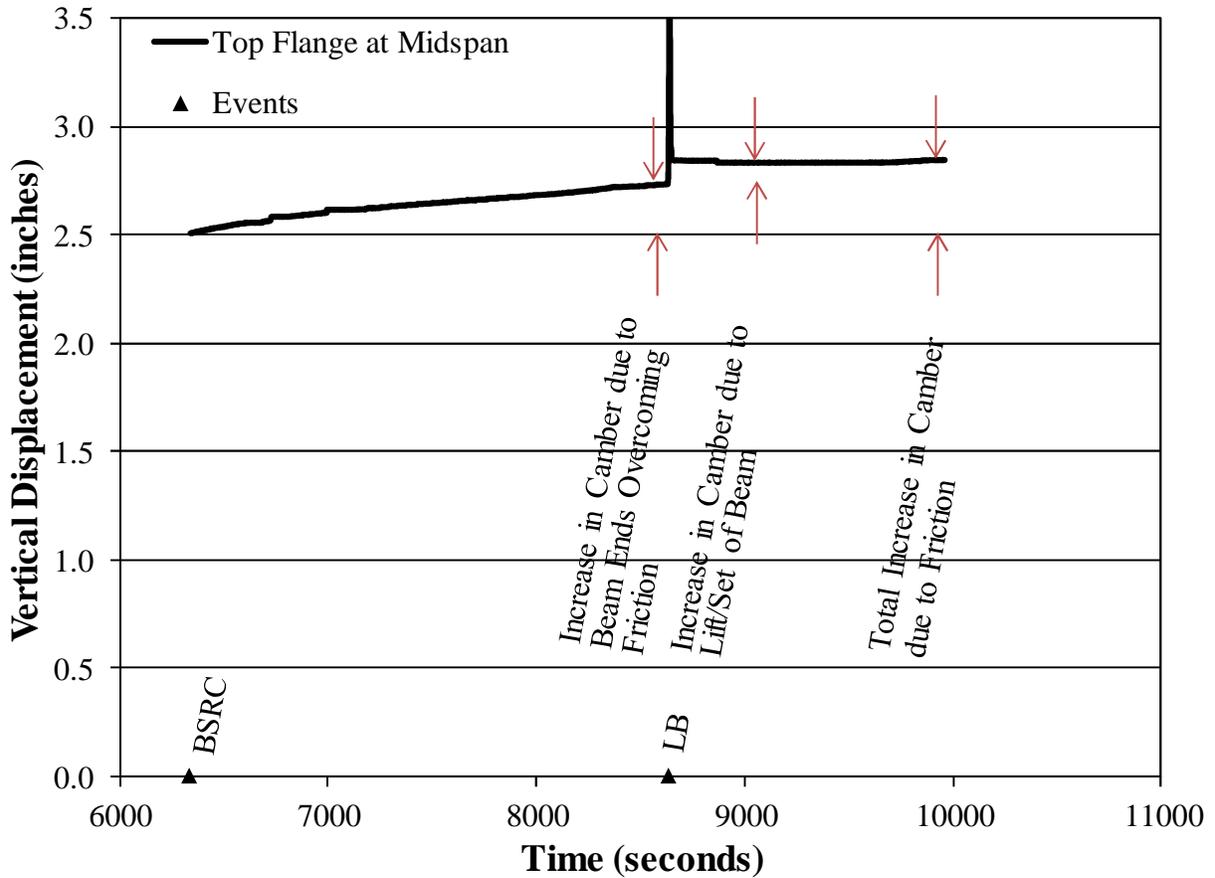
Figure 5-12: Time vs. Displacement after the Transfer of Prestress on a BTB 100

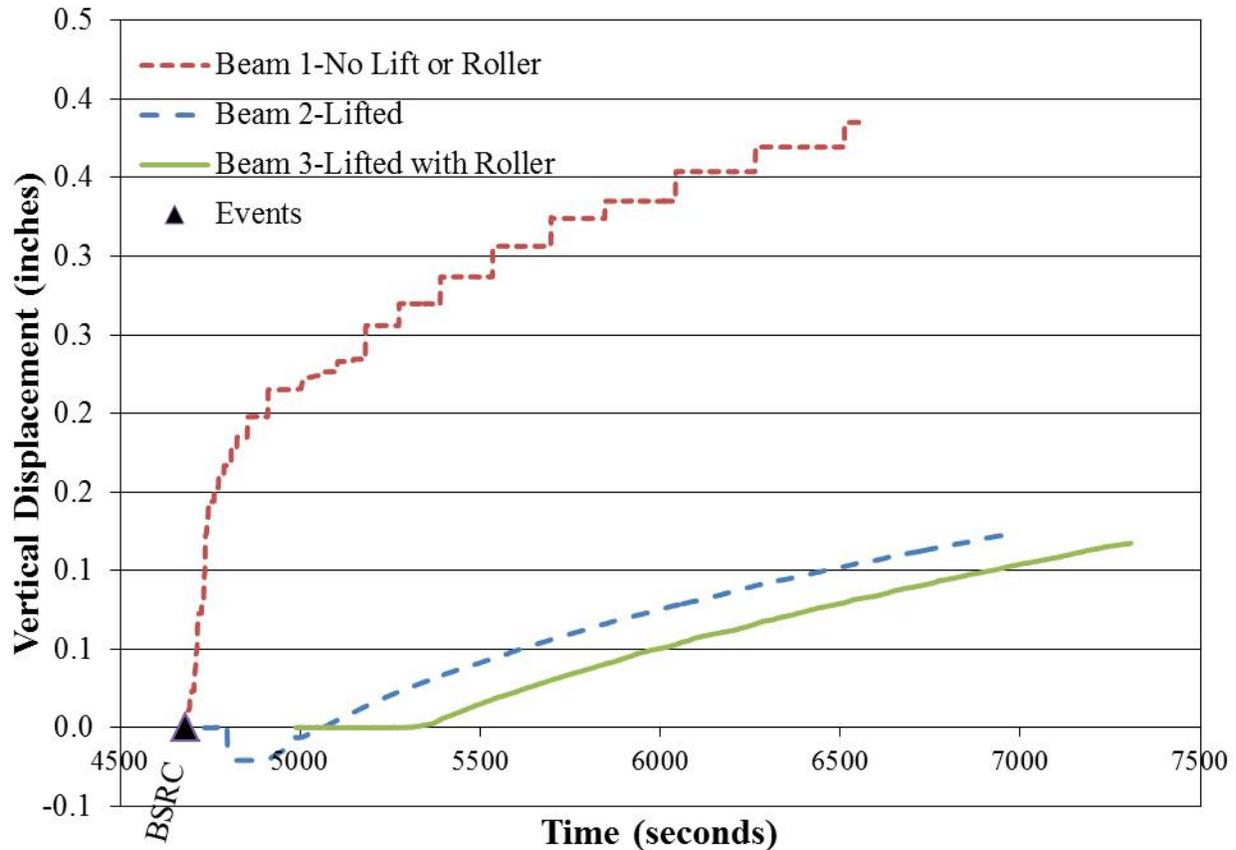
Figure 5-13: Increase in Camber due to Friction for Three PPCBs

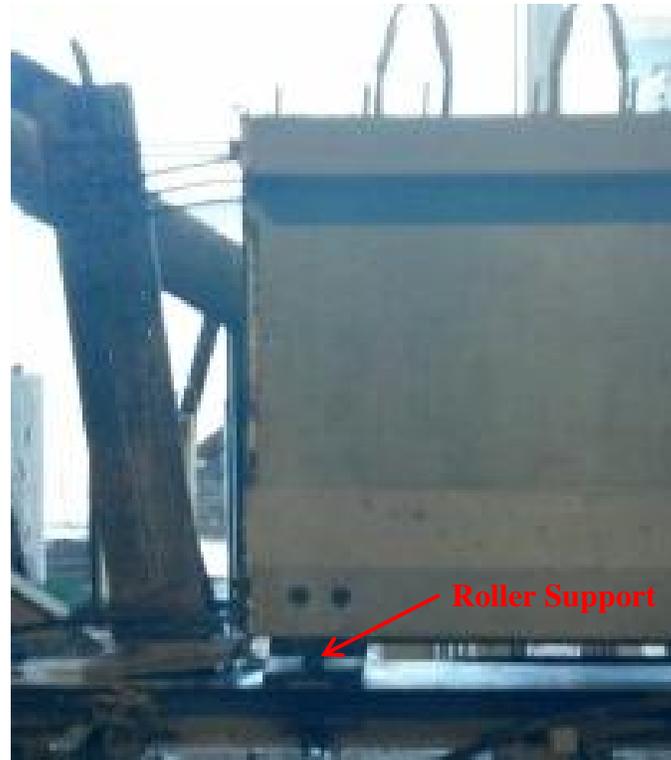
Figure 5-14: Roller Support Under a D90 PPCB

In beam 3, friction is eliminated by lifting the beam immediately after the transfer of prestress and placing it down on a roller support resting on the precasting bed (Fig. 5-14 and Fig. 5-15). Since one end of the beam is resting on a frictionless roller support, the beam had the ability to camber to its full potential. Like beam 2, there was a slight increase in camber after the beam had been placed on the roller support. The resulting increase in camber can be attributed to creep since the beam had the ability to move longitudinally in and out from the midspan with relatively little effort to overcome the friction of a roller support.

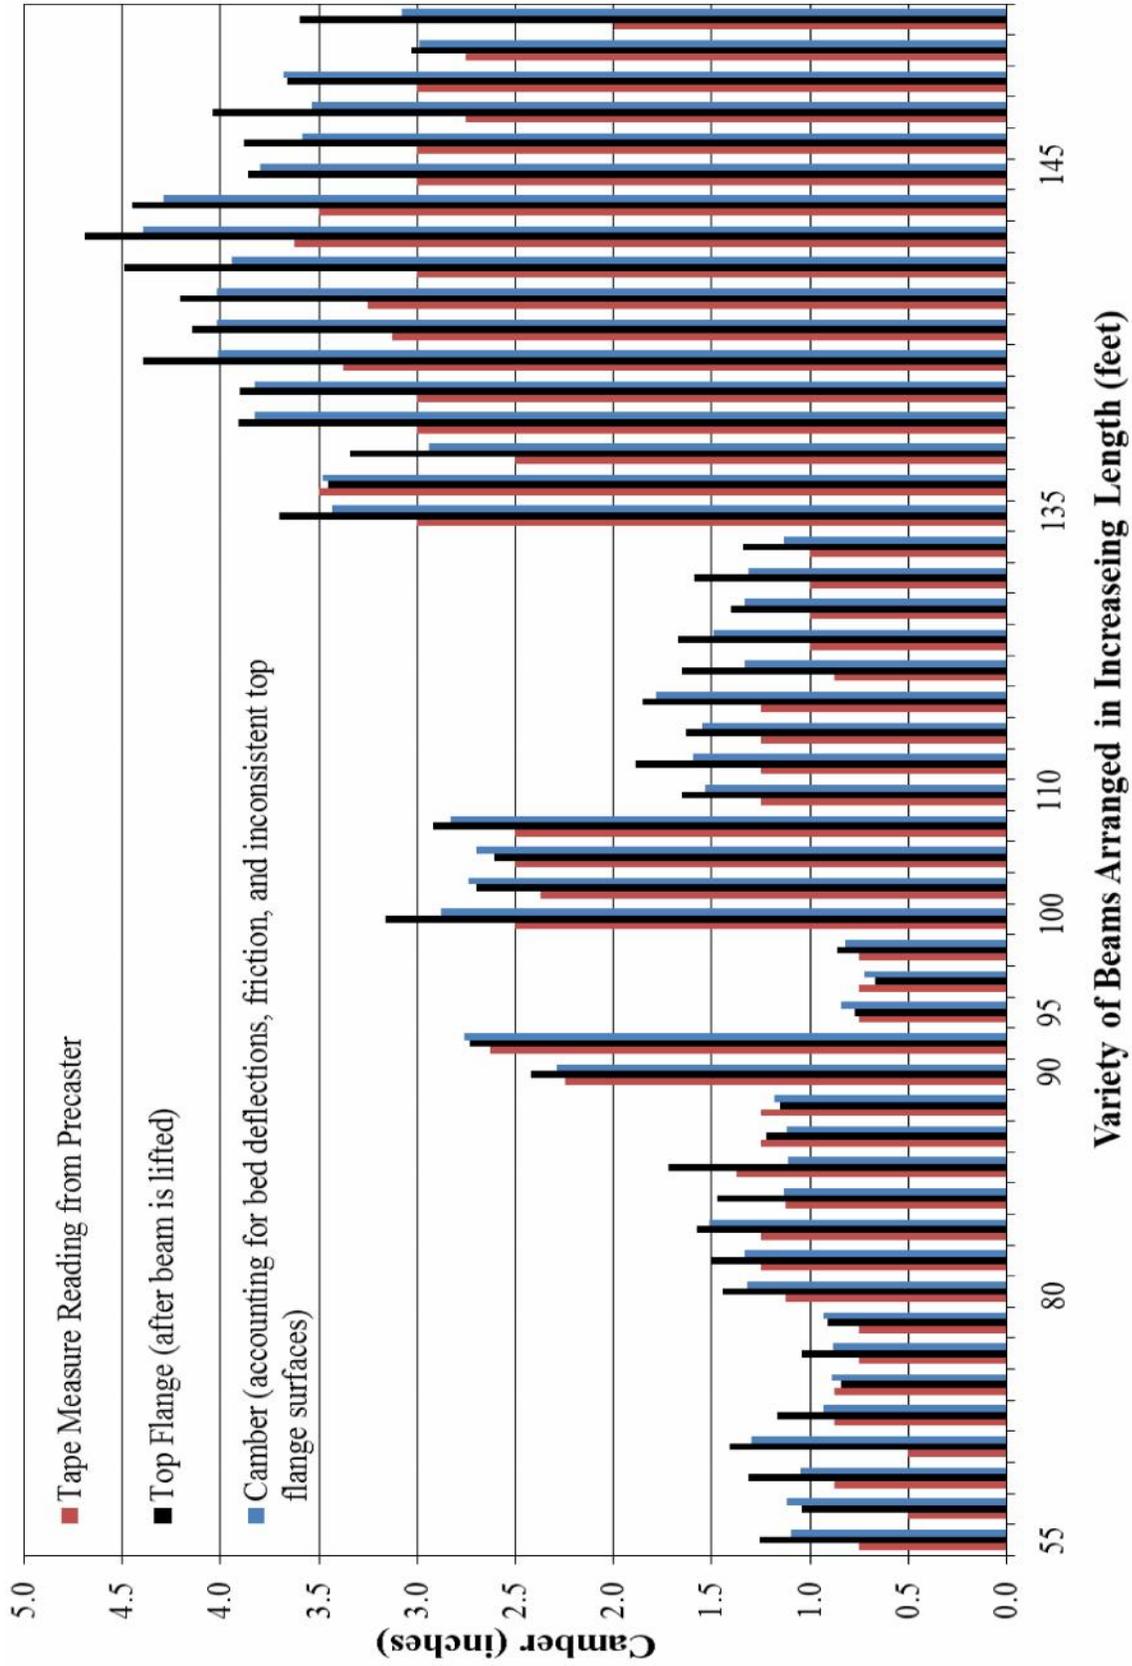
Figure 5-16: Comparison of the Measurement Technique between Precasters, Contractors, and Researchers

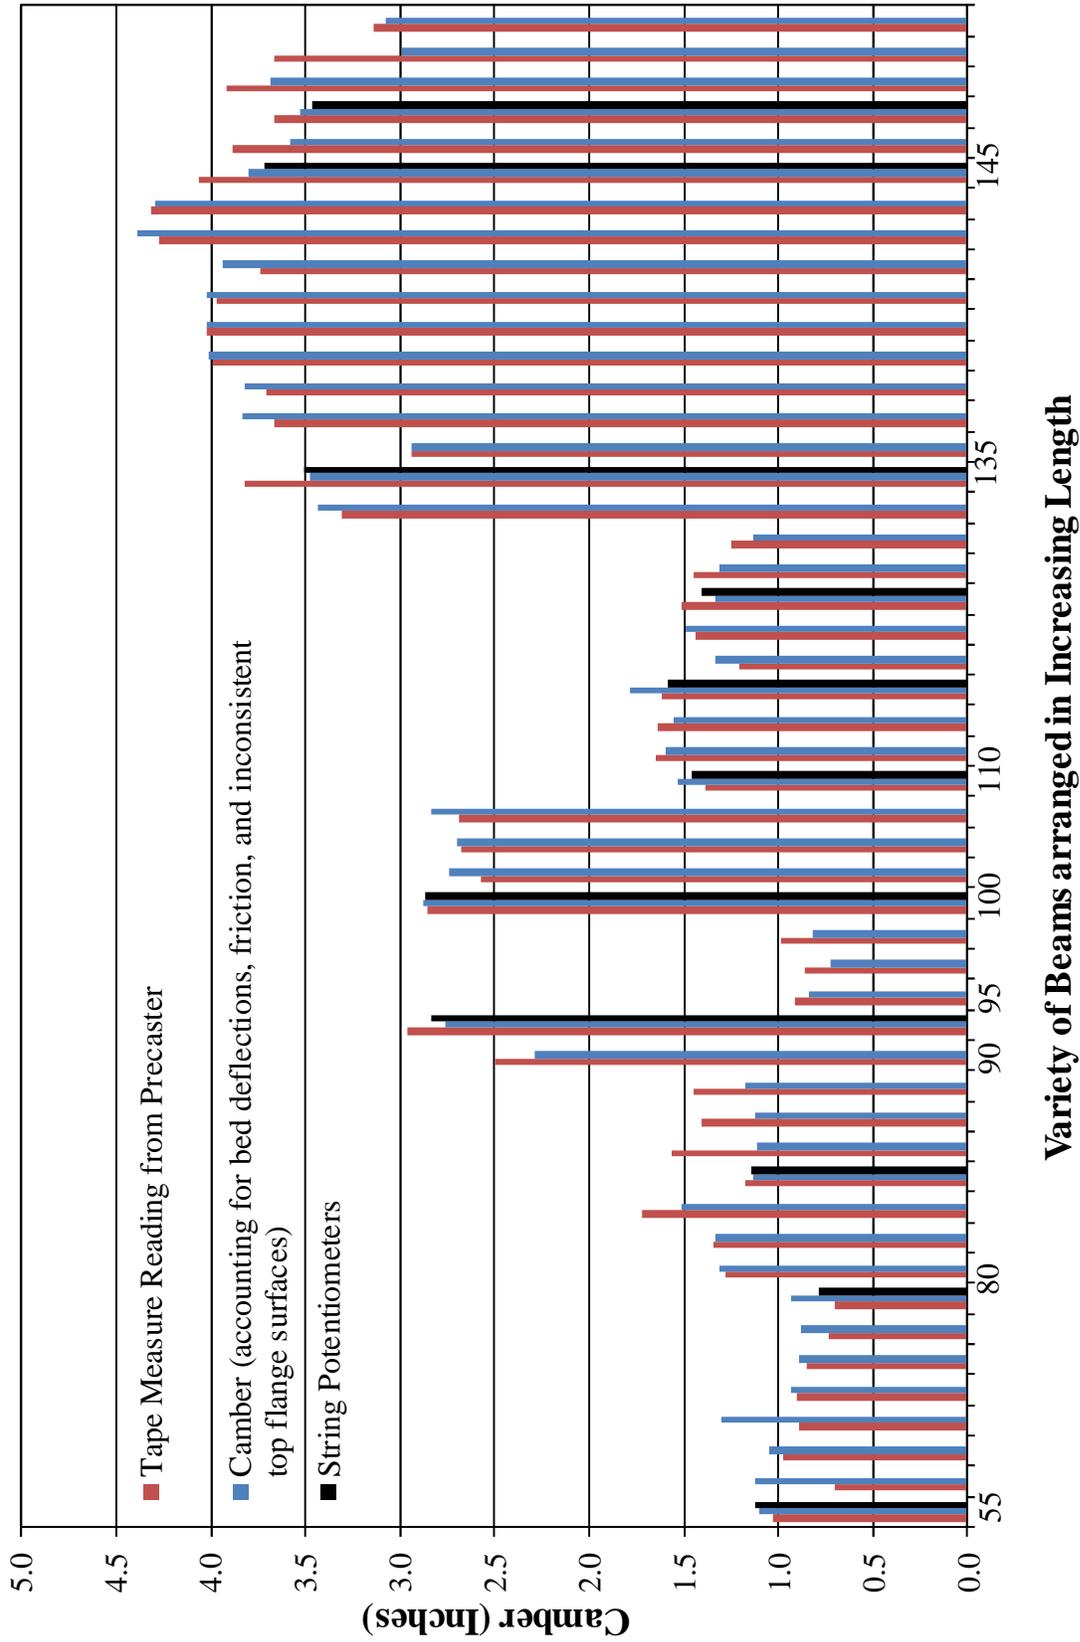
Figure 5-17: Differences between Measurement Techniques after Adjusting Data to Account for Bed Deflections, Friction, and Inconsistent Top Flange Surfaces

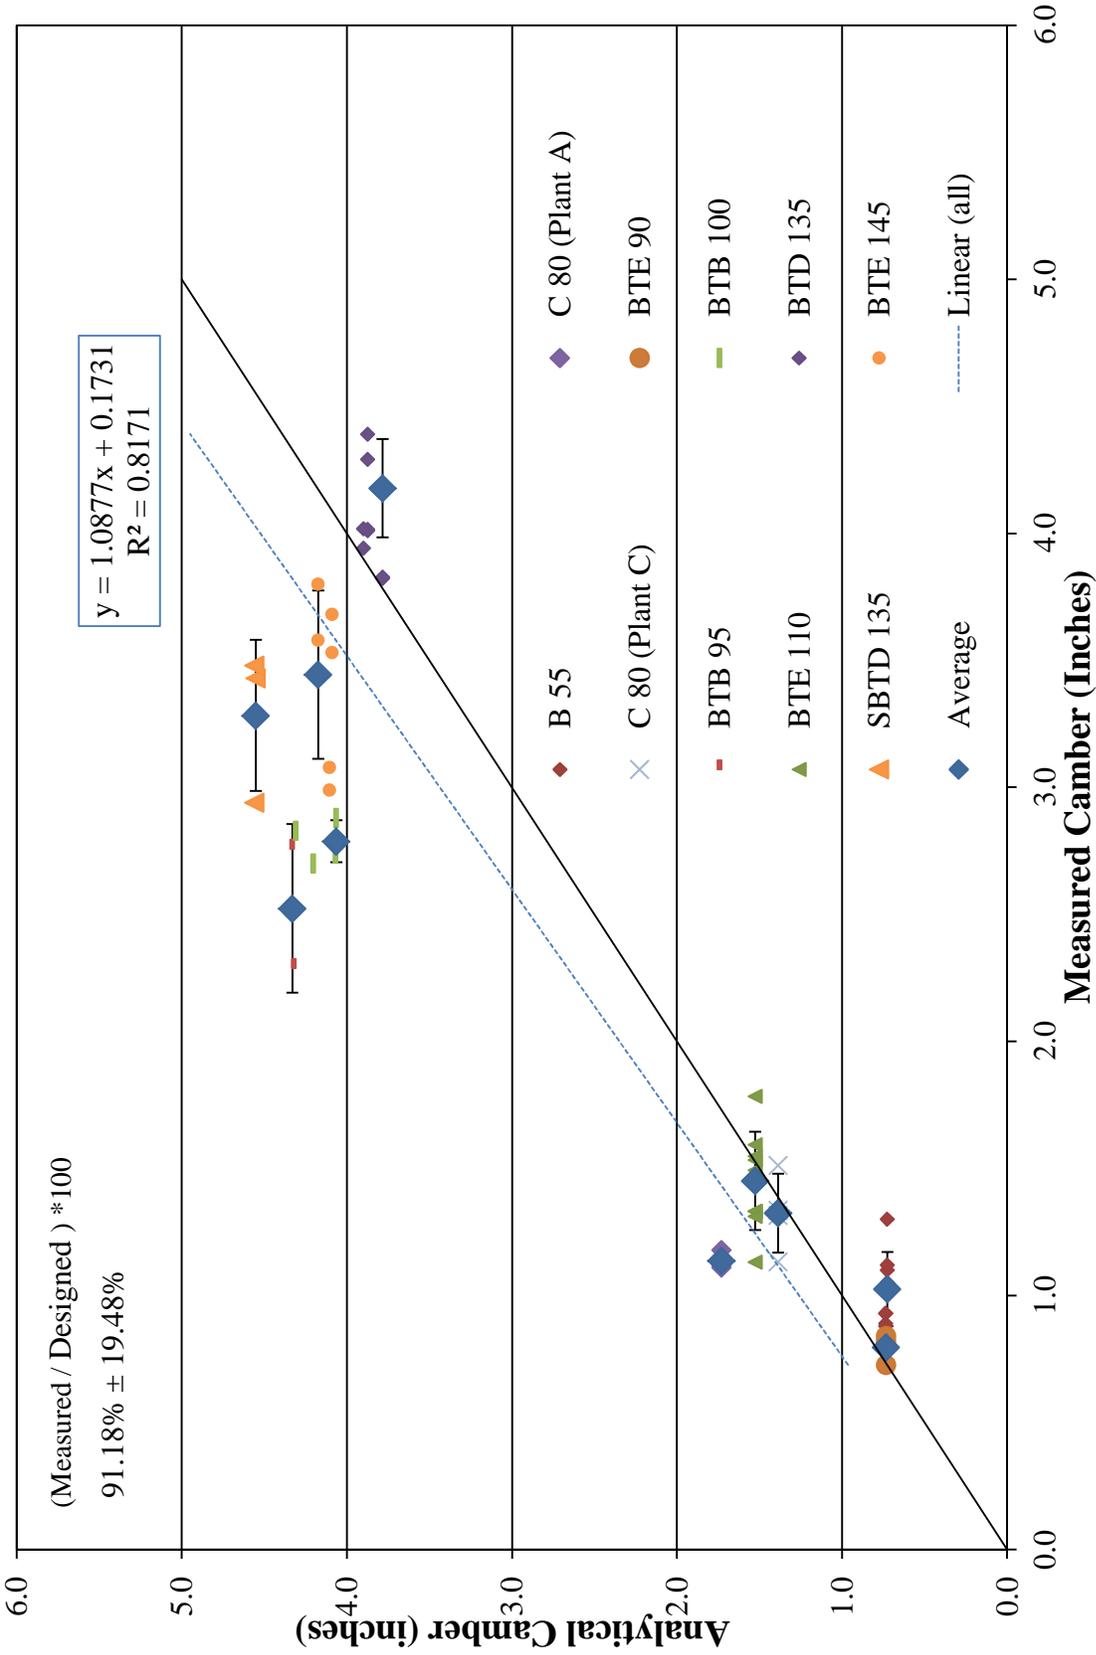
Figure 5-20: Measured Camber vs. Analytical Camber using E_{ci} obtained from Creep Frames

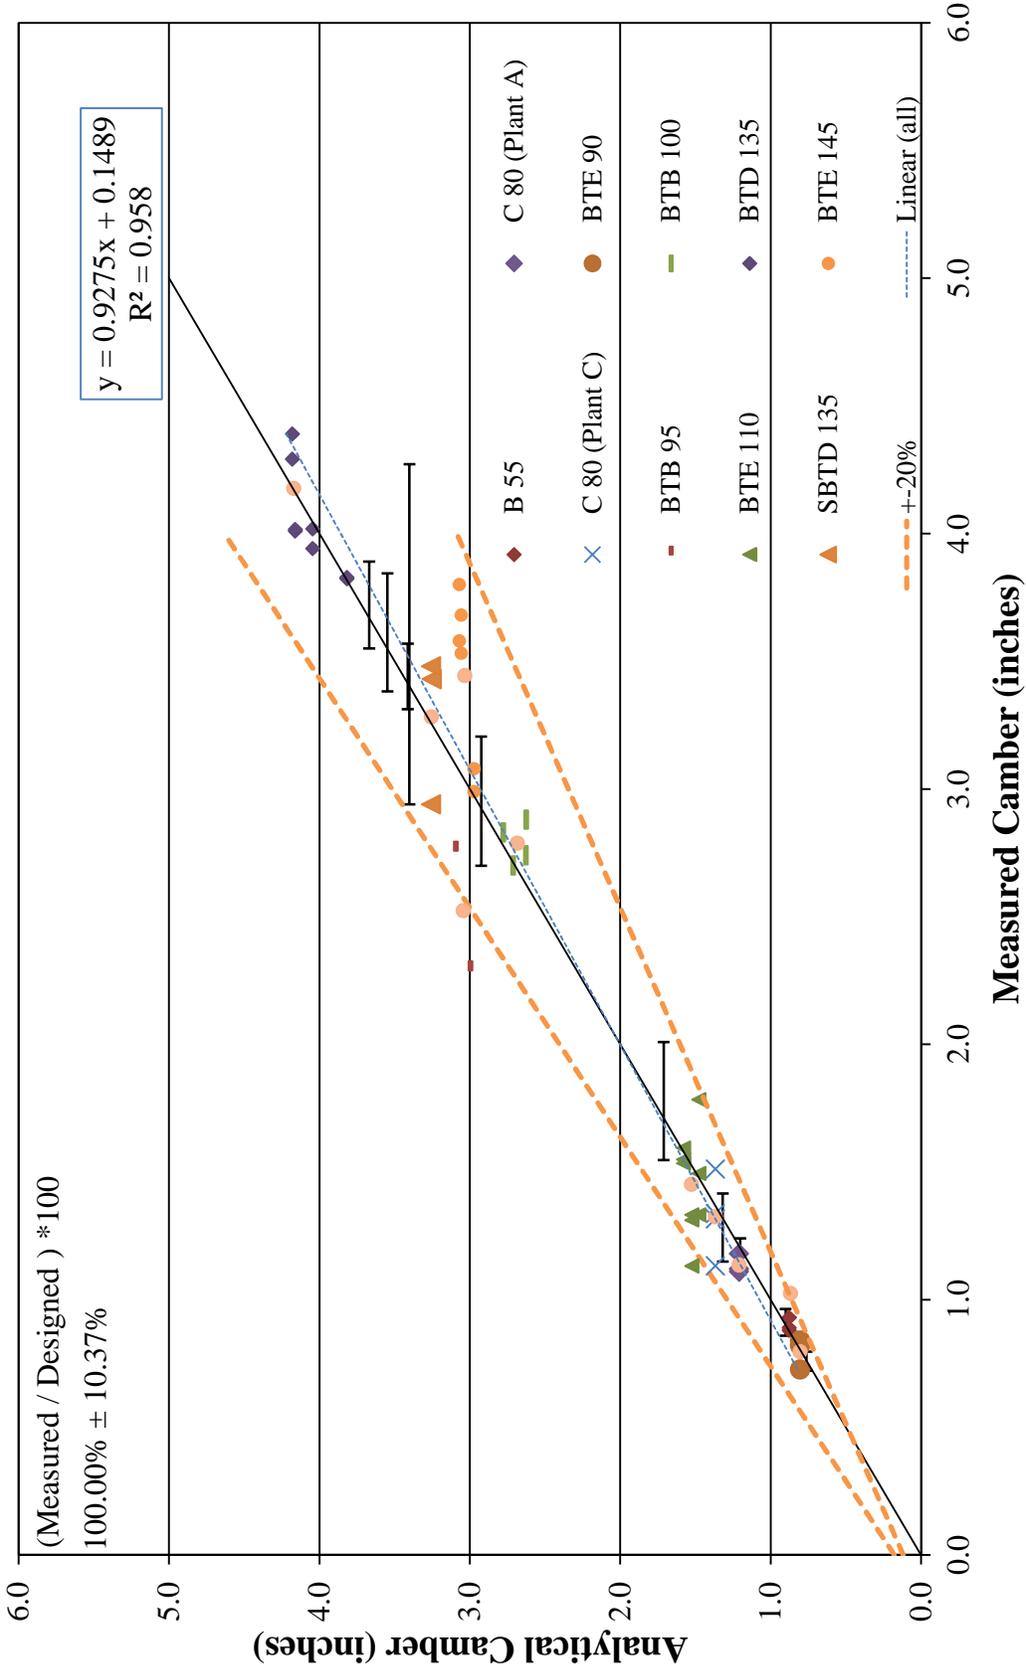
Figure 5-24: Measured Camber vs. Analytical Camber adjusting Camber Values based on Averages using AASHTO E_{ci} from Specific Beam Release Strengths

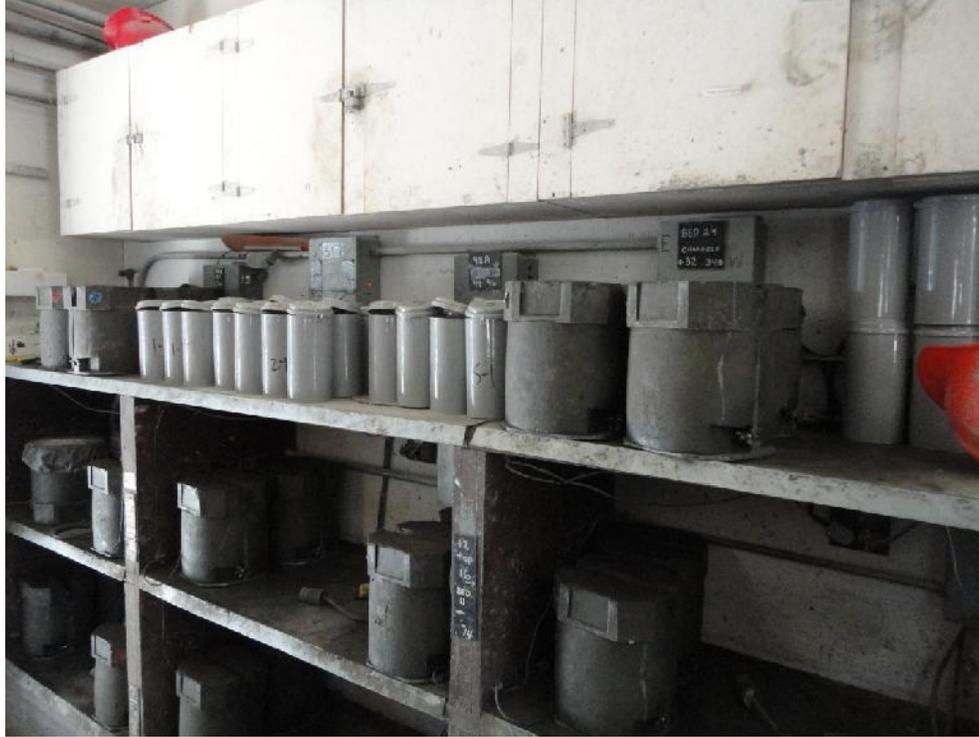
Figure 5-25: Plastic molded and Sure Cure Cylinders

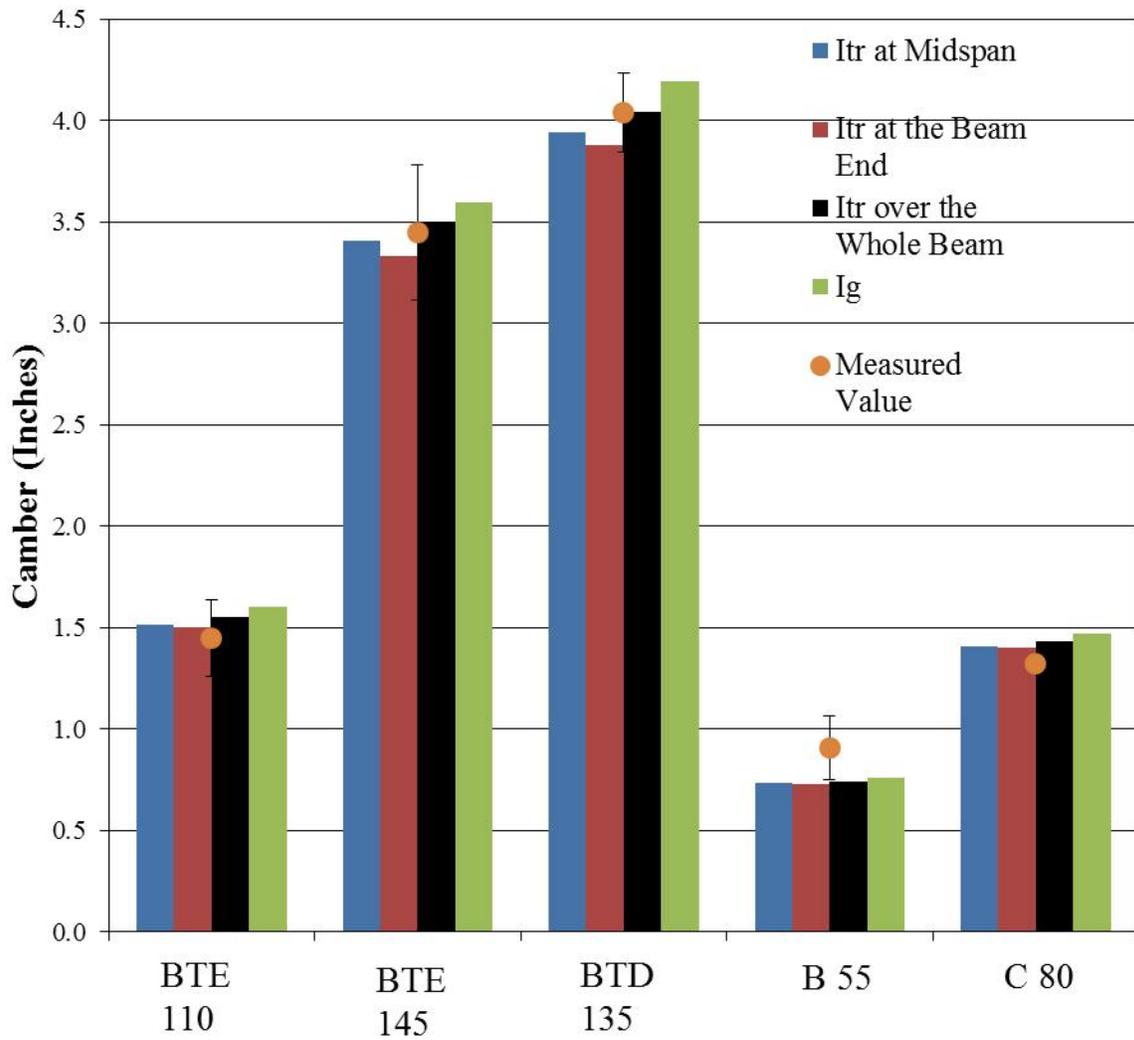
Figure 5-26: Comparison of Camber using Different Moment of Inertia Values

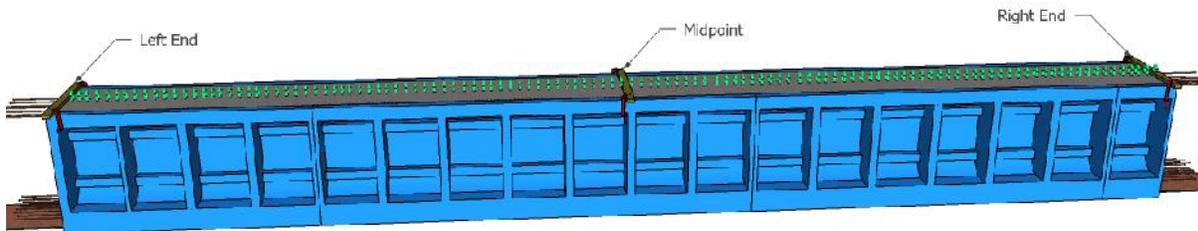
Figure 6-1: PPCB with Locations of 2x4's

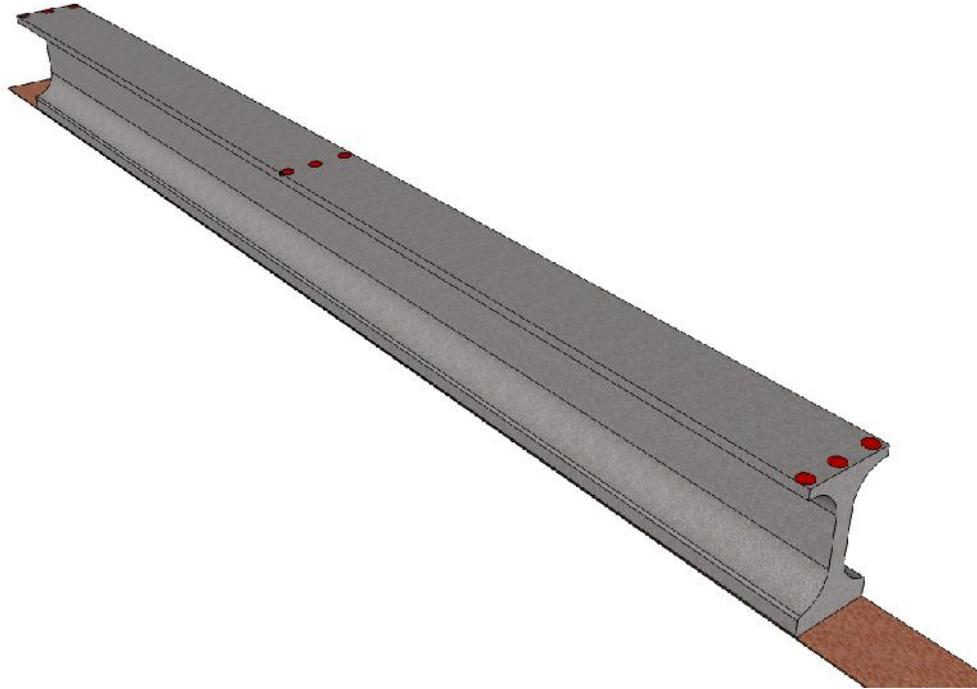
Figure 6-3: Location of Camber Measurements after the Transfer of Prestress

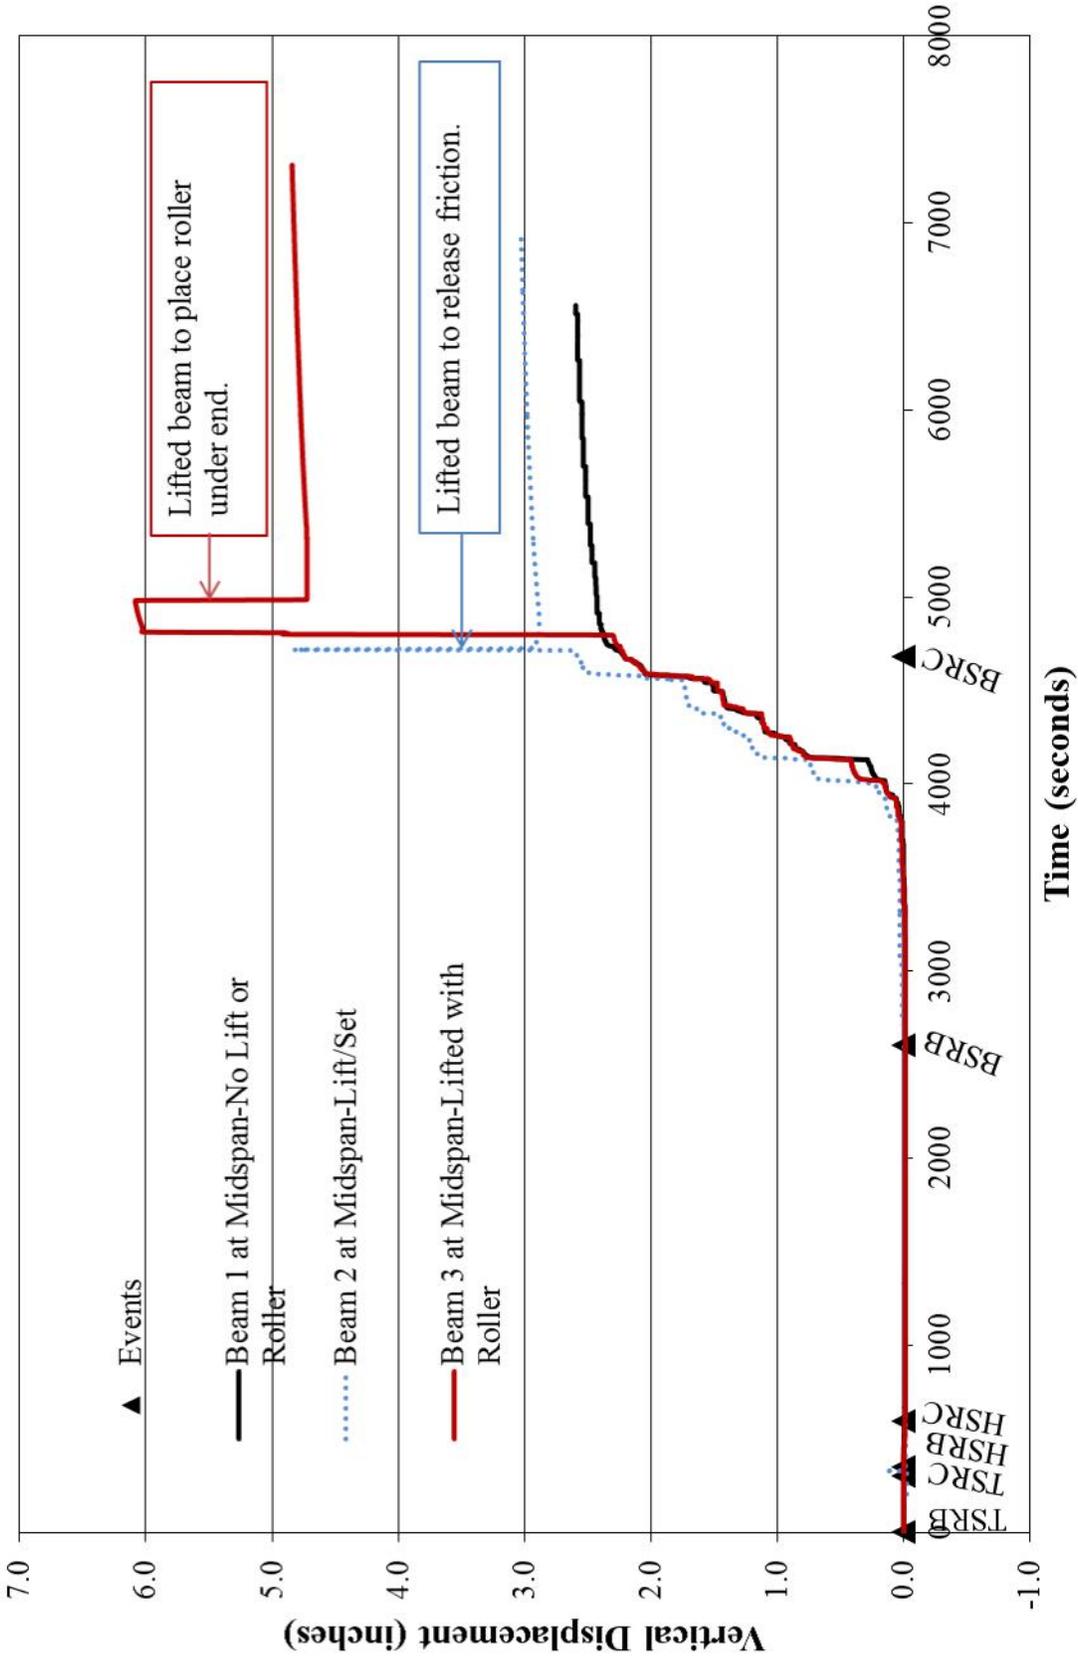
Figure B-9: Time vs. Vertical Displacement for 3 D110 PPCBs with Different Support Conditions after the Transfer of Prestress
