Improving predictions of instantaneous camber for prestressed concrete bridge girders

A thesis submitted to the graduate faculty

Major: Civil Engineering (Structural Engineering)

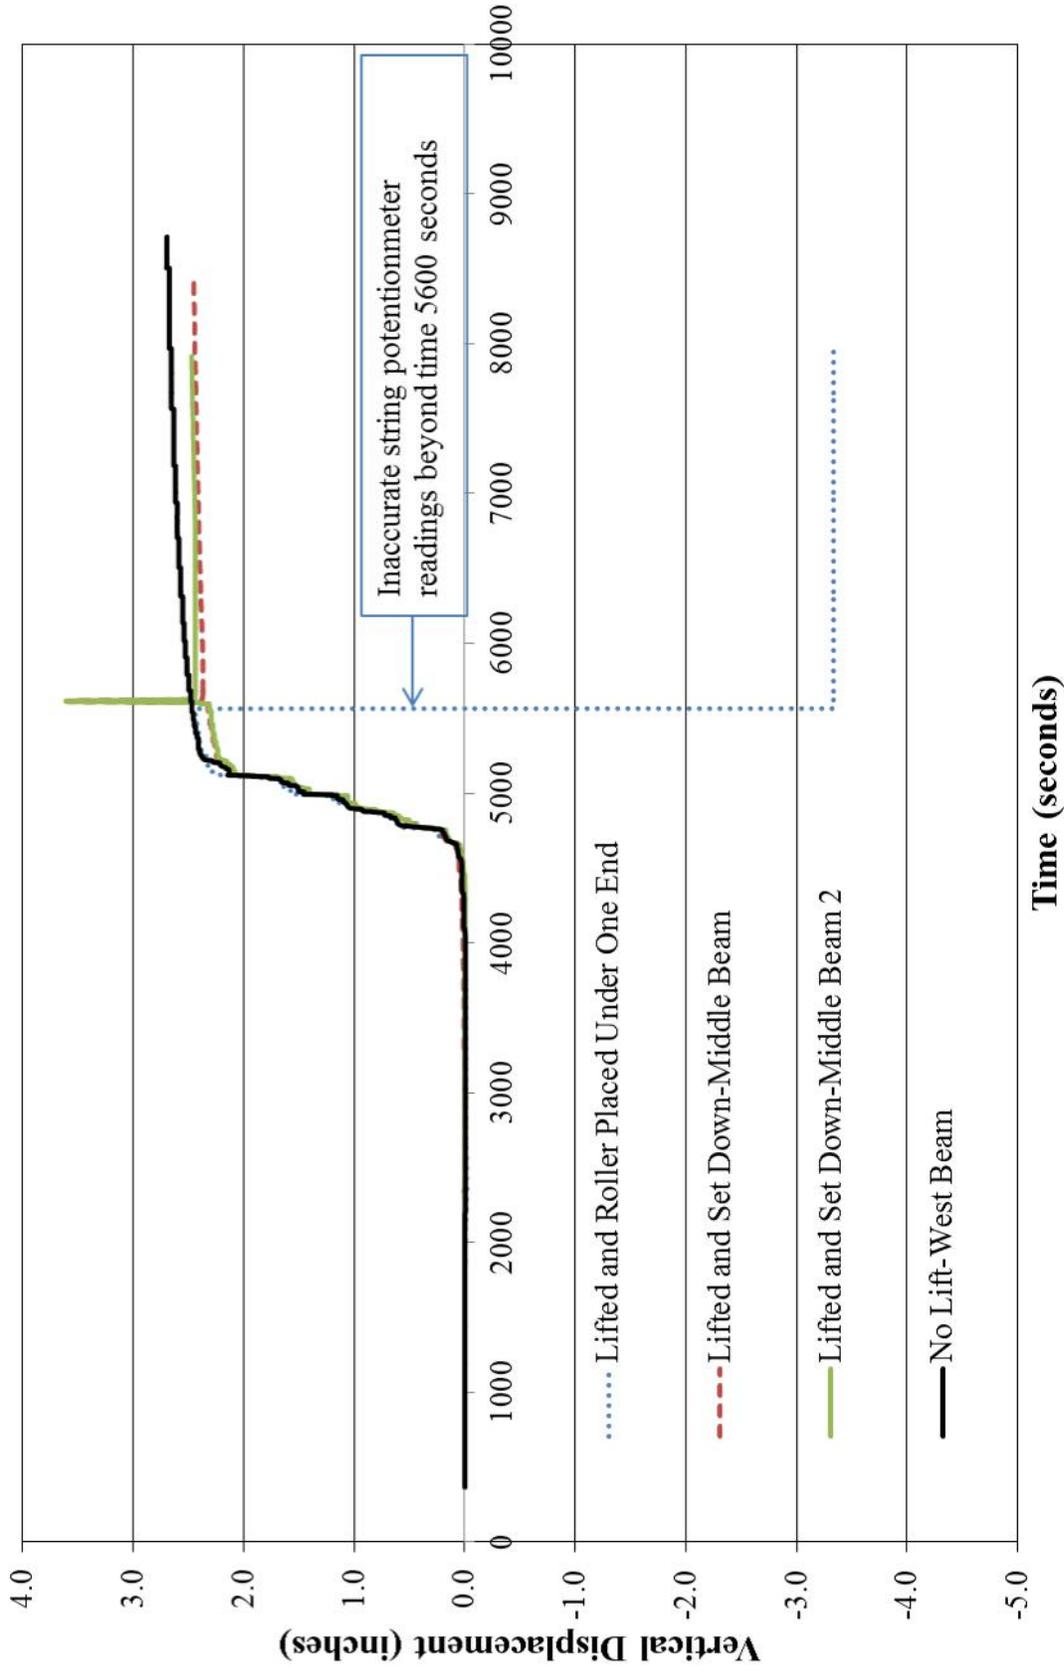
Figure B-33: Time vs. Vertical Displacement of 3 D 110 PPCBs with Different Support Conditions after Transfer of Prestress
