Increasing service life at bridge ends of moveable abutment bridges

A thesis submitted to the graduate faculty

Major: Civil Engineering (Structural Engineering)

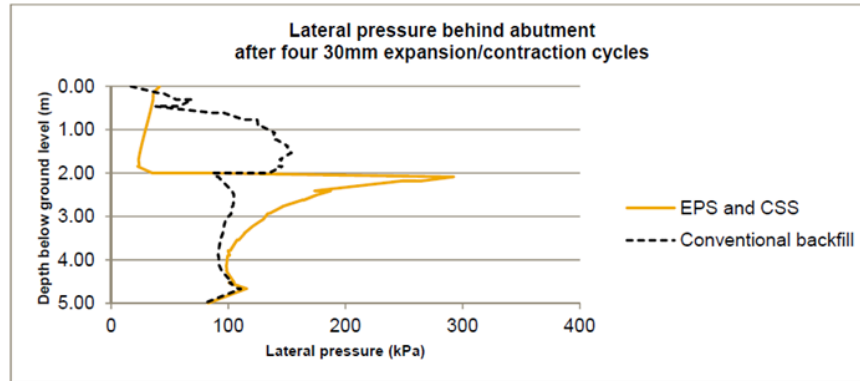
Figure 2.5. Comparison of Horizontal Stress behind Abutment after Fourth Cycle of 30mm Bridge Expansion (Varmazyar et al. 2017)

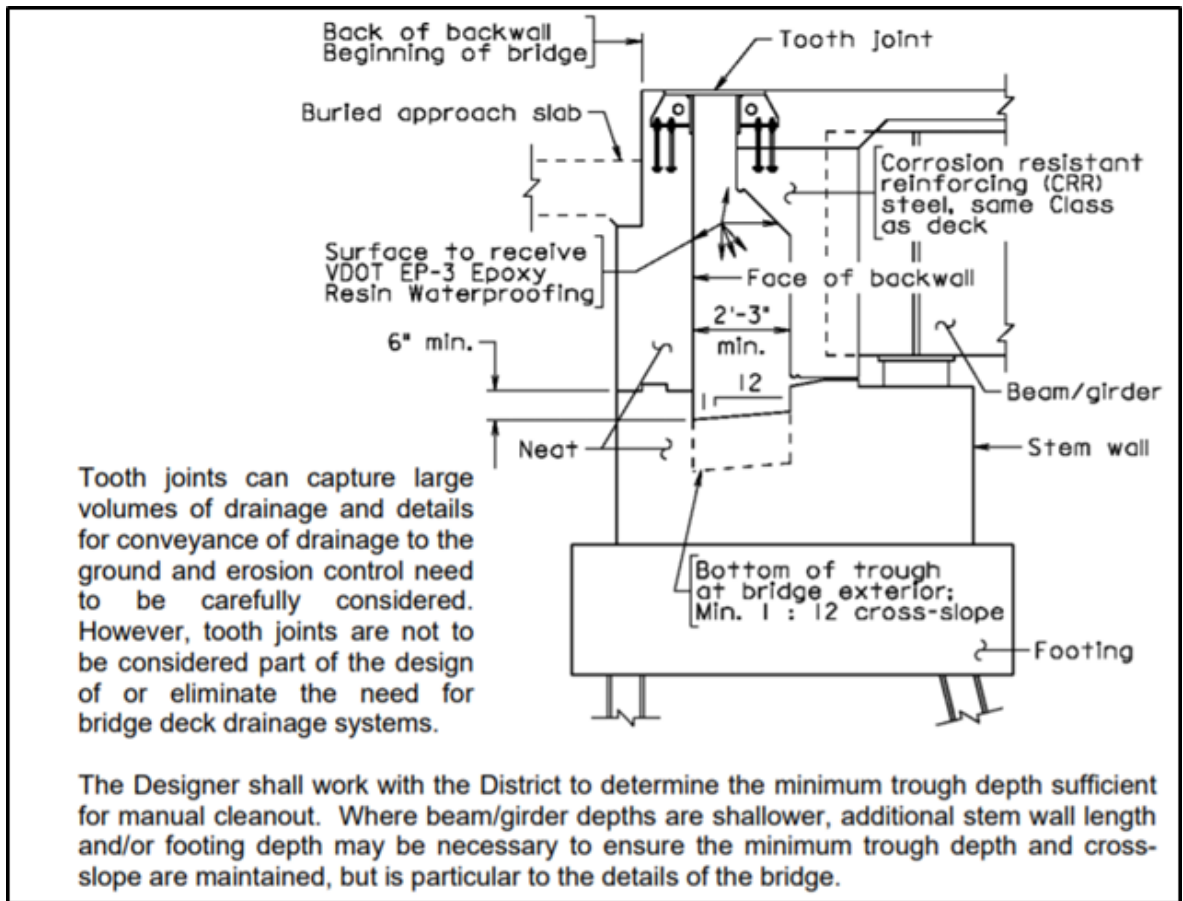
Figure 2.12. Example Detail of Virginia Abutment (VDOT Manual of the Structure and Bridge Division p.17.01-4)

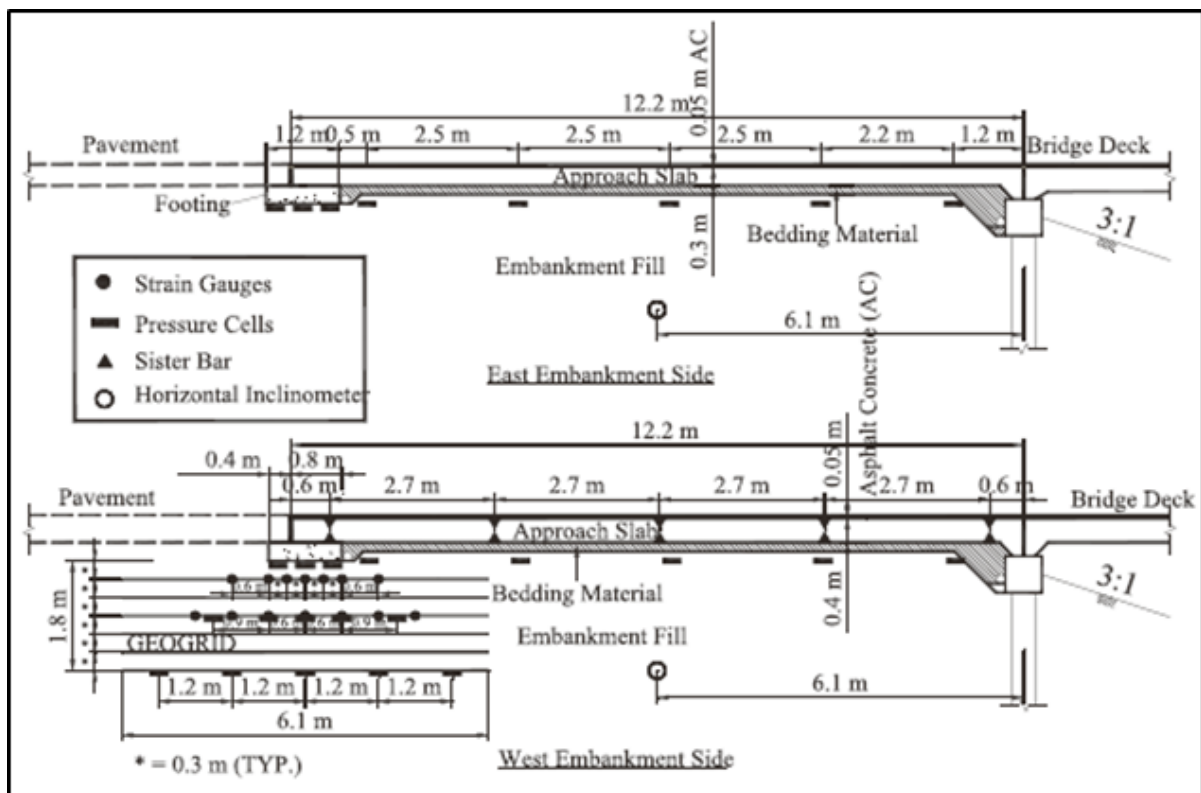
Figure 2.21. Standard and New Approach Slab Design Systems (Chen and Abu-Farsakh 2016)

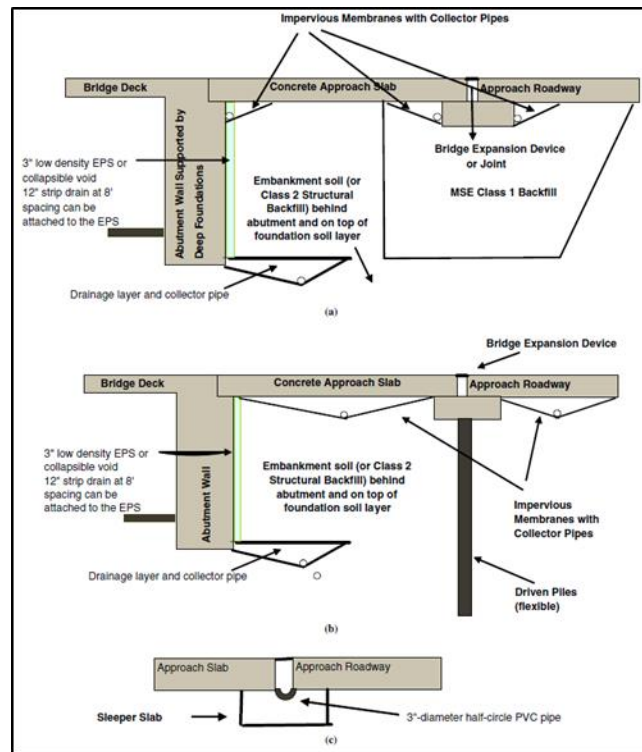
Figure 2.23. Recommended Supporting Systems and Drainage Details for Sleeper Slab: (a) Placement of MSE Wall under Sleeper Slab, (b) Use of Class 2 Backfill and Driven Piles to Support Sleeper Slab, and (c) Placement of Gutter and Half-Circle PVC Pipe to Drain Water (Abu-Hejleh et al. 2008)

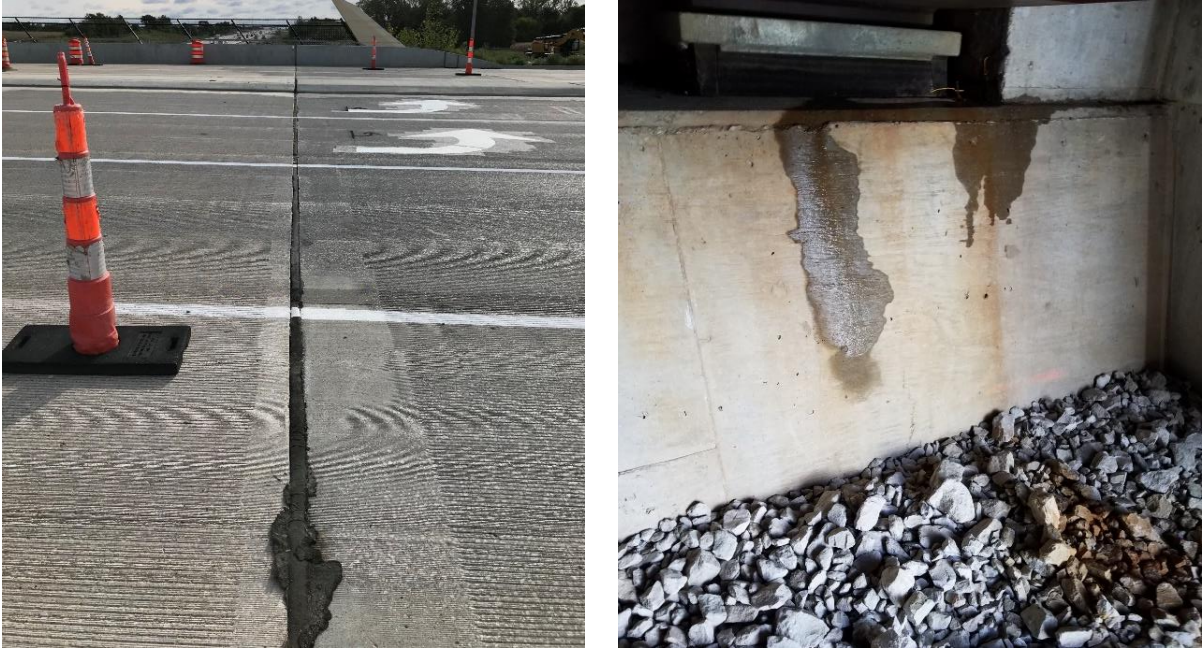
Figure 4.1. (a) South Bridge Deck to Approach Slab Joint with Excess Sealant (left), (b) Water and Abutment Staining at the Outermost Girder (right)

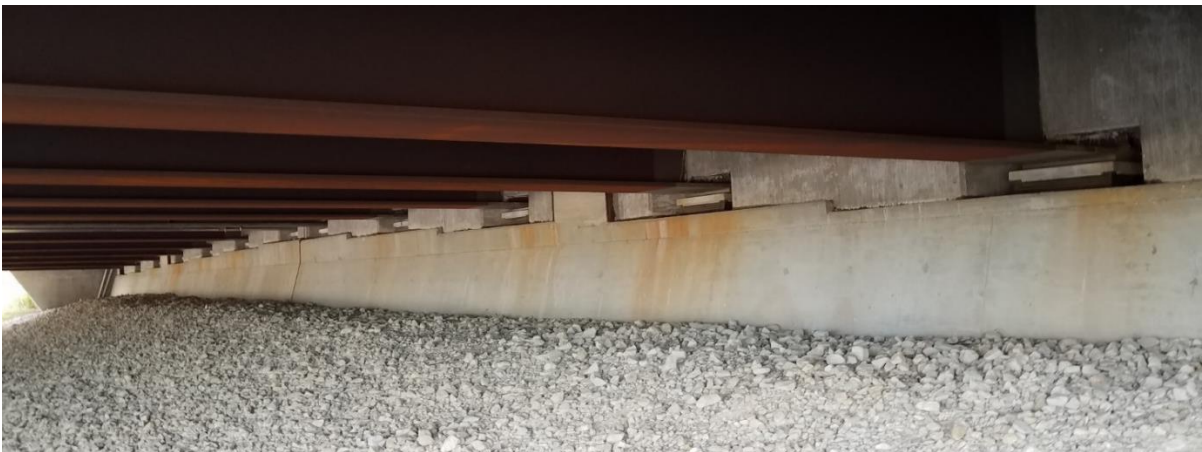
Figure 4.2. North Abutment Face

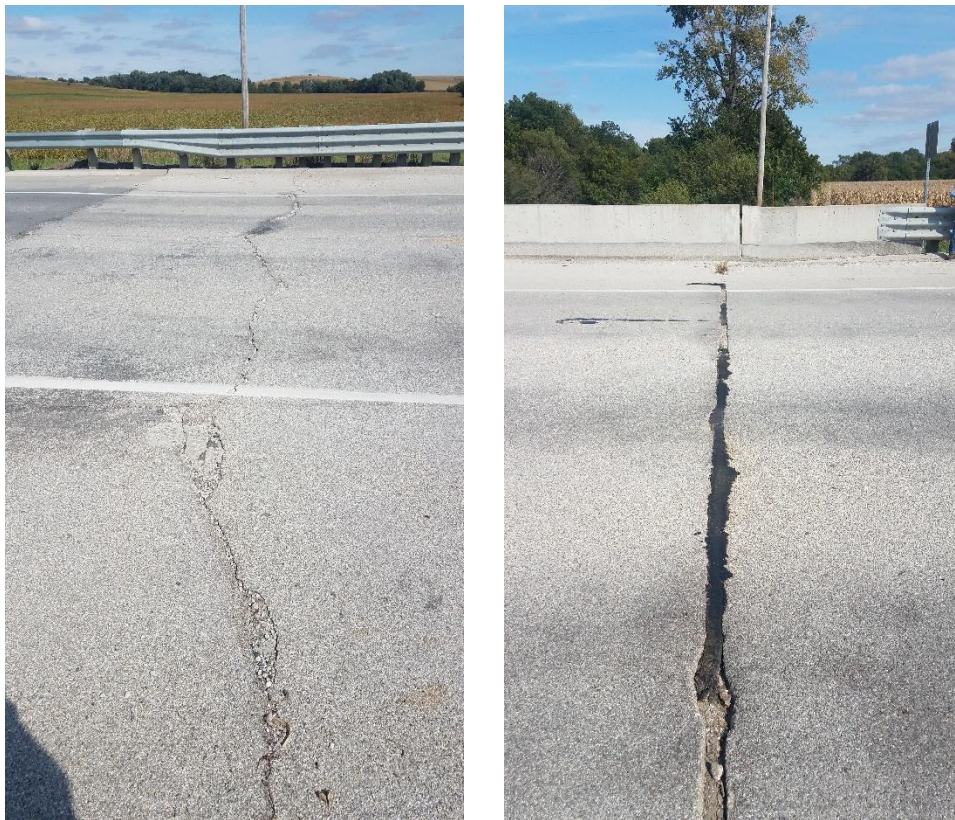
Figure 4.3. (a) Transverse Approach Slab Crack (left), (b) Bridge Deck to Approach Slab Joint (right)

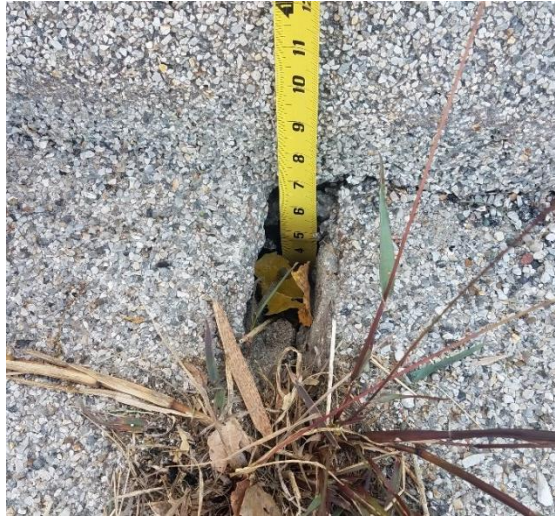
Figure 4.4. Void at the Intersection of Deck to Approach Joint and Barrier

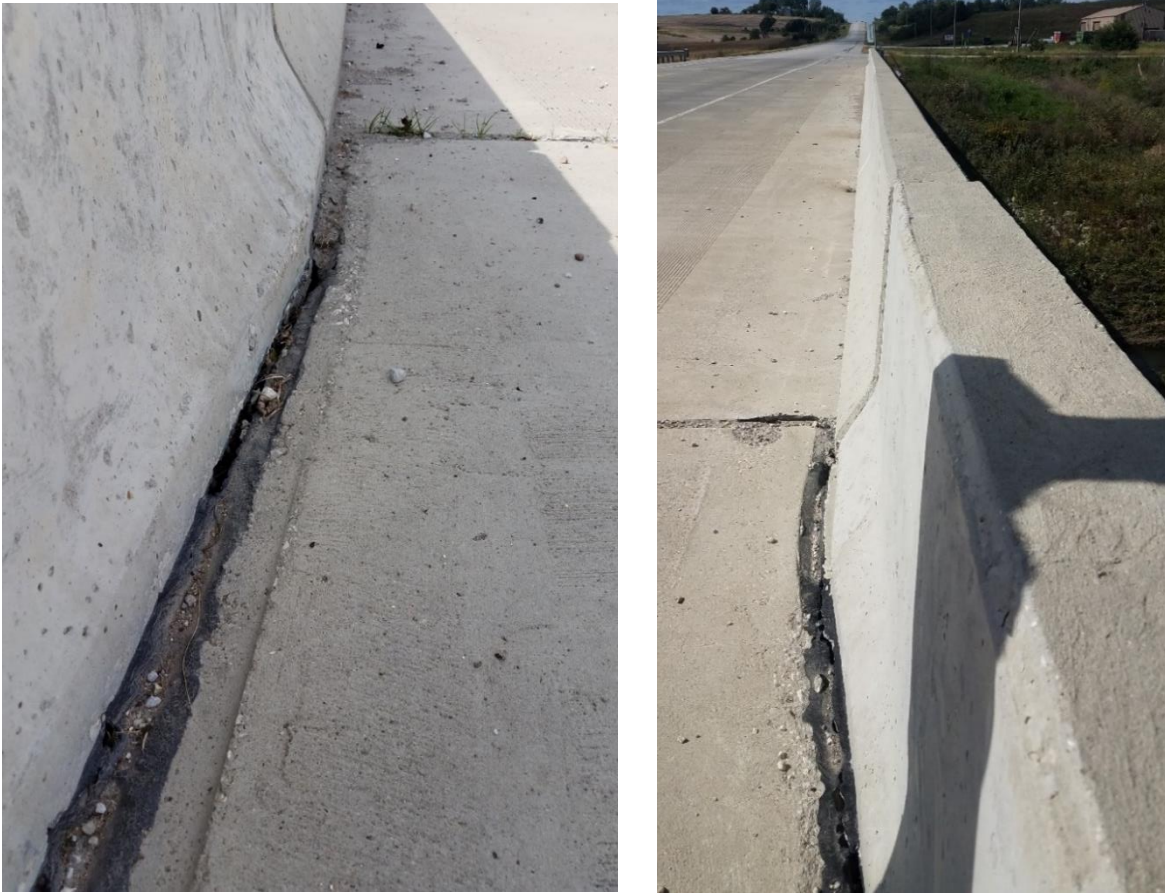
Figure 4.5. (a) Approach Slab to Wingwall Joint Showing Separation (left), (b) Misaligned Wingwall and Barrier (right)

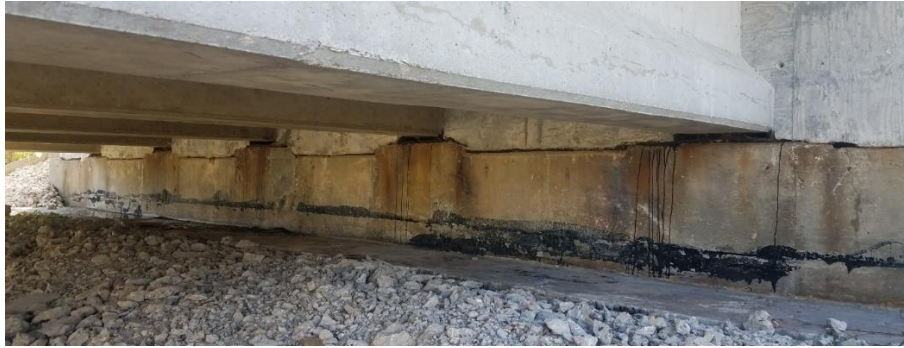
Figure 4.7. Abutment Face Showing the New Backwall on top of the Old Footing

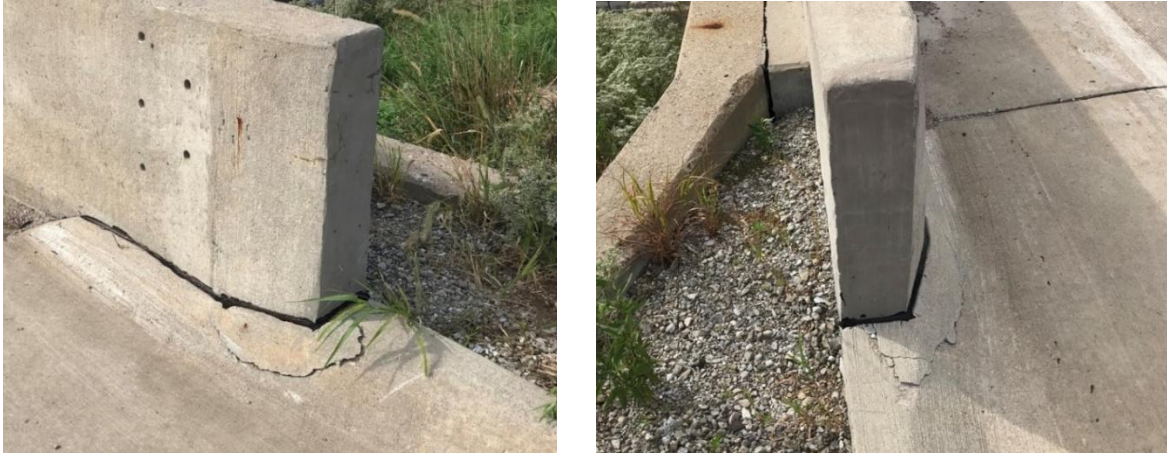
Figure 4.8. (a) Concrete Cracking at the end of the Wingwall (left), (b) Additional Cracking at the end of the Wingwall (right)

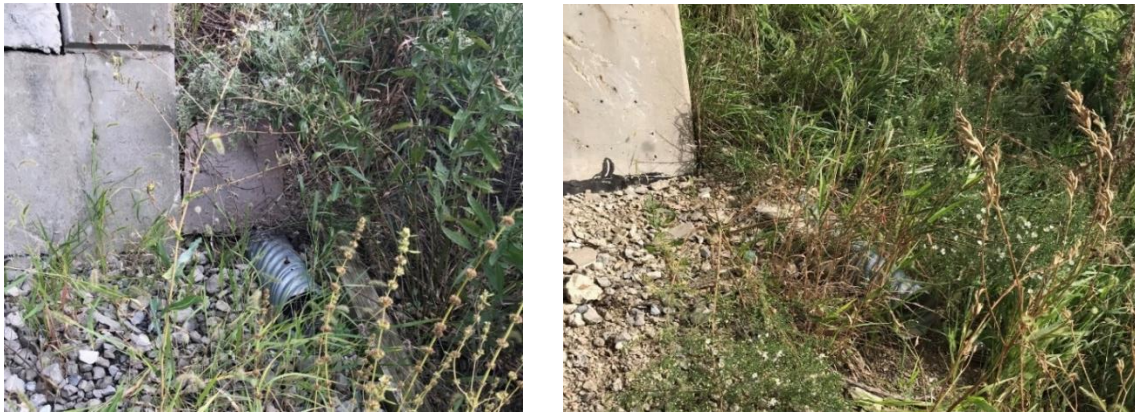
Figure 4.9. (a) Blocked Embankment Drainage (left), (b) Additional Blocked Embankment Drainage (right)

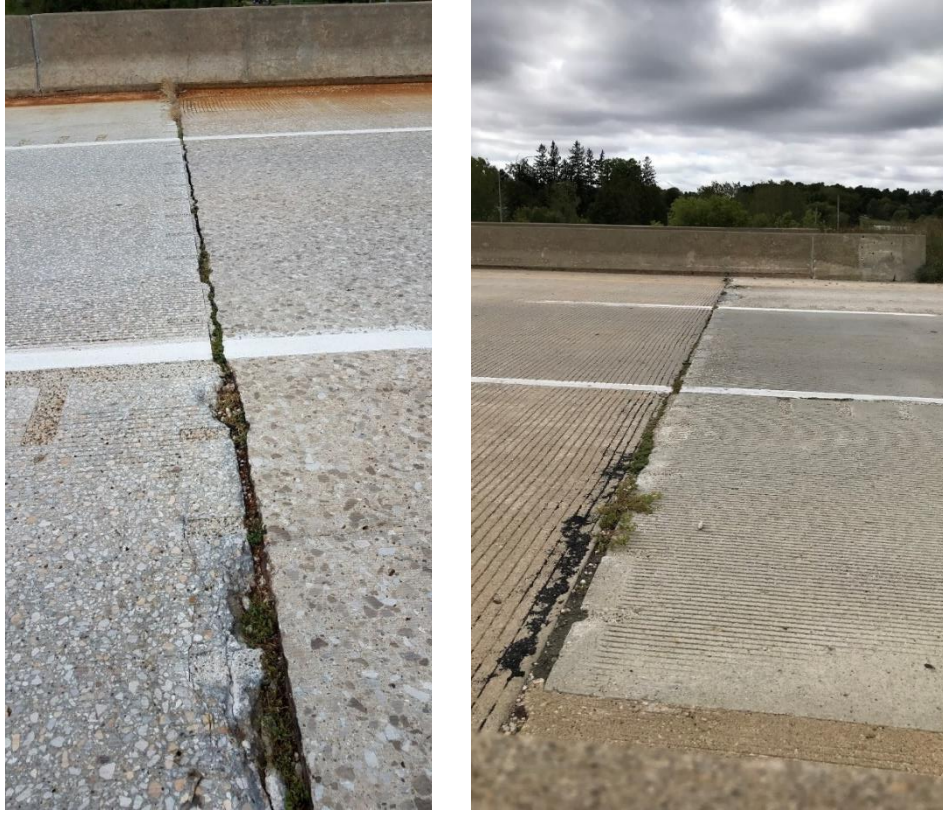
Figure 4.10. (a) Deck to Approach Slab Joint Showing Severe Spalling (left), (b) Additional Deck to Approach Slab Joint Showing Severe Spalling (right)

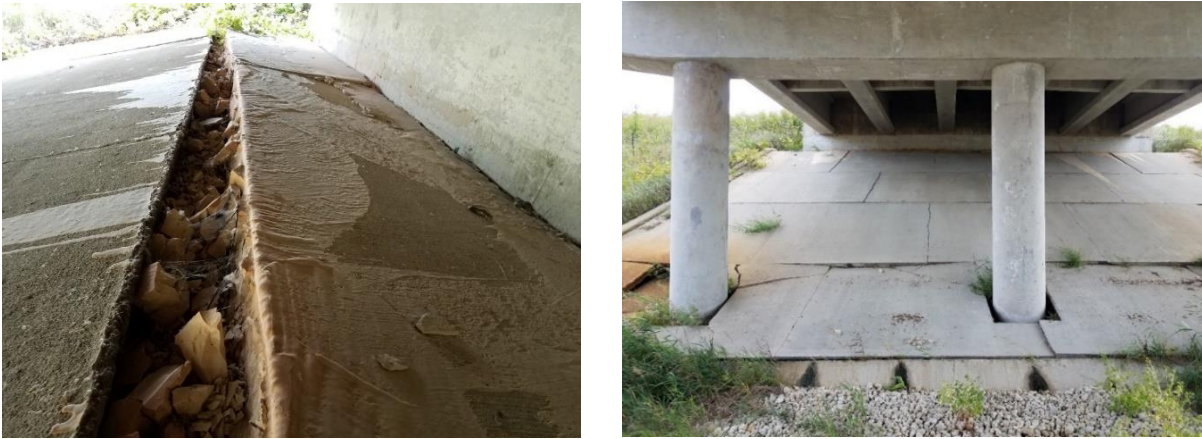
Figure 4.11. (a) Typical Embankment Condition (left), (b) Embankment Condition at the Abutment (right)

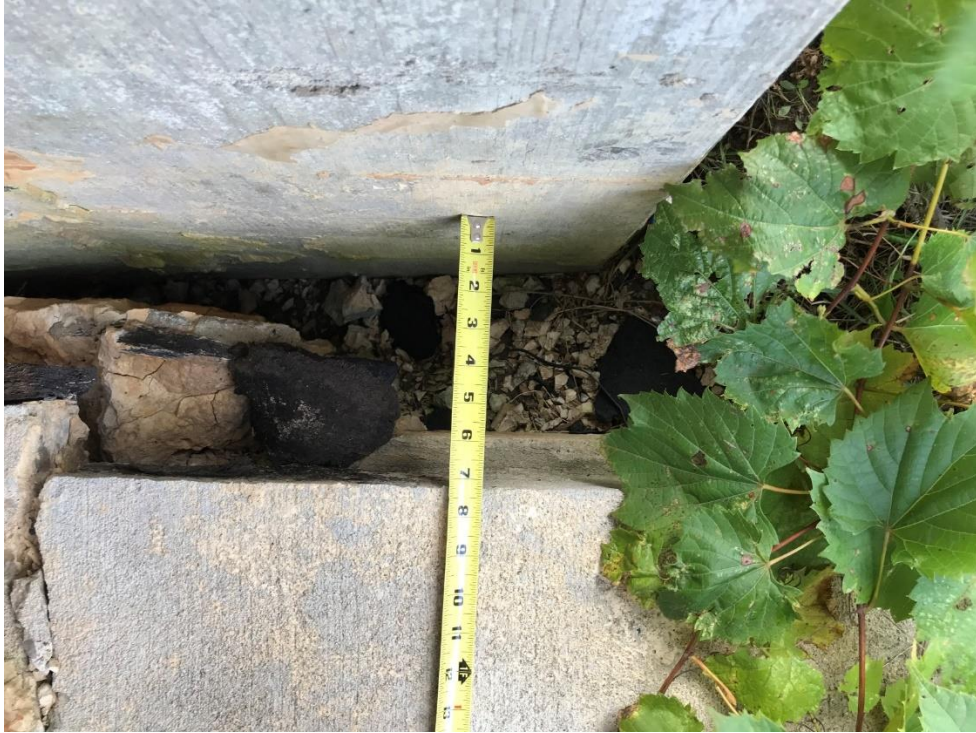
Figure 4.12. Horizontal Void Created by the Embankment Pulling away from the Abutment

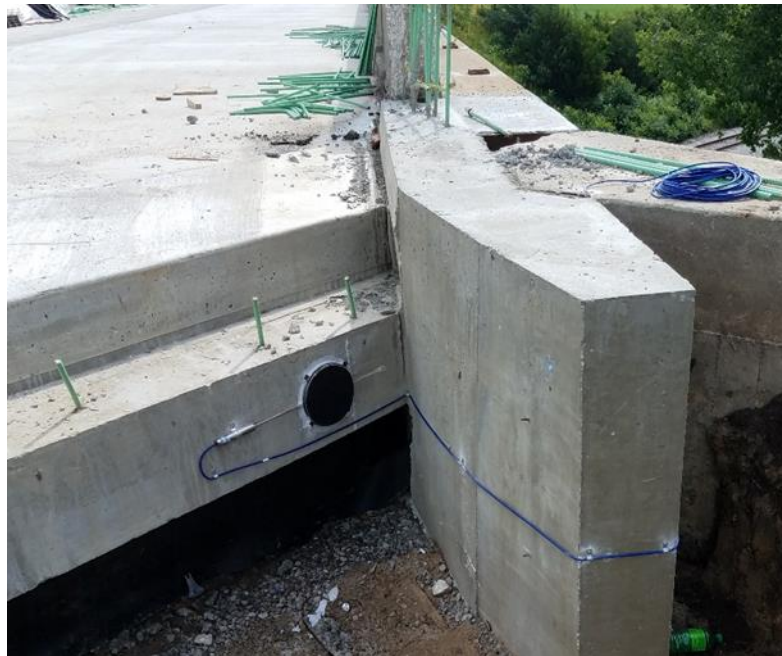
Figure 5.4. Jasper - EP1-W Earth Pressure Sensor after Installation

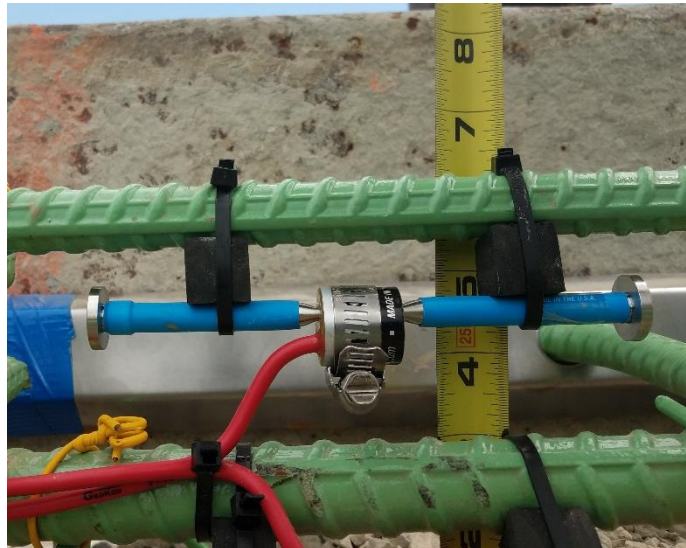
Figure 5.5. Jasper - Typical Strain Gauge Installation

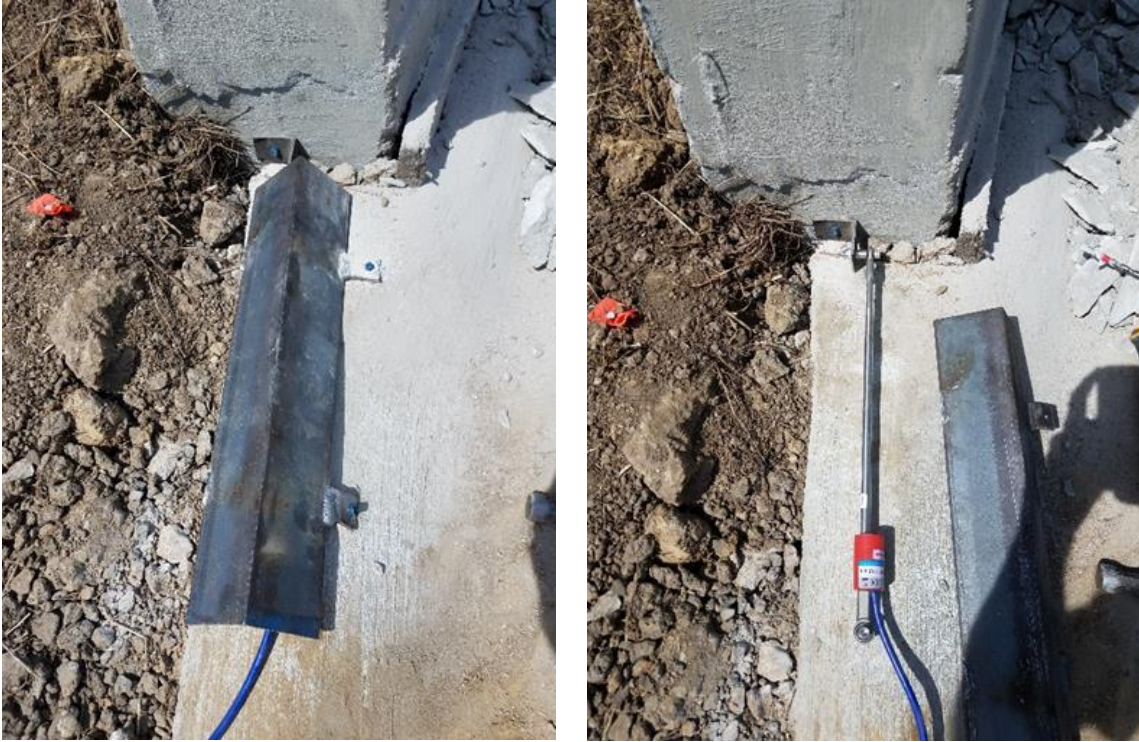
Figure 5.6. Jasper - (a) Crackmeter without Protective Cover (left), (b) Crackmeter with Protective Cover Installed (right)

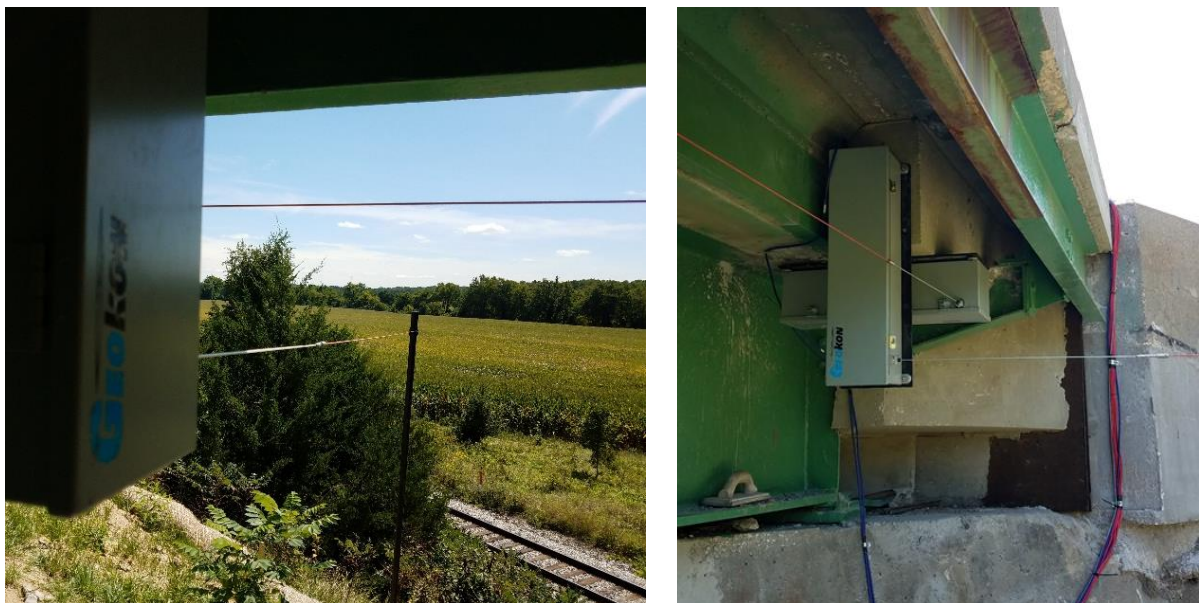
Figure 5.7. Jasper - (a) Displacement Transducer with Reference Post (left), (b) Longitudinal and Transverse Displacement Transducers Attached at the Acute Bridge Corner (right)

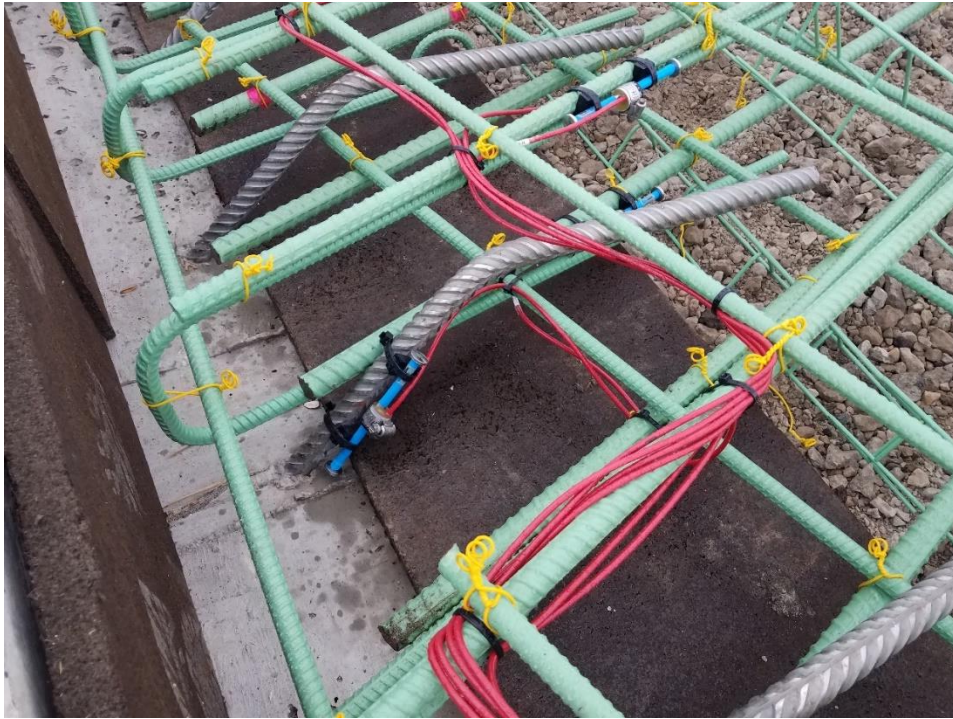
Figure 5.26. Story - Strain Gauges Installed on the Longitudinal Rebar and Tie Bars

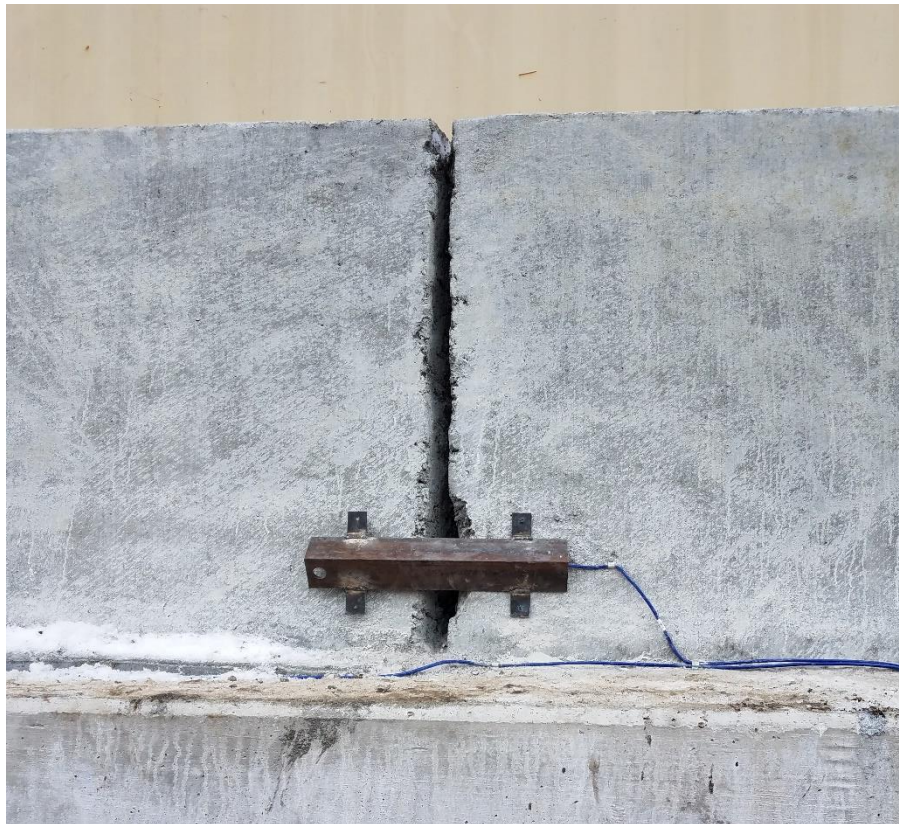
Figure 5.27. Story - Crackmeter Installation across the Barrier Rail Joint

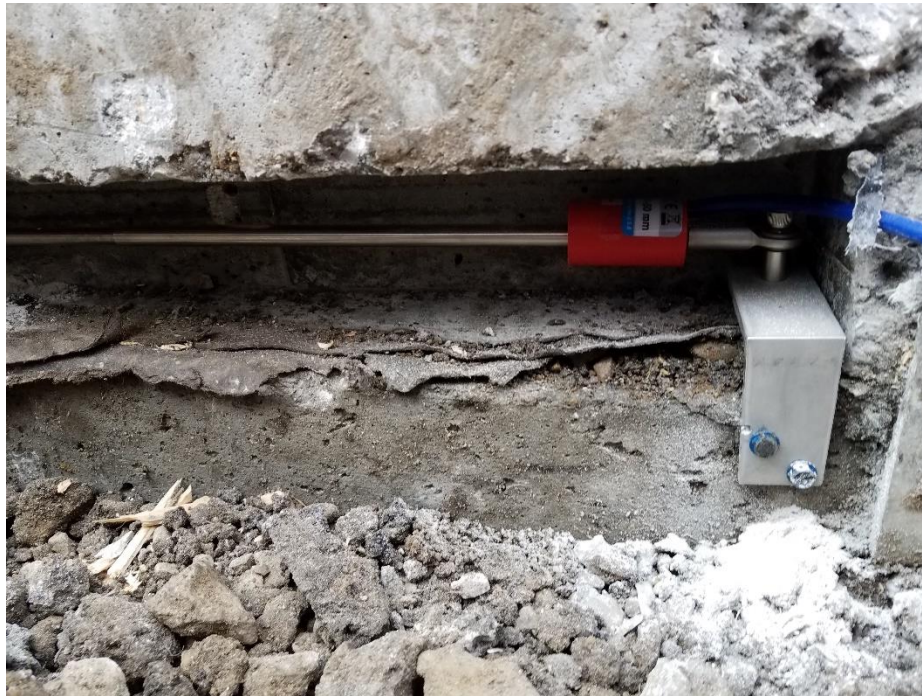
Figure 5.28. Story - Crackmeter Approach Slab Side Blockout Location

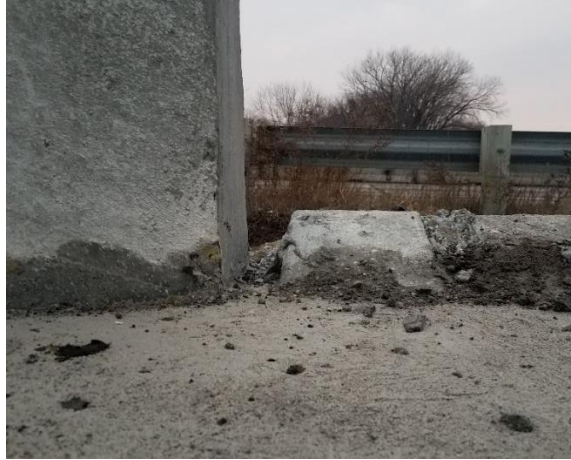
Figure 5.40. Story - Curb Gap at the Barrier End (Typical)

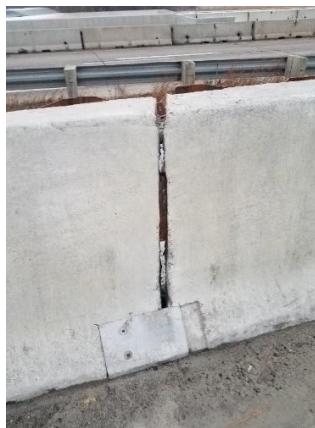
Figure 5.41. Story - Open Barrier Joint (Typical)

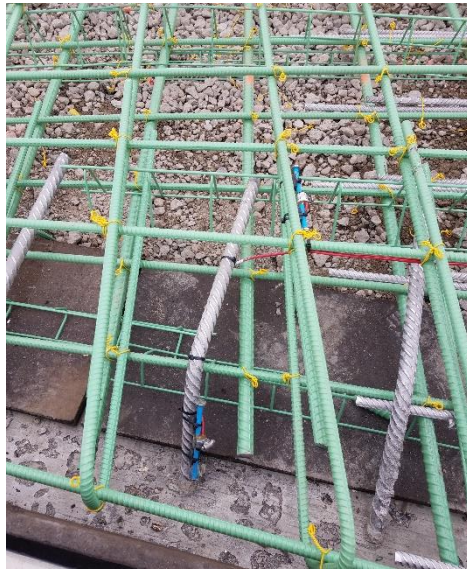
Figure 5.43. Story - Approach Slab Modified Subbase Condition Immediately before Concrete Pouring

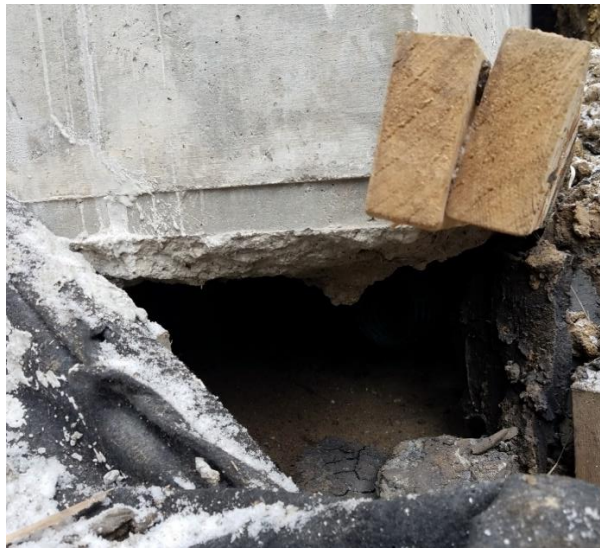
Figure 5.44. Story - Large Void under the South Abutment Corner

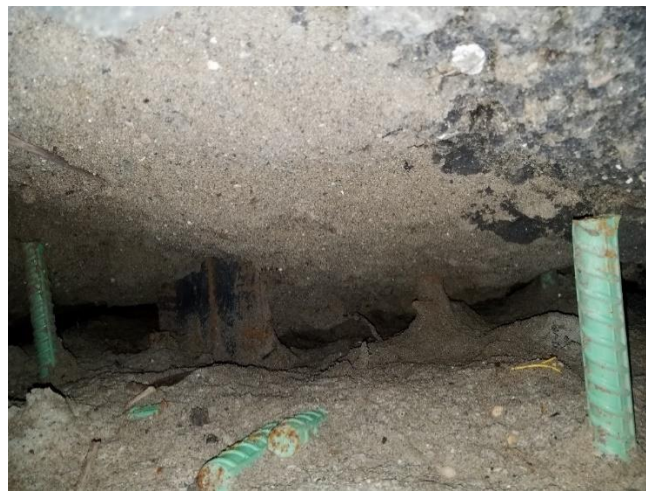
Figure 5.45. Story - Visible Exposed Rebar and Foundation Pile
