Innovations in integral abutment connection details for accelerated bridge construction

Austin James DeJong
Iowa State University

MASTER OF SCIENCE

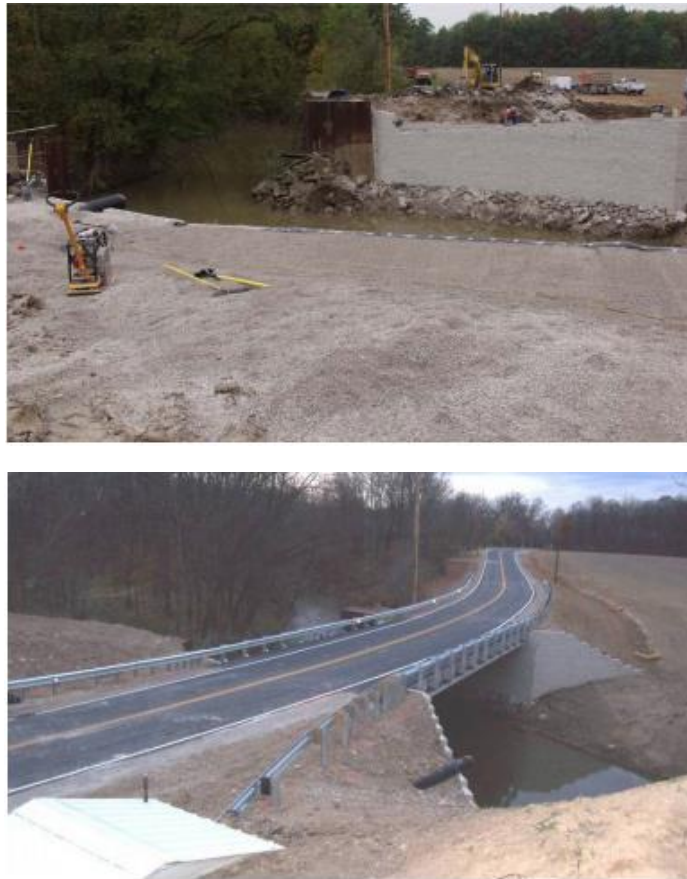
Figure 2.4 *GRS-IBS bridge in Ohio. GRS Abutment during construction (top). Completed bridge built in 47 days (bottom).* (Culmo M. P., 2011)

the systems to act as one whole unit. The geosynthetic walls are direct supports for the superstructure, which allows the superstructure to settle with the approach fill removing the requirement for an approach slab. Ohio implemented this abutment system for a bridge (Figure 2.4) and it was reported that the GRS-IBS abutments could be constructed in one week or less, since there is no curing time for cementitious materials, and resulted in a total construction time of approximately eight weeks (Culmo M. P., 2011).

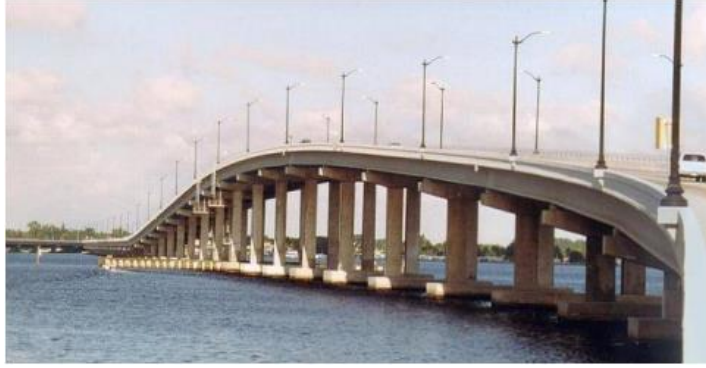
Figure 2.10 *Precast open frame pier bent constructed bridge in Florida.* (Culmo M. P., 2011)

Another example of PBES for piers is the use of prefabricated open frame bent caps. Projects done in Florida, Utah, and Georgia, shown in Figures 2.10 through 2.12, respectively, have shown successful connections between precast bent caps and precast columns made with grouted sleeve reinforcing bar couplers. The erection of precast concrete piers can be conducted rather swiftly compared to conventional construction practices, some typical pier bents may be installed in two days after the footings are properly placed (Culmo M. P., 2011).

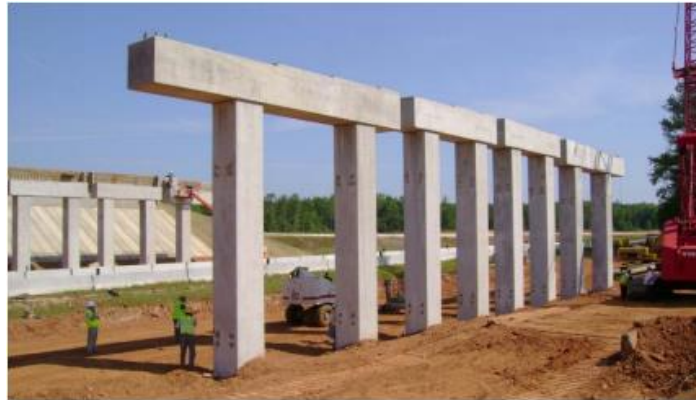
Figure 2.12 *Precast open frame pier bent constructed in Georgia.* (Culmo M. P., 2011)

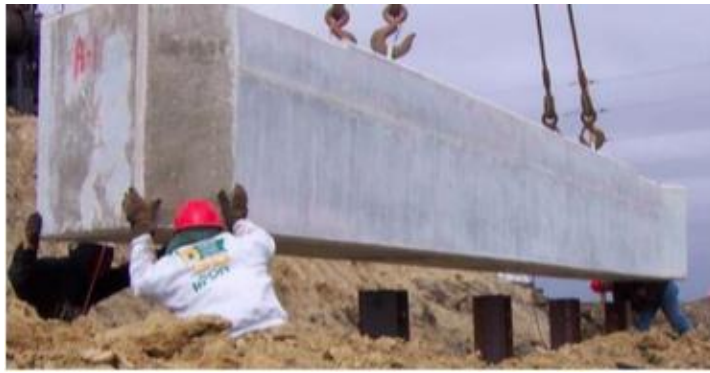
Figure 2.18 *Abutment cap being lowered in place.* (Wipf, Klaiber, & Hockerman, 2009)

County, Iowa. The replacement bridge was designed to use integral abutments using abutment caps with CMP voids for the five H-piles per abutment and used pier caps with CMP voids for the nine pipe piles per pier. After the piles were driven and cut to their final elevation, the caps were delivered to the site and placed in approximately fifteen minutes without any significant issues. Figures 2.18 through 2.22 show the process of placing the caps and filling the CMP voids with concrete.

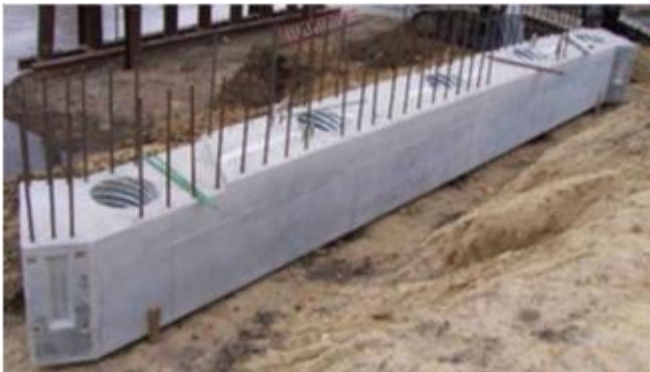
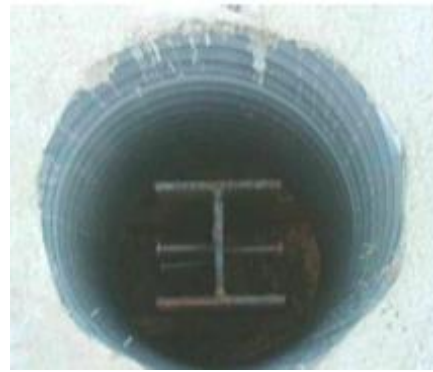
Figure 2.19 *Abutment cap final position (left) H-pile in CMP void (right).* (Wipf, Klaiber, & Hockerman, 2009)

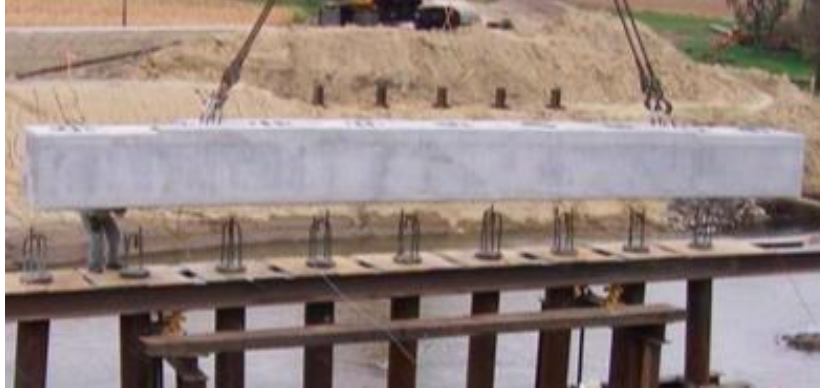
Figure 2.20 *Pier cap being lowered in place.* (Wipf, Klaiber, & Hockerman, 2009)

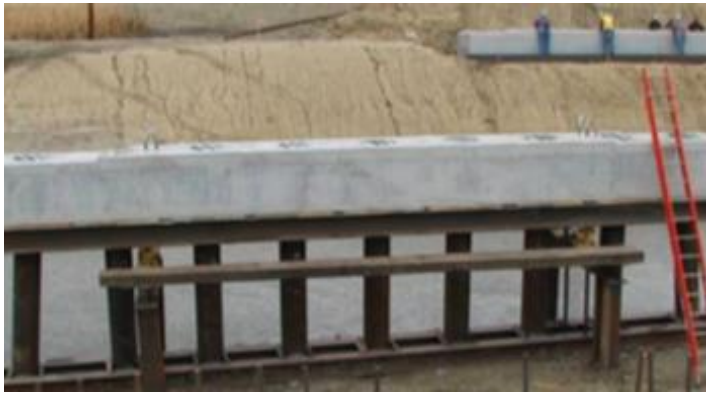
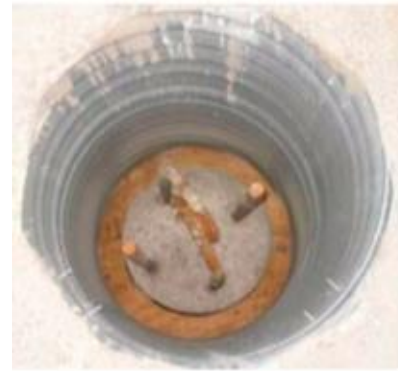
Figure 2.21 *Pier cap final location (left) Pipe pile in CMP void (right).* (Wipf, Klaiber, & Hockerman, 2009)

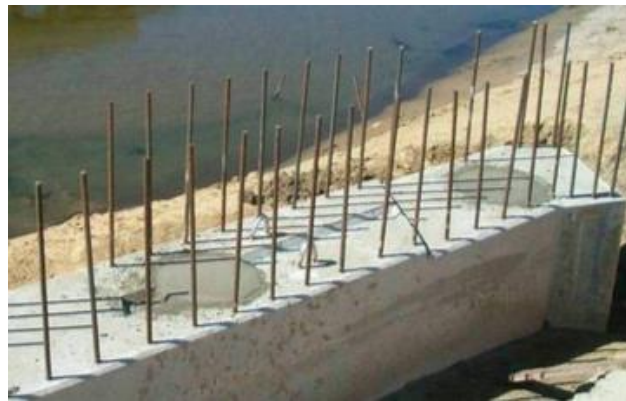
Figure 2.22 *Finished abutment cap with CMP voids filled.* (Wipf, Klaiber, & Hockerman, 2009)

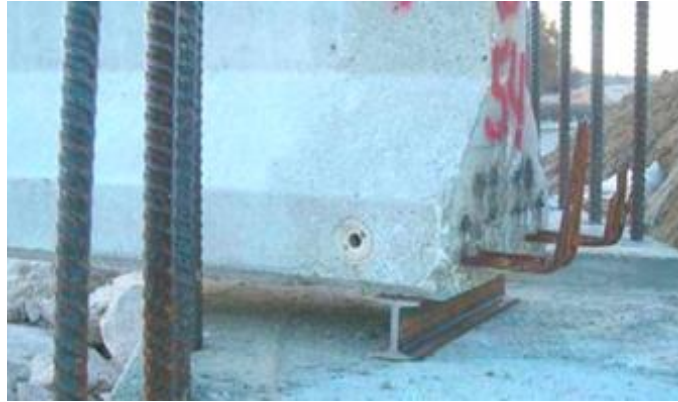
Figure 2.23 *Beam end supported by abutment cap by steel beam to provide clearance for concrete placement.* (Wipf, Klaiber, & Hockerman, 2009)

the beams ends was prepared on the abutment and pier caps. Figures 2.23 through 2.27 show the process of placing the beams, preparing the beam ends to be cast in concrete at the abutment and pier caps, and the final bridge. Unloading the girders and placing them to their final location took approximately ten minutes, each, and all the girders were placed within a day.

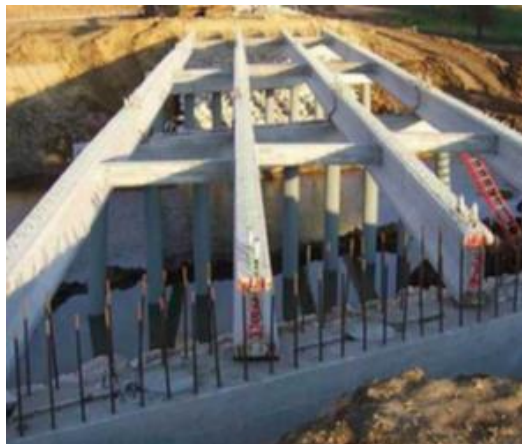
Figure 2.24 *Bridge girders in final locations.* (Wipf, Klaiber, & Hockerman, 2009)

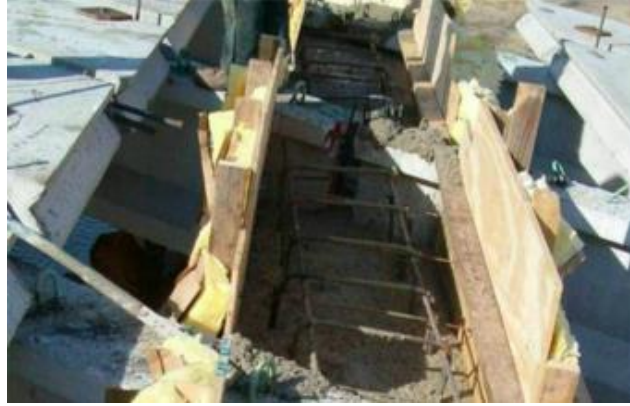
Figure 2.25 *Pier cap diaphragm formwork for beam ends.* (Wipf, Klaiber, & Hockerman, 2009)

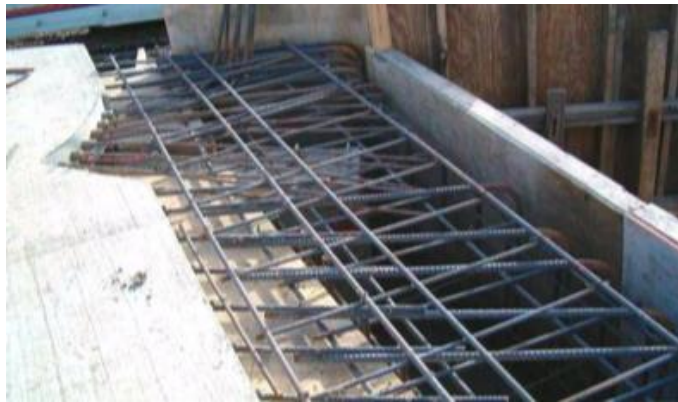
Figure 2.26 *Abutment cap diaphragm formwork for beam ends.* (Wipf, Klaiber, & Hockerman, 2009)

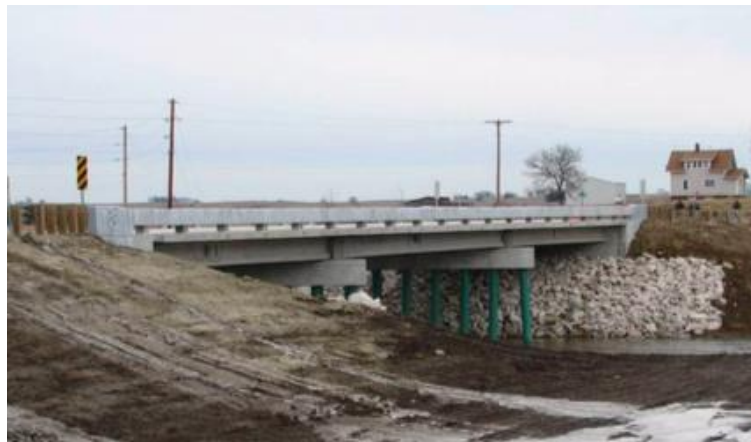
Figure 2.27 *Completed bridge.* (Wipf, Klaiber, & Hockerman, 2009)

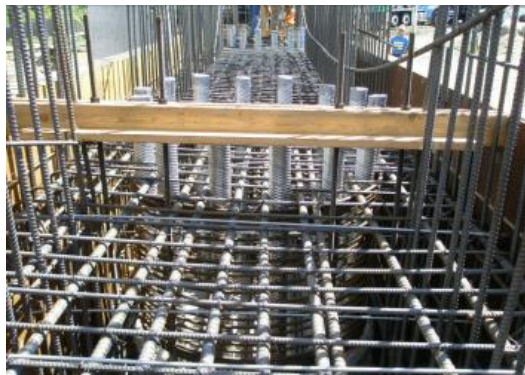
Figure 2.30 *Corrugated ducts in precast cap beam in Washington State. (Kapur, et al., 2012)*

The design for this test was based on the large-diameter bars anchored in corrugated metal ducts connection used by Florida and was then implemented by the Washington State DOT. An example bridge in Washington State is shown in Figures 2.30 and 2.31. (Kapur, et al., 2012)

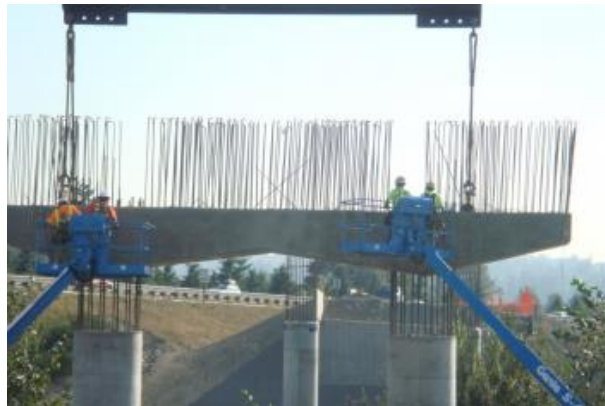
Figure 2.31 *Placement of cap beam on column bars inserted in corrugated ducts in Washington State. (Kapur, et al., 2012)*

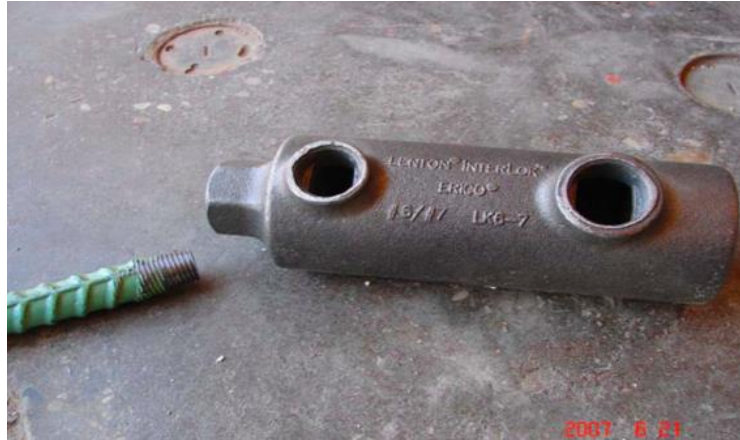
This assumption of an “emulative” design was investigated by the Michigan Department of Transportation (MDOT) (Jansson, 2008). The scope of this project was to determine the suitability of two grout-filled mechanical couplers, the Lenton Interlok and the NMB Splice Sleeve. The Lenton Interlok is a steel sleeve having one end connection completed via threaded reinforcing bar and the other end is connected through having a reinforcement bar placed into the grout filled sleeve (Figure 2.32). The NMB Splice Sleeve is

Figure 2.32 *Lenton Interlok for #6 reinforcing bar.* (Jansson, 2008)

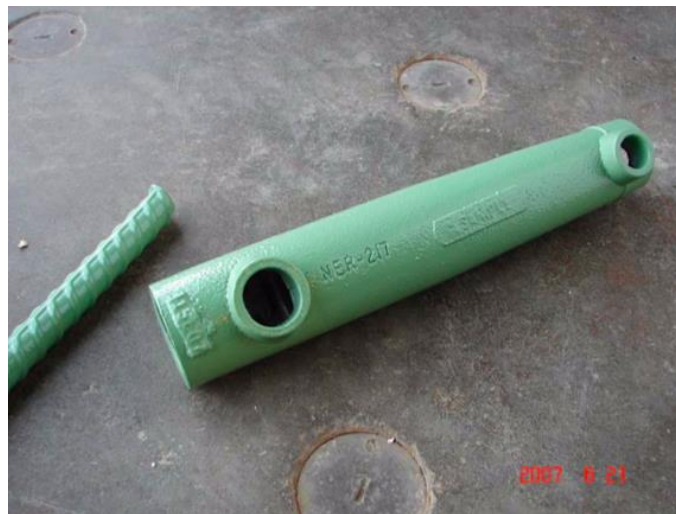
a steel sleeve that has both ends being connected to reinforcing bars through the bars being placed into the grout filled sleeve (Figure 2.33).

Figure 2.33 *NMB Splice Sleeve for #6 reinforcing bar.* (Jansson, 2008)

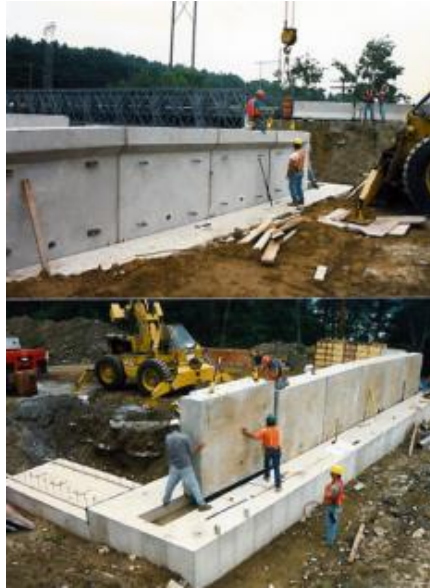
Figure 2.36 *Precast abutment wall and footings with grouted coupler connections in Massachusetts.* (Kapur, et al., 2012)

Massachusetts has also used the grouted splice coupler to connect precast abutment walls to precast footings (Figure 2.36), but they have also reported using these couplers to connect longitudinal bars in precast superstructure (Figure 2.37) (Kapur, et al., 2012).

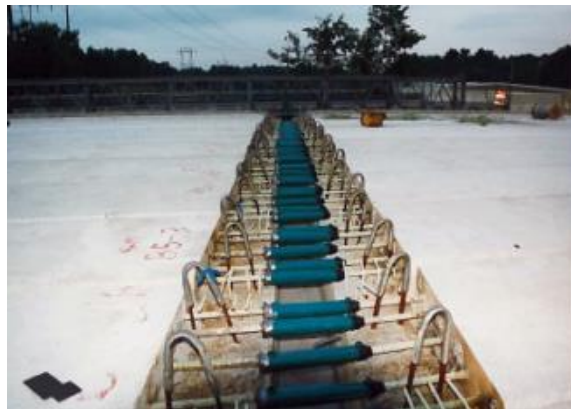
Figure 2.37 *Grouted coupler as continuity splice over pier in Massachusetts.* (Kapur, et al., 2012)

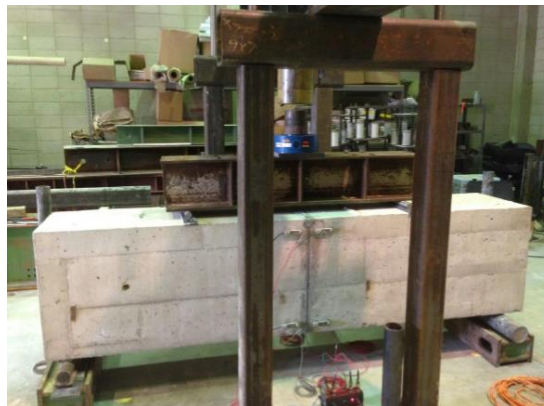
Figure 2.39 *Specimen setup for static four-point bending test.* (Hosteng, Phares, Abu-Hawash, Bierwagen, & Nelson, 2015)

Grouted reinforcing steel couplers were tested for strength and durability in bending, specifically to represent the field application of the connection used in the Keg Creek Bridge located in Pottawattamie County, Iowa (Hosteng, Phares, Abu-Hawash, Bierwagen, & Nelson, 2015). To accomplish this, seven specimens were erected in two parts and connected via two #14 epoxy-coated grouted reinforcing steel couplers in the tension zone of the square columns (Figure 2.38). Five of the seven specimens utilized the W.R. Meadows 588-10K grout to fill the grout bed, while two used UHPC. The specimens were erected, underwent a “dry-fit” for the coupler connections, were grouted together per manufacturer’s instructions, and were set up for four-point testing (Figure 2.39).

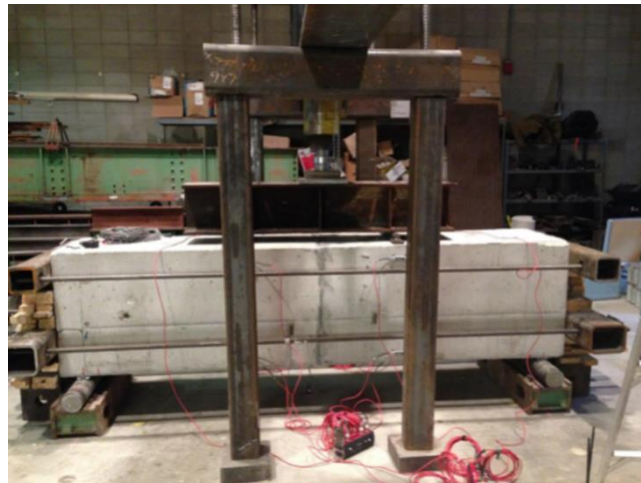
Figure 2.40 *Specimen setup for static four-point bending test with applied axial load.* (Hosteng, Phares, Abu-Hawash, Bierwagen, & Nelson, 2015)

It was suggested that an axial load be applied to the ends of the specimen to represent the dead load of the bridge on the columns and that these additional loads may have an impact on results of the four-point bending tests (Figure 2.40).

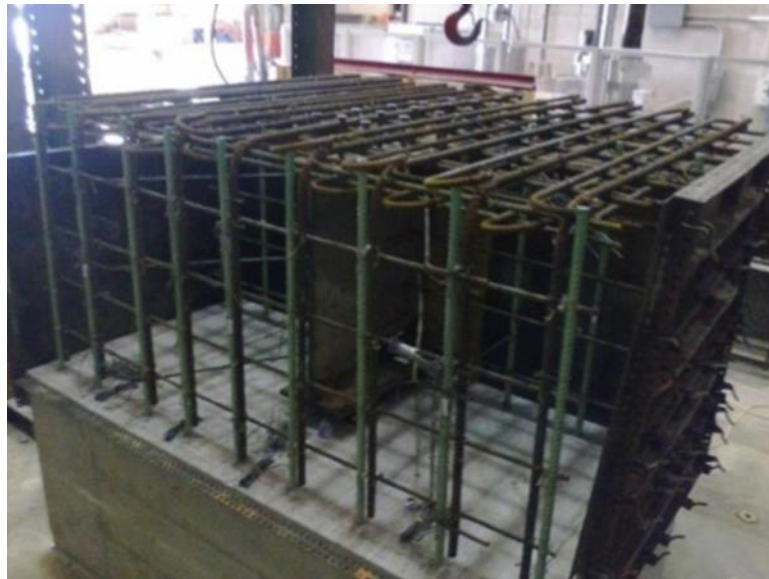
Figure 2.44 *Cast-in place integral diaphragm.* (Hosteng, Phares, & Redd, 2016)

Construction of the three specimens did not pose any significant challenges. The cast-in-place control specimen was erected by forming the steel reinforcement cage (Figure 2.44), and then simply pouring concrete.

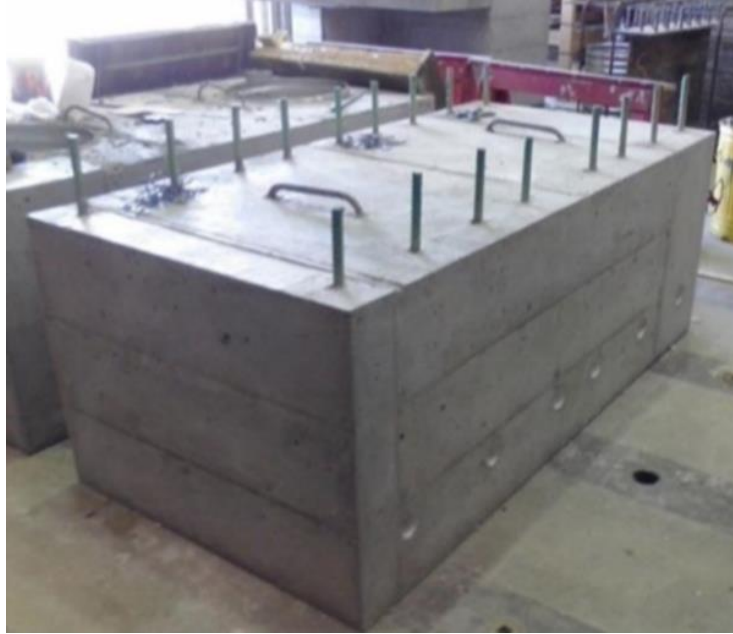
Figure 2.45 *Grouted coupler pile cap.* (Hosteng, Phares, & Redd, 2016)

The grouted reinforcing bar coupler specimen had the pile cap cast with protruding reinforcing bars (Figure 2.45); it utilized a match-casting procedure (Figure 2.46) to cast the sleeves for the connection in the integral diaphragm element; the integral diaphragm was placed on top of the pile cap via crane (Figure 2.47); and finally the sleeves were filled with grout to complete the connection.

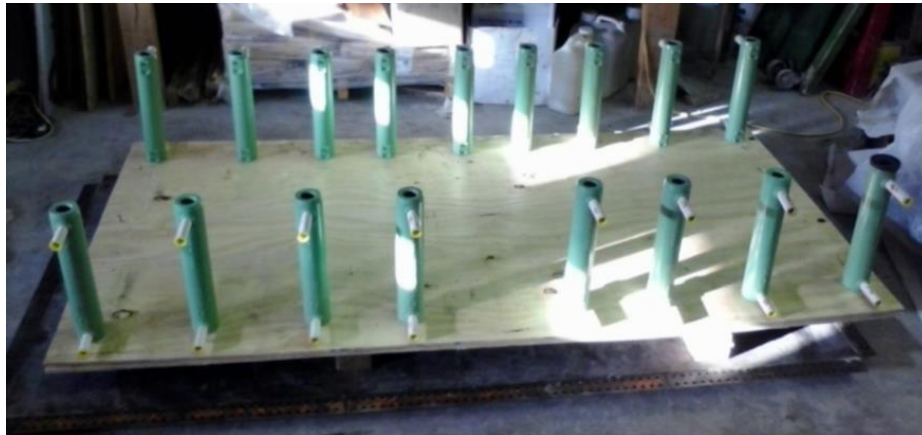
Figure 2.46 *Grouted coupler template.* (Hosteng, Phares, & Redd, 2016)

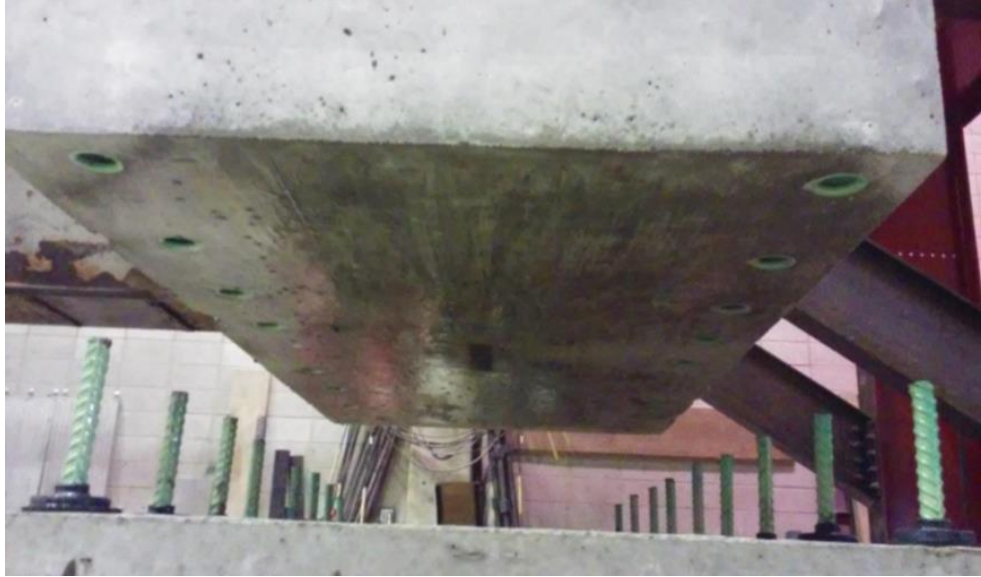
Figure 2.47 *Integral diaphragm placement.* (Hosteng, Phares, & Redd, 2016)

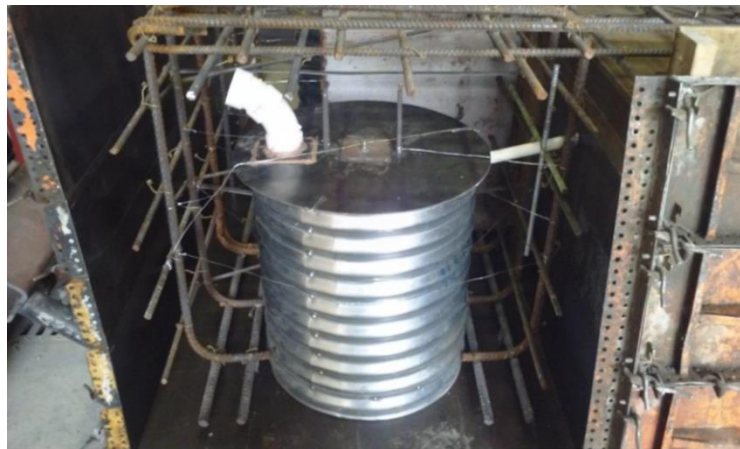
Figure 2.48 *Side view of CMP void.* (Hosteng, Phares, & Redd, 2016)

The pile coupler was constructed like the grouting reinforcing bar coupler, by having two elements cast with a part of the connection, but instead of protruding reinforcing bars and sleeves, each element had CMP voids. The integral diaphragm had a longer CMP void with the HP section being suspended within the void (Figure 2.48 and Figure 2.49), while the pile cap had CMP voids half the length of the HP section (Figure 2.50).

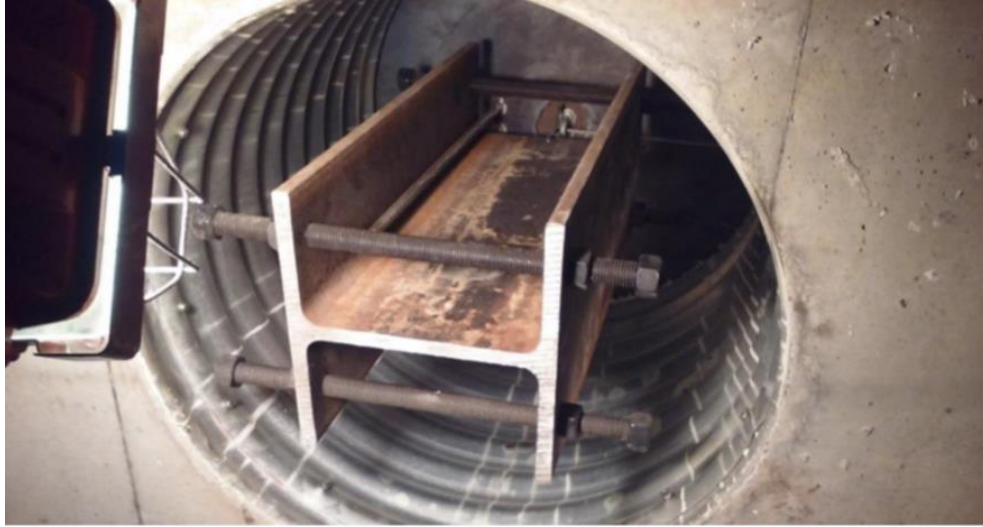
Figure 2.49 *Suspended HP sections.* (Hosteng, Phares, & Redd, 2016)

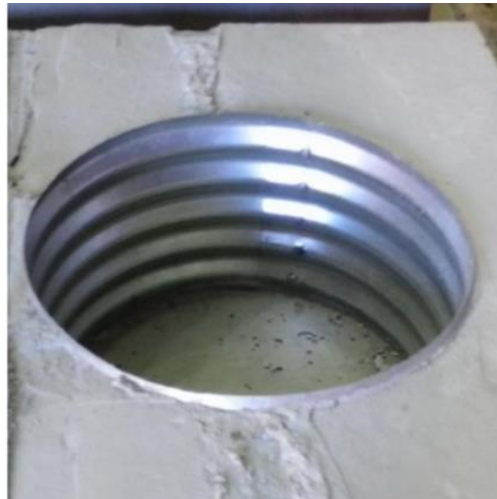
Figure 2.50 *CMP void in pile cap.* (Hosteng, Phares, & Redd, 2016)

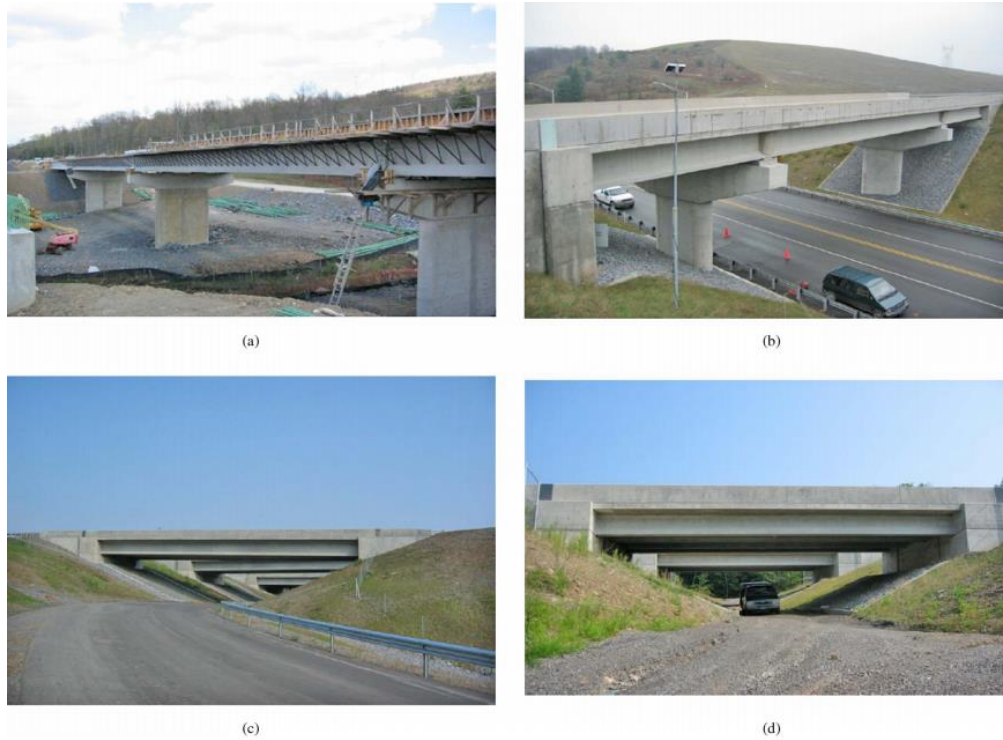
Figure 2.62 *Instrumented bridges. (a) Bridge 109; (b) Bridge 203; (c) Bridge 211; (d) Bridge 222* (Kim & Laman, 2012)

The behavior of integral abutment bridges had been shown to be different from predictions made during the design process for the bridge, sometimes displacements due to thermally induced loads differed in the order of 10% to 25%. For this reason, a long-term, seven years, field monitoring of four integral abutment bridges (Figure 2.62) was conducted in Pennsylvania (Kim & Laman, 2012).

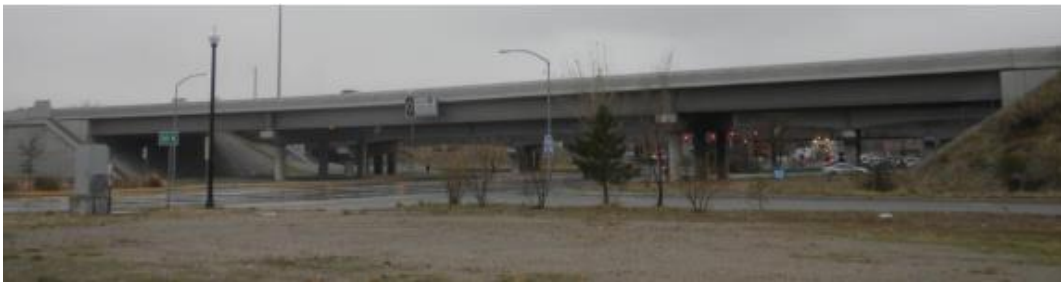
Figure 2.64 *Photograph of 400 South Street Bridge in elevation view.* (Huffaker, 2013)

The bridge under investigation was the 400 South Street Bridge in Salt Lake City, Utah (Figures 2.63 and 2.64). This four-lane bridge would typically see 29,447 vehicles for an Average Daily Traffic (ADT), and an Average Daily Truck Traffic (ADTT) of 6%.

The curved deck is supported by three spans of eight prestressed girders that are divided in three straight segments of 84.5-ft, 150.4-ft, and 84.5-ft placed at skewed angles of 0.2 degrees, 5.6 degrees, and 11.7 degrees to accommodate the 8-inch curved deck. The bridge is supported at the ends by integral abutments that are 3.0-ft thick and 11.0-ft tall (Figure 2.65), and each abutment is supported by twelve 12-in diameter piles spaced at 6-ft.

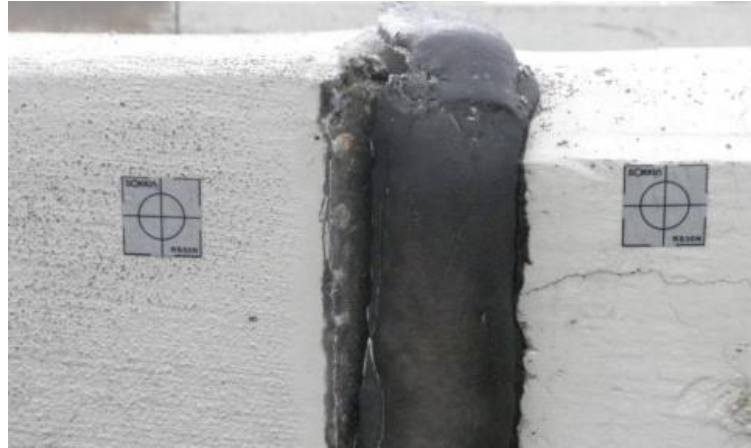
Figure 2.66 Survey targets at approach slab. (Huffaker, 2013)

The bridge was monitored for variations in displacement due to temperature, primarily changes in the length of the bridge and how those changes affected the expansion joint gaps. Monthly surveys done at approximately the same time of morning, in addition to one full-day survey, utilized markers placed on various points along the abutments, girders, and approach slabs (Figure 2.66) of the bridge and surveying equipment to measure the changing length of the bridge, and a conventional tape measure was used to measure the expansion joint gaps.

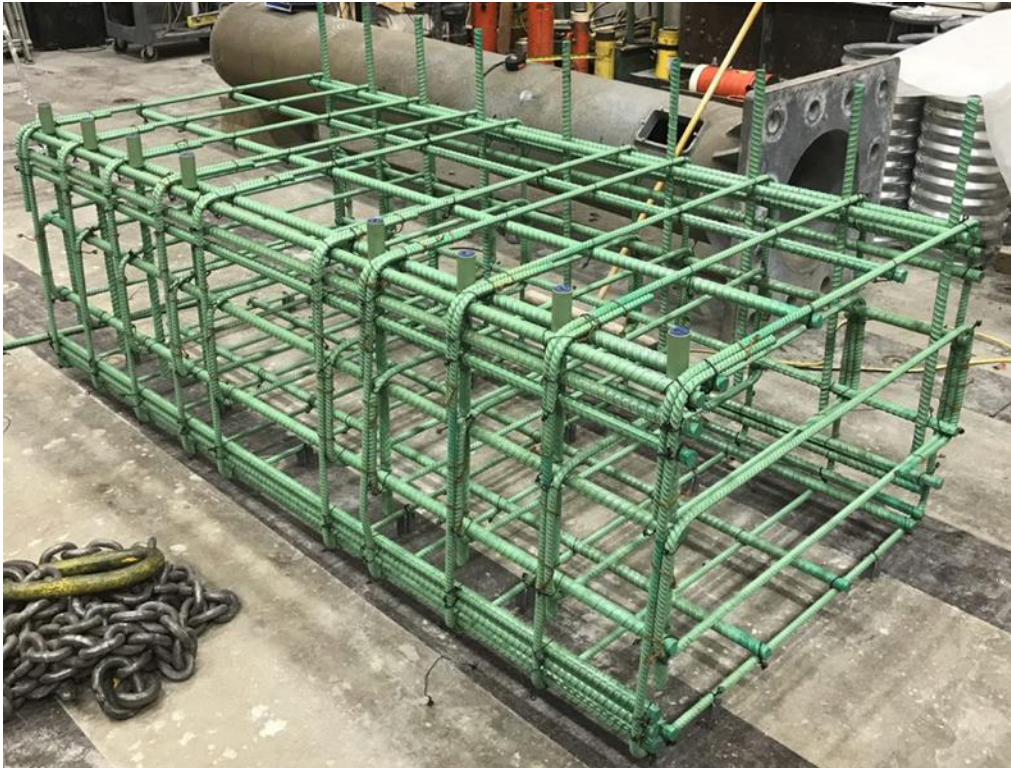
Figure 4.1 *UHPC-Joint pile cap reinforcing cage.*

Construction of the specimen began with the pile cap. A reinforcing cage was erected following the design drawings (Figure 4.1).

Multiple checks were done to ensure the protruding bars were at their designed locations, specifically in respect to elevation to ensure the 8 in. protrusion required for proper development in the UHPC filled joint. Also, the D310 threaded couplers had to be checked to ensure the tops would be flush with the top of the concrete when complete.

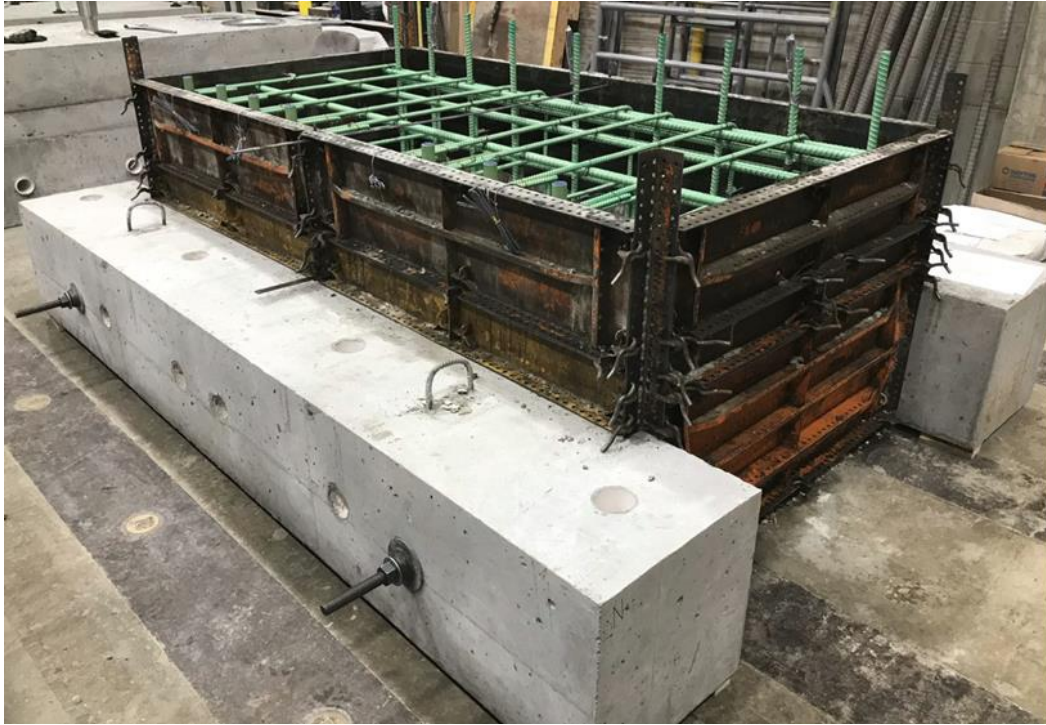
Figure 4.2 UHPC-Joint pile cap formwork.

With the cage complete, formwork for the pile cap was erected and the cage was then placed inside (Figure 4.2).

Since a process referred to as “match-casting” was to be done to align the PVC ducts to the reaction blocks, the blocks were utilized as formwork in addition to the EFCO steel formwork. With the cage set in the forms, checks were done to ensure the 2 in. concrete cover required per design were going to be met, all reinforcement was secure and installed as the designed locations, and the formwork was properly fastened.

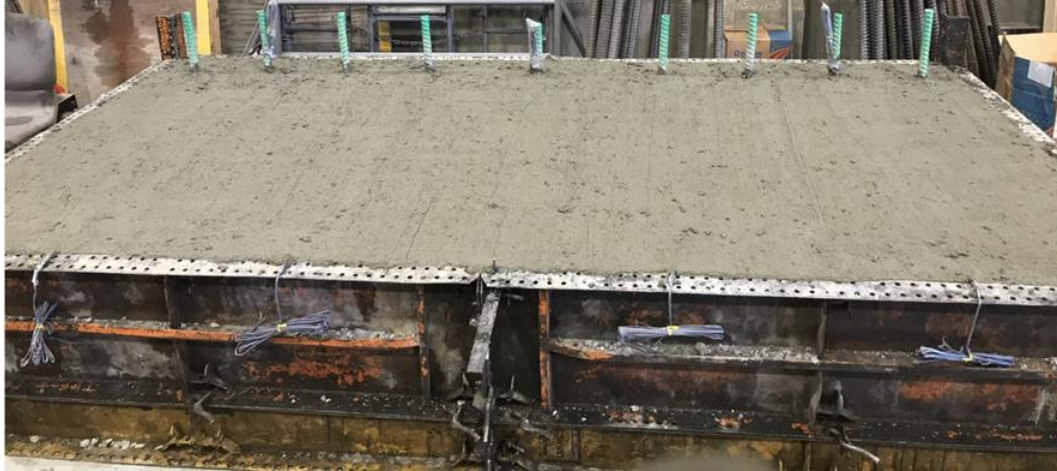
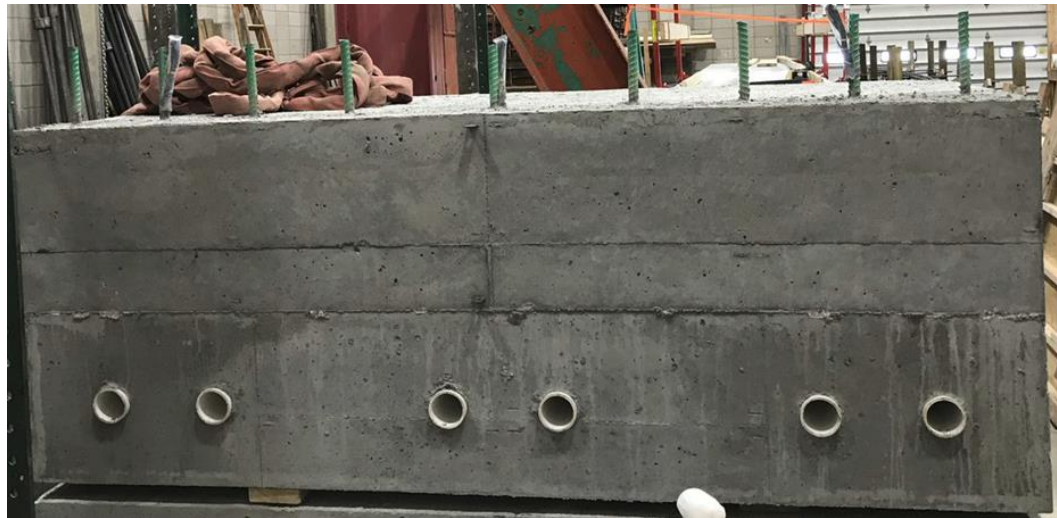
Concrete from a local Ames redi-mix plant was cast in the formwork using materials in the Structural Engineering Research Laboratory at Iowa State University. Electric concrete vibrators were used to make sure the concrete was encasing the cage and filling the form to maximum capacity. The surface was given a roughened finish to ensure a 1/4 in. amplitude, which is required by the IowaDOT, by roughly brushing with a stiff-bristled broom in multiple directions (Figure 4.3 and 4.4).

Figure 4.3 UHPC-Joint pile cap cast in concrete.

Figure 4.4 UHPC-Joint pile cap completed.

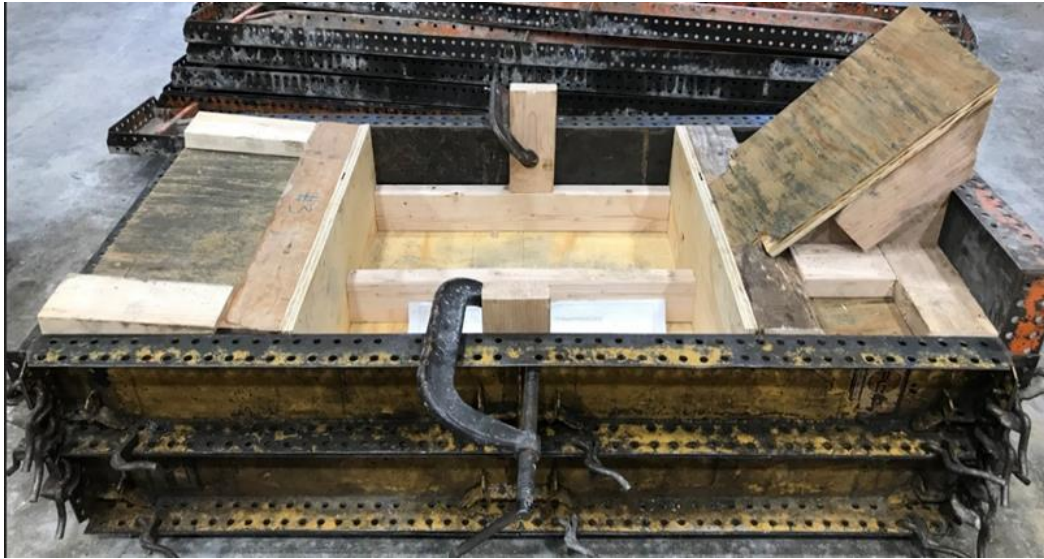
Figure 4.5 *UHPC flowability test formwork.*

The initial step for constructing the integral diaphragm for the UHPC-Joint specimen was to conduct the flowability test of the UHPC in the proposed cross section. A decision

was made by the design team to negate the initial cross section, and test only the 5° rise cross section (Figure 4.5).

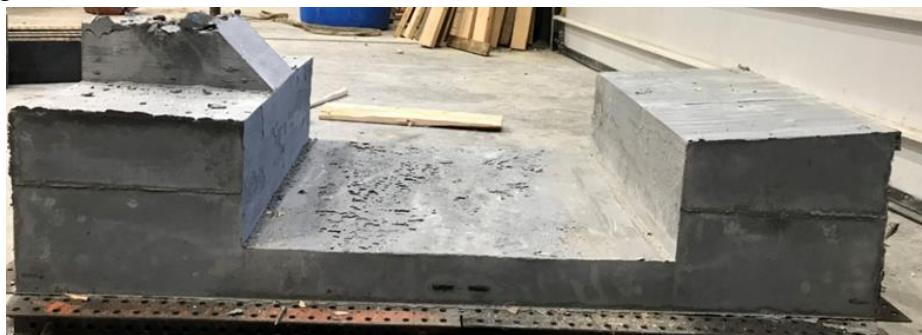
Figure 4.6 *UHPC flowability test completed.*

The UHPC mix produced by Ductal from Lafarge was used as the UHPC material for this project, and the mix proportions used were that of the Special Provisions document by the IowaDOT for Ultra-High-Performance Concrete. (IowaDOT, 2014) The flowability quantity of approximately 5.11 ft³ was designed to fill the test section, fill multiple testing cylinders, and account for material loss. The section was filled and left to cure for three days, at which point the formwork was stripped to analyze the adequacy of the flowability of the UHPC (Figure 4.6).

As shown in Figure 4.1.6, it is apparent that the UHPC material successfully filled the entirety of the cross section without any issues of voids caused by the volume of air. With this knowledge, the formwork for the integral diaphragm could be constructed through multiple 3/4 in. plywood diaphragms fastened together, which had the same dimensions used for the flowability test section (Figures 4.7 through 4.9).

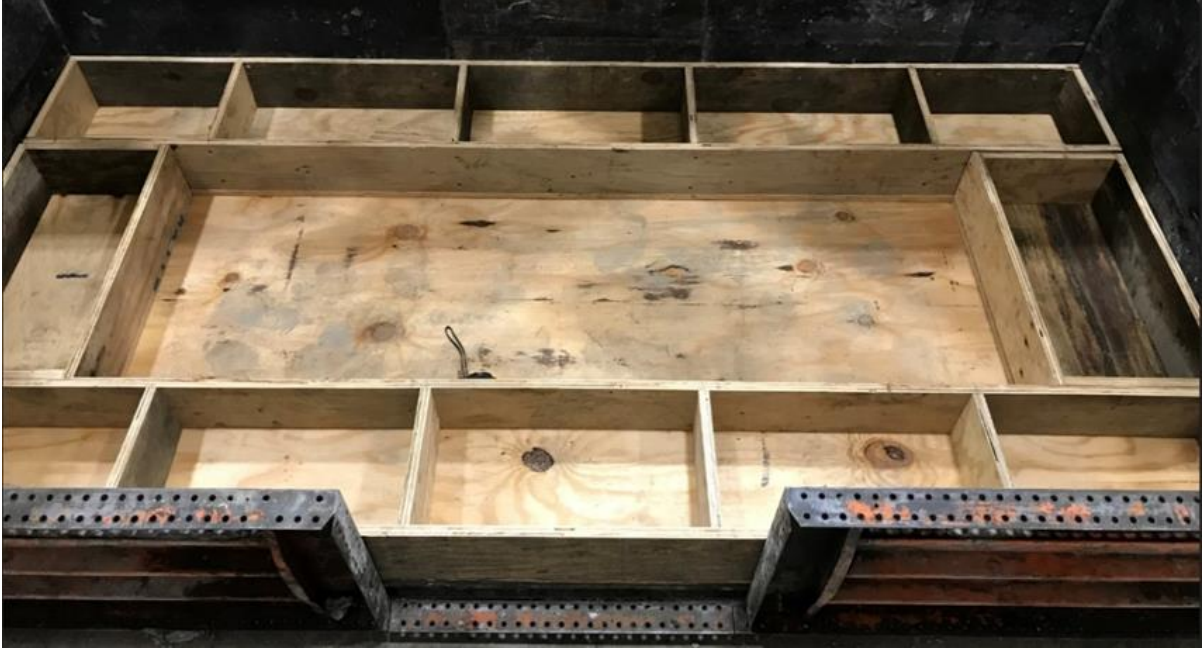
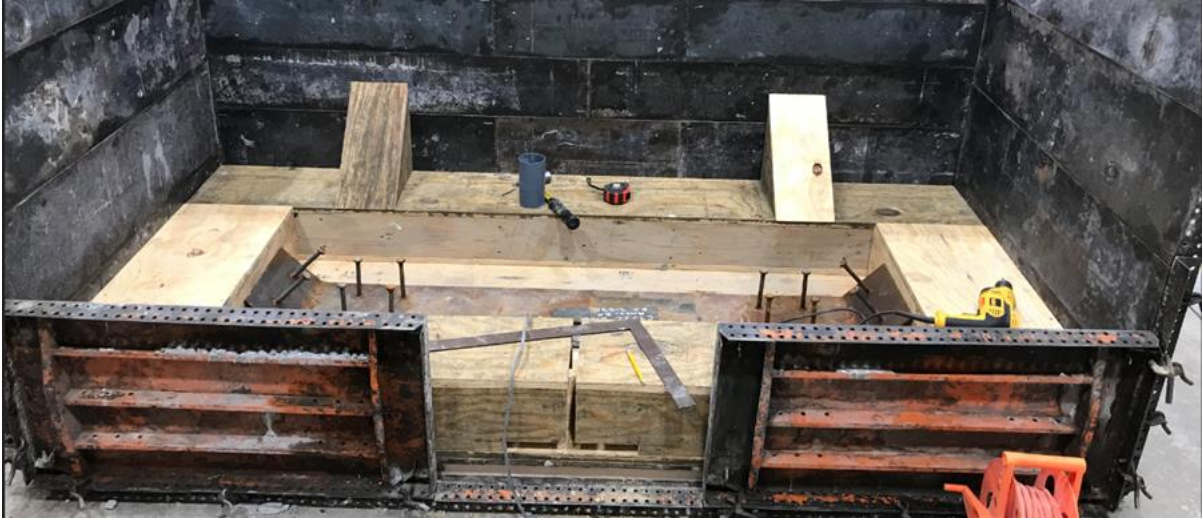
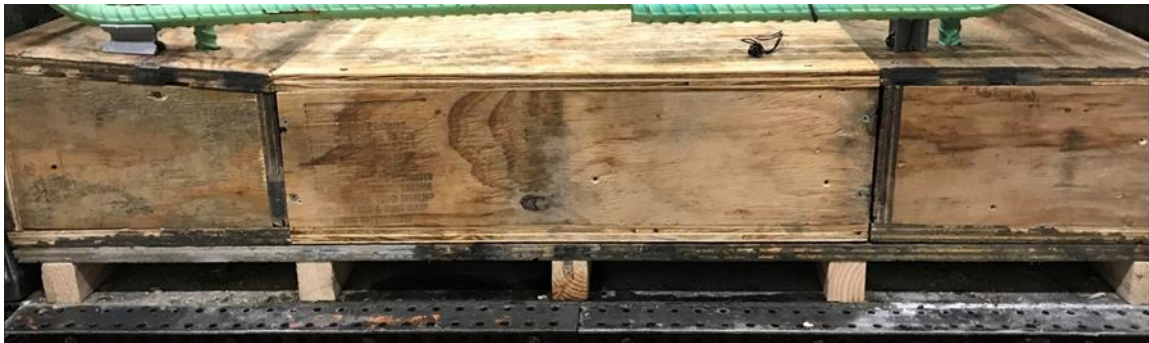
Figure 4.7 UHPC integral diaphragm formwork top view of diaphragms.

Figure 4.8 UHPC integral diaphragm formwork completed.

Figure 4.9 UHPC integral diaphragm bottom formwork side view.

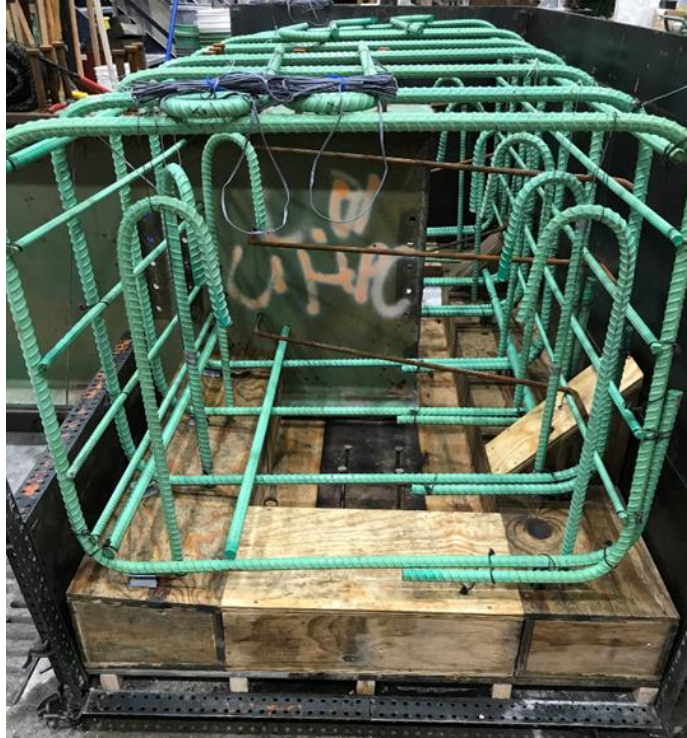
Figure 4.10 *UHPC integral diaphragm reinforcement cage.*

With the bottom formwork completed, the reinforcement cage was erected. One important note was to ensure the 17 coupling #7 bars would protrude through the bottom plywood formwork by 1 in. to ensure the bars would protrude through the bottom of the section at the required 8 in. (Figure 4.10 and 4.11).

Note the coupler bars passing through the plywood formwork.

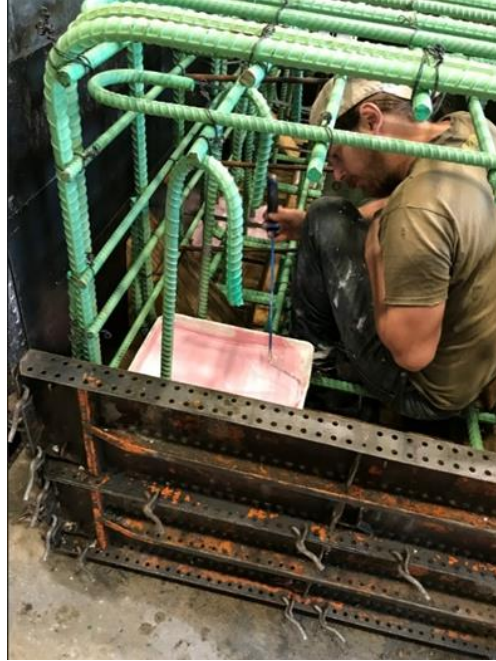
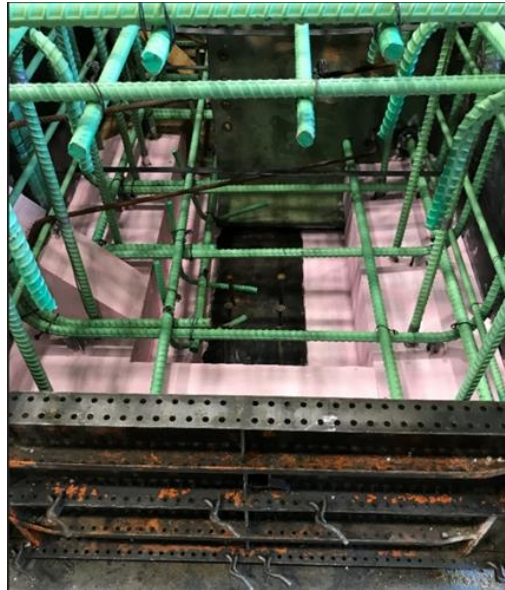
Teflon during the actual slide of the bridge, but no slide would be done in the laboratory, instead, the diaphragm was to be lifted into place by crane. Therefore, to simplify formwork in the laboratory, the sliding shoe was not protruding from the bottom of the diaphragm. To create the best bond surface for the UHPC and precast concrete interface, a form retarder needed to be applied to the bottom formwork of the integral diaphragm. To apply the form retarder (Figure 4.12), it was decided to use a paint roller and brush to ensure the form retarder would be applied to the entirety of the formwork, while not being applied to any reinforcing bars (Figures 4.13 and 4.14).

Figure 4.13 *Form retarder being applied to integral diaphragm formwork.*

Figure 4.14 *Form retarder application completed.*

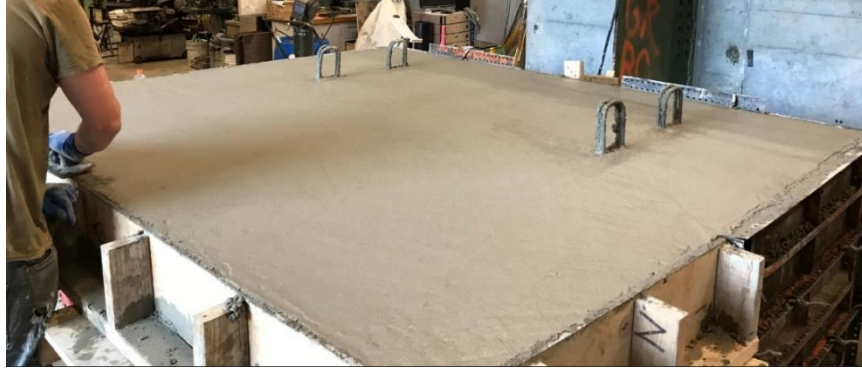
Figure 4.15 *UHPC integral diaphragm cast in concrete.*

With the form retarder applied and final checks done to the formwork, the integral diaphragm was cast in concrete (Figure 4.15).

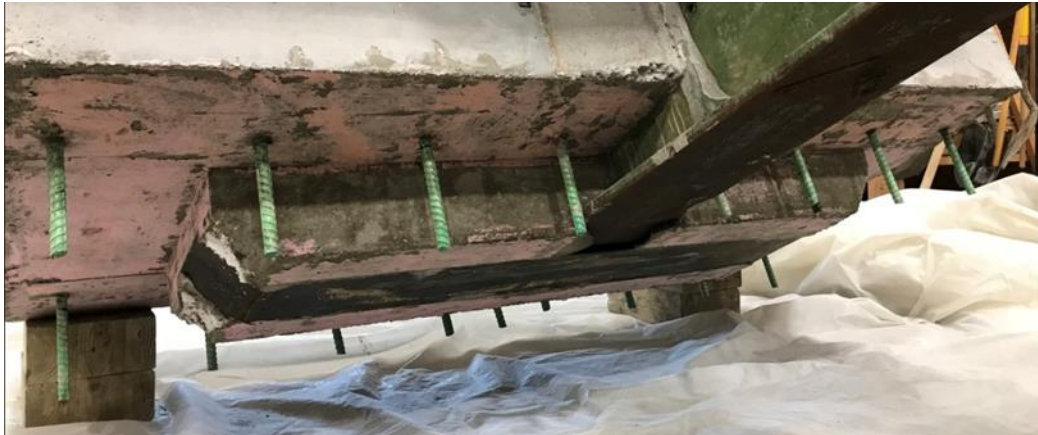
Figure 4.16 *UHPC integral diaphragm completed.*

The formwork was stripped, and the integral diaphragm was inspected, and it was noted that concrete did not pass underneath the beam as intended, and the coupler bars did not have consistent protruding lengths from the bottom of the section (Figure 4.16).

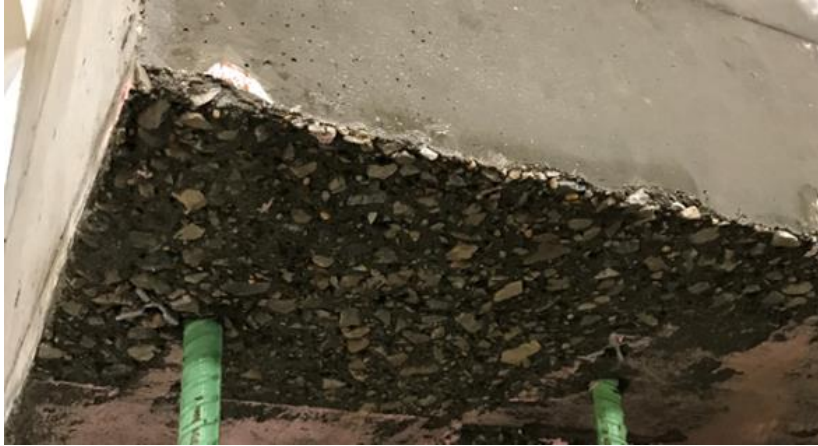
Figure 4.17 UHPC integral diaphragm exposed aggregate finish.

To finish the required bottom-side finish for the integral diaphragm, a 3,000-psi power wash was used to spray off the form retarder and leave an exposed aggregate finish (Figure 4.17).

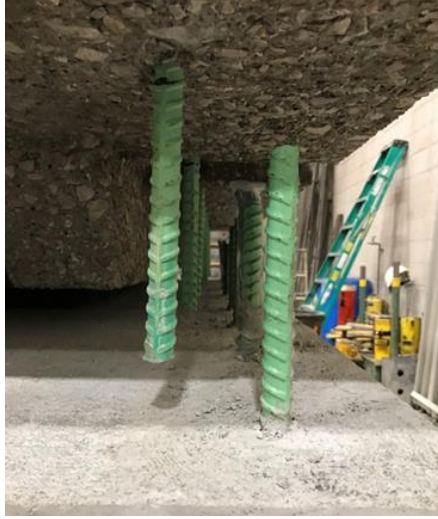
Figure 4.18 *UHPC joint rear connection bars with adequate clearance.*

of “slide-in” construction, a slide had to be simulated to ensure the protruding bars on the back side of the abutment would have proper clearance during the installation process. The integral diaphragm was suspended just over the neoprene pads enough to allow for movement, the slide was simulated, and the clearance of the rear bars was proven to be adequate (Figure 4.18).
