Innovations in integral abutment connection details for accelerated bridge construction

Austin James DeJong
Iowa State University

MASTER OF SCIENCE

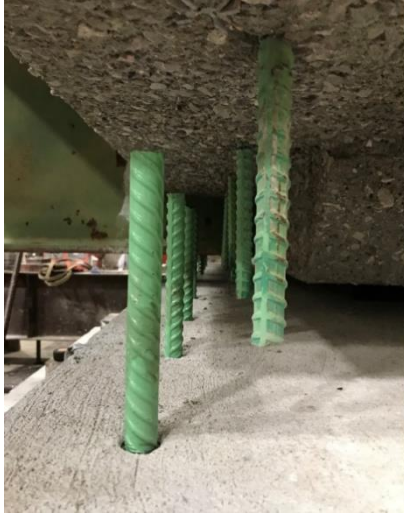
Figure 4.19 *Front connection bars with installed threaded bars in pile cap.*

After the integral diaphragm was placed in its final location, the threaded bars on the front side of the specimen were installed. One concern was the available space to insert the bar into the threaded coupler in the pile cap and be able to properly tighten the bar, but this was proven to be done without any issues (Figure 4.19).

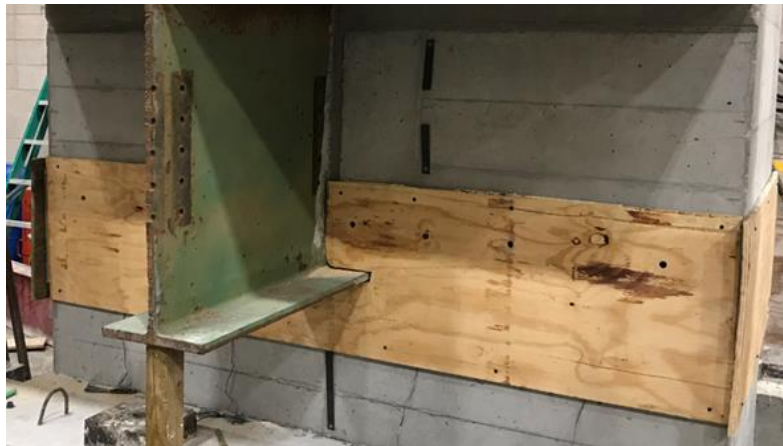
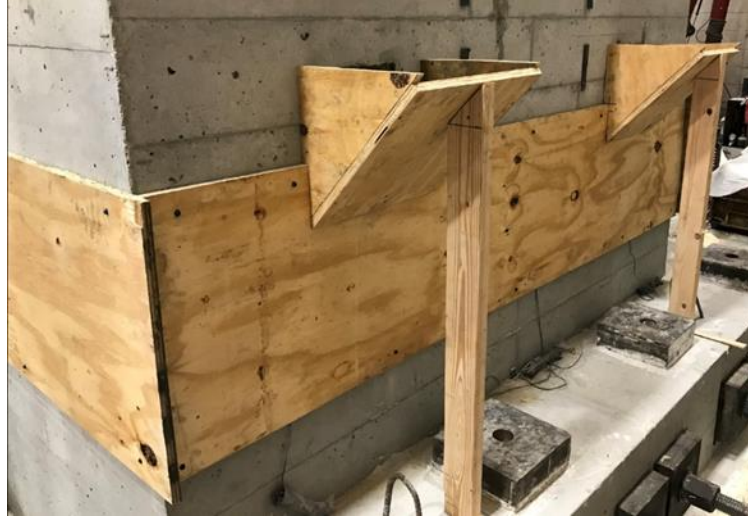
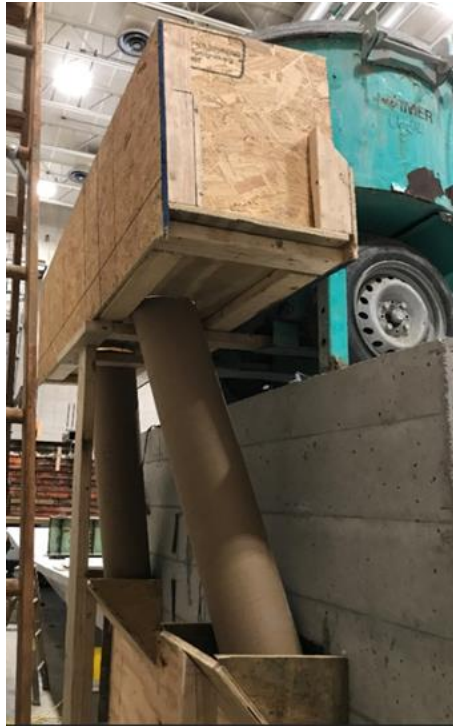
With the connection bars properly installed, the joint formwork was erected. This formwork included ports along the side and front faces to allow for air to be pushed out by the UHPC during the install, and a spout and chimney system to allow for a simplified installation of the material into the joint from the mixer (Figures 4.20 through 4.22).

Figure 4.20 *Front face joint formwork with air ports.*

Figure 4.21 *Rear face joint formwork with chimneys.*

Figure 4.22 *Spout and chimney system for installation of UHPC material.*

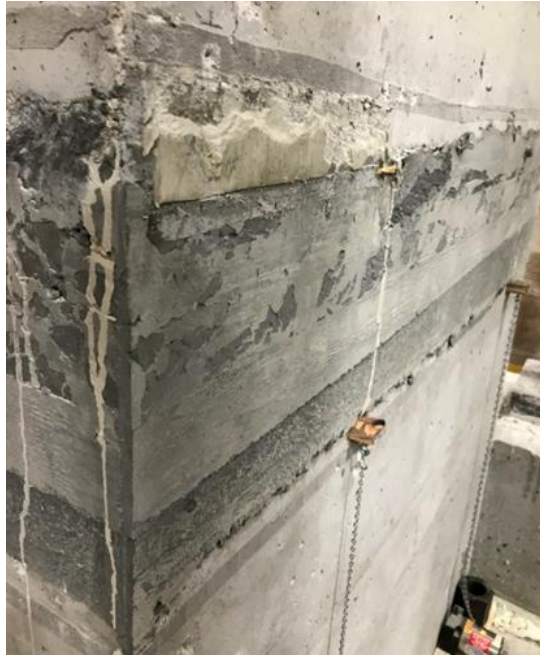
Figure 4.23 *Completed UHPC joint showing the multiple layers of material.*

The UHPC material, Ductal by LaFarge, had to be installed in five batches due to the equipment available in the Structural Research Laboratory, and each batch took approximately 30 minutes to mix and then pour into the joint. This caused issues with the casting of the joint since each batch set up too quickly to allow for the batch being cast to

flow into the previous batch, which caused layers of material within the joint instead of one layer of material (Figure 4.23).

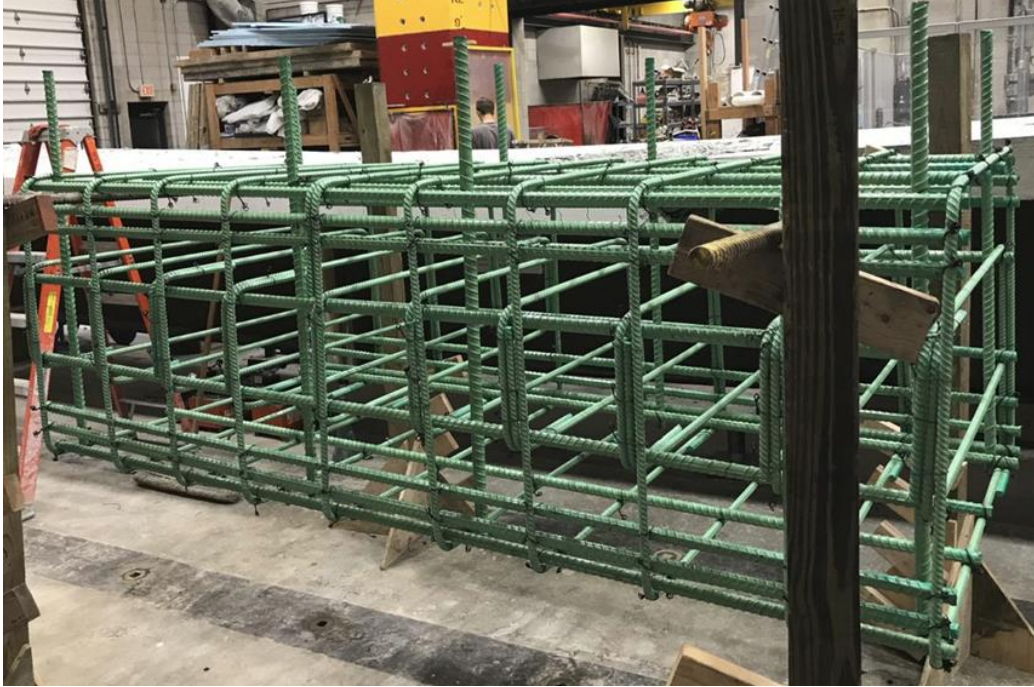
Figure 4.24 *GRBC pile cap reinforcing cage.*

Construction of the specimen began with the pile cap. A reinforcing cage was erected following the design drawings (Figure 4.24).

Multiple checks were done to ensure the protruding bars were at their designed locations, specifically in respect to elevation to ensure the 8 in. protrusion required for proper development in the grout sleeves.

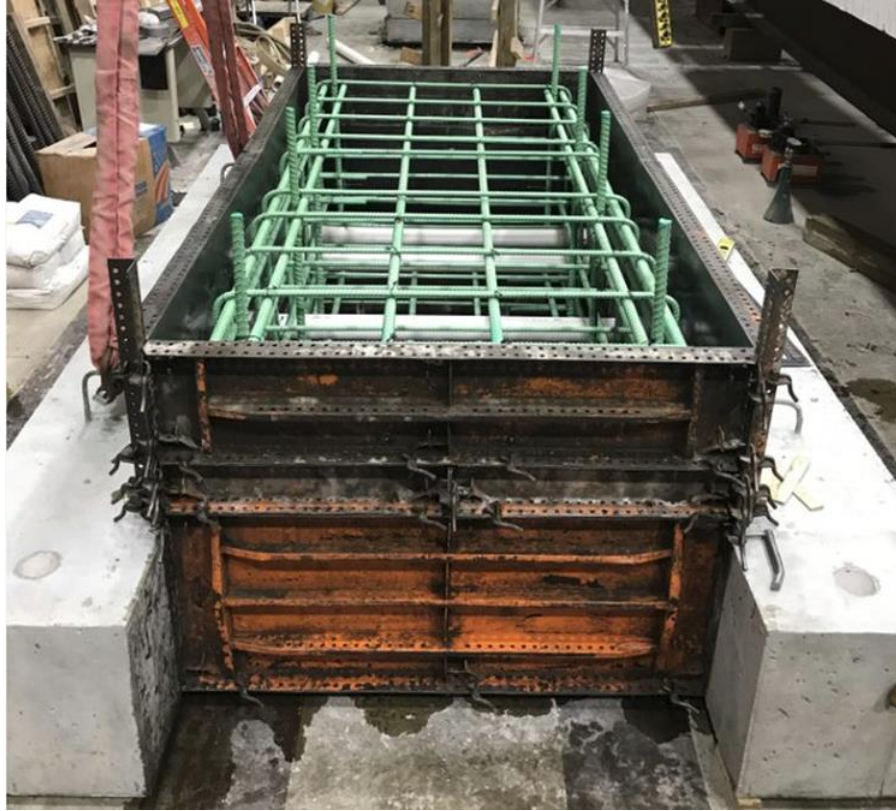
Figure 4.25 *GRBC pile cap formwork.*

With the cage complete, formwork for the pile cap was erected and the cage was then placed inside (Figure 4.25).

Since a process referred to as “match-casting” was to be done to align the PVC ducts to the reaction blocks, the blocks were utilized as formwork in addition to the EFCO steel formwork. With the cage set in the forms, checks were done to ensure the 2 in. concrete cover required per design were going to be met, all reinforcement was secured and installed at the designed locations, and the formwork was properly fastened.

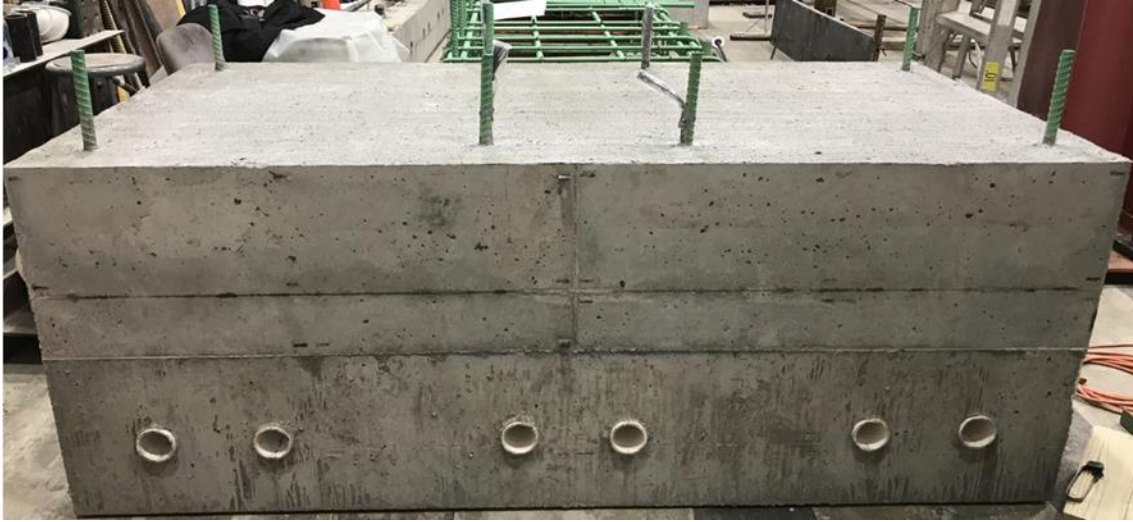
Figure 4.26 GRBC pile cap completed.

Concrete from a local plant was cast in the formwork using materials in the Structural Research Laboratory at Iowa State University. Electric concrete vibrators were used to make sure the concrete was encasing the cage and filling the form to maximum capacity. The surface was given a roughened finish by brushing with a stiff-bristled broom along the long direction (Figure 4.26).

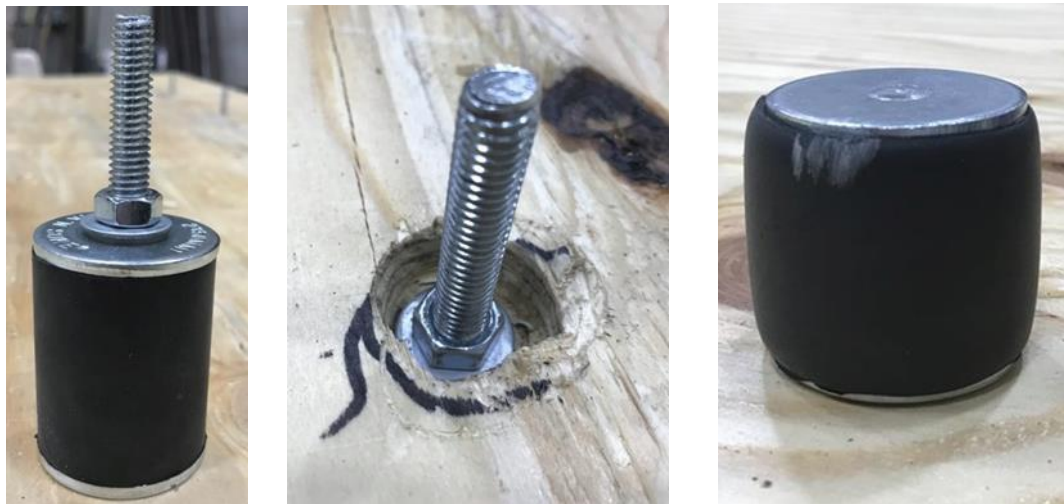
Figure 4.27 Dayton Superior form plug.

To properly align the protruding bars to the grout sleeves, match-casting was used to set the locations of the grout sleeves. Using a full 4 ft x 8 ft x 3/4 in. sheet of plywood, the Dayton Superior D492 Sleeve-Lock form plugs (Figure 4.27) were installed to hold the grout sleeves in place during erection of the GRBC integral diaphragm.

The plywood was placed on top of the pile cap and ensured that it was square with the pile cap. Then, marks were placed on the plywood where the protruding bars were located, and those marks were then drilled with two different drilling bits. A 1 in. diameter spade bit was used to cause the nuts and washers of the form plug to be recessed in the plywood so that the bottom surface would be flat, and a 7/16 in. diameter twist drill bit was used to make holes in the plywood for the form plug bolt to pass through (Figure 4.27 middle).

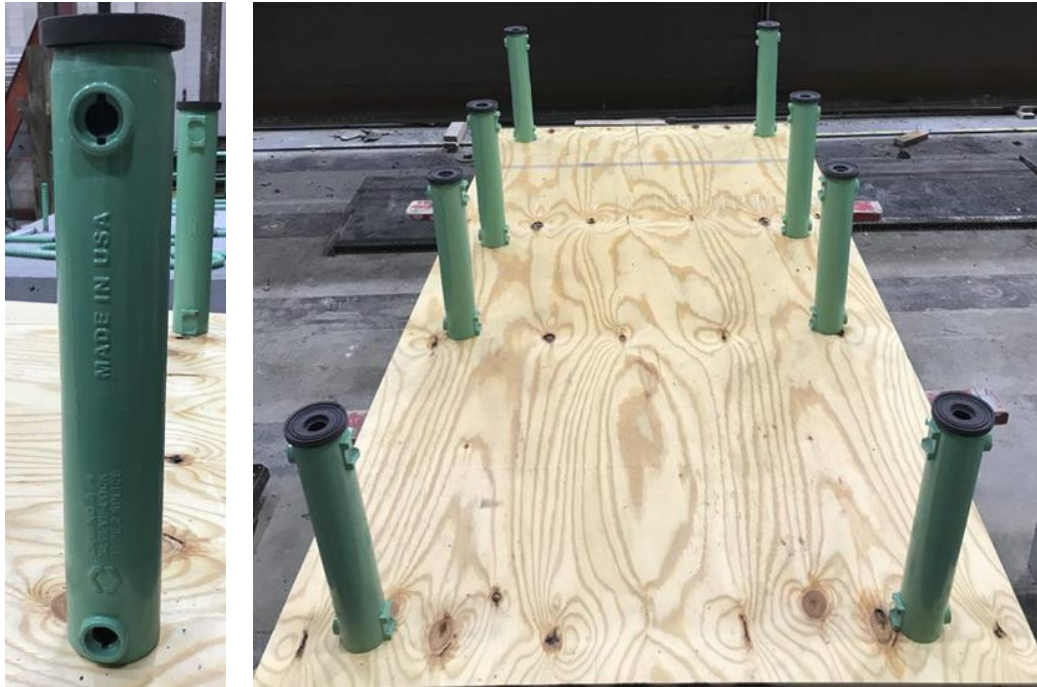
Figure 4.28 Dayton Superior form plug.

The form plugs were installed and tightened, with a 14-mm socket, enough to allow for the grout sleeves to be placed and turned to have the port plugs facing the designed locations, which were out the front and back faces of the integral diaphragm. When the position of the sleeves was verified, the form plugs were tightened until the sleeves would not turn, and the Dayton Superior D487 seal plugs were placed on the tops of the grout sleeves (Figure 4.28).

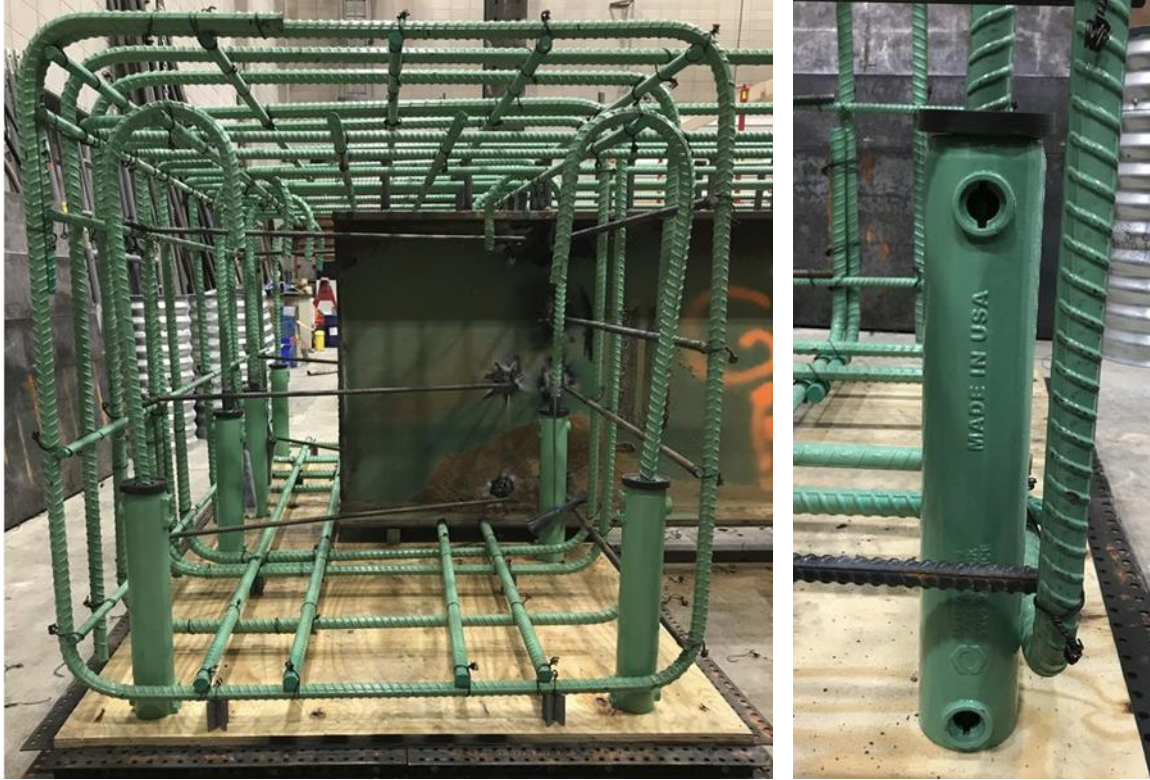
Figure 4.29 GRBC reinforcing cage with Dayton Superior grout sleeves.

The bolts of the form plugs were cut to be flush with the plywood surface, and then the match-casted formwork was placed down to begin the formwork for casting the integral diaphragm in concrete (Figure 4.29).

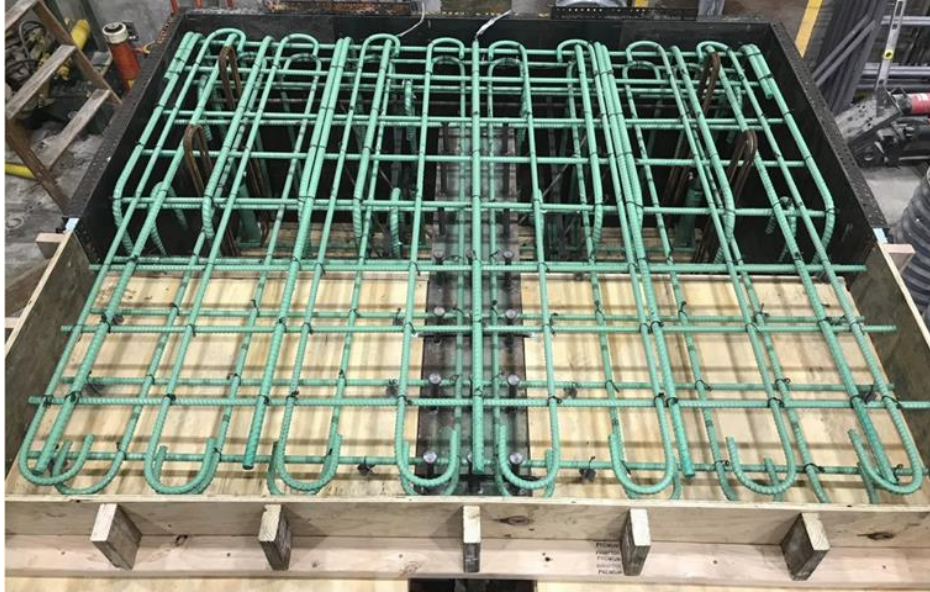
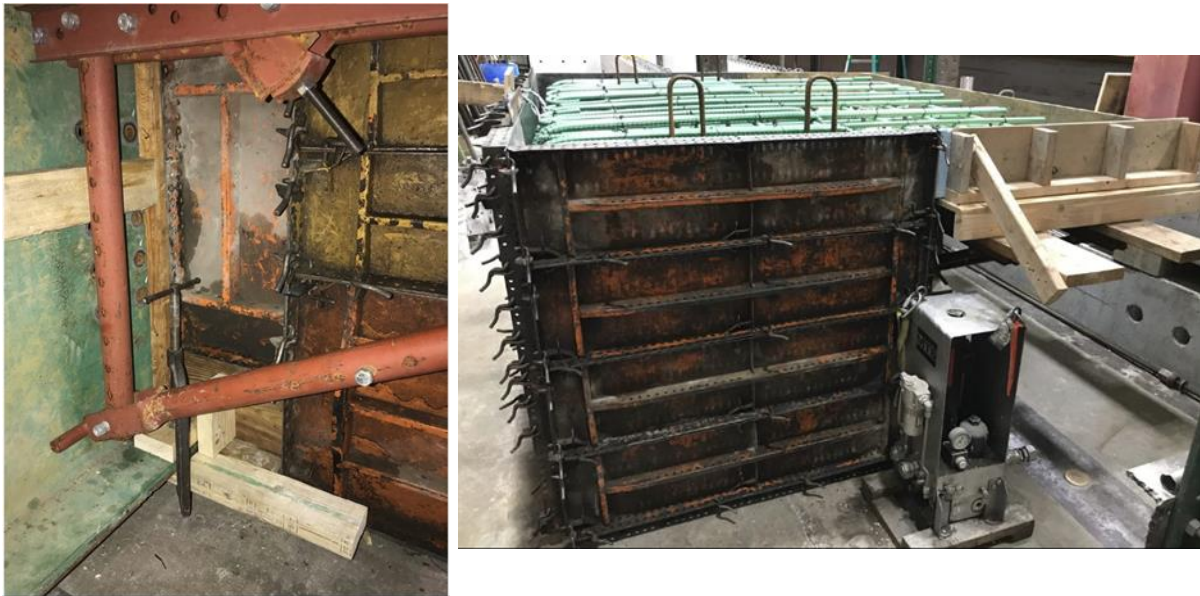
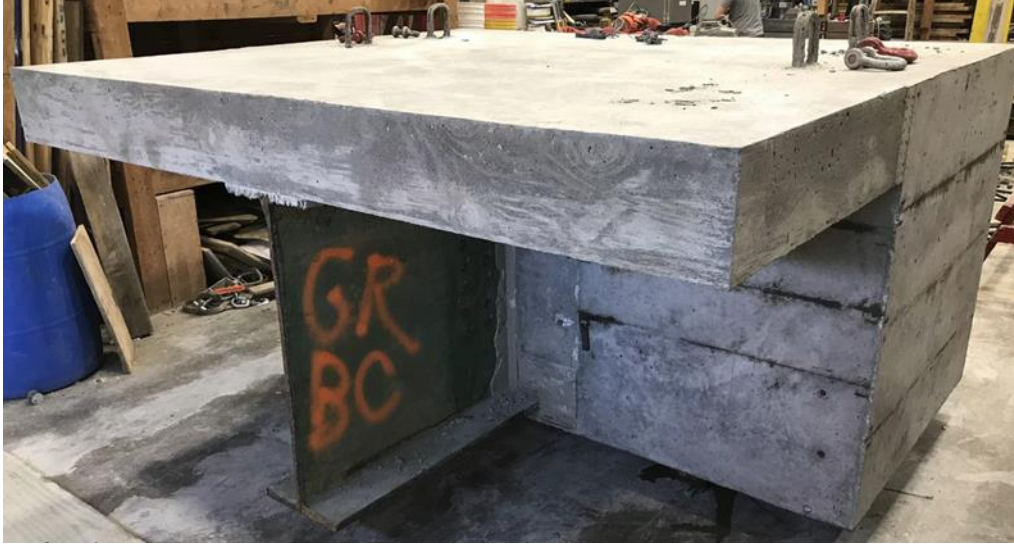
With the grout sleeves and steel beam set in their designed places, the reinforcing cage was erected, and formwork was placed. Steel forms made most of the formwork, but custom woodworking was required to adequately provide formwork for the area around the beam. Finally, the integral diaphragm was encased in concrete (Figures 4.30 through 4.32).

Figure 4.30 GRBC reinforcing cage.

Figure 4.31 GRBC integral diaphragm formwork.

Figure 4.32 *GRBC integral diaphragm completed.*

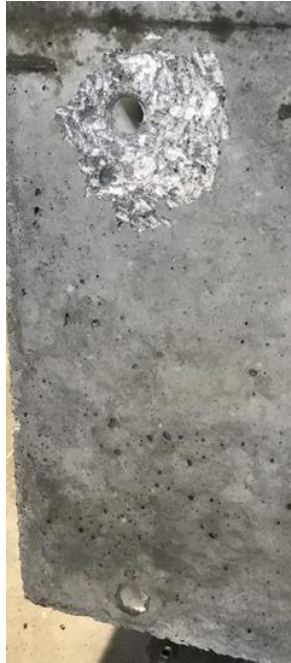
Figure 4.33 *GRBC grout sleeve ports located post concrete casting.*

When the GRBC integral diaphragm was stripped from the formwork, the grout sleeves and ports were checked to ensure there was no concrete blocking any holes. All eight sleeve bottoms were open, and all the ports for the sleeves were located (Figure 4.33).

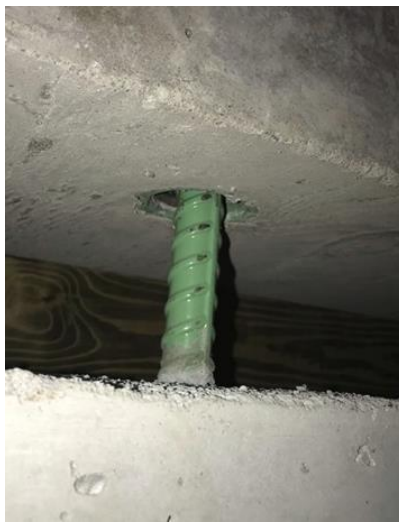
Figure 4.34 *GRBC connection alignment.*

After the pile cap was set in place for testing, the integral diaphragm was lowered into position. A dry fit was done to make sure all the protruding bars and grout sleeves were in alignment, and all eight connections lined up without any issues (Figure 4.34).

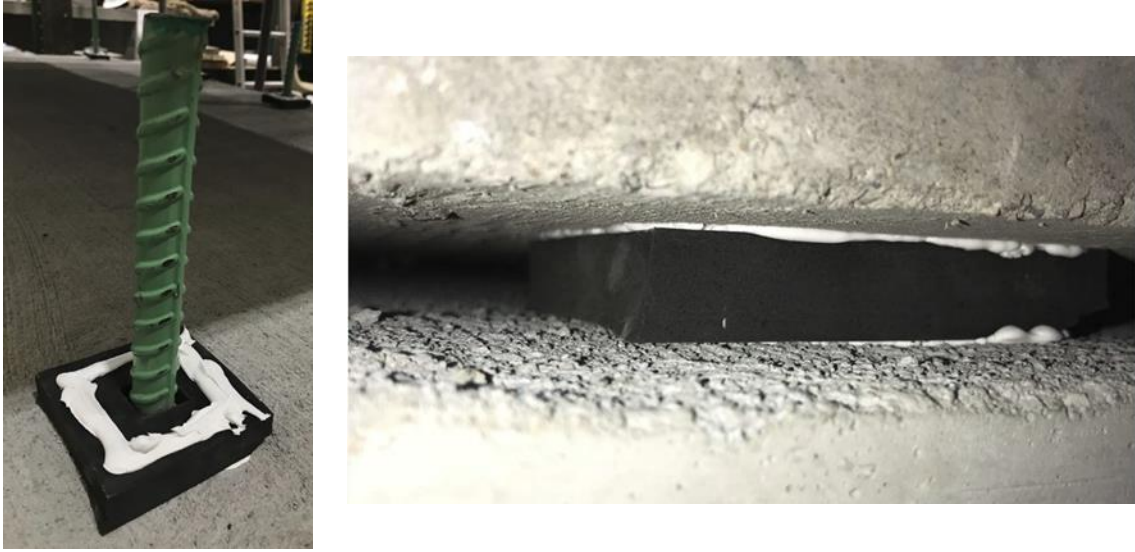
Figure 4.35 *GRBC 3/4 in. neoprene pad and silicone seal.*

To create the 3/4 in. gap between the pile cap and integral diaphragm for the grout bed, 3/4 in. neoprene pads were installed. These pads were cut to be larger than the grout sleeve opening and have a hole in the middle for the protruding bar. To ensure a seal around the neoprene pads and grout sleeves, silicone was placed around the neoprene pads and dispersed when the integral diaphragm was installed (Figure 4.35).

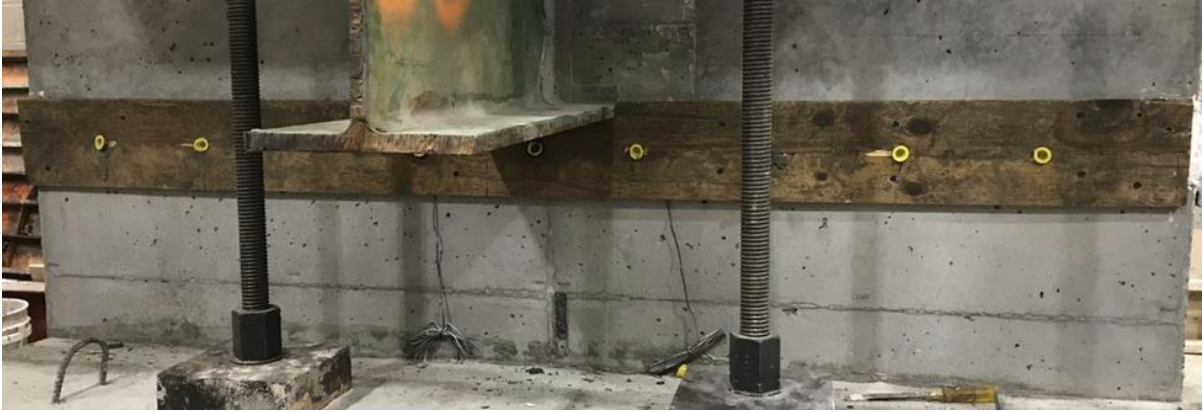
Figure 4.37 *GRBC grout bed completed.*

Port plugs were installed into ports when the grout would begin to seep out until the entirety of the bed was filled with grout and all ports were plugged (Figure 4.37).

One important note was to ensure the lower port for the grout sleeves was plugged so no grout from the grout bed would enter the port.

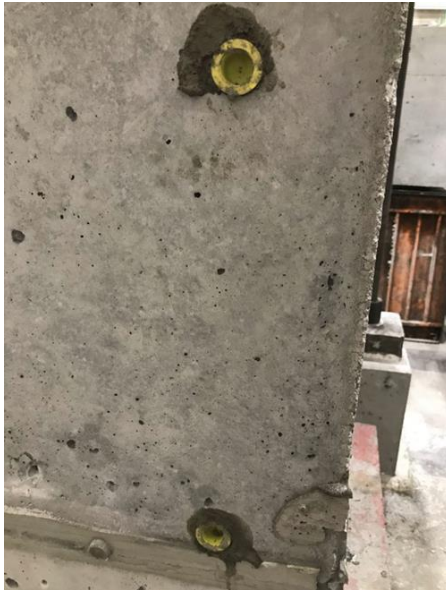
Figure 4.38 *GRBC grout sleeve completed.*

The formwork was removed after the grout bed had set, then the eight grout sleeves were filled with the Dayton Superior grout mix. After the sleeves were verified to be clear of debris, the pump hose was placed into the lower port and grout was pumped so that the grout was seeping out of the top port, then both ports were plugged (Figure 4.38).

This procedure is meant to ensure that the air within the sleeves is pushed out by the grout and properly encasing the coupling bars.

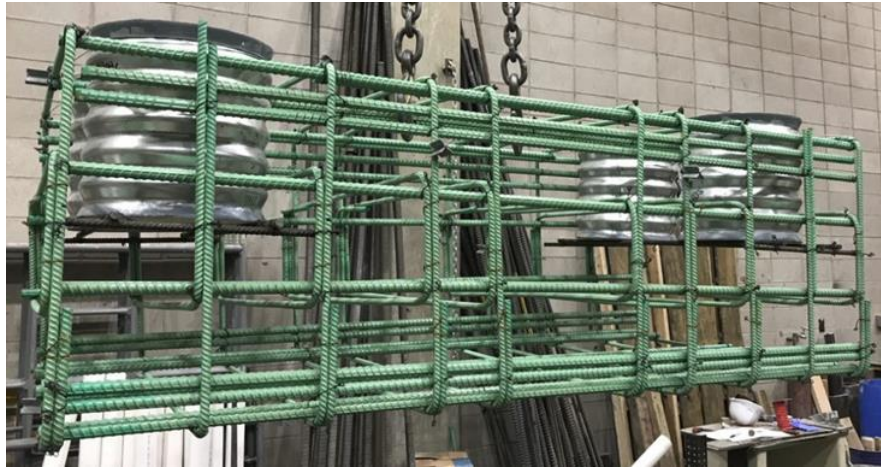
Construction of the specimen began with the pile cap. A reinforcing cage was erected following the design drawings (Figure 4.39).

Figure 4.39 *Pile coupler pile cap reinforcing cage.*

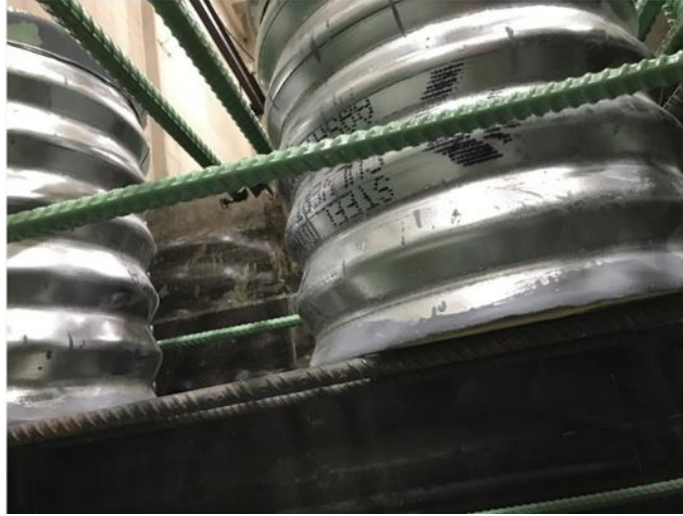
Multiple checks were done to ensure the corrugated metal pipes (CMPs) were in the proper locations, specifically that the tops of the CMPs would be flush with the top surface of the pile cap. The CMPs were installed into the reinforcing cage using salvage rebar to set the elevation (Figure 4.40), and metal wire to set the locations (Figure 4.41).

Figure 4.40 *Salvage reinforcing steel bar holding up CMPs.*

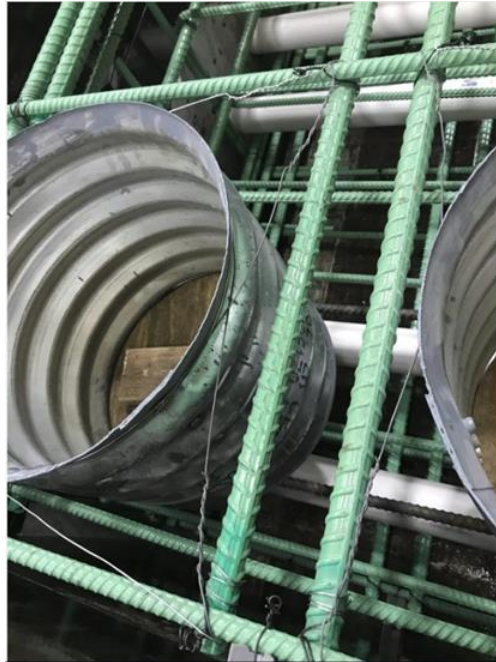
Figure 4.41 *Metal wire holding CMPs in designed locations.*

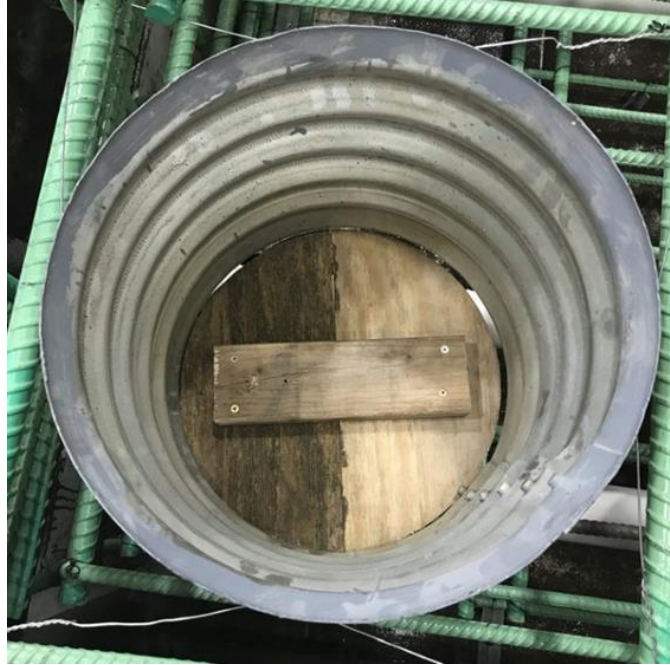
To keep the concrete from flowing to the inside of the CMP's, a plug was constructed by using a circle of plywood cut to the inside diameter of the CMP, cut in half to allow for pullout when casting is complete, and a 2x4 holding the two halves together (Figure 4.42).

Figure 4.42 *CMP plug.*

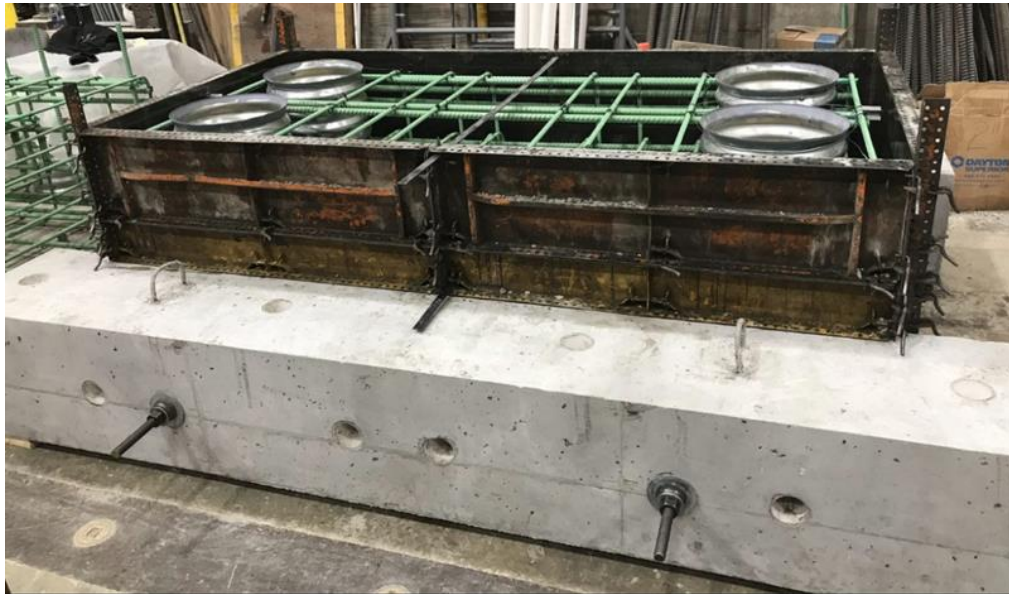
With the cage complete, formwork for the pile cap was erected and the cage was then placed inside (Figure 4.43).

Figure 4.43 *Pile coupler pile cap formwork.*

Since a process referred as “match-casting” was to be done to align the PVC ducts to the reaction blocks, the blocks were utilized as formwork in addition to the EFCO steel

formwork. With the cage set in the forms, checks were done to ensure the 2 in. concrete cover required per design were going to be met, all reinforcement was secure and installed at the designed locations, and the formwork was properly fastened.

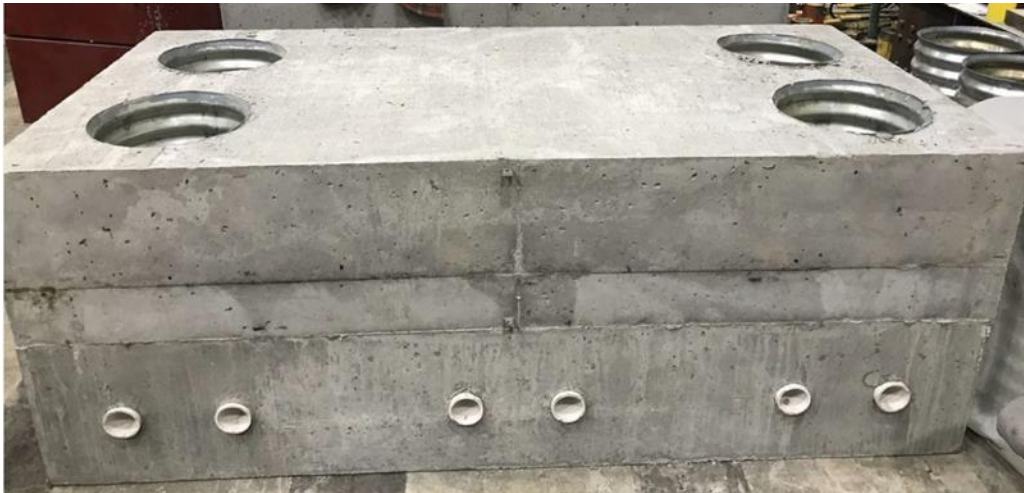
Concrete from a local Ames redi-mix plant was cast in the formwork using materials in the Structural Research Laboratory at Iowa State University. Electric concrete vibrators were used to make sure the concrete was encasing the cage and filling the form to maximum capacity. The surface was given a roughened finish by brushing with a stiff-bristled broom along the long direction (Figure 4.44).

Figure 4.44 *Pile coupler pile cap completed.*

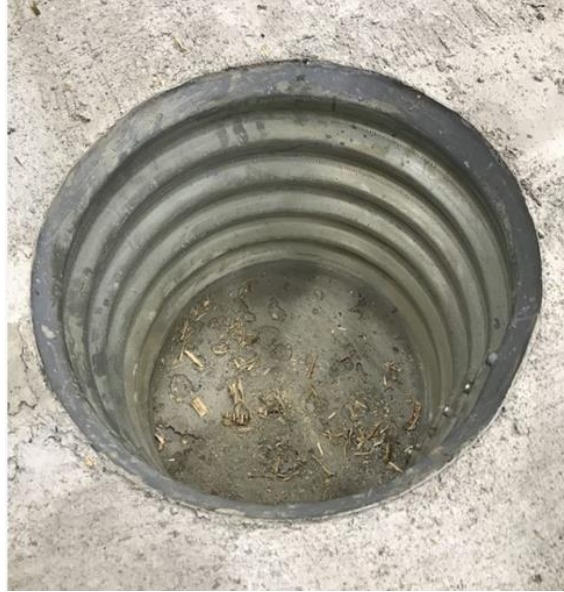
After the concrete had cured, the formwork was removed, and the plugs were taken out of the CMPs (Figure 4.45).

Figure 4.45 *CMP void completed.*

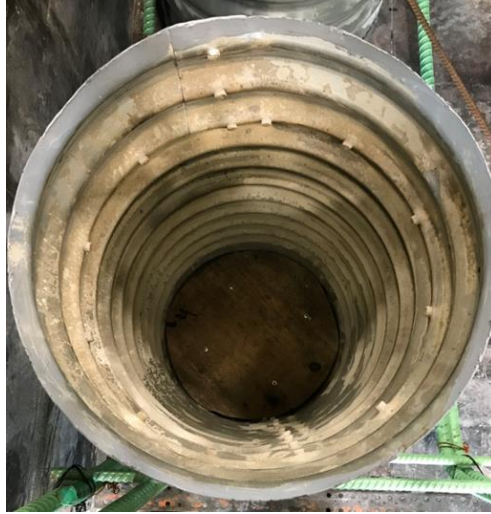
Plywood circles were made to align the CMPs in the integral diaphragm to be aligned with the CMPs of the pile cap (Figure 4.46).

Figure 4.46 *Plywood alignment of integral diaphragm CMP.*

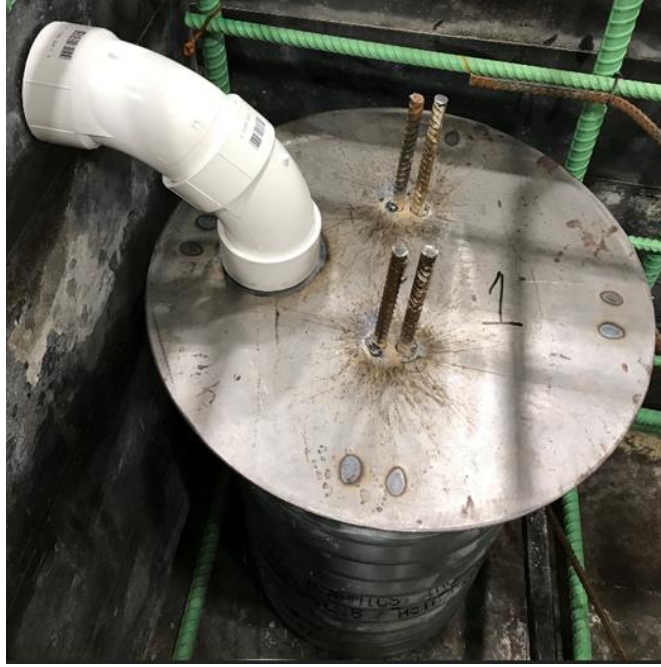
The CMP lid was fabricated using a circular steel plate that was fabricated to have the 3 in. duct to install the cementitious material into the CMP void, four reinforcing steel bars to act as guides for the steel sections to be encased within the CMPs, and a U-bolt that would act as a pulley system for the wire to raise and lower the steel section within the CMP voids.

The wire would pass through the 1 in. duct installed at the top of the CMP just below the lid, and this duct also acts as an air-port to allow all air within the voids to be forced out when the cementitious material is installed (Figures 4.47 through 4.49).

Figure 4.47 *CMP lid with accessories.*

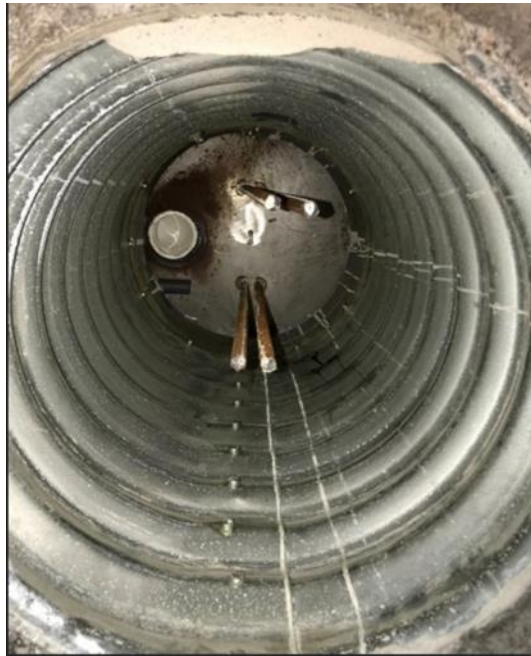
Figure 4.48 *Bottom view of CMP void.*

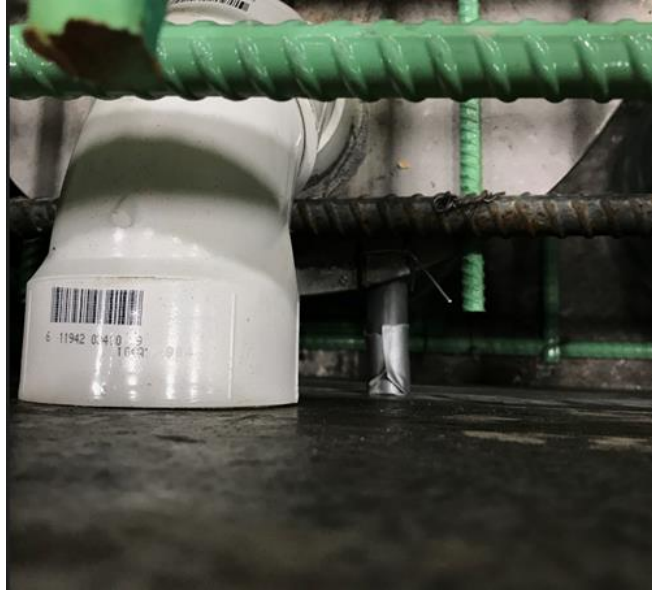
Figure 4.49 *CMP ducts against formwork.*

The ducts for the specimen constructed in the laboratory were designed to surface at the sides of the specimen, opposed to the design details requiring the ducts to surface at the front and back faces, to make the installation of the cementitious material easier with the equipment available in the laboratory. Larger equipment available to contractors would allow for the ducts to be on the front and back faces, since having the surface of the duct at the sides of the real-world application would not be possible due to multiple sections being adjacent to each other, which would prevent the installation of the cementitious material.

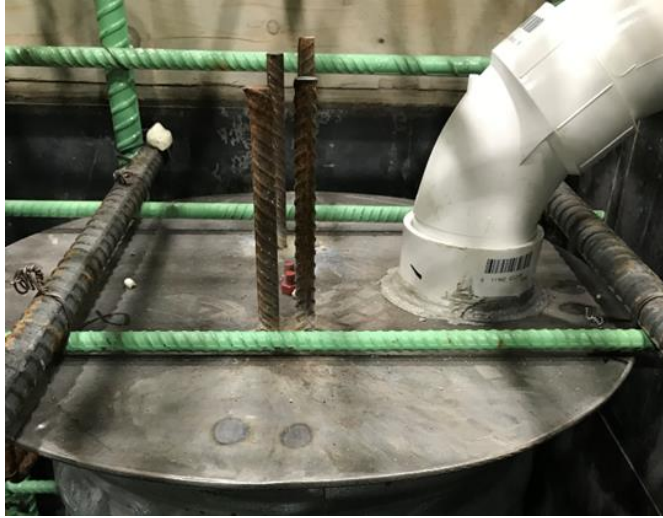
To ensure the CMPs would not shift upwards when casting the integral diaphragm, a “locking” mechanism was installed within the reinforcement cage. This mechanism consisted of using salvage reinforcing steel bars to span across the CMP lids to be tied to other reinforcing bars, which were then tied to the reinforcement cage (Figure 4.50).

Figure 4.50 *CMP “locking” reinforcing steel bar.*

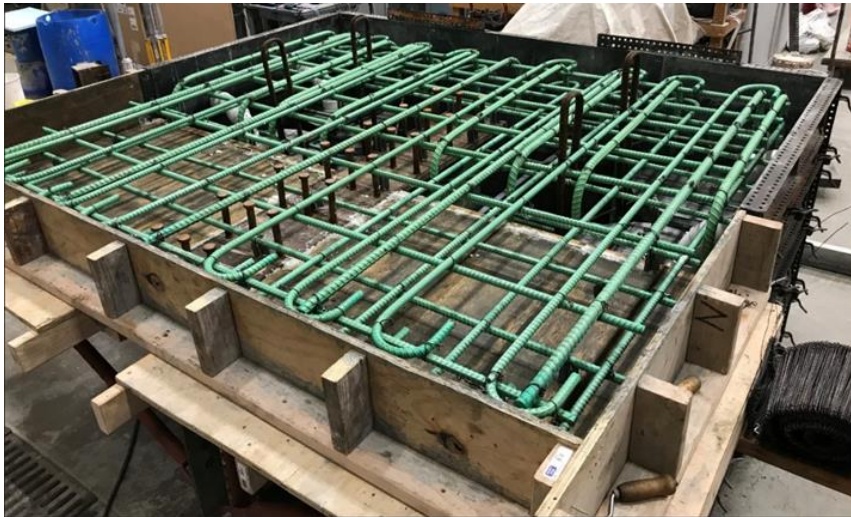
With the CMPs, and accessories, and steel beam set in their designed places, the reinforcing cage was erected, and formwork was placed. Just as the GRBC specimen, steel forms made most of the formwork, but custom woodwork was required to adequately provide formwork for the area around the beam. Finally, the integral diaphragm was encased in concrete (Figures 4.51 and 4.52).

Figure 4.51 *Pile coupler reinforcement cage.*

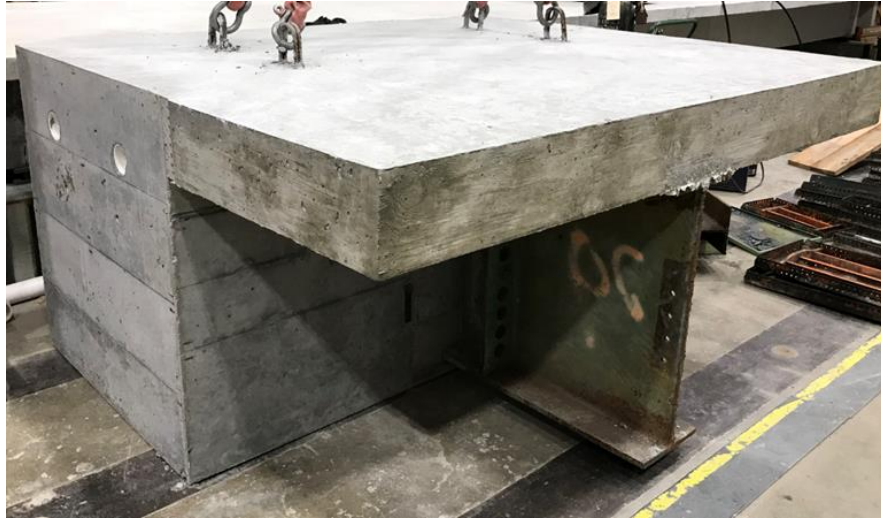
Figure 4.52 *Pile coupler integral diaphragm completed.*

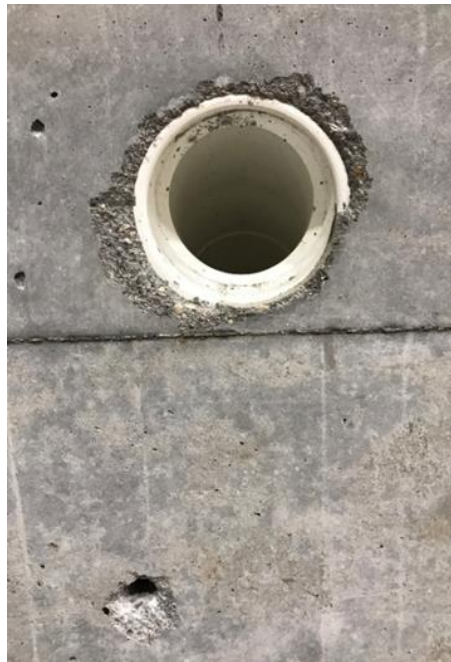
When the formwork was stripped from the completed pile coupler integral diaphragm, a few of the 1 in. ducts had to be found through chipping away of concrete, but all the 3 in. ducts and CMP voids had successfully surfaced (Figures 4.53 and 4.54).

Figure 4.53 *Surfaced 3 in. duct and 1 in. duct found after chipping concrete.*

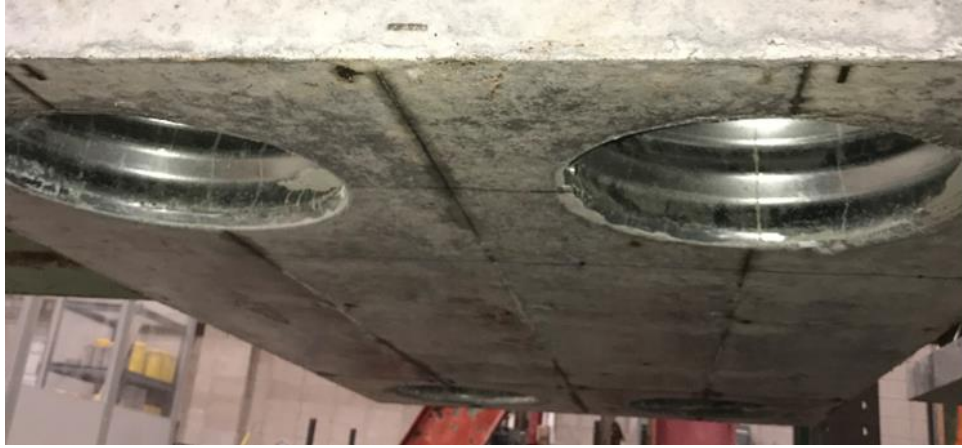
Figure 4.54 *Surfaced CMPs.*

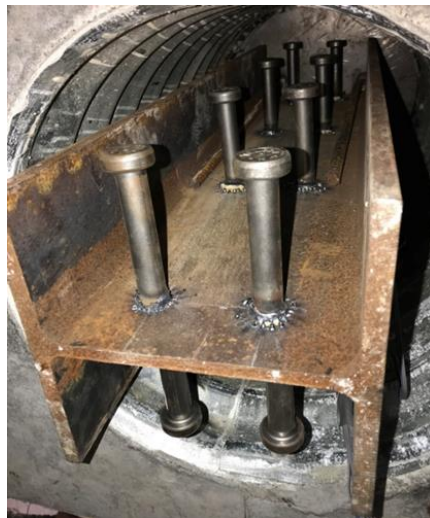
The design of the steel sections was revised from having four lines of threaded rods along the length of the section, to have two rows of shear studs on each face of the web along the length of the section (Figure 4.55).

Figure 4.55 *Steel section coupler with shear studs.*

This was done based on the studs being able to cause the axial development of the sections as the threaded rods would but would also simplify the fabrication.

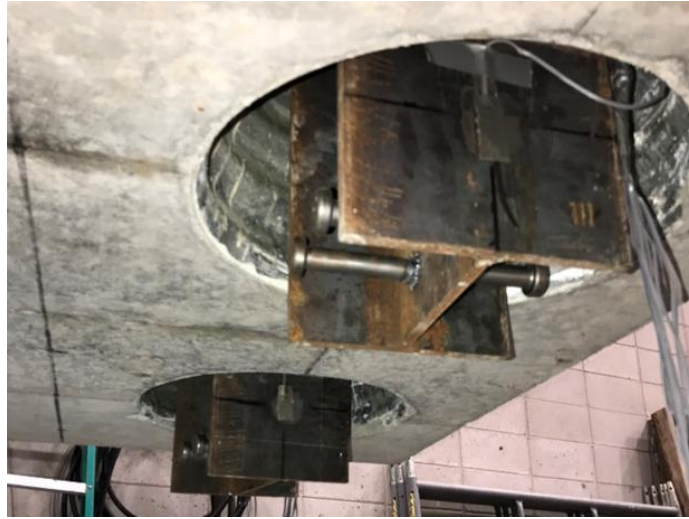
Steel wire was used to suspend the steel sections within the CMP voids in the integral diaphragm during the installation of the diaphragm, and then the sections were lowered into the CMPs in the pile cap after the diaphragm was in position (Figure 4.56).

Figure 4.56 *Steel sections suspended within integral diaphragm CMPs.*

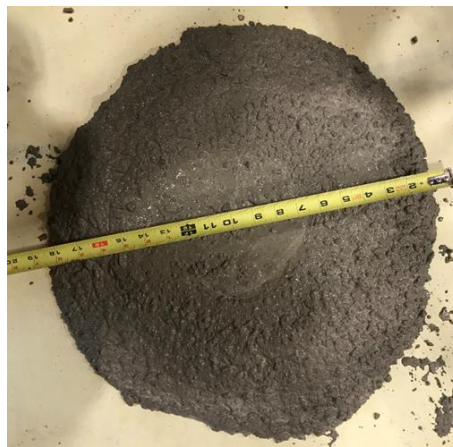
The CMPs were filled with a self-consolidating concrete (SCC) mix from a local plant, which had an 18 in. spread (Figure 4.57).

Figure 4.57 *SCC 18 in. spread.*

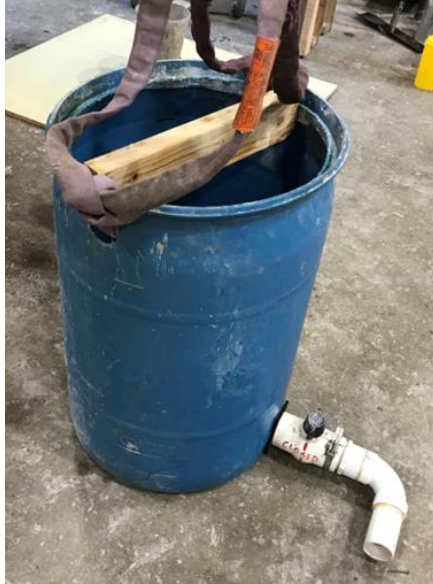
The SCC was installed by using a barrel with a funnel, as well as dumping with buckets (Figure 4.58).

Figure 4.58 *Barrel with funnel to install SCC.*

- SCC aggregate consolidated to the bottom of barrel with funnel when installing, and bucketing material had to be done to finish install.
 - Avoid using equipment that would allow for settlement of SCC aggregate.
 - Add water to SCC to cause larger spread, and higher flowability.
- Reinforcing steel bar guides for steel sections were too close to edges of web and flanges, preventing the sections from being completely suspended within CMP voids.
 - Revise design of guides to avoid this “pinching” issue.

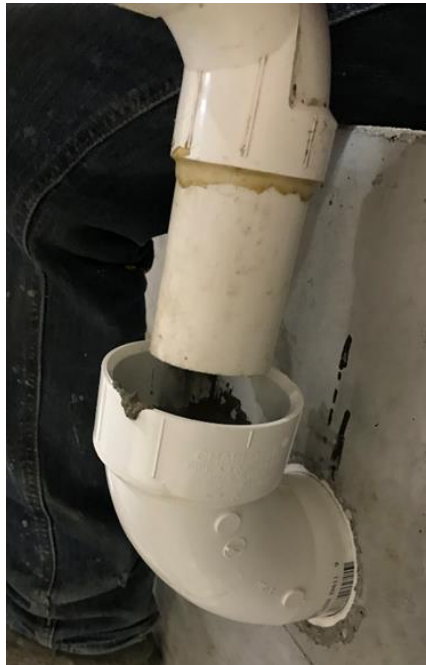
The SCC was installed through the 3 in. ducts until filled, and the 1 in. duct was plugged when material began to flow through it (Figures 4.59 and 4.60).

Figure 4.59 *SCC installed through 3 in. duct.*

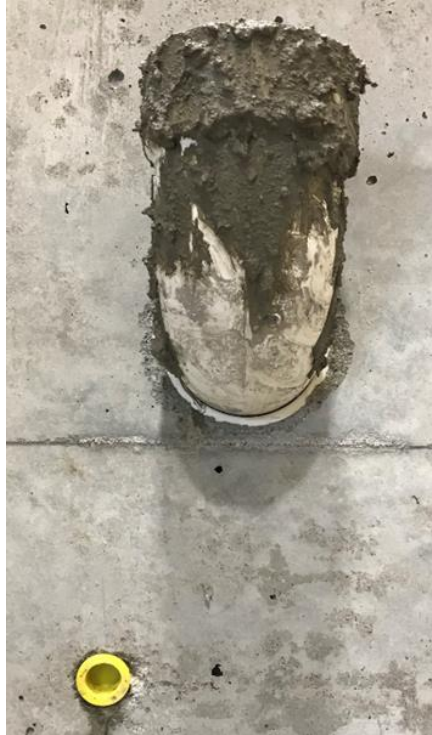
Figure 4.60 SCC completed install with 1 in. duct plugged and 3 in. duct filled.

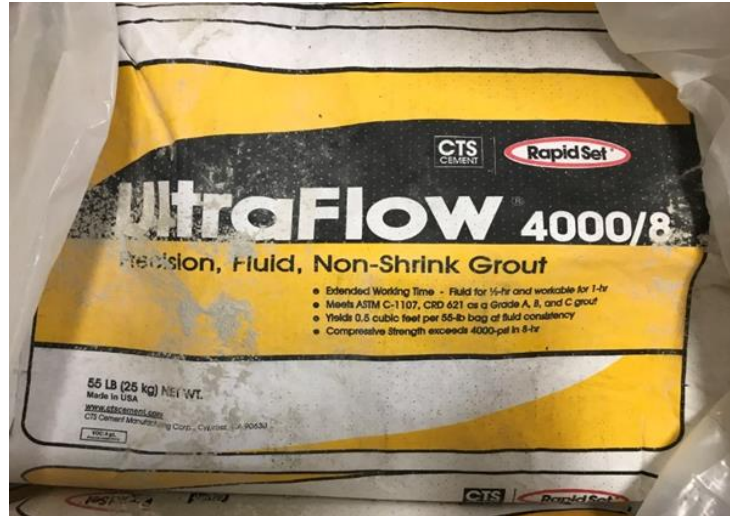
Formwork similar to the GRBC grout bed formwork was erected and a non-shrink grout complying to Iowa DOT standards (Figure 4.61) was installed using the grout pump and procedure used for the GRBC grout bed (Figure 4.62).

Figure 4.61 Non-shrink grout used for pile coupler grout bed.

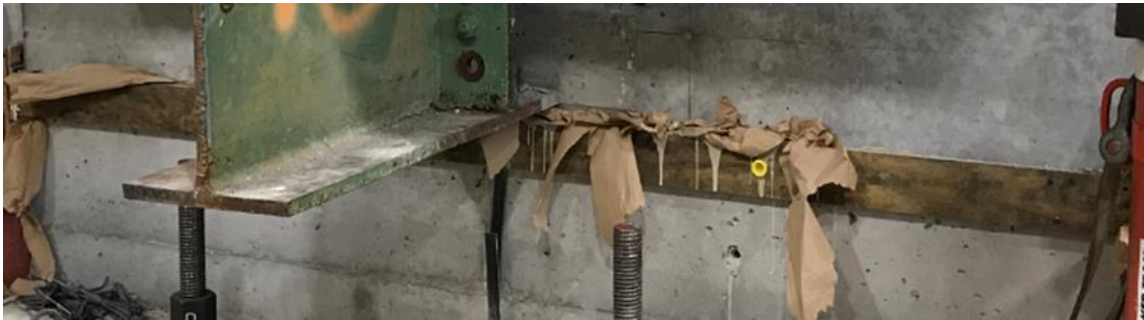
The 3/4 in. grout bed was created by using 3/4 in. thick nuts to create the required gap. To ensure a seal around the CMP voids, 1 in. insulation foam rings were glued around the pile cap CMP voids, which would compress when the diaphragm was installed.

Figure 4.62 Pile coupler grout bed completed.

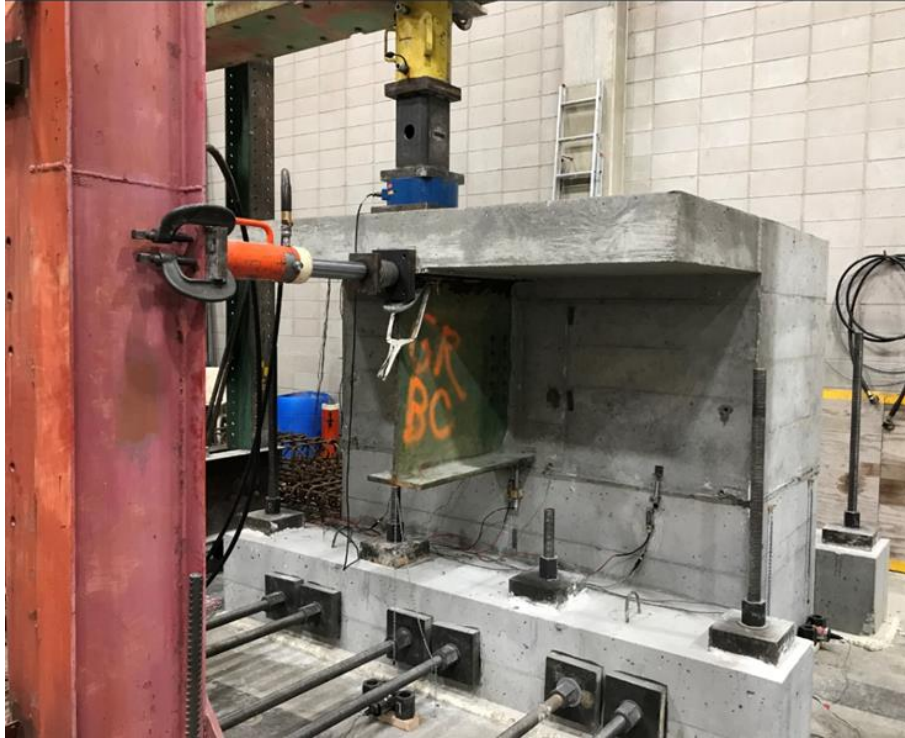
Figure 5.3 *Laboratory testing setup.*
