Innovations in integral abutment connection details for accelerated bridge construction

Austin James DeJong
Iowa State University

MASTER OF SCIENCE

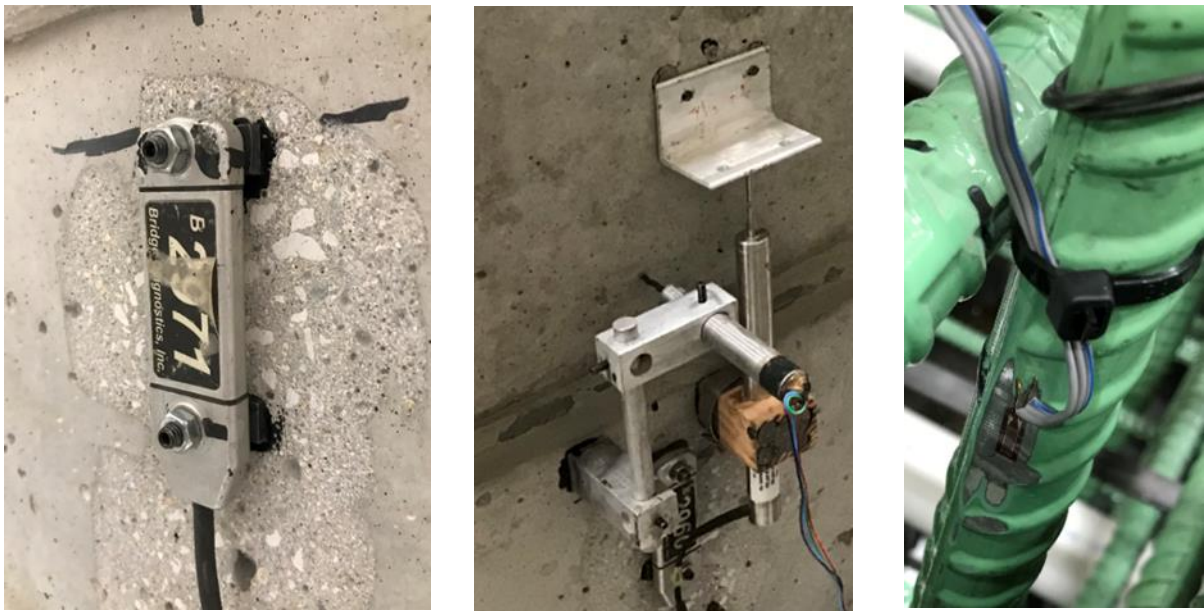
Photographs of the setup of the instrumentation for each specimen are shown in Figure 5.11.

Figure 5.11 *External strain gauge (left), vertical displacement transducer, horizontal displacement transducer, and external strain gauge (center), and sacrificial strain gauge (right).*

A variety of instruments were installed on the specimens to monitor and analyze the strength and durability of the three integral abutment connection details. First, to record the magnitude of the tension-side crack widths for each loading case, displacement transducers, called DCDTs, were installed at three positions on both the front and rear face of the specimens. These transducers would record the vertical displacements caused by cracking of the cold joint between the integral diaphragm and pile cap of the integral abutment. The result of these recordings would be compared to those of (Hosteng, Phares, & Redd, 2016) and report the severity of the possibility of infiltration of water or other chemicals that could cause structural deterioration of the connection details. Another two displacement transducers were installed at the rear face of the specimen to monitor any horizontal displacement, or slip, between the integral diaphragm and pile cap during horizontal loading.

Third, external strain gauges, called BDIs, were installed at the locations of the vertical displacement transducers to record the overall strength of the integral abutment during both load cases. The recorded values would be compared to values determined by AASHTO to declare which type of failure was present during the test.

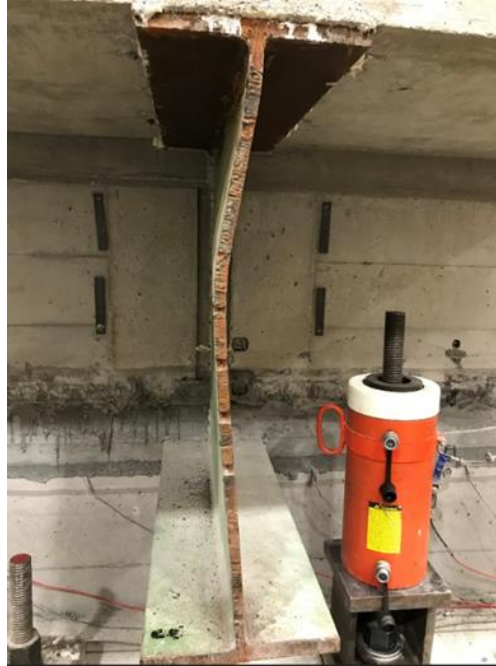
The vertical load was then applied up to a value of 397 kips, at which point the beam began to fail due to the buckling of the web (Figure 5.13).

Figure 5.13 *Beam buckling failure causing end of test.*

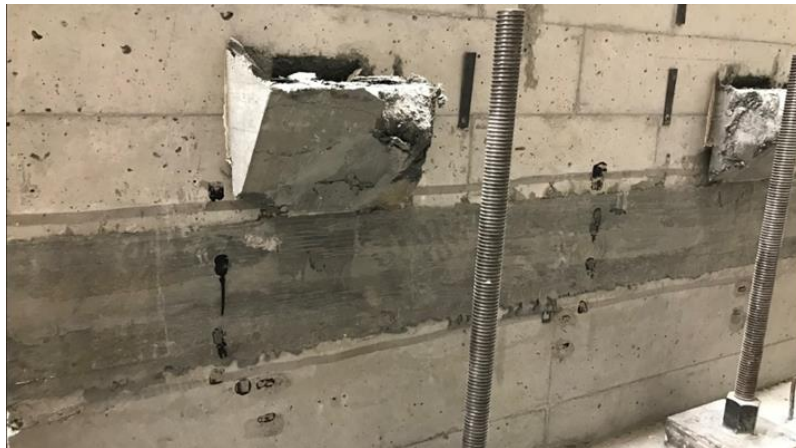
The control specimen reached a maximum load of 385 kips and reported a maximum joint crack of 0.025 in. The UHPC joint specimen had a crack of 0.031 in. under a 385-kip load, which is approximately 1.3 times greater than the control specimen. Again, it is shown most of the maximum joint cracks derived from the joint to pile cap interface, but after unloading the cracks closed (Figure 5.15).

Figure 5.15 *UHPC joint rear face after testing.*

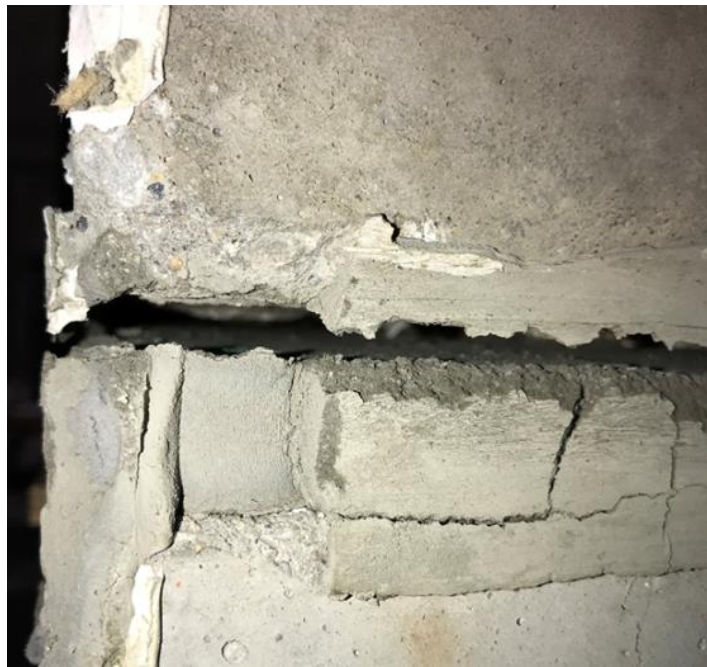
Figure 5.19 GRBC rear face crack due to vertical load.

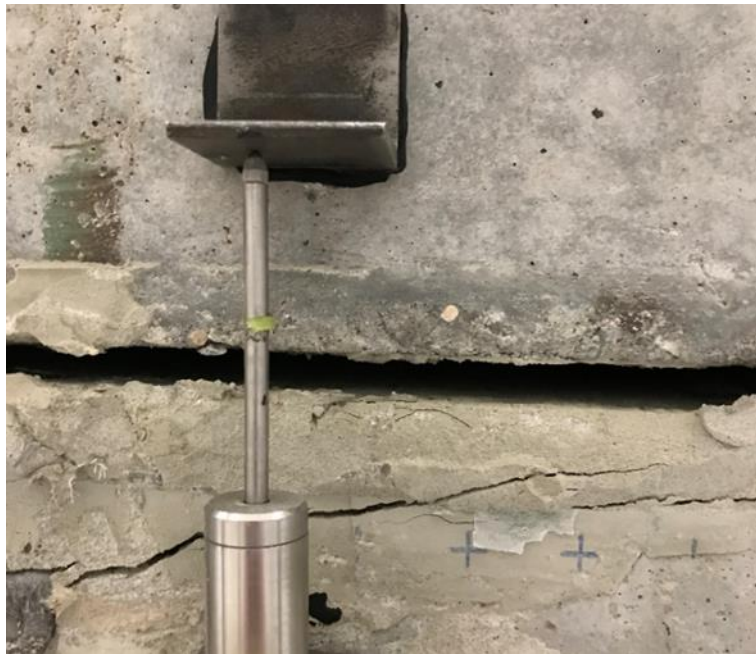
The vertical load was then applied to a maximum of 377 kips, or a moment of 1,677-k-ft, which caused a crack at the rear face of the abutment to be 0.306 in. (Figures 5.22 and 5.23).

Figure 5.23 Crack width versus moment due to vertical load.

When more load was attempted to be applied, only more displacement was gained from the specimen. During the sustained load, the joint crack reached a maximum value of 0.627 in. Also, during loading cracks propagated in the pile cap of the abutment near the

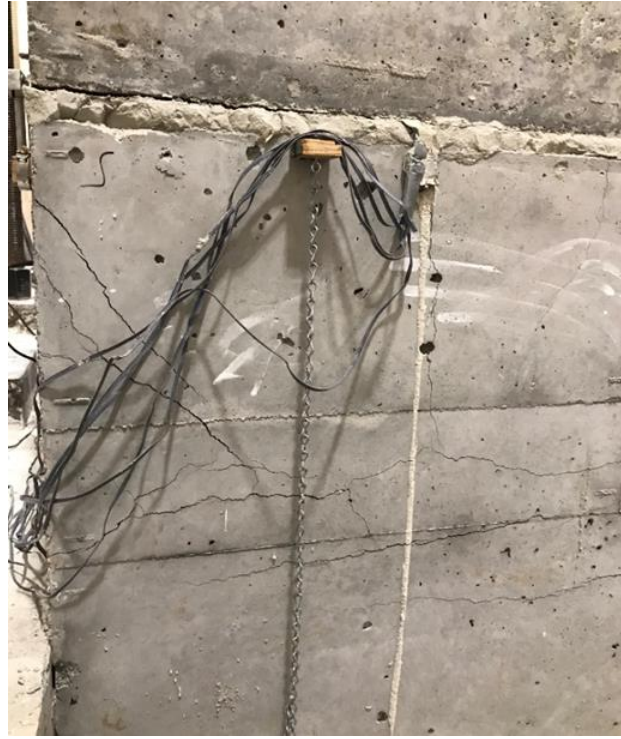
Figure 5.24 *Pile coupler pile cap cracking due to vertical load.*
