Installation and performance evaluation of coaxial cable sensors for crack and corrosion detection

A THESIS

MASTER OF SCIENCE IN CIVIL ENGINEERING

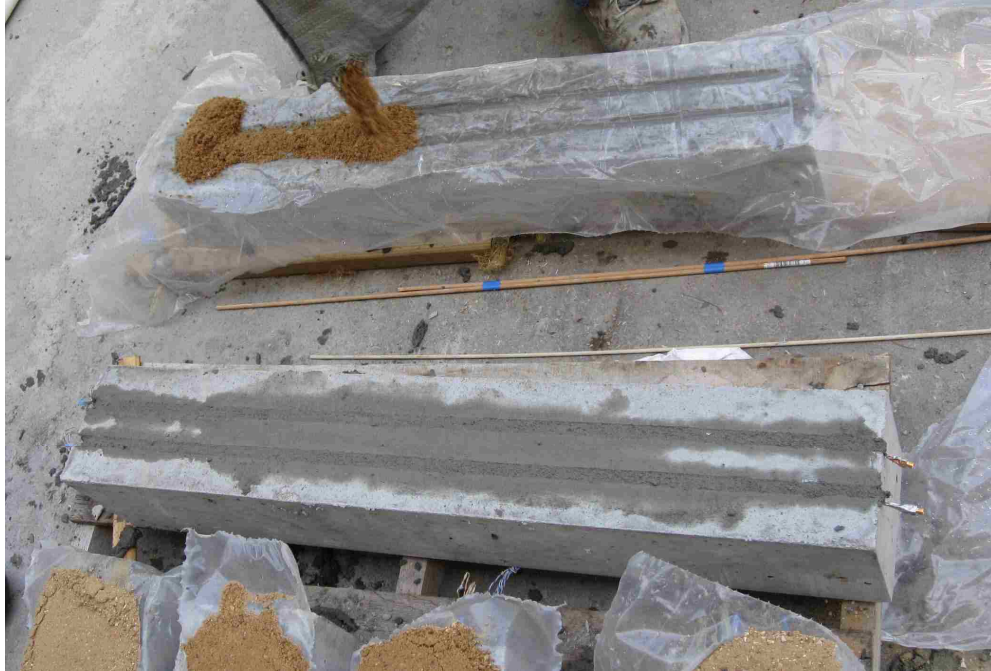
All sensors were placed along the tension face of the tested beams. Each beam was instrumented with three (3) topology-based sensors. As shown in Figure 4.5, two sensors were embedded into 0.5 in deep precut grooves and one sensor was attached to the tension face of the beam along its center line. The goal of this study was to select the best way for installation of the above mentioned crack sensor. Two types of installation (embedded vs. surface attached) were compared. For each installation type, various types of adhesive materials are compared, including grouting (SikaGrout212), epoxy (HoldTight®102), structural resin (M_BRACE Saturant), and mortar with a weight mixture of 1 part of Portland cement, 0.5 part of hydrated lime (type S), and 3.5 to 4.5 parts of masonry sands according to ASTM-C-144. The test matrix is given in Table 4.2.

Figure 4.5. Grouting procedure

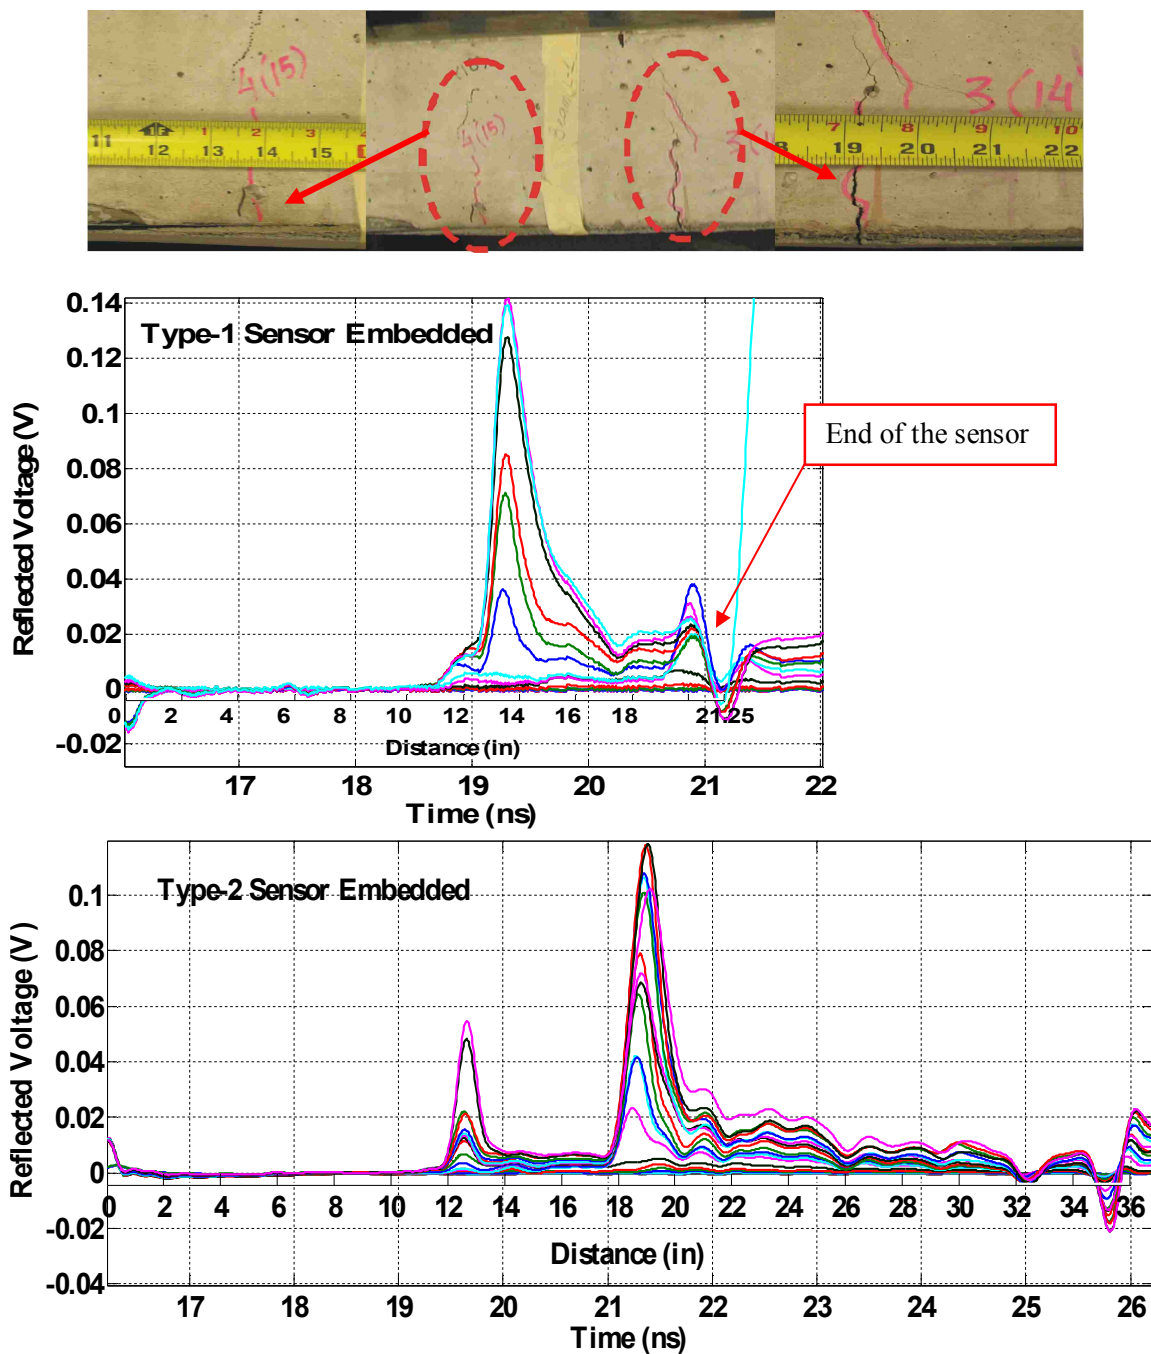
The TDR signature corresponding to a crosshead displacement of 0.06 in (1.53 mm) included a prominent spike at 21.4 ns (19 in) from the left end of the beam. As soon as the first spike appeared, the beam was visually inspected and no apparent crack lines were observed at the surface. It suggests that the sensor was able to pick up a very beginning of the crack opening when its aperture is less than 0.0039 in. (0.1 mm). At the next increment of crosshead displacement, the first crack has been observed. That was followed by an impedance increase on the TDR signature that corresponds well to the physical location of the crack. At the crosshead displacement of 0.14 in (3.56 mm), the second spike was recorded at about 19.5ns (~13 in) from the left end of the sensor. That was immediately followed by the second crack development at 13.75 in from the left support of the beam, Figure 5.2.

Figure 5.2. Crack pattern and TDR responses from the previously developed sensor (Type-1) and the miniaturized sensor (Type-2)

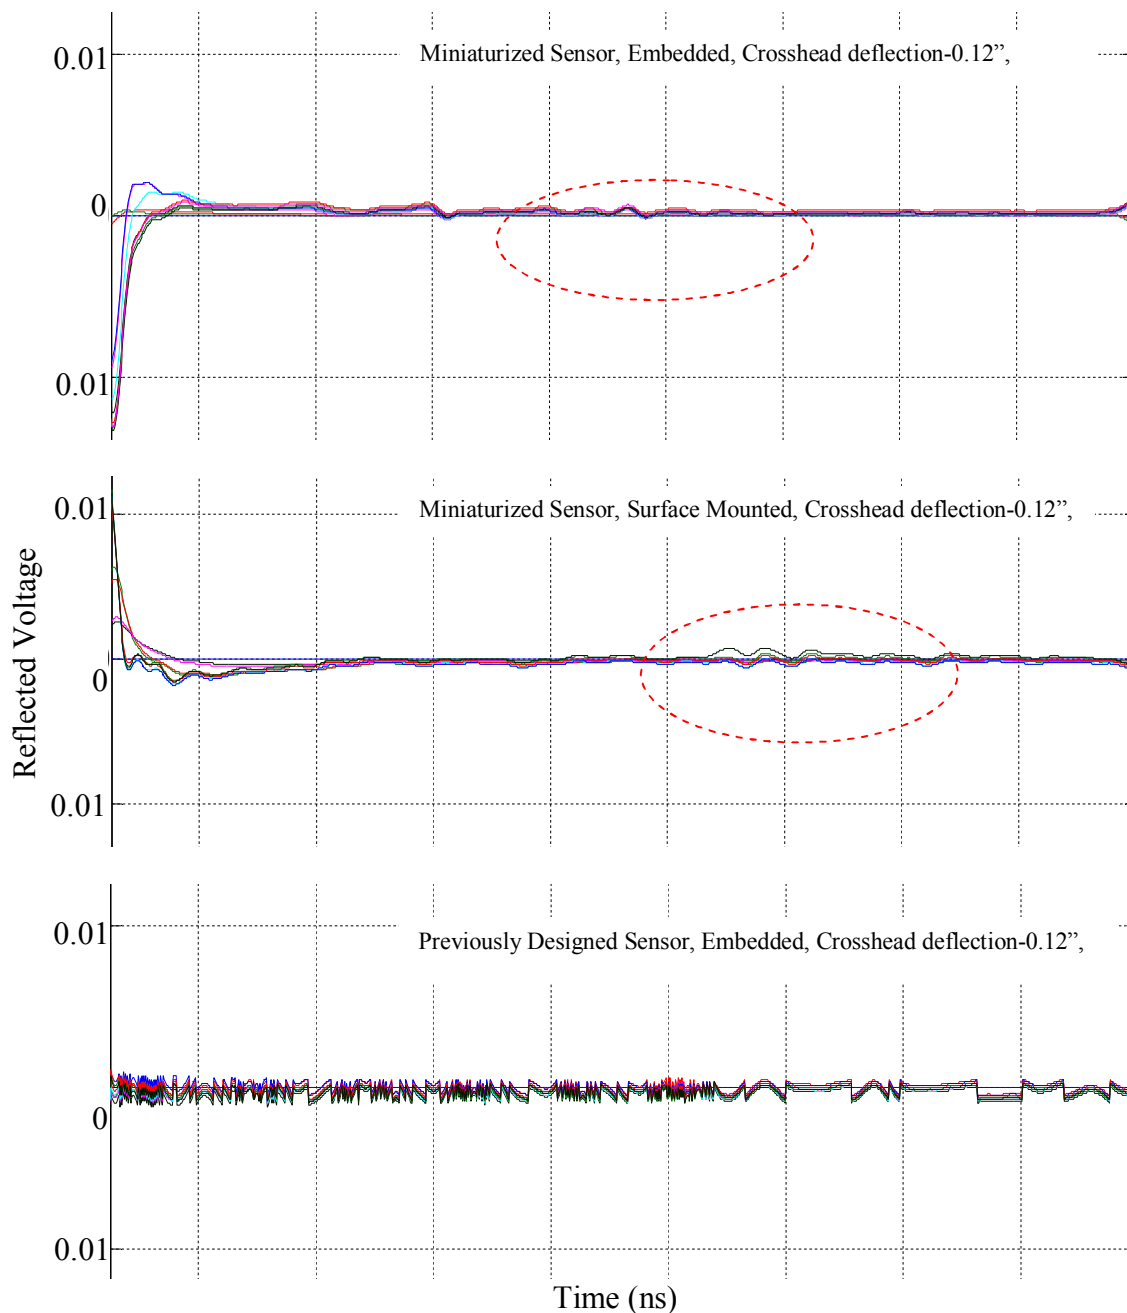
of stresses at the mid-span region, while the previously designed sensor at that stress level has a high noise-to-signal ratio.

Figure 5.3. Comparison of the waveforms recorded from the previously designed and the miniaturized sensors

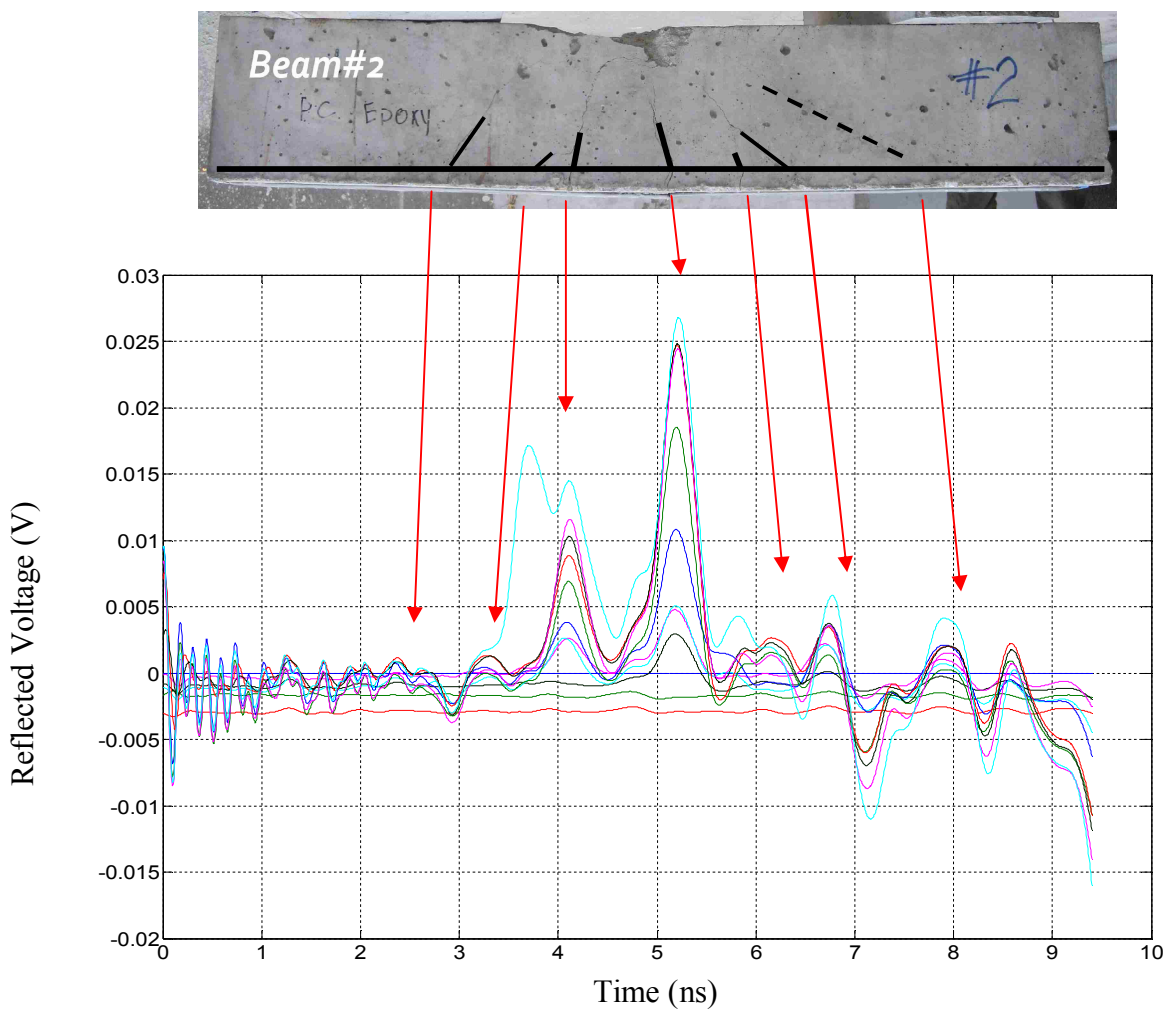
Figure 5.4. Crack pattern of Beam # 2 and TDR signatures from Sensor # 1: embedded with Portland cement

Figures 5.4 through 5.21 show the TDR data recorded from the miniaturized sensors installed in Beams #2 to #7. In all figures, embedded sensors are marked as sensors #1 and #2, whereas all surface attached sensors are identified as sensor #3.

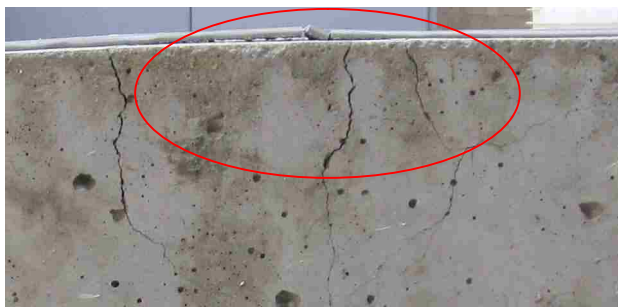
Figure 5.7 HoldTight 102 spalling at the midspan of Beam # 2

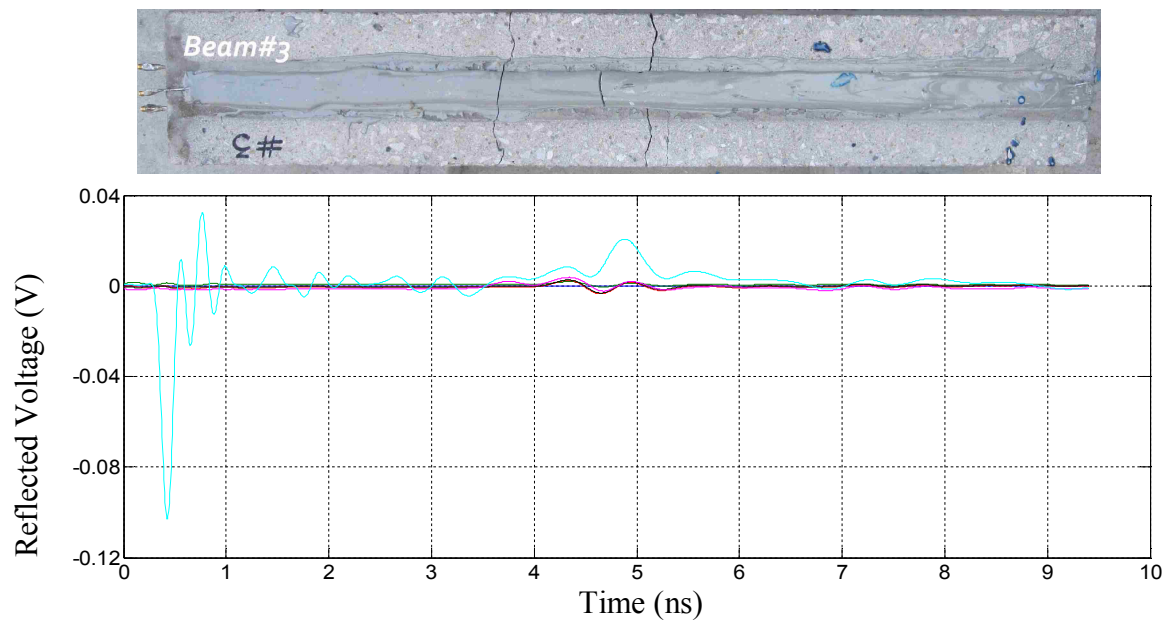
Sensor #3 was surface attached to Beam #3 with Hold Tight ® 102 adhesives. As shown in Figure 5.10 and Figure 5.11, the adhesives delaminated at midspan. The crack patterns on the beam and the sensor are different. The surface attached sensor tended to respond to the crack patterns from both materials and is thus ineffective.

Figure 5.11. Crack pattern of Beam # 3 and TDR signatures from Sensor # 3: surface attached with HoldTight 102 adhesives

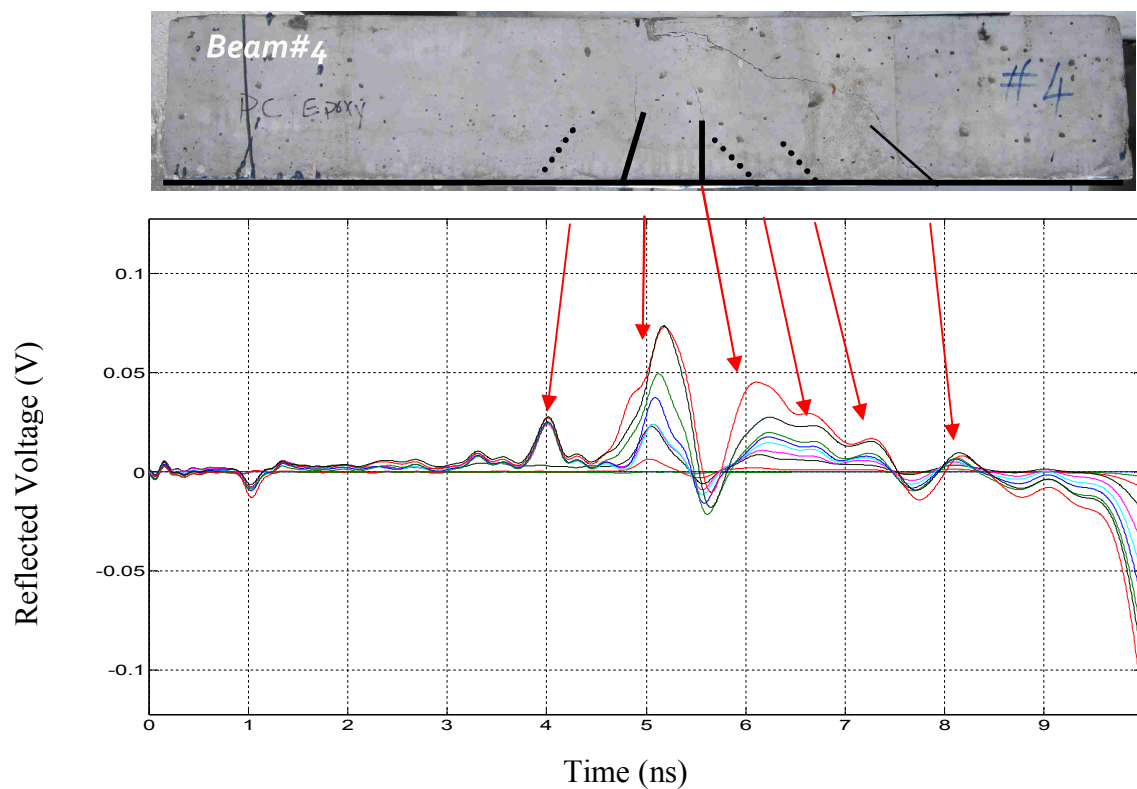
The crack patterns developed on the surface of Beam #4 together with the waveforms acquired from the miniaturized crack sensors are illustrated in Figure 5.12 and Figure 5.13. To enhance attraction between grouting and the host materials, the grooves molded on the tension face of the beam were brushed with the primer. The sensors were grouted with the mortar. During the beam transportation, one of the embedded sensors was damaged. As seen in Figure 5.12, location of all cracks within the beam is reflected fairly accurately by the TDR signatures. In addition, the sensor suggests the presence of the crack zones missed by visual inspection.

Figure 5.12. Crack pattern of Beam # 4 and TDR signatures from Sensor # 1: embedded with mortar

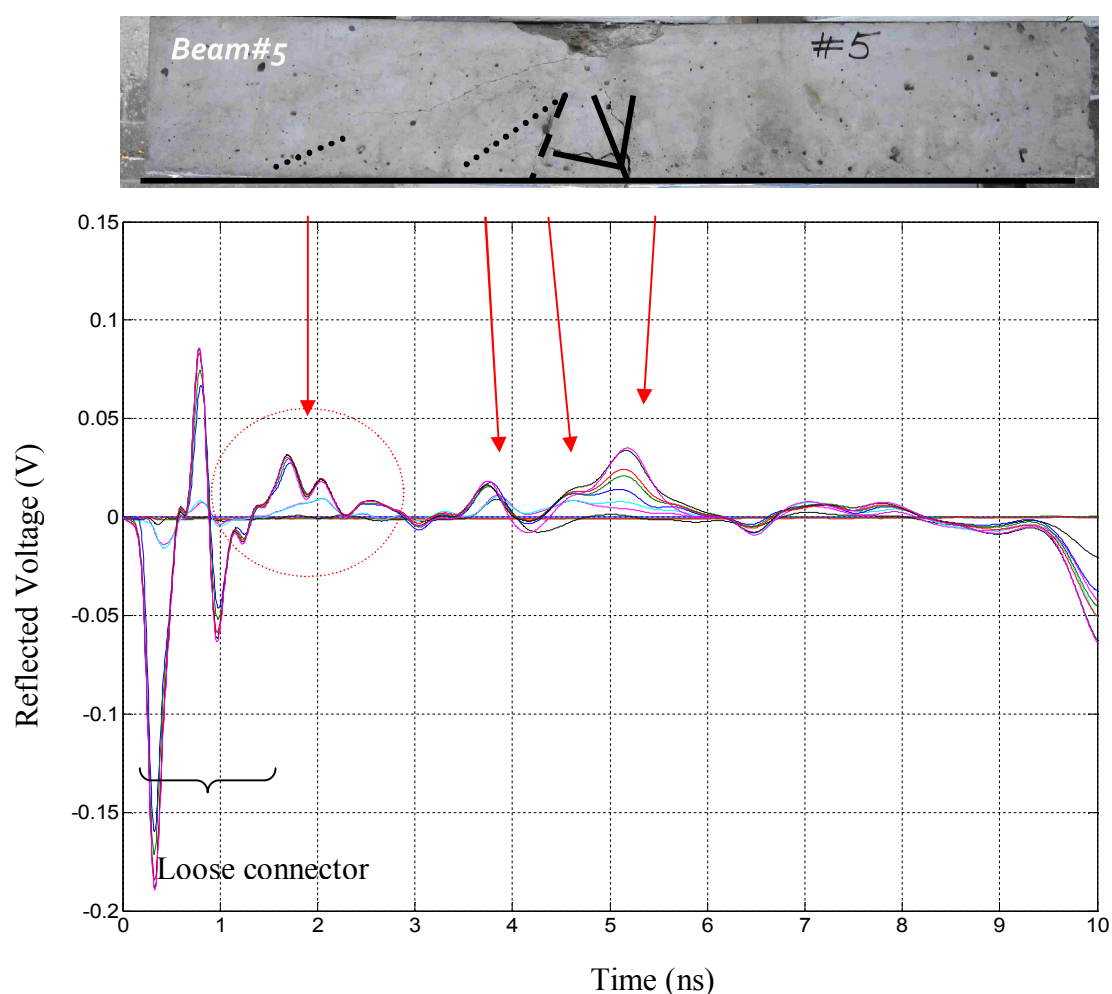
Figure 5.15. Crack pattern of Beam # 5 and TDR signatures from Sensor # 1: embedded with mortar

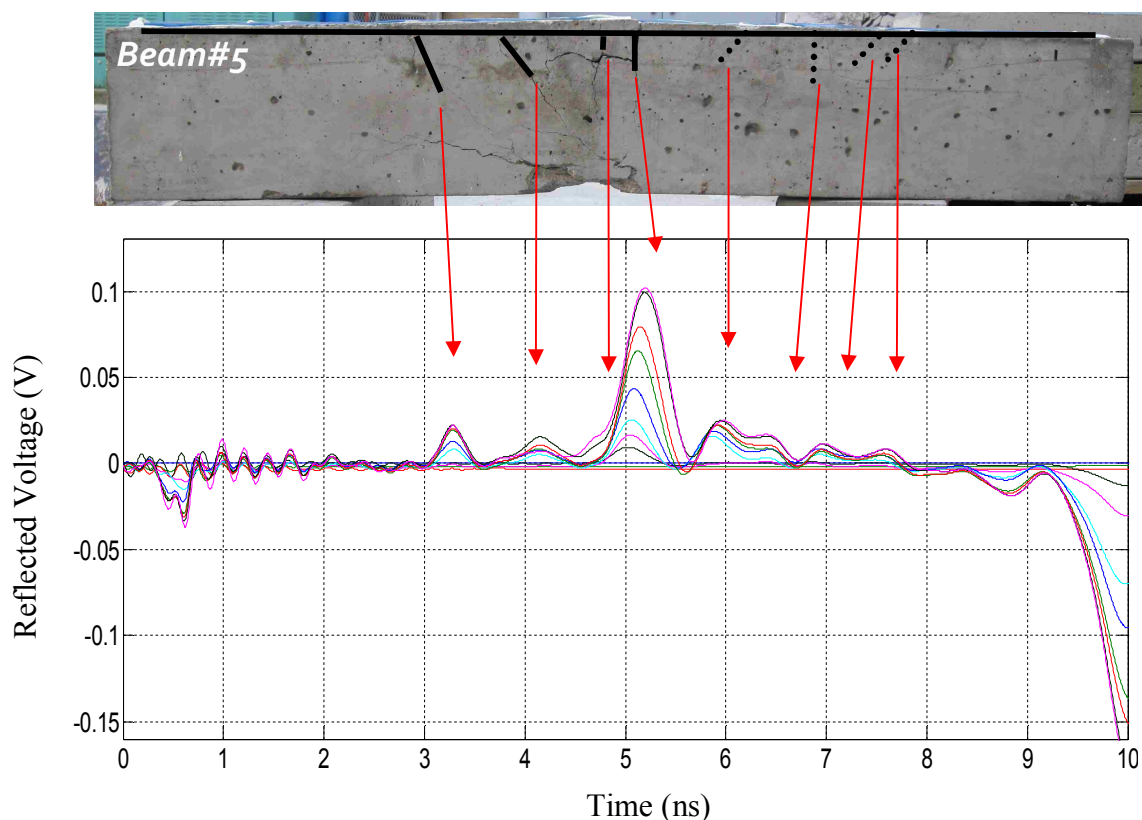
There were cracks observed on the side surface of the beam that had not reached at the tension fibers of the beam where the sensor was grouted. The fact that all visually available cracks were identified correctly, suggests that the additional spikes on the TDR signatures (at 6.5 ns and 7 ns) are produced by smaller cracks that were not visually seen on the beam's surface, Figure 5.16.

Figure 5.16. Crack pattern of Beam # 5 and TDR signatures from Sensor # 2: embedded with mortar

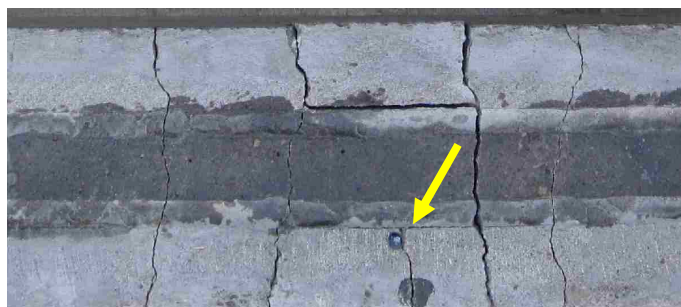
Figure 5.20. Close-up view of the crack pattern within the midspan of the tension face of the Beam # 6

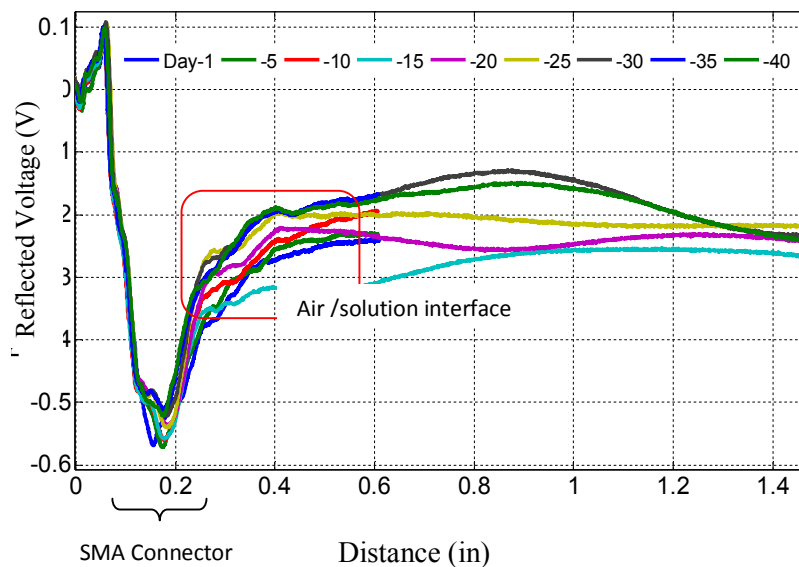
6.5.1. The First Test Series. TDR signatures were collected at the time when the sensors were submerged and every fifth day of a week after beginning of the test. The TDR signatures are presented in Figure 6.2.

Figure 6.2. TDR signatures taken at every fifth day after beginning of the corrosion test

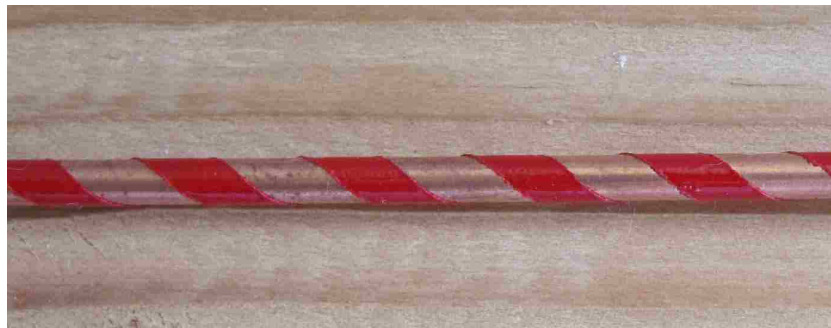
Figure 6.9. Corrosion resistant helical paints over a coaxial cable sensor
