**INTEGRATED LIFE-CYCLE COST & RISK OPTIMIZATION
FRAMEWORK FOR COASTAL PROTECTION STRUCTURES**

A Thesis Submitted To
Department of Construction and Architectural Engineering
In partial fulfillment of the requirements for the degree of

Master of Science
in
Construction Management

February 2015

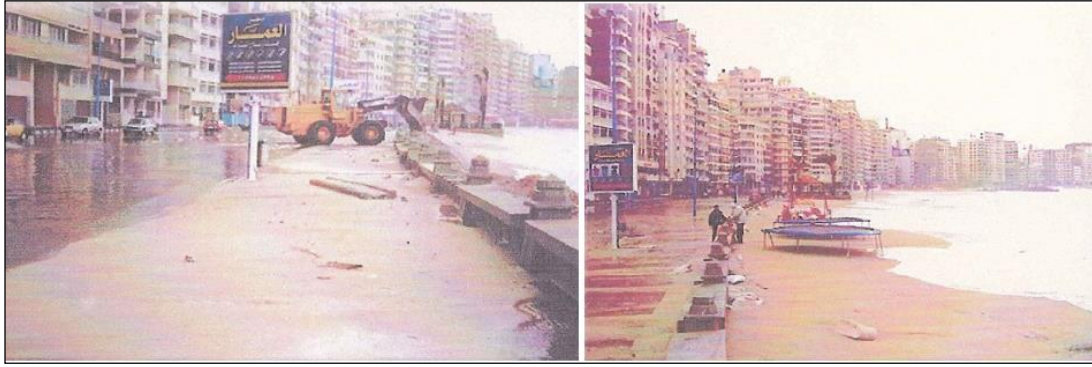
Figure 1-3: Storm surge in Al-Mandara area in 2003 (Courtesy of Arab Contractors).

Climate was also blamed for the recent increase in storm surges and change in wave characteristics along Egypt's Mediterranean coasts, posing further risks on Alexandria's beaches, especially during winter storms (Iskander, 2013). In 2003, a heavy winter storm caused the flooding of the Pharos Promenade tourist area in addition to the busy Al-Manshiya district in the Eastern Harbor. Moreover, a severe winter storm in December 2010 inflicted critical damages to the Cornice Road, and caused severe erosion of recreational beaches in several places. Figures 1-3 and 1-4 show examples of the damage of assets, infrastructure, and flooding caused by excessive wave run-up induced by the storm surge in two winter storms in December 2003 and December 2010, respectively. Figure 1-4 shows the impact of the winter storm in the following areas: (a) Engineers Club, Saba Pacha; (b) Armed Forces Club, Mustapha Kamel Pacha; (c) Western Harbor; and (D) Tharwat area (Photos are courtesy of AF Co. and Dr. Mahmoud Fayez Zaki Consulting Office).

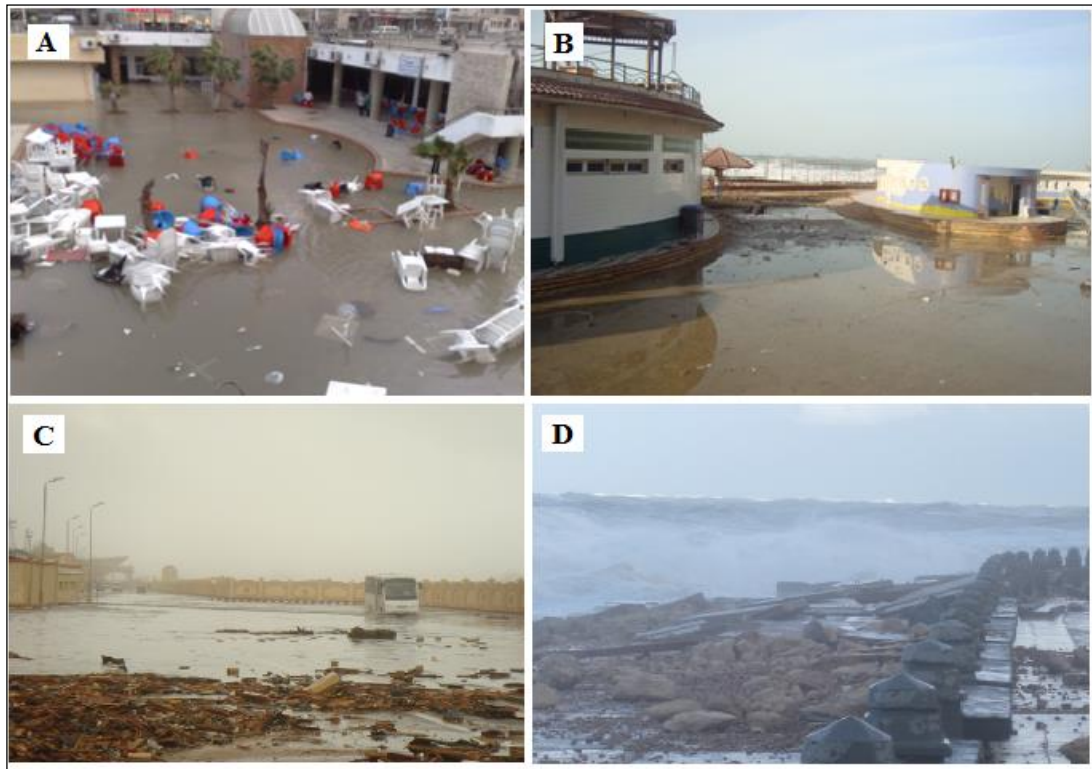
Figure 1-4: Impact of the December 2010 storm in Alexandria.

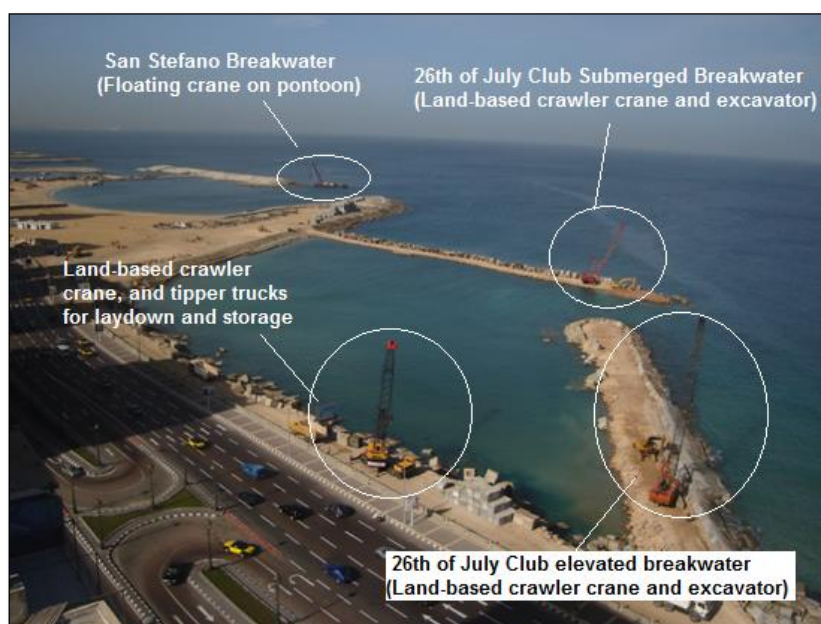
Figure 2-21: Combining land-based and waterborne equipment (Courtesy of AF Co.).

Figure 2-21 provides a real-life example on the use of land-based and waterborne construction. The photo was taken during the construction of the San Stefano and the 26th of July Club breakwaters in Alexandria, Egypt, 2011. In most situations, optimizing the utilization of both land-based and waterborne methods and their corresponding equipment is key towards achieving the near optimum cost and time schedule in not only marine construction, but also in maintenance and repair jobs. CIRIA (2007) includes a general comparison between land-based and waterborne construction. The comparison criteria include the concept behind determining the structure's cross-sectional dimensions and length, logistics, relation with seabed morphology, limiting factors, environmental constraints, damage to the structure whilst execution takes place.

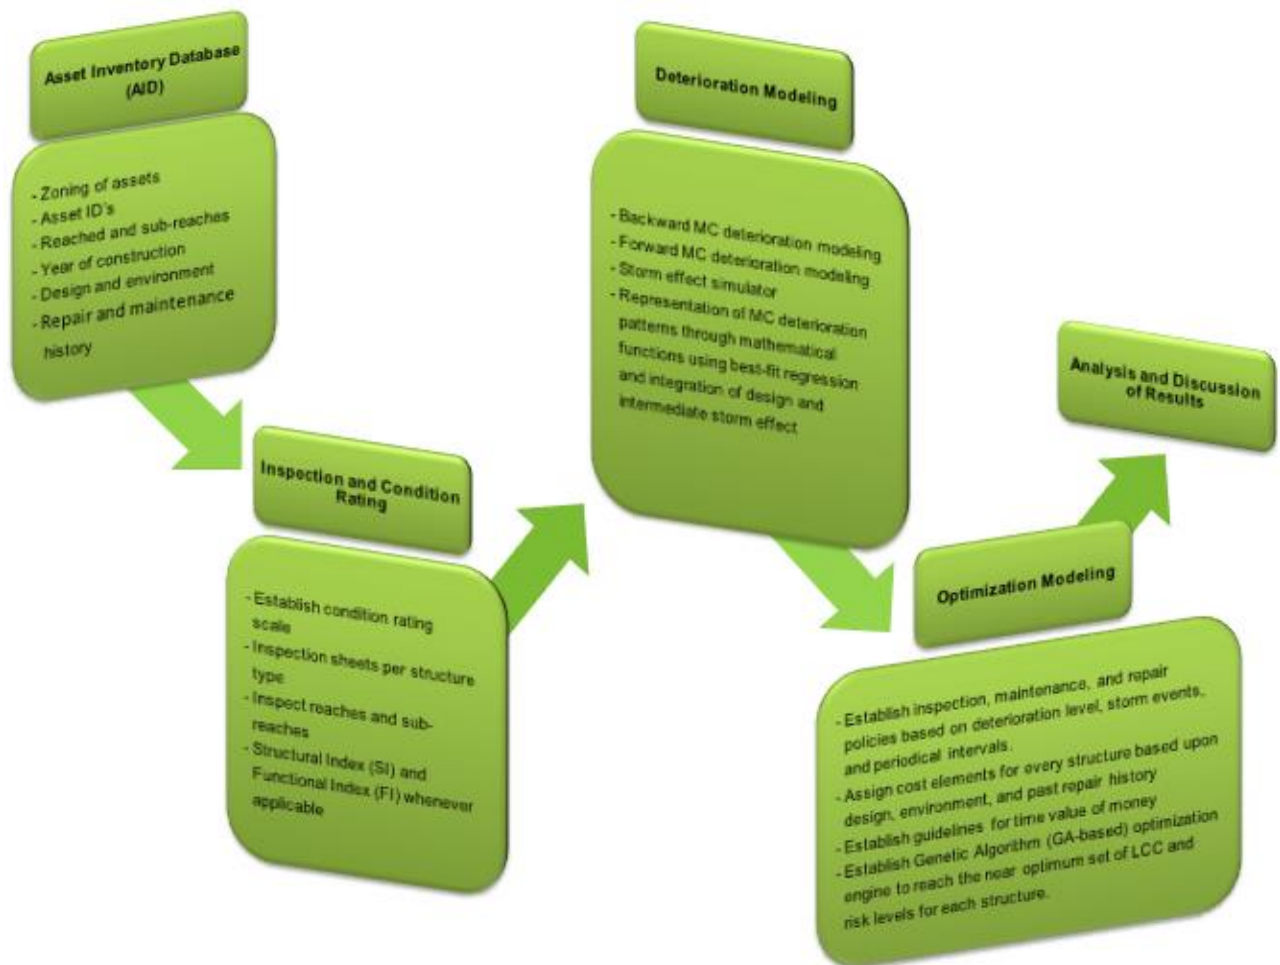
Figure 3-1: Research general outline.

Figure 3-1 outlines the stages of the methodology development of this thesis.

This thesis work started by data collection with regard to design and environmental attributes of coastal structures in the study zone. This data was verified through field visits carried out by the author, and through interviews with contracting companies, governmental institutions, private owners, and design offices that are or were involved in marine projects. After the stage of data acquisition, comes the stage of formulating the AID, prior to conducting a visual inspection and condition assessment of all structures using established condition assessment and rating criteria and guidelines. The results of such field work were then verified through expert consultation, and an analysis was performed from a zone perspective as well as in view of the structure categories. Furthermore, the results of this single inspection point were traced back to the initial condition of each structure at the year of construction or the last major rehabilitation, using the backward MC Module. The DTM obtained from the Backward MC Module were then utilized to project future deterioration up to year 2050, while including the single-event impact of intermediate and design storms. The latter forward MC deterioration trends were then expressed in terms of mathematical functions peculiar to each individual structure, using best-fit regression. The following step was establishing a series of CI thresholds triggering their corresponding intervention policies, and taking into account the unit cost of each of such observe and monitor, maintenance, repair, and replacement policies; the end product is there: the LCC Optimization Module. The construction of such module necessitated another wave of data collection, but this time concerning the cost of maintenance and repair policies associated with each structure within the study area. As for the Risk Optimization Module, data collection was primarily guided towards obtaining numerical factors representing the consequence of failure of each structure within the study area through expert opinion and literature review of high-risk areas. Figure 3-1 describes the general work methodology development outline.

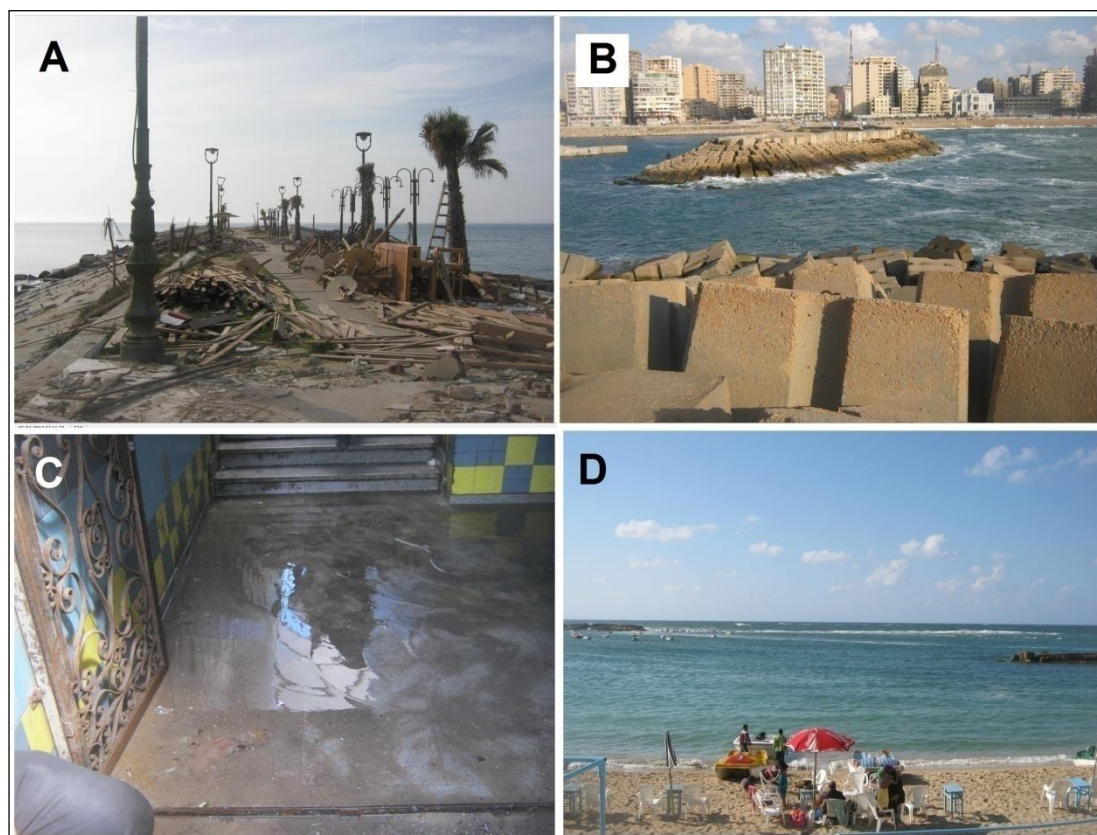
Figure 3-5: Functional inspection by the author in Alexandria, Egypt, 2013.

Selected photographs documenting observations recorded during the functional inspection of various types of structures are shown in Figure 3-5. The figure is the courtesy of the author, and the legend is explained as follows: (a) Waste accumulated on top of the Glim Bay West Groin crest; (b) waves breaking on the Glim Bay East

Groin; (c) Seawater flooding a pedestrian tunnel at the lee of Al-Chatby Revetment; and (d) Waves breaking on the submerged Miami Breakwater creating safe haven for beach users and protecting the beach from erosion.

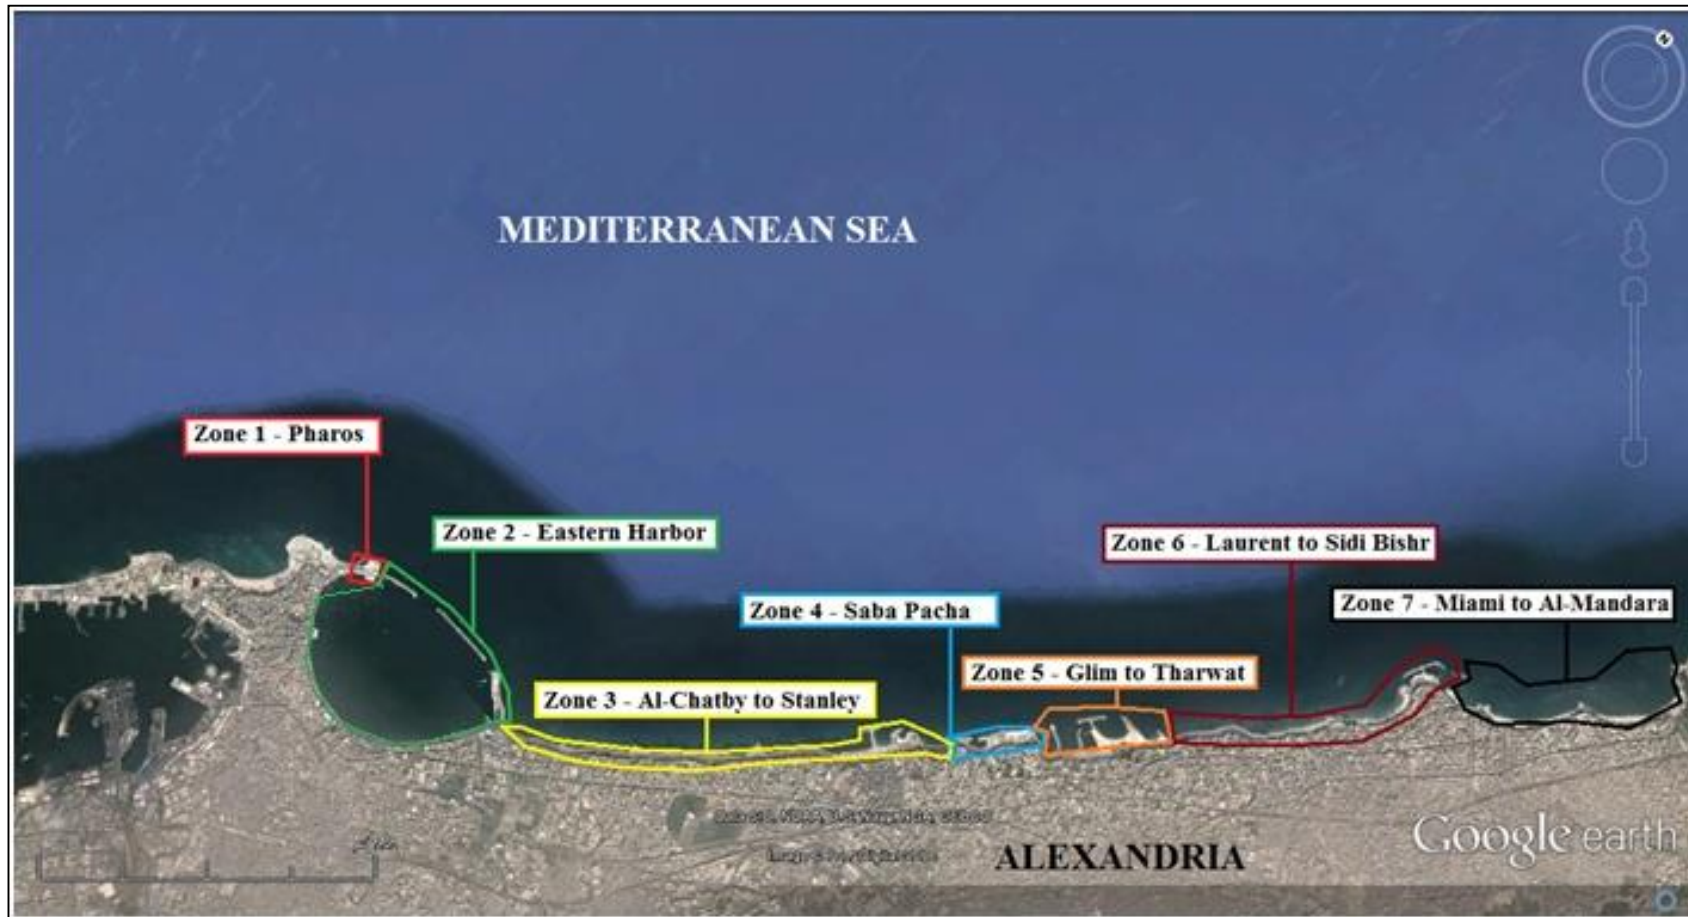
Figure 4-2: Scope of the case study area and its zoning layout.

The geographic location of the case study is shown in Figure 4-2 (Map modified by author from Google Earth Pro 2013) and extends over an approximate distance of 18.5 km, from the Pharos headland to the west all along to Al-Montaza beach to the east. It is divided into 7 distinct zones, with the AID summary provided under Appendix 2. Alexandria is renowned as being Egypt's top summer tourist destination, by virtue of its sandy beaches attracting almost 2.5 million tourists annually during summer seasons (El-Raey et al., 1995). While seasonal tourism constitutes a major income source to the Alexandria, the governorate provides nearly 40% of Egypt's industrial output, and is considered as Egypt's main port and second largest city, with a winter population of 4 million and a summer population of about 5 million people (UNESCO, 2003).

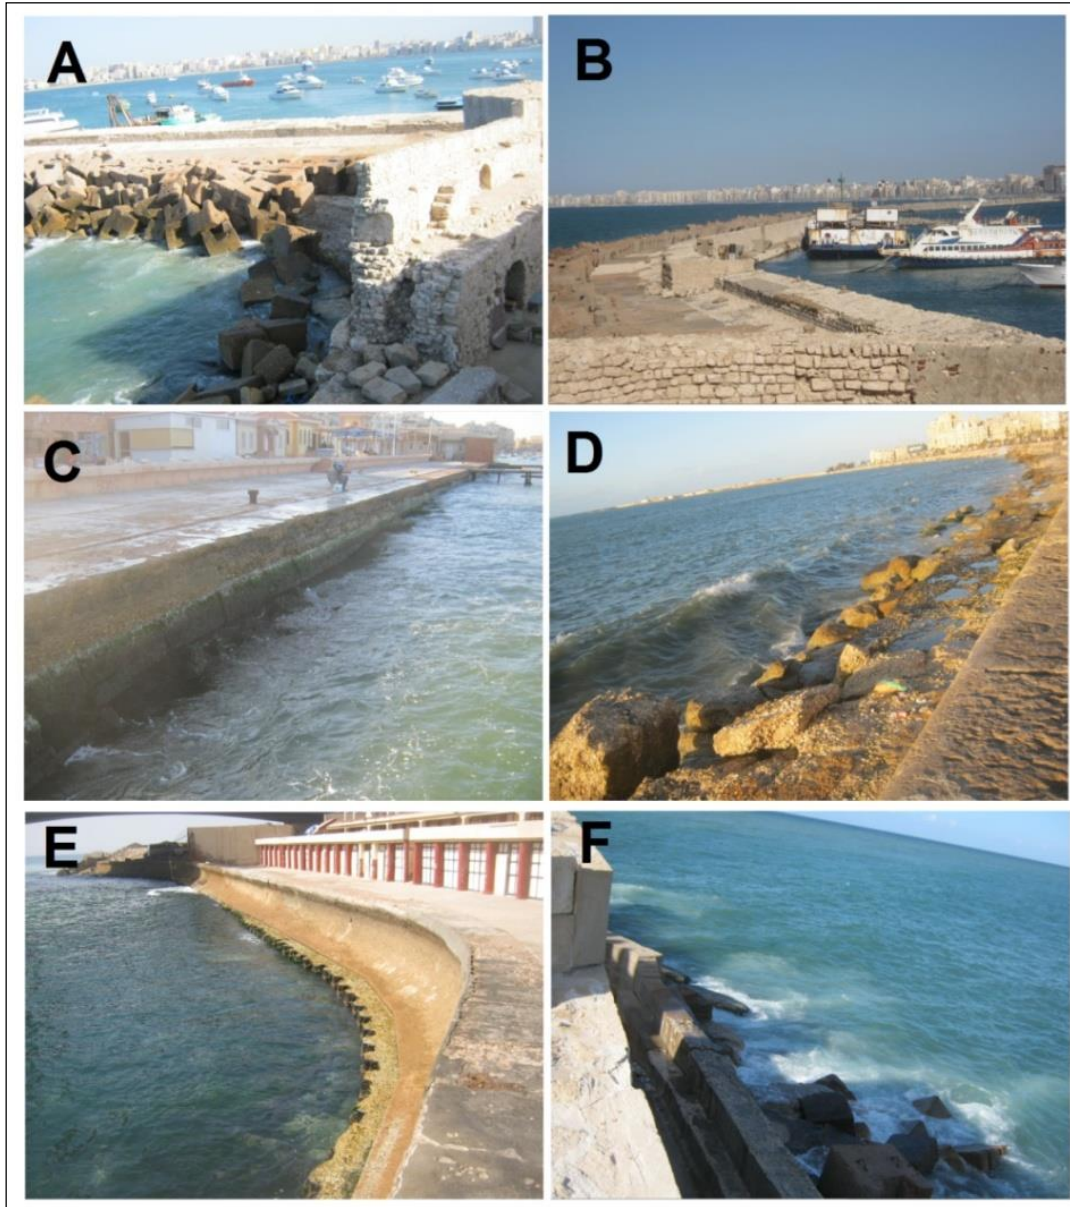
Figure 4-13: Structural inspection of non-rubble and composite structures in year 2013.
